INSPECTION REPORT

For the Property at:
100 N WEST STREET
ANYTOWN, PA

Prepared for: TOM & JANE DOE
Inspection Date: Thursday, April 19, 2007
Prepared by: David Steinman

RE: Report No. 1854, v.4
100 N West Street
Anytown, PA
00001

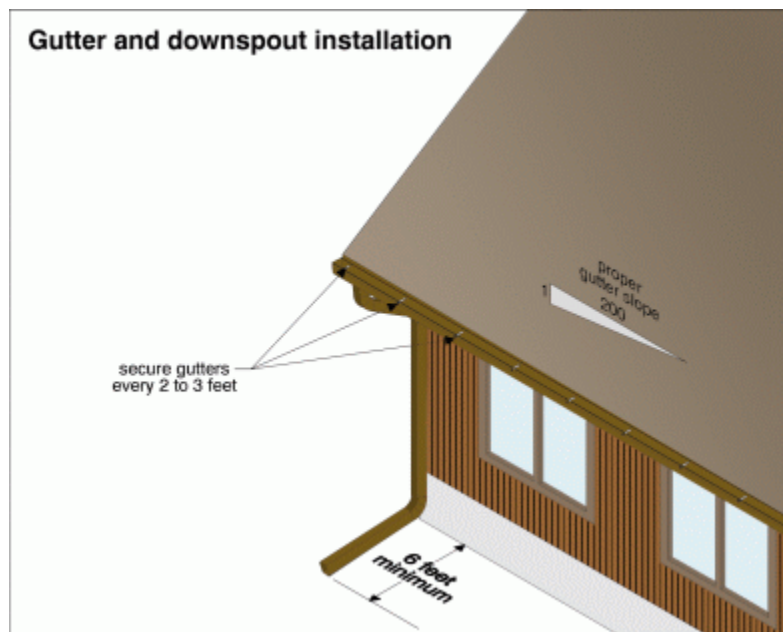
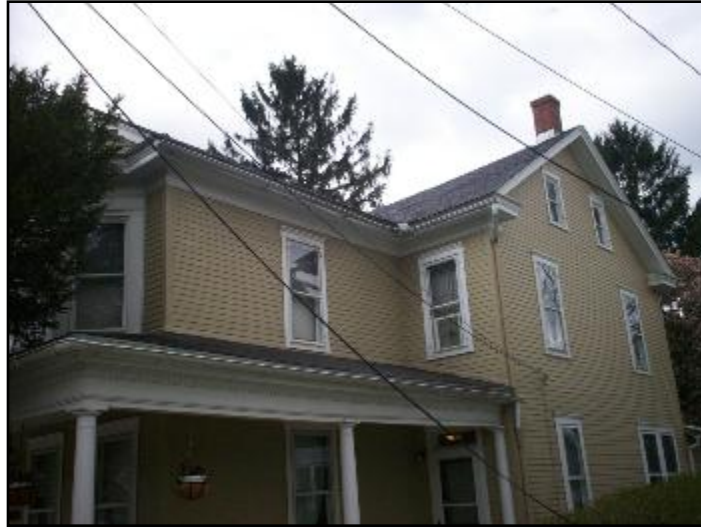
1. Upper gutter inside corner

Condition: • [Improper slope, ponding](#)

Implication(s): Chance of water damage to contents, finishes and/or structure

Location: Right side Second floor

Note: Front inside corner dumping onto porch roof

Task: Repair

Time: Immediate

Cost: \$200 - \$300

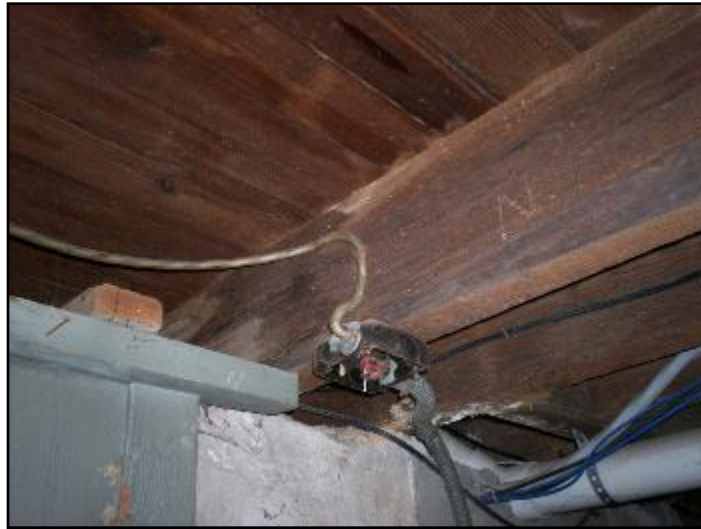
5.

Condition: • [Cover loose or missing](#)

Implication(s): Electric shock | Fire hazard

Location: Left side Basement

Task: Provide

Time: Immediate

Cost: Minor

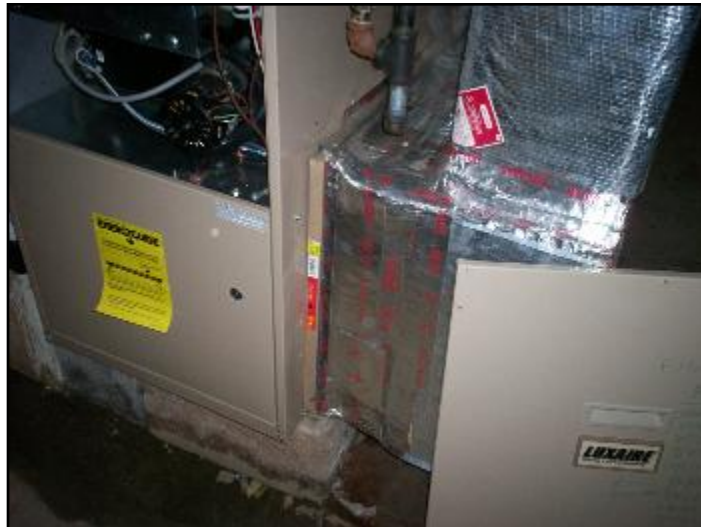
6.

Condition: • Filter cap missing

Location: Right side

Task: Provide

Time: Immediate

Cost: Minor

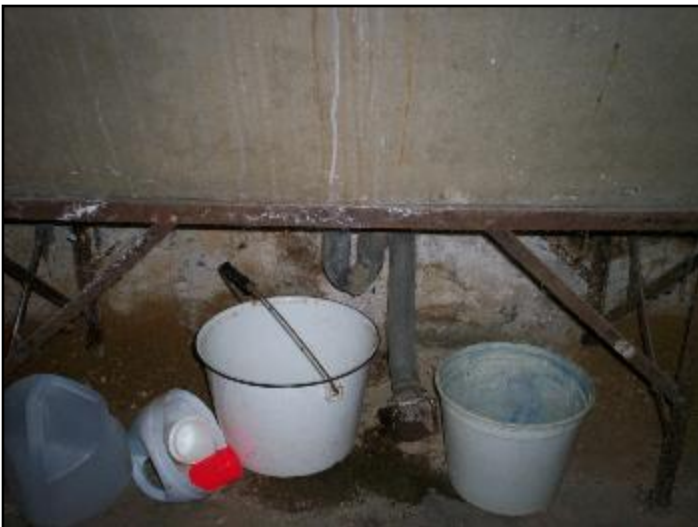
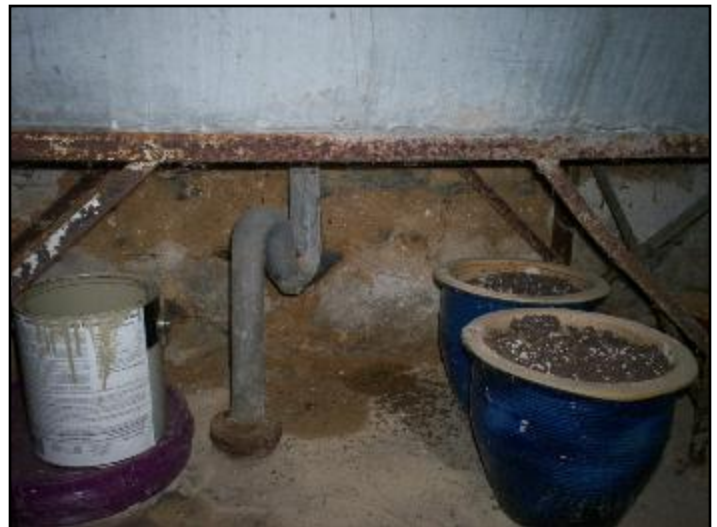
Condition: • [Leak](#)

Implication(s): Chance of water damage to contents, finishes and/or structure | Sewage entering the house

Location: Basement

Note: Two utility sink shells

Task: Replace

Time: Discretionary

Cost: \$300 - \$600 each sink

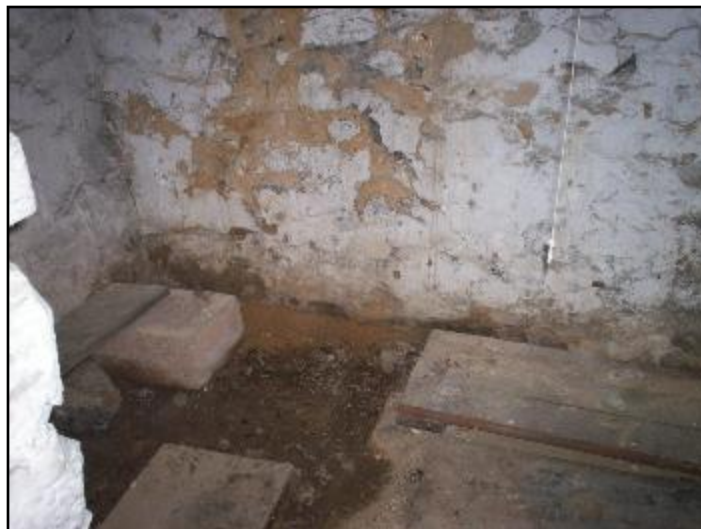
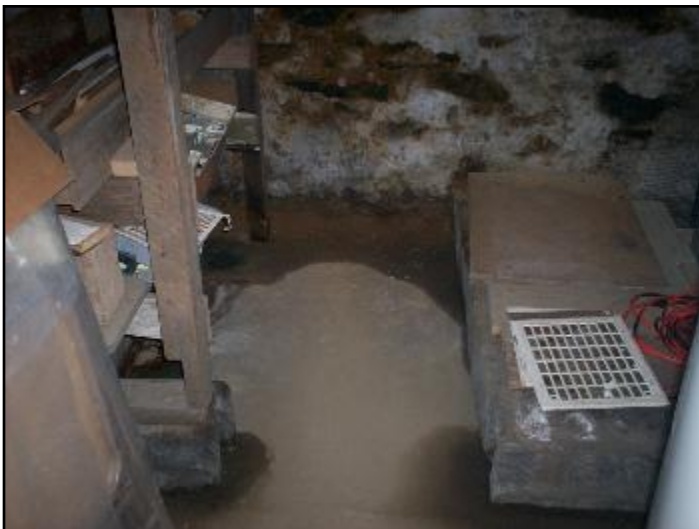
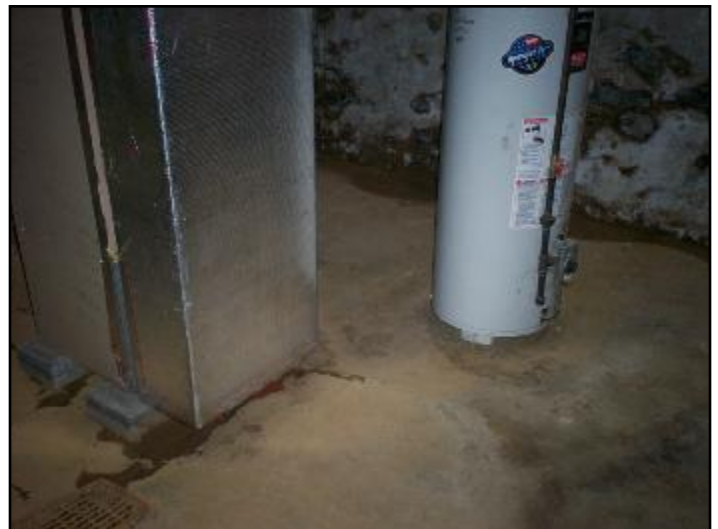
Evidence of basement leakage:

- Efflorescence
- Stains
- Dampness

• Water

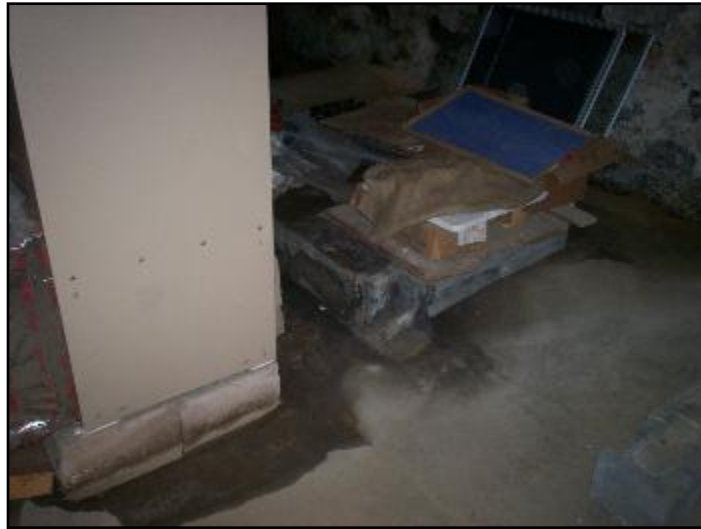
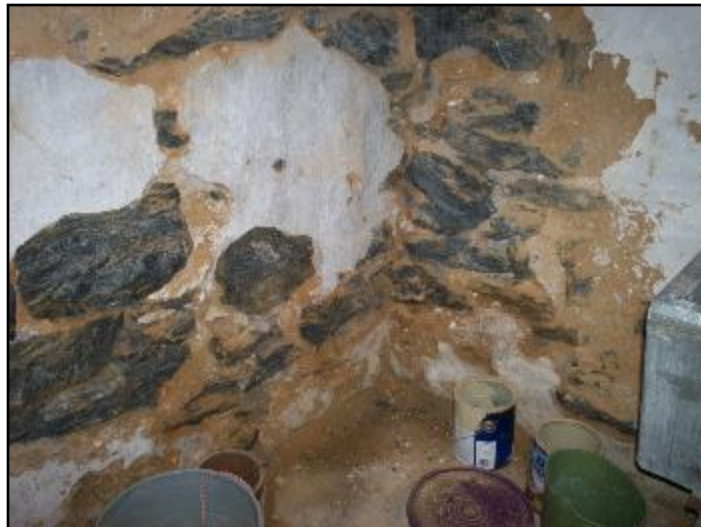
- Loose concrete or mortar

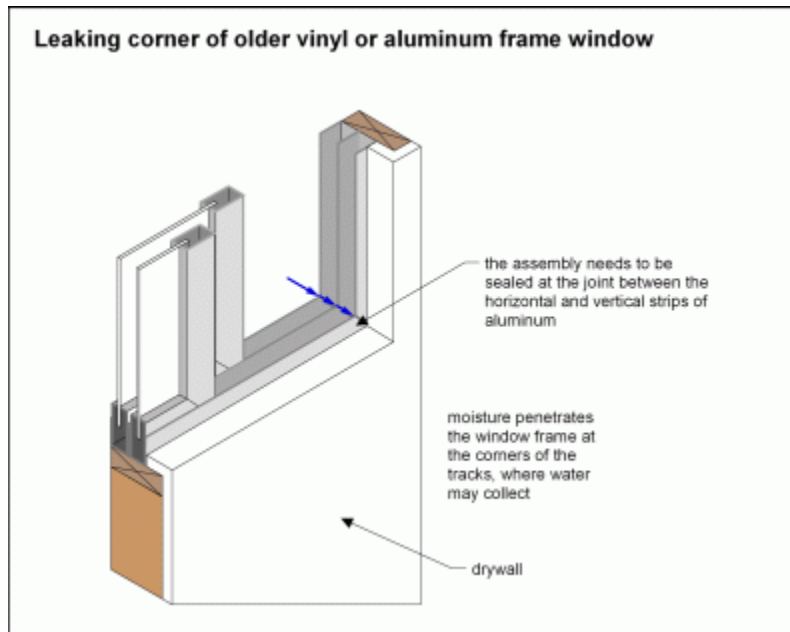
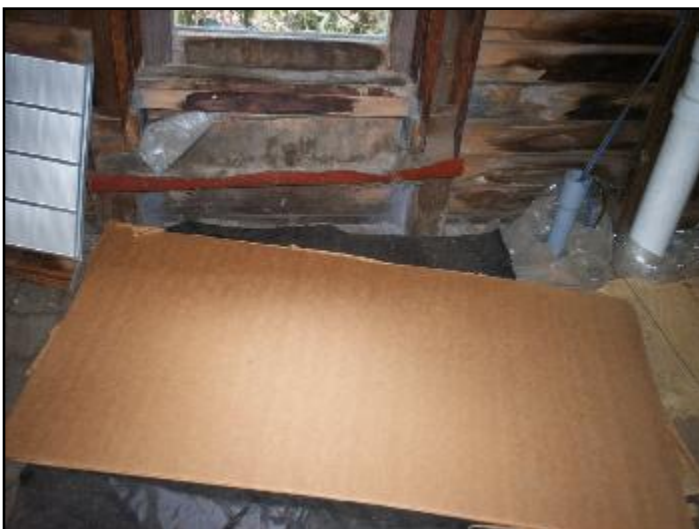
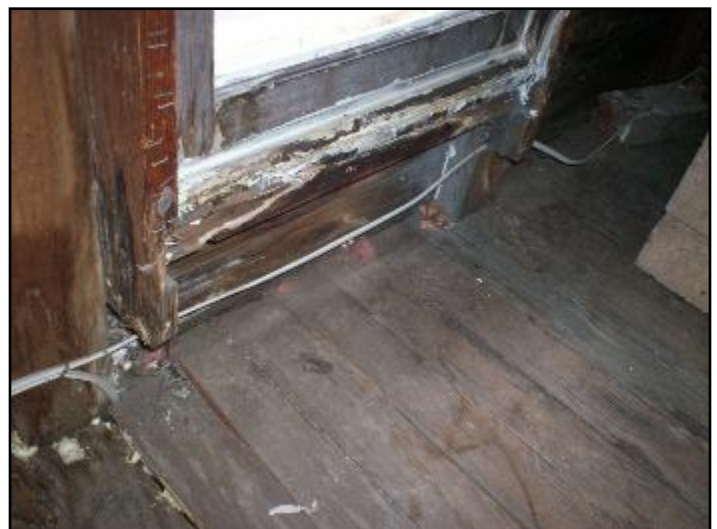
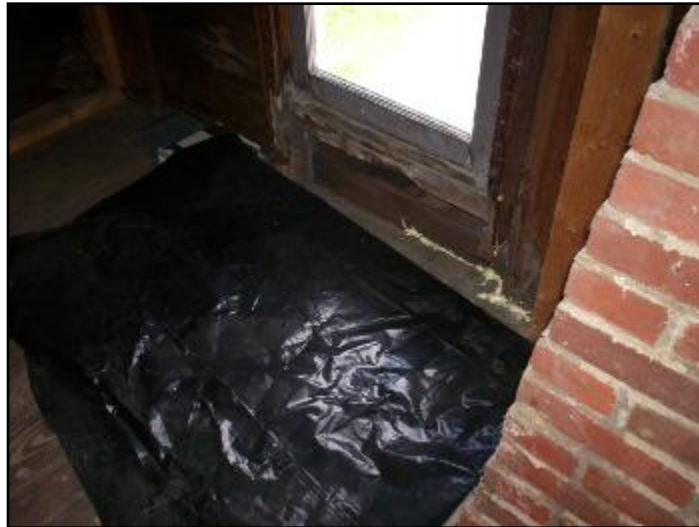
Condition: • [Water leaks](#)

Implication(s): Chance of damage to finishes and structure | Chance of damage to structure

Location: Attic

Note: Eight windows

Task: Replace

Time: Immediate

Cost: \$2,500 - \$4,000
