INSPECTION REPORT

For the Property at:
2720 NE SKIDMORE ST
PORTLAND, OR 97211

Prepared for: PETE DAVIS
Inspection Date: Tuesday, November 18, 2014
Prepared by: Shelter Home Inspection

RE: Report No. 1008
2720 NE Skidmore St
Portland, OR
97211

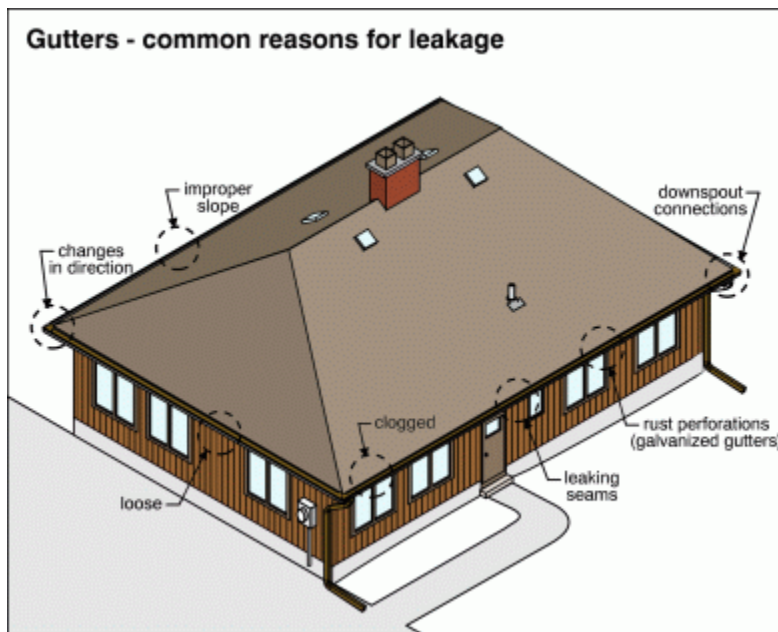
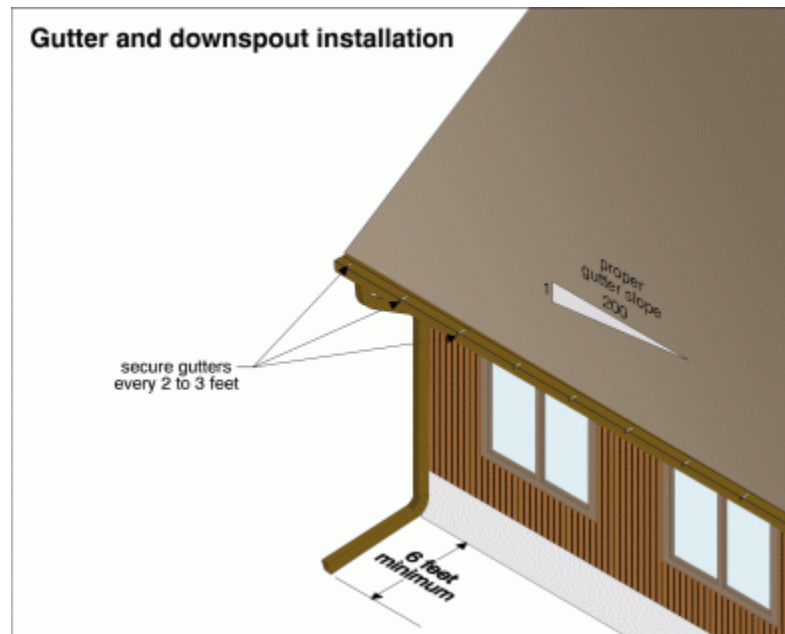
2. Condition: • [Improper slope, ponding](#)

Implication(s): Chance of water damage to contents, finishes and/or structure

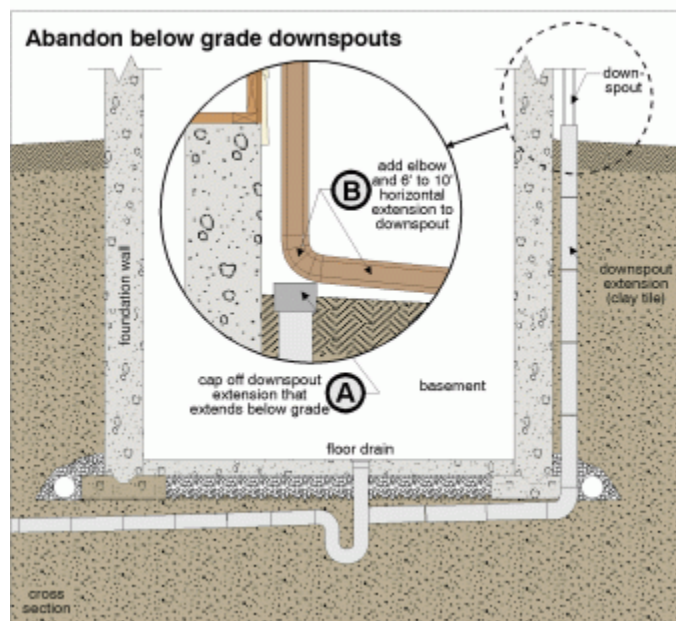
3. Condition: • [Downspouts discharging below grade](#)

Implication(s): Chance of water damage to contents, finishes and/or structure

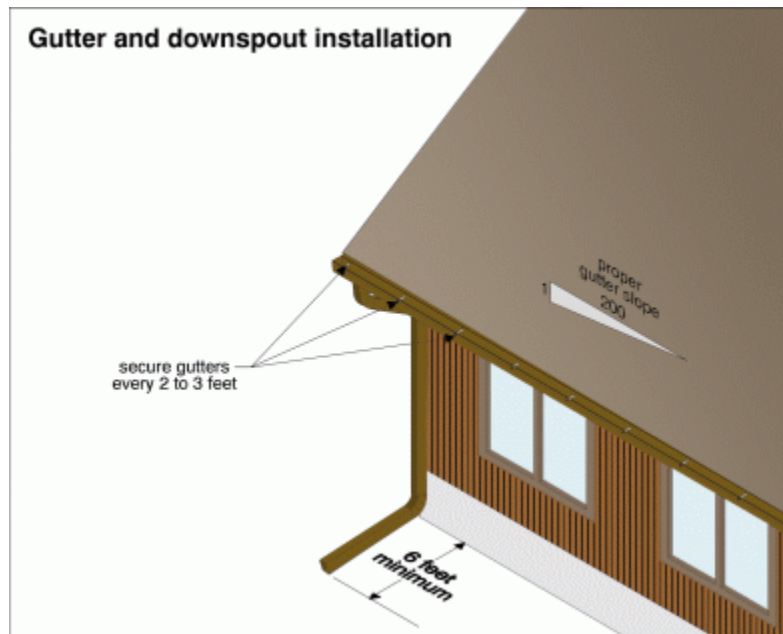
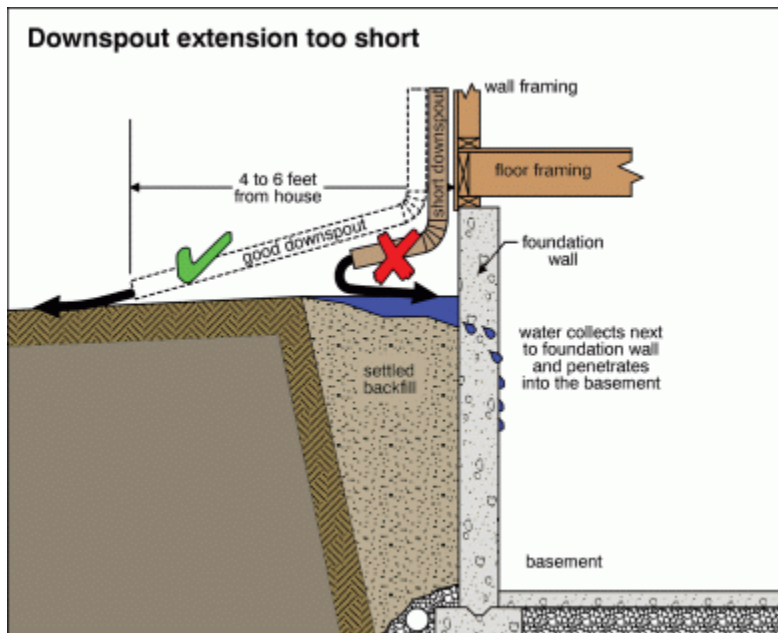
4. Condition: • [Downspouts end too close to building](#)

Implication(s): Chance of water damage to contents, finishes and/or structure

Downspout extension too short

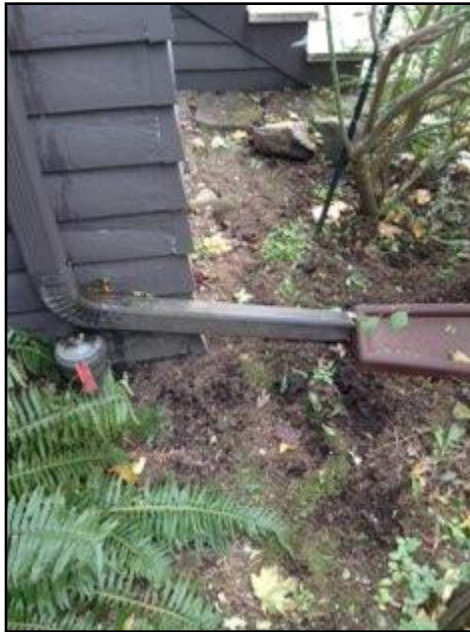
1. Downspouts end too close to building

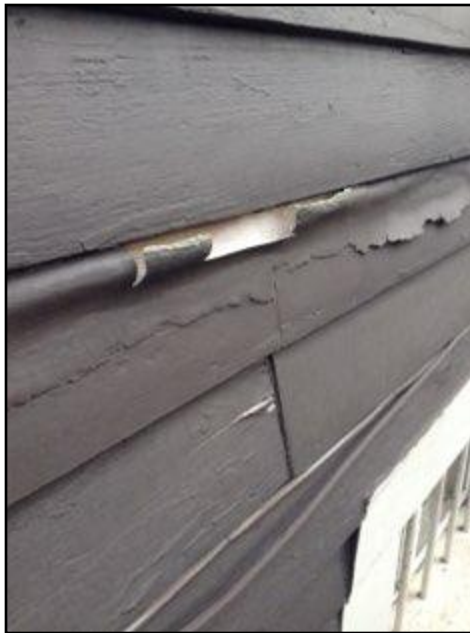
5. Condition: • [Paint or stain - needed](#)

Implication(s): Shortened life expectancy of material

2. Paint or stain - needed

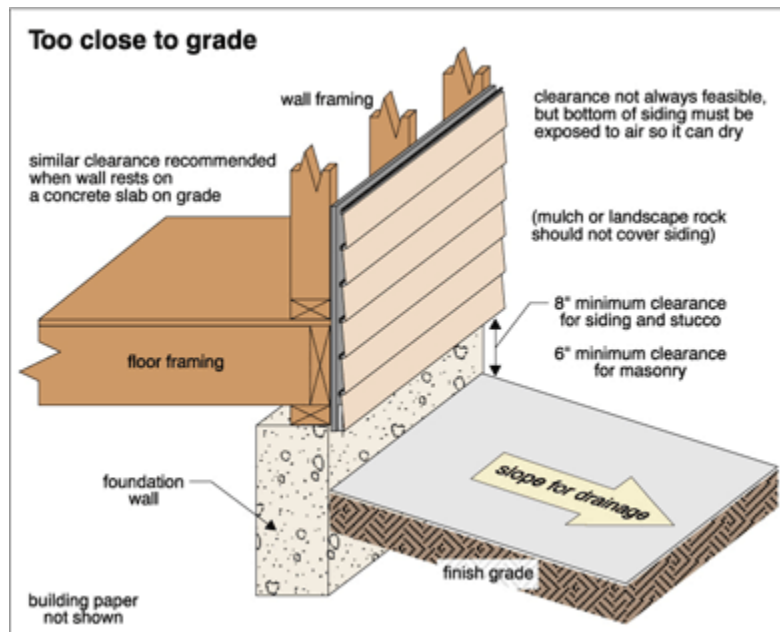
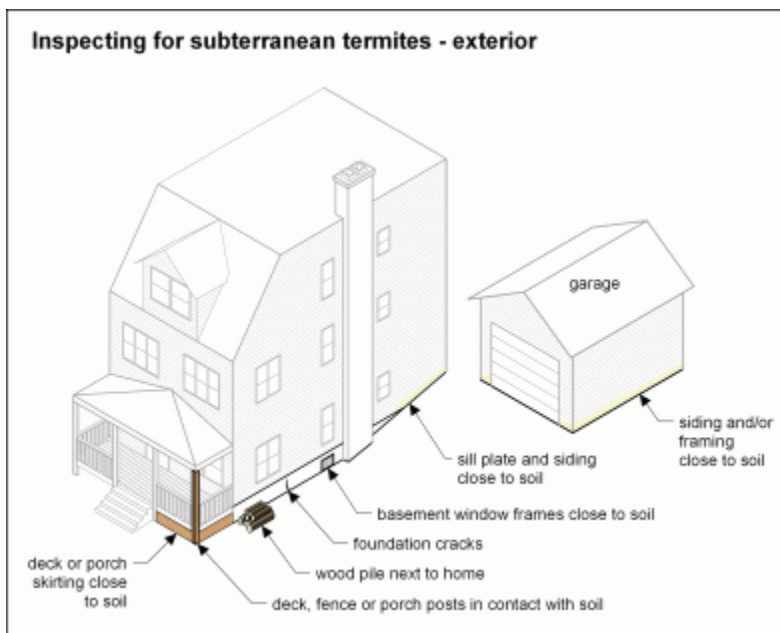
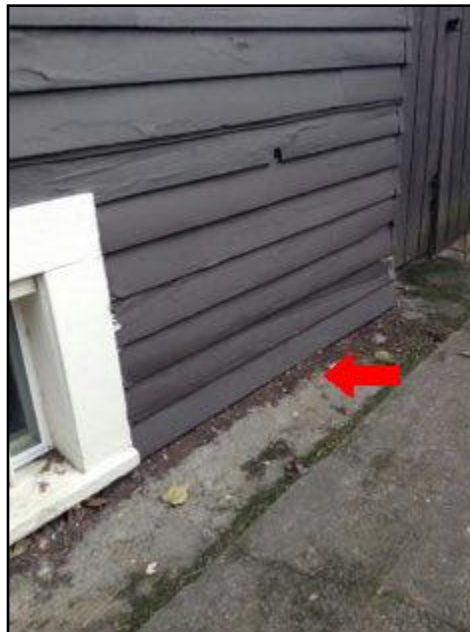
6. Condition: • [Too close to grade](#)

Implication(s): Chance of water damage to contents, finishes and/or structure | Material deterioration | Rot | Insect damage

3. Too close to grade

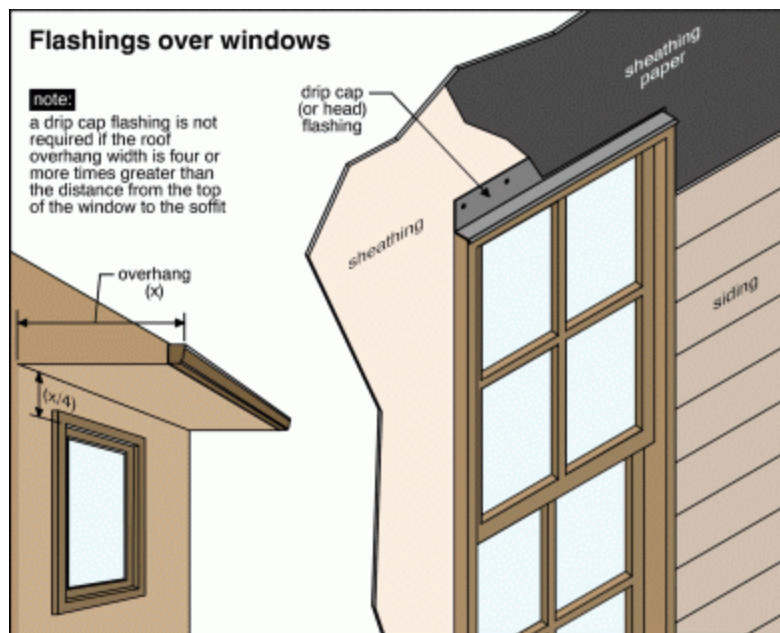
7. Condition: • [Missing](#)

Implication(s): Chance of water damage to contents, finishes and/or structure

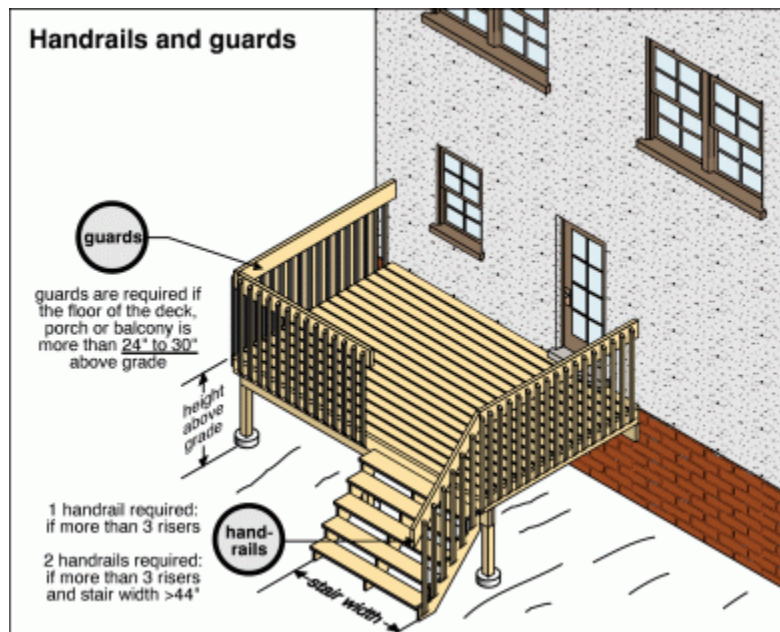
10. Condition: • [Missing](#)

Implication(s): Fall hazard

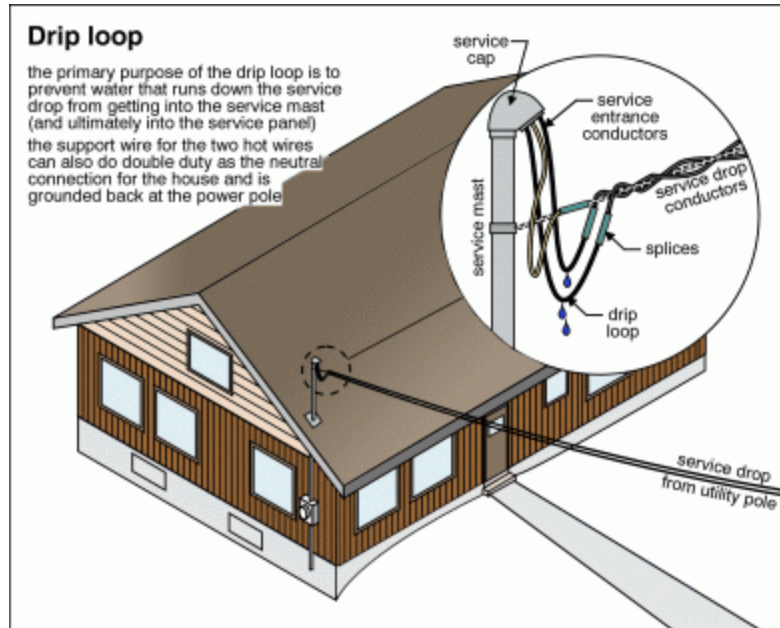
13. Condition: • [No drip loop](#)

Implication(s): Shock hazard or interruption of electrical service

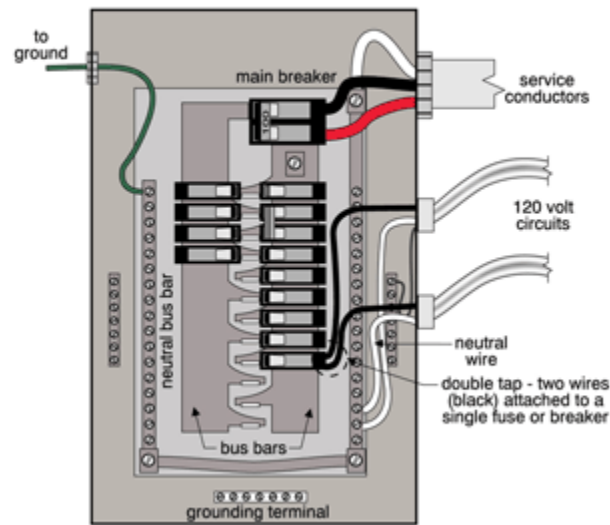
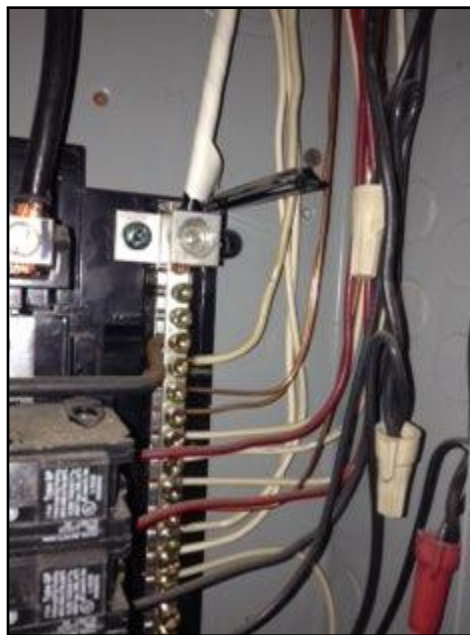
16. Condition: • [Double taps](#)

Implication(s): Fire hazard

8. Double taps

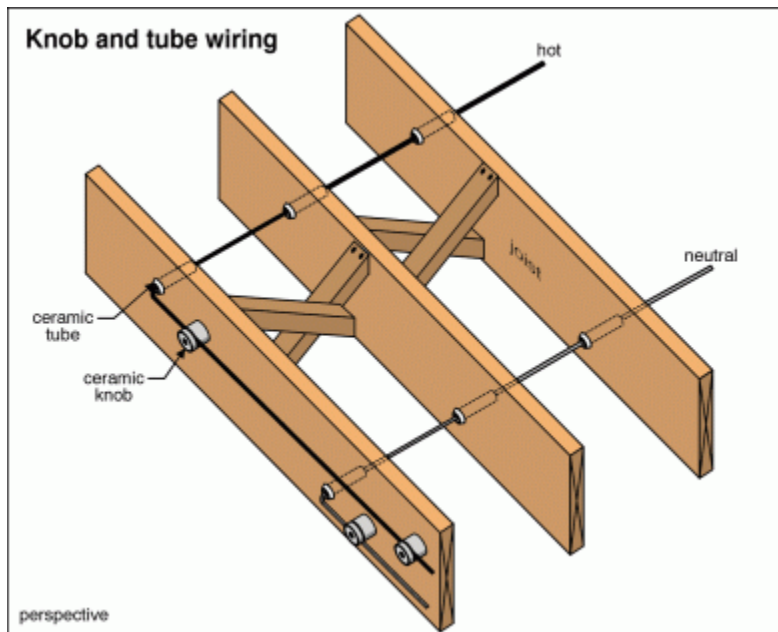
17. Condition: • [Replace when renovating](#)

Implication(s): Nuisance | Potential problem when obtaining home insurance

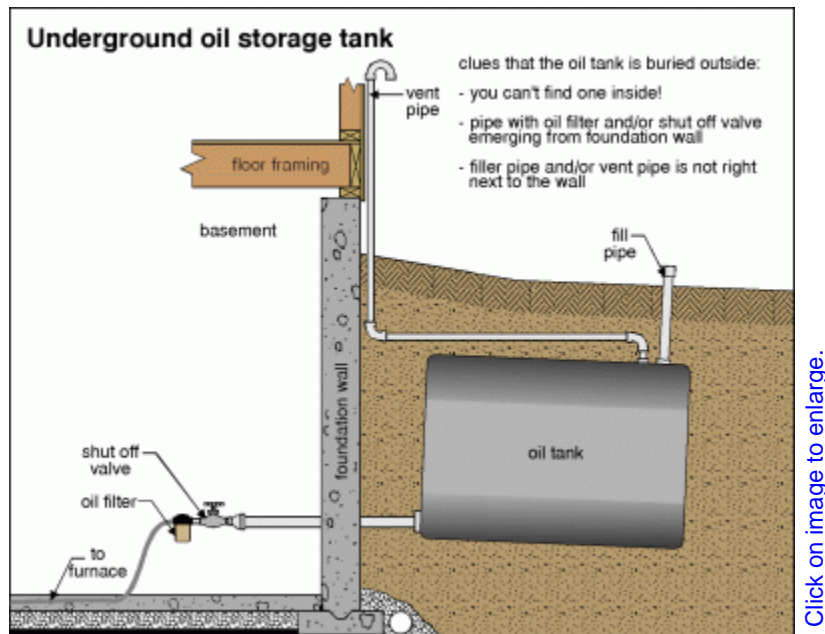
19. Condition: • [Old](#)

Implication(s): Equipment failure | No heat for building

21. Condition: • [Underground](#)

Implication(s): Leakage | Environmental contamination

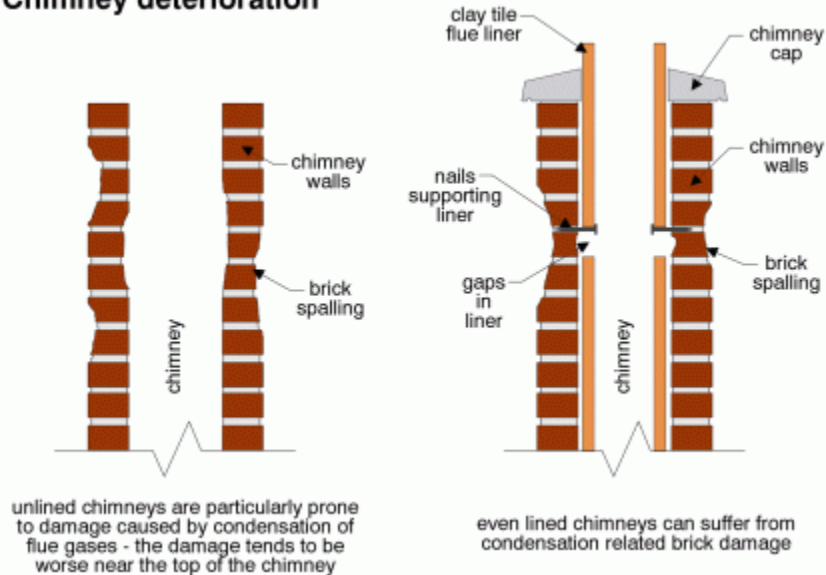
25. Condition: • [Spalling](#)

Mortar spalling around bricks just under the roofline

Implication(s): Material deterioration

Chimney deterioration

Task: Further evaluation

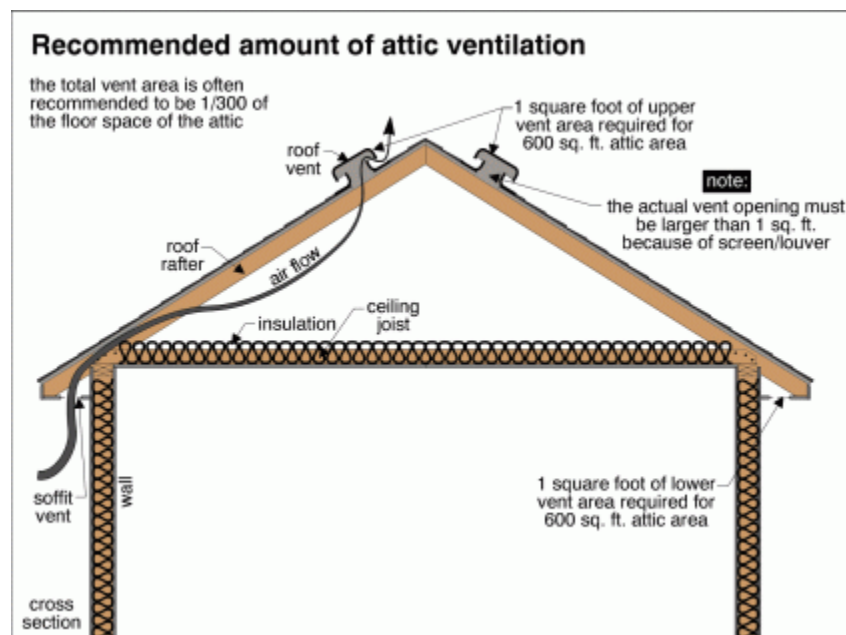
30. Condition: • [Inadequate](#)

Implication(s): Chance of condensation damage to finishes and/or structure

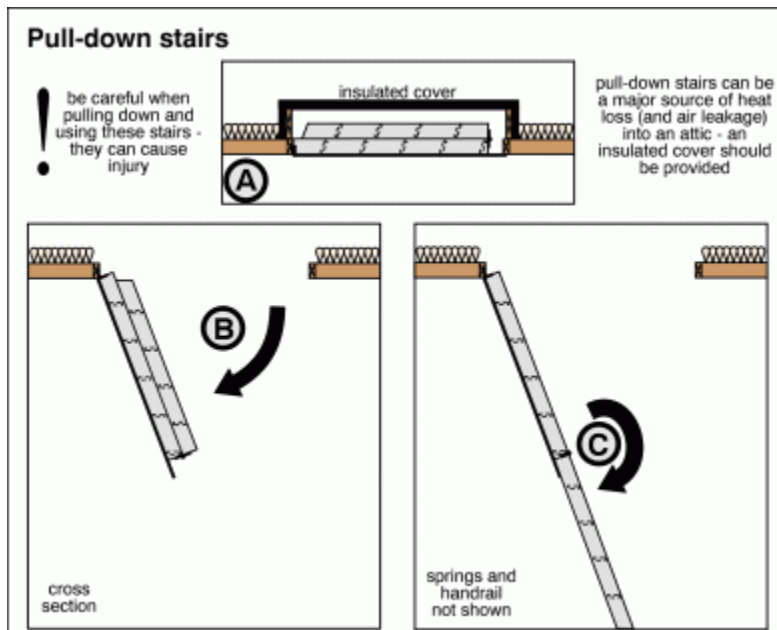
31. Condition: • [Unsafe to climb](#)

Attic ladder does not reach the floor. it is unsafe to climb

Implication(s): Physical injury

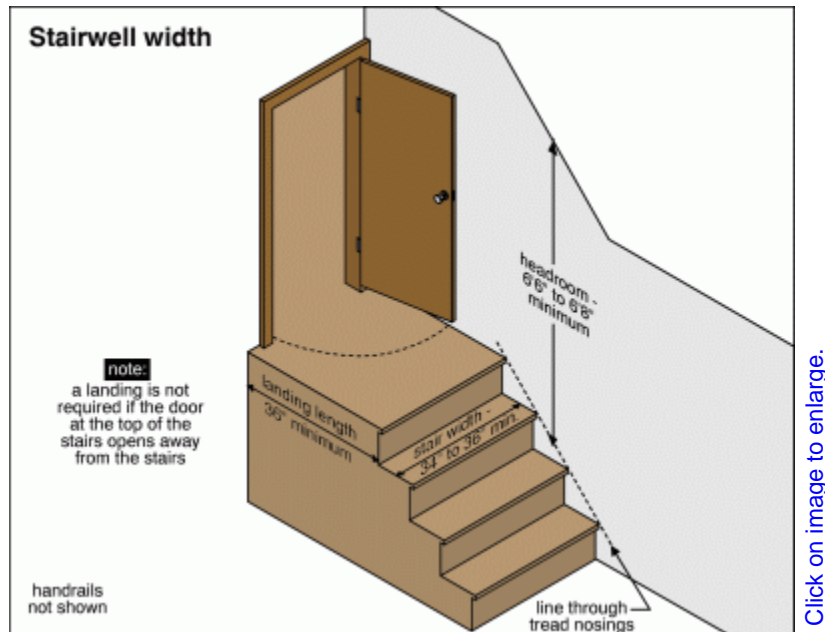
40. Condition: • [Too narrow](#)

Stairs narrow from kitchen to basement

Implication(s): Physical injury
