YOUR INSPECTION REPORT

321 Home Inspection Blvd.
Fresno, CA 93711

Sunday, November 25, 2012

RE: Report No. 1284, v.3
321 Home Inspection Blvd.
Fresno, CA
93711

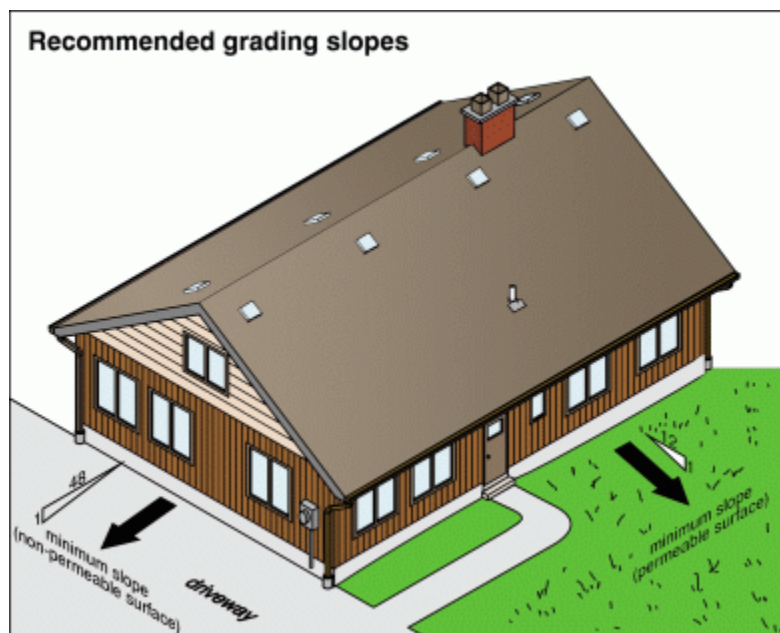
2. Condition: • [Improper slope](#)

Implication(s): Chance of water damage to contents, finishes and/or structure

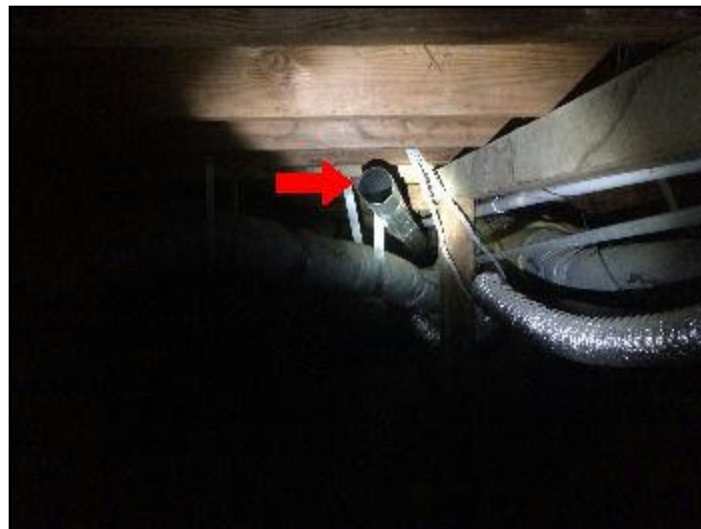
5. Condition: • [Poor slope](#)

Furnace exhaust system is terminating in crawlspace allowing flue gases to enter home. Recommend a qualified HVAC contractor to correct. HAZARD (Dangerous to human life)

Implication(s): Equipment not operating properly | Hazardous combustion products entering home

1. Poor slope / terminating in crawlspace

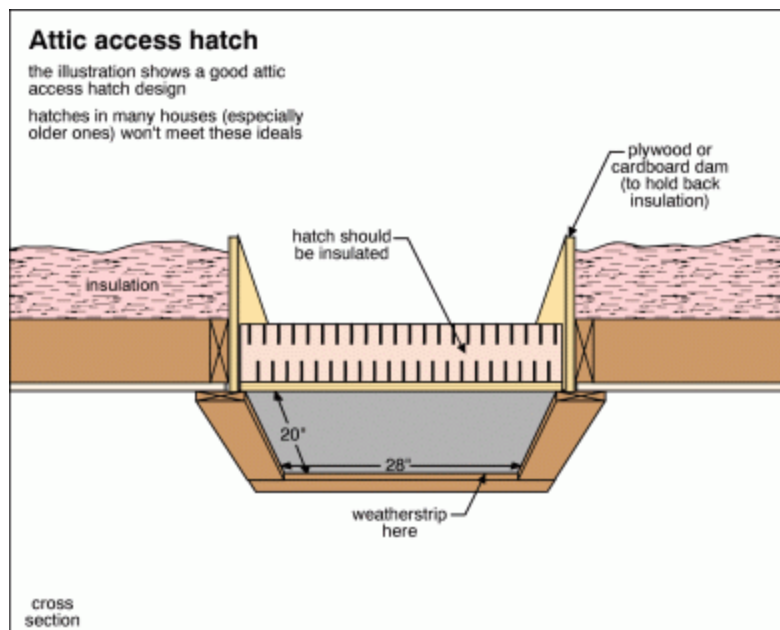
7. Condition: • [Not insulated and not weatherstripped](#)

Implication(s): Chance of condensation damage to finishes and/or structure | Increased heating and cooling costs | Reduced comfort

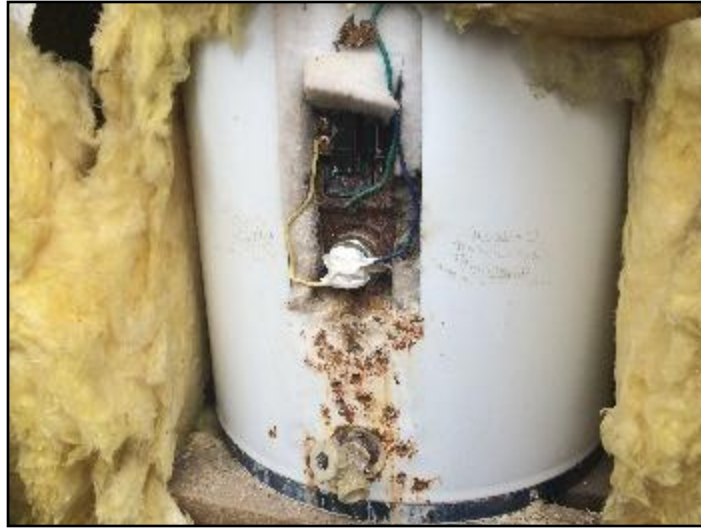
9. Condition: • Evidence of leaking at bottom element

Evidence of leaking at bottom elements. Recommend further evaluation by a qualified contractor.

2. Evidence of leaking at bottom element

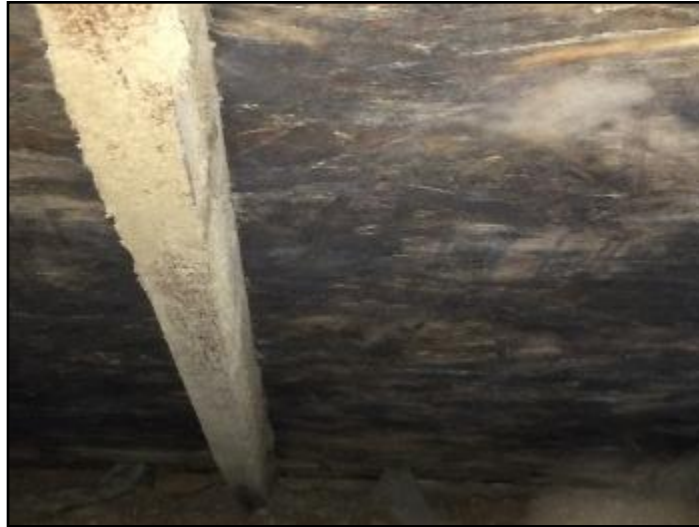
11. Condition: • Stains

Suspect stains / moisture to underneath of attic roof sheathing. Recommend further evaluation by a qualified contractor..

3. Suspect Stains
