Your Inspection Report

190 Pickering St
Toronto, ON

PREPARED BY:
Walter Collodel, P.Eng.

RE: Report No. 28570
190 Pickering St
Toronto, ON

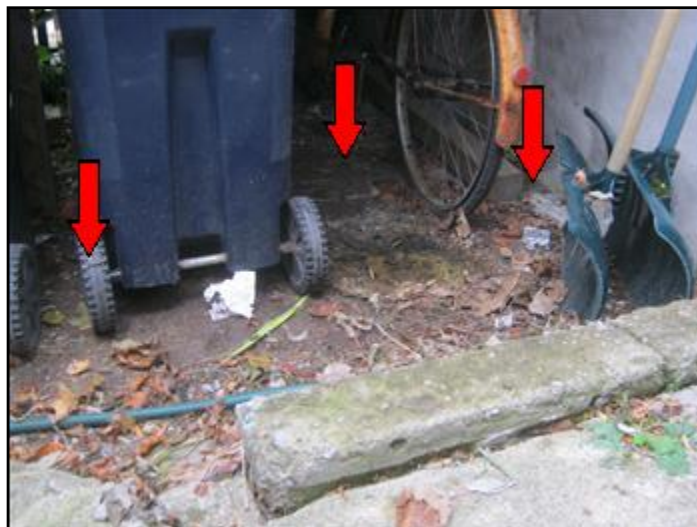
Condition: • [Low areas](#)

Runoff from walkway can collect in low area under the rear deck. Build up the soil in this area to encourage drainage away from the building.

low area under deck

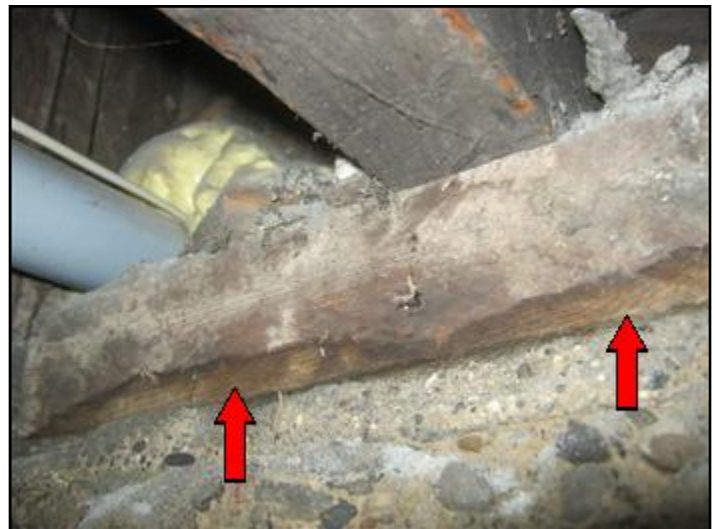
Condition: • [Utility entrances](#)

Seal abandoned opening at wall and caulk around the electrical service conduit. Wind driven rain can be blown into the wall framing in this area under certain conditions.

water stains under service entrance conduit

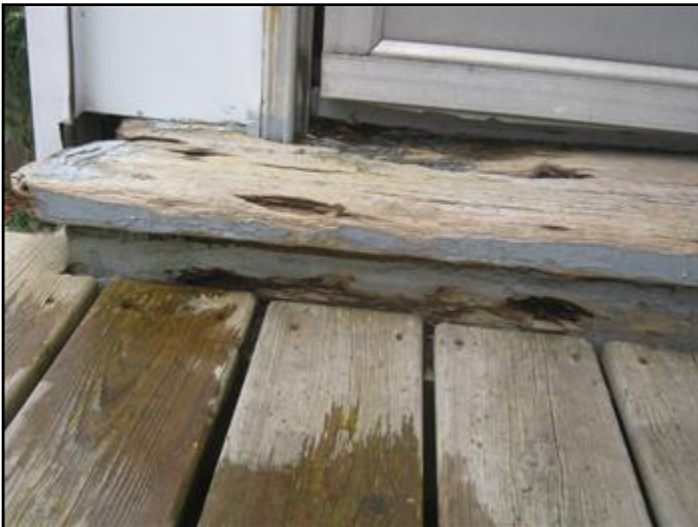
Condition: • [Rot](#)

Covered deck structure has deteriorated over the years. Damaged and rotted wood can be removed and replaced as necessary to keep the structure intact but removal of damaged wood may just uncover more damaged wood.

damage at threshold

Replacement of the deck structure may be needed.

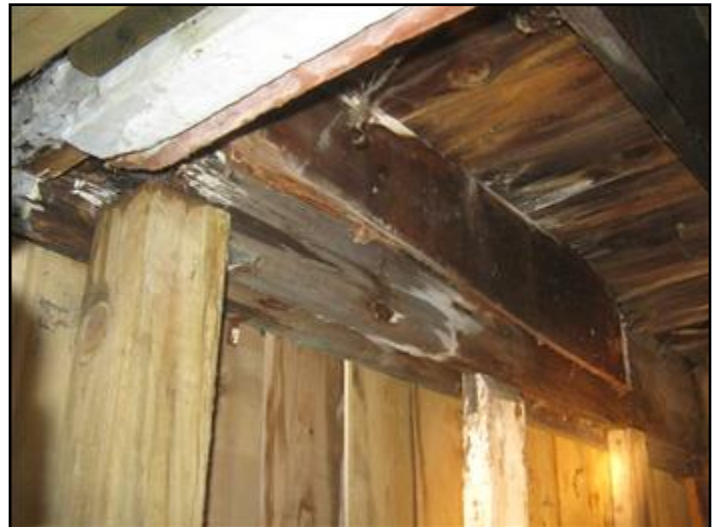
soft, rotted framing under deck

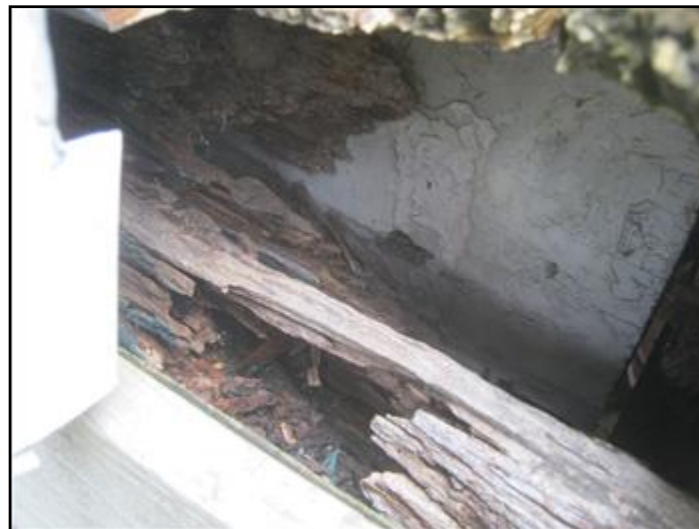
rotted framing

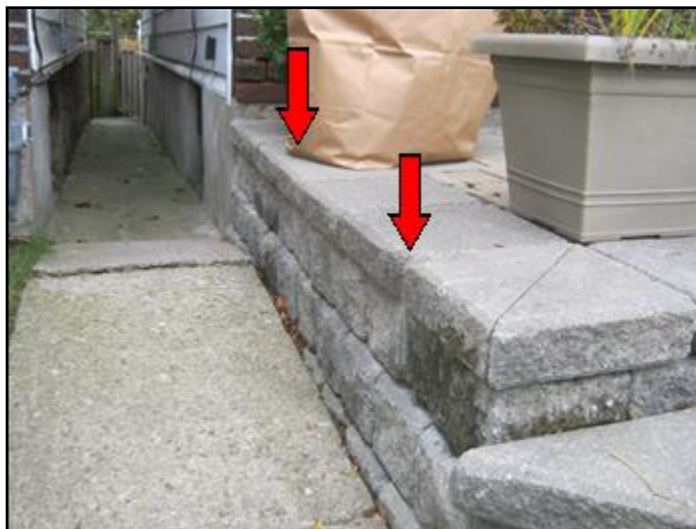
Condition: • [Missing](#)

fall hazard for small children?

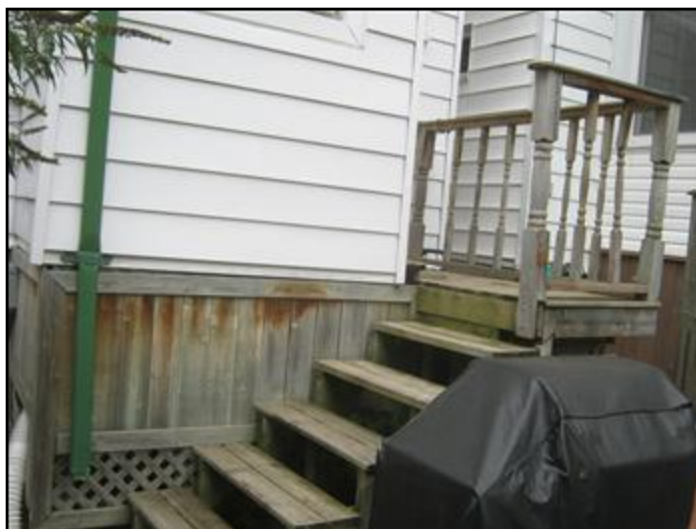
Condition: • [Missing](#)

railing needed at stairs

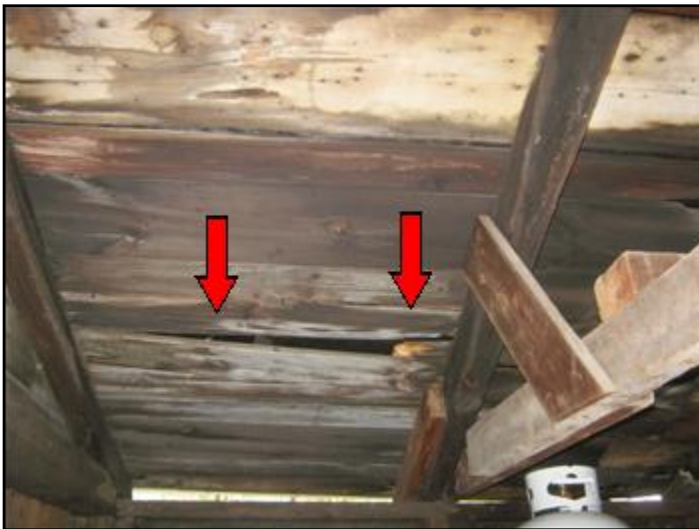
Condition: • [Disrepair](#)

Old wood frame garage has held up over the years but is showing its age as it is starting to sag in the roof. Add lumber to stiffen and reinforce the structure as necessary. Monitor around the base for deterioration as there is a lot of wood/soil contact here.

damage at garage roof sheathing

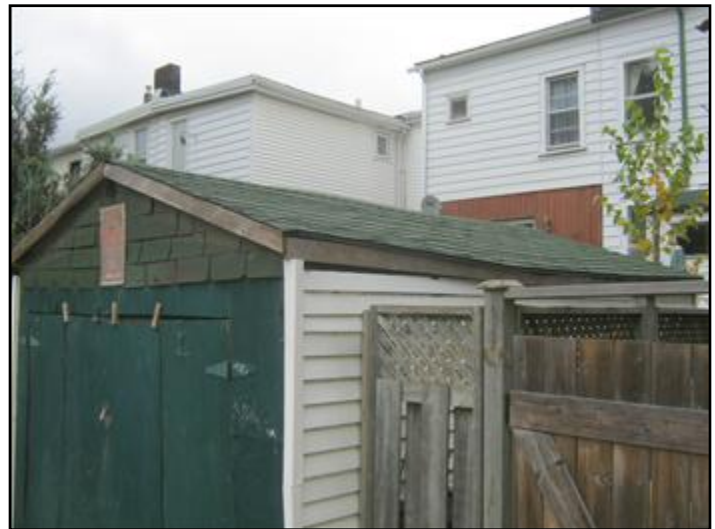
sagging roof

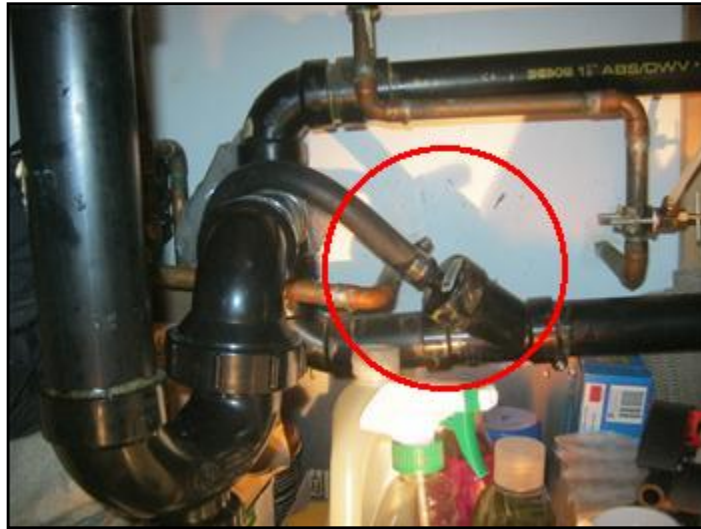
Condition: • Dishwasher drain hose is connected to the wrong side of the drain trap but this has not been a problem in the past. This condition has been present for years.

connection on wrong side of trap

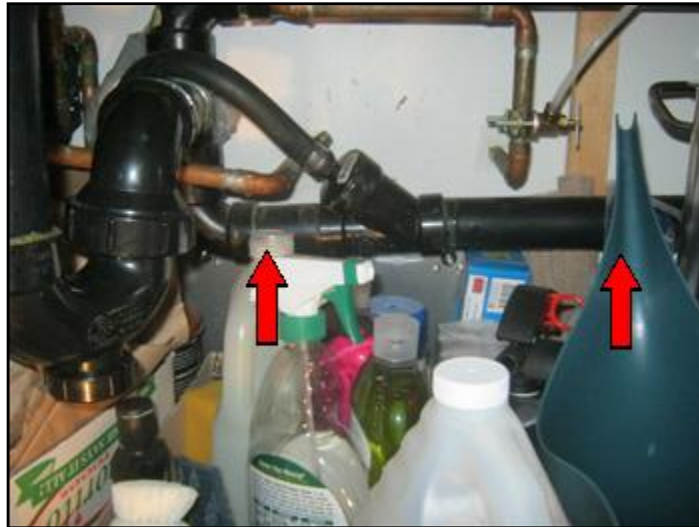
Condition: • [Slope improper](#)

pipe slopes slightly upwards

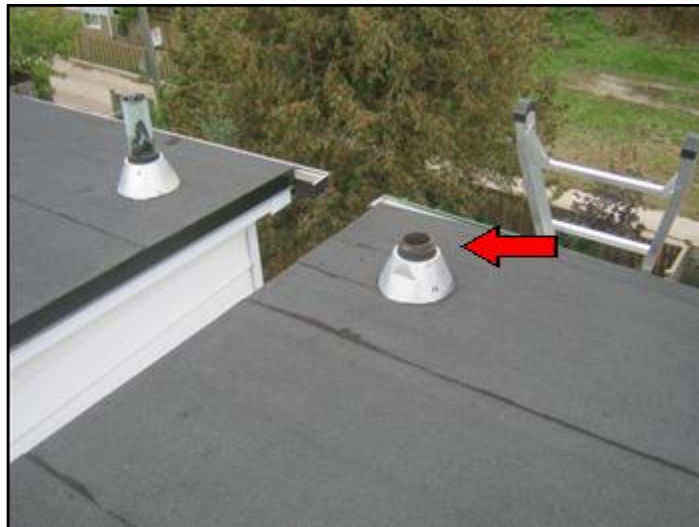
Condition: • [Height above roof not adequate \(risk of obstruction\)](#)

plumbing stack is short

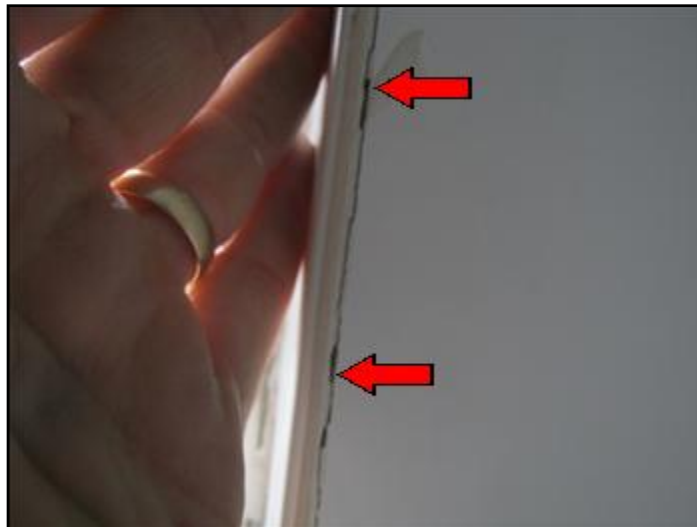
Condition: • [Caulking and grout deteriorated/missing](#)

cracked grout at window frame

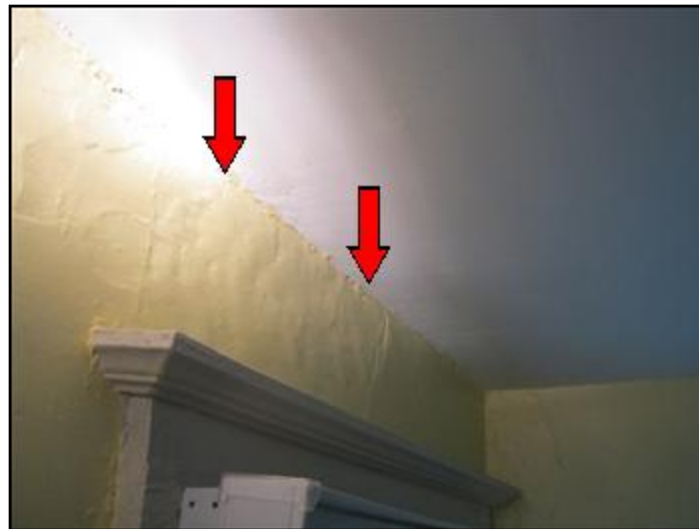
Condition: • Patched - Dry when tested at inspection

old repair noted above window

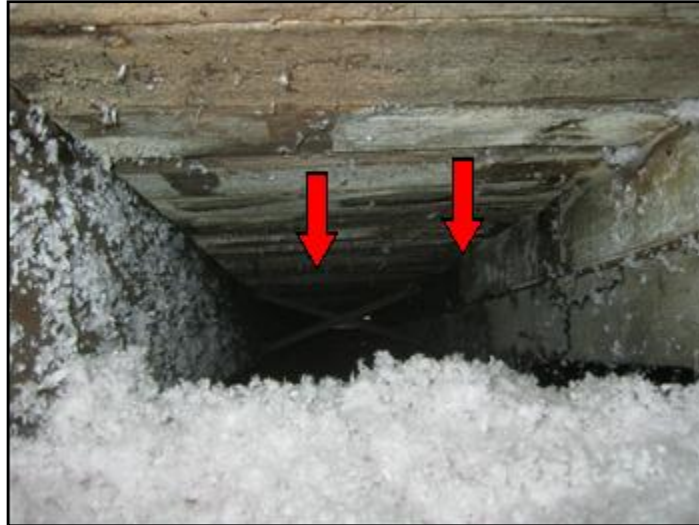
Condition: • [Missing \(cost to add may be \\$4000-\\$8000\)](#)

no party wall between attic spaces
