Your Inspection Report

4321 Any Street
Lower Mainland, BC

Thursday, March 21, 2013

RE: Report No. 1632, v.6
4321 Any Street
Lower Mainland, BC

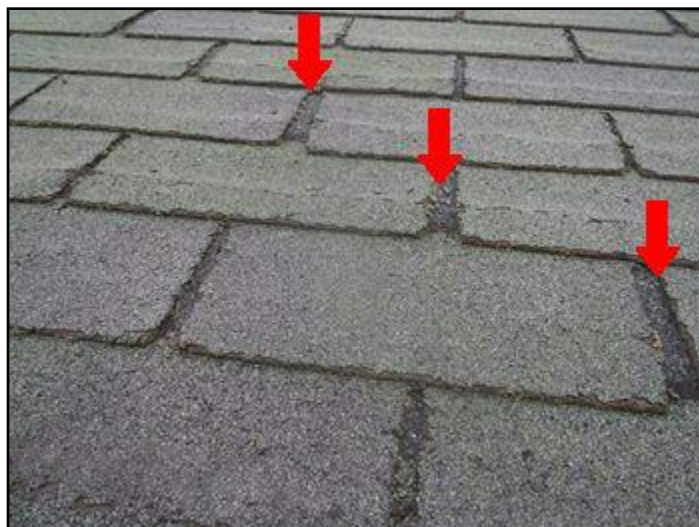
2. Condition: • [Slots wide](#)

Implication(s): Chance of water damage to contents, finishes and/or structure

Location: Various Exterior Roof

Task: Replace

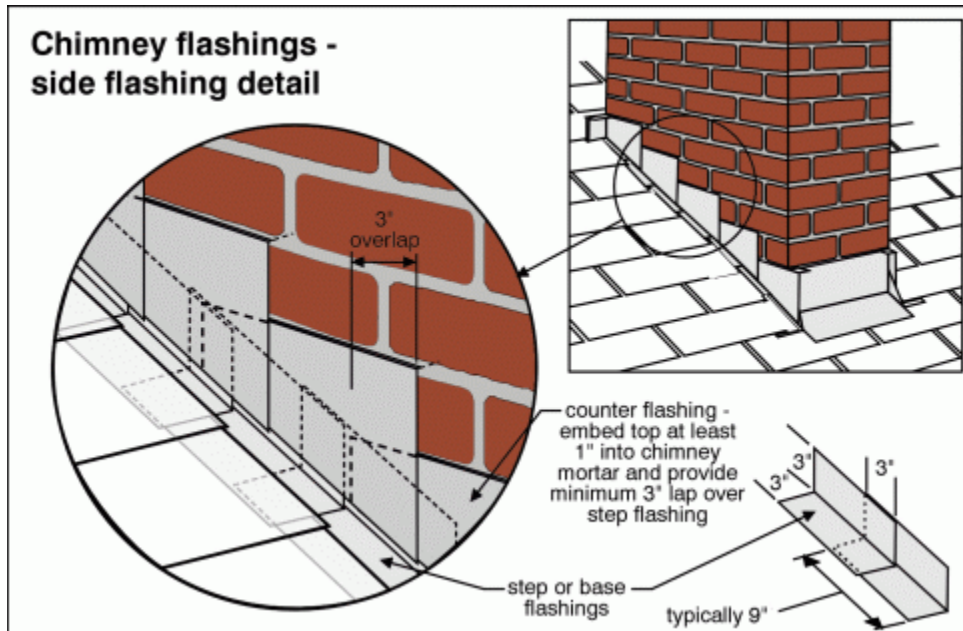
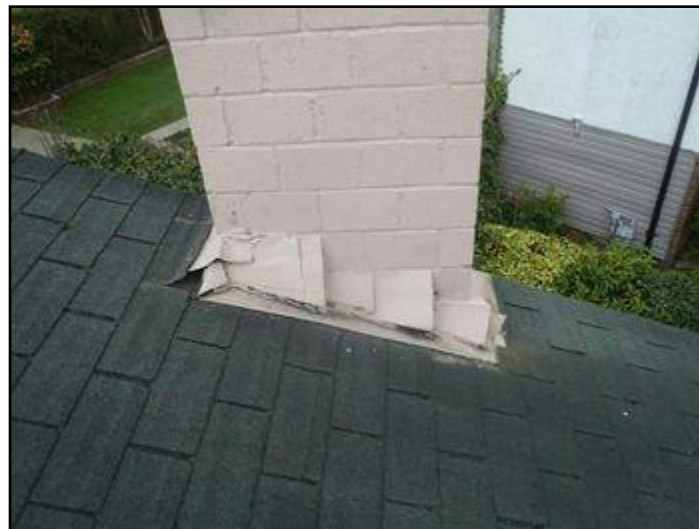
3. Condition: • [Overlap inadequate on base or cap flashings](#)

Poor flashing detail, we recommend that you improve when re-roofing.

Implication(s): Chance of water damage to contents, finishes and/or structure

Location: West Exterior

Task: Repair

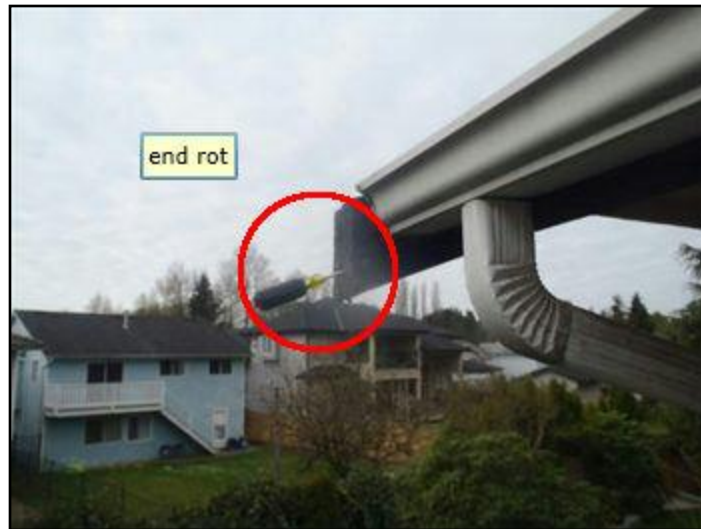
5. Condition: • [Rot or insect damage](#)

We noted end rot on various fascia boards

Implication(s): Cosmetic defects | Chance of water damage to contents, finishes and/or structure | Material deterioration

Location: Various Exterior

Task: Repair or Replace

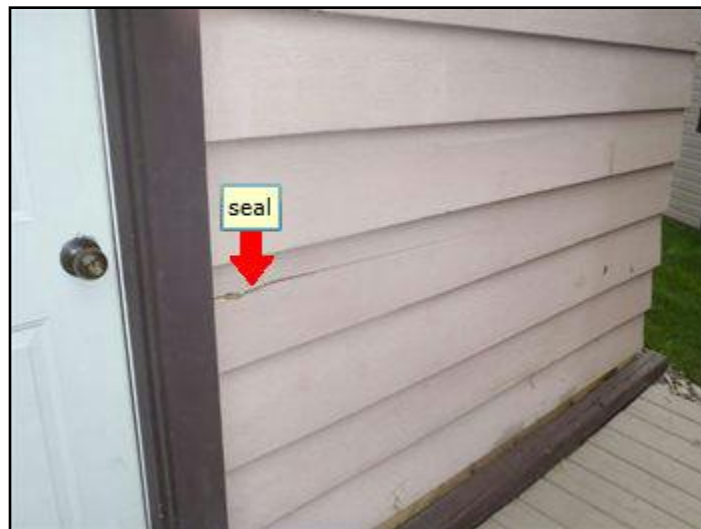
6. Condition: • [Cracked, split or broken](#)

We noted that there were a few boards that have split typical for the age. Sealing the cracks will help reduce the chance of water ingress.

Location: Various Exterior

Task: Repair

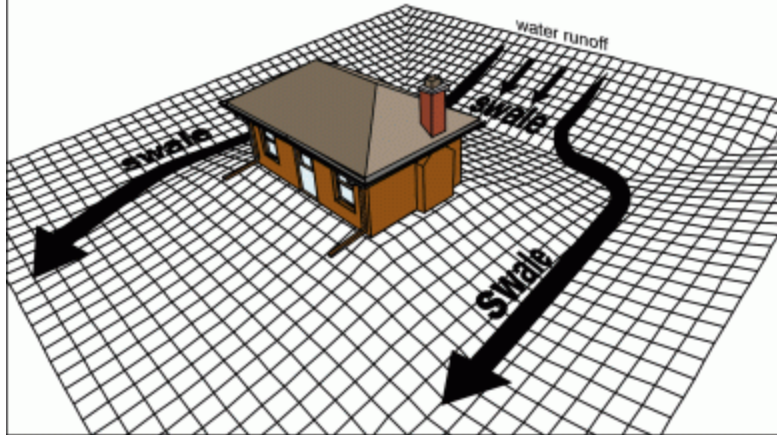
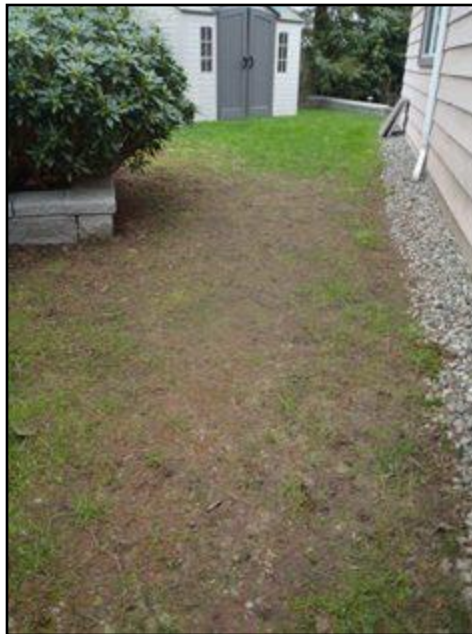
7. Condition: • [Improper slope](#)

There is no slope in the yard and pooling water could be an issue.

Implication(s): Chance of water damage to contents, finishes and/or structure

Location: East Exterior

Task: Improve

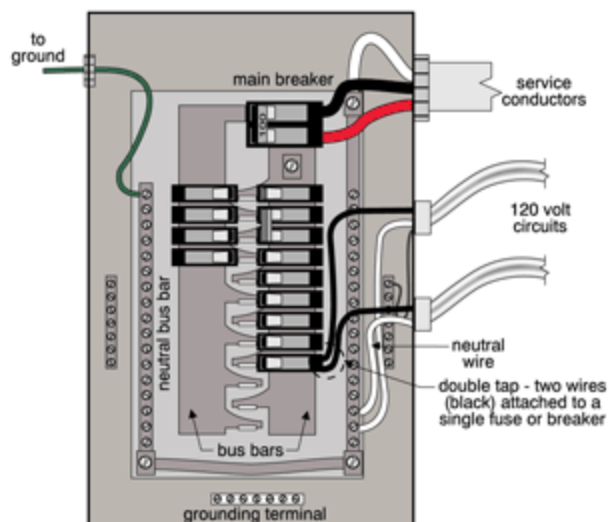
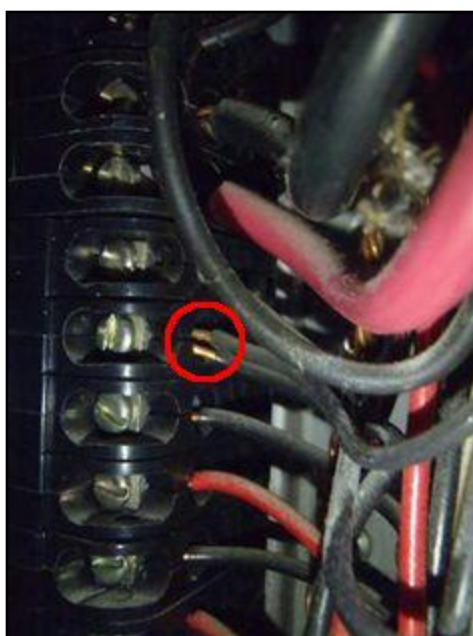
Double tapping (double lugging)

9. Condition: • [Double taps](#)

Implication(s): Fire hazard

Location: Northwest Basement

It is recommend that you bring in an electrician to repair the condition

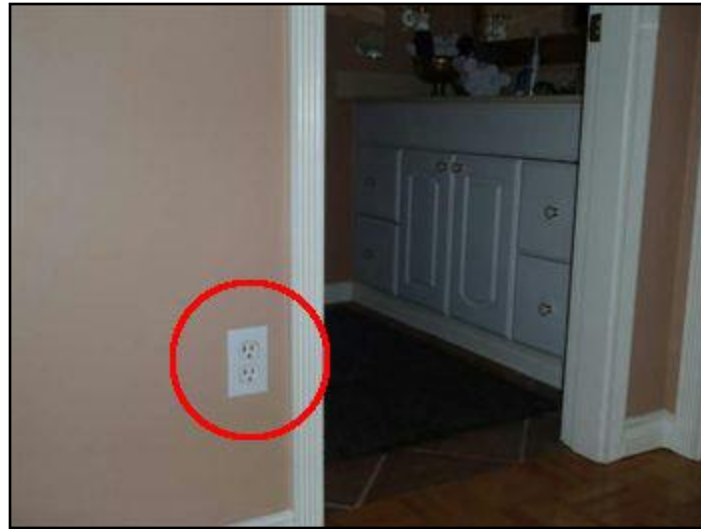
10. Condition: • [Loose](#)

Implication(s): Electric shock | Fire hazard

Location: Third Floor Hall

Task: Repair

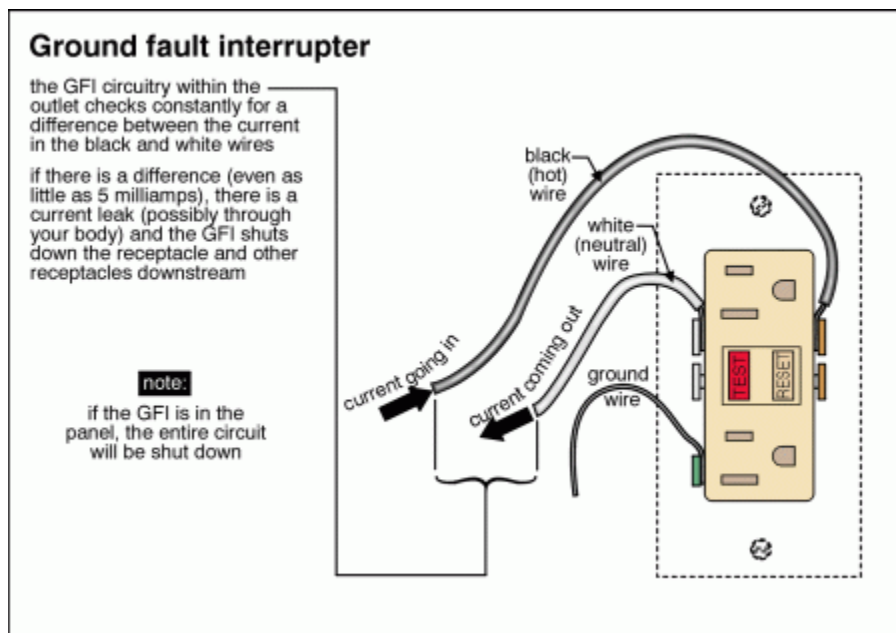
11. Condition: • [Ground Fault Interrupter \(GFI\) needed](#)

Implication(s): Electric shock

Location: West Exterior

It is recommended that all outdoor receptacles be protected by a GFCI.

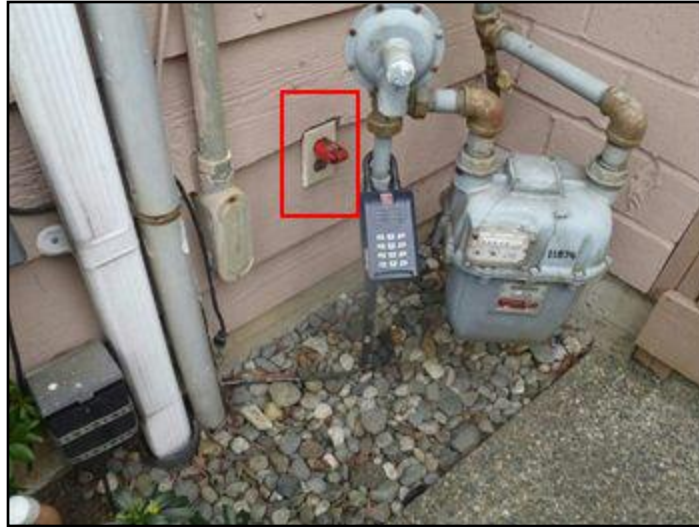
12. Condition: • [Missing](#)

Implication(s): Electric shock

Location: Garage

Task: Provide

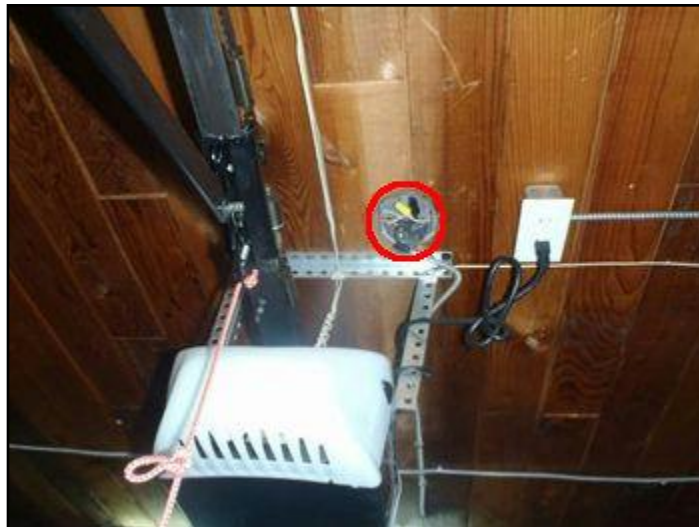
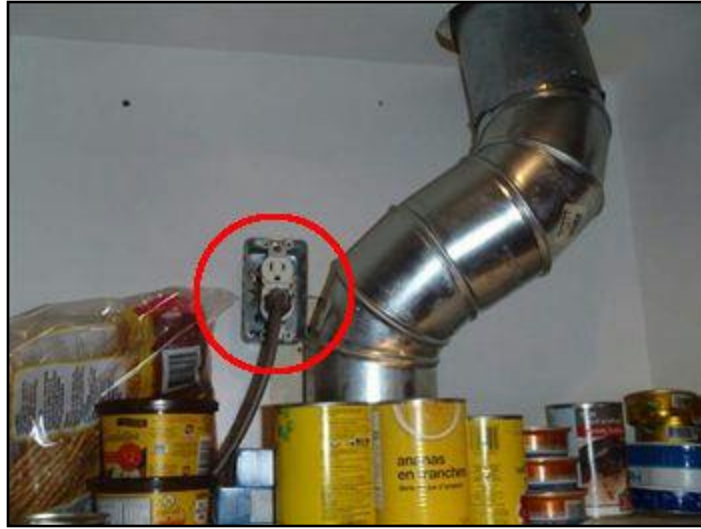
13. Condition: • [Missing](#)

Implication(s): Electric shock

Location: Kitchen

Task: Provide

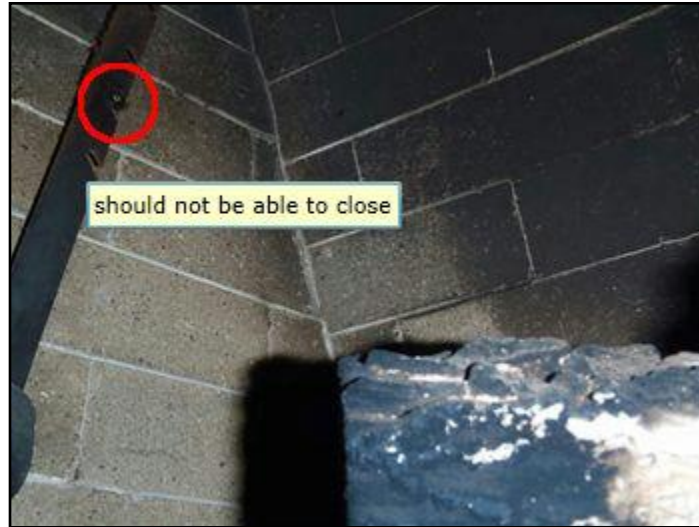
16. Condition: • [Damper in existing fireplace not fixed open](#)

Implication(s): Hazardous combustion products entering home

Location: West Basement

I recommend that you have the damper fixed open to prevent hazardous gases from entering the home

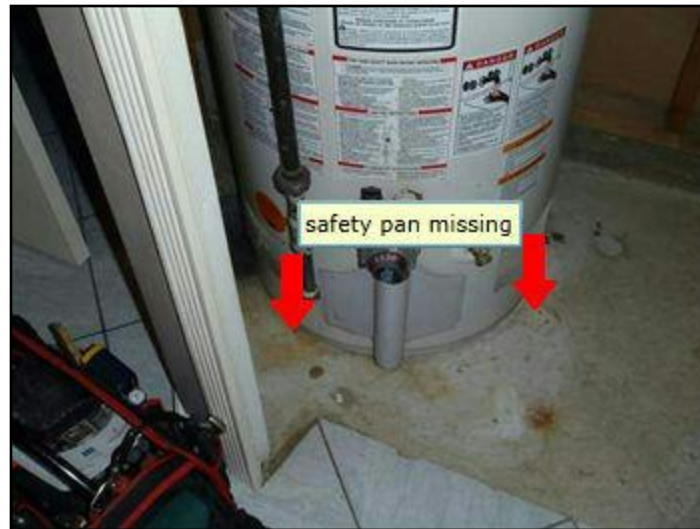
18. Condition: • Safety pan and drain missing

Implication(s): Chance of water damage to contents, finishes and/or structure

Installing a safety drain pan can greatly reduce the chance of damage caused by tank failure.

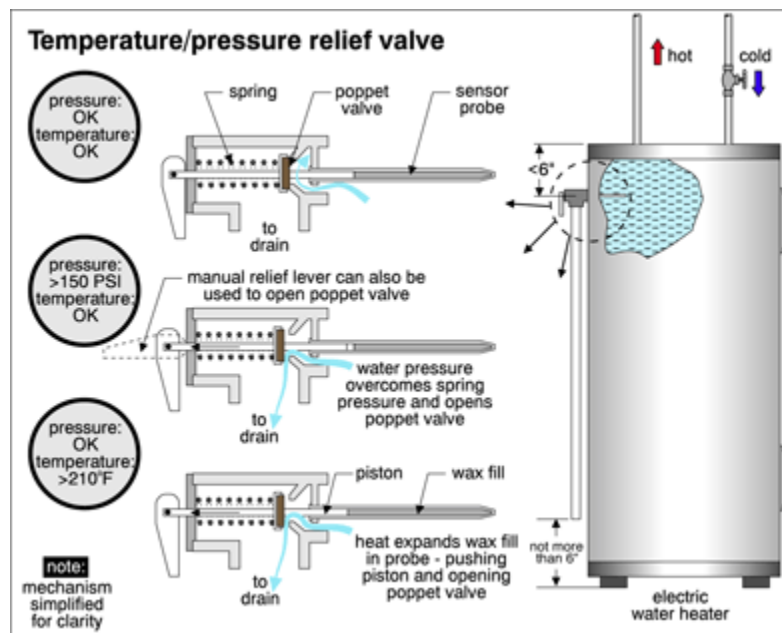
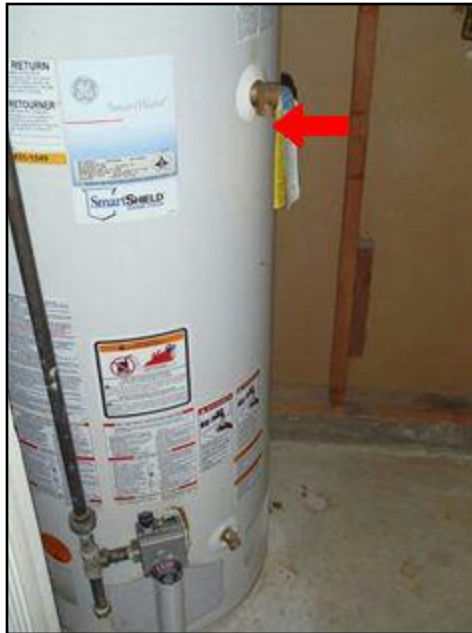
Discharge tube missing

19. Condition: • [Discharge tube missing](#)

Task: Provide

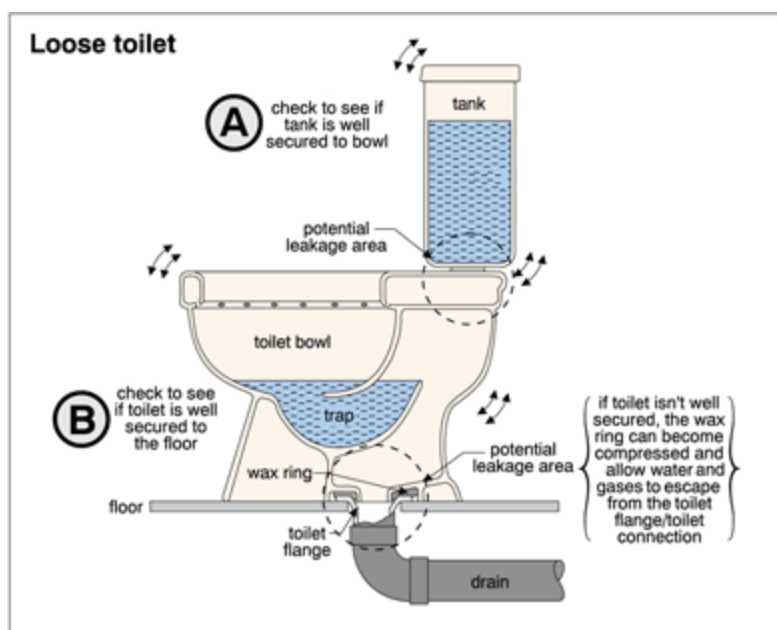
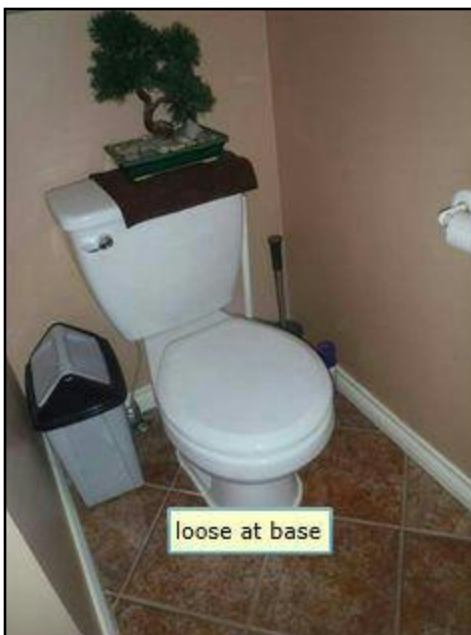
20. Condition: • [Loose](#)

The base to flange connection is loose and leaking water into the ceiling cavity. It's recommended that you have a plumber reseal the toilet. Its advised to also do further evaluation to the area below the toilet to determine if mold is present in the ceiling cavity.

Implication(s): Chance of water damage to contents, finishes and/or structure | Sewage entering the building

Task: Repair

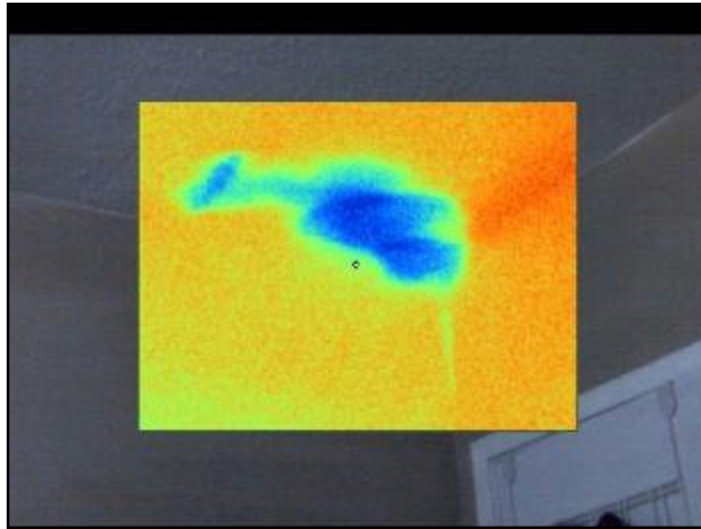
21. Condition: • Thermal Anomaly

The area noted in the photo is below the loose toilet in the main bathroom. Moisture was present during the inspection. See plumbing section for details on the condition.

Implication(s): Chance of water damage to structure

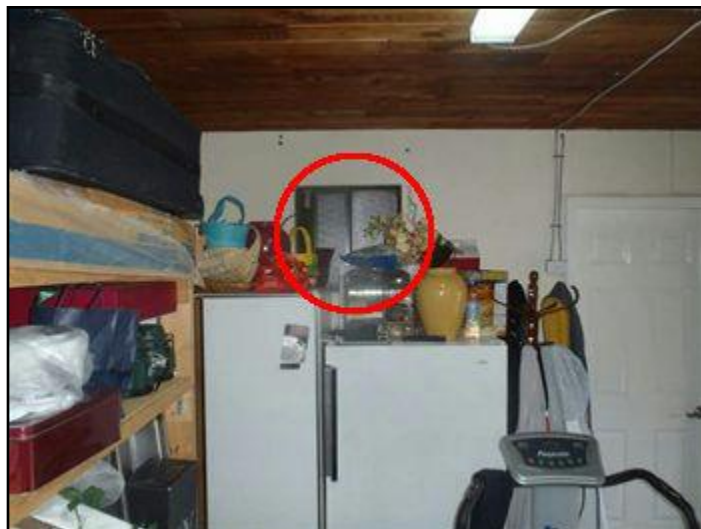
22. Condition: • [Not gastight](#)

Implication(s): Hazardous combustion products entering home

We recommend that the window be sealed to prevent hazardous gases from entering the home.

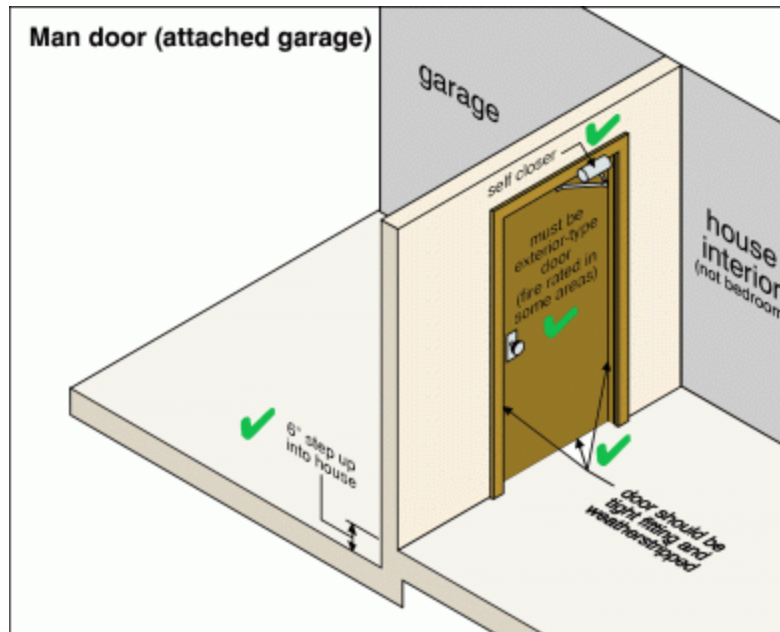
23. Condition: • [No self closer](#)

Implication(s): Hazardous combustion products entering home

Having a self closing hinge installed on the door will help prevent hazardous gases from entering the home.

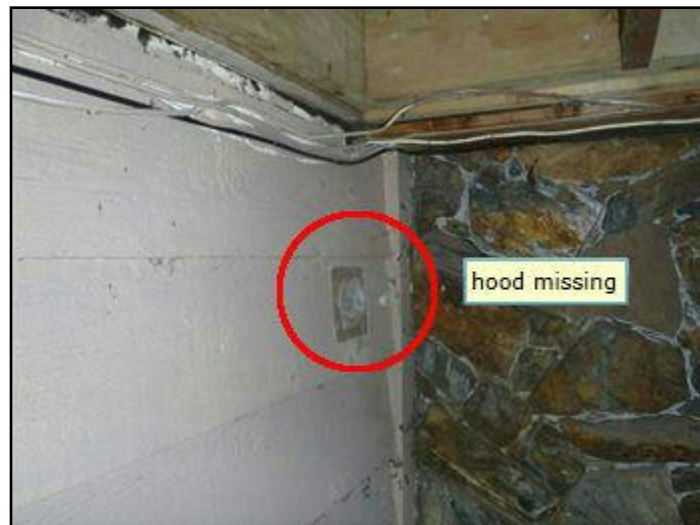
24. Condition: • [Weather hood missing or loose](#)

Implication(s): Chance of water damage to contents, finishes and/or structure | Chance of pests entering building

Task: Provide
