Your Inspection Report

5249 Gem Lake Ct
Colorado Springs, CO

INSPECTION DATE:
Tuesday, July 7, 2015

RE: Report No. 1525
5249 Gem Lake Ct
Colorado Springs, CO

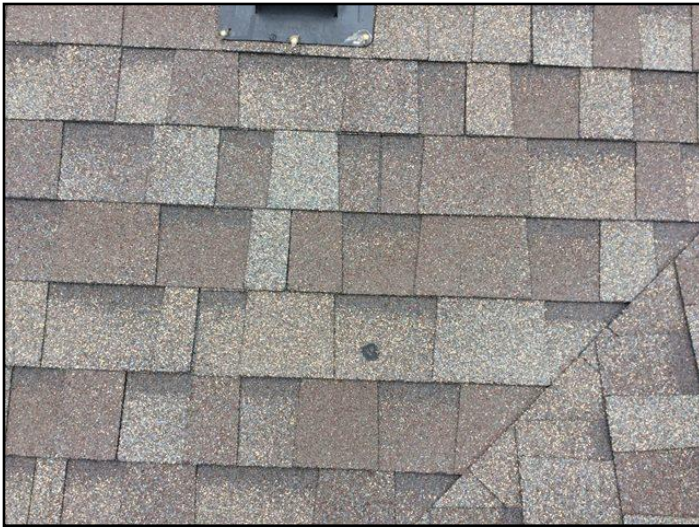
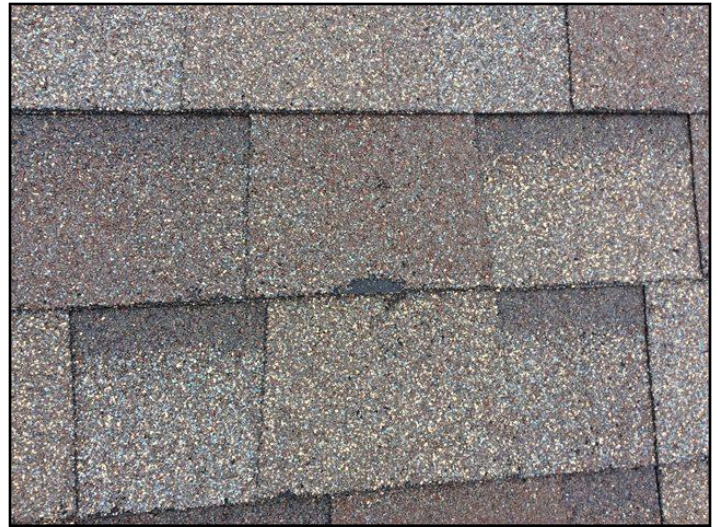
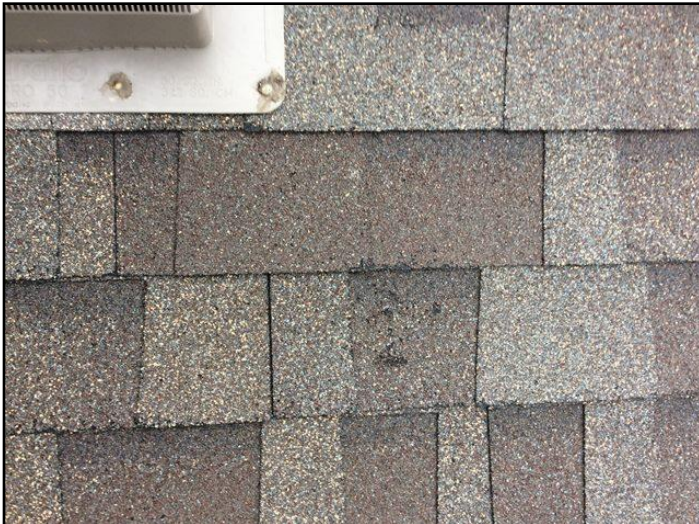
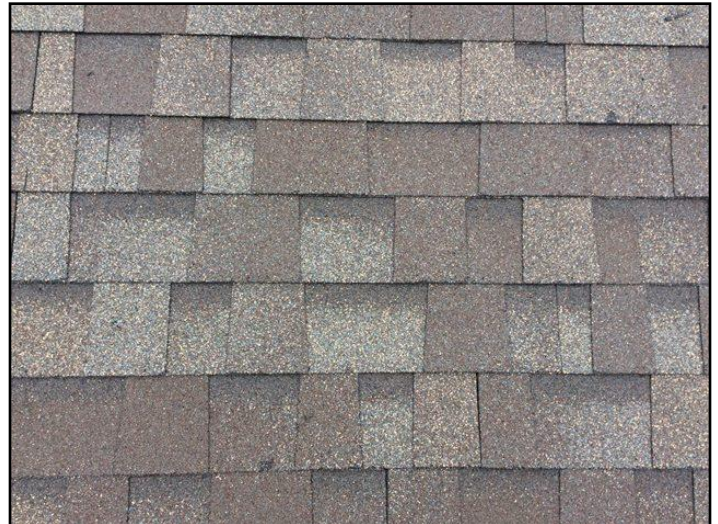
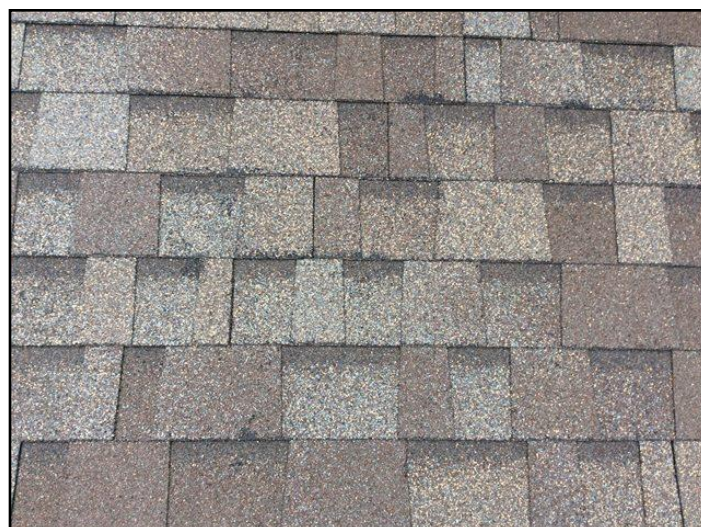
Approximately 10 damaged shingles, likely due to equipment & tools during original installation . Recommend roof maintenance to replace damaged shingles by roof contractor.

Implication(s): Chance of water damage to contents, finishes and/or structure

Task: Repair / Replace damaged shingles

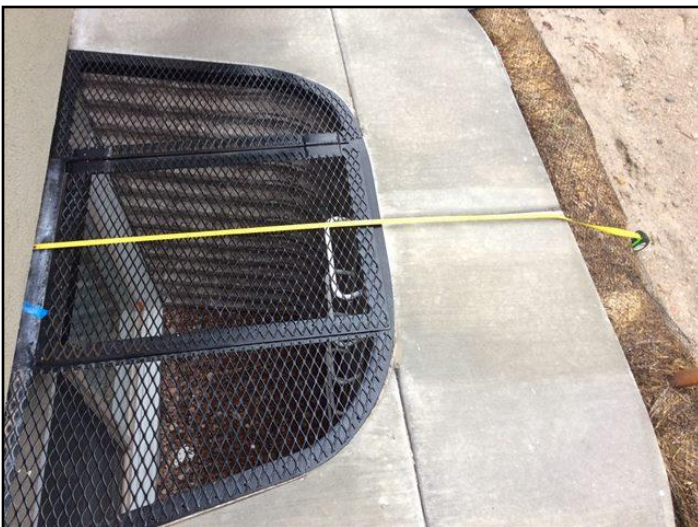
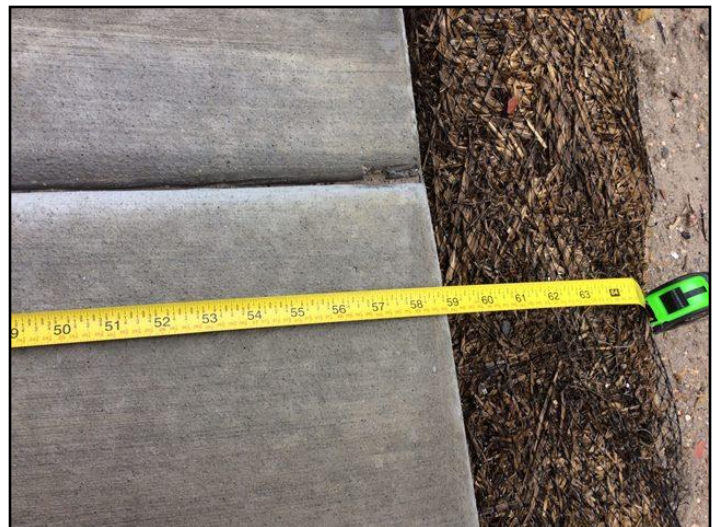
2. • House probably situated just less than 5' from property boundary. Only a surveyor could precisely measure, but home appears to be approx 4'10" from property line. This could cause potential issues related to fencing, drainage repairs or re-sale.

Task: Further evaluation

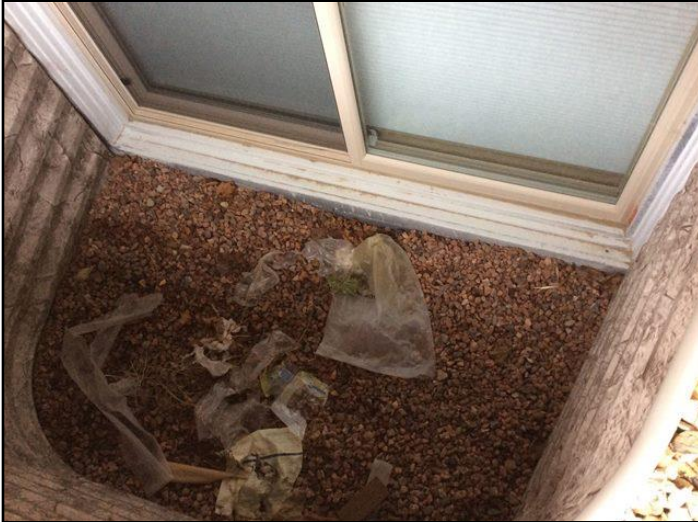
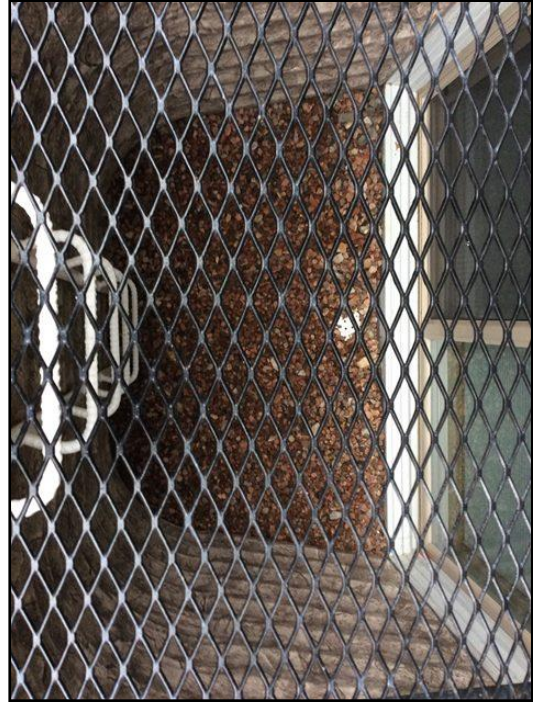
3. **Condition:** • Bottom of window well too close to window sill - improper drainage/clearance. Window well is too shallow

- bottom should be at least 4 inches below the window sill. Potential for water entry into home.

Location: Window well near AC (west) & east window well

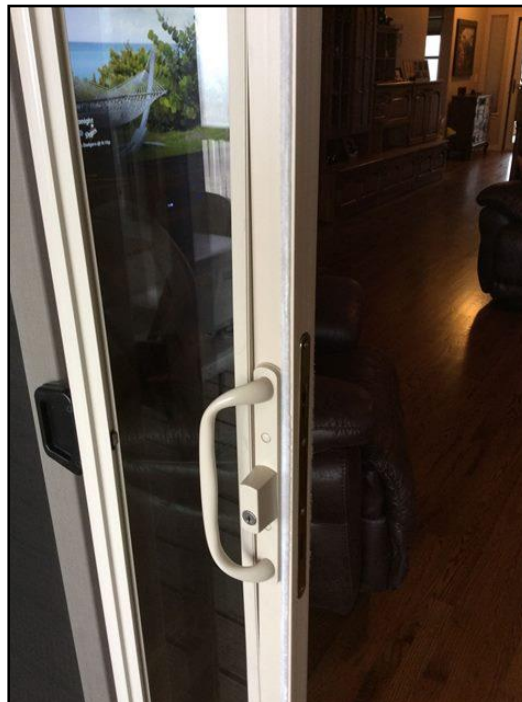
4. Condition: • Insulation strip coming loose / detaching from door style

Location: Rear sliding glass door

Task: Repair

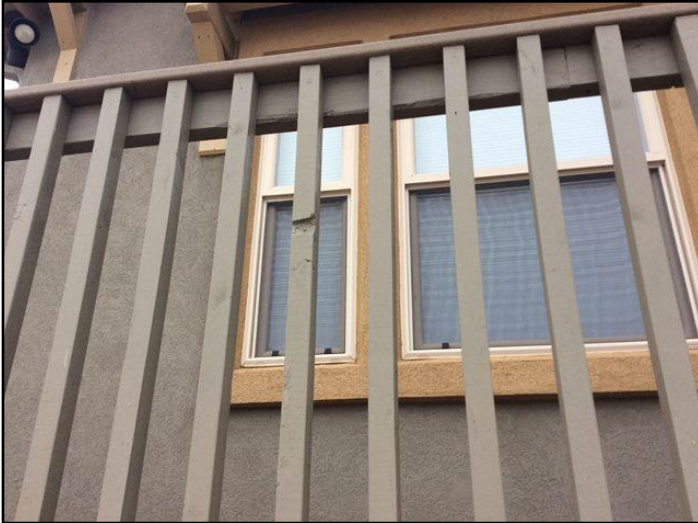
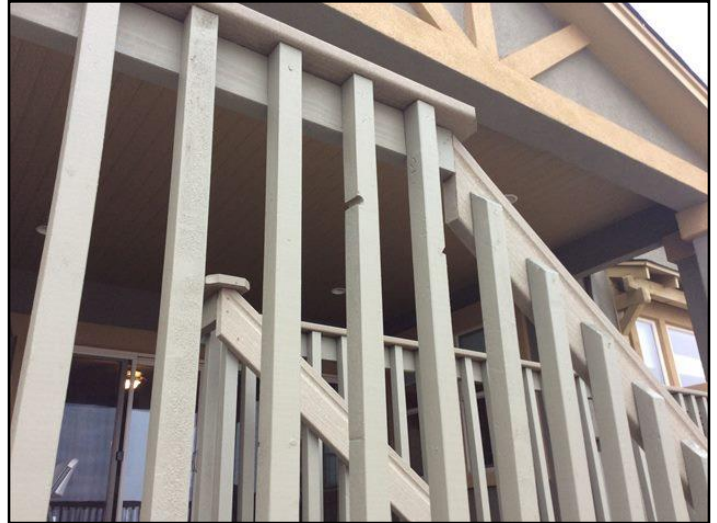
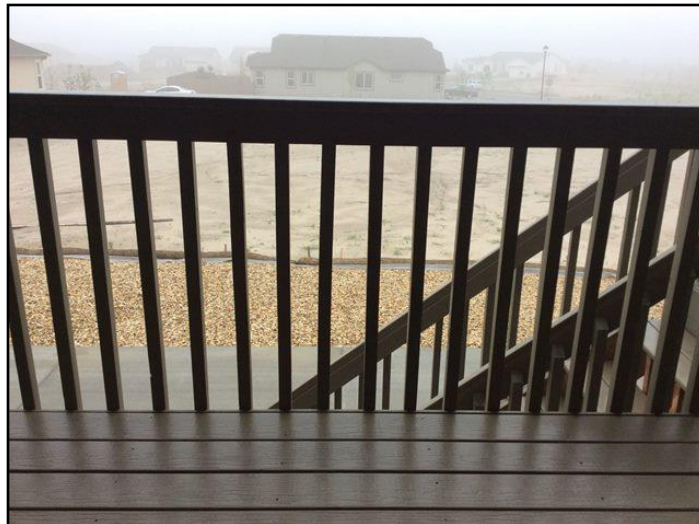
5. Condition: • 2 notched, 1 bent/bowed

Location: Rear Deck spindles

Task: Repair or replace

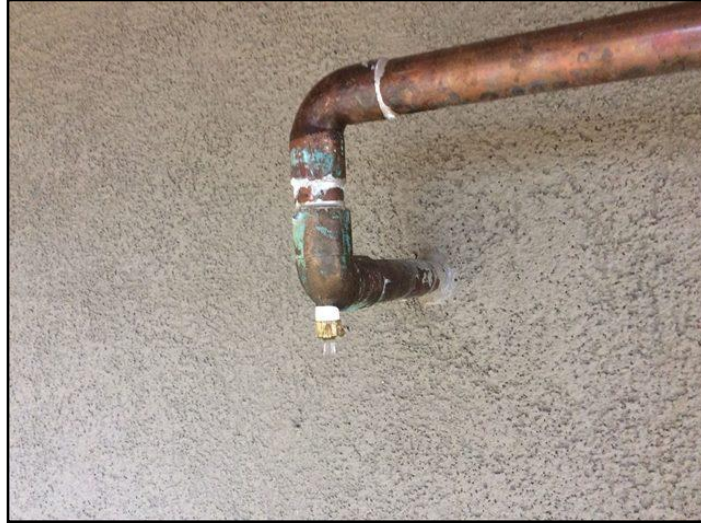
7. Condition: • Leak

Leak - exterior sprinkler piping bleed valve

Implication(s): Reduced operability

Recommend immediate repair by qualified landscape/sprinkler contractor

Task: Repair

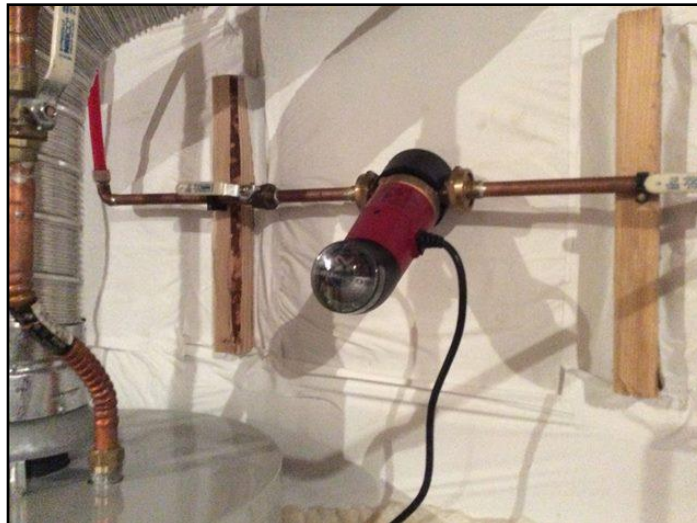
8. Condition: • Master bath shower & basement fixtures did not receive instant hot water

Recommend further assessment of the circulating pump - it may need adjustment or possible replacement

Task: Further evaluation

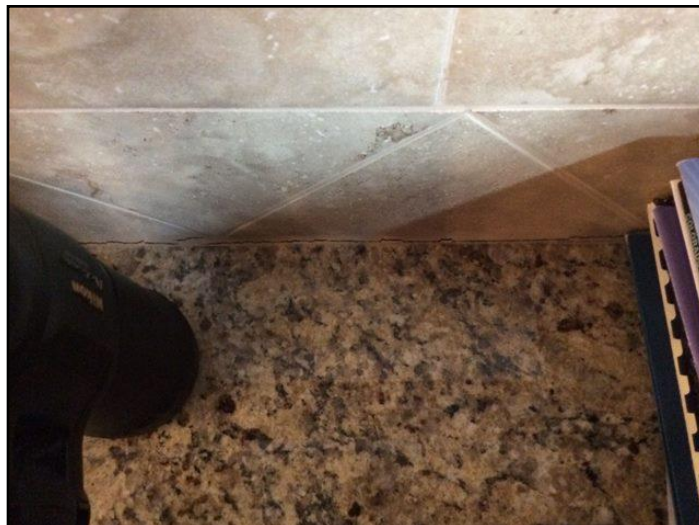
Grout cracked - rear Kitchen counter

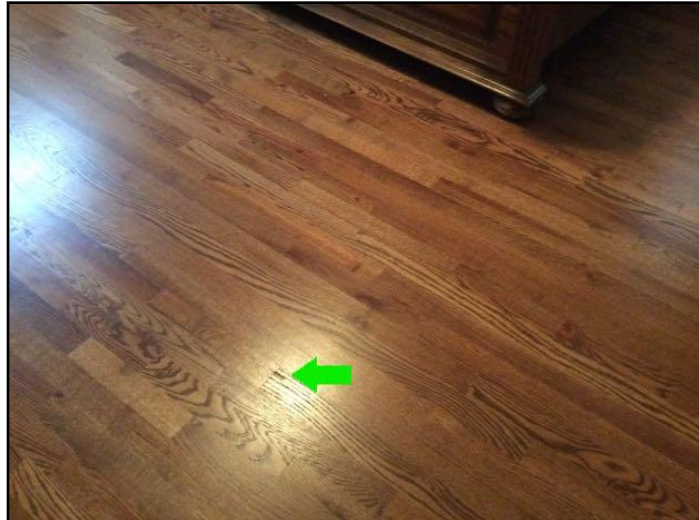
10. **Condition:** • Nick / indentation / imperfection in floor board

Location: Master Bedroom

Task: Repair / replace

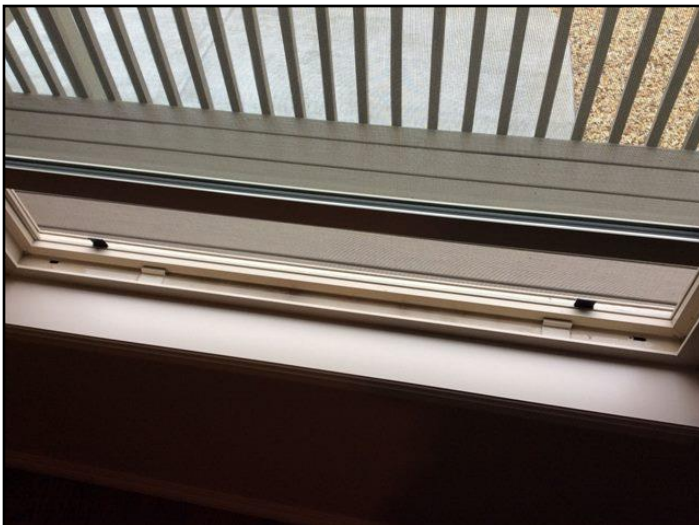
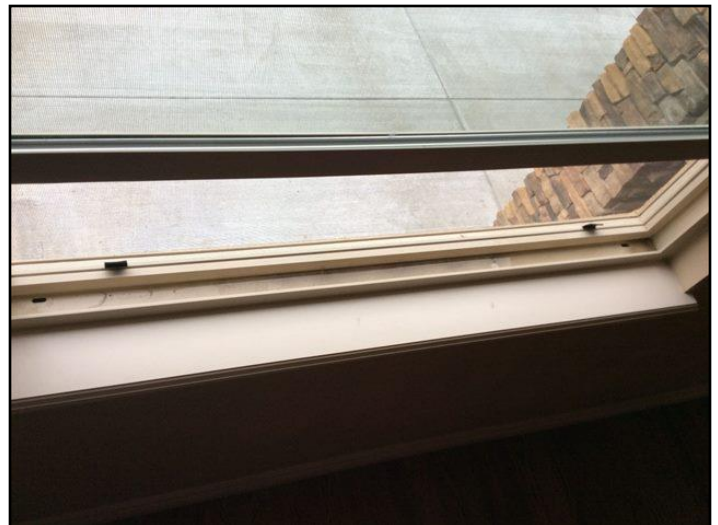
11. Condition: • Standing water in bottom sill track - water not draining towards drain holes - low point in middle of track
See Note 3 in Index of Notes

Location: Rear center windows in dining room & master bedroom

Task: Repair by window repair professional
