# INSPECTION REPORT

For the Property at:  
**199 GILLARD AVENUE**  
TORONTO, ON

Prepared for: LAWRENCE DAY  
Inspection Date: Sunday, June 25, 2006  
Prepared by: Steven Silva, B.A.Sc.

RE: Report No. 2000, v.2  
199 Gillard Avenue  
Toronto, ON

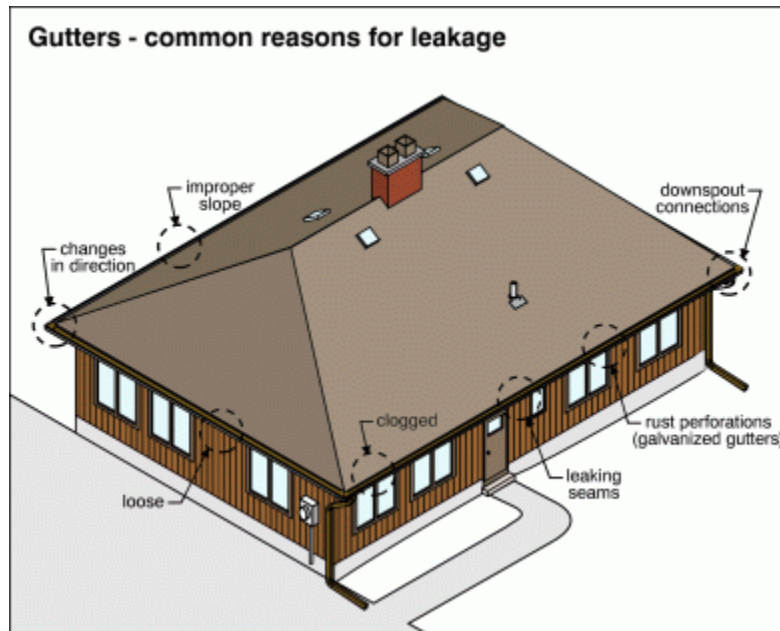
### Roof drainage \ Gutters

Condition: • [Clogged](#)

Implication(s): Chance of water damage to contents, finishes and/or structure

Note: Were clean today

Task: Clean

Time: Regular maintenance

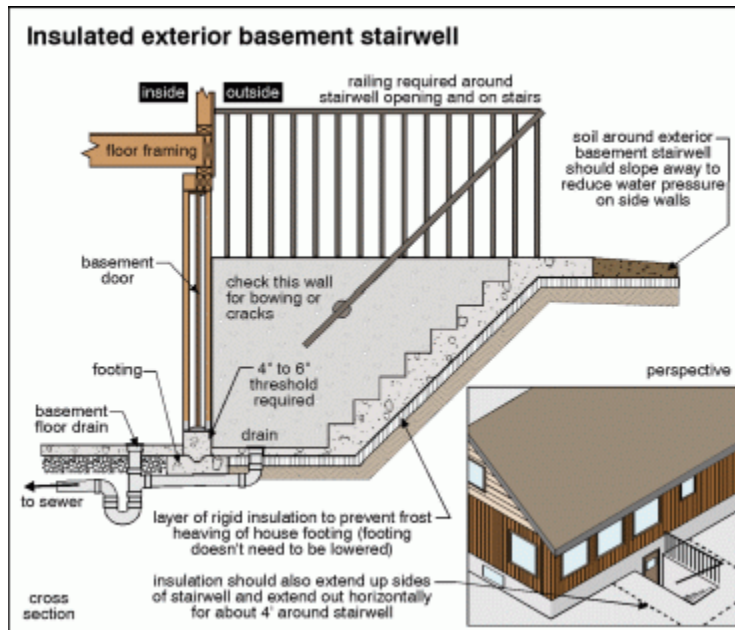
## Insulated exterior basement stairwell

## Basement entrances \ Basement stairwells

**Condition:** • [Guard and handrail problems](#)

**Implication(s):** Fall hazard

**Task:** Provide

**Time:** Immediate

**Cost:** \$200-400

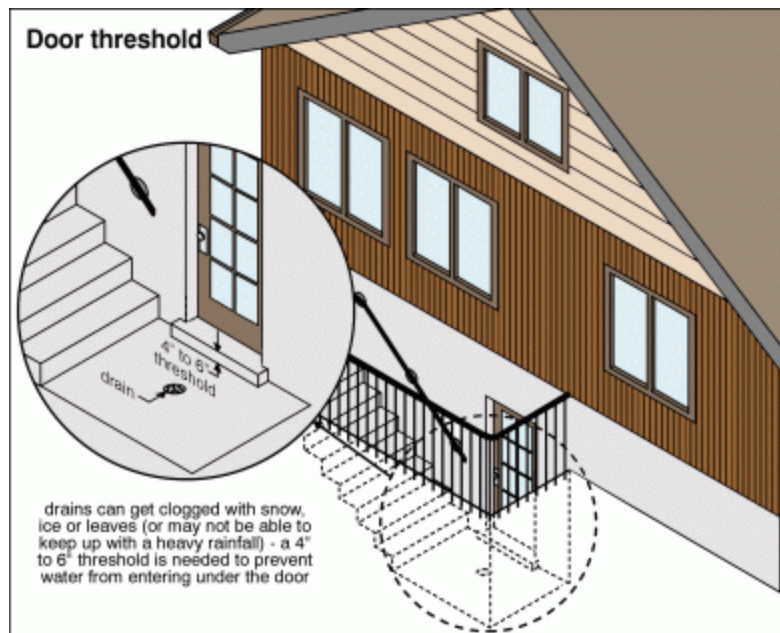
**Condition:** • [Door threshold missing, too low, not watertight](#)

**Implication(s):** Chance of water damage to contents, finishes and/or structure

**Location:** South Exterior

**Task:** Improve

**Time:** If necessary

**Cost:** Depends on approach

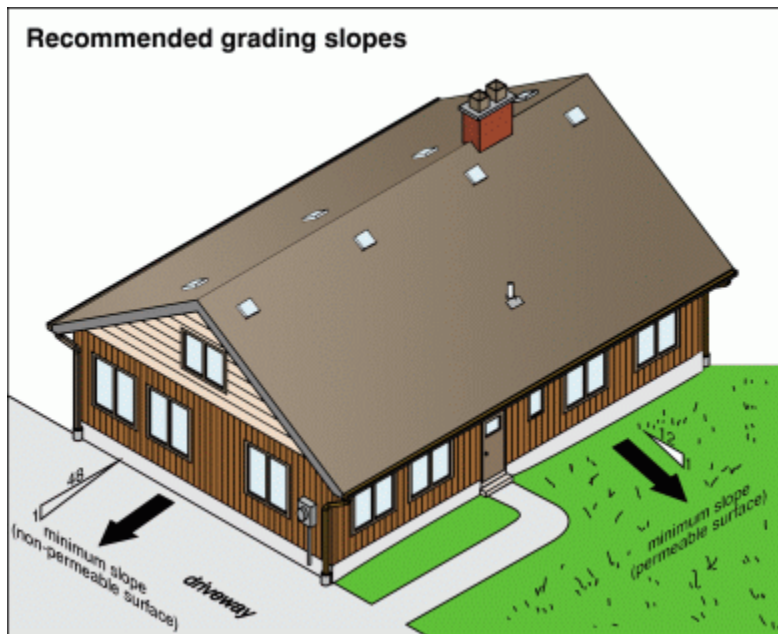
## Landscaping \ Lot grading

**Condition:** • [Improper slope](#)

**Implication(s):** Chance of water damage to contents, finishes and/or structure

**Location:** Exterior

**Note:** It is possible that this was improved recently. Generally appears to be in good condition.

**Task:** Improve

**Time:** Less than 1 year

**Cost:** Depends on approach

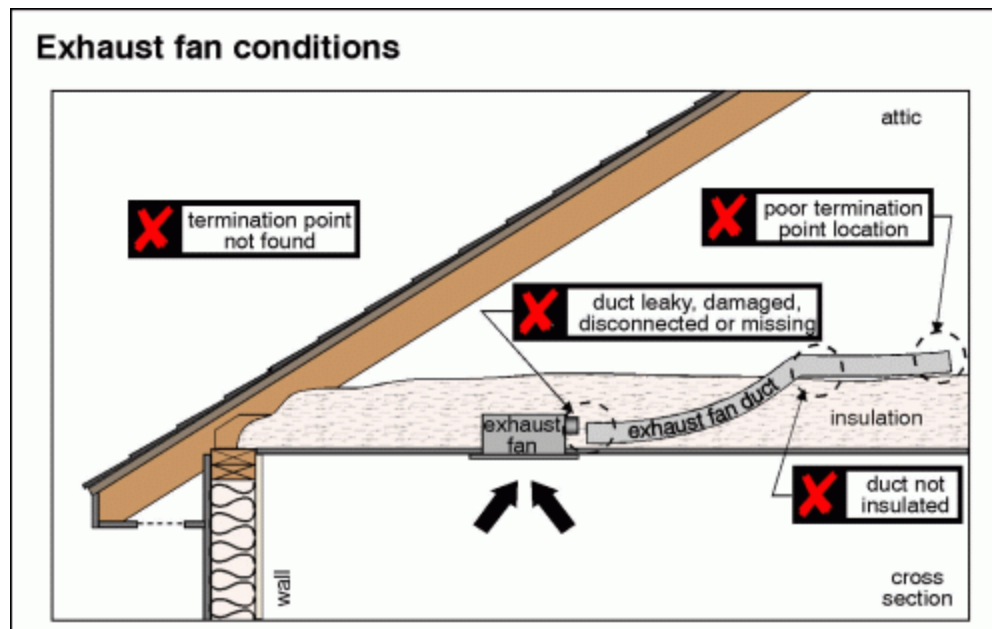
## Exhaust fans \ Kitchen exhaust system

**Condition:** • Not vented to exterior

**Implication(s):** Chance of condensation damage to finishes and/or structure

**Location:** First floor, Second floor

**Task:** Improve

**Time:** Discretionary

**Cost:** \$500 - \$900 each
