# Your Inspection Report

4321 2nd Street  
Surrey, BC V3W 3E5

**INSPECTION DATE:**  
Monday, November 24, 2008

Report No. 1006, v.3

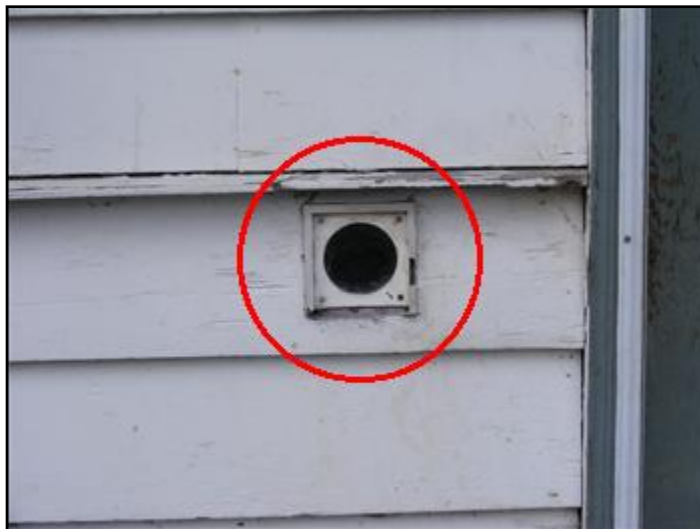
1.

• Dryer vent hood missing

**Implication(s):** Water damage / insect access

**Location:** Southeast Exterior Wall

**Task:** Repair

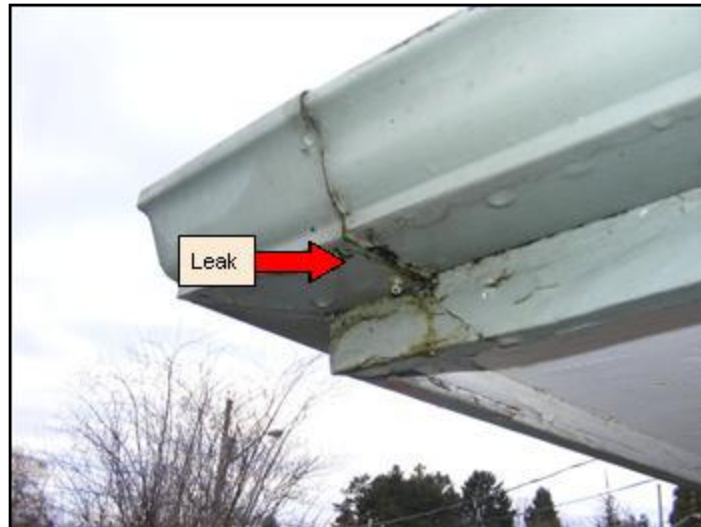
2.

**Condition:** • [Leak](#)

**Implication(s):** Chance of water damage to contents, finishes and/or structure

**Location:** Southwest Exterior

**Task:** Repair

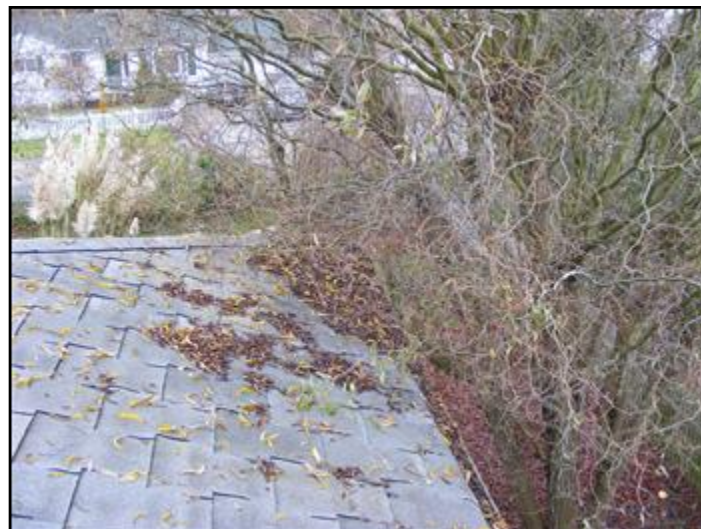
3.

**Condition:** • [Clogged](#)

**Implication(s):** Chance of water damage to contents, finishes and/or structure

**Location:** Northwest Roof

**Task:** Clean

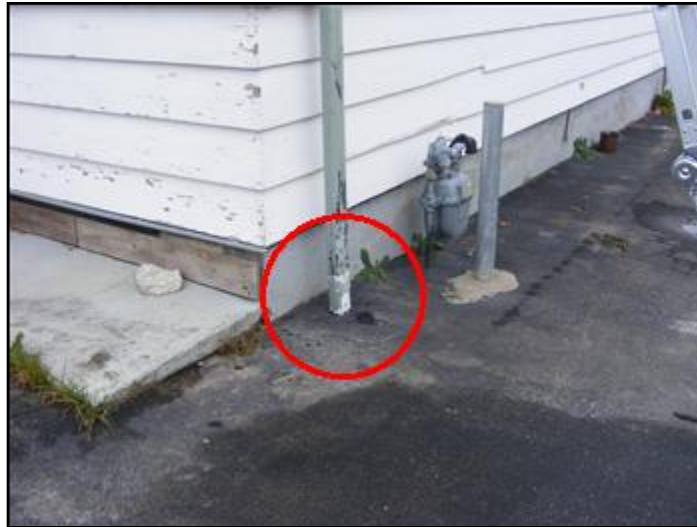
4.

**Condition:** • [Downspouts discharging below grade](#)

Southwest, northwest and northeast discharge below grade

**Implication(s):** Chance of water damage to contents, finishes and/or structure

**Location:** Throughout Exterior

**Task:** Further evaluation

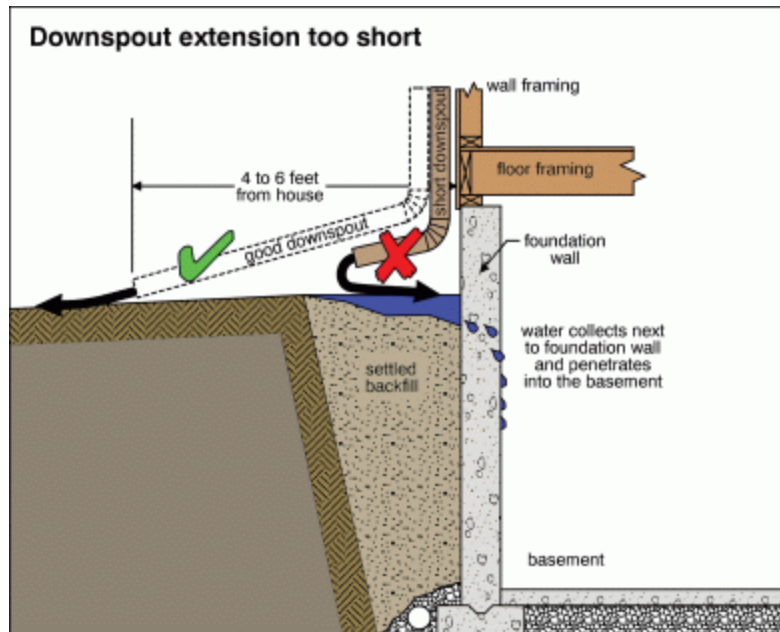
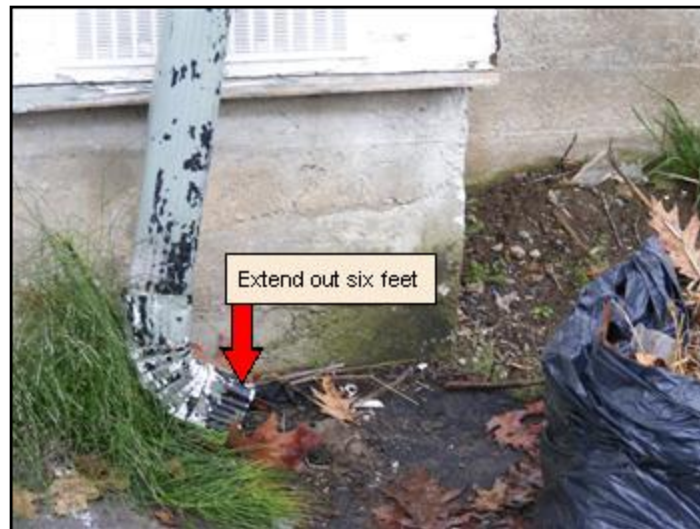
5.

**Condition:** • [Downspouts end too close to building](#)

**Implication(s):** Chance of water damage to contents, finishes and/or structure

**Location:** Southeast Exterior

**Task:** Improve

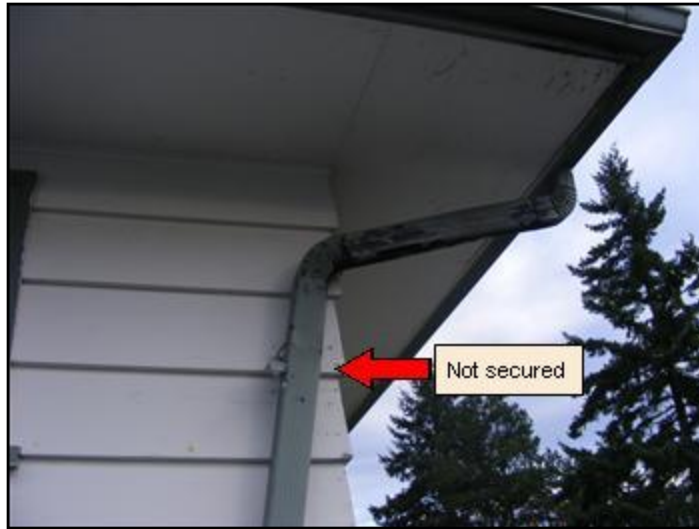
6.

**Condition:** • [Not well secured](#)

**Implication(s):** Leakage

**Location:** Southeast Exterior

**Task:** Repair

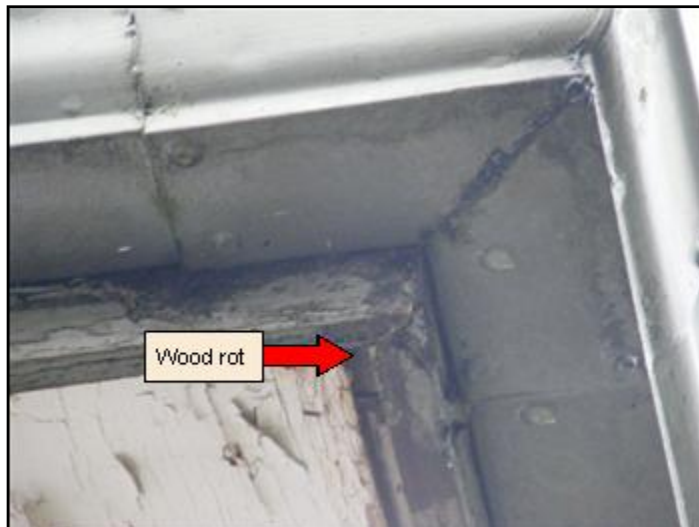
7.

**Condition:** • [Rot or insect damage](#)

**Implication(s):** Cosmetic defects | Chance of water damage to contents, finishes and/or structure | Material deterioration

**Location:** Southwest Exterior

**Task:** Repair

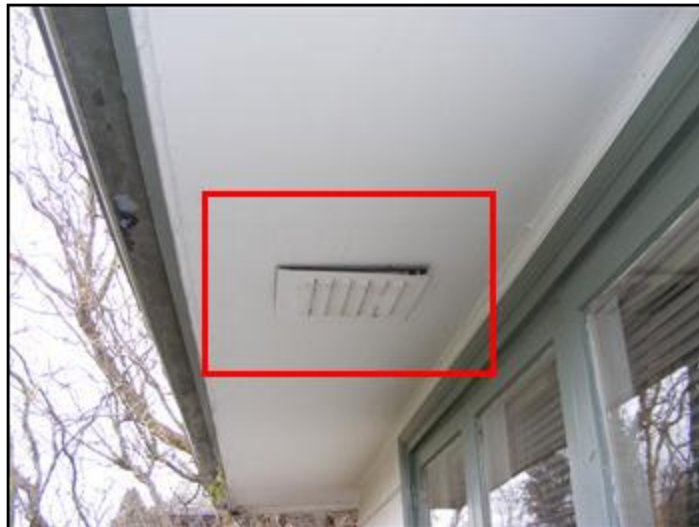
8.

**Condition:** • [Loose or missing pieces](#)

**Implication(s):** Cosmetic defects | Chance of water damage to contents, finishes and/or structure | Chance of pests entering house

**Location:** Northwest Exterior

**Task:** Repair

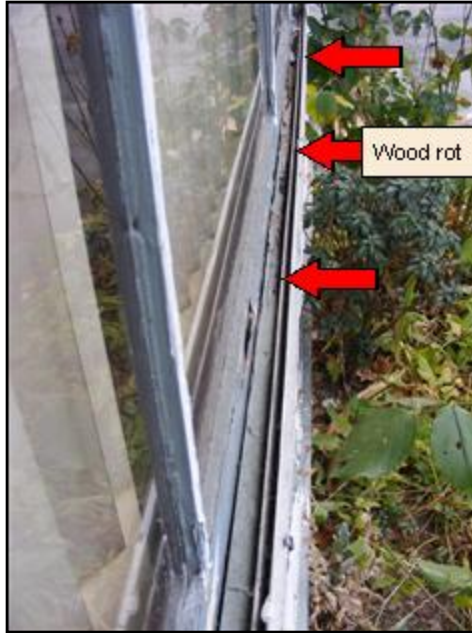
9.

**Condition:** • [Rot](#)

**Implication(s):** Cosmetic defects | Chance of water damage to contents, finishes and/or structure | Material deterioration

**Location:** Front Living Room

**Task:** Further evaluation

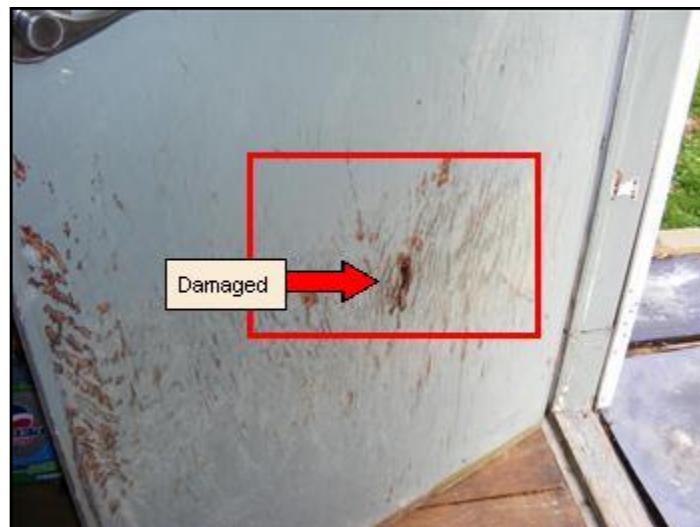
10.

**Condition:** • [Damage](#)

**Implication(s):** Cosmetic defects | Chance of damage to finishes and structure | Poor security

**Location:** Rear Foyer

**Task:** Replace

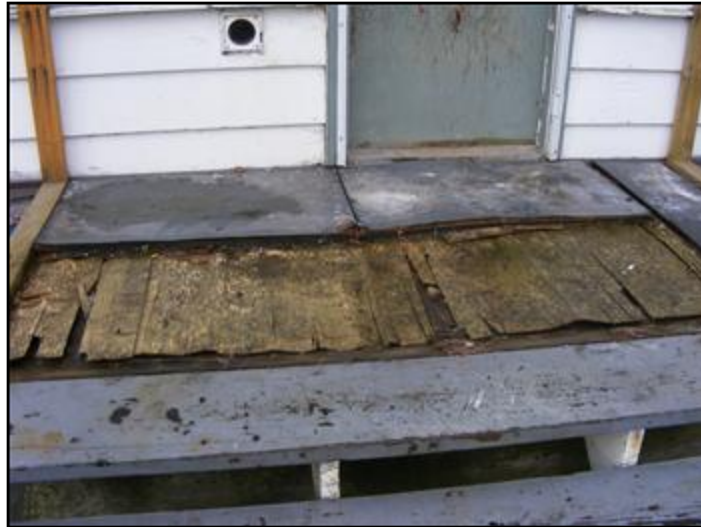
11.

**Condition:** • [Rot or insect damage](#)

**Implication(s):** Weakened structure | Chance of movement | Material deterioration

**Location:** Throughout Exterior Porch

**Task:** Replace

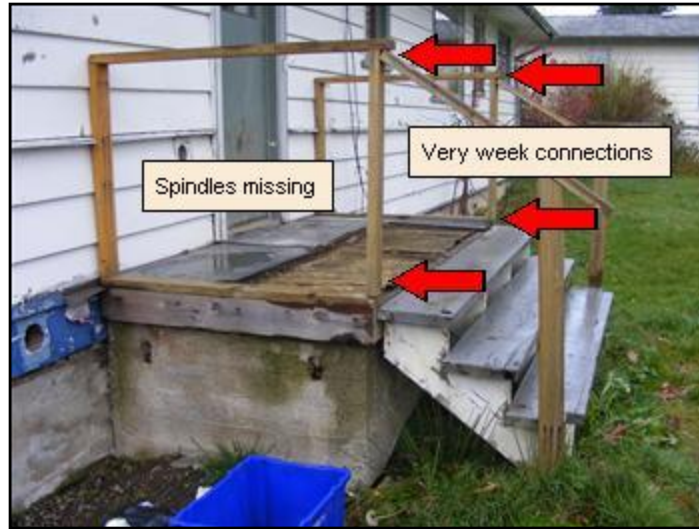
12.

**Condition:** • [Weak](#)

**Implication(s):** Fall hazard

**Location:** Throughout Exterior Porch

**Task:** Improve

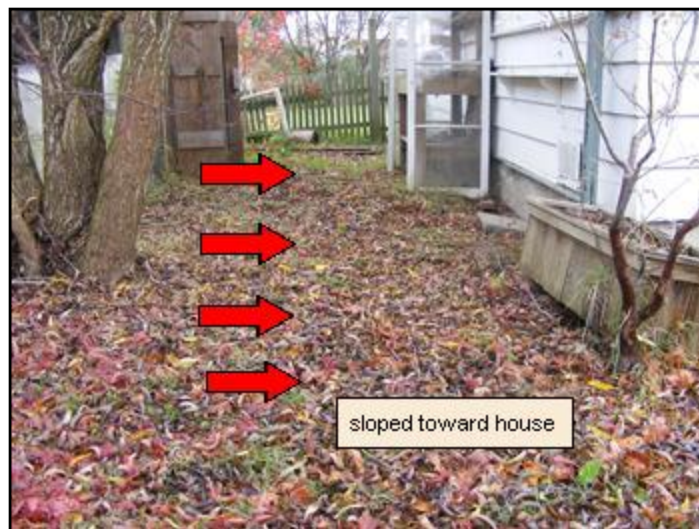
13.

**Condition:** • [Improper slope](#)

**Implication(s):** Chance of water damage to contents, finishes and/or structure

**Location:** North Yard

**Task:** Improve

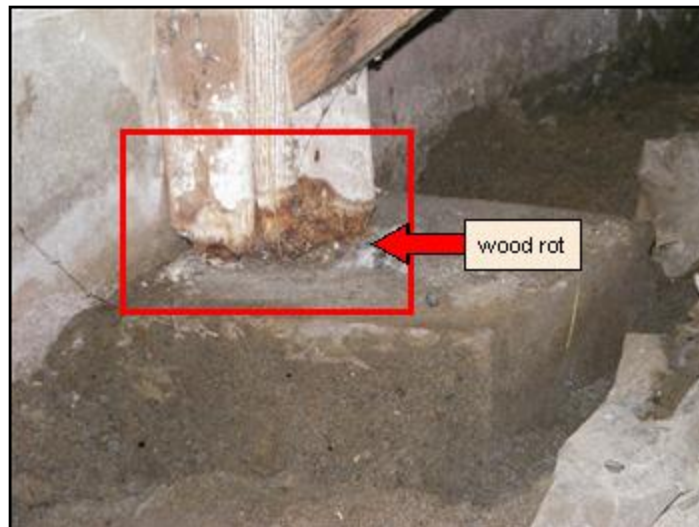
14.

**Condition:** • [Rot, insect or fire damage](#)

**Implication(s):** Weakened structure | Chance of structural movement

**Location:** South Crawl Space

**Task:** Further evaluation

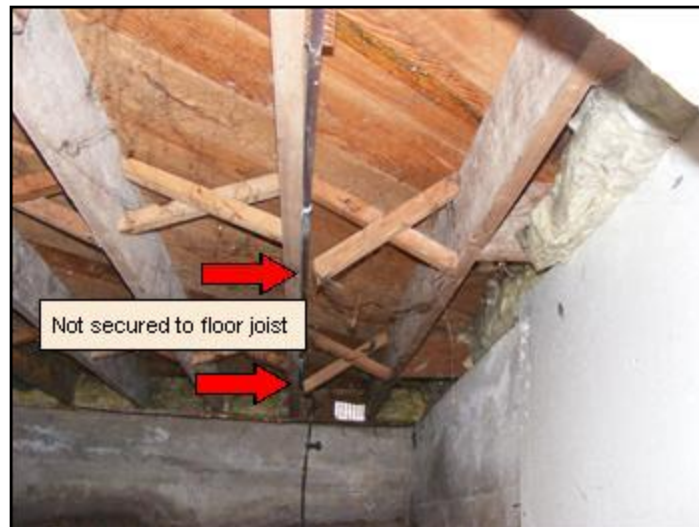
15.

**Condition:** • [Ineffective blocking, bracing or bridging](#)

**Task:** Improve

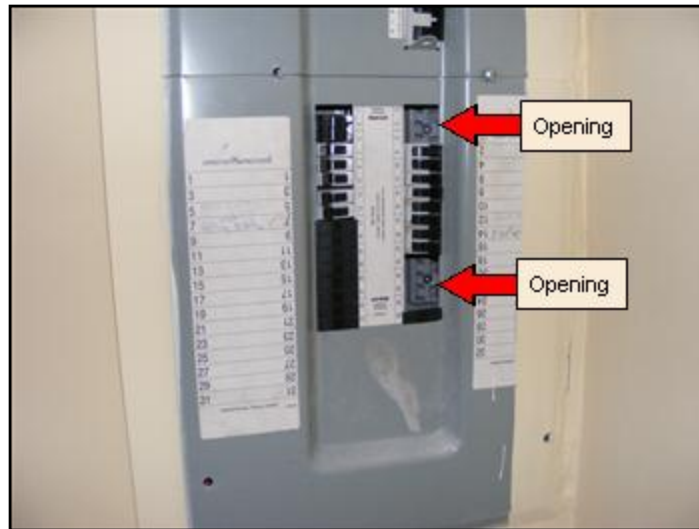
16.

**Condition:** • [Openings in panel](#)

**Implication(s):** Electric shock | Fire hazard

**Task:** Correct

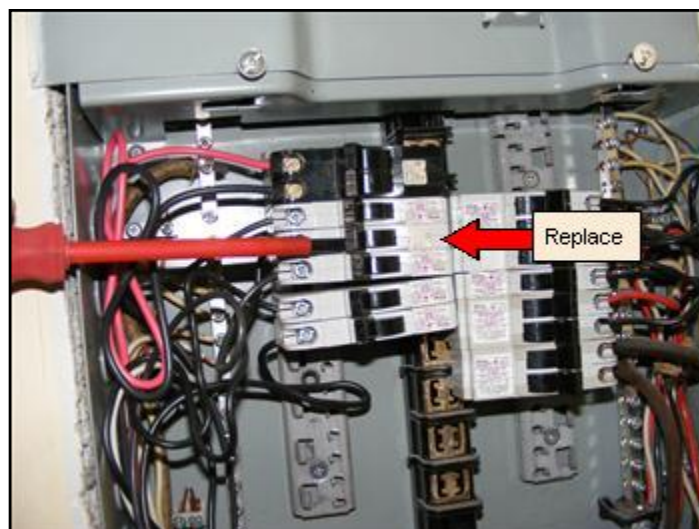
17.

**Condition:** • [Fuses or breakers too big](#)

**Implication(s):** Equipment overheating | Fire hazard

**Task:** Replace

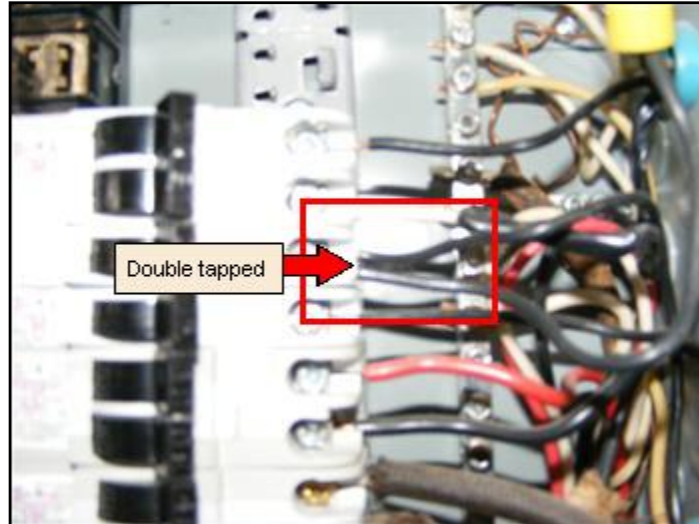
18.

**Condition:** • [Double taps](#)  
**Implication(s):** Fire hazard  
**Location:** South Bedroom  
**Task:** Correct  
**Time:** Immediate

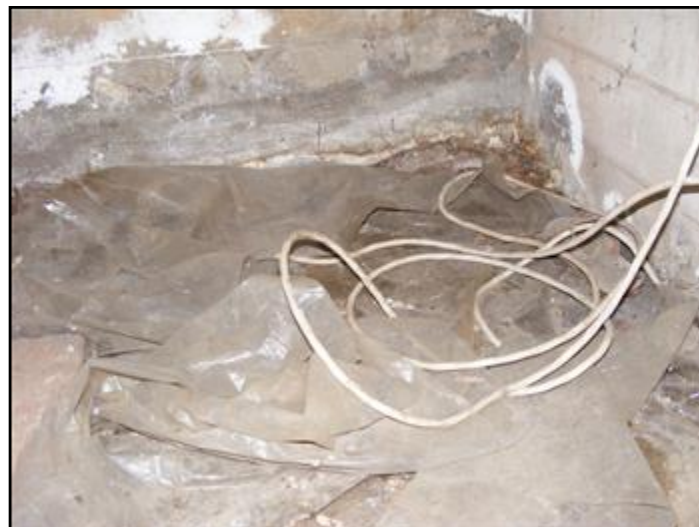
19.

**Condition:** • [Abandoned wire](#)  
**Implication(s):** Electric shock  
**Location:** South Crawl Space  
**Task:** Further evaluation  
**Time:** Immediate

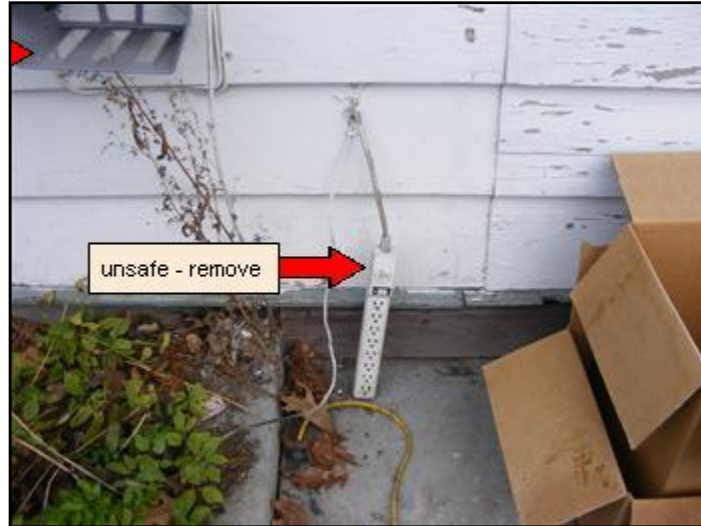
20.

**Condition:** • [Permanent wiring used as extension cord](#)

**Implication(s):** Electric shock | Fire hazard

**Task:** Remove

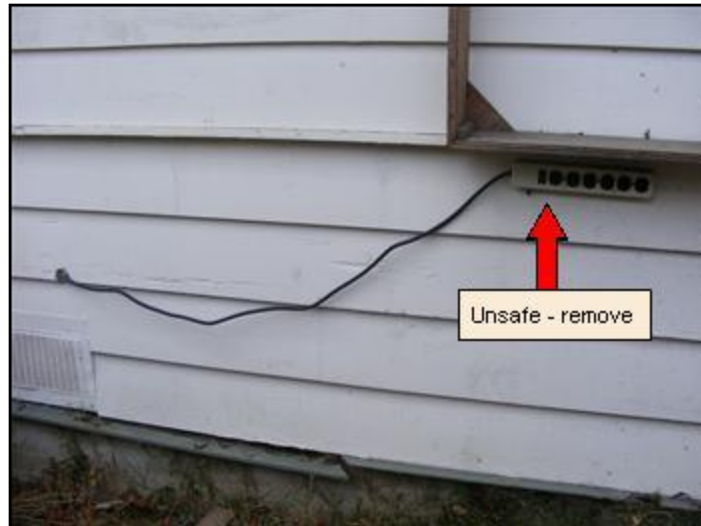
21.

**Condition:** • [Permanent wiring used as extension cord](#)

**Implication(s):** Electric shock | Fire hazard

**Task:** Remove

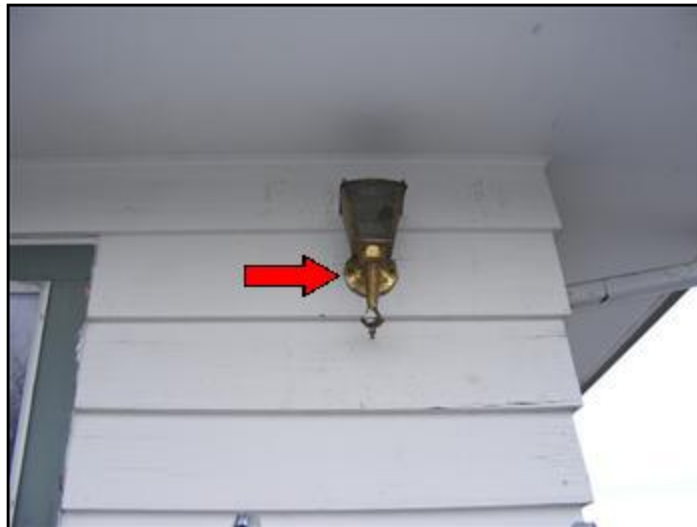
22.

**Condition:** • [Inoperative](#)

**Implication(s):** Inadequate lighting

**Task:** Further evaluation

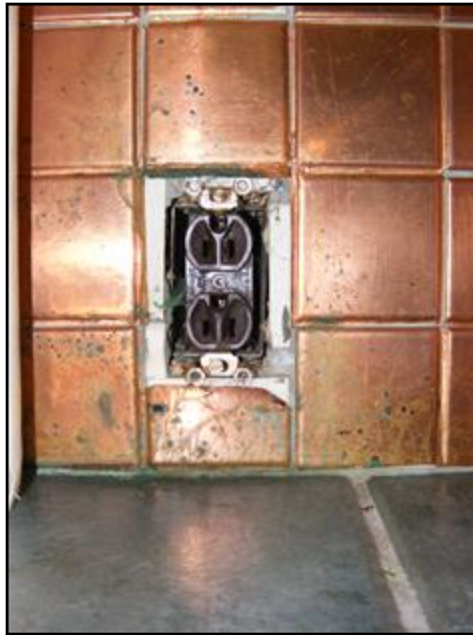
23.

**Condition:** • [Reversed polarity](#)

**Task:** Repair

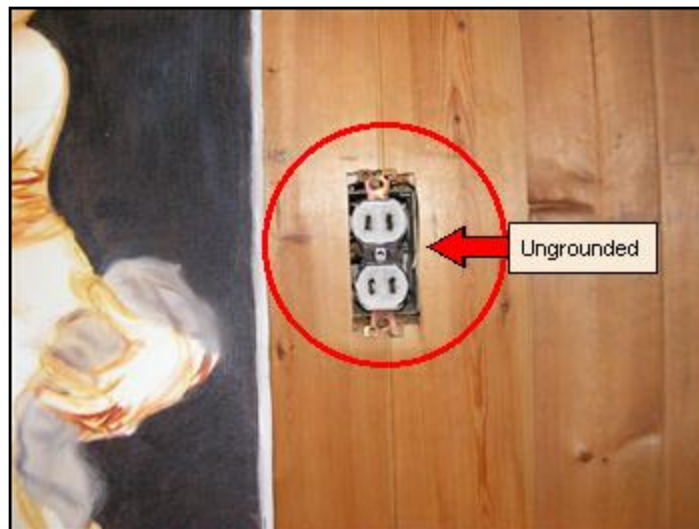
24.

**Condition:** • [Ungrounded](#)

**Task:** Improve

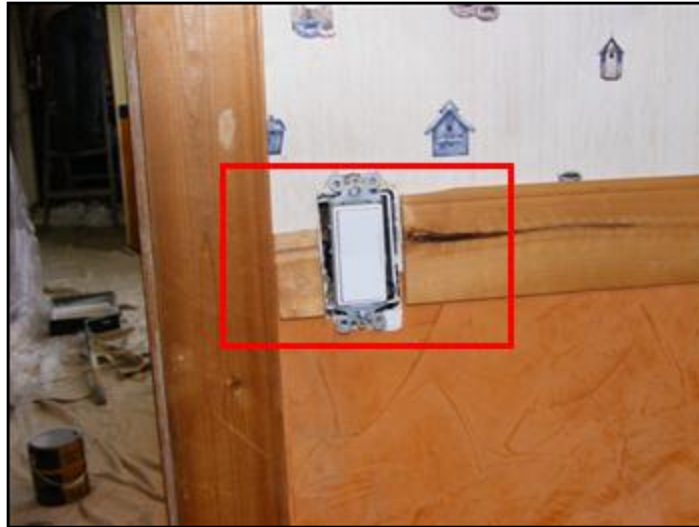
25.

**Condition:** • [Missing](#)

**Task:** Replace

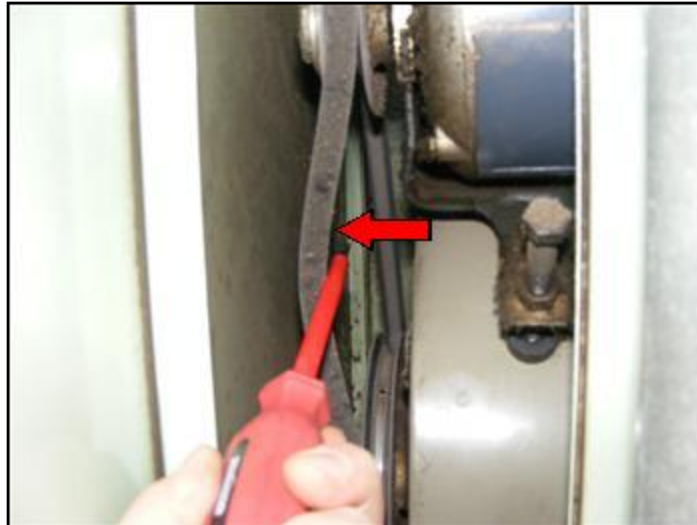
26.

**Condition:** • [Fan belt loose, worn, damaged](#)

**Task:** Service

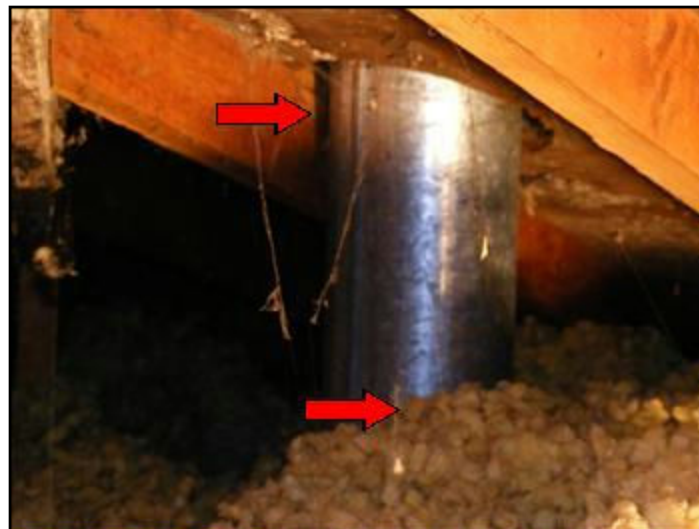
27.

**Condition:** • [Combustible clearance](#)

**Implication(s):** Fire hazard

**Task:** Further evaluation

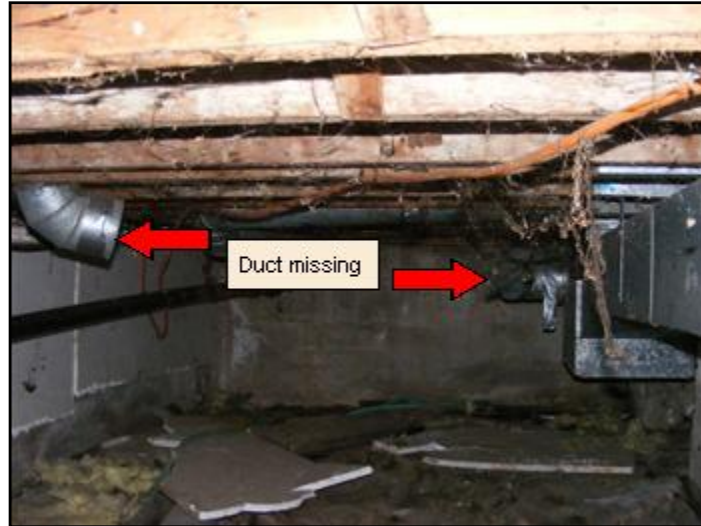
28.

**Condition:** • [Dirty, obstructed or collapsed](#)

Heating duct system very dirty due too missing furnace filter

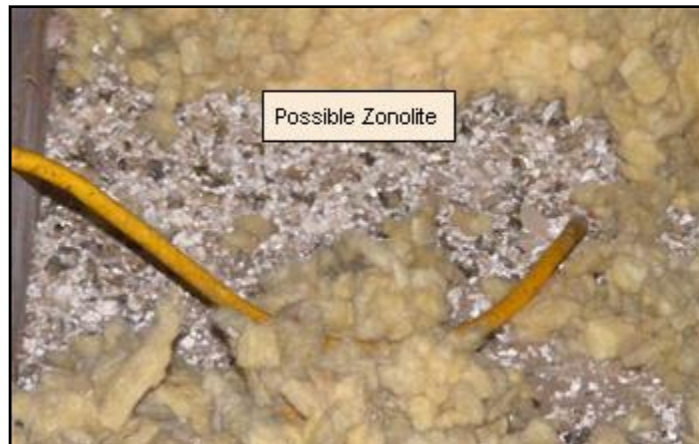
29.

- Condition:** • [Possible Zonolite](#)
- Implication(s):** Environmental contamination
- Location:** Throughout Attic
- Task:** Further evaluation
- Time:** Immediate

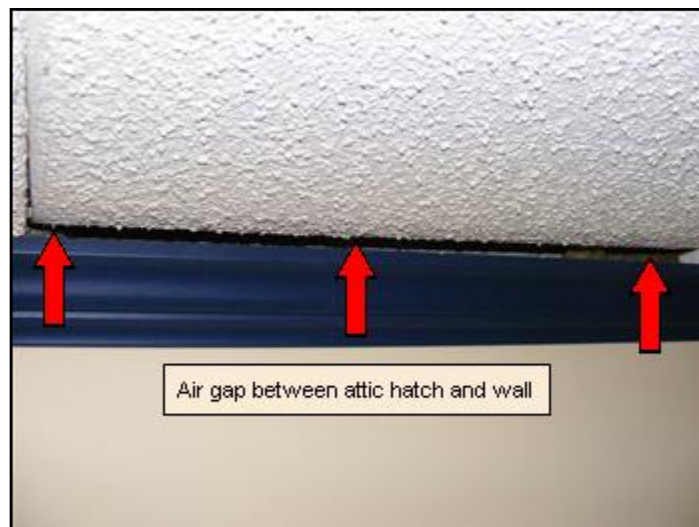
30.

**Condition:** • [Not insulated and not weatherstripped](#)

**Implication(s):** Chance of condensation damage to finishes and/or structure | Increased heating and cooling costs | Reduced comfort

**Task:** Improve

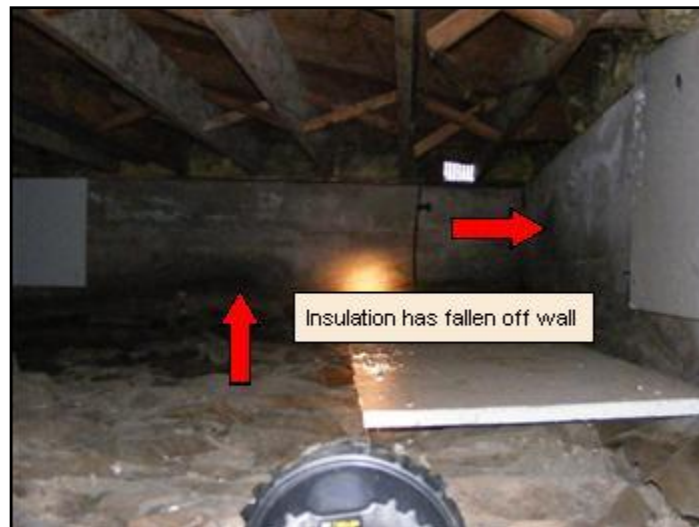
31.

**Condition:** • [Loose, sagging or voids](#)

**Task:** Improve

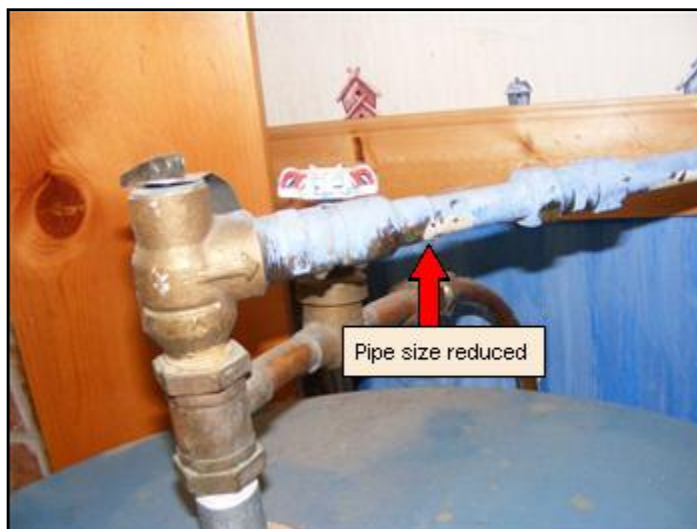
33.

**Condition:** • [Discharge tube too narrow](#)

**Task:** Improve

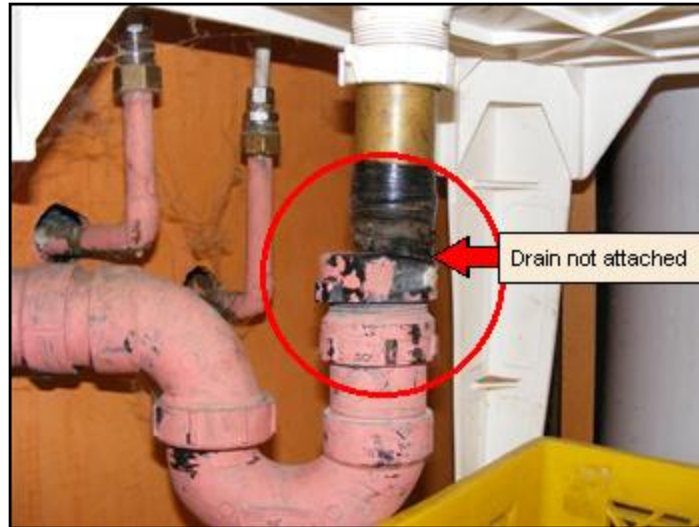
34.

**Condition:** • [Leak](#)

**Task:** Repair

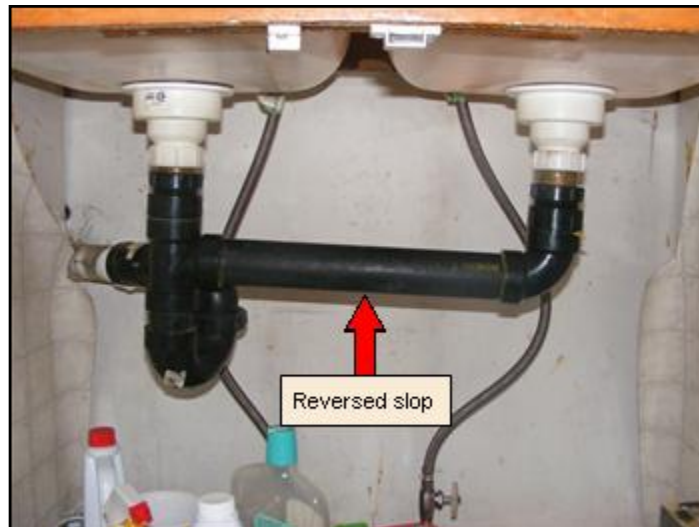
35.

**Condition:** • [Poor slope](#)

**Task:** Improve

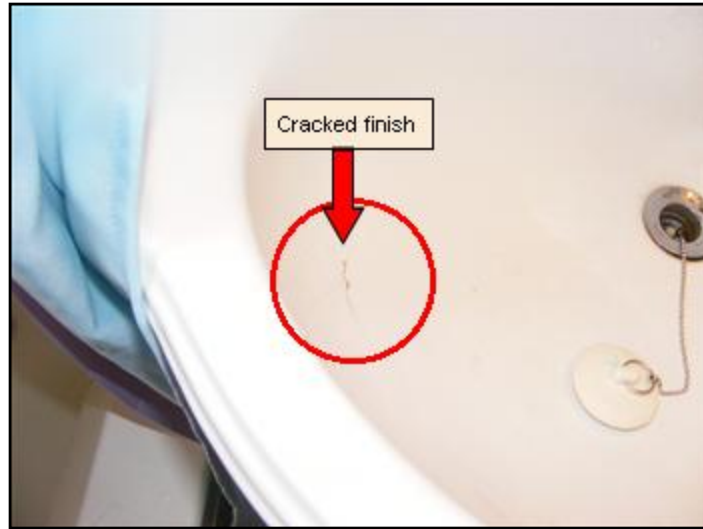
36.

**Condition:** • [Surface defects](#)

**Implication(s):** Cosmetic defects | Hygiene issue

**Task:** Monitor

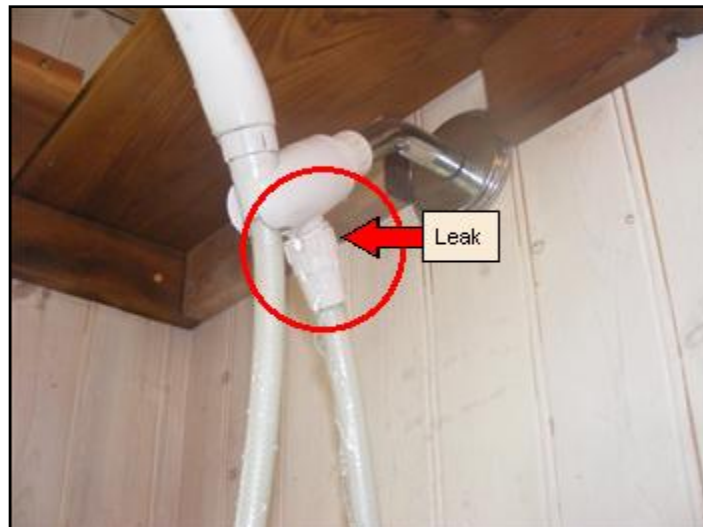
37.

**Condition:** • [Leak](#)

**Implication(s):** Chance of water damage to contents, finishes and/or structure

**Task:** Repair

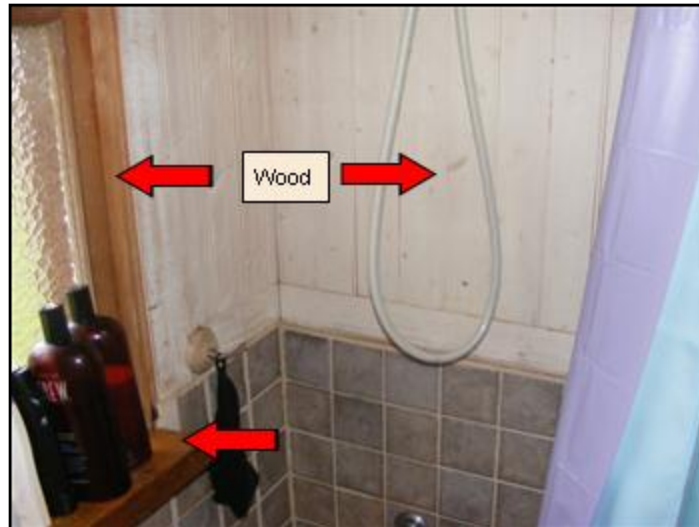
38.

**Condition:** • [Not smooth, impervious or water resistant](#)

**Implication(s):** Cosmetic defects | Hygiene issue

**Task:** Improve

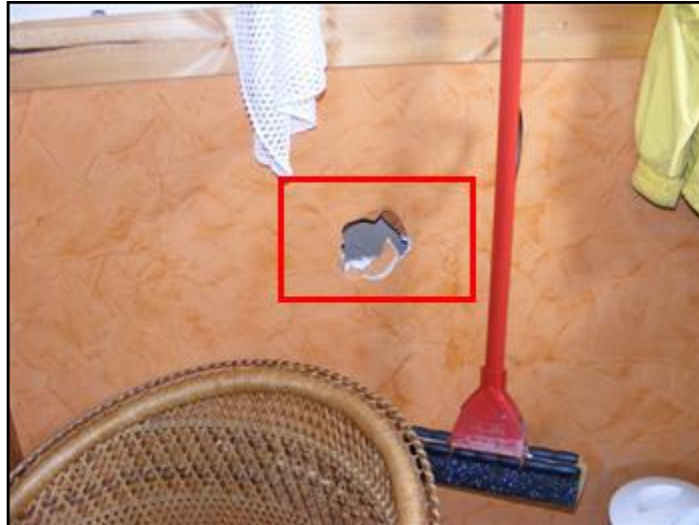
40.

**Condition:** • Damaged

**Implication(s):** Cosmetic defects

**Task:** Repair

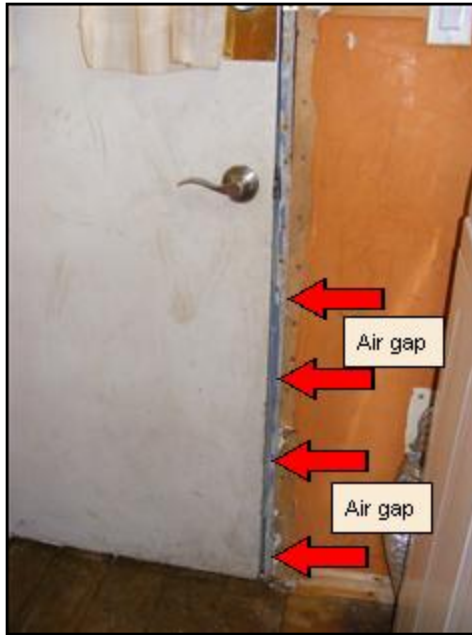
41.

**Condition:** • [Weatherstripping missing or ineffective](#)

**Task:** Improve

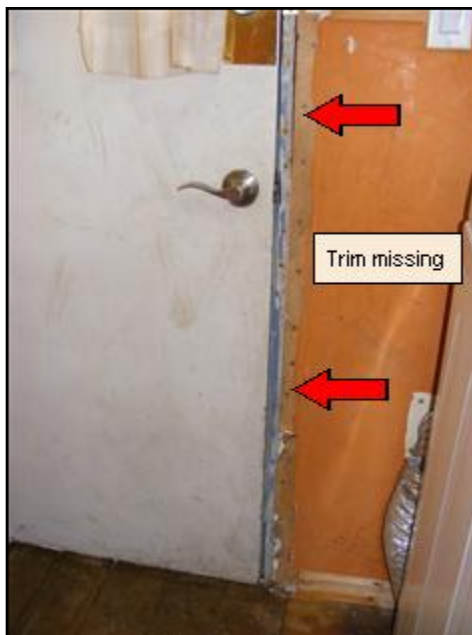
42.

**Condition:** • [Missing](#)

**Implication(s):** Cosmetic defects

**Task:** Replace

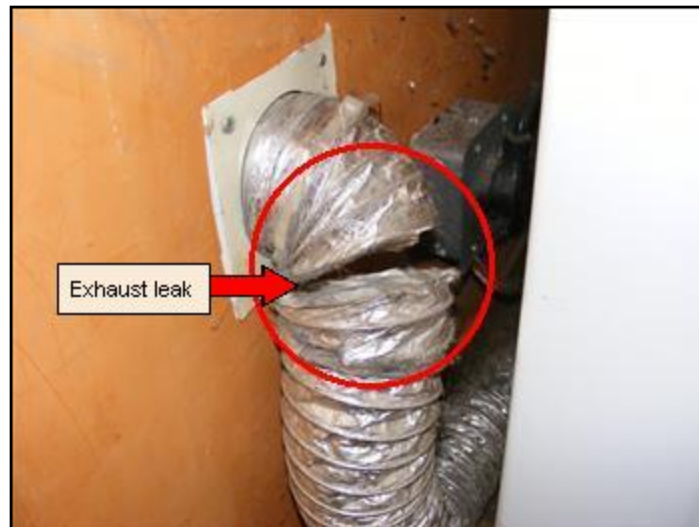
43.

**Condition:** • Not vented to exterior

**Implication(s):** Chance of condensation damage to finishes and/or structure

**Task:** Repair
