YOUR INSPECTION REPORT

123 Any Street
Anytown, KS 11111

Monday, August 22, 2011

RE: Report No. 1160, v.6
123 Any Street
Anytown, KS
11111

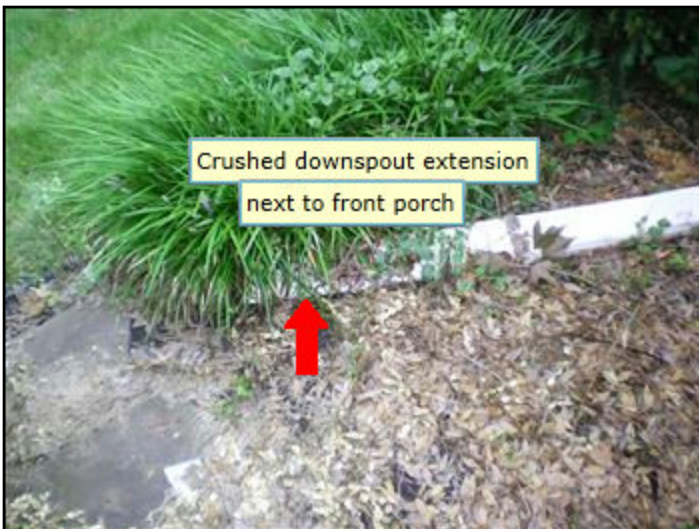
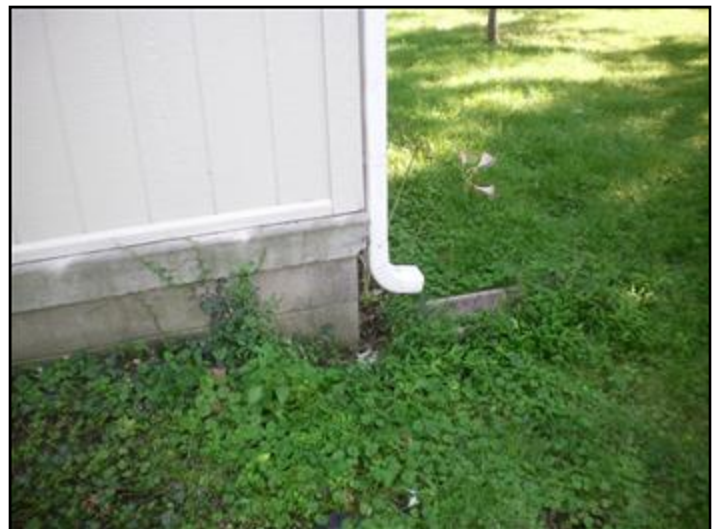
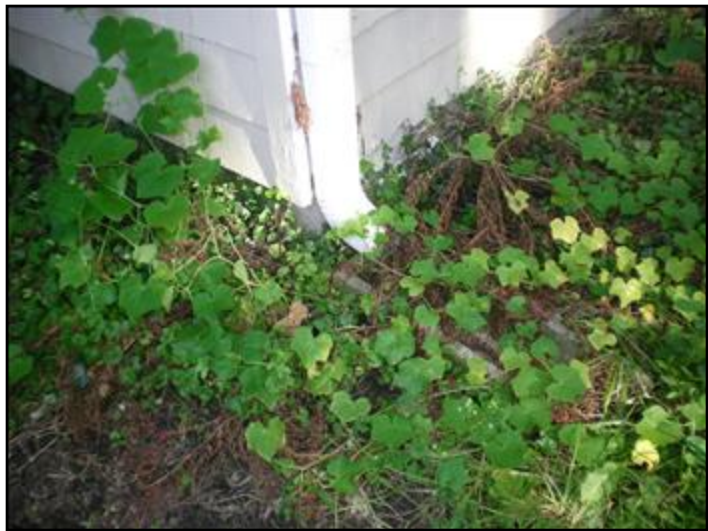
1. Condition: • Should discharge 6ft. from home

1. Should discharge 6ft. from home

2. Should discharge 6ft. from home

3. Should discharge 6ft. from home

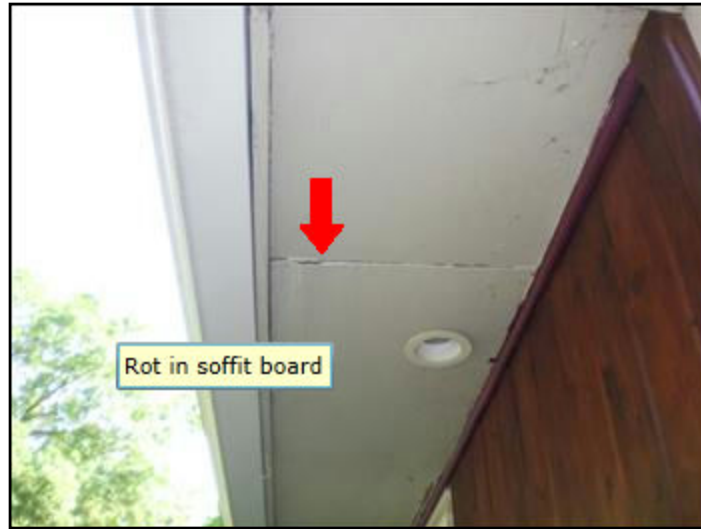
2. Condition: • [Rot or insect damage](#)

4. Rot or insect damage

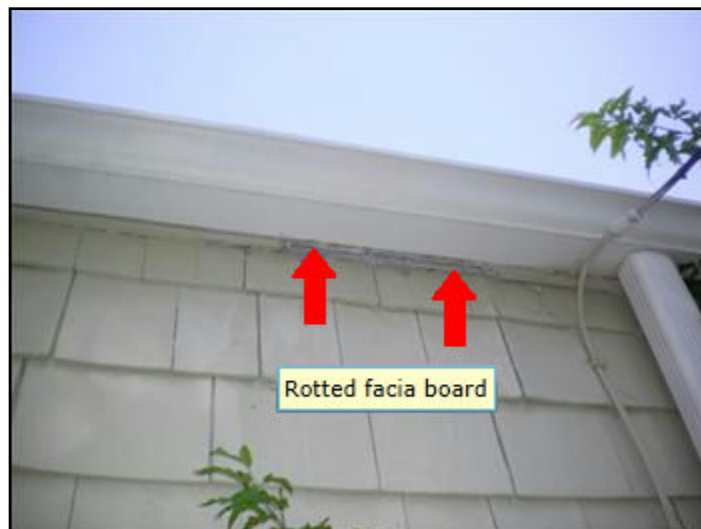
3. Condition: • [Rot or insect damage](#)

5. Rot or insect damage

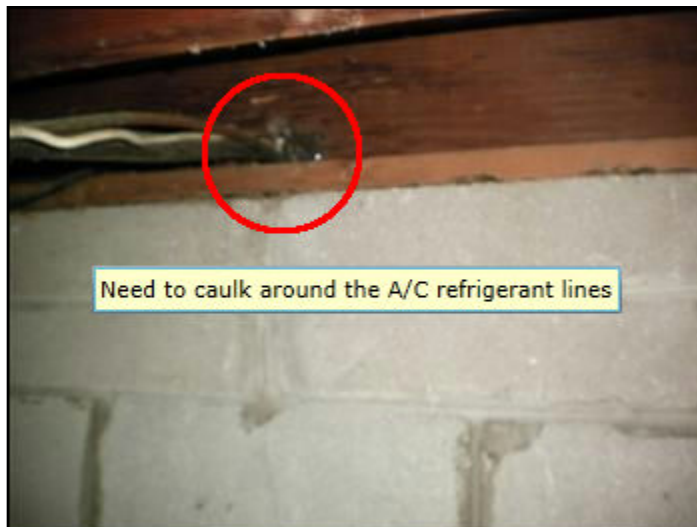
4. Condition: • [Caulking missing or ineffective](#)

6. Caulking missing or ineffective

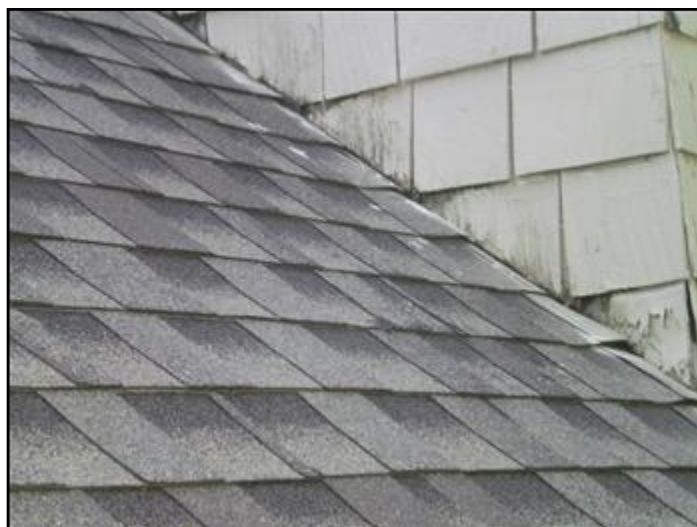
5. Condition: • [Cracked, split or broken](#)

7. Cracked, split or broken

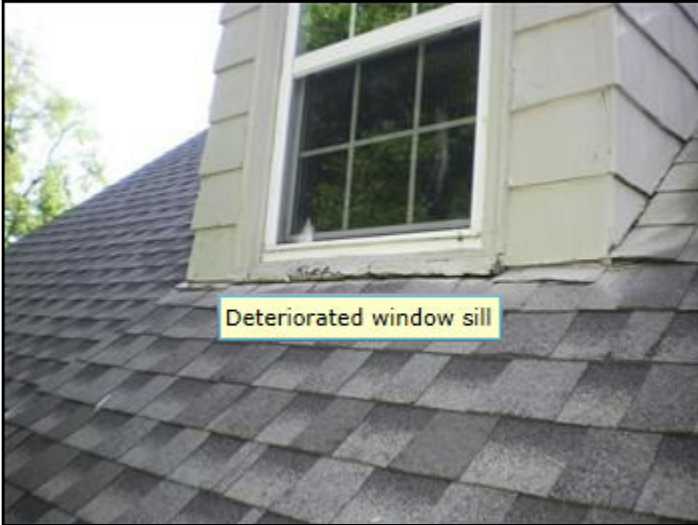
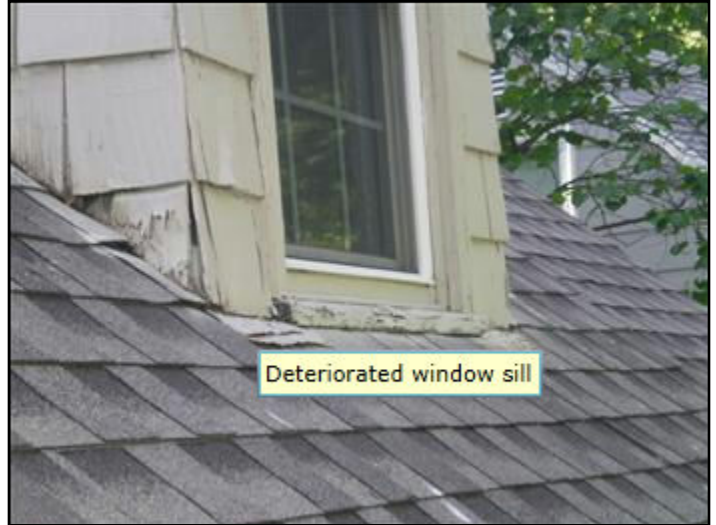
6. Condition: • [Rot](#)

8. Rot

9. Rot

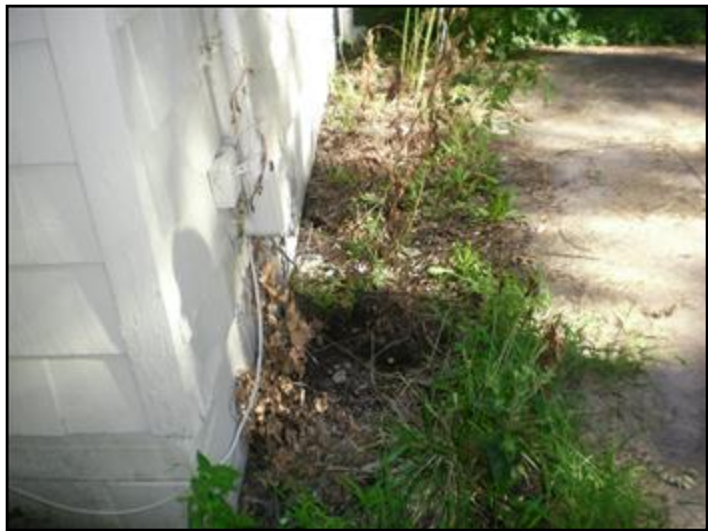
7. Condition: • [Improper slope](#)

Grading needs improvement in various places all around. One inch of fall per foot for six feet away from the house is recommended.

10. *Improper slope*

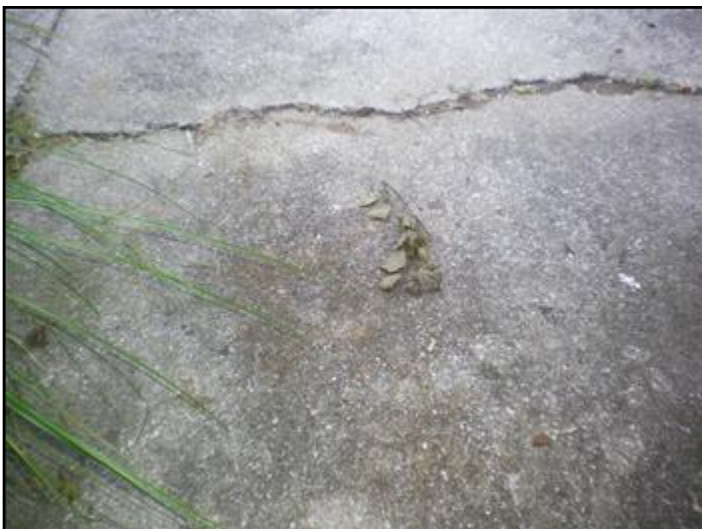
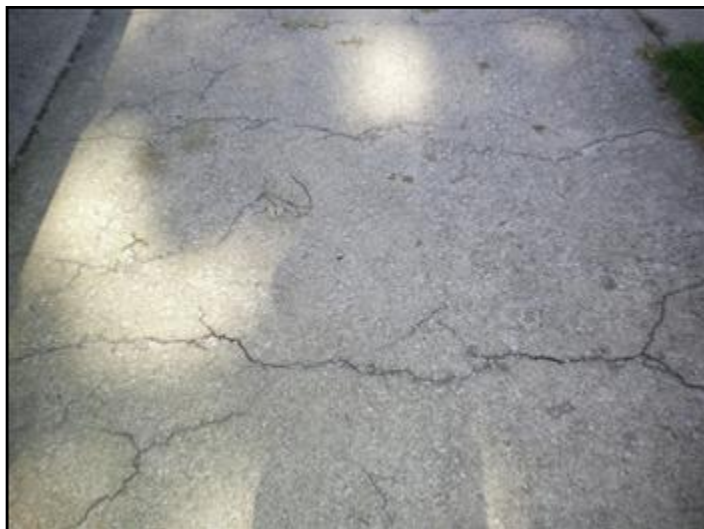
8. Condition: • [Cracked or damaged surfaces](#)

The driveway is cracked and spalling in places but still serviceable.

11. *Cracked or damaged surfaces*

12. *Cracked or damaged surfaces*

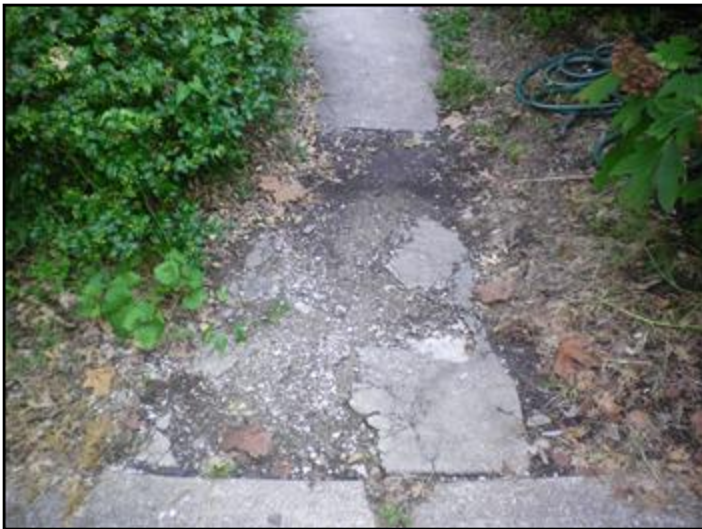
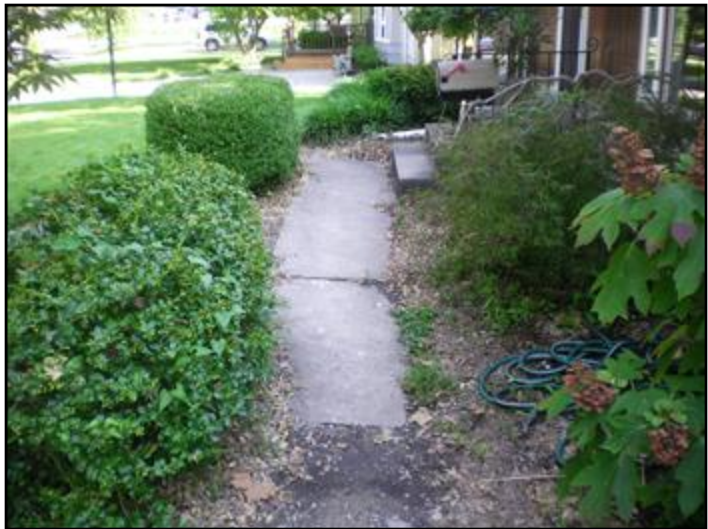
9. Condition: • [Improper slope or drainage](#)

The front walk is badly deteriorated and sloping toward the house.

13. *Improper slope or drainage*

14. *Improper slope or drainage*

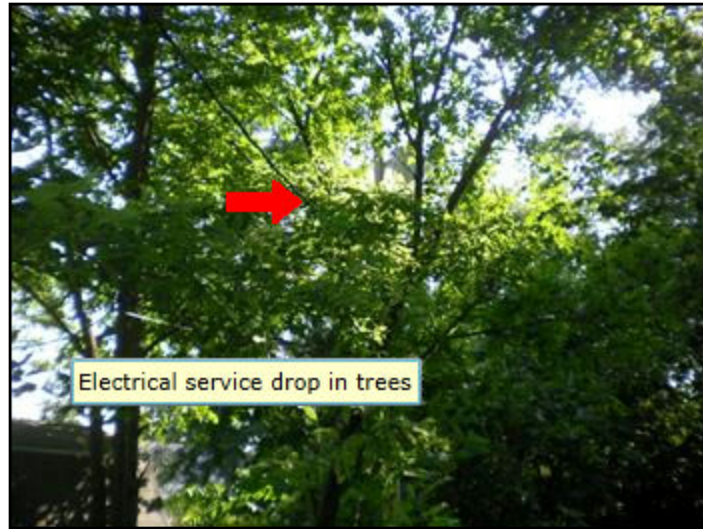
- SERVICE DROP AND SERVICE ENTRANCE \ Service drop**
- 10. Condition:** • [Branches, vines interfering with wires](#)
 - Implication(s):** Damage to wire | Electric shock | Interruption of electrical service
 - Location:** Rear Exterior
 - Task:** Correct
 - Time:** Immediate
 - Cost:** Minor

15. Branches, vines interfering with wires

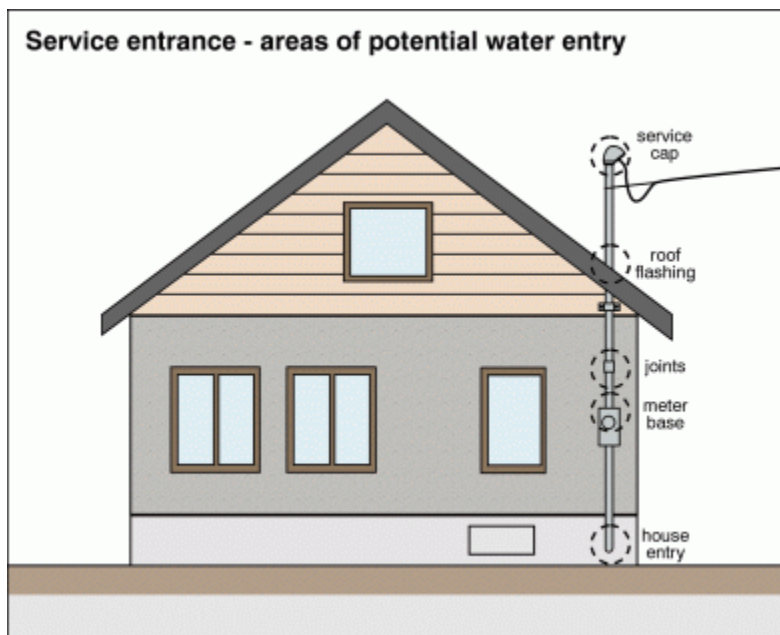
11. Condition: • [Rust or water in panel](#)

There is rust and corrosion on connections in the main electrical panel.

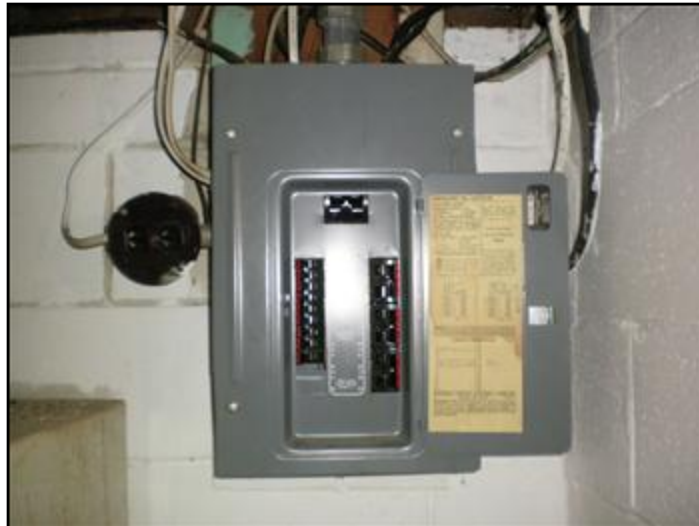
12. Condition: • [Obsolete](#)

The main electrical panel is a Federal Pacific Stab-Lok brand. These panels have proved to be fire hazards due to poor connections. It should be replaced with a modern panel by a qualified licensed electrician. The work should be done in accordance with all municipal requirements.

16. *Obsolete*

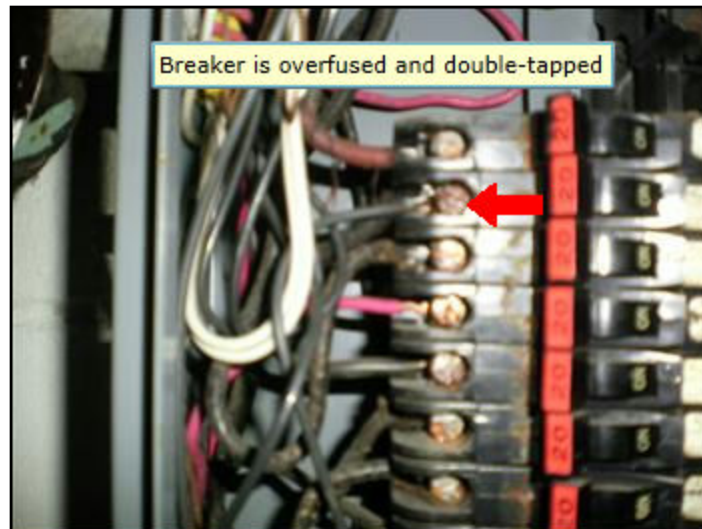
13. Condition: • [Double taps](#)

17. Double taps

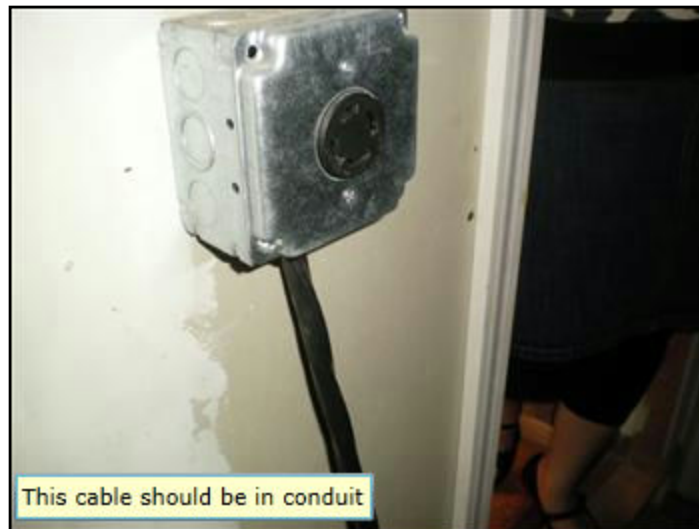
14. Condition: • [Exposed on walls or ceilings](#)

18. Exposed on walls or ceilings

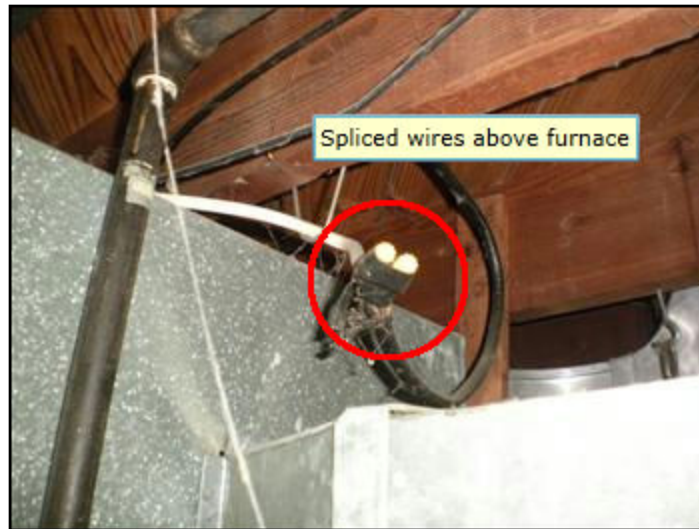
15. Condition: • [Open splices](#)

19. Open splices

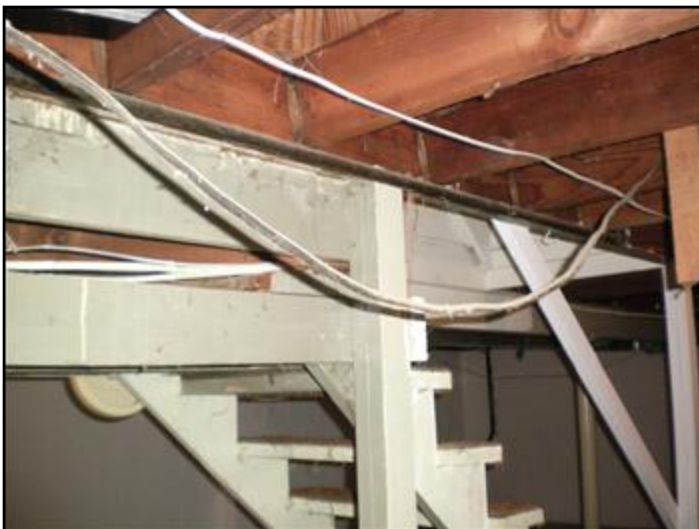
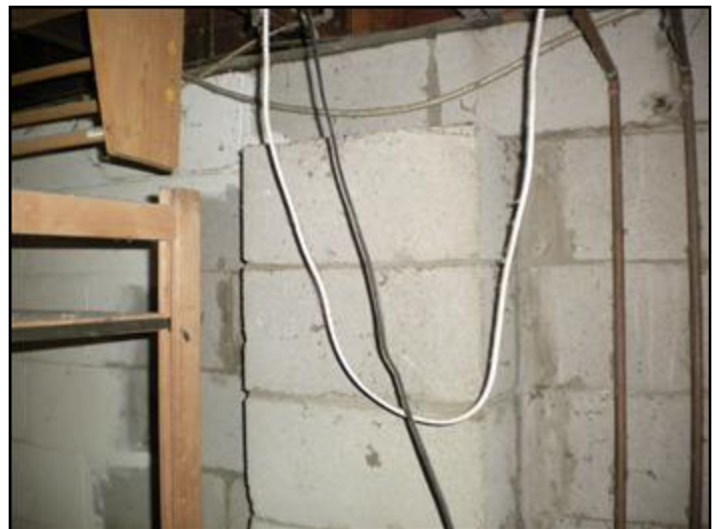
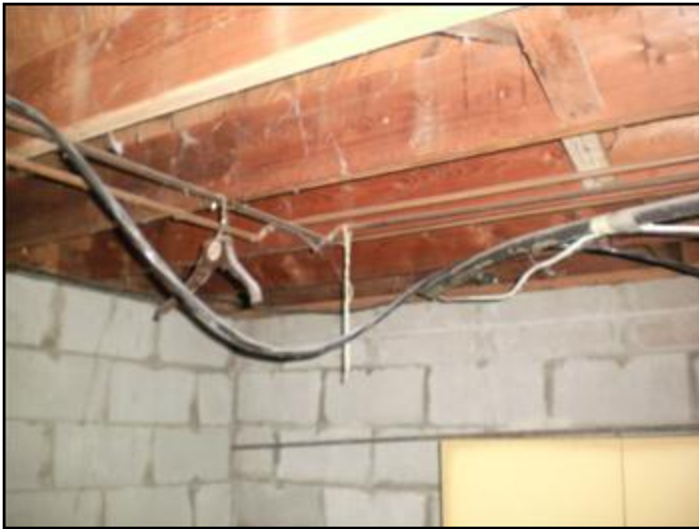
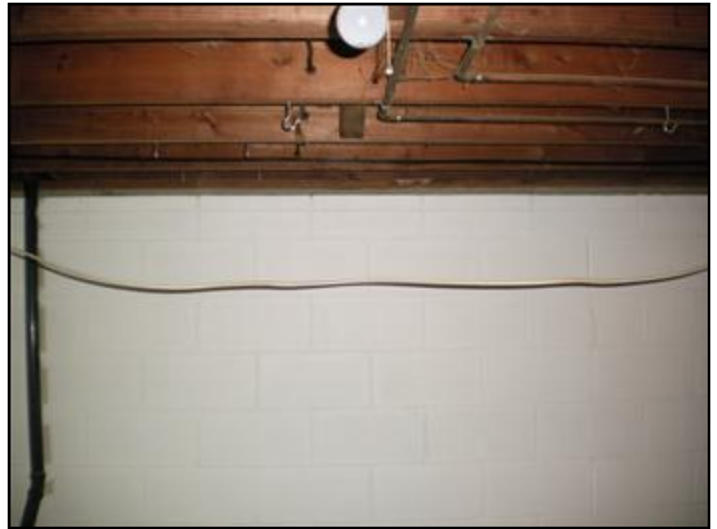
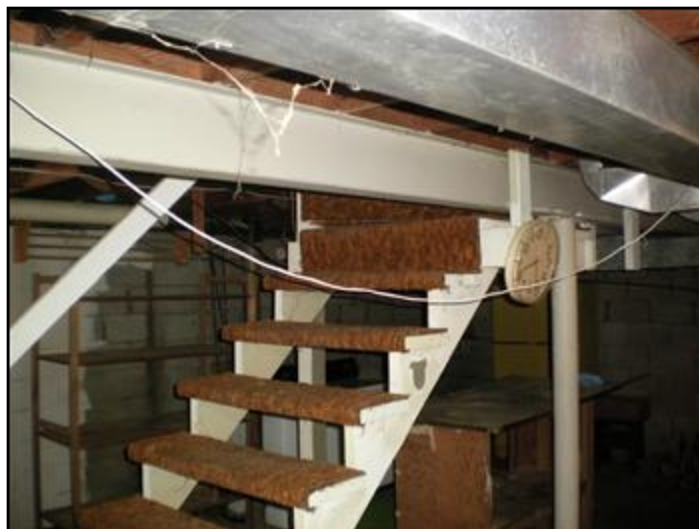
16. Condition: • [Not well secured](#)

20. Not well secured

21. Not well secured

22. Not well secured

23. Not well secured

24. Not well secured

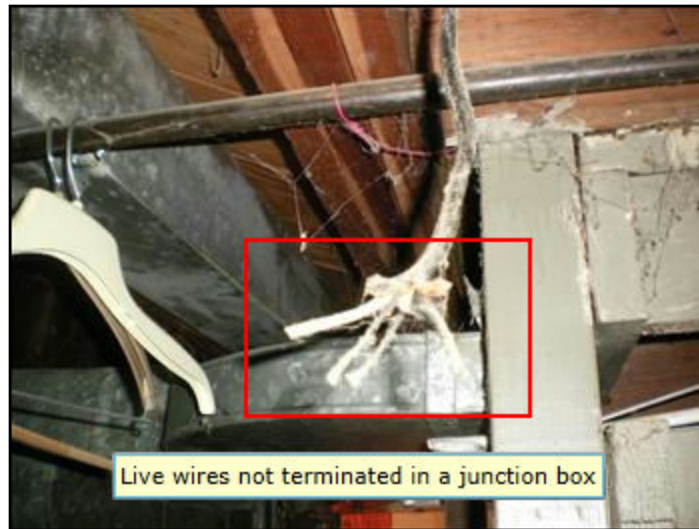
17. Condition: • [Abandoned wire](#)

25. Abandoned wire

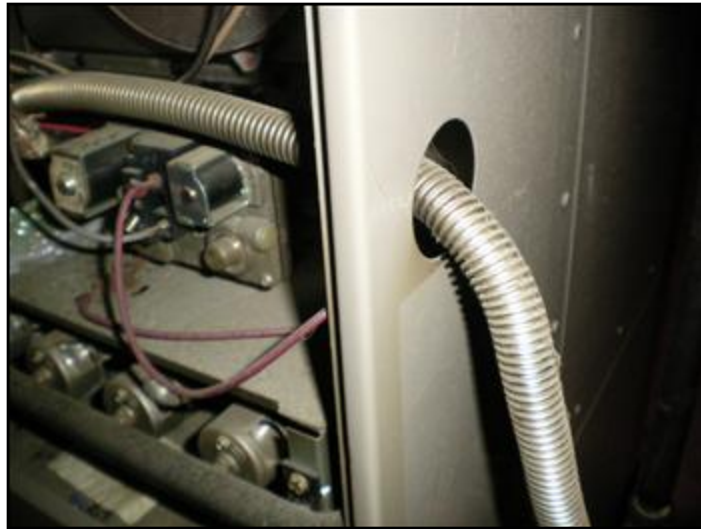
A flexible gas connector is run through the furnace cabinet - should be steel pipe only.

19. Condition: • [Inappropriate materials](#)

26. *Inappropriate materials*

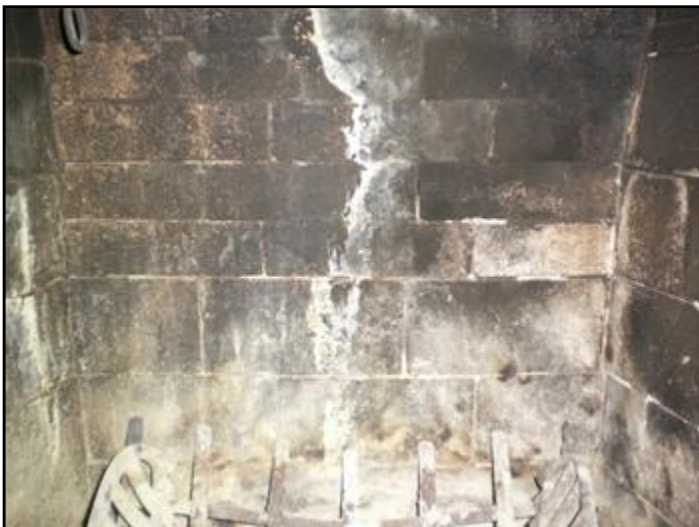
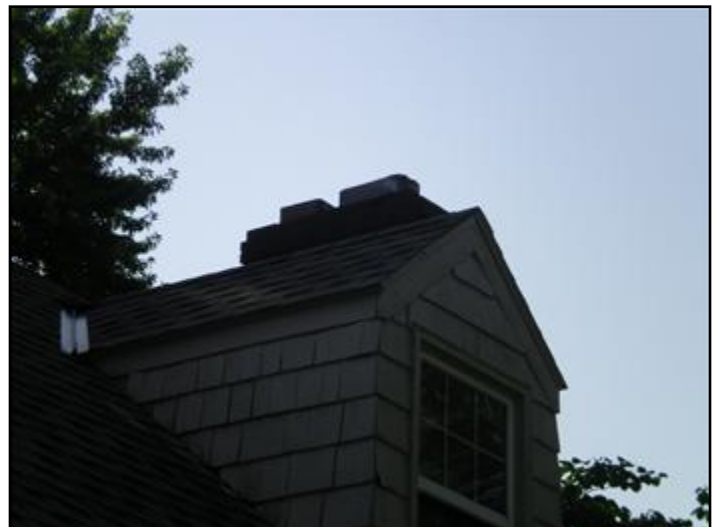
20. Condition: • Inspect chimney, and sweep, if needed before using
Recommend a qualified professional chimney sweep to evaluate the firebox and chimney, in their entirety, and clean/repair as needed. Note: It is evident that some repairs are needed inside and out. Also, caps and screens should be installed on both flues.

27. *Inspect chimney, and sweep, if needed before using*

28. *Inspect chimney, and sweep, if needed before using*

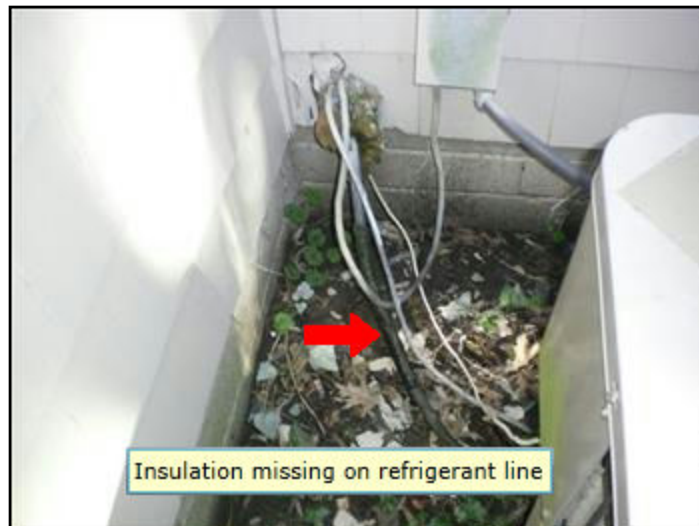
21. Condition: • [Missing insulation](#)

29. Missing insulation

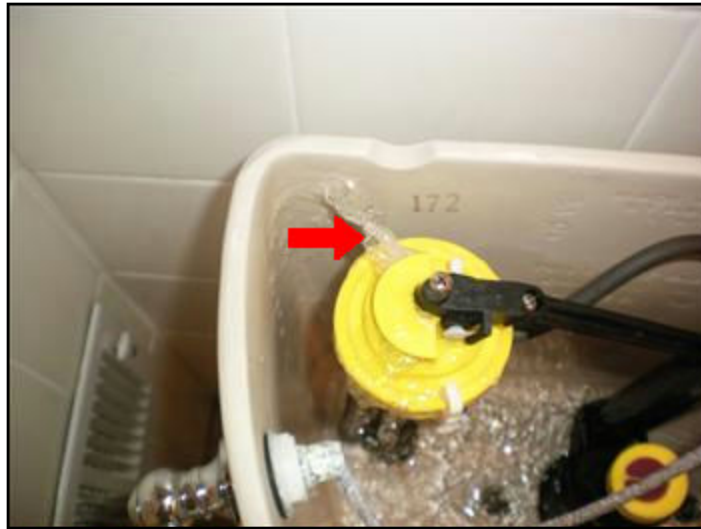
22. Condition: • [Leak](#)

The tank fill valve is leaking.

30. Leak

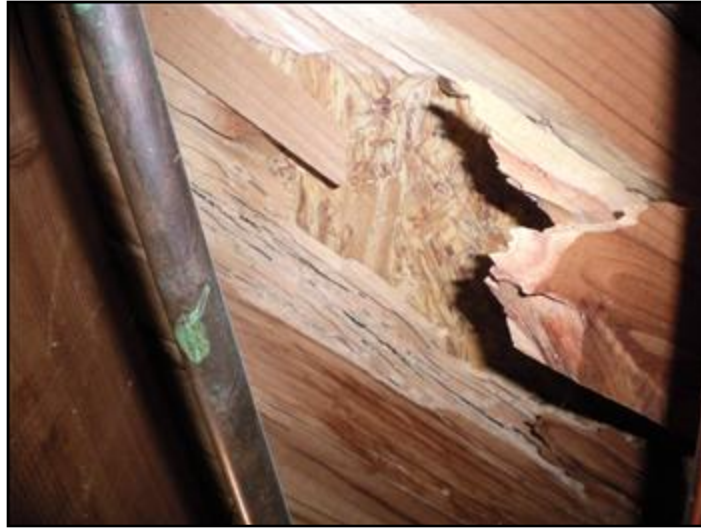
24. Condition: • [Damage](#)

There is termite-damaged sub-floor under the kitchen.

31. *Damage*

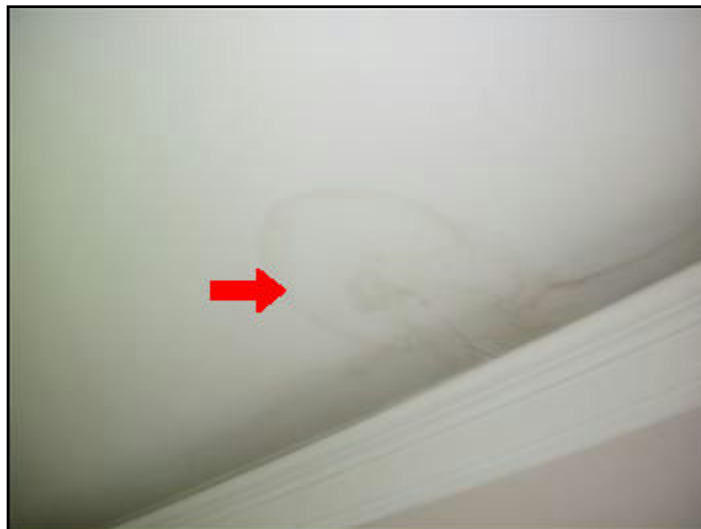
25. Condition: • Stains

Note: There are stains on the ceiling of the converted screened porch. They were dry at the time of the inspection. It appears that these stains may have occurred prior to roof replacement.

32. *Stains*

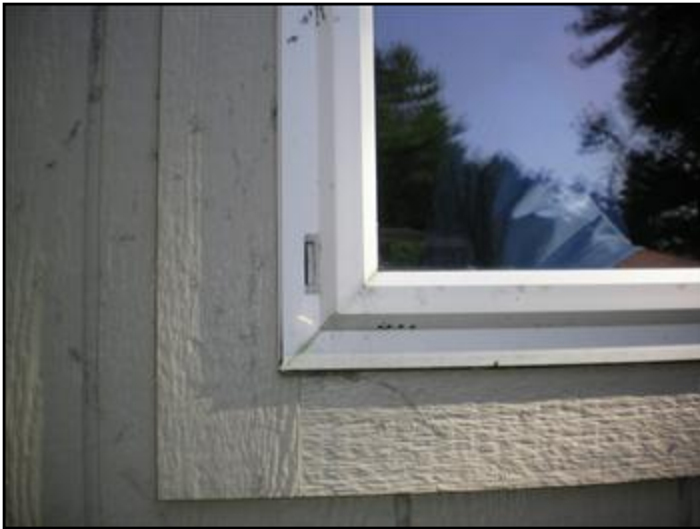
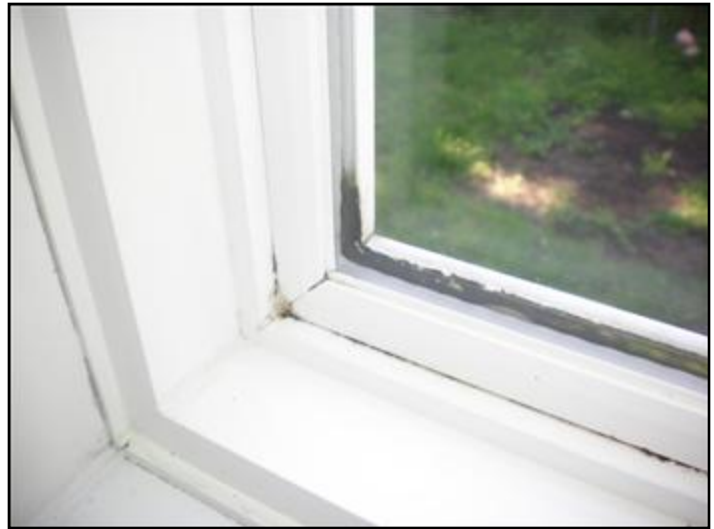
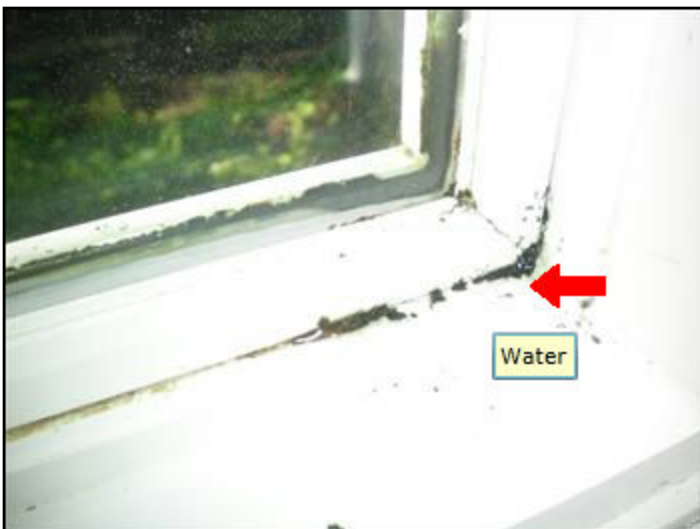
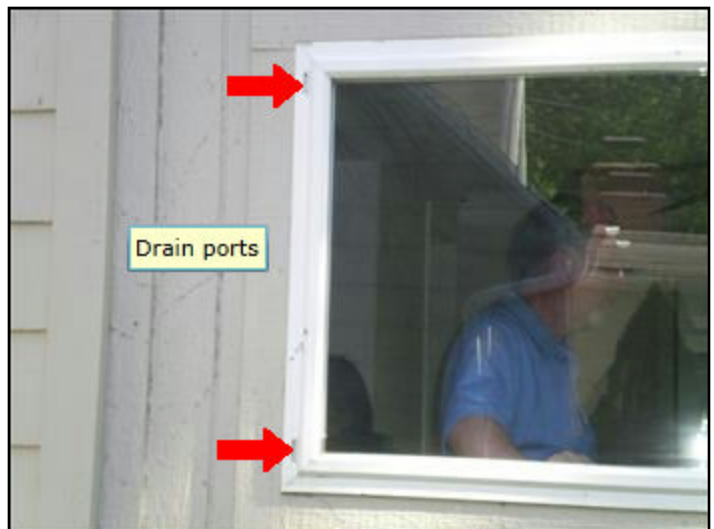
26. Condition: • [Water leaks](#)

The window installed in the north family room wall appears to be manufactured for vertical installation but installed horizontally. Water is leaking into the window and into the house. Consult a window expert for evaluation and repair/replacement recommendations.

33. Water leaks

34. Water leaks

35. Water leaks

36. Water leaks

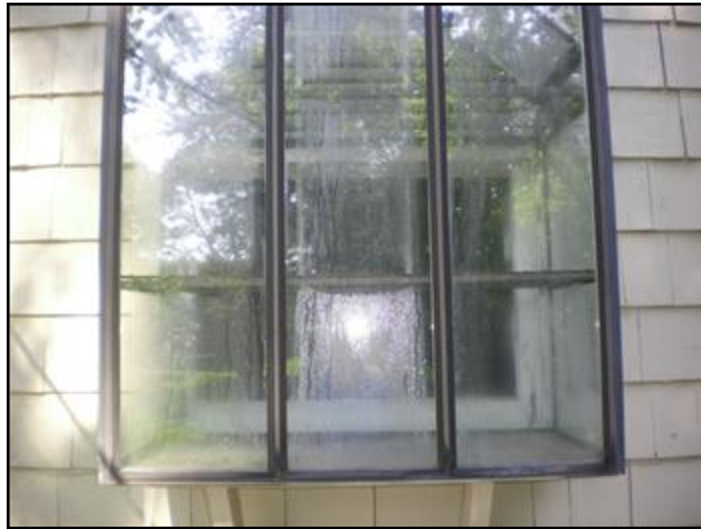
27. Condition: • [Lost seal on double or triple glazing](#)

37. Lost seal on double or triple glazing

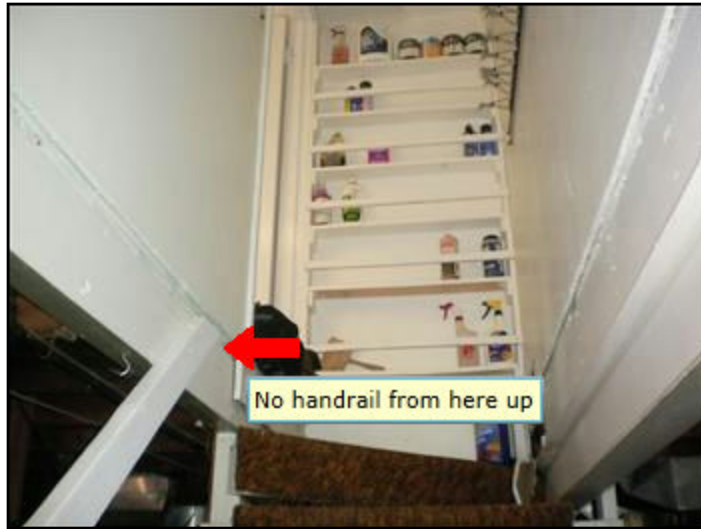
28. Condition: • **Missing**

38. Missing

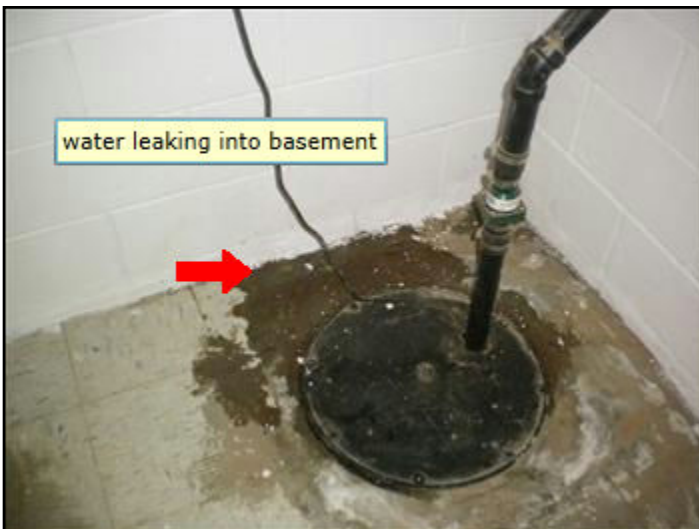
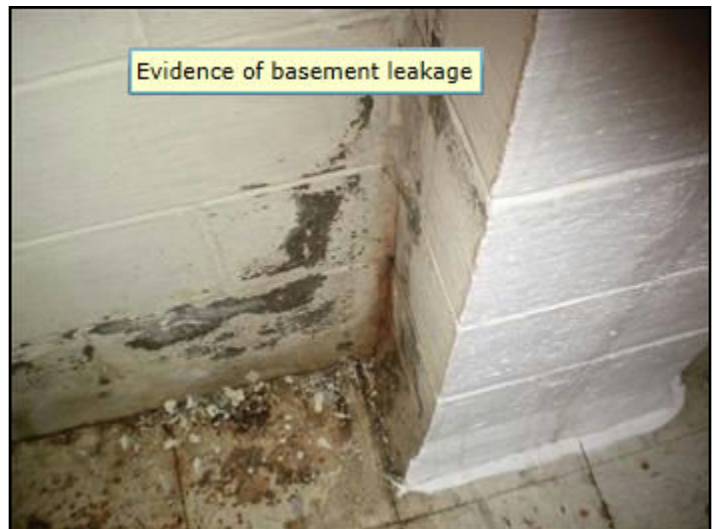
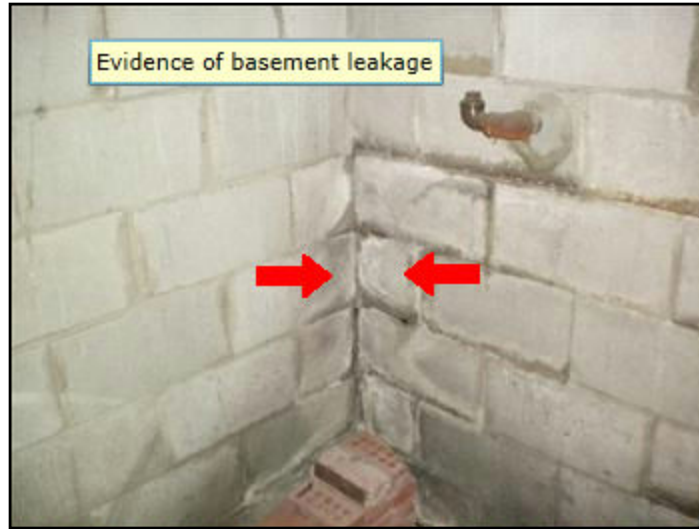
30. Condition: • [Leakage - See EXTERIOR section for relevant recommendations](#)

There is evidence of basement leakage in numerous places. Hopefully, recommended outdoor measures will minimize the problem.

39. Leakage - See EXTERIOR section for relevant recommendations

40. Leakage - See EXTERIOR section for relevant recommendations

41. Leakage - See EXTERIOR section for relevant recommendations

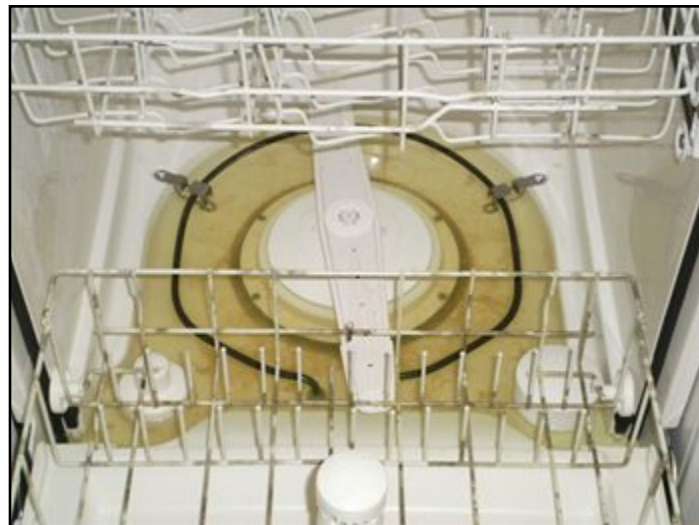
The dishwasher will not pump water out.

31. Condition: • Inoperative

42. Inoperative

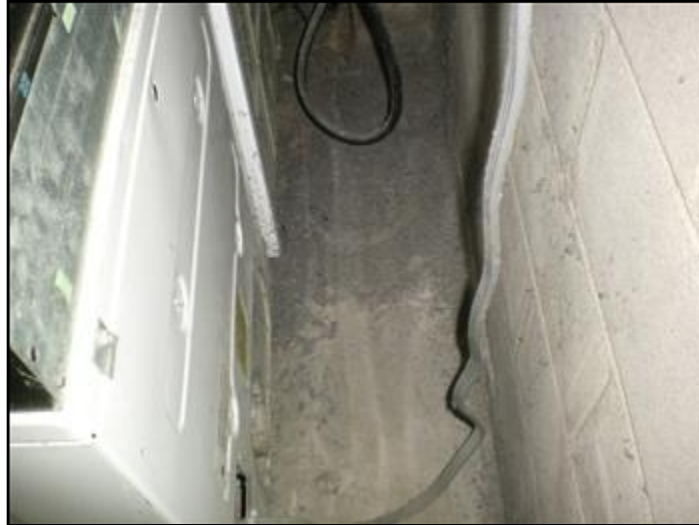
32. Condition: • Not vented to exterior

43. *Not vented to exterior*
