Your Inspection Report

123 Karter Street
Saskatoon, SK

Tuesday, October 9, 2012

RE: Report No. 1014, v.6
123 Karter Street
Saskatoon, SK

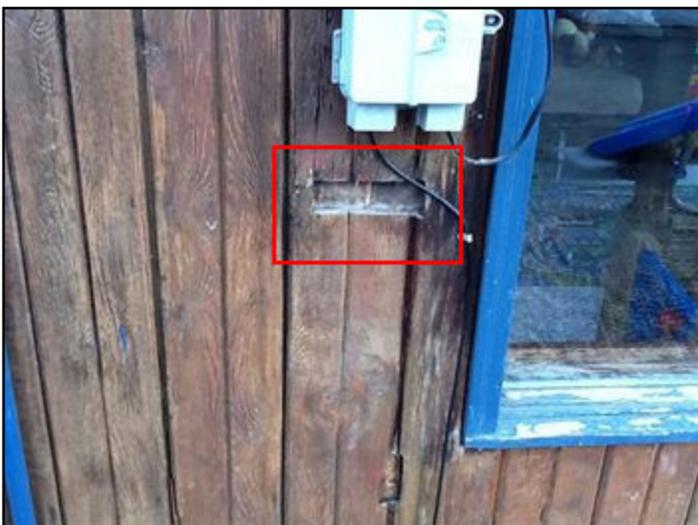
Condition: • Cracked, split or broken

There are many holes and open bare spots exposing paper and sheathing behind

Implication(s): Cosmetic defects | Chance of water damage to contents, finishes and/or structure

1. Cracked, split or broken

Task: Provide

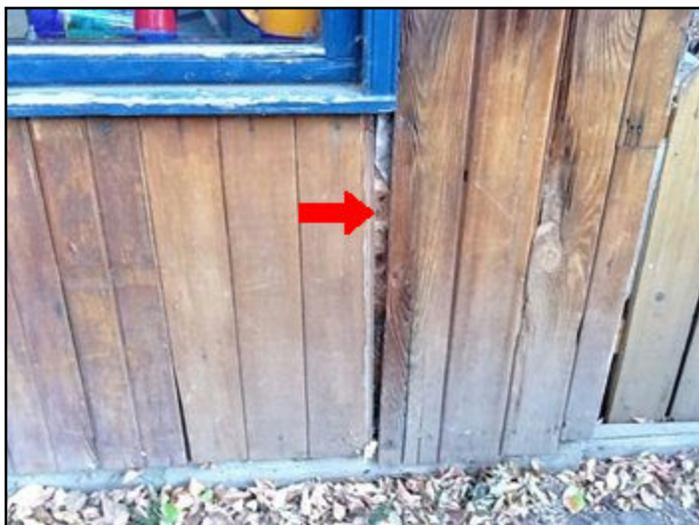
2. Cracked, split or broken

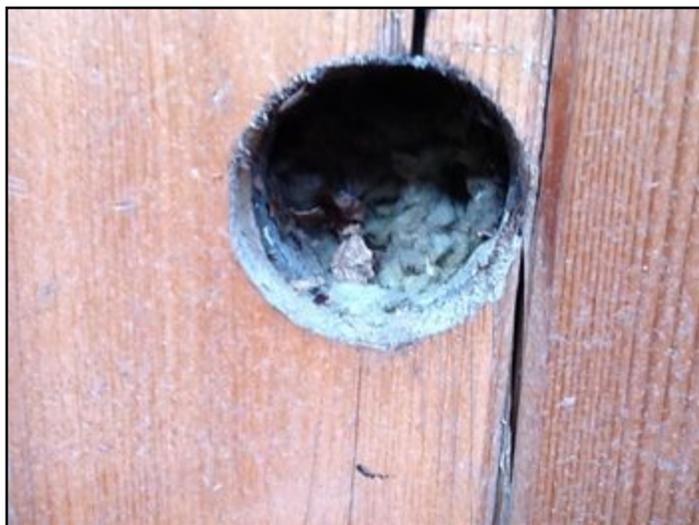
3. Cracked, split or broken

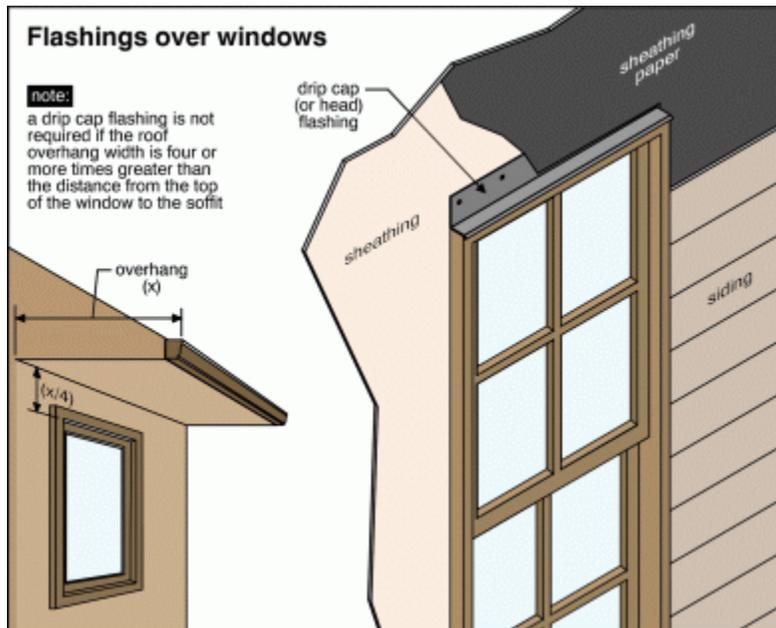
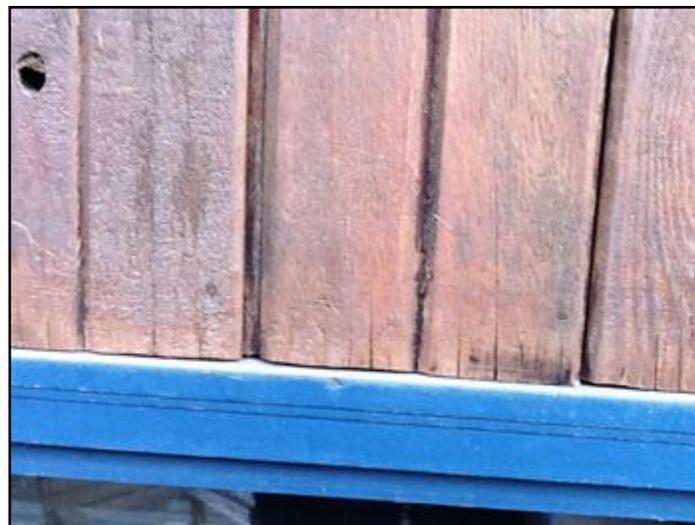
Condition: • Missing

There is no drip cap flashing on top of the windows on the back of the house

Implication(s): Chance of water damage to contents, finishes and/or structure

4. Missing

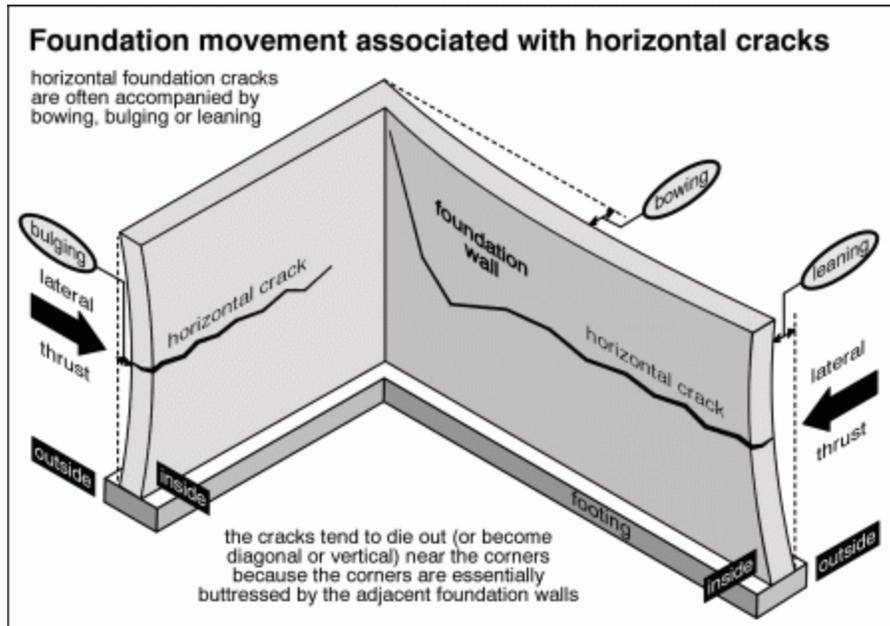
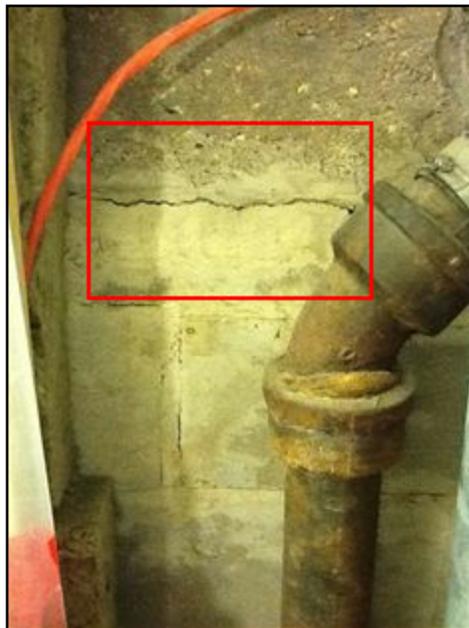
Condition: • Cracked horizontally

There is a crack where the original concrete block foundation meets new footings for the addition and the top of the wall is leaning at the time of inspection

Implication(s): Chance of structural movement

5. Cracked horizontally

Task: Repair

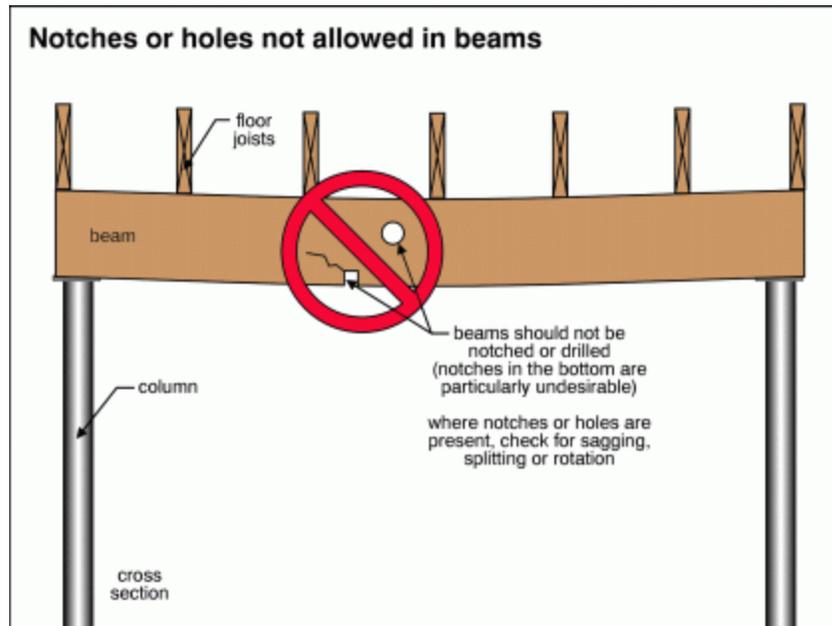
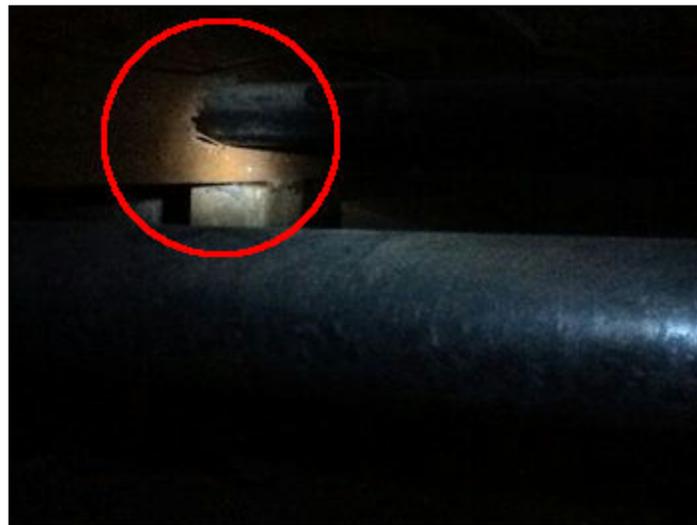
Condition: • Notches or holes

The main beam in crawlspace of add on has 3 inch hole notched in it within 1 foot of load bearing point.

Implication(s): Weakened structure | Chance of structural movement

6. Notches or holes

Task: Repair

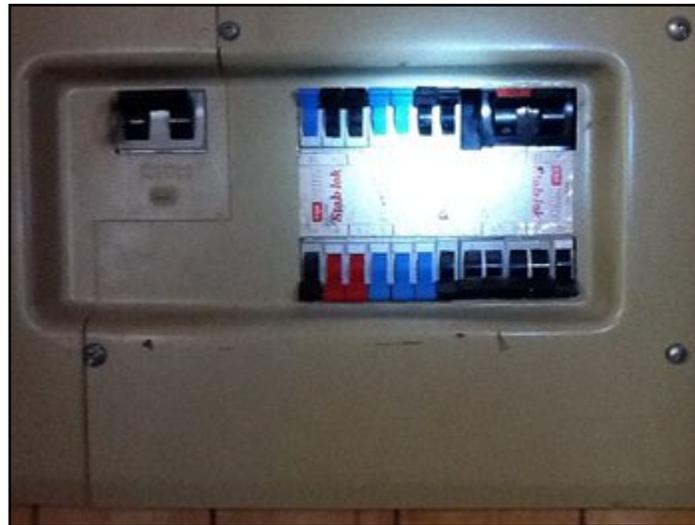
Condition: • Obsolete

The electrical panel is not obsolete but these older models have been known not to trip on overload. It does have the new breakers which have been proven to be much better.

Implication(s): Electric shock | Fire hazard

7. Obsolete

Task: Monitor

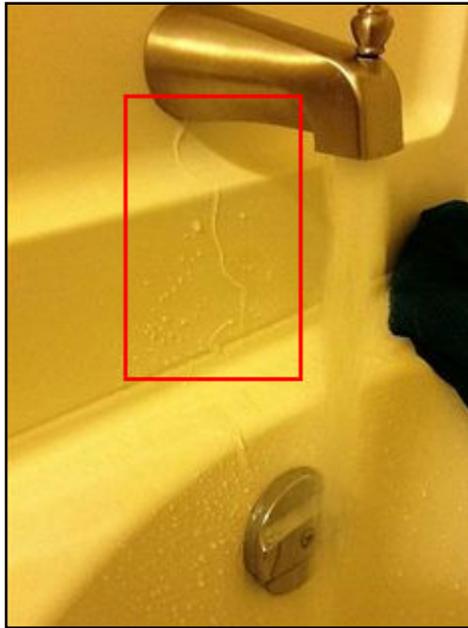
Condition: • Leak

Bath tub leaks from behind the spout. Had water running while looked underneath in crawlspace and saw no water below at time of inspection.

8. Leak

Task: Repair

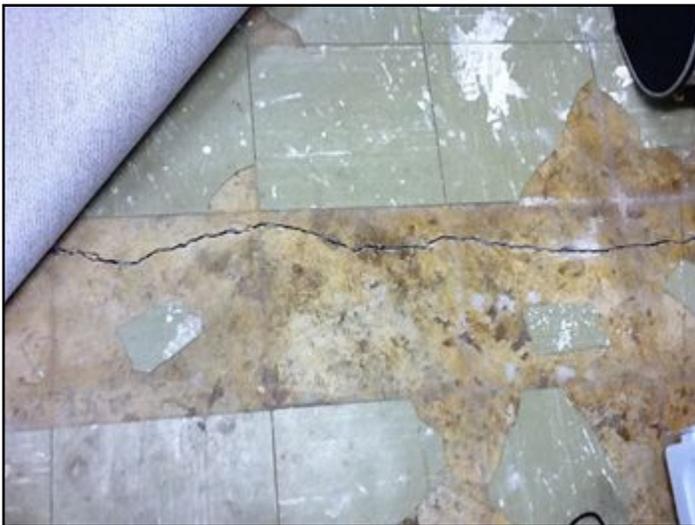
Condition: • Cracked

Basement floor has numerous cracks at the time of inspection and one being relatively large. Cracks are full of cob webs and debris indicating they have been there a while

9. Cracked

Task: Monitor

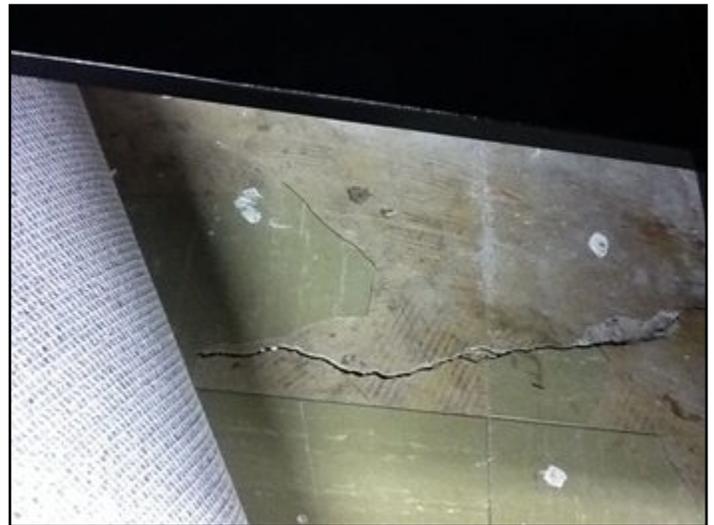
10. Cracked

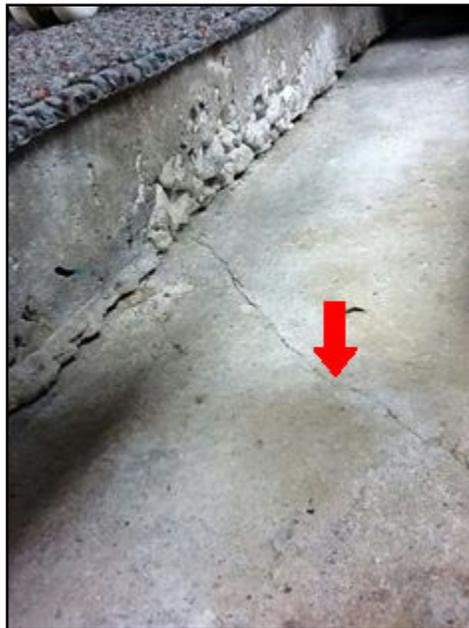
11. Cracked

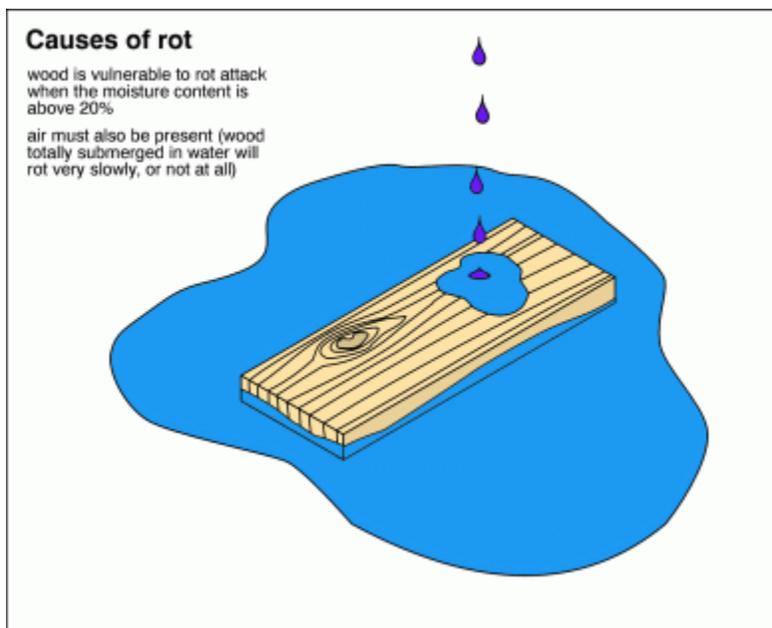
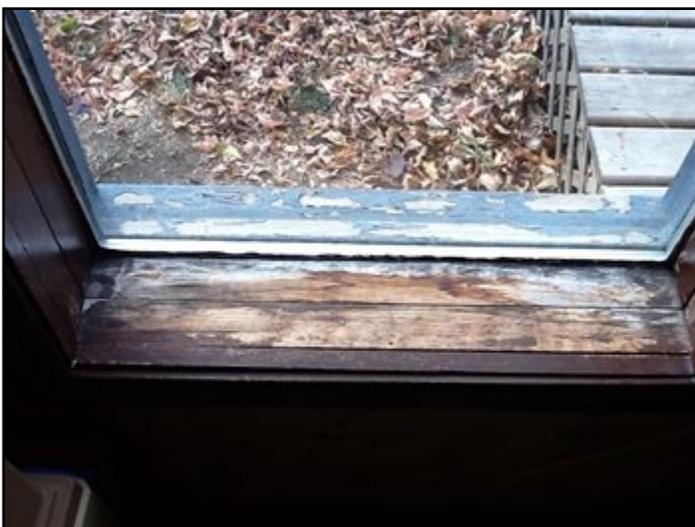
Condition: • Rot

Back windows have excess moisture and show signs of rot at the time of inspection.

Implication(s): Cosmetic defects | Chance of damage to structure | Material deterioration

12. Rot

Task: Replace

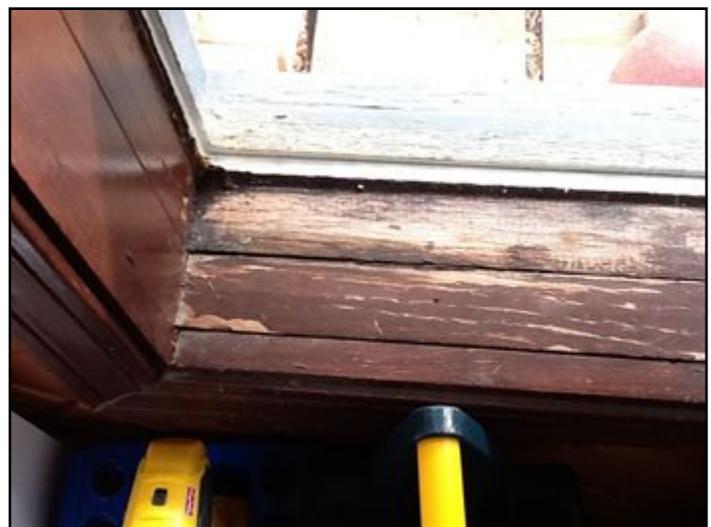
13. Rot

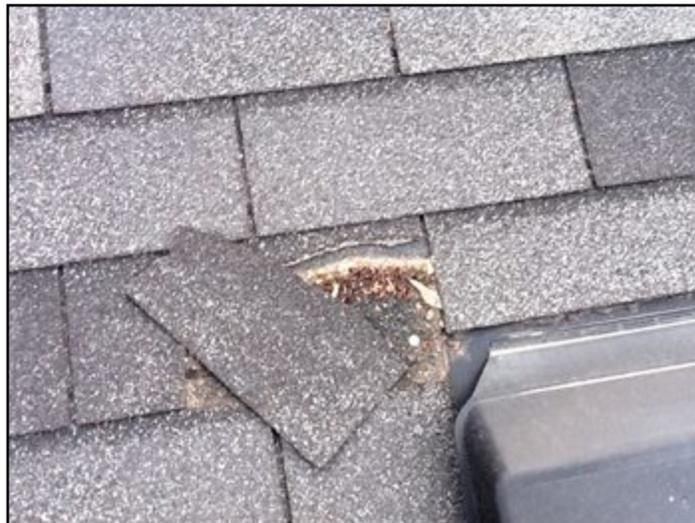
1. Condition: • Damage
piece of shingle broken off

Implication(s): Chance of water damage to contents, finishes and/or structure

14. Damage

Task: Repair

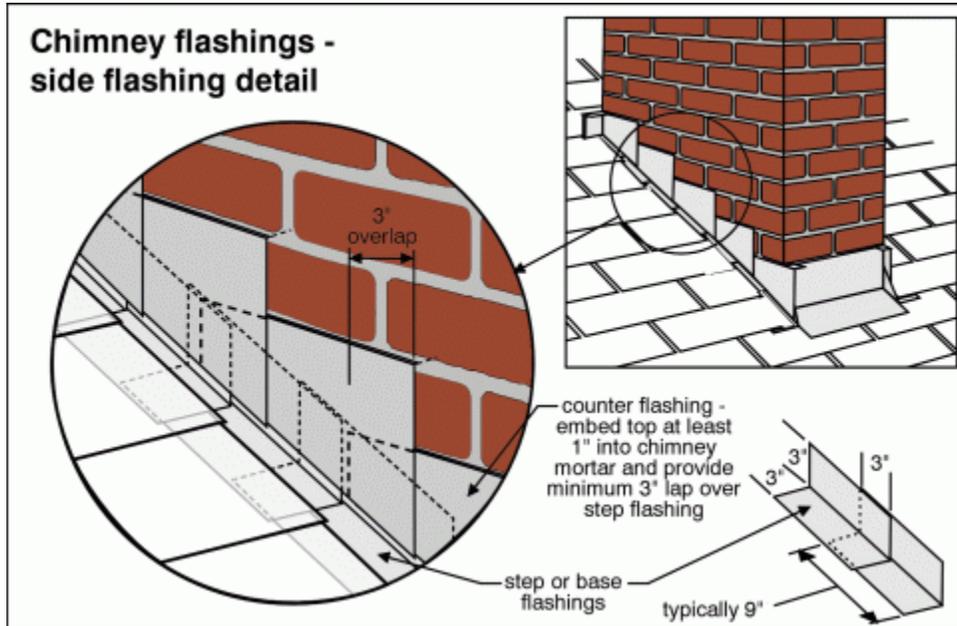
2. Condition: • Not let into mortar joints
flashing was not let into mortar joints but was secure and siliconed.

Implication(s): Chance of water damage to contents, finishes and/or structure

15. *Not let into mortar joints*

Task: Monitor

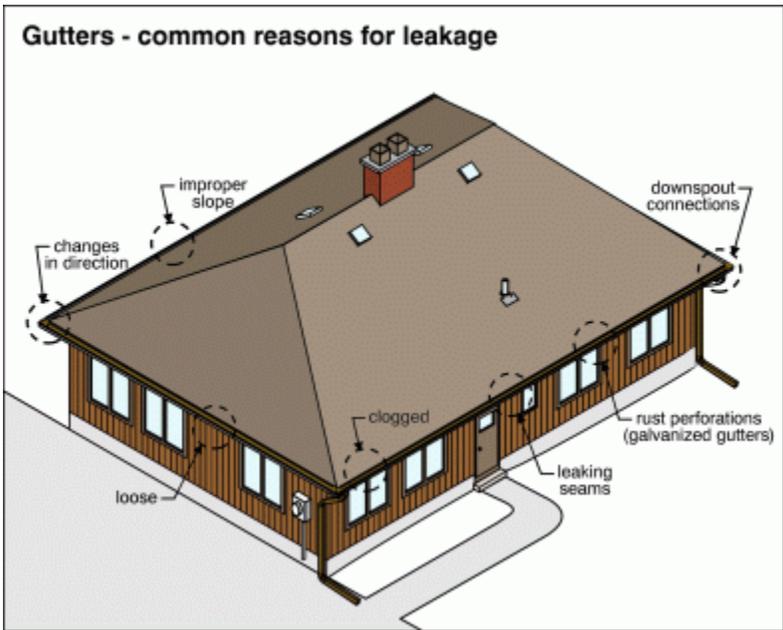
3. Condition: • Clogged
gutters were full of leaves

Implication(s): Chance of water damage to contents, finishes and/or structure

16. Clogged

Task: Clean

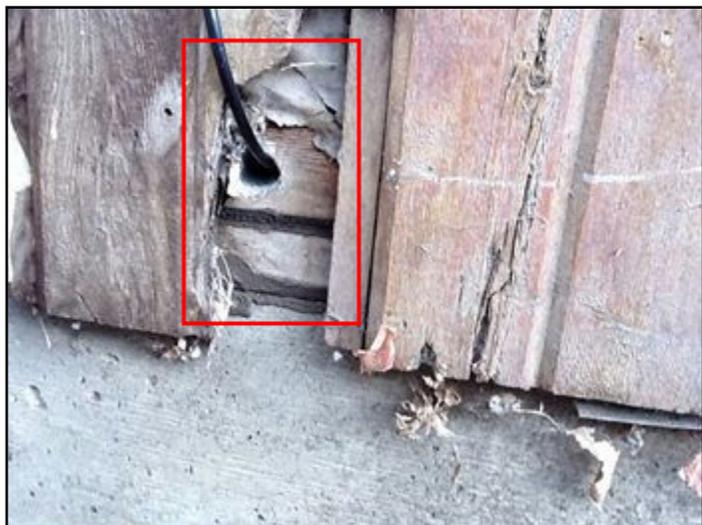
4. Condition: • Caulking missing or ineffective
Implication(s): Chance of water damage to contents, finishes and/or structure
Location: Throughout
Task: Improve
Time: Immediate

17. Caulking missing or ineffective

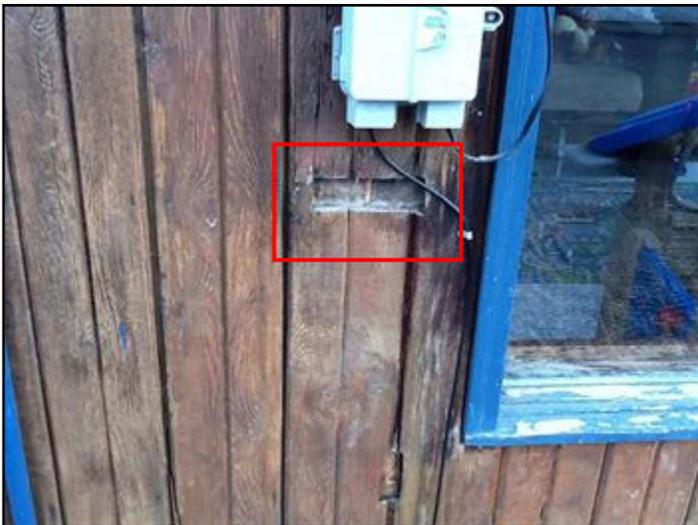
5. Condition: • Cracked, split or broken

There are many holes and open bare spots exposing paper and sheathing behind

Implication(s): Cosmetic defects | Chance of water damage to contents, finishes and/or structure

18. Cracked, split or broken

Task: Provide

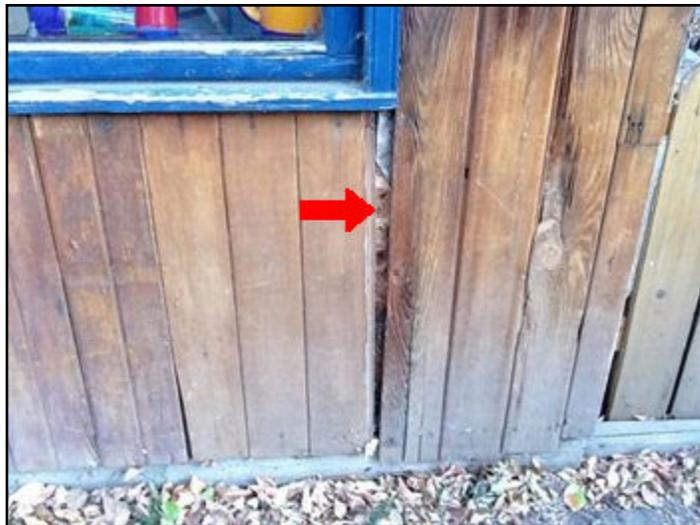
19. Cracked, split or broken

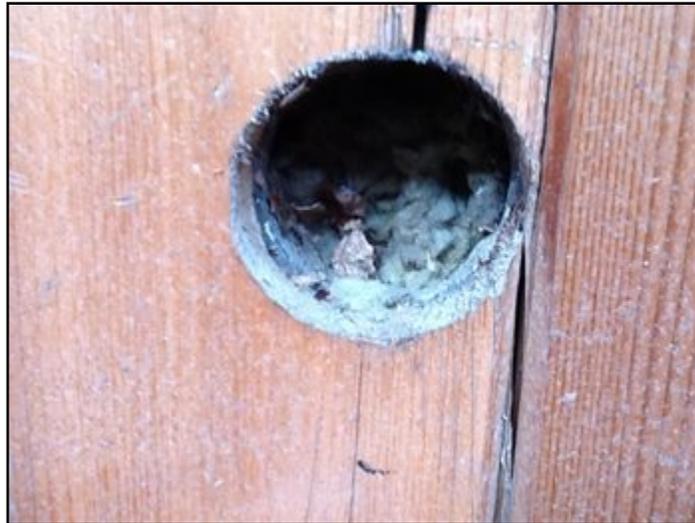
20. Cracked, split or broken

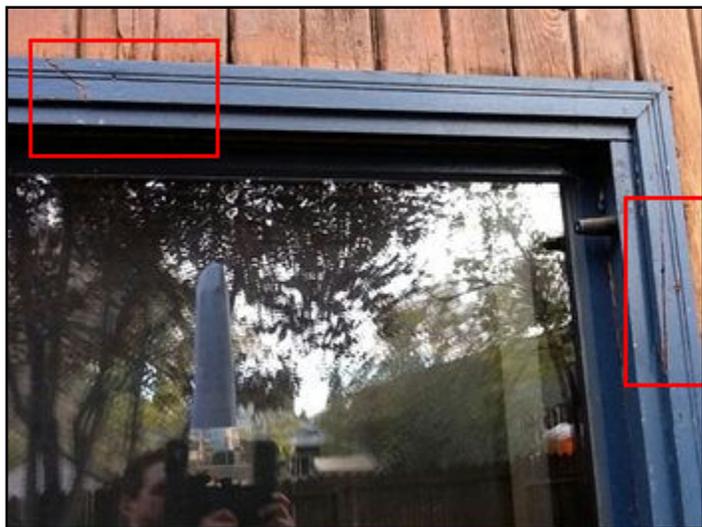
8. **Condition:** • Damage

back picture window has damaged frame.

Implication(s): Cosmetic defects | Chance of water damage to contents, finishes and/or structure

21. Damage

Task: Repair or replace

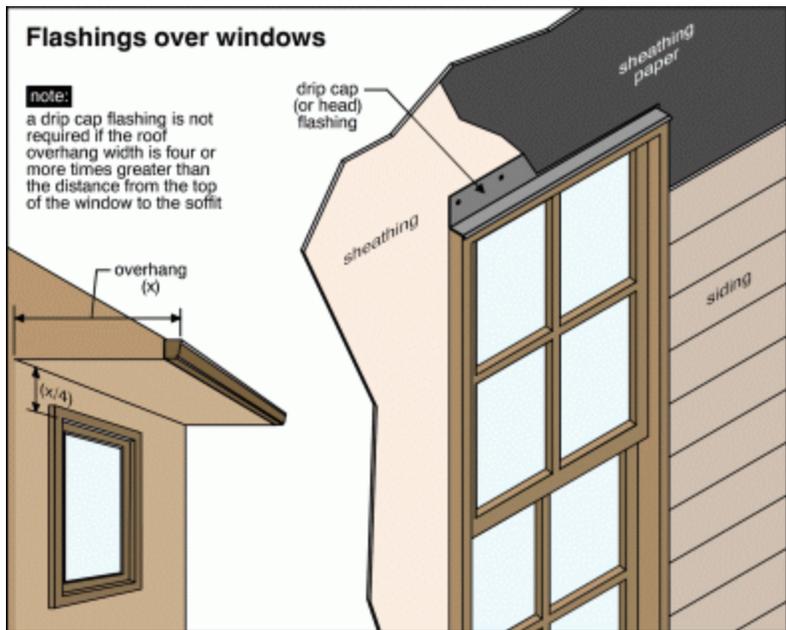
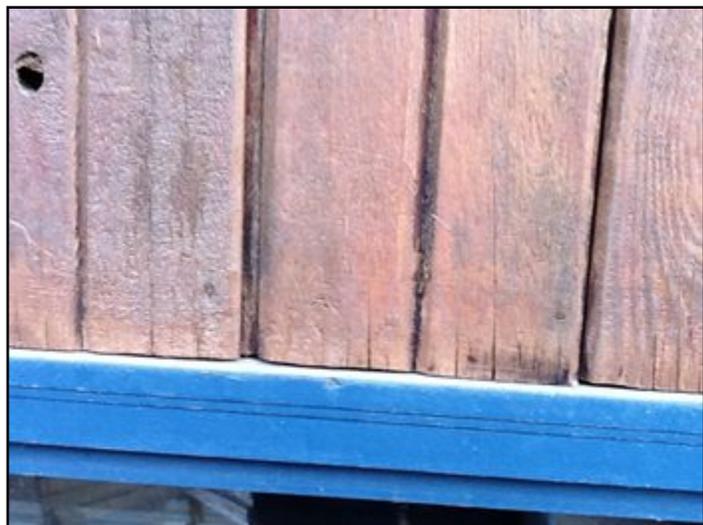
9. Condition: • Missing

There is no drip cap flashing on top of the windows on the back of the house

Implication(s): Chance of water damage to contents, finishes and/or structure

22. Missing

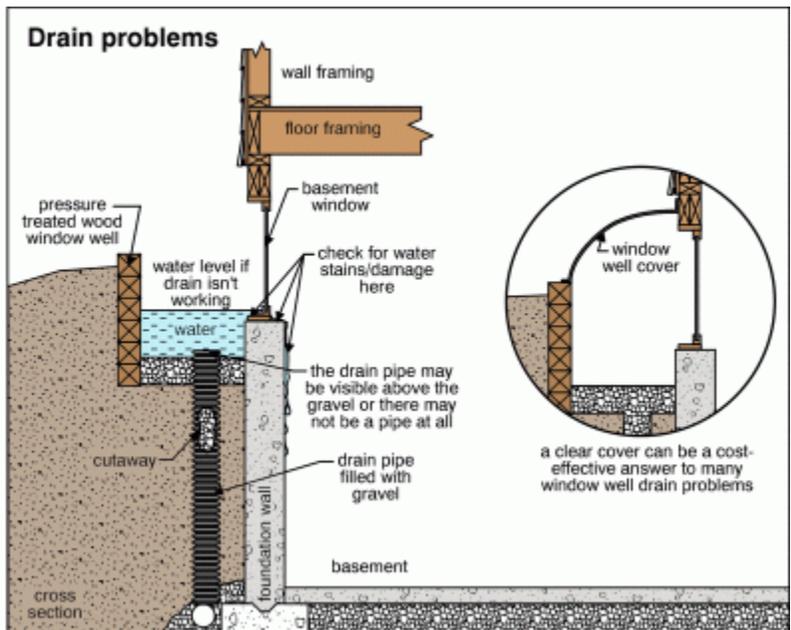
10. Condition: • Missing

Implication(s): Chance of water damage to contents, finishes and/or structure | Material deterioration

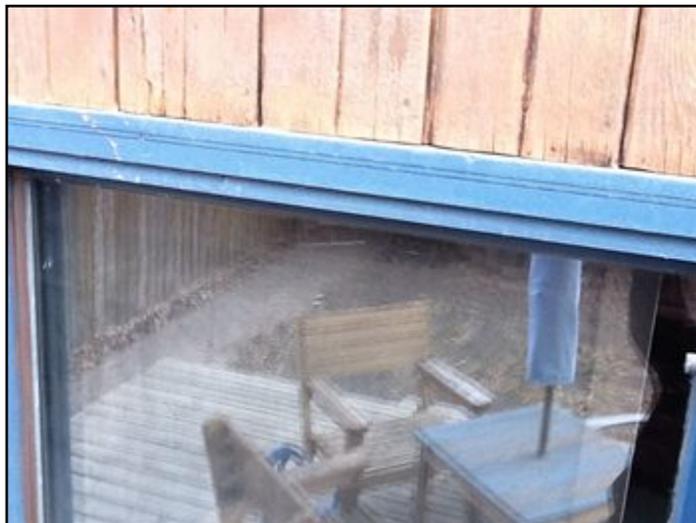
12. Condition: • Missing

Implication(s): Chance of damage to finishes and structure

23. Missing

Task: Provide

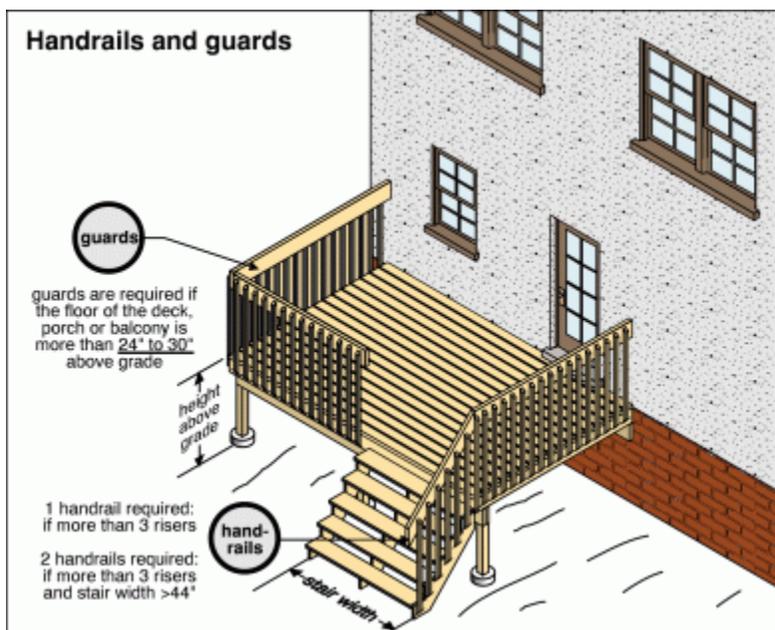
13. Condition: • Missing

There are no handrails on front steps

Implication(s): Fall hazard

Task: Provide

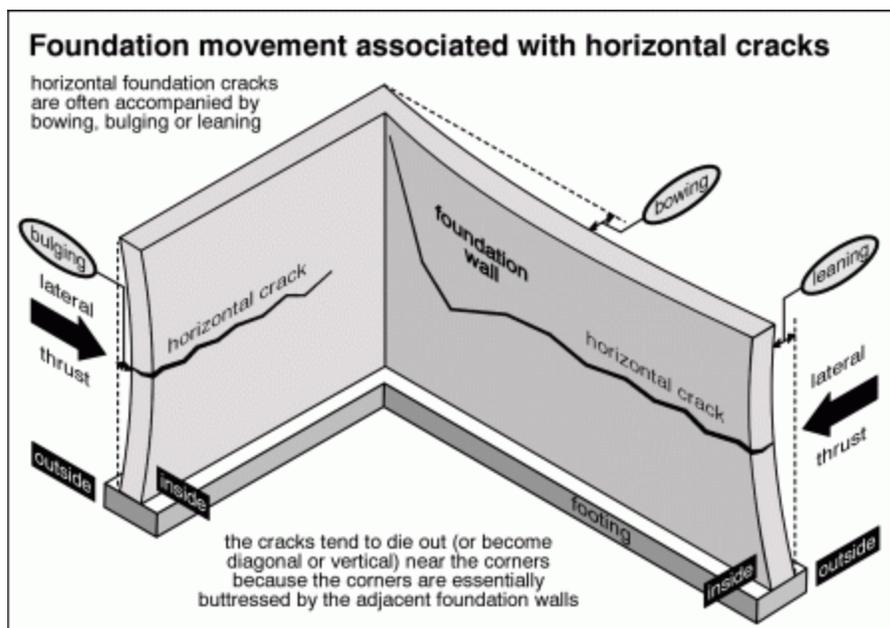
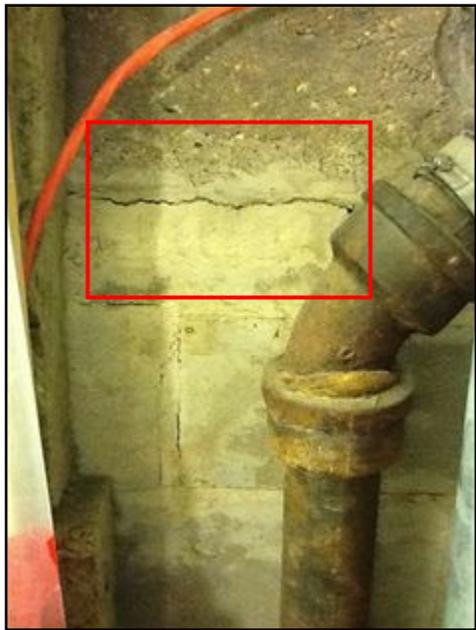
14. Condition: • Cracked horizontally

There is a crack where the original concrete block foundation meets new footings for the addition and the top of the wall is leaning at the time of inspection

Implication(s): Chance of structural movement

24. Cracked horizontally

Task: Repair

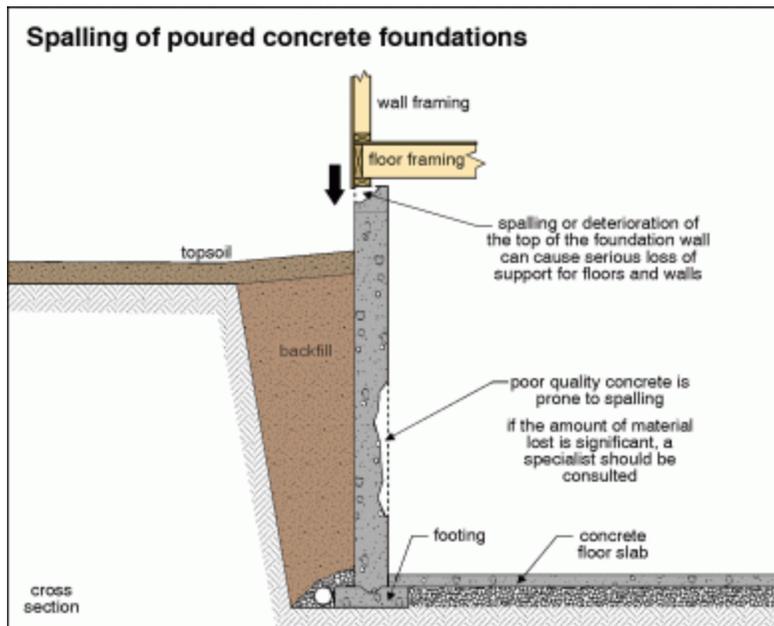
15. Condition: • Spalling, crumbling or broken material

Concrete has been damaged around penetration of furnace ducts and piping into crawlspace

Implication(s): Weakened structure | Chance of structural movement

Task: Monitor

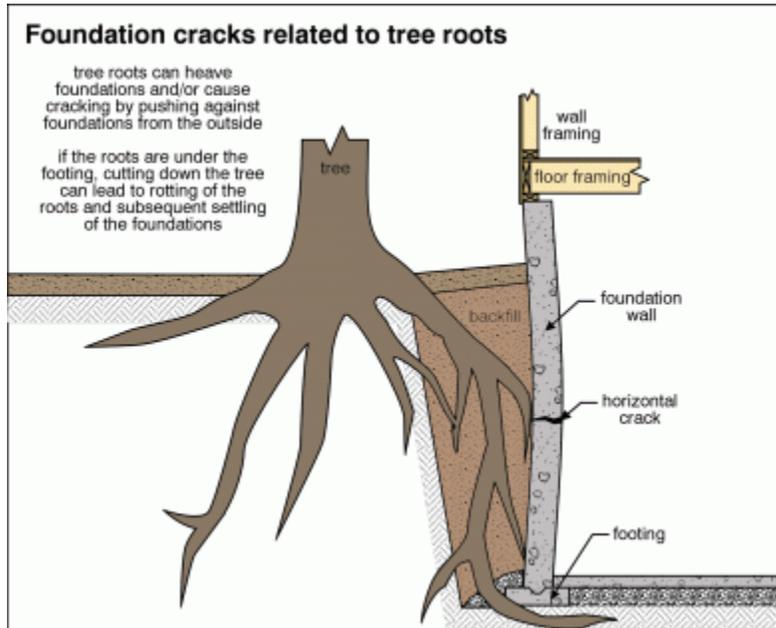
16. Condition: • Large trees close to building

Implication(s): Weakened structure | Chance of structural movement

25. Large trees close to building

Task: Monitor

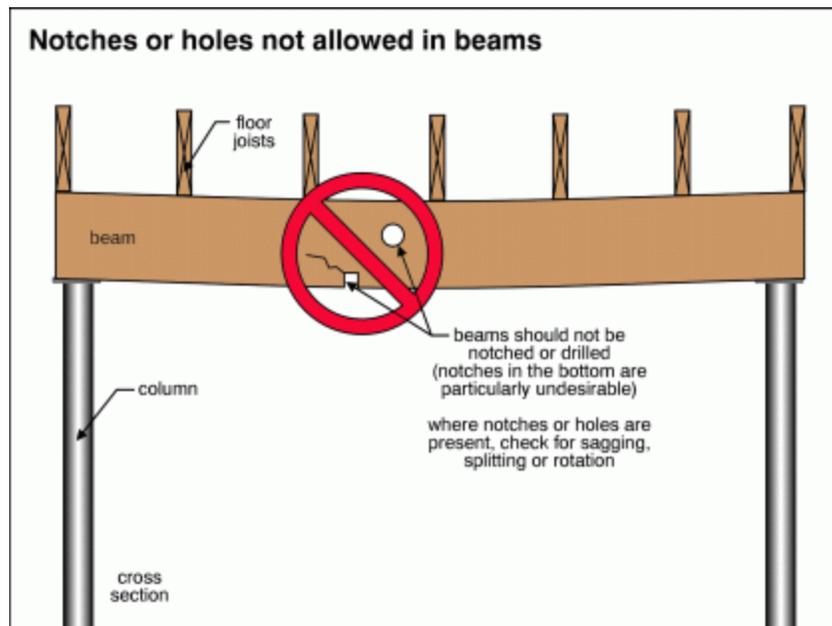
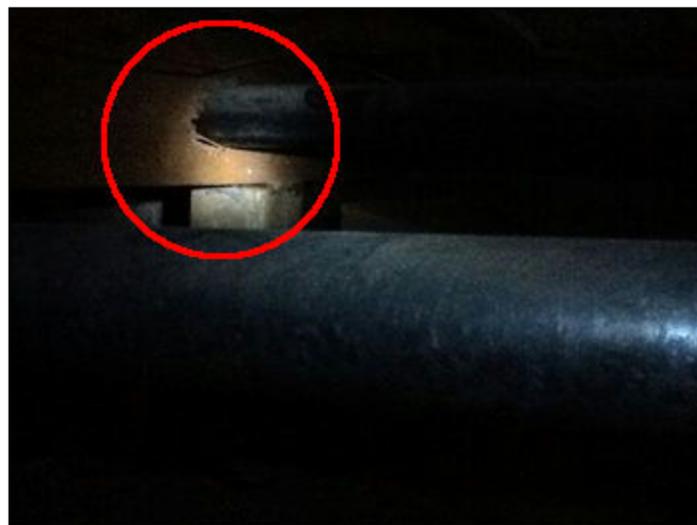
17. Condition: • Notches or holes

The main beam in crawlspace of add on has 3 inch hole notched in it within 1 foot of load bearing point.

Implication(s): Weakened structure | Chance of structural movement

26. *Notches or holes*

Task: Repair

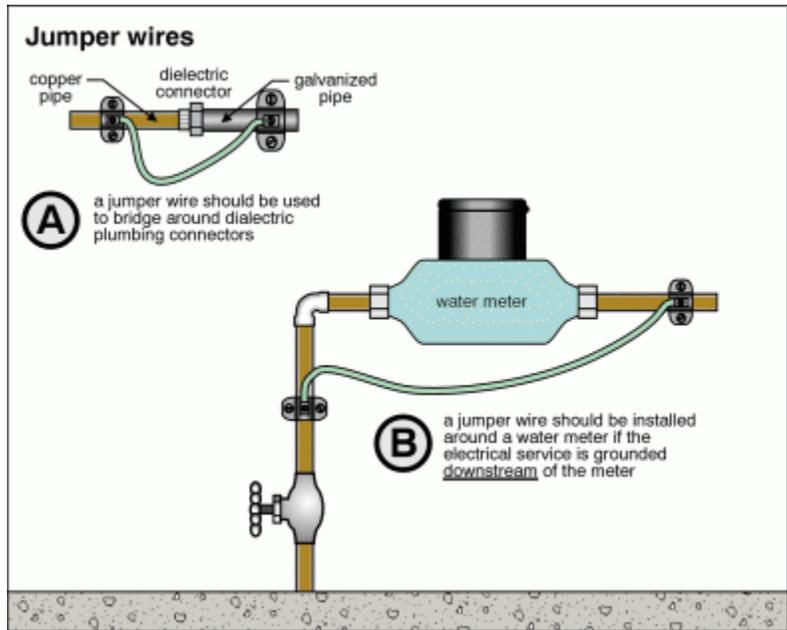
19. Condition: • No jumper for meters and valves

Implication(s): Electric shock

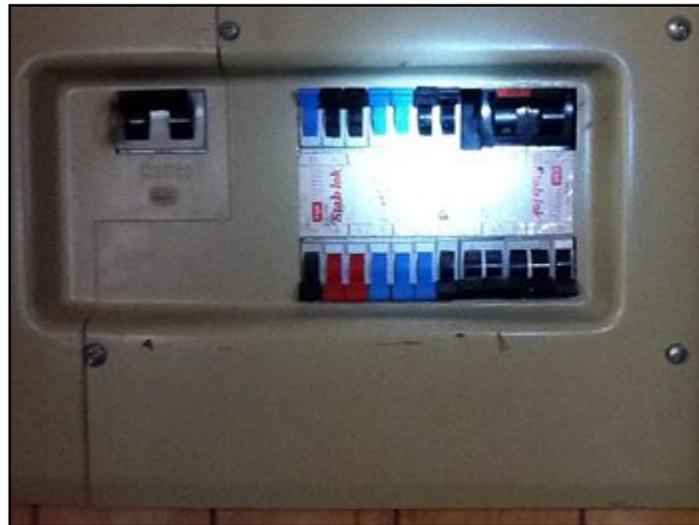
20. Condition: • Obsolete

Implication(s): Electric shock | Fire hazard

28. *Obsolete*

Task: Monitor

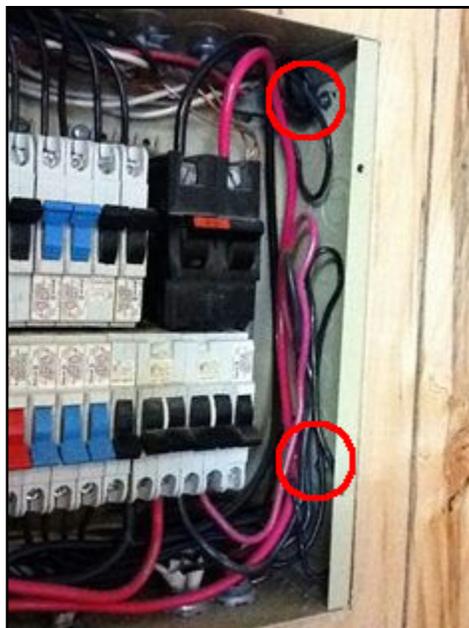
21. **Condition:** • Abandoned wires in panel

29. *Abandoned wires in panel*

Task: Repair or replace

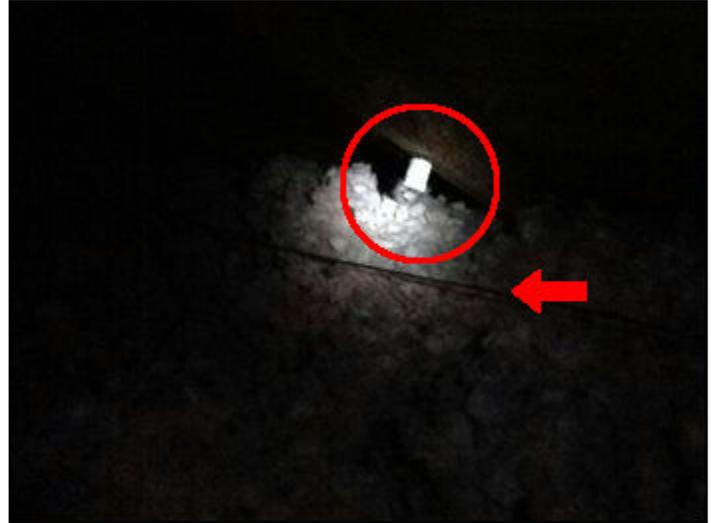
22. Condition: • Abandoned wire

31. Abandoned wire

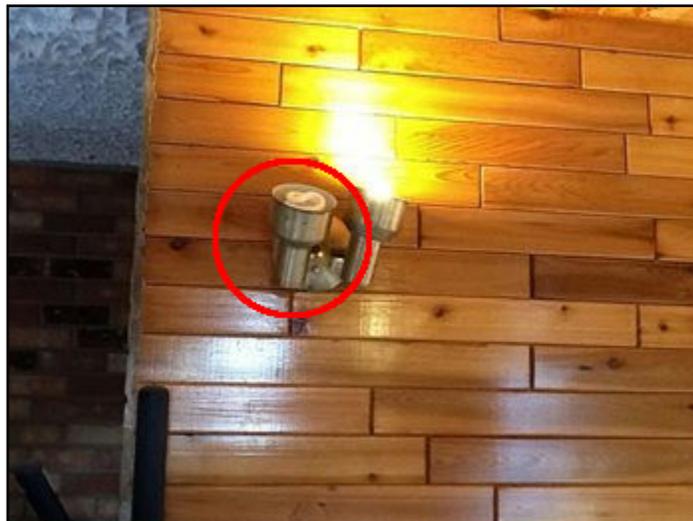
23. Condition: • Inoperative

only one of the lights and the left fixture in back play area works

Implication(s): Inadequate lighting

32. Inoperative

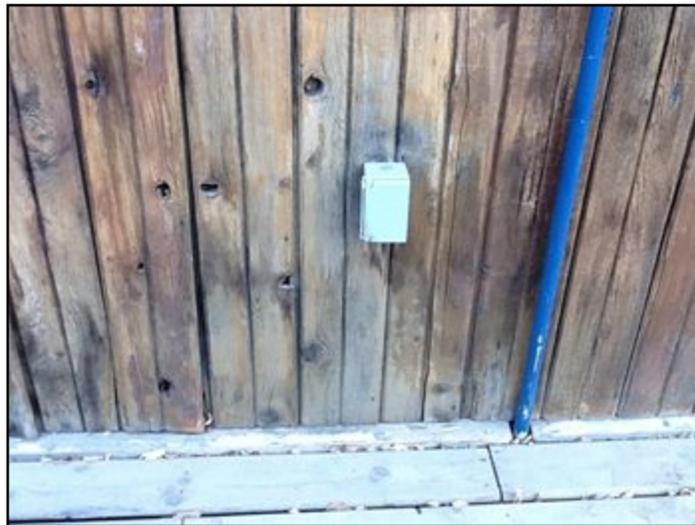
25. Condition: • Inoperative

Implication(s): Equipment inoperative

33. Inoperative

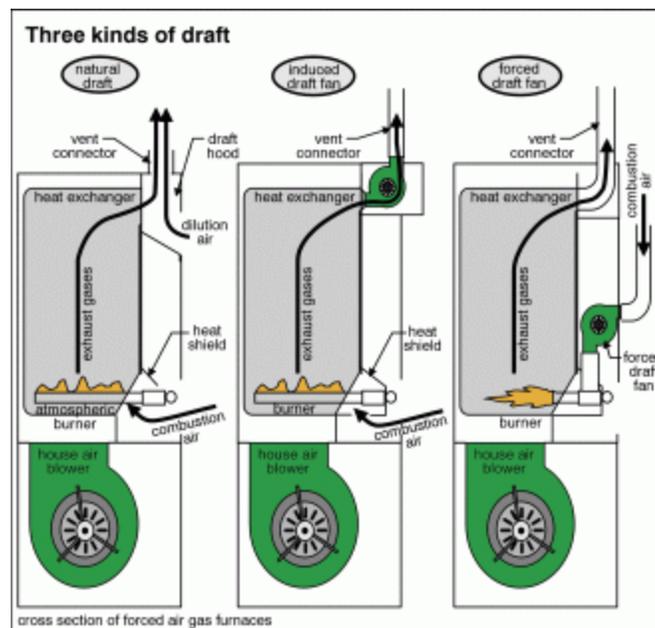
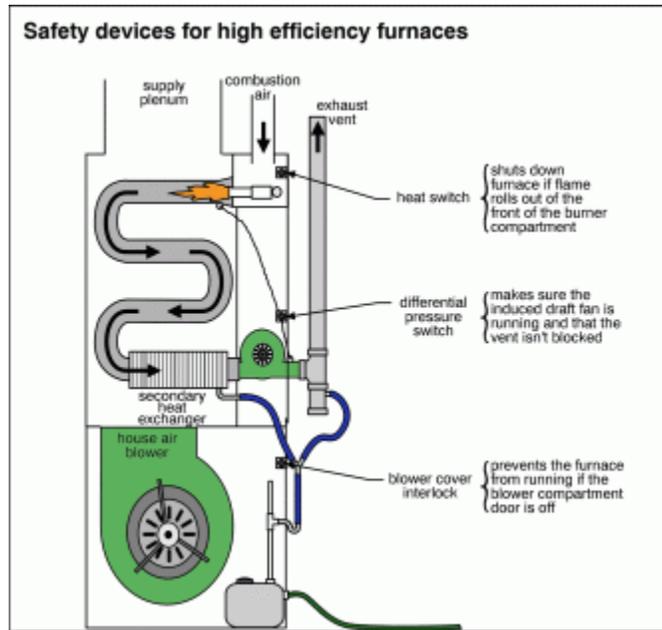
27. **Condition:** • Induced draft fan problems

induction fan very noisy upon start up

Implication(s): Equipment not operating properly | Equipment inoperative | Hazardous combustion products entering home

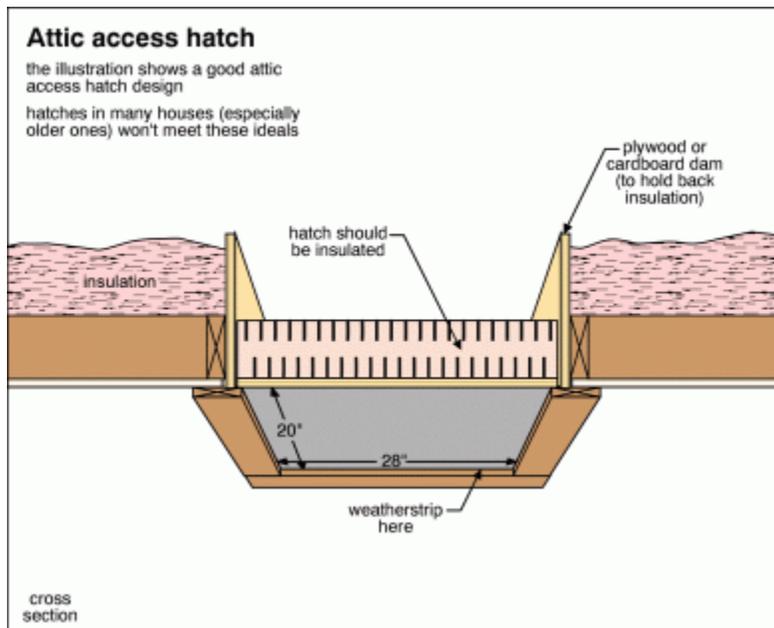
29. Condition: • Not insulated and not weatherstripped

Implication(s): Chance of condensation damage to finishes and/or structure | Increased heating and cooling costs | Reduced comfort

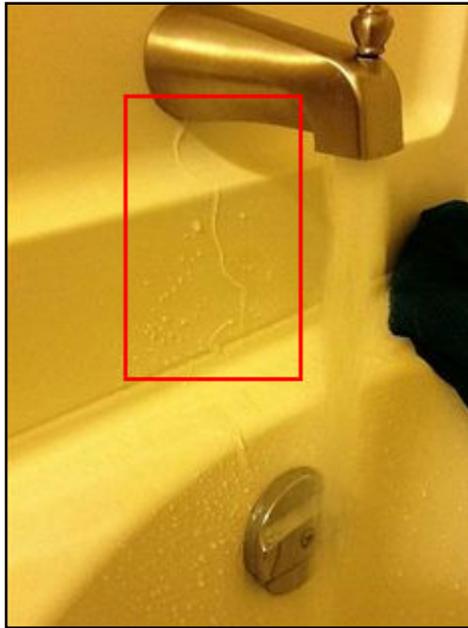
33. Condition: • Leak

Bath tub leaks from behind the spout. Had water running while looked underneath in crawlspace and saw no water below at time of inspection.

Implication(s): Chance of water damage to contents, finishes and/or structure

34. Leak

Task: Repair

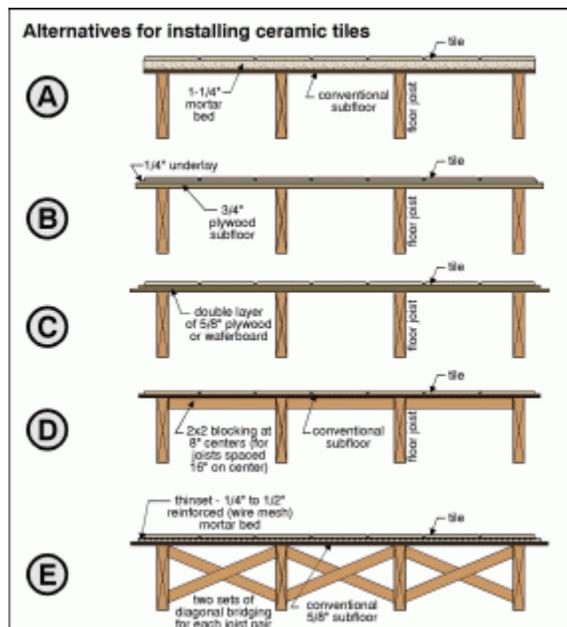
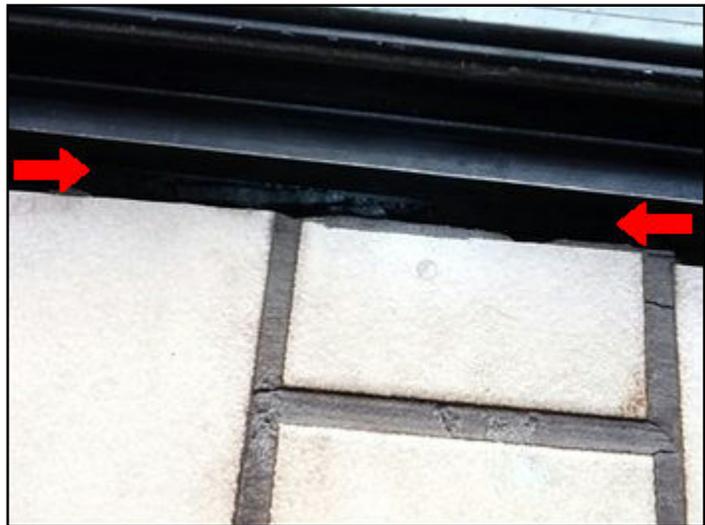
34. Condition: • Grout missing

tile floor at back door missing significant amount of grout at door sill exposing sub floor at the time of inspection.

Implication(s): Cosmetic defects | Trip or fall hazard

35. Grout missing

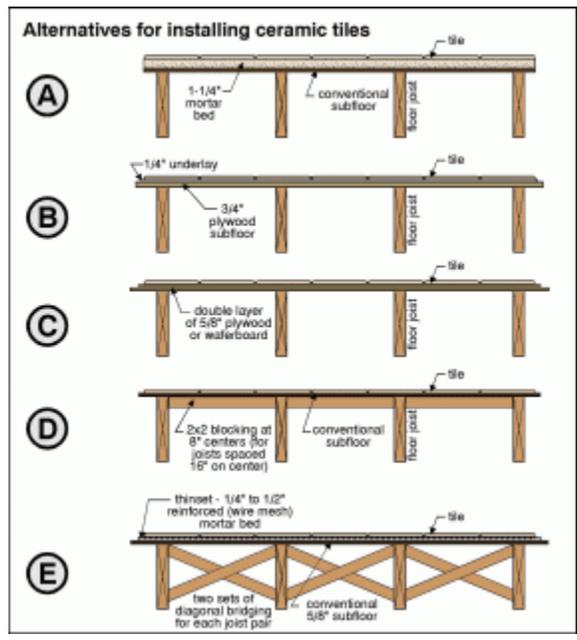
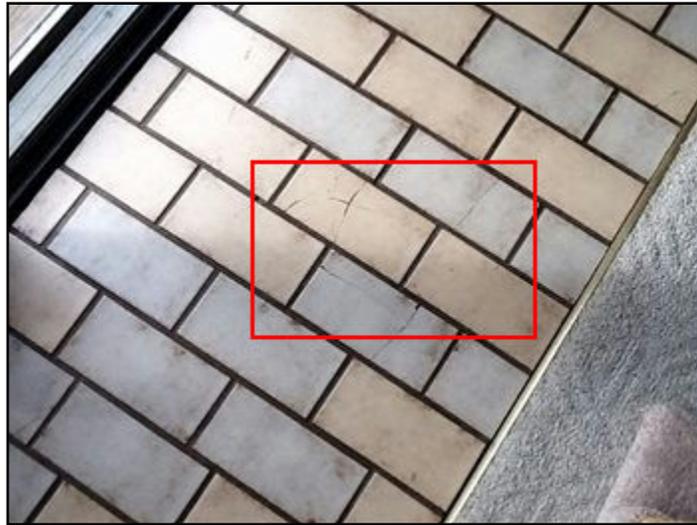
35. Condition: • Tiles cracked
tiles at back door are cracked

Implication(s): Cosmetic defects | Trip or fall hazard

36. Tiles cracked

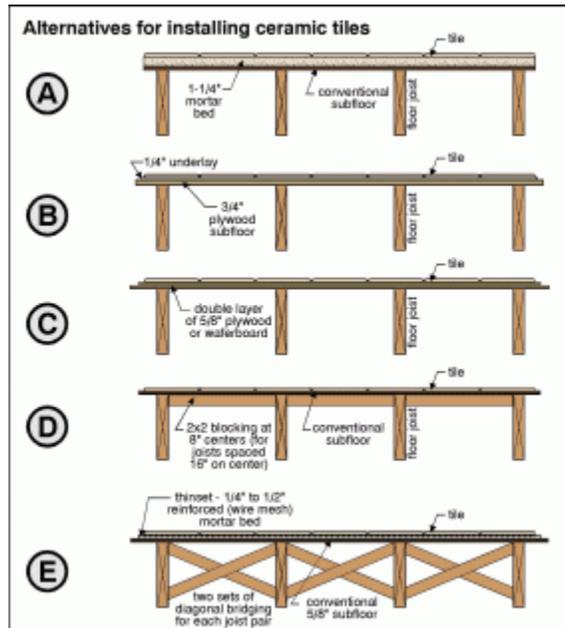
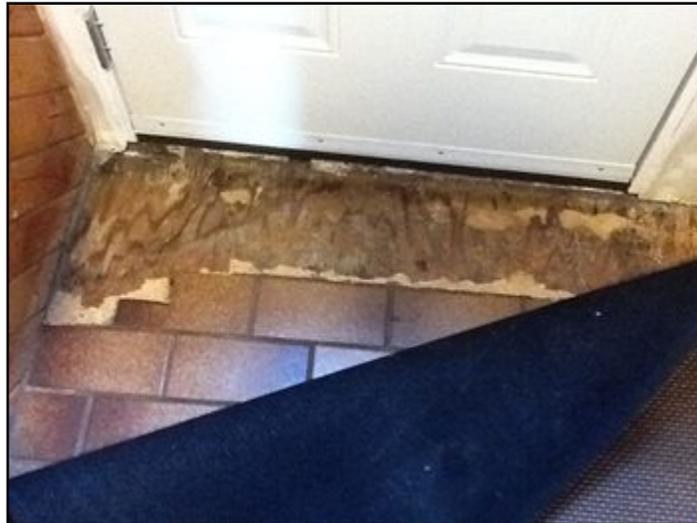
36. Condition: • Tiles missing

Tile at side door is incomplete and has sub floor exposed in front of door at the time of location

Implication(s): Cosmetic defects | Trip or fall hazard

37. Tiles missing

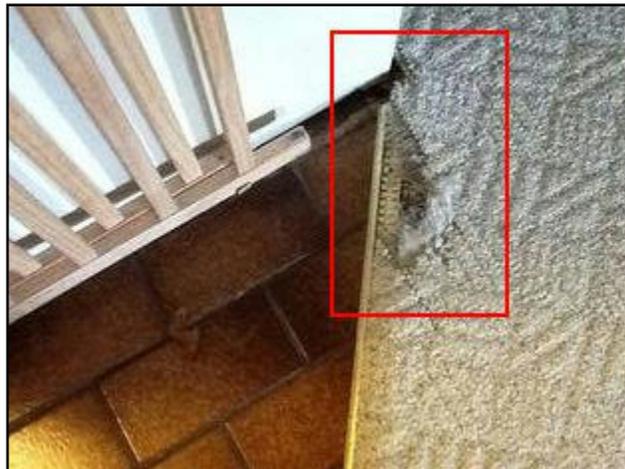
37. Condition: • Lifted at seams or edges
carpet is ripped at corner exposing tack strip

Implication(s): Cosmetic defects | Trip or fall hazard

38. Lifted at seams or edges
