Your Inspection Report

123 Karter Street
Saskatoon, SK

Tuesday, October 9, 2012

RE: Report No. 1014, v.6
123 Karter Street
Saskatoon, SK

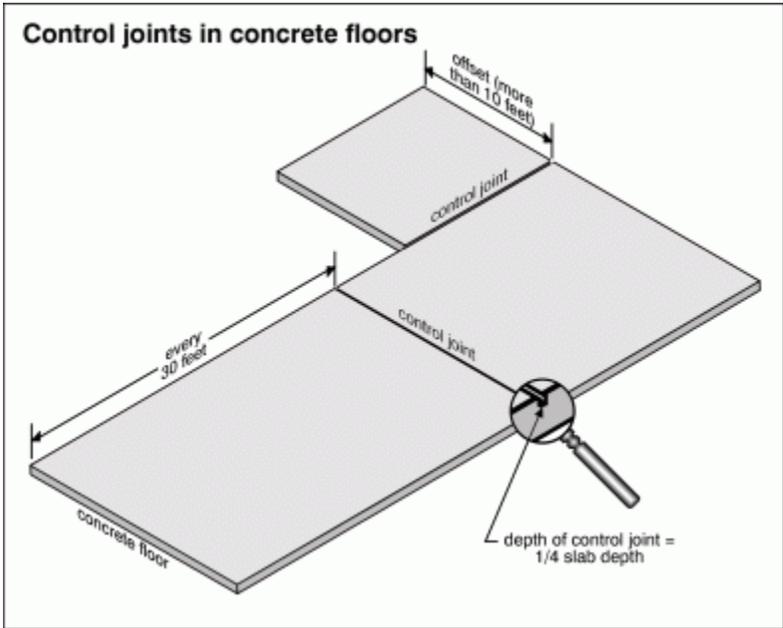
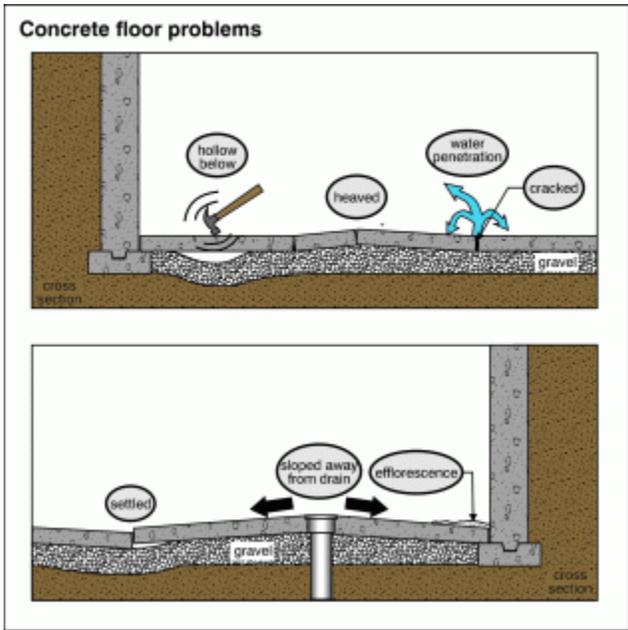
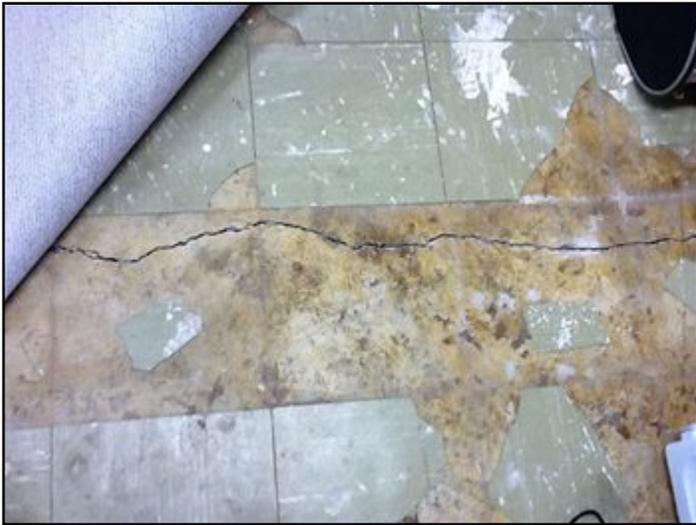
38. Condition: • Cracked

Basement floor has numerous cracks at the time of inspection and one being relatively large. Cracks are full of cob webs and debris indicating they have been there a while

Implication(s): Cosmetic defects | Trip or fall hazard | Difficult access

39. Cracked

Task: Monitor

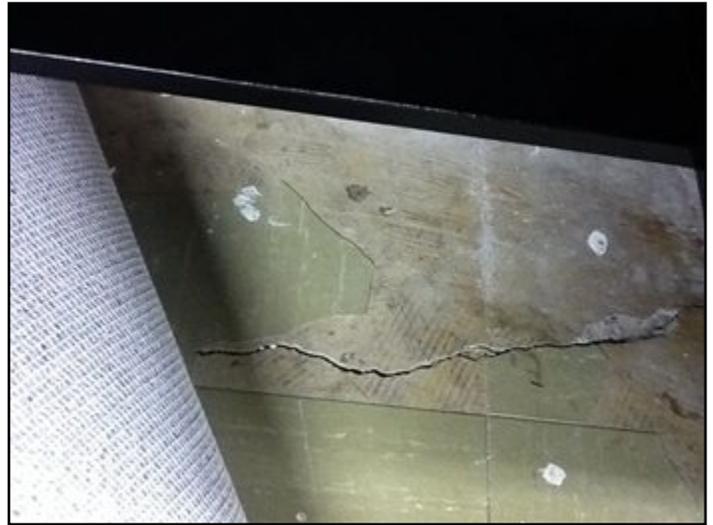
40. Cracked

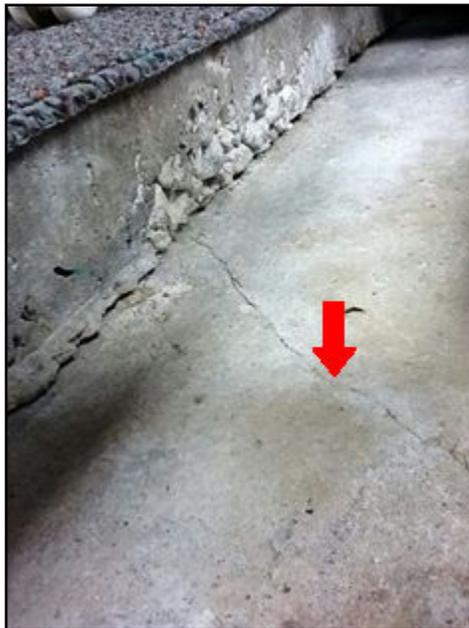
41. Cracked

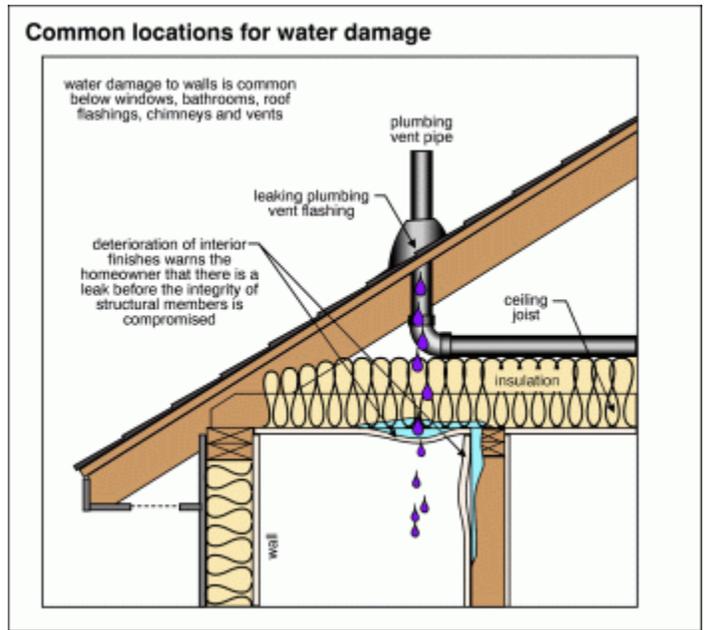
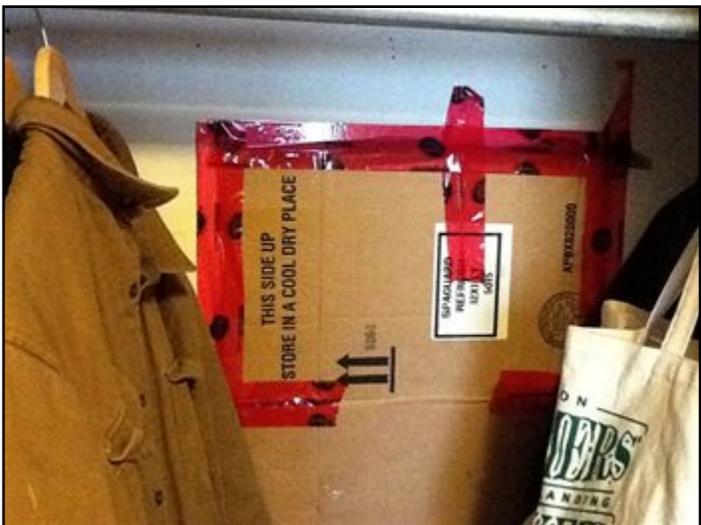
39. Condition: • Damaged

There is a hole in the closet near back entrance that is covered over with cardboard

Implication(s): Cosmetic defects

42. Damaged

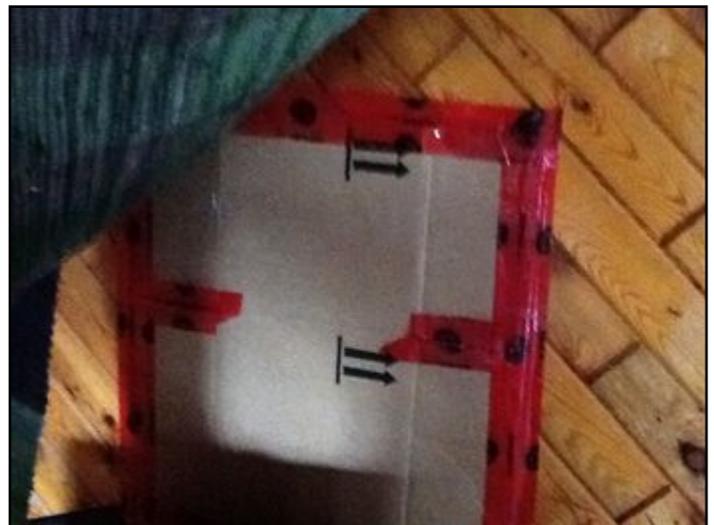
43. Damaged

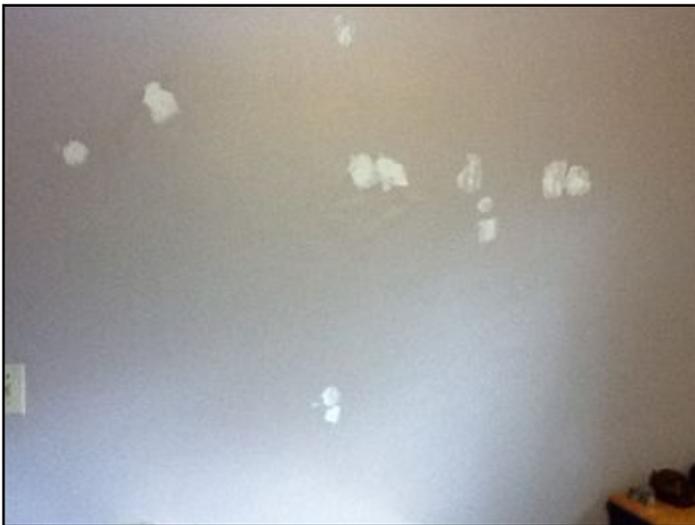
40. Condition: • Damaged
Implication(s): Cosmetic defects
Location: Master Bathroom
Task: Repair

44. Damaged

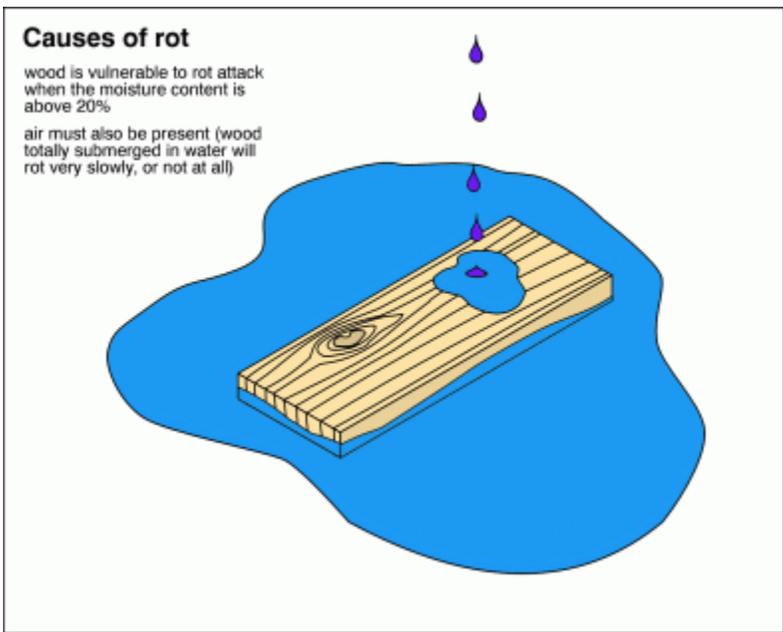
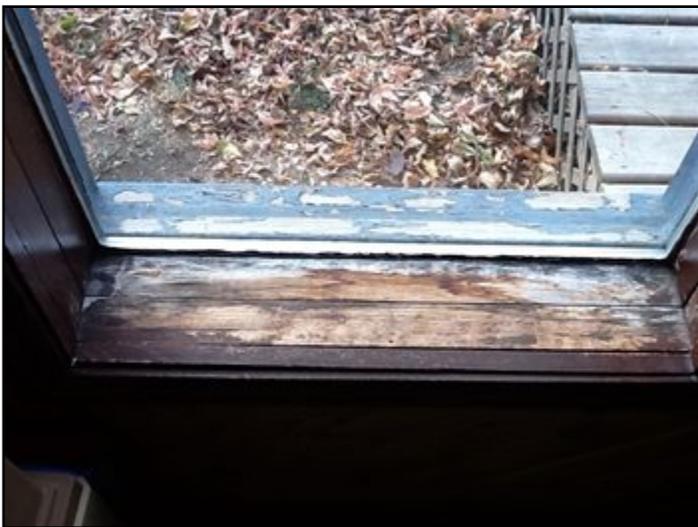
42. Condition: • Rot

Back windows have excess moisture and show signs of rot at the time of inspection.

Implication(s): Cosmetic defects | Chance of damage to structure | Material deterioration

46. Rot

Task: Replace

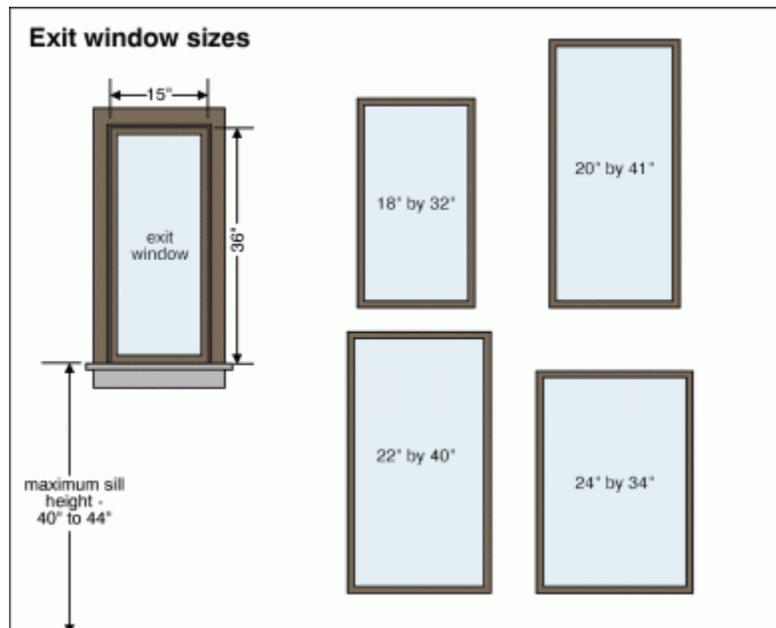
43. Condition: • Too small
Basement windows are too small to be used as an egress window.
Implication(s): Restricted emergency exits
Location: Basement
