Your Inspection Report

1234 Somewhere Blvd
Anytown, LA 71111

Monday, June 22, 2015

RE: Report No. 1015, v.2
1234 Somewhere Blvd
Anytown, LA
71111

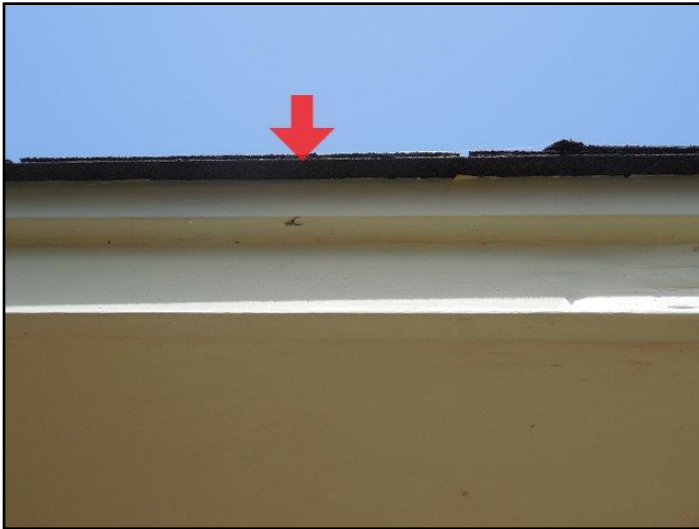
1. Condition: • [Missing](#)

1. Missing

Task: Repair

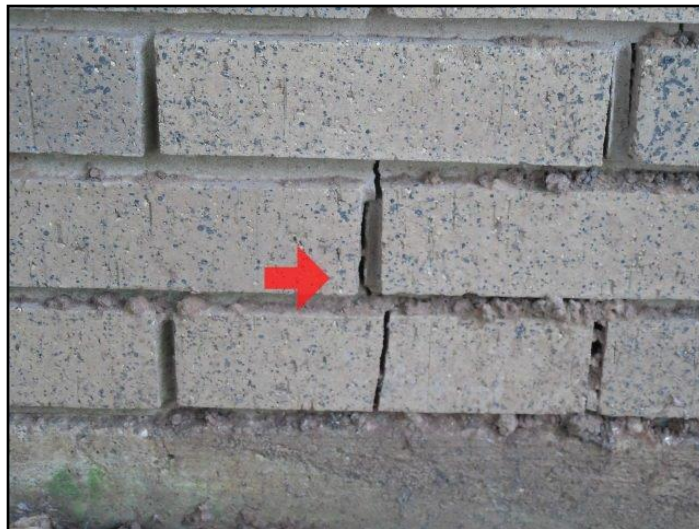
4. Condition: • [Cracked](#)

3. Cracked

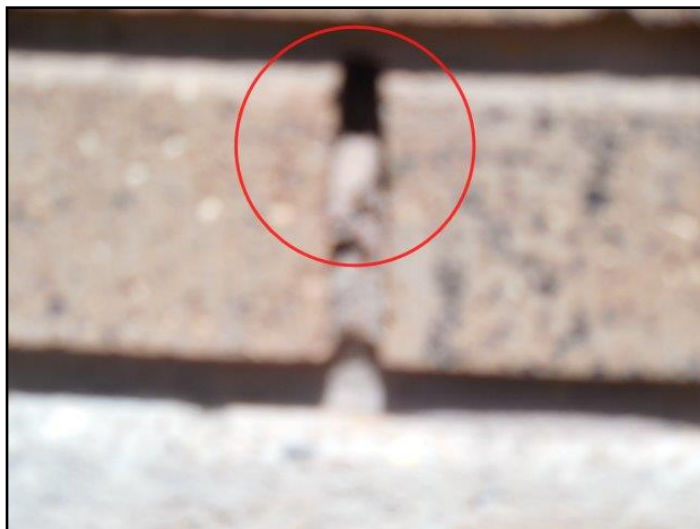
5. Condition: • [Missing, ineffective weep holes or flashings](#)

Implication(s): Chance of water damage to contents, finishes and/or structure | Material deterioration

4. Missing, ineffective weep holes or flashings

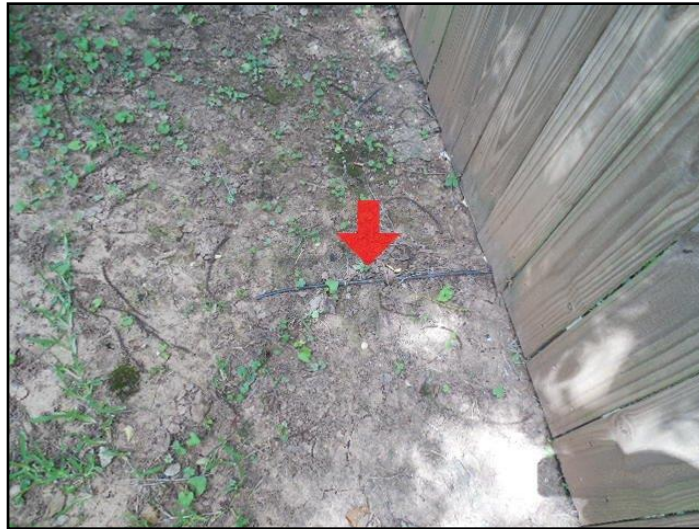
7. Condition: • Exposed communication cables

6. Exposed cables

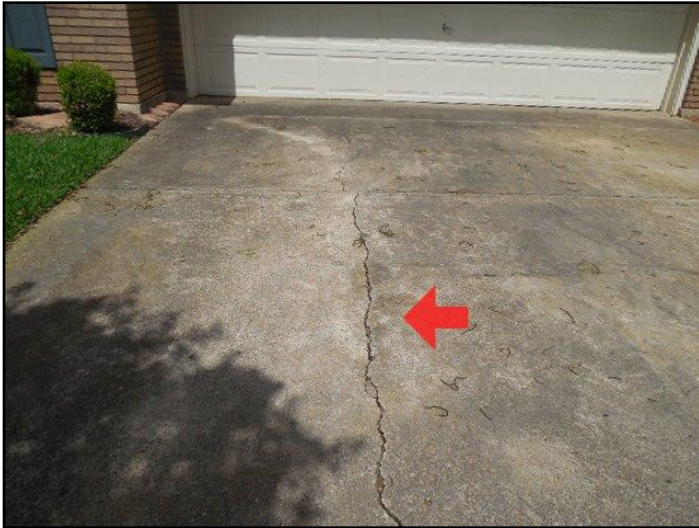
8. Condition: • [Cracked or damaged surfaces](#)

7. Cracked or damaged surfaces

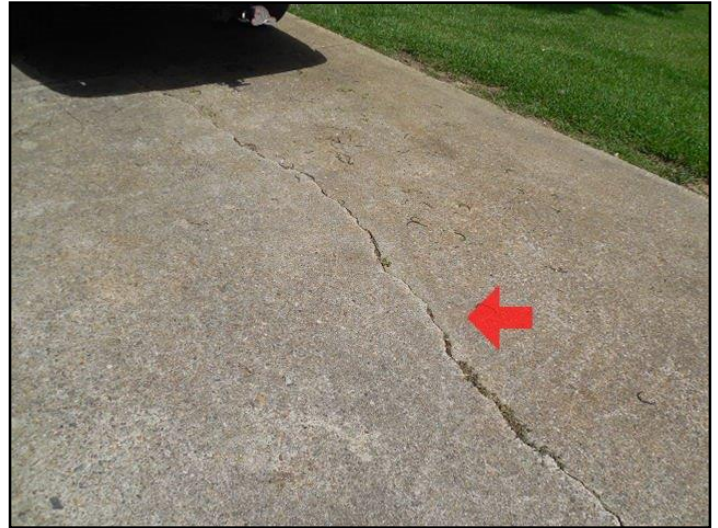
8. Cracked or damaged surfaces

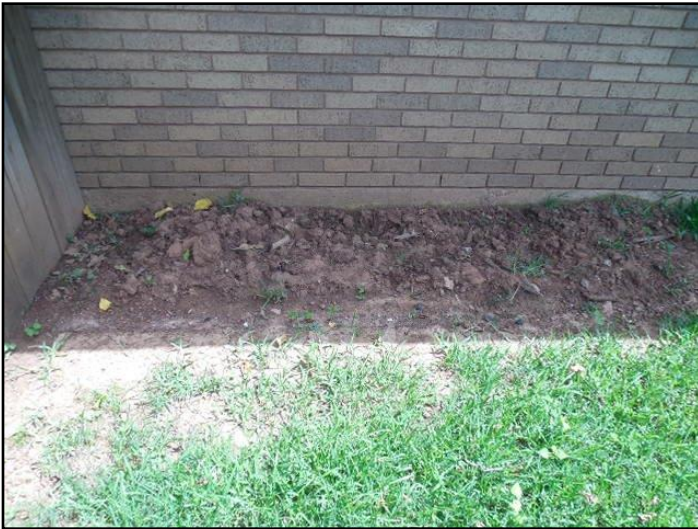
9. Condition: • [Disturbed ground](#)

9. Disturbed ground

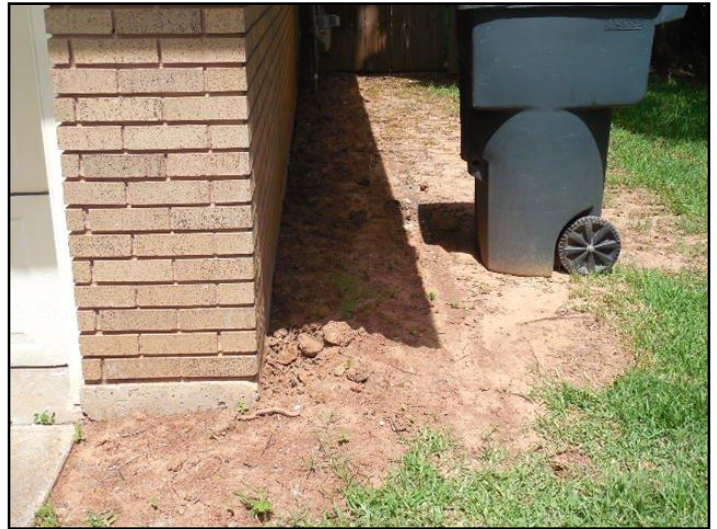
10. Disturbed ground

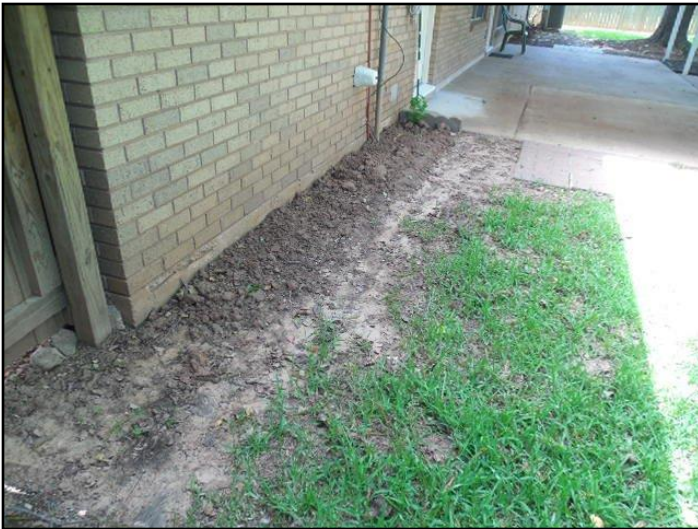
11. Disturbed ground

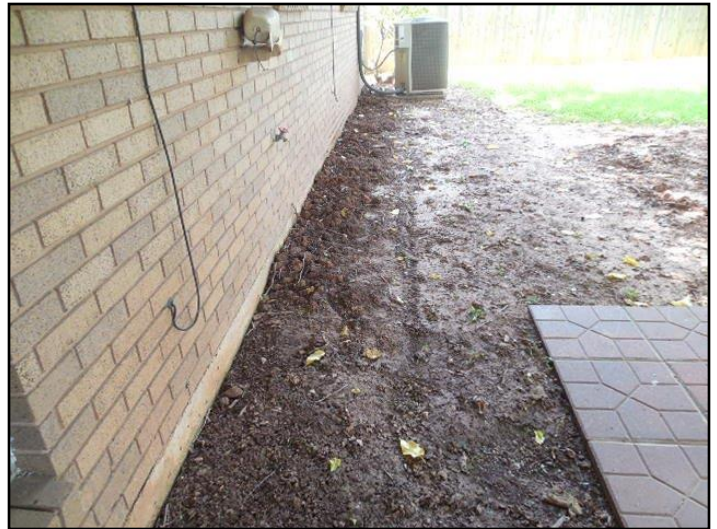
12. Disturbed ground

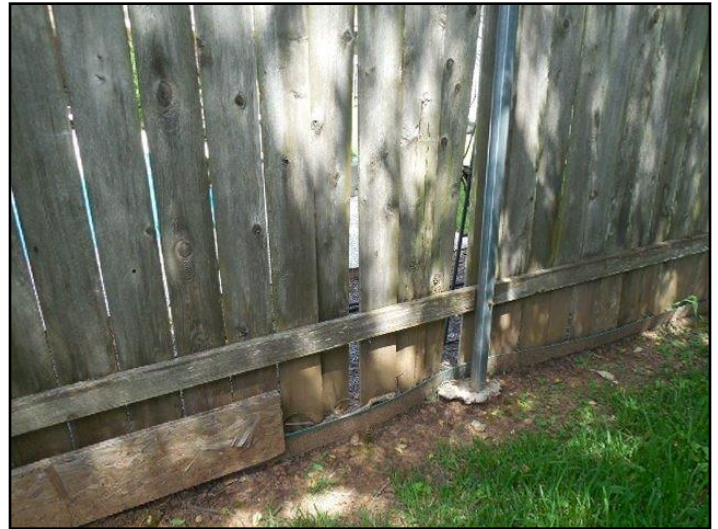
10. Condition: • Boards damaged

14. Boards damaged

Repairs to fence recommended if fence is the property of the home owner.

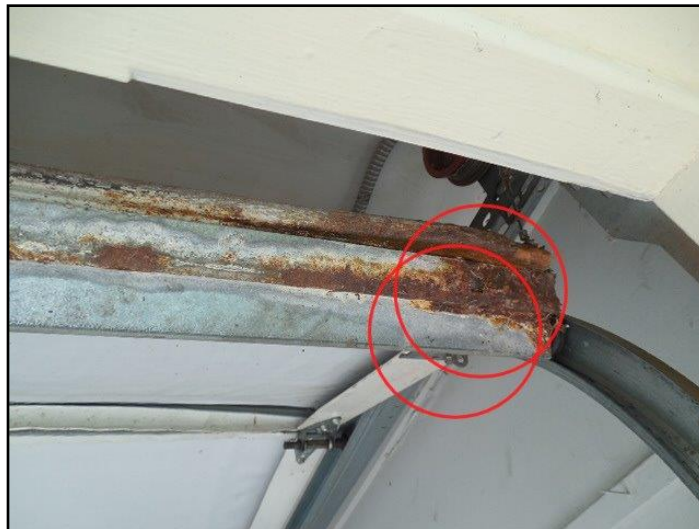
11. Condition: • Rusted

15. Rusted

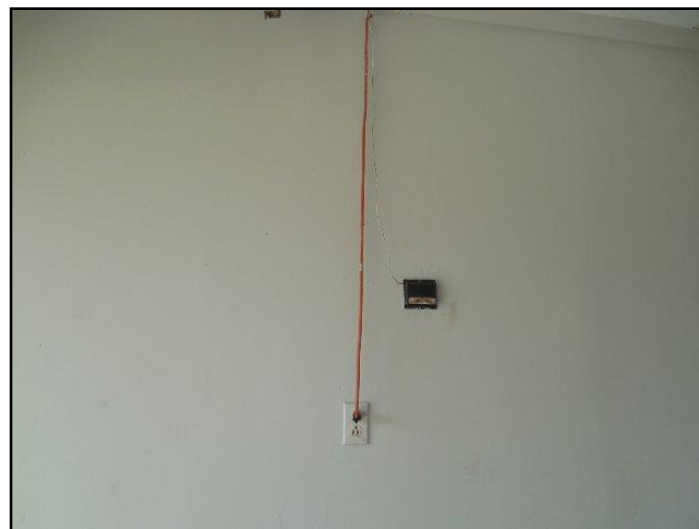
12. Condition: • [Extension cord for opener](#)

16. Extension cord for opener

Check electrical connection

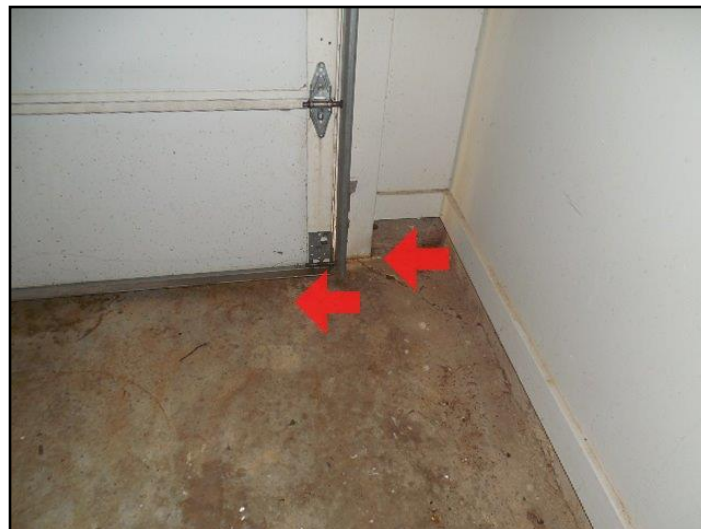
13. Condition: • [Sensors inoperative](#)

Missing safety sensors

17. Unsafe

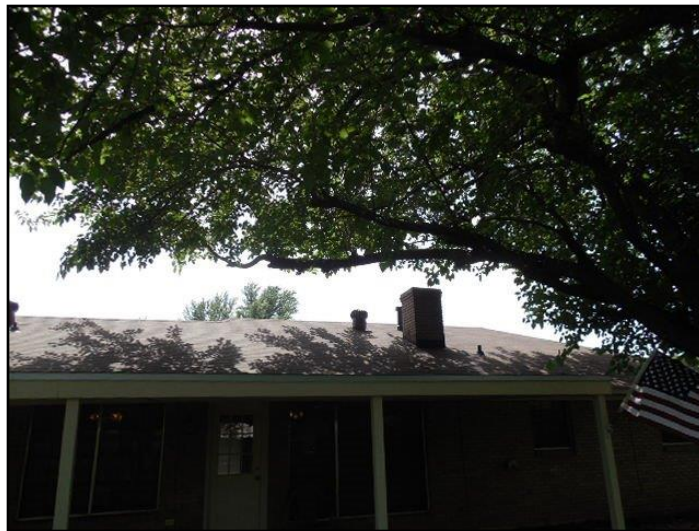
18. *Over hanging tree branches*

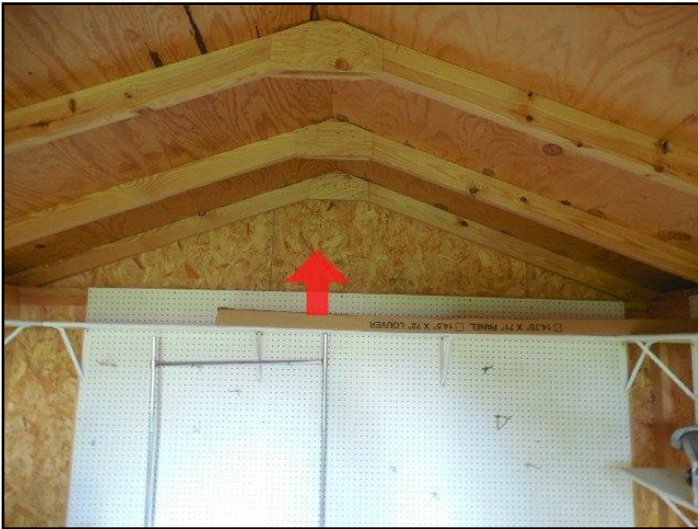
19. Ventilation needed

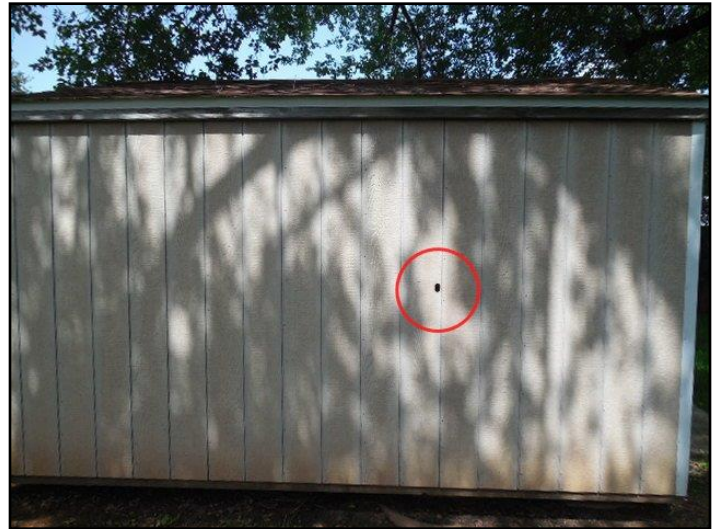
May be the result of recent foundational repair

20. Hole noted

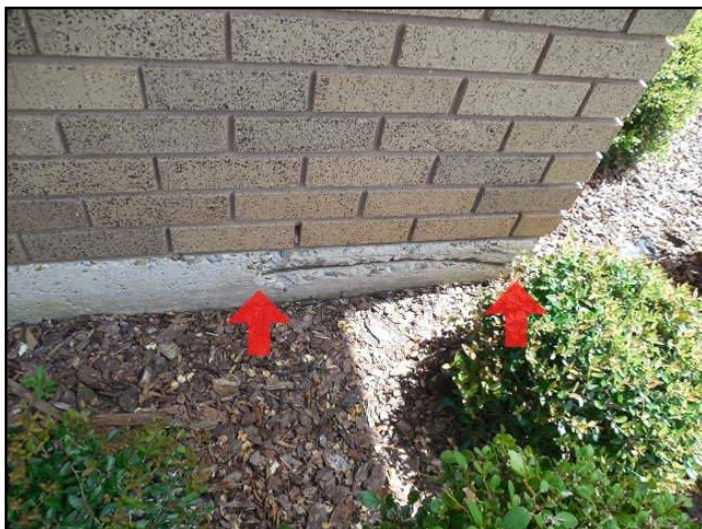
16. Condition: • Typical minor cracks

21. Typical minor cracks

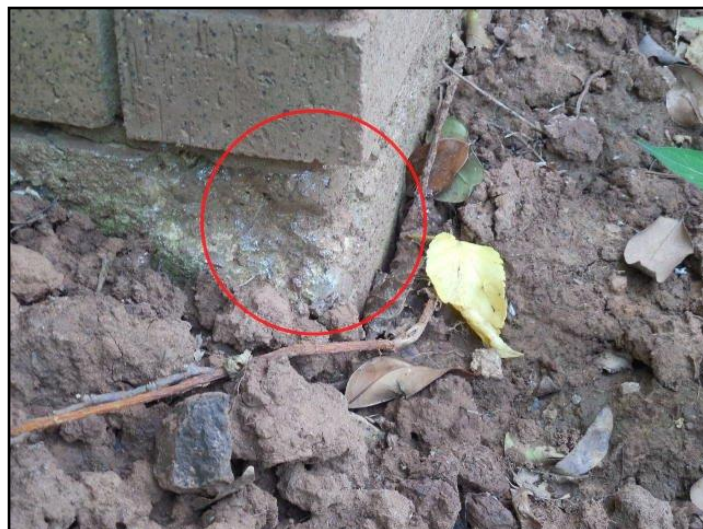
22. Typical minor cracks

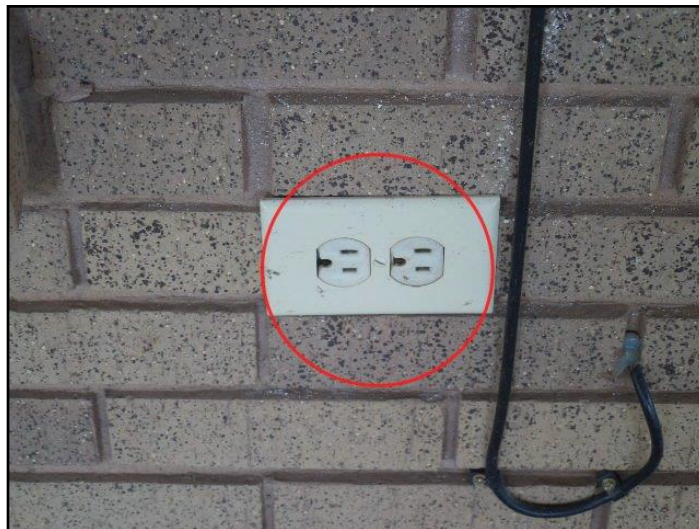
24. No GFCI

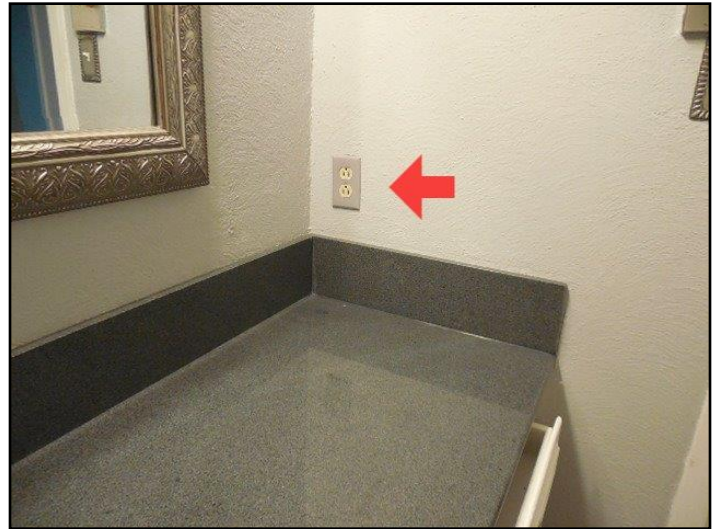
26. No GFCI - bathroom

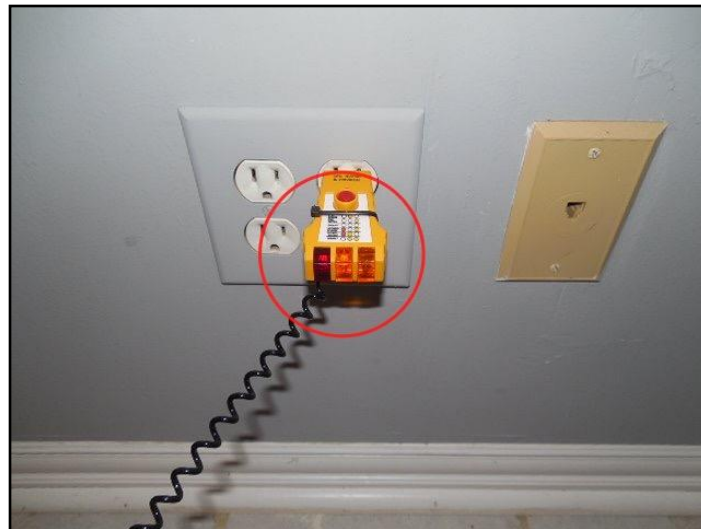
17. Condition: • [Reversed polarity](#)

27. Reversed polarity

Further evaluation by licensed electrician recommended

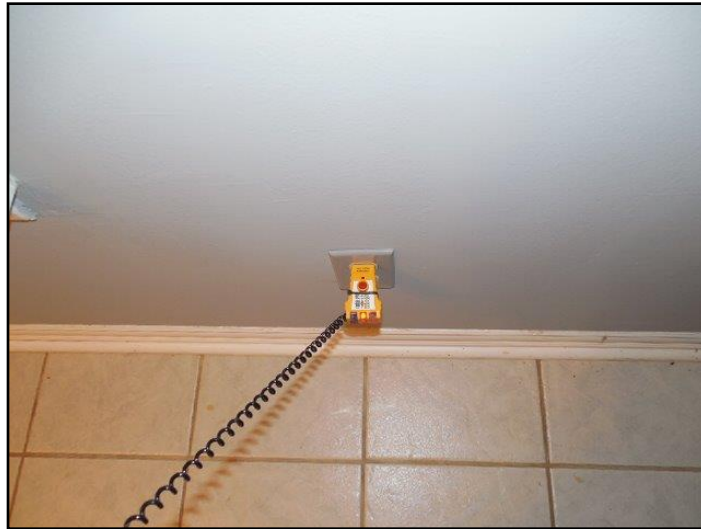
18. Condition: • [Open neutral](#)

28. Open neutral

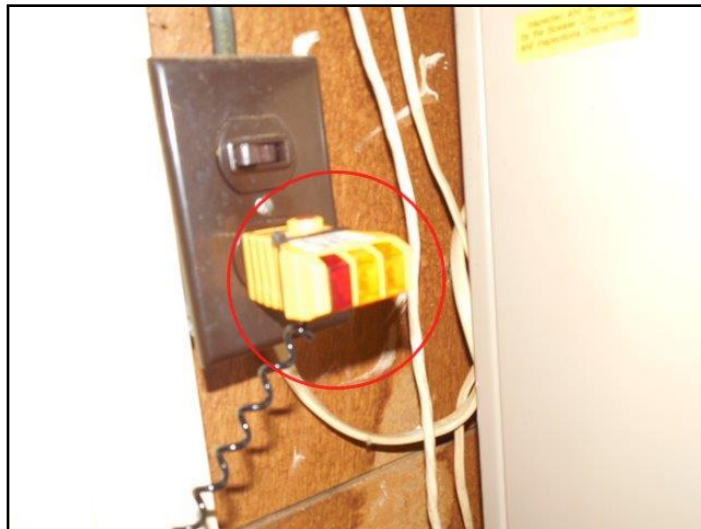
19. Condition: • [Open neutral](#)

29. Open neutral

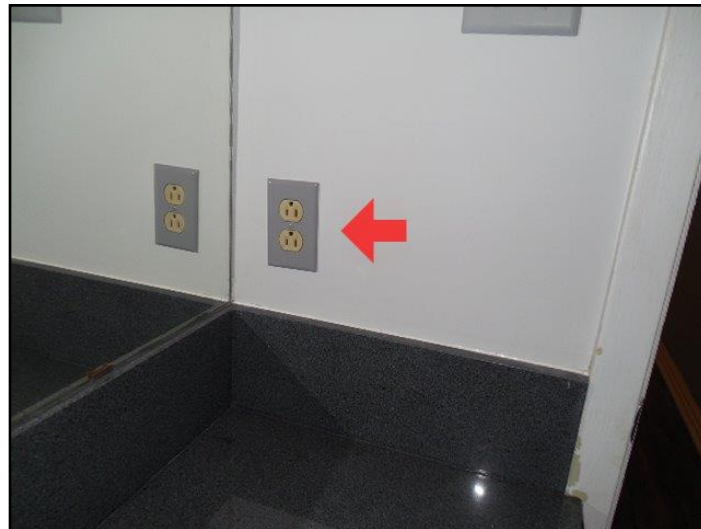
20. Condition: • [No GFI \(Ground Fault Interrupter\)](#)

30. No GFI (Ground Fault Interrupter)

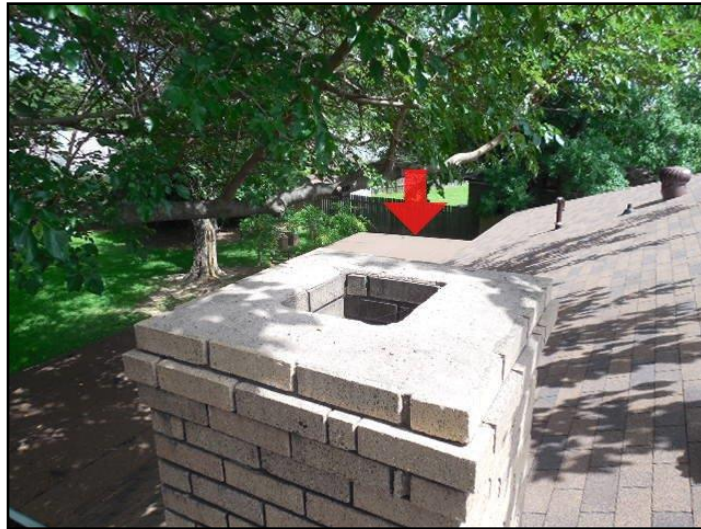
25. Condition: • Chimney cap needed

31. Chimney cap needed

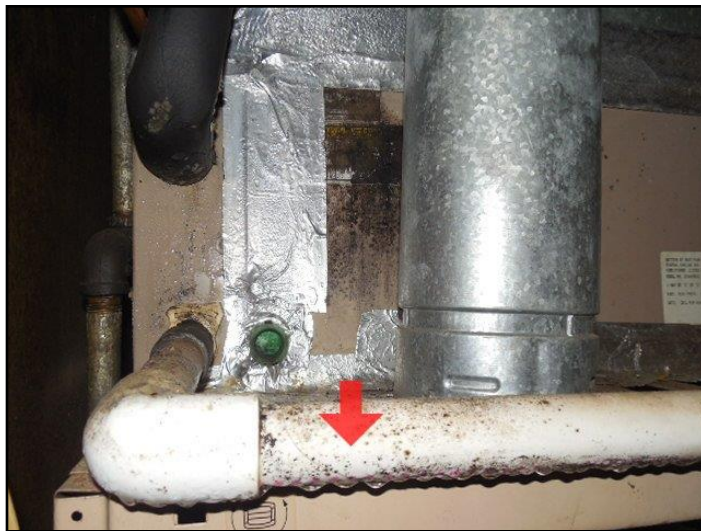
32.

26. • Condensation may cause moisture damage

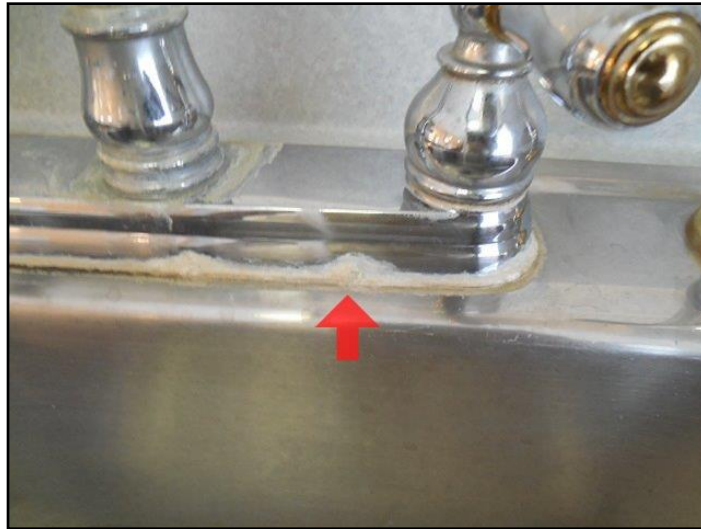
31. Condition: • Rust noted but no leak noted on the day of this inspection

33. Rust noted

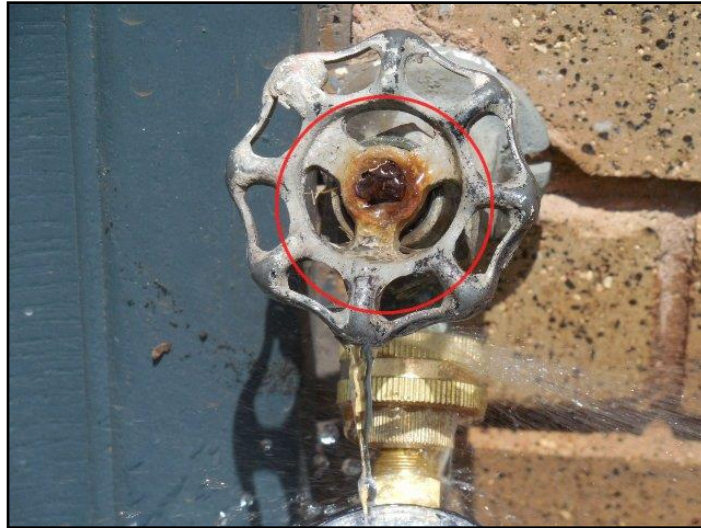
32. Condition: • [Leak or drip](#)

Implication(s): Chance of water damage to contents, finishes and/or structure

34. Leak or drip

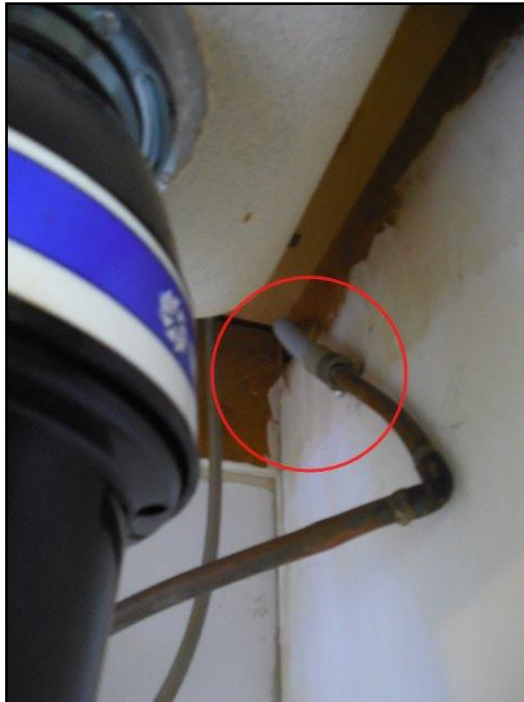
34. Condition: • Backflow prevention missing

35. Backflow prevention missing
