Your Inspection Report

62 Brunswick Avenue
Toronto, ON

INSPECTION DATE:
Tuesday, March 27, 2012

RE: Report No. 30624
62 Brunswick Avenue
Toronto, ON

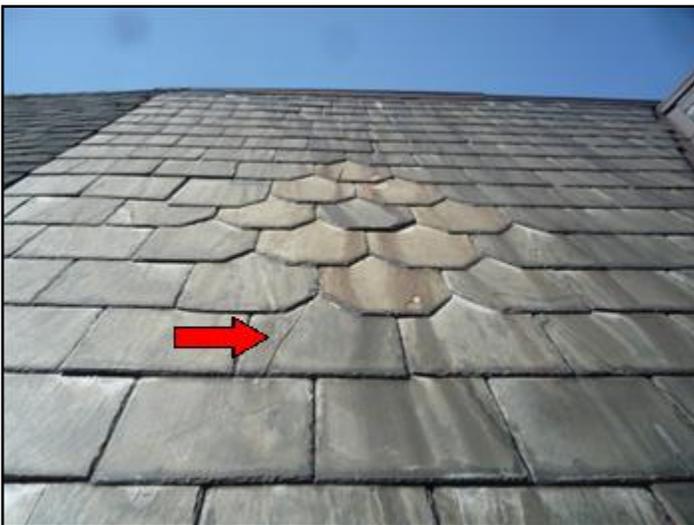
The slate roof is an original aspect of the house that adds aesthetic and traditional appeal but is very costly to maintain. The slates are in relatively good shape although one or two are cracked and one or two are missing. The flashings will fail before the slates and may need replacement in the short term. A slate roof specialist should be engaged to determine a repair and maintenance plan. Evidence of present leakage makes this a more immediate cost. Budget at least \$1000/year for annual maintenance.

cracked slate

Task: Further evaluation/Repair

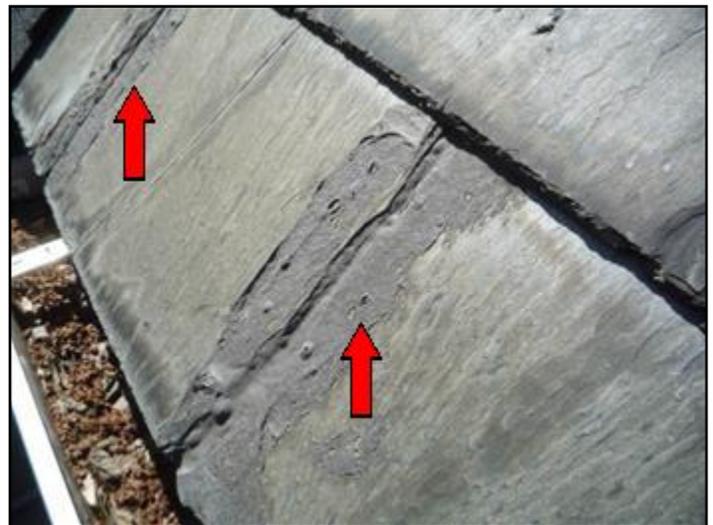
patched slates

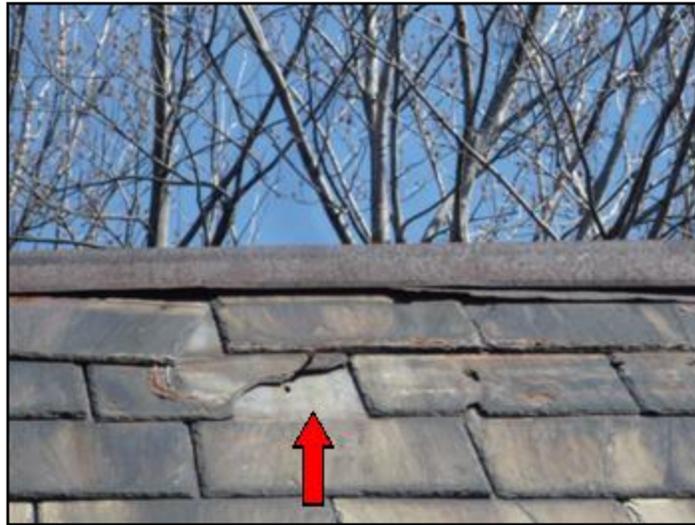
missing slates

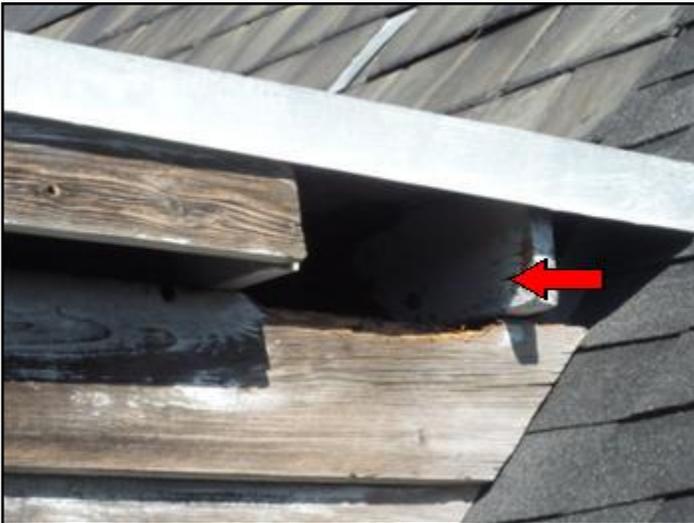
The dormer is in poor condition. It appears that a squirrel or raccoon has nested in the roof and caused a leak into the ceiling below. The wood siding has aged due to poor maintenance.

vermin damage

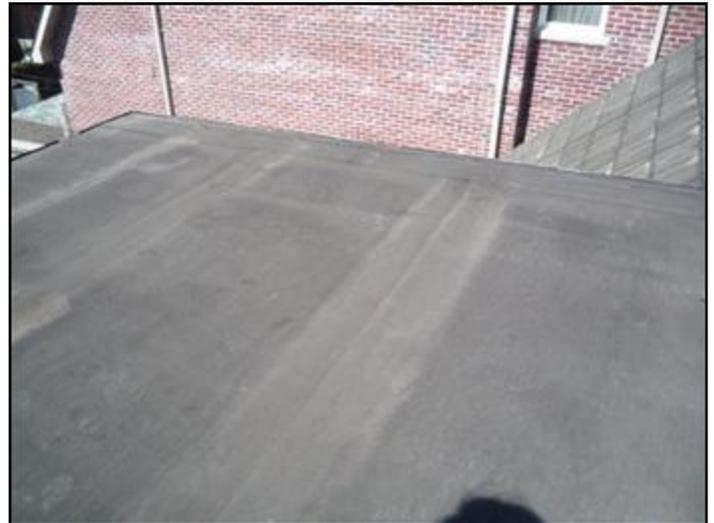
ageing membrane

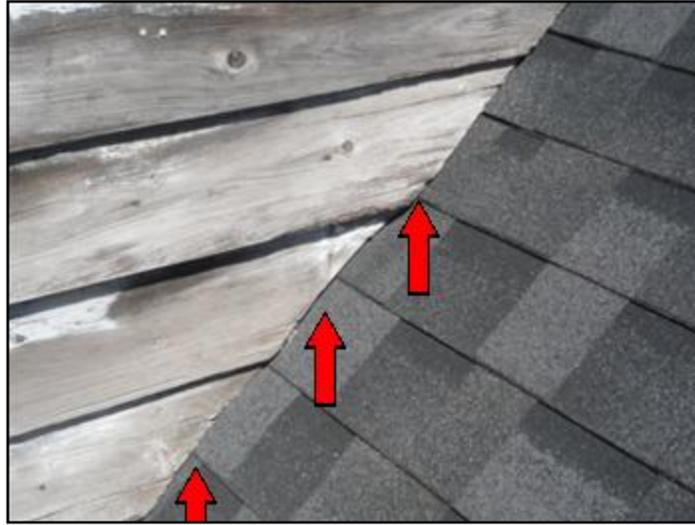
siding touches roof

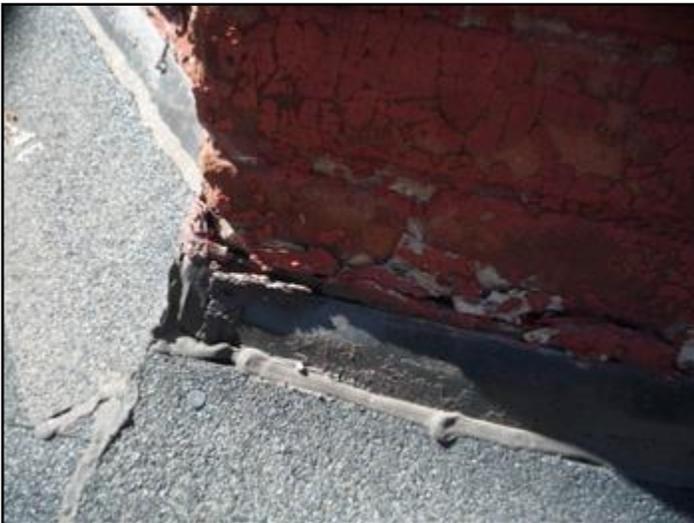
poor seal at flashing

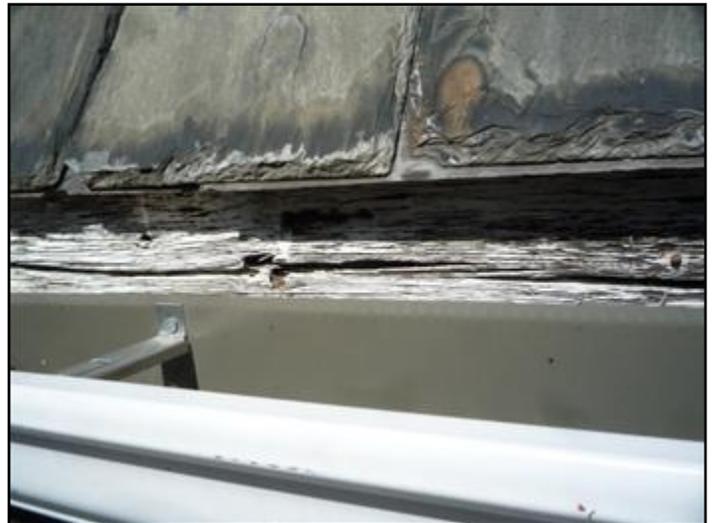
provide drip edges

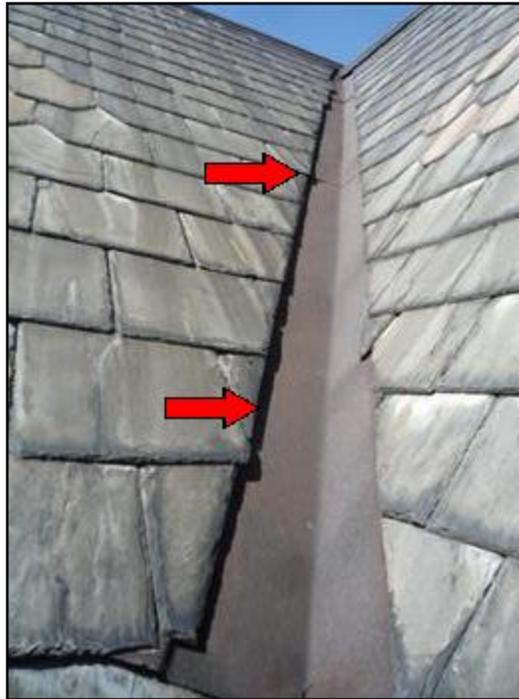
rusted valley flashing

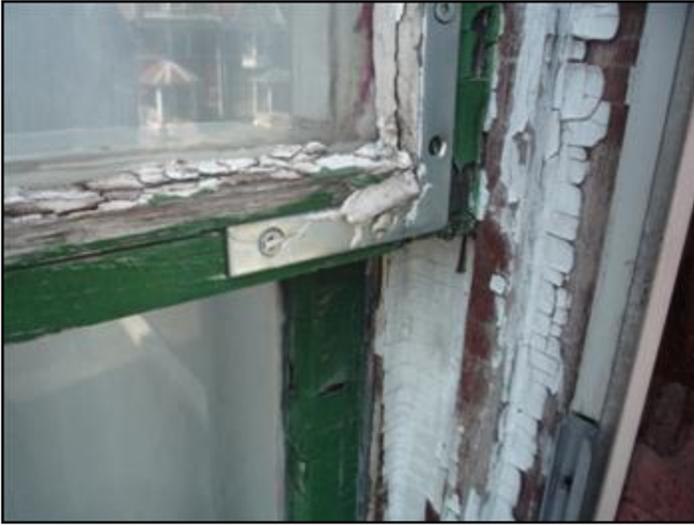
rot at windows

A carpenter or handy person should be engaged to repair and finish all of the exterior wood surfaces including trim, sills, windows, doors and porches.

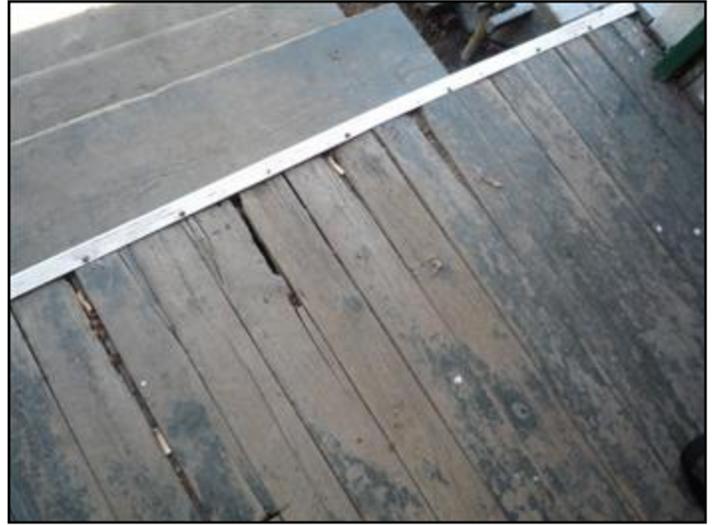
rot at porch

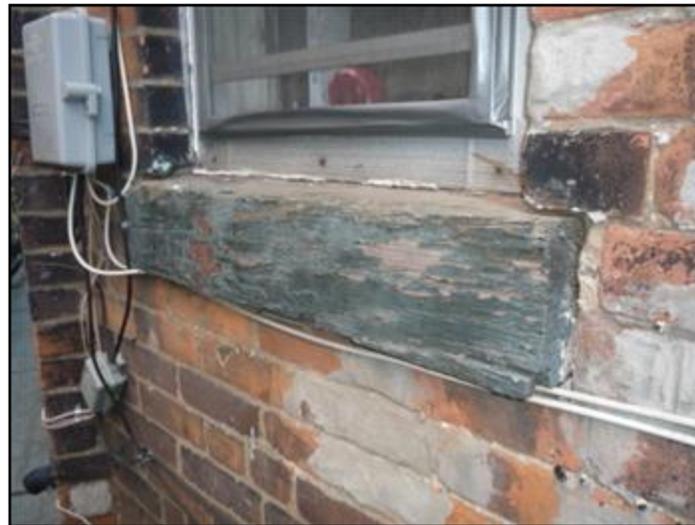
rot at sills

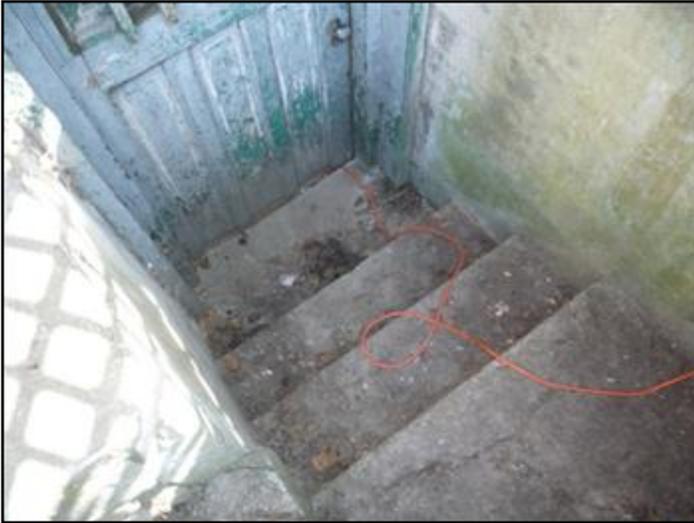
provide hand rail

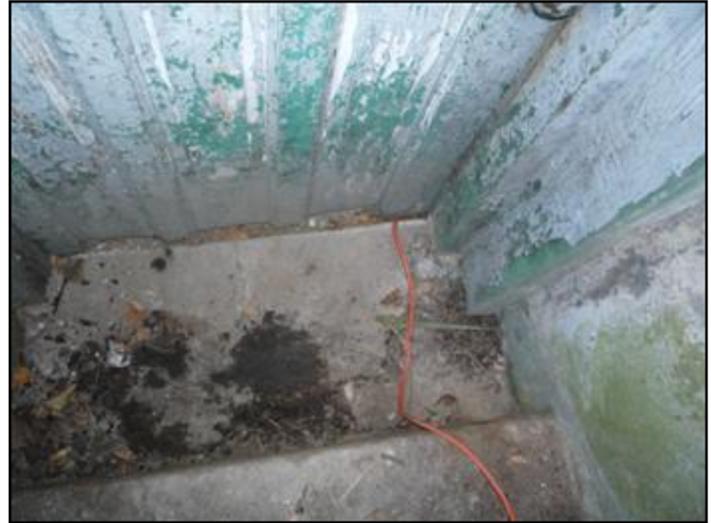
provide drain and threshold

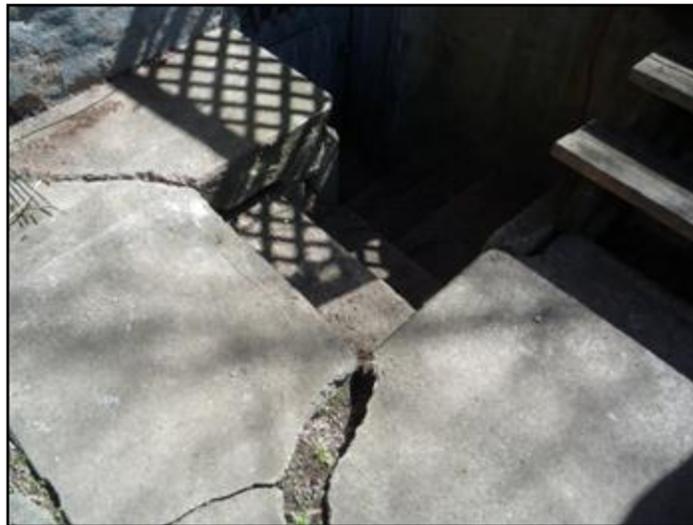
repair cracks and provide guardrail

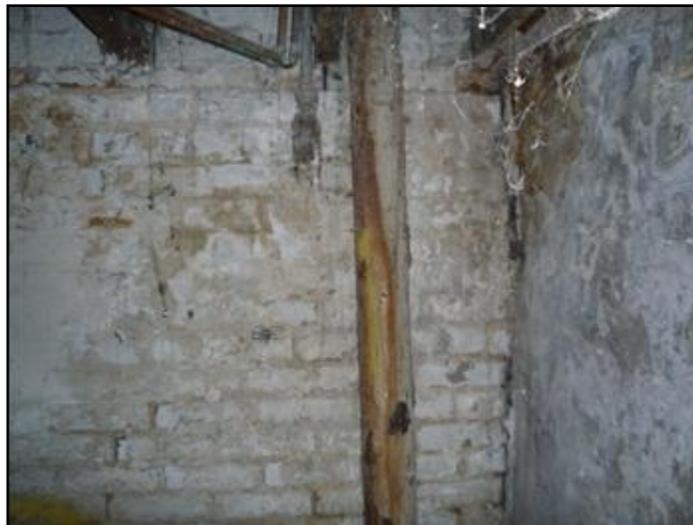
Condition: • The cast iron waste piping is near the end of its normal life expectancy and is prone to rusting through or splitting. Replacement may be required in the near future.

old stack leaks

Task: Replace

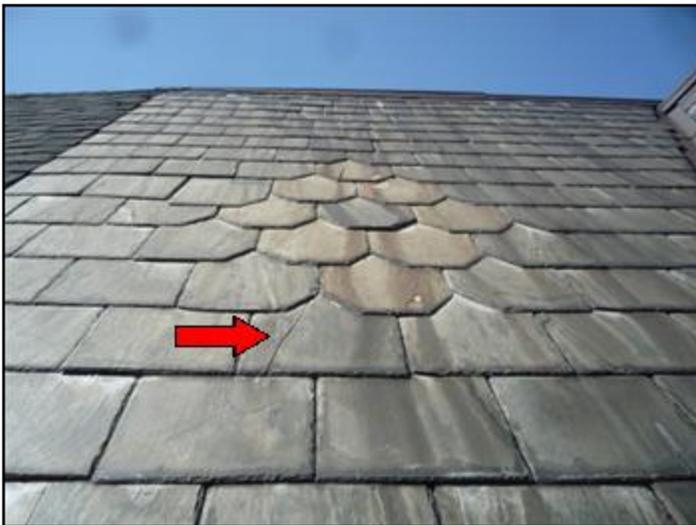
The slate roof is an original aspect of the house that adds aesthetic and traditional appeal but is very costly to maintain. The slates are in relatively good shape although one or two are cracked and one or two are missing. The flashings will fail before the slates and may need replacement in the short term. A slate roof specialist should be engaged to determine a repair and maintenance plan. Evidence of present leakage makes this a more immediate cost. Budget at least \$1000/year for annual maintenance.

cracked slate

Task: Further evaluation/Repair

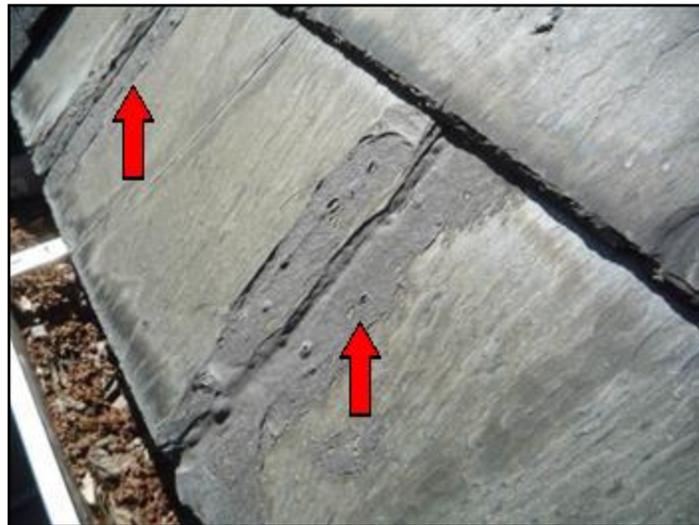
patched slates

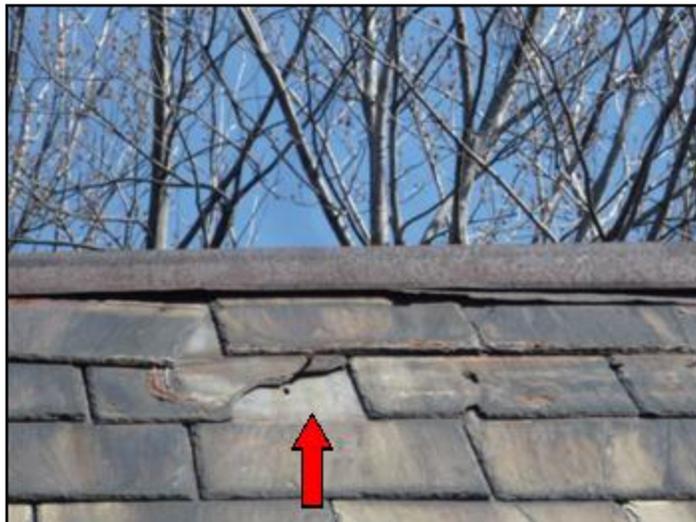
missing slates

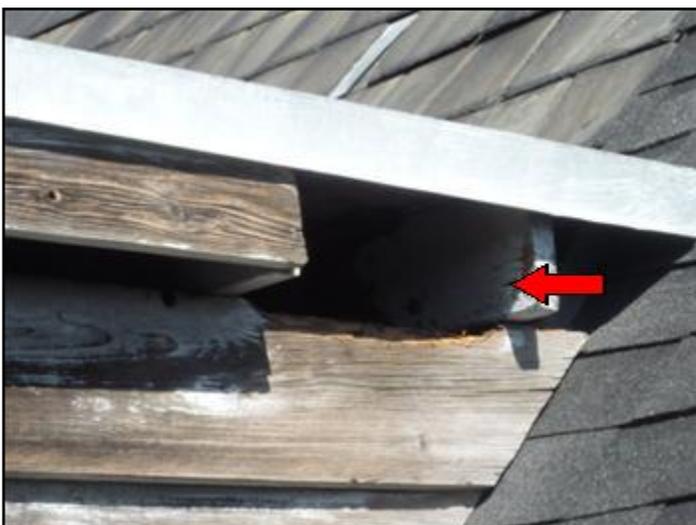
The dormer is in poor condition. It appears that a squirrel or raccoon has nested in the roof and caused a leak into the ceiling below. The wood siding has aged due to poor maintenance.

vermin damage

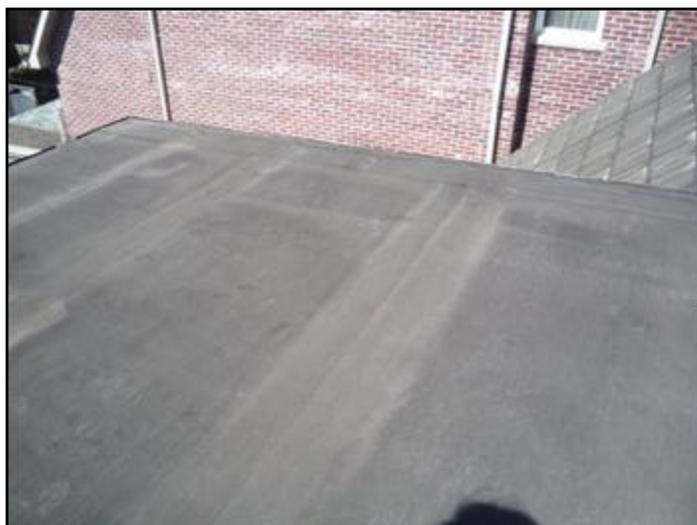
ageing membrane

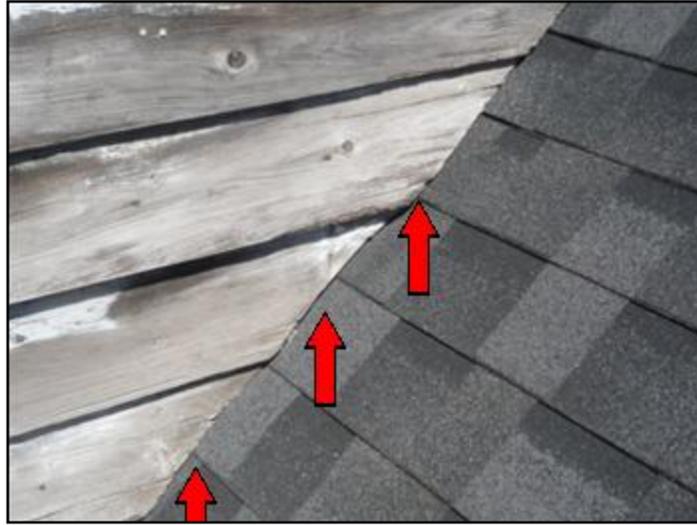
siding touches roof

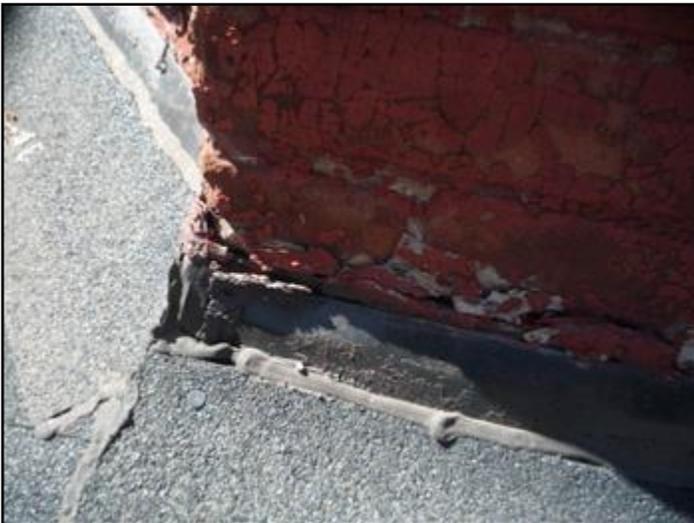
poor seal at flashing

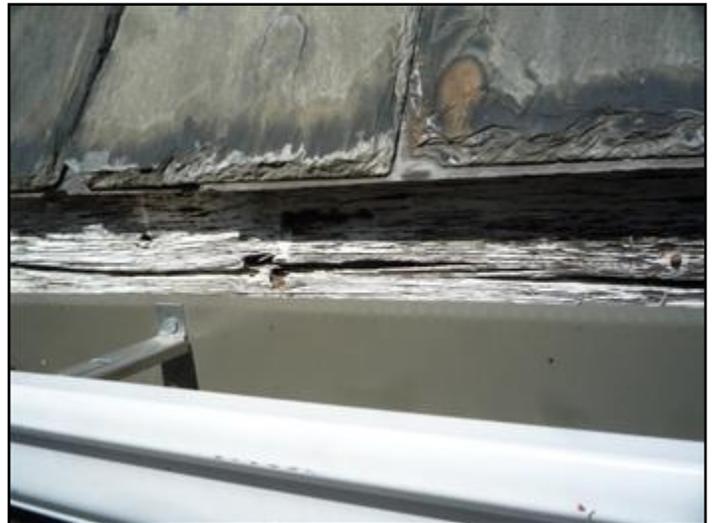
provide drip edges

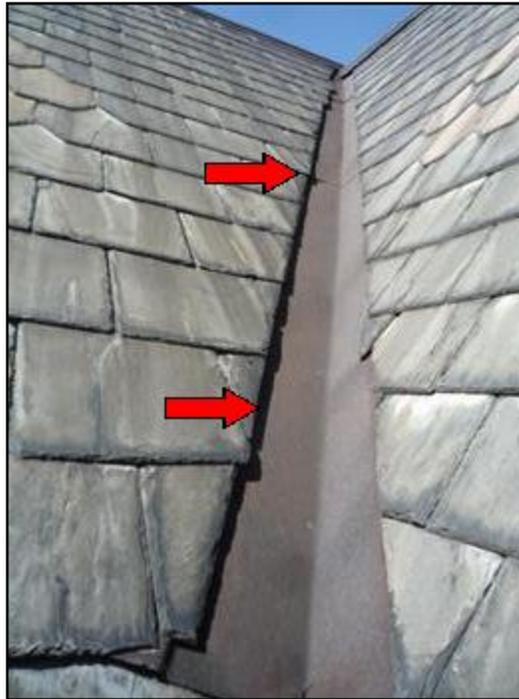
rusted valley flashing

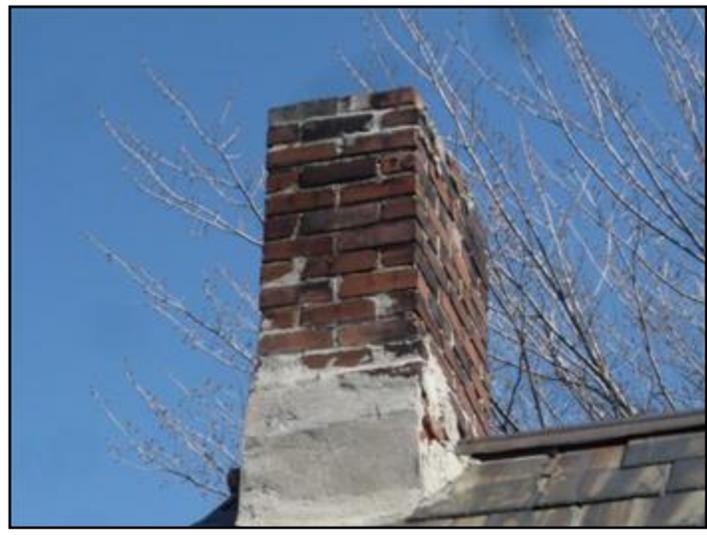
This original chimney was built to vent the coal fireplaces when they were operational. If intending to upgrade the fireplaces to the point that they can be used in future, then the chimney should be repaired and a cap installed. Consideration should be given to demolishing the chimney and patching the roof. The vulnerable slate roof surface will make this repair more costly than is typical.

abandoned chimney

Task: Repair or remove

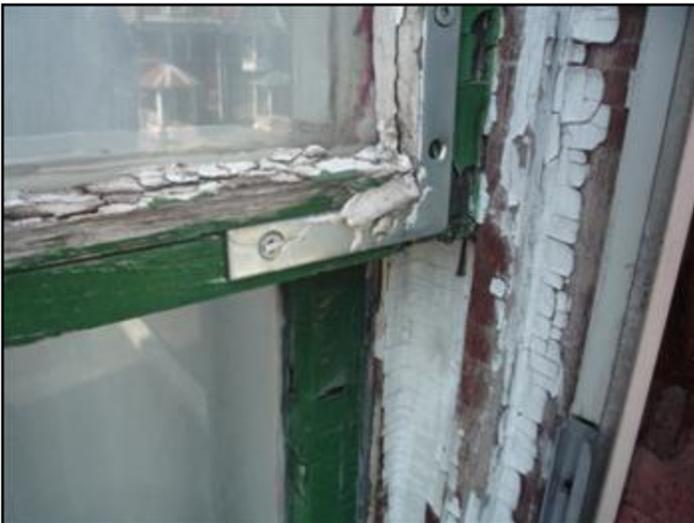
rot at windows

A carpenter or handy person should be engaged to repair and finish all of the exterior wood surfaces including trim, sills, windows, doors and porches.

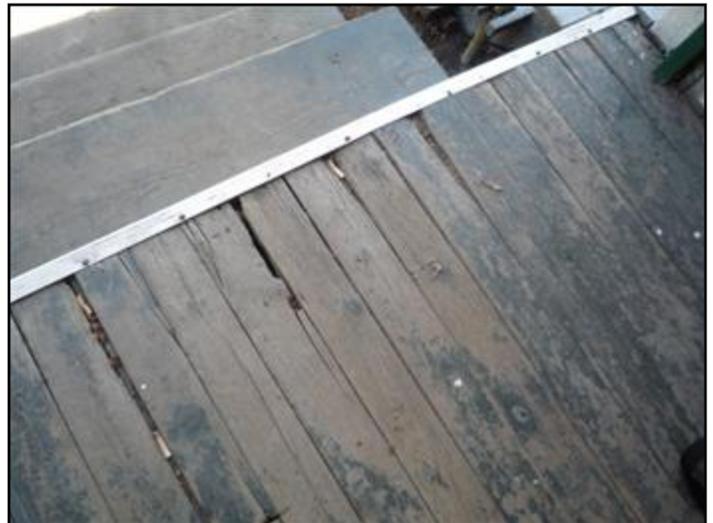
rot at porch

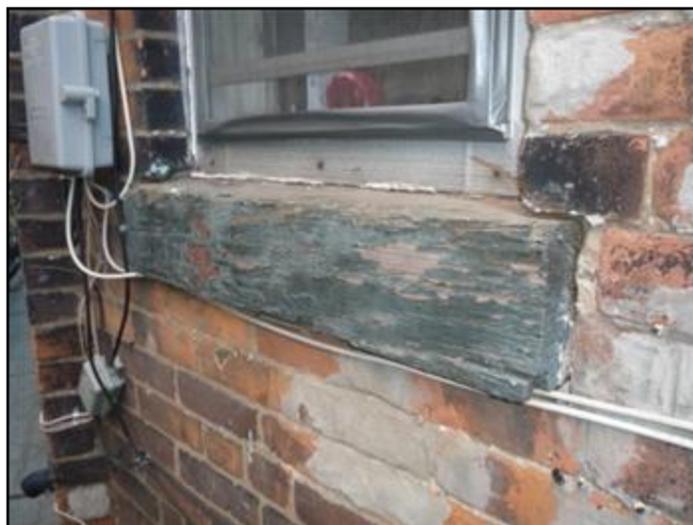
rot at sills

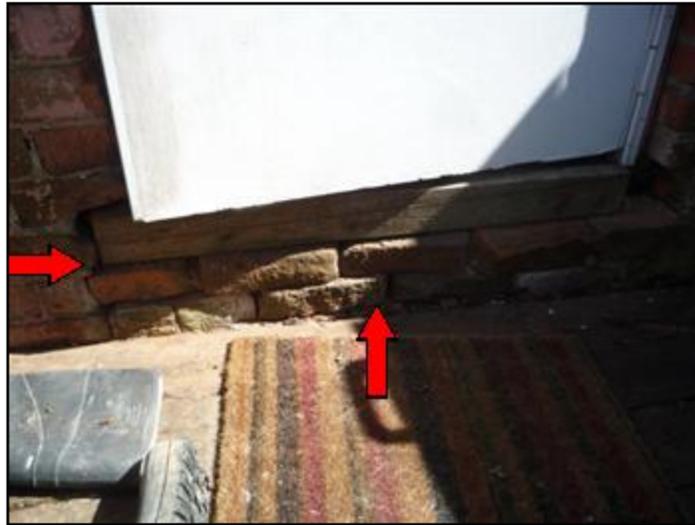
Mortar deterioration

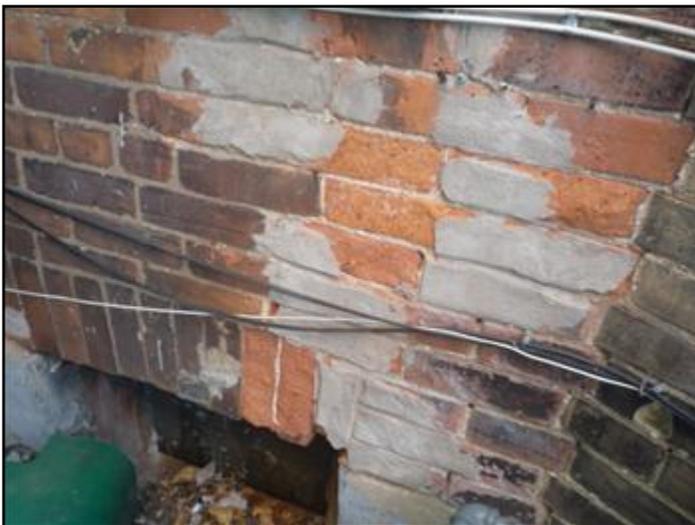
water damage

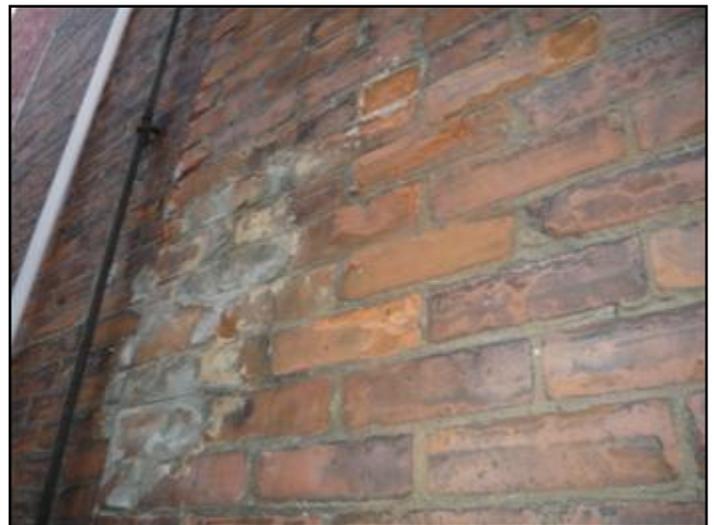
spalling chimney

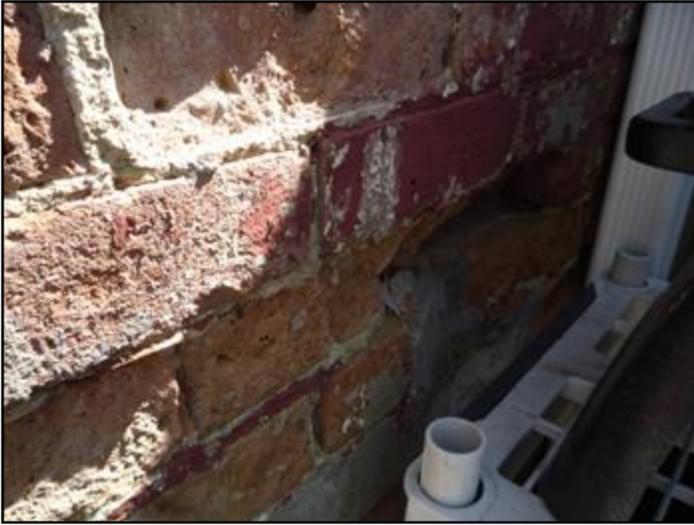
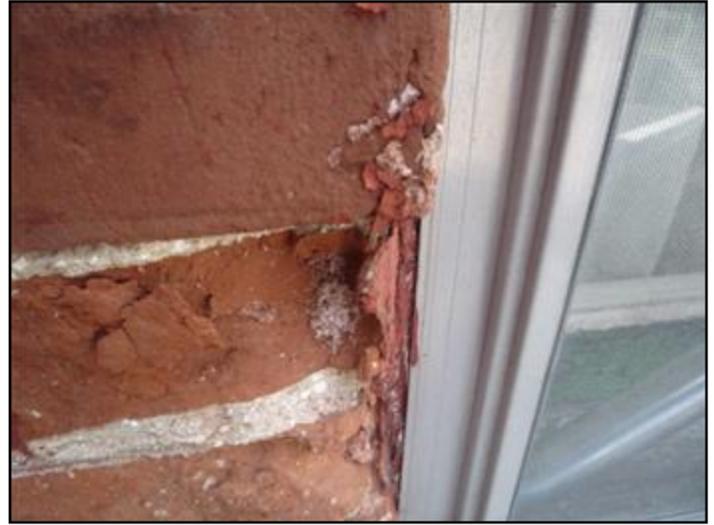
spalling bricks

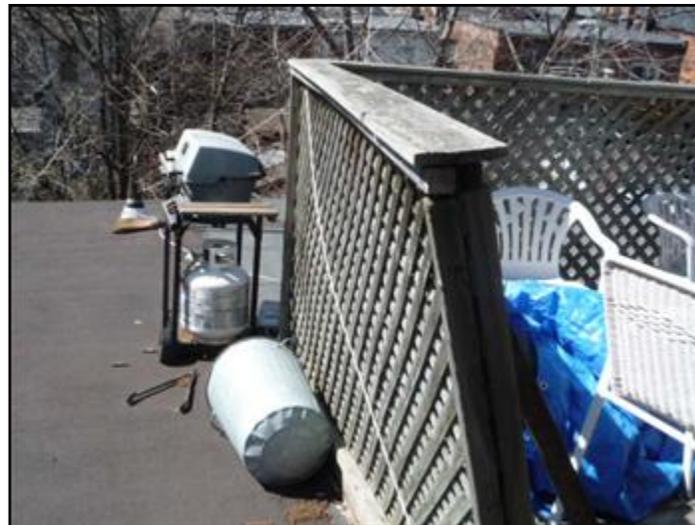
Condition: • [Loose](#)

loose and missing rail

Task: Correct

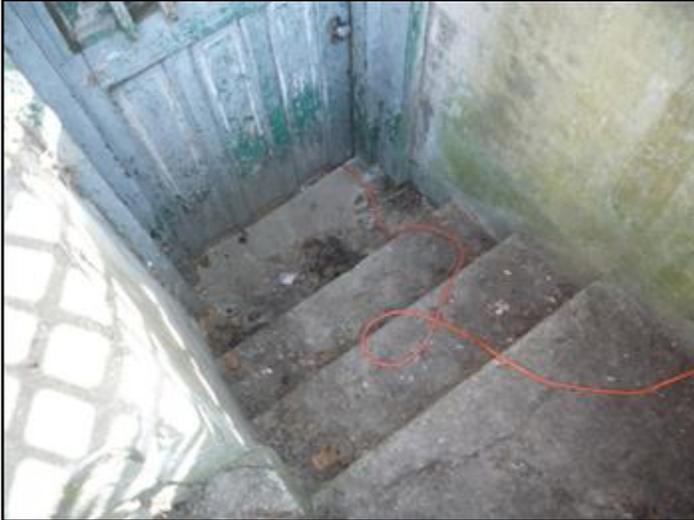
provide hand rail

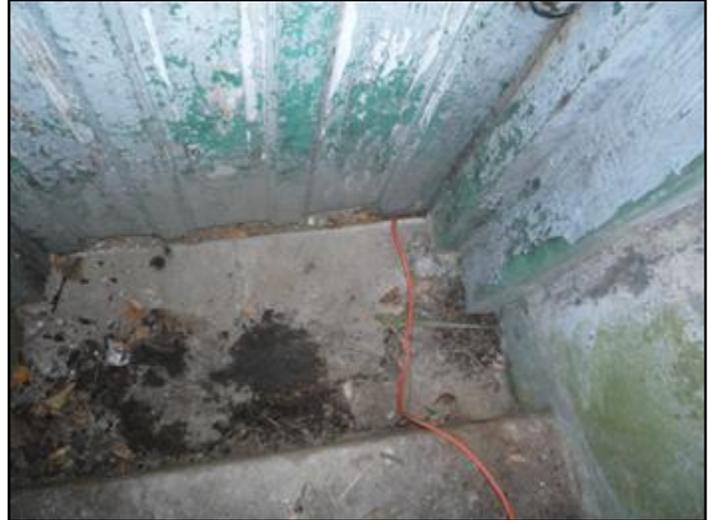
provide drain and threshold

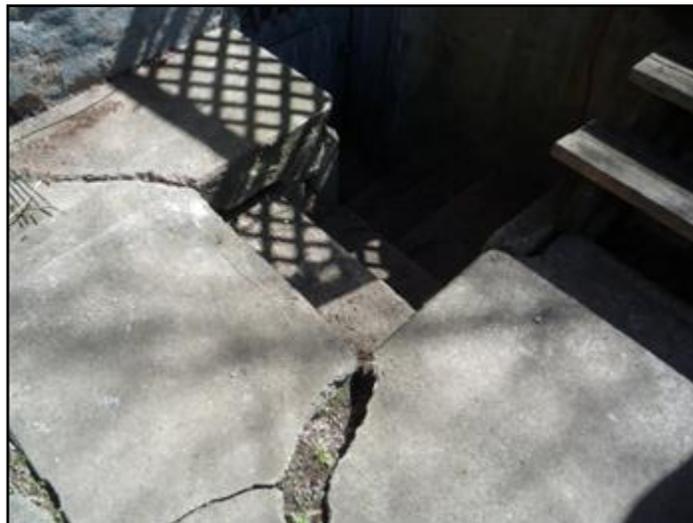
repair cracks and provide guardrail

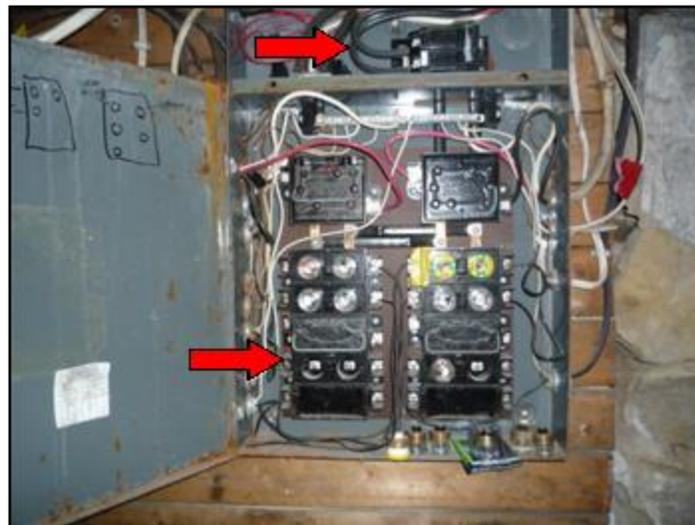
unprotected openings

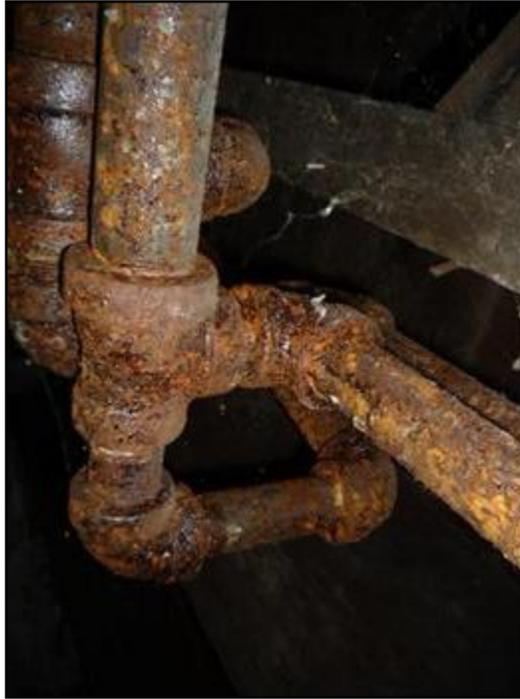
Condition: • [Piping rust](#)

This rust is extensive. An specialist should be engaged to test the entire piping and radiator system to determine potential leakage areas.

Task: Replace

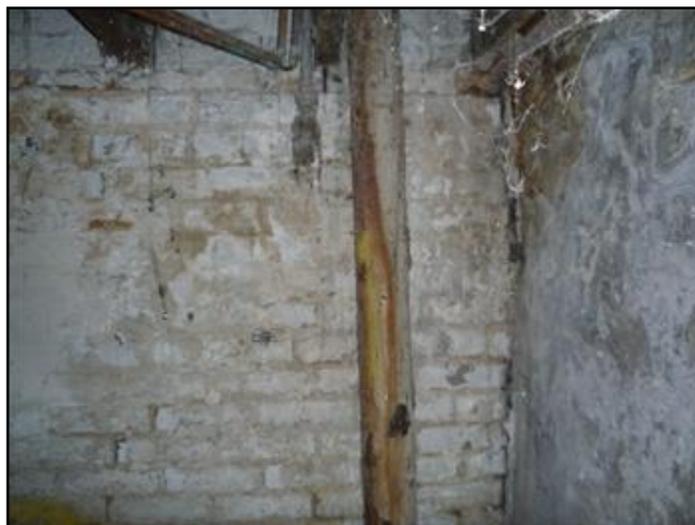
Condition: • The cast iron waste piping is near the end of its normal life expectancy and is prone to rusting through or splitting. Replacement may be required in the near future.

old stack leaks

Task: Replace

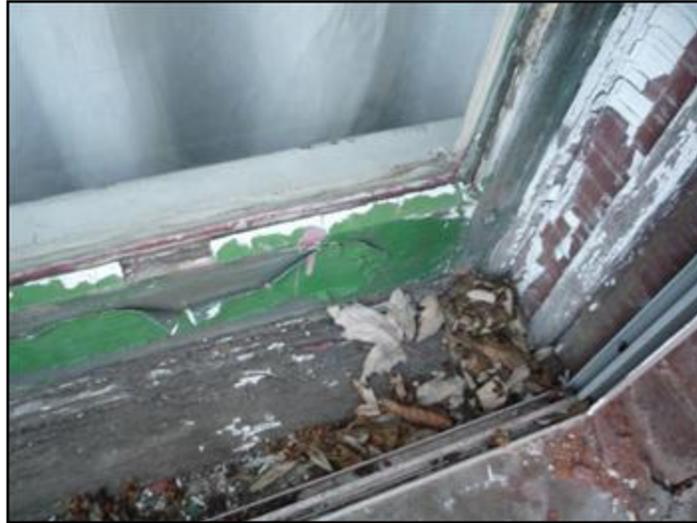
Condition: • [Frame rot](#)

Task: Repair or replace

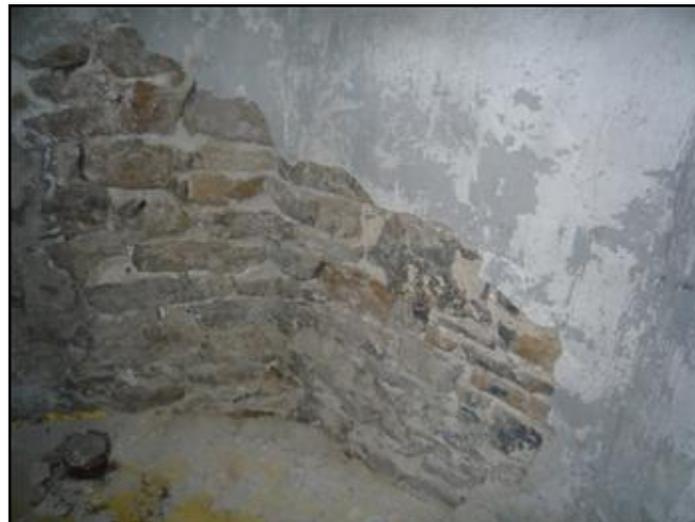
Condition: • Evidence of basement leakage was noted.
