INSPECTION REPORT

For the Property at:
32819 XXXXXX AVE
MISSION, BC V2V2J9

Prepared for: TOM CUSTOMER
Inspection Date: Thursday, January 13, 2011
Prepared by: Doug Johns

RE: Report No. 1003, v.12
32819 xxxxxx Ave
Mission, BC
V2V2J9

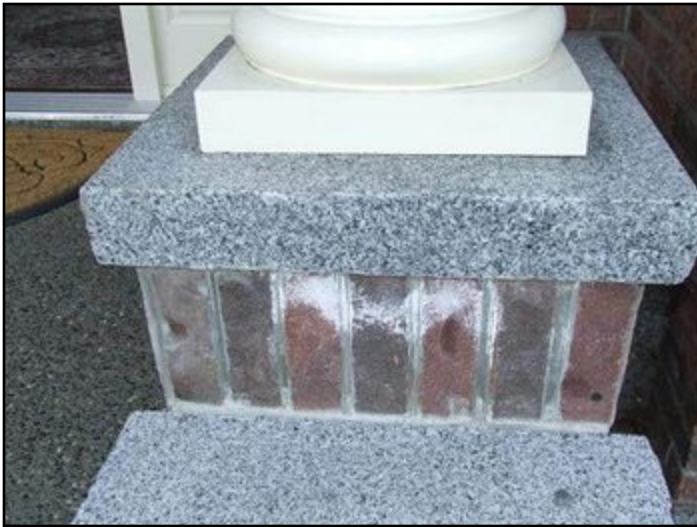
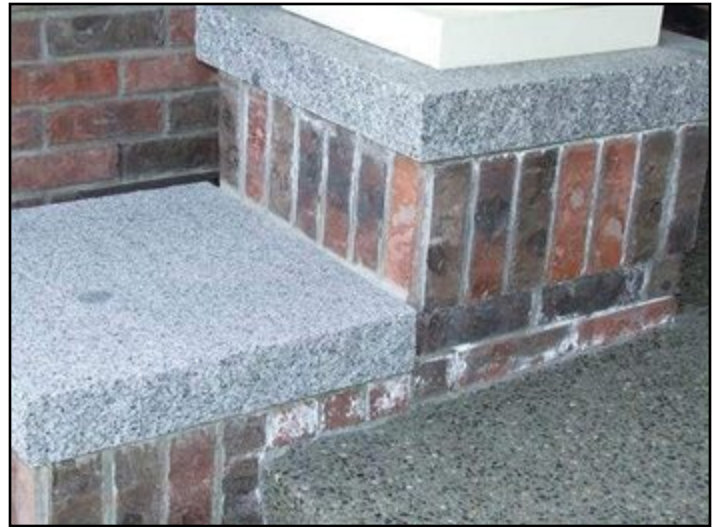
Minor Efflorescent noted Requires cleaning/maintenance

1. Minor Efflorescent

2. Minor Efflorescent

Condition: • [Efflorescence](#)

Implication(s): Cosmetic defects | Chance of damage to finishes | Material deterioration

Task: Clean Correct Inspect annually Monitor Protect

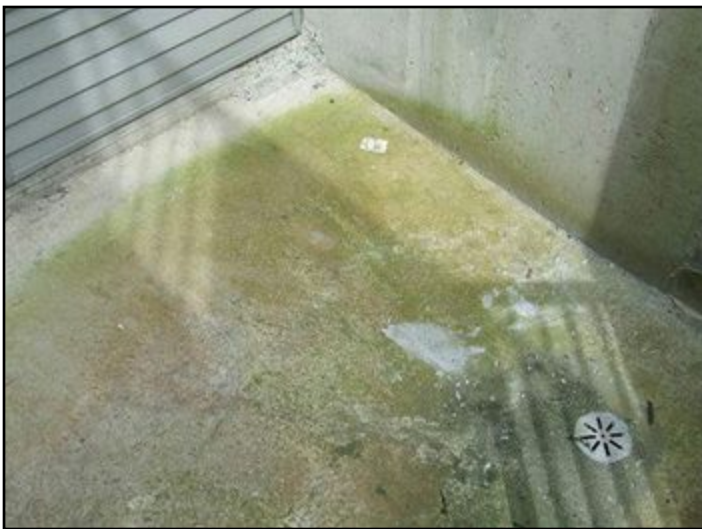
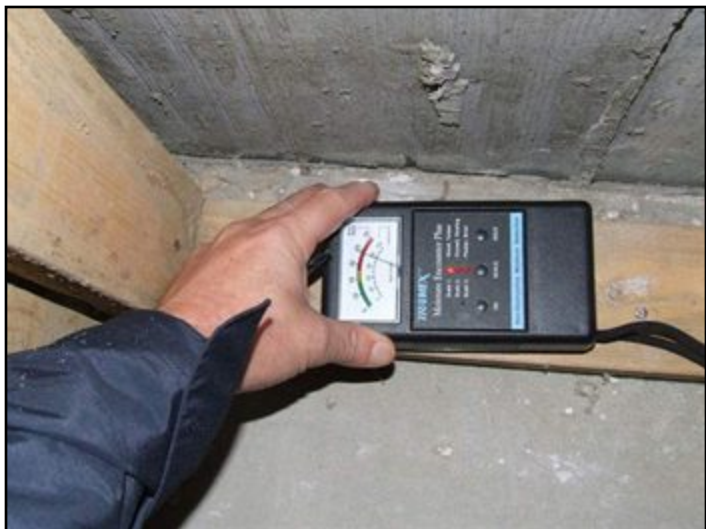
Algae on floor of exterior stairwell noted as well as excessive moisture on interior wall adjacent. No Drain Trap present in floor drain of stairwell.

4. Excessive moisture reading on interior wall f

Task: Correct Further evaluation Inspect annually Repair Request disclosure Service annually

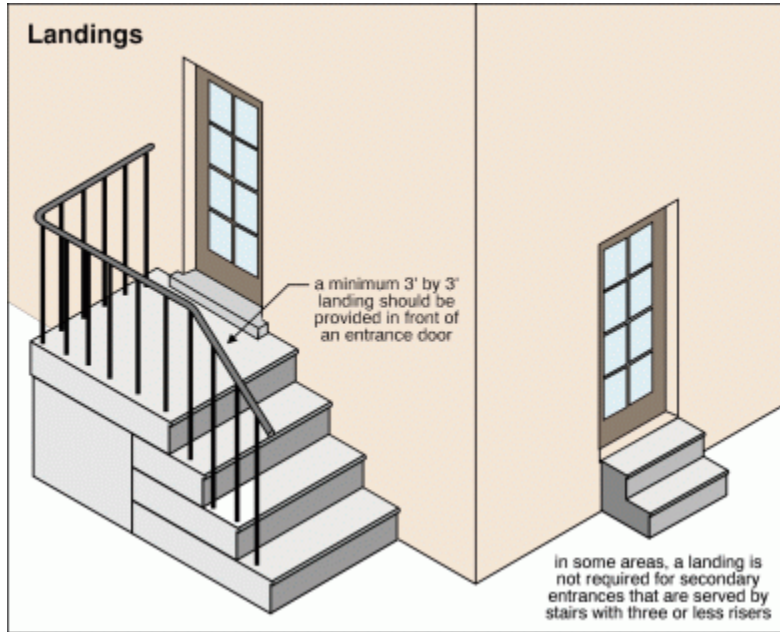
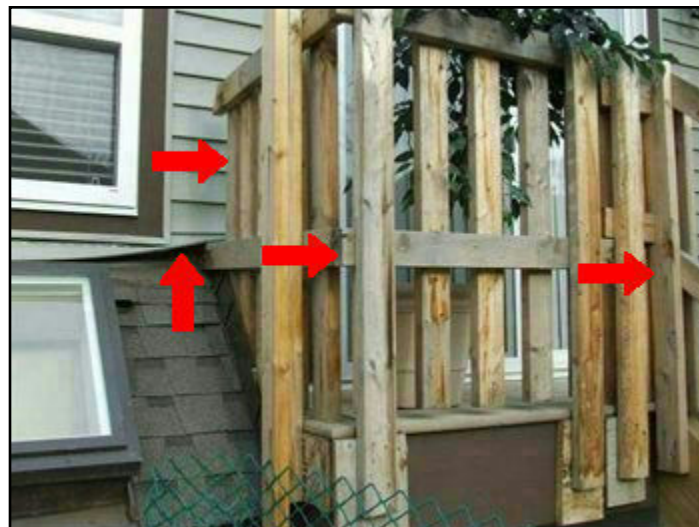
Deck at the rear of the home has not been properly built. No newel posts have been used and Guard rail and balustrade have not been properly secured. Inspector recommends consulting a qualified carpenter to rebuild

Task: Repair or replace

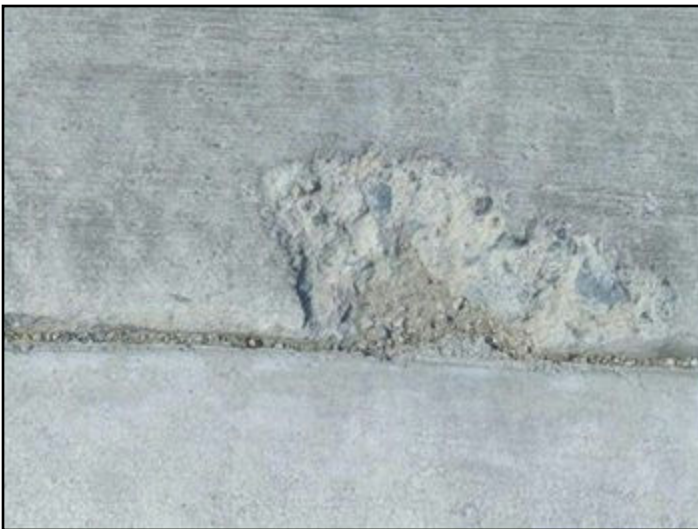
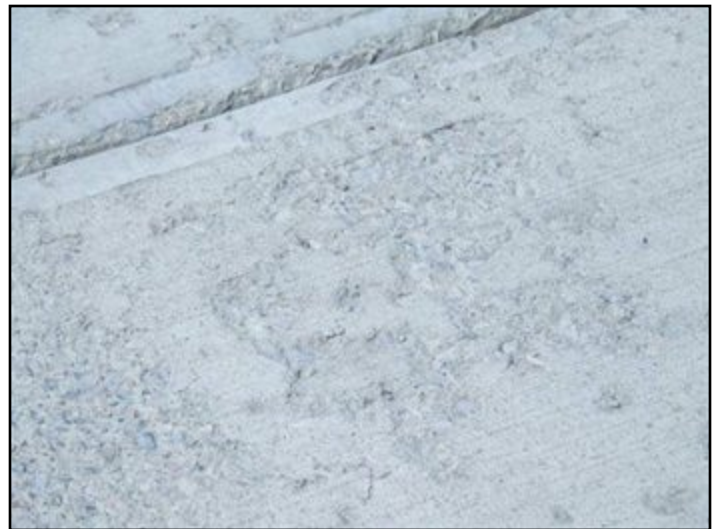
6.

Some spalling was noted on the driveway to the home. Salt spalling is a specific type of weathering which occurs in porous building materials, such as brick, natural stone, tiles and concrete. Dissolved salt is carried through the material in water and crystallizes inside the material near the surface as the water evaporates. As the salt crystals expand this builds up shear stresses which break away spall from the surface. Spalling on this driveway is not severe and may be relative to driveway surface not being sealed or from parking/driving habits of previous owners A qualified concrete professional should be consulted as the condition, left unsurprised may worsen

Task: Further evaluation

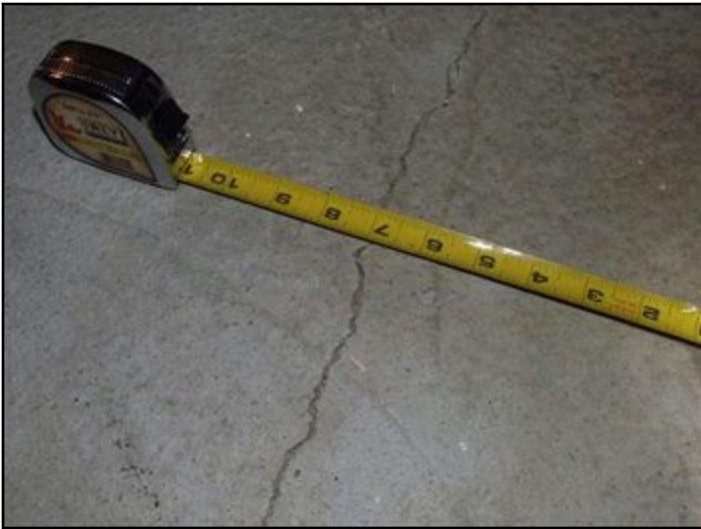
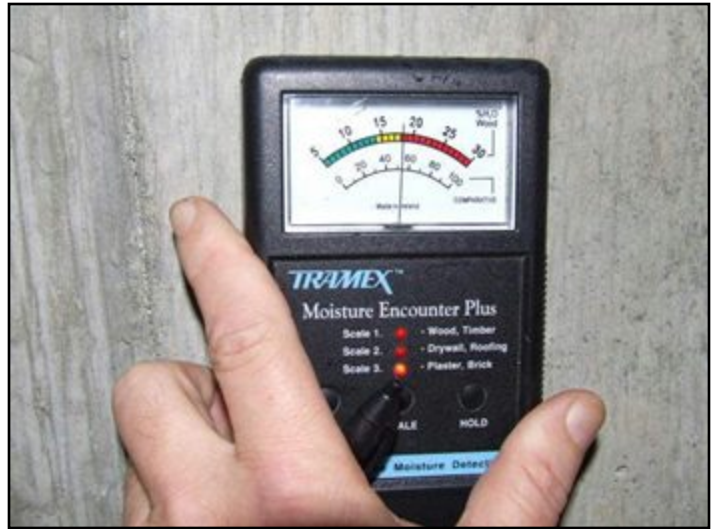
Minimal cracks noted on Garage floor, recommend monitoring. Moisture reading normal.

8. Not excessive

9. Normal

Task: Monitor

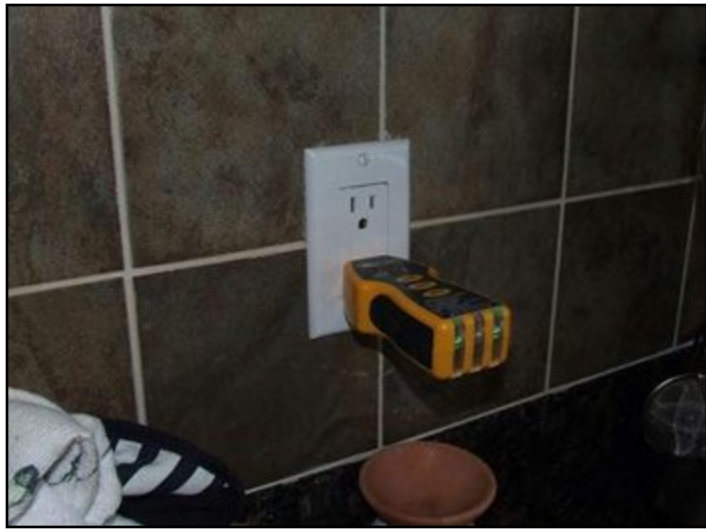
10.

No GFI noted on upstairs of home.

Task: Correct Monitor Repair or replace Request disclosure

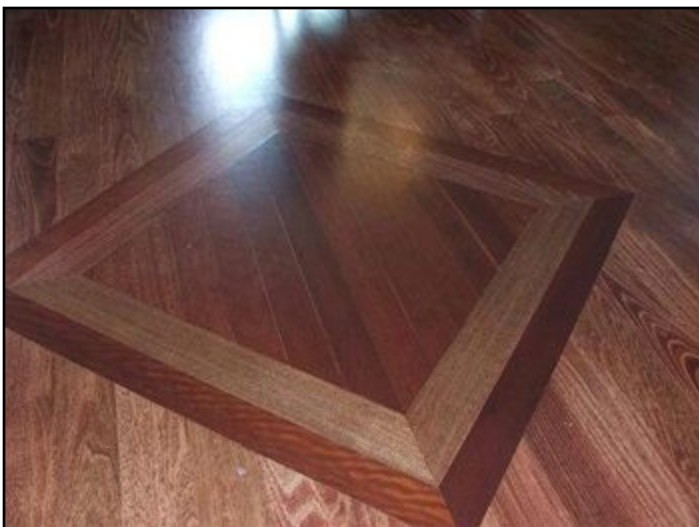
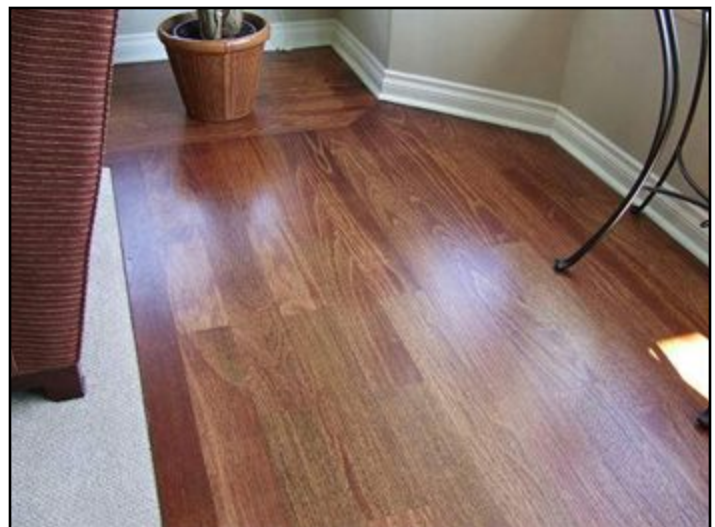
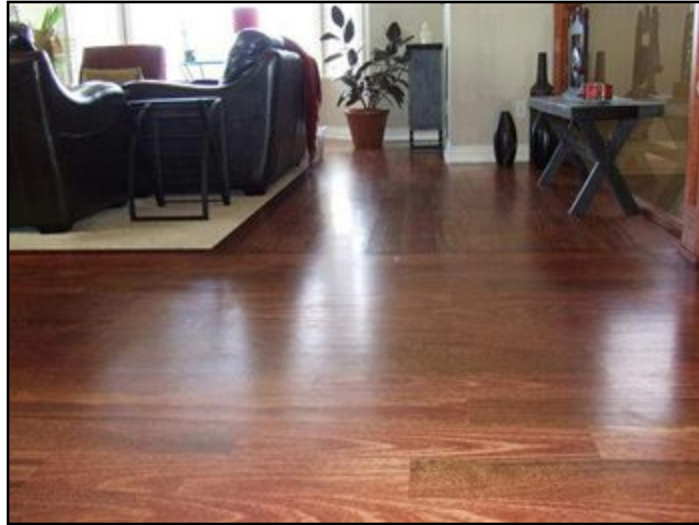
Minor selection of sub-floor (typical). Minor lateral movement of Hardwood floor. It is typical for Solid Wood flooring to climatically adjust to humidity throughout the season. Solid wood floors that do not close tightly (1/8 inch cracks or less) at least once/year may be considered excessive.

Task: Monitor
Time: 2 years
Cost: Depends on work needed

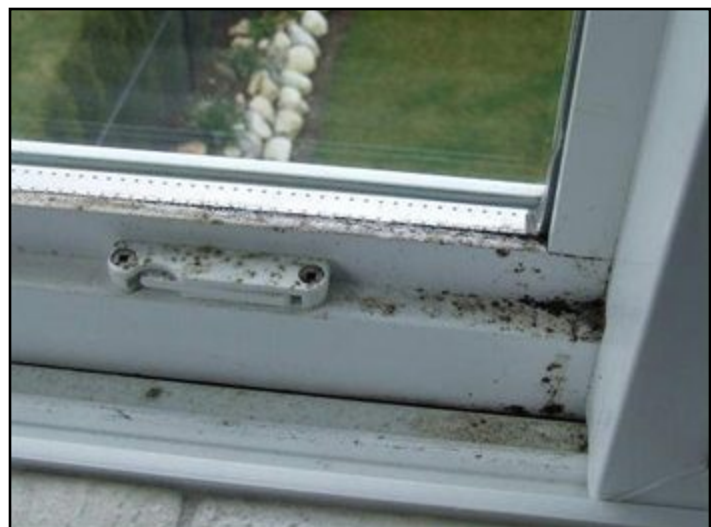
Condition: • Mould noted on south facing, upstairs main bathroom. Recommend cleaning and monitoring

14. mould noted

Task: Clean Correct Monitor

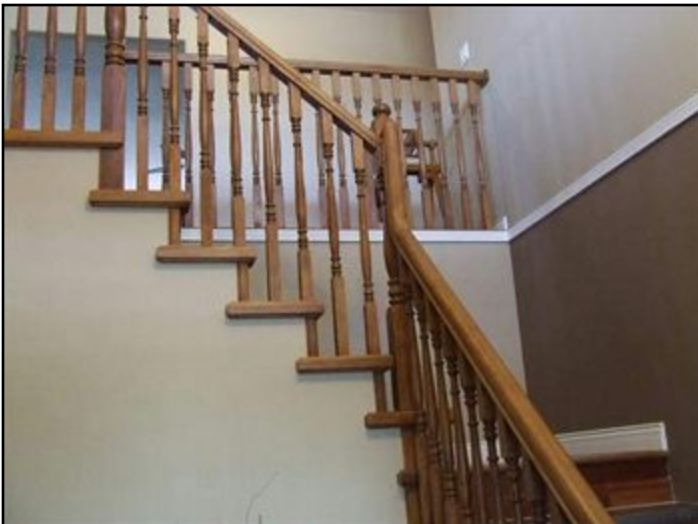
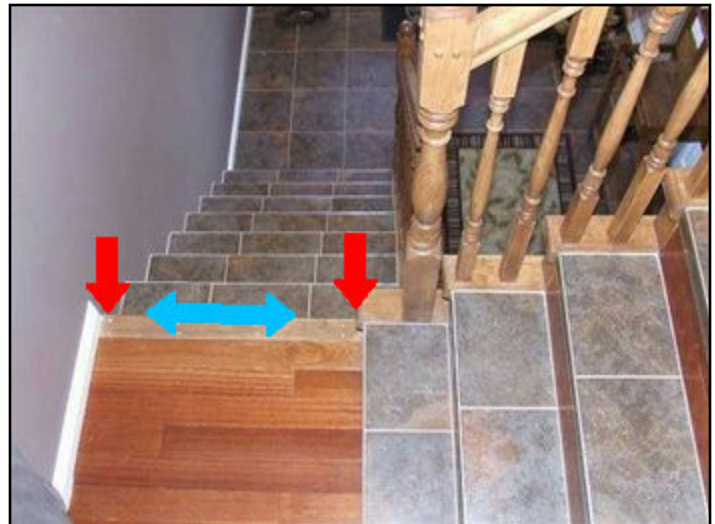
Landing is 32 inches wide / should be 36, newel post sits too far back on a stair tread which is only 8 inches wide (should be 9+)

16. Landing is 32 inches wide, should be 36

Task: Repair or replace

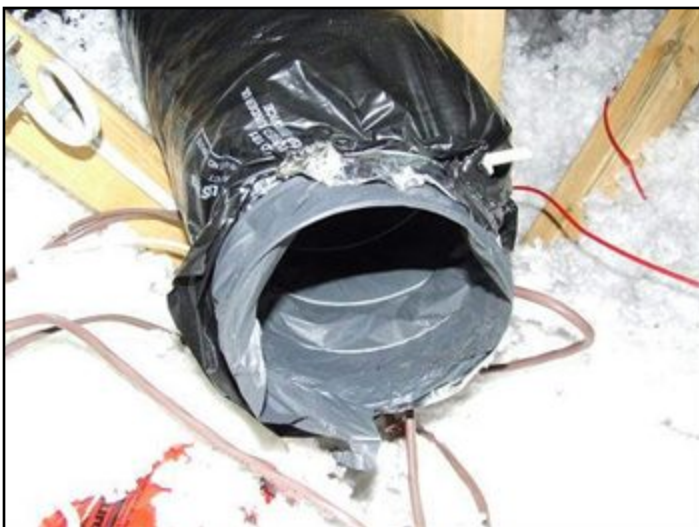
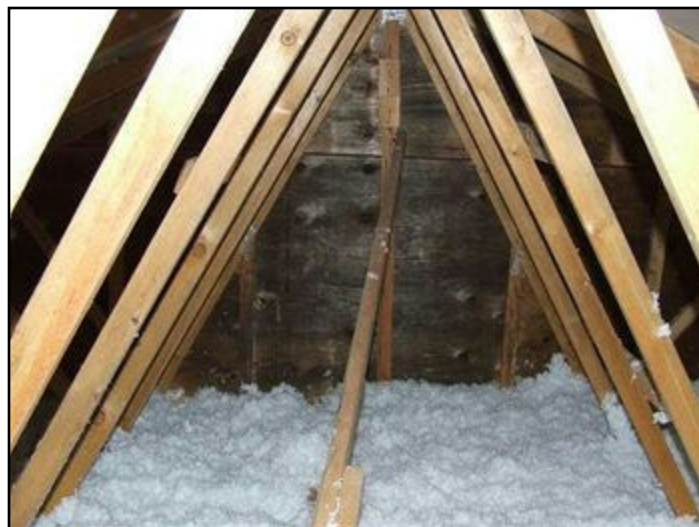
Disconnected bathroom exhaust fan noted in Attic as well as loose telephone wires. Recommend further investigation by qualified professional. Mold/mildew present.

17. loose telephone wires and exhaust fan

Task: Correct

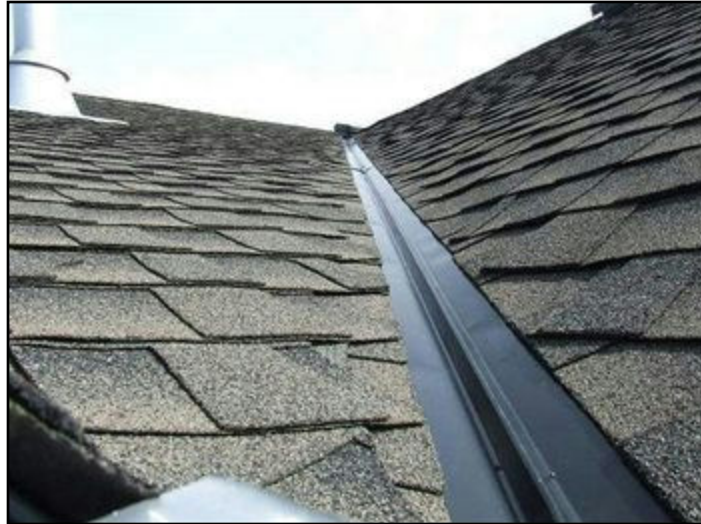
20.

General: • Large expanse of roof may create oversize hydraulic load for the gutter/drainage system. Recommend monitoring during heavy rain.

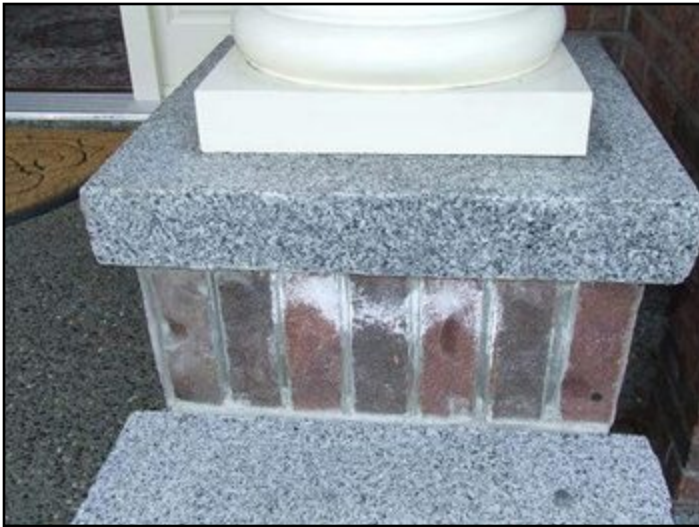
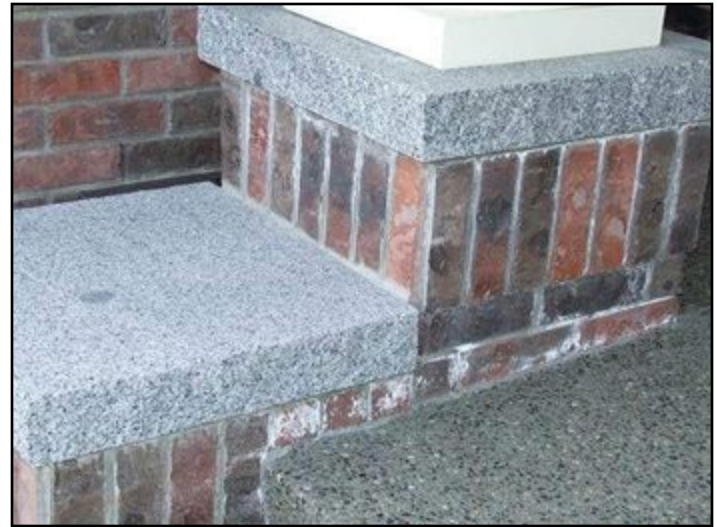
Minor Efflorescent noted Requires cleaning/maintenance

23. Minor Efflorescent

24. Minor Efflorescent

4. Condition: • [Efflorescence](#)

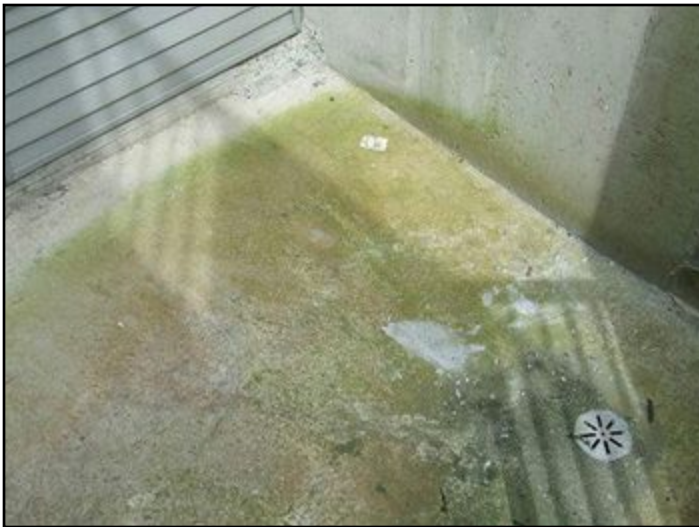
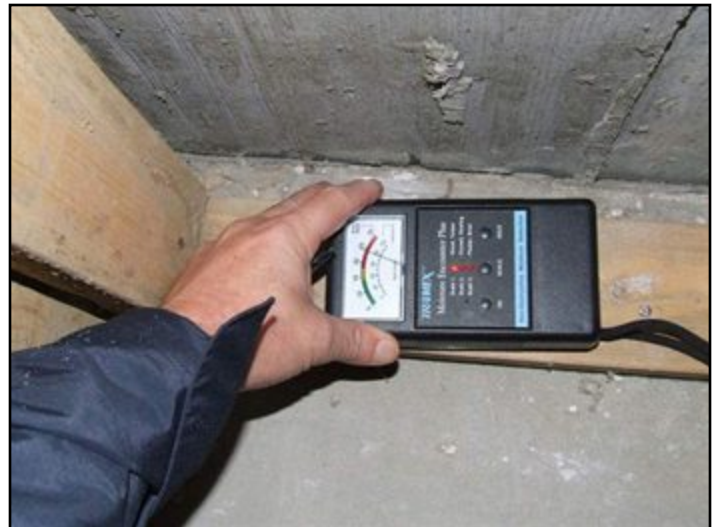
Algae on floor of exterior stairwell noted as well as excessive moisture on interior wall adjacent. No Drain Trap present in floor drain of stairwell.

26. Excessive moisture reading on interior wall f

Task: Correct Further evaluation Inspect annually Repair Request disclosure Service annually

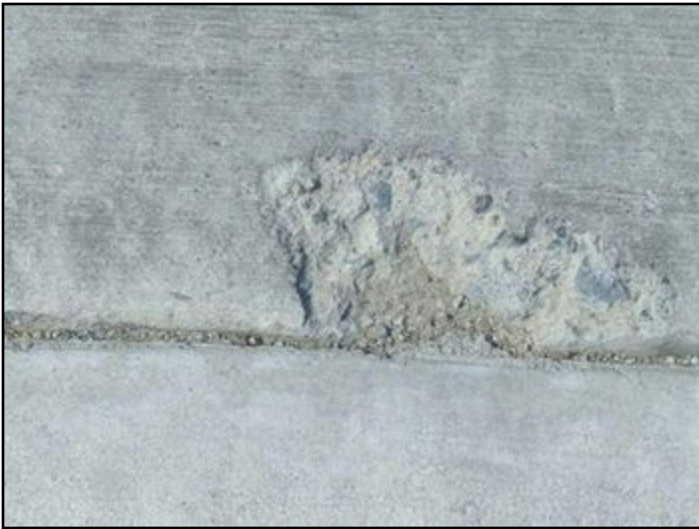
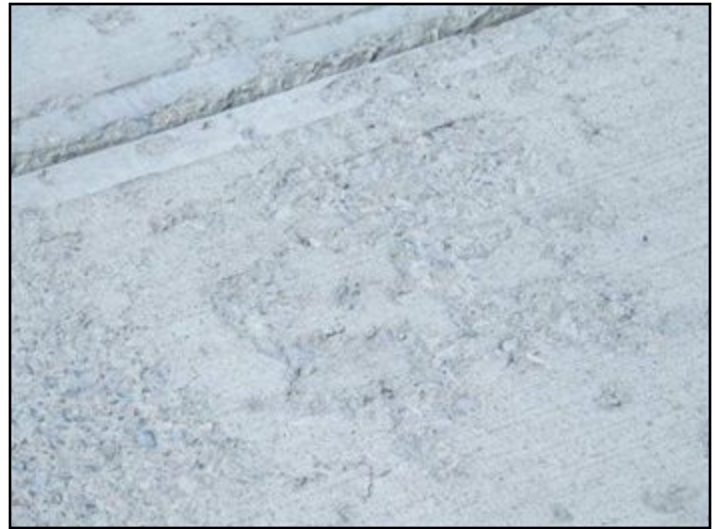
Some spalling was noted on the driveway to the home. Salt spalling is a specific type of weathering which occurs in porous building materials, such as brick, natural stone, tiles and concrete. Dissolved salt is carried through the material in water and crystallizes inside the material near the surface as the water evaporates. As the salt crystals expand this builds up shear stresses which break away spall from the surface. Spalling on this driveway is not severe and may be relative to driveway surface not being sealed or from parking/driving habits of previous owners A qualified concrete professional should be consulted as the condition, left unsurprised may worsen

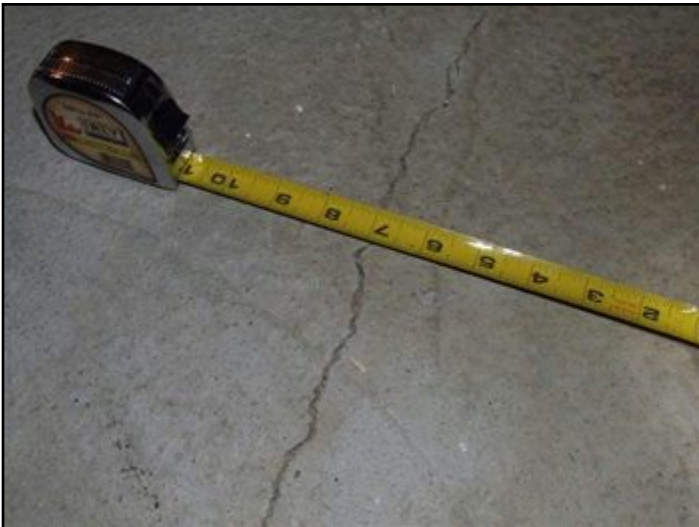
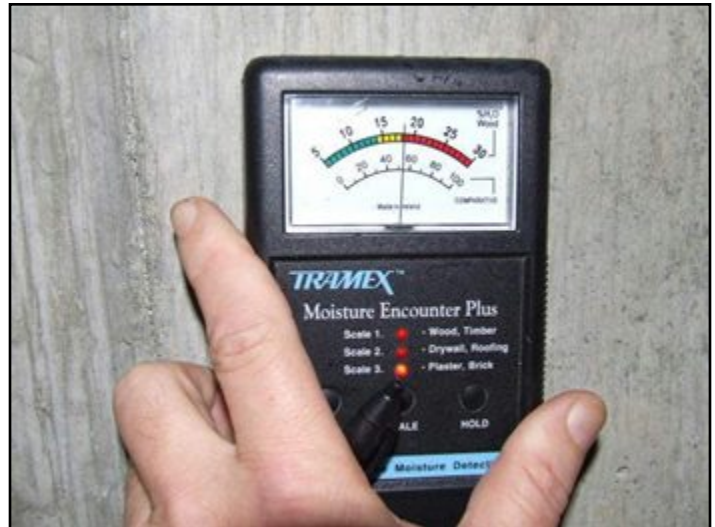
Minimal cracks noted on Garage floor, recommend monitoring. Moisture reading normal.

30. Not excessive

31. Normal

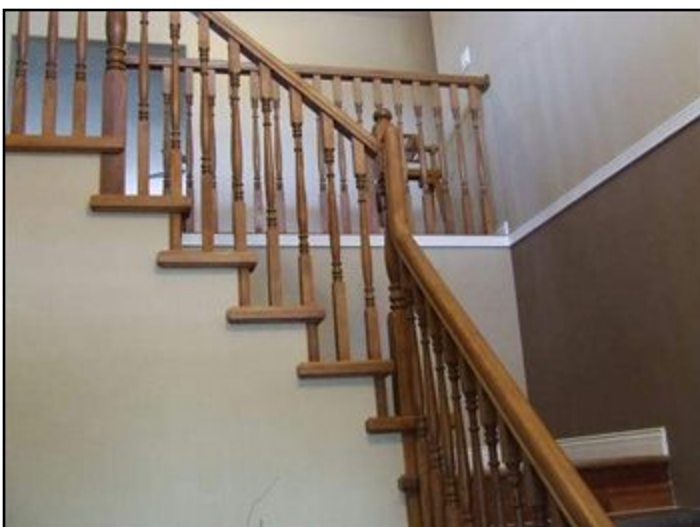
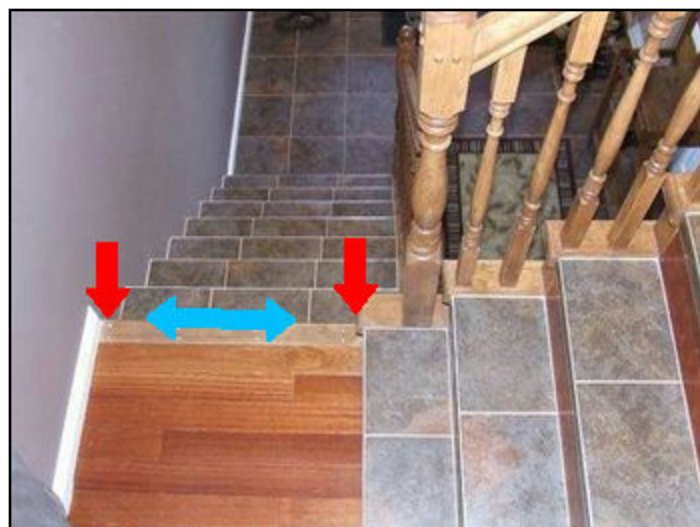
Stairs and railings: • Interior stairway from foyer to the upstairs of the home has a stair landing that is undersized. Minimum requirement is 36 inch X 36 inch. This landing has been installed incorrectly @ 26 in. X 36 in. It represents a potential trip hazard and should be Repaired by a qualified Carpenter.

37. 38. Landing is 32 inches wide, should be 36

Task: Repair or replace

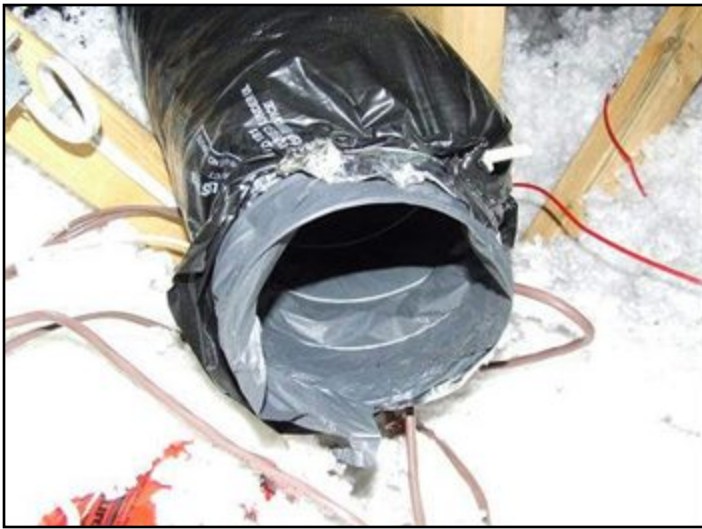
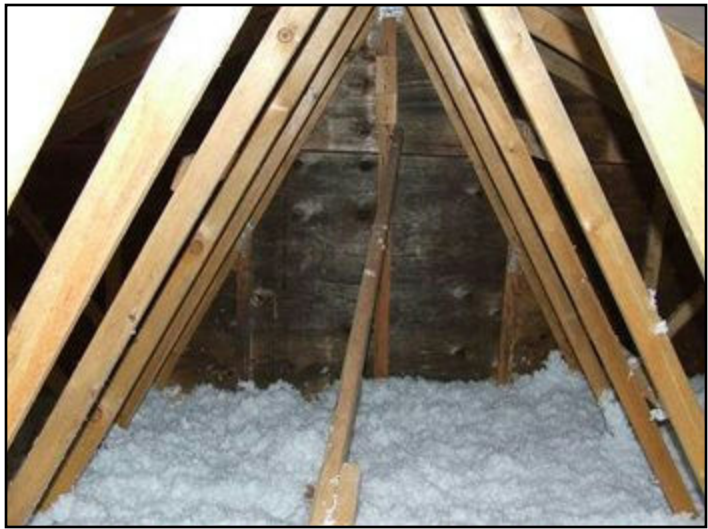
Disconnected bathroom exhaust fan noted in Attic as well as loose telephone wires. Recommend further investigation by qualified professional. Mold/mildew present.

39. loose telephone wires and exhaust fan
