# Your Inspection Report

4321 2nd Street  
Surrey, BC V3W 3E5

**INSPECTION DATE:**  
Monday, November 24, 2008

Report No. 1006, v.5

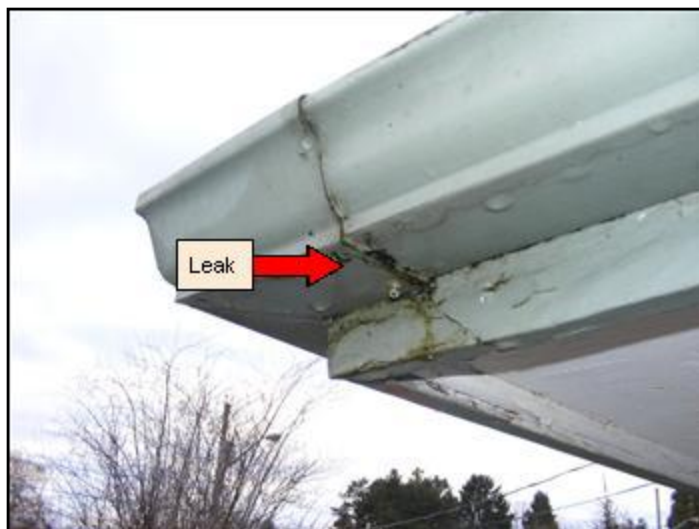
1.

**Condition:** • [Leak](#)

**Implication(s):** Chance of water damage to contents, finishes and/or structure

**Location:** Southwest Exterior

**Task:** Repair

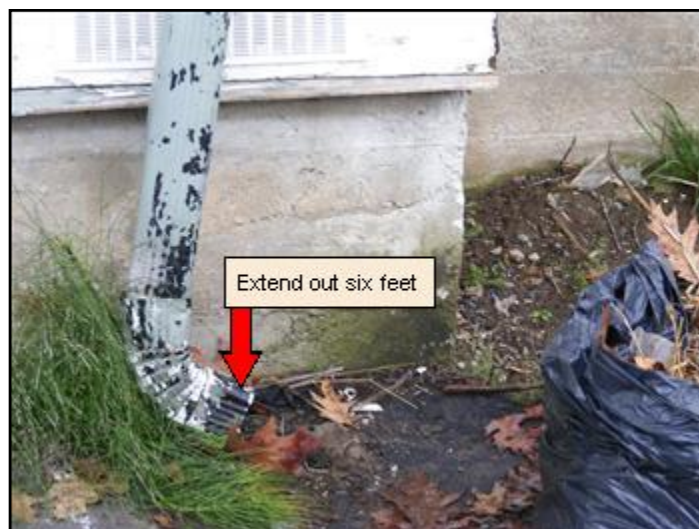
2.

**Condition:** • [Downspouts end too close to building](#)

**Implication(s):** Chance of water damage to contents, finishes and/or structure

**Location:** Southeast Exterior

**Task:** Improve

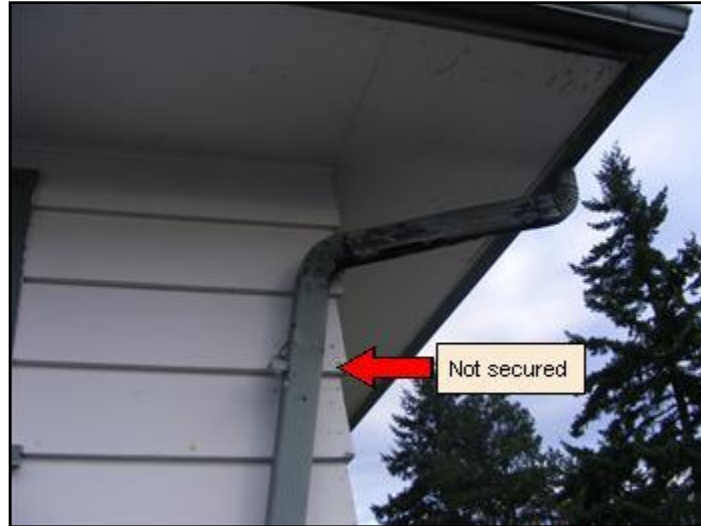
3.

**Condition:** • [Not well secured](#)

**Implication(s):** Leakage

**Location:** Southeast Exterior

**Task:** Repair

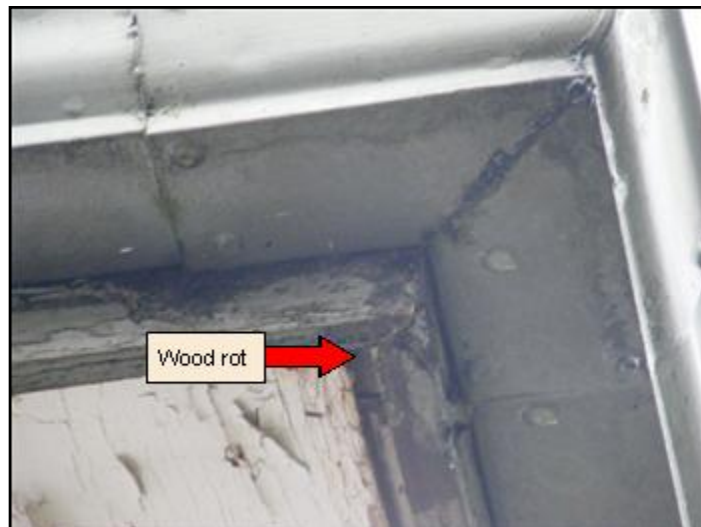
4.

**Condition:** • [Rot or insect damage](#)

**Implication(s):** Cosmetic defects | Chance of water damage to contents, finishes and/or structure | Material deterioration

**Location:** Southwest Exterior

**Task:** Repair

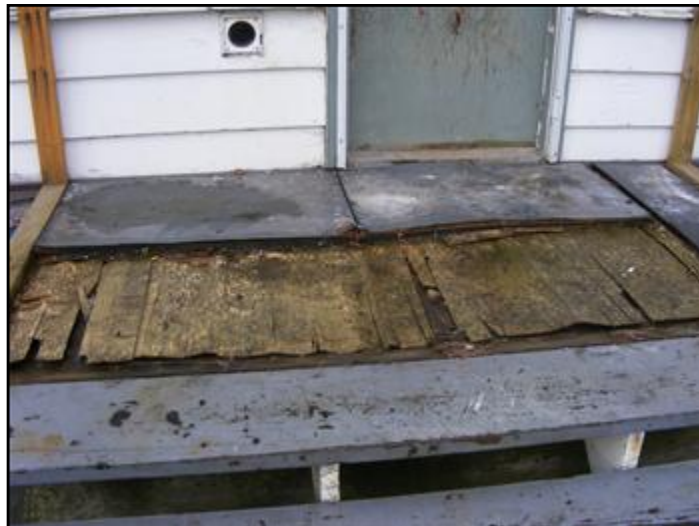
7.

**Condition:** • [Rot or insect damage](#)

**Implication(s):** Weakened structure | Chance of movement | Material deterioration

**Location:** Throughout Exterior Porch

**Task:** Replace

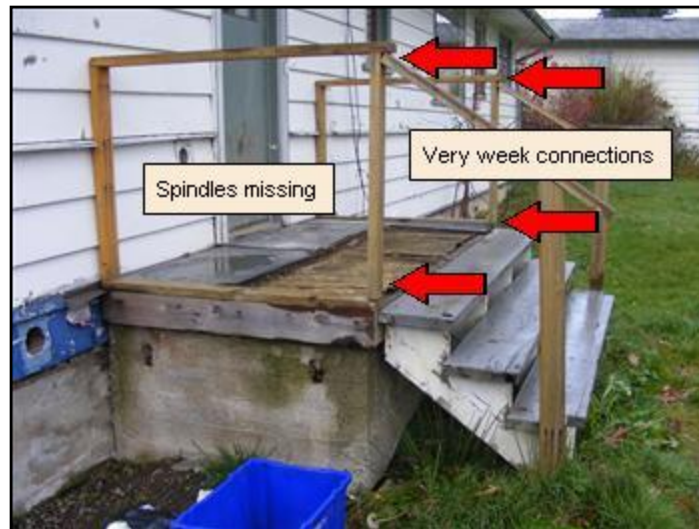
8.

**Condition:** • [Weak](#)

**Implication(s):** Fall hazard

**Location:** Throughout Exterior Porch

**Task:** Improve

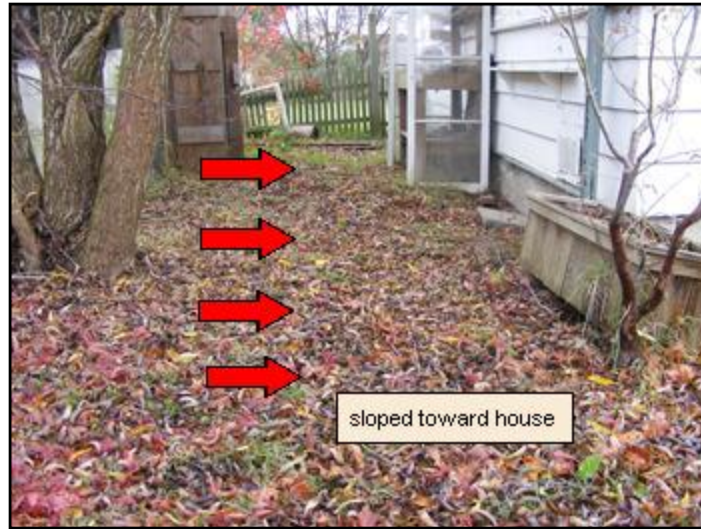
9.

**Condition:** • [Spindles missing](#)

**Implication(s):** Fall hazard

**Location:** Rear Porch

**Condition:** • [Improper slope](#)

**Implication(s):** Chance of water damage to contents, finishes and/or structure

**Location:** North Yard

**Task:** Improve

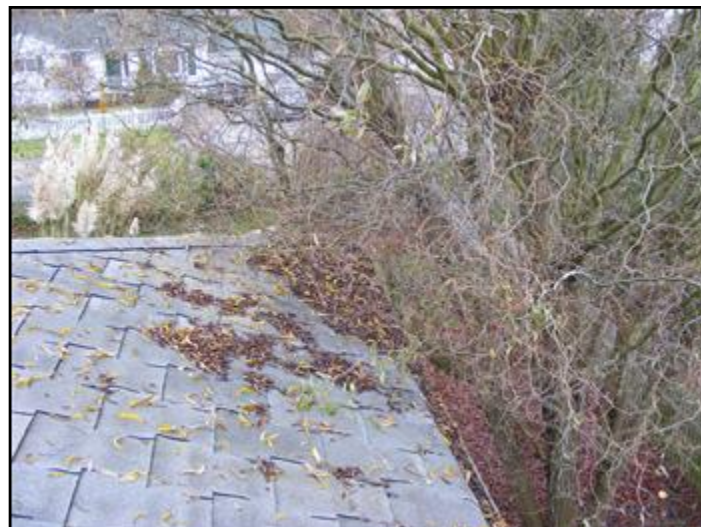
10.

**Condition:** • [Trees or shrubs too close to house](#)

Tree needs to be cut back from roof

**Implication(s):** Chance of water damage to contents, finishes and/or structure | Chance of pests entering house | Material deterioration

**Location:** Northwest Roof

**Task:** Improve

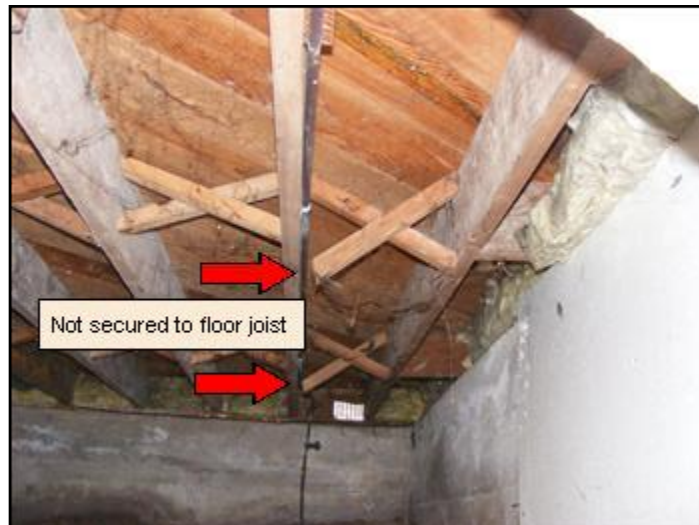
11.

**Condition:** • [Ineffective blocking, bracing or bridging](#)

In many areas throughout the crawlspace the bracing needs to be re secured

**Implication(s):** Weakened structure | Chance of structural movement

**Location:** Throughout Crawl Space

**Task:** Improve

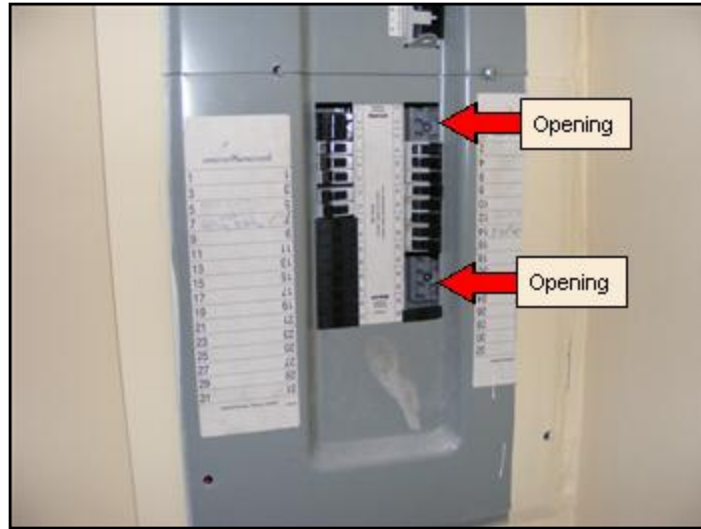
12.

**Condition:** • [Openings in panel](#)

**Implication(s):** Electric shock | Fire hazard

**Location:** South Bedroom

**Task:** Correct

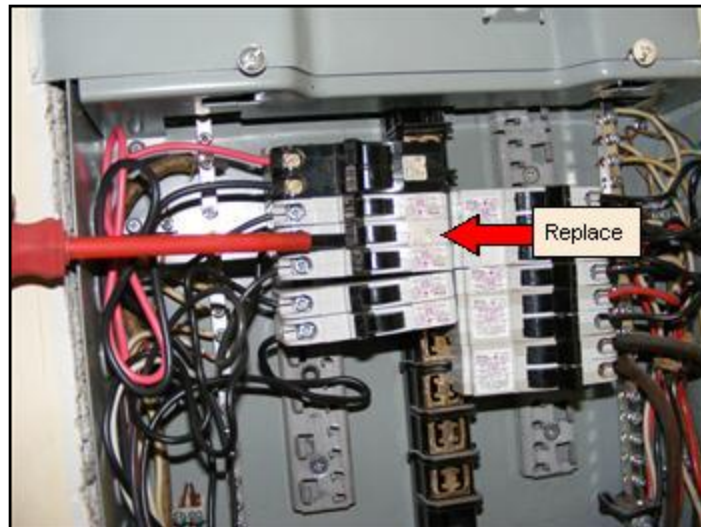
13.

**Condition:** • [Fuses or breakers too big](#)

30 amp breaker installed on 15 amp circuit

**Implication(s):** Equipment overheating | Fire hazard

**Location:** South Bedroom

**Task:** Replace

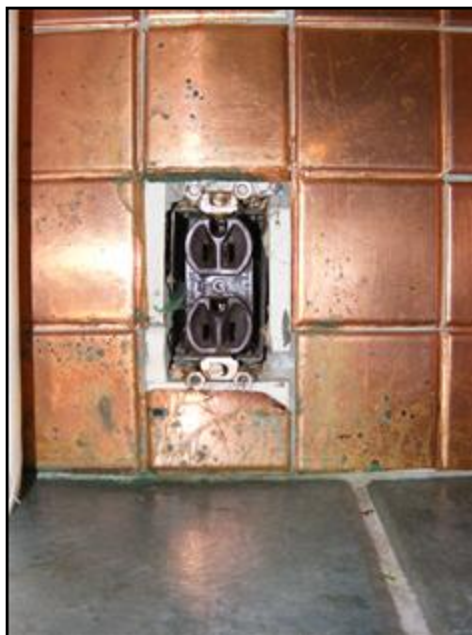
16.

Condition: • [Reversed polarity](#)

Implication(s): Electric shock

Location: East Exterior Wall Kitchen

Task: Repair

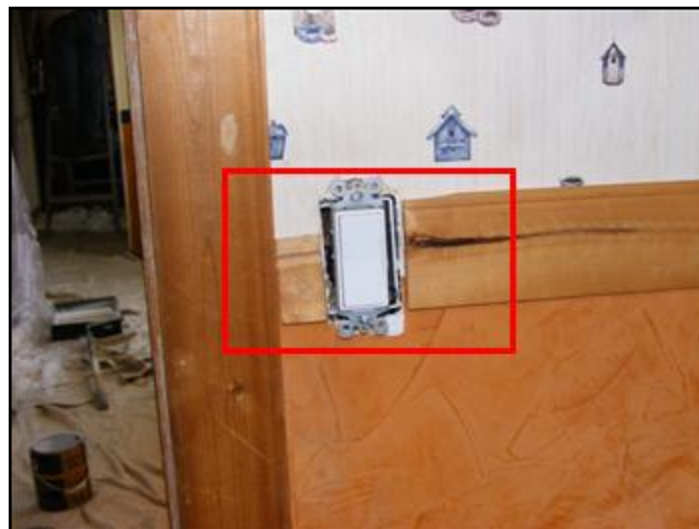
18.

**Condition:** • [Missing](#)

**Implication(s):** Electric shock

**Location:** East Living Room

**Location:** East Exterior Wall Kitchen

**Location:** Rear Foyer

**Task:** Replace

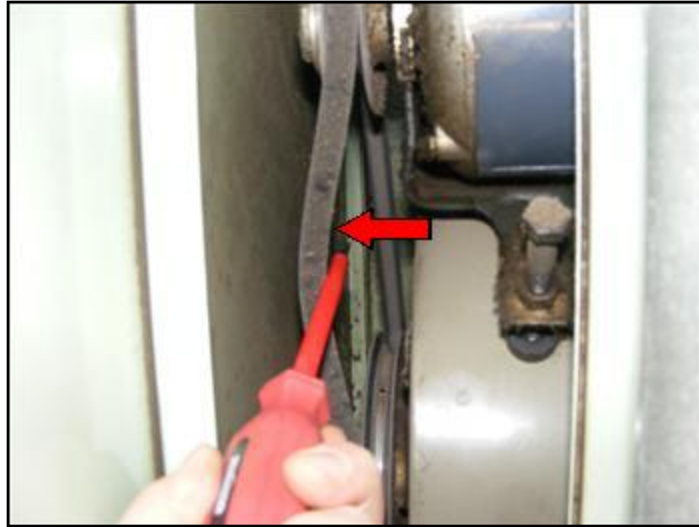
19.

Condition: • [Near end of life expectancy](#)

Implication(s): Equipment failure | No heat for house

Location: Furnace Room

Condition: • [Fan belt loose, worn, damaged](#)

Implication(s): Increased heating costs | Reduced comfort

Task: Replace

Task: Service

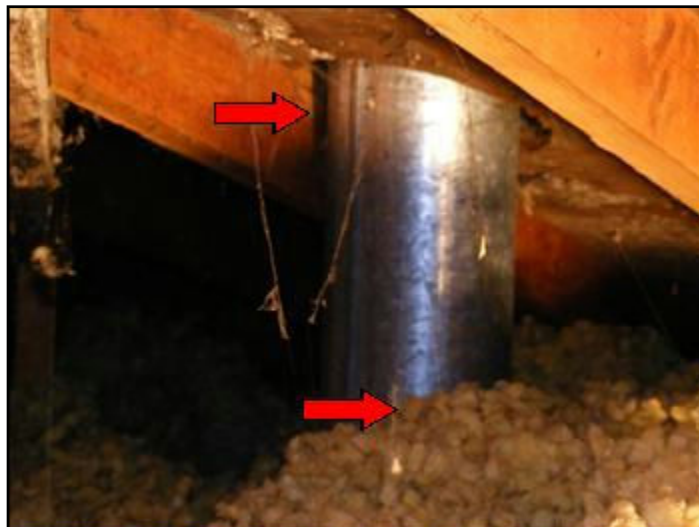
20.

**Condition:** • [Combustible clearance](#)

**Implication(s):** Fire hazard

**Location:** Southeast Attic

**Task:** Further evaluation

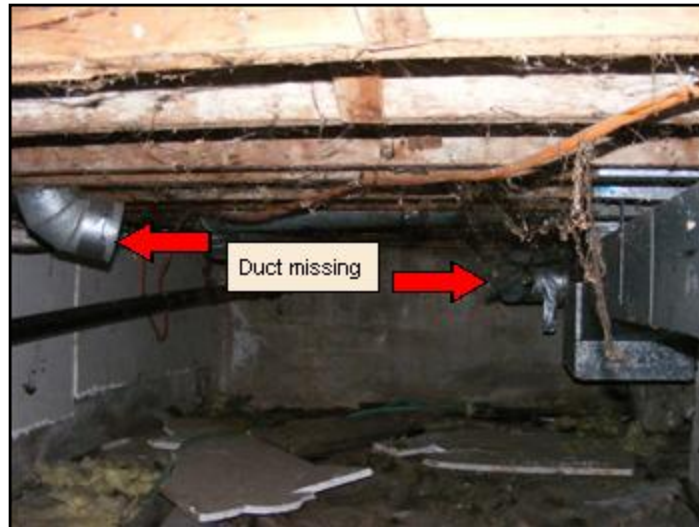
21.

**Condition:** • Missing

**Implication(s):** Increased heating costs | Reduced comfort

**Task:** Improve

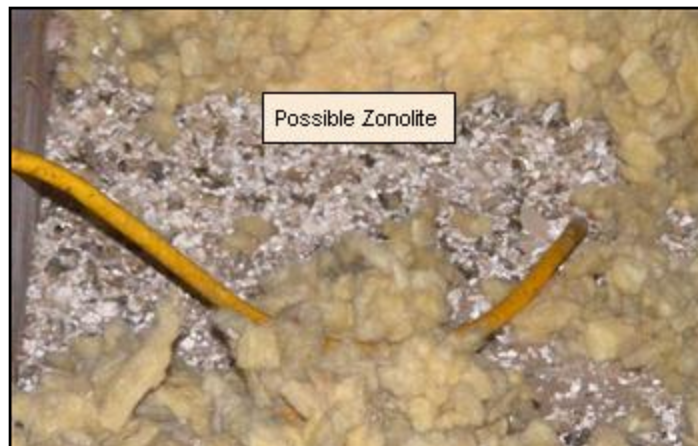
22.

**Condition:** • [Possible Zonolite](#)

**Task:** Further evaluation

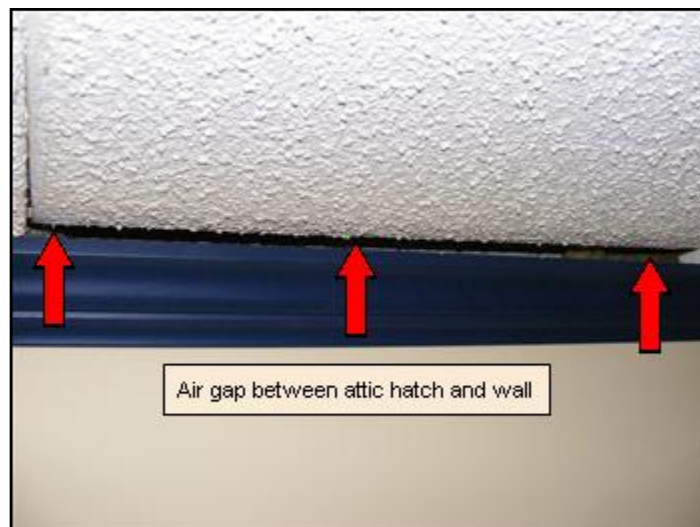
23.

**Condition:** • [Not insulated and not weatherstripped](#)

**Implication(s):** Chance of condensation damage to finishes and/or structure | Increased heating and cooling costs | Reduced comfort

**Task:** Improve

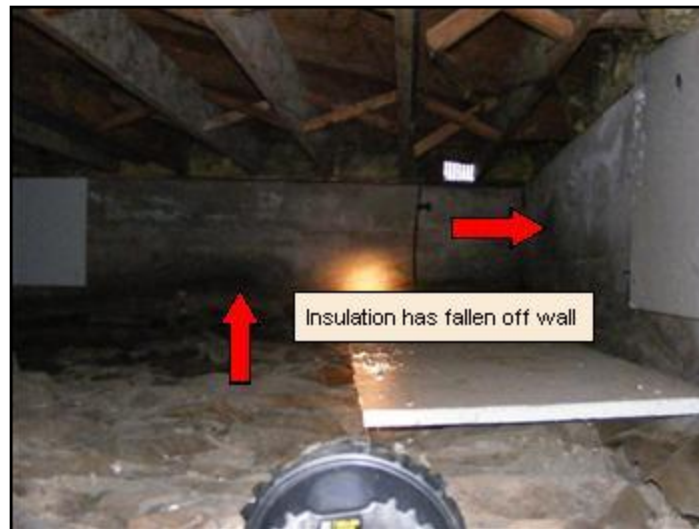
24.

**Condition:** • [Loose, sagging or voids](#)

**Task:** Improve

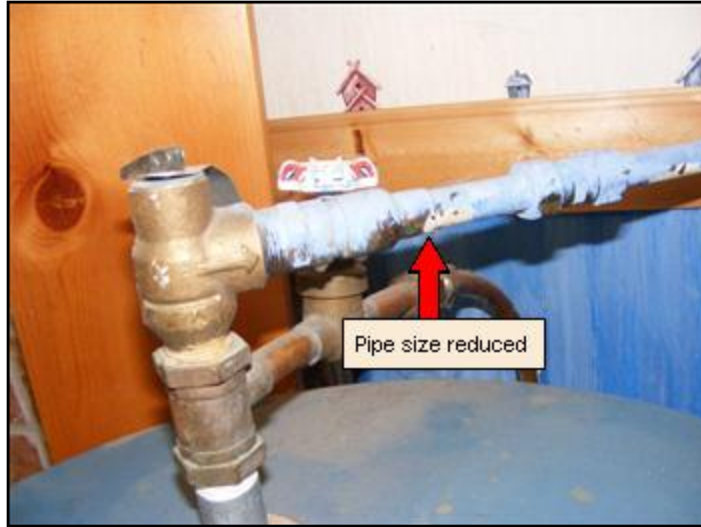
25.

**Condition:** • [Discharge tube too narrow](#)

**Task:** Improve

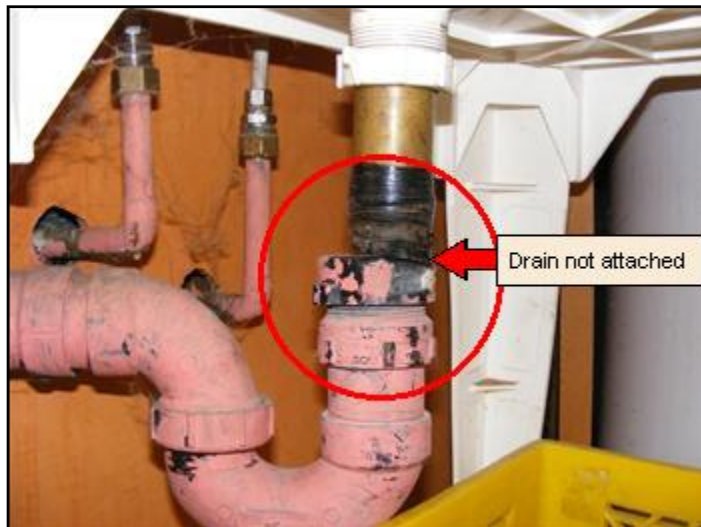
26.

**Condition:** • [Leak](#)

**Task:** Repair

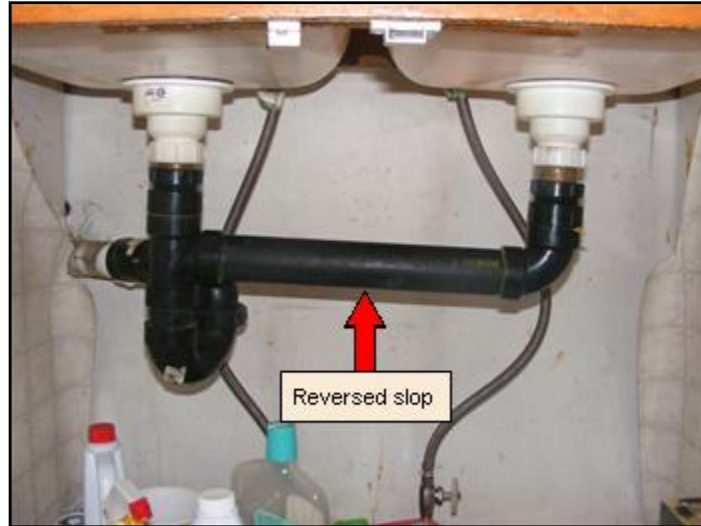
27.

**Condition:** • [Poor slope](#)

**Task:** Improve

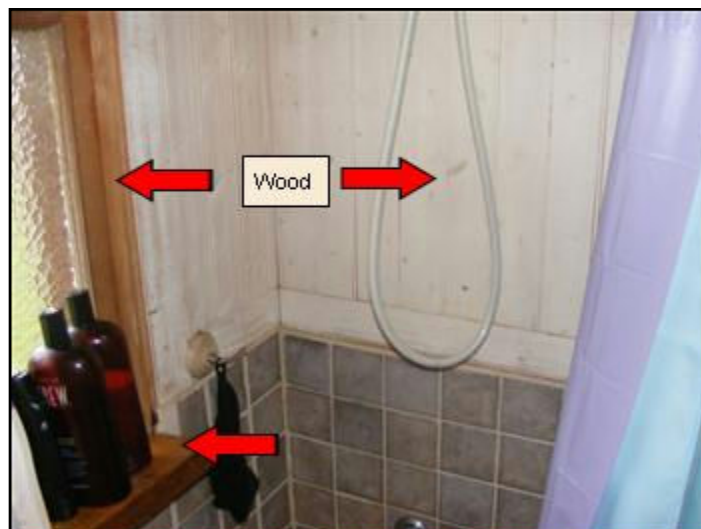
28.

**Condition:** • [Not smooth, impervious or water resistant](#)

**Implication(s):** Cosmetic defects | Hygiene issue

**Task:** Improve

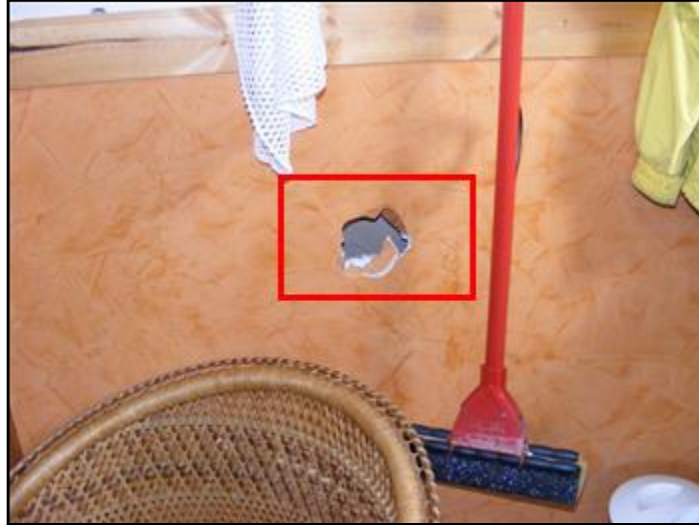
29.

**Condition:** • Damaged

**Implication(s):** Cosmetic defects

**Task:** Repair

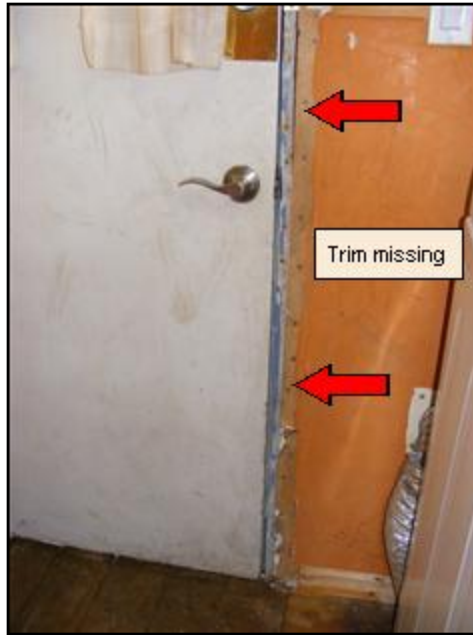
30.

**Condition:** • [Missing](#)

**Implication(s):** Cosmetic defects

**Task:** Replace

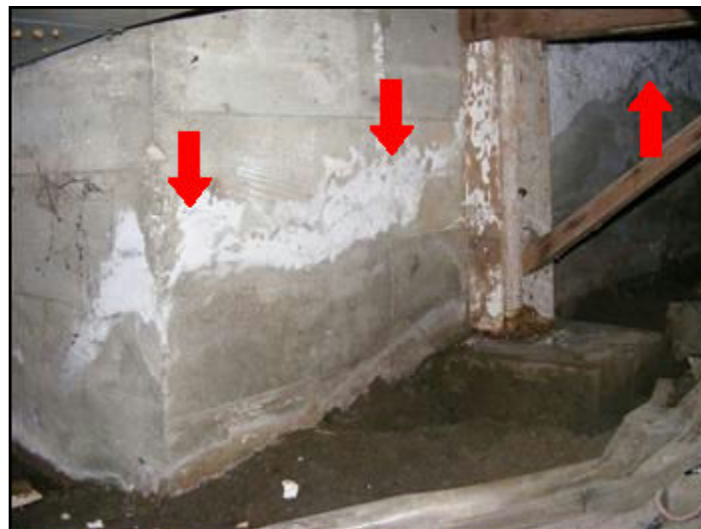
31.

**Condition:** • [Efflorescence](#)

Improving the roof drainage to extend away from the foundation should help to reduce the amount of dampness in the crawlspace. It would also be advised to improve the lot grading on the north side of the property to direct water away from the foundation.

**Implication(s):** Cosmetic defects | Chance of water damage to contents, finishes and/or structure

**Task:** Improve

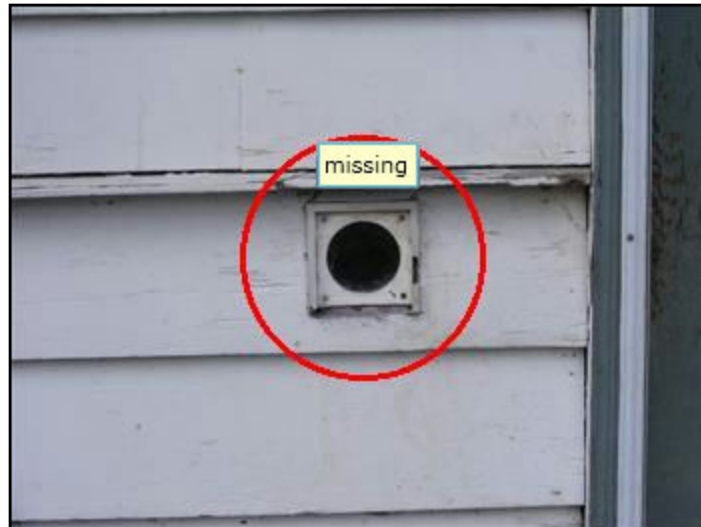
32.

**Condition:** • [Weather hood missing or loose](#)

**Implication(s):** Chance of water damage to contents, finishes and/or structure | Chance of pests entering house

**Task:** Provide

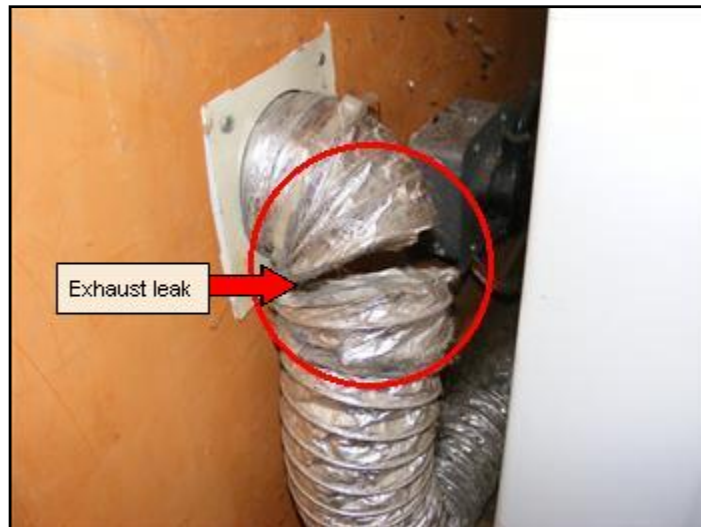
33.

**Condition:** • Not vented to exterior

**Implication(s):** Chance of condensation damage to finishes and/or structure

**Task:** Repair
