Your Inspection Report

123 Main Street
Harrisburg, PA 17102

INSPECTION DATE:
Friday, September 19, 2008

PREPARED BY:
Enviroquest Inc.

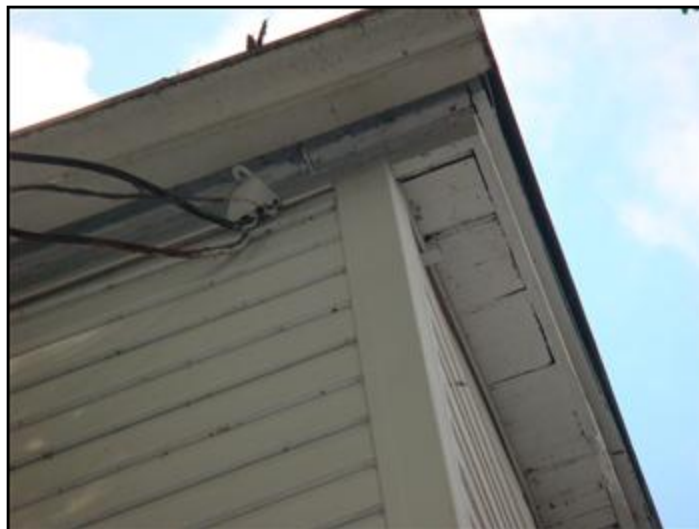
Condition: • [Conduit or cable covered by siding](#)

Implication(s): Electric shock

2. cable covered with siding

Task: Repair

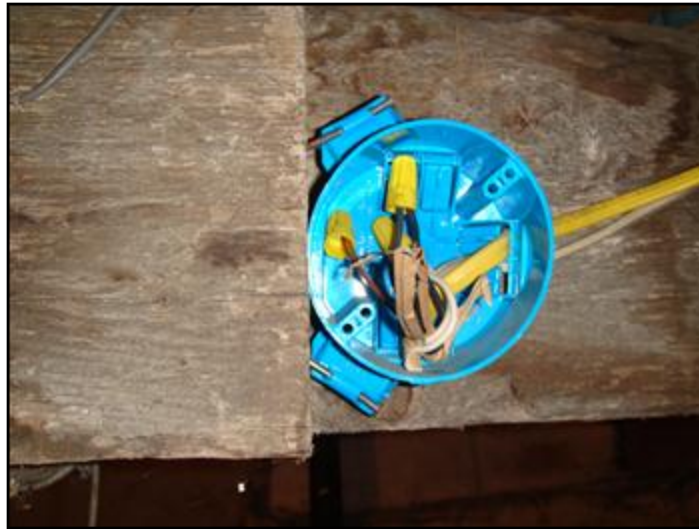
Condition: • [Cover loose or missing](#)

Implication(s): Electric shock | Fire hazard

3. cover j box

Task: Repair

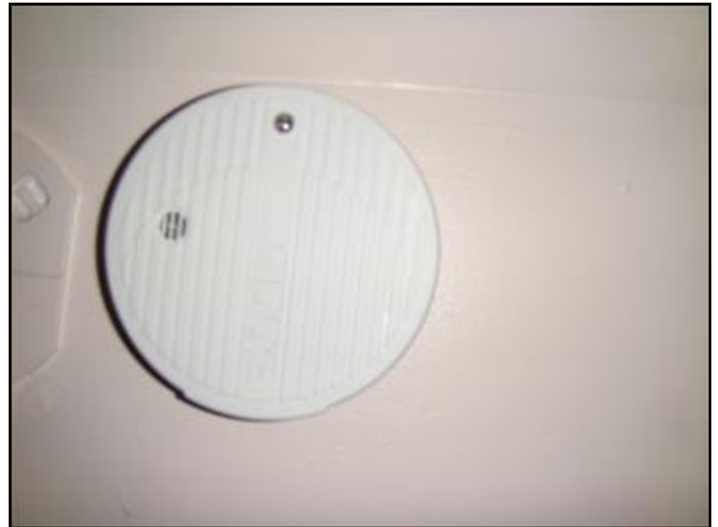
Condition: • [Inoperative](#)

5. not working 2nd floor

Task: Correct

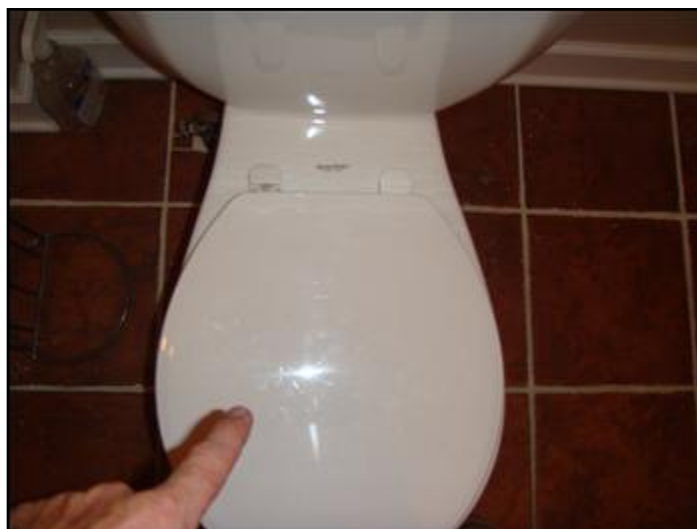
Condition: • [Loose](#)

Implication(s): Chance of water damage to contents, finishes and/or structure | Sewage entering the house

6. loose toilet

Re install toilet.

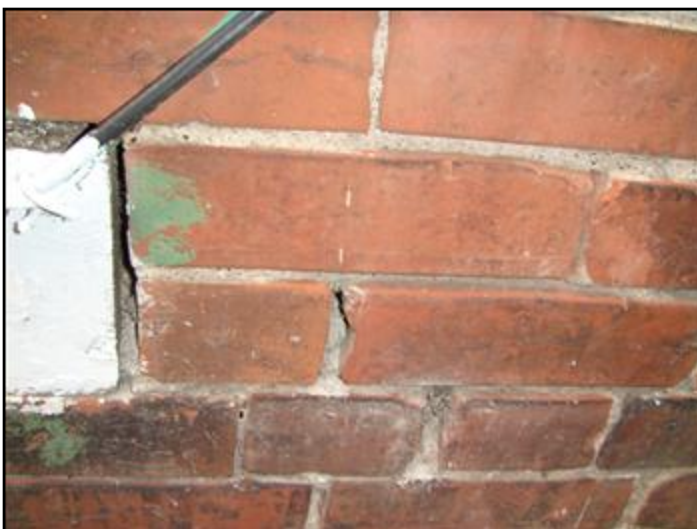
2. Condition: • [Mortar deterioration](#)

Some minor brick repairs are needed at the rear of the property.

Implication(s): Chance of water entering house | Weakened structure | Chance of structural movement

9. repoint

Task: Repair

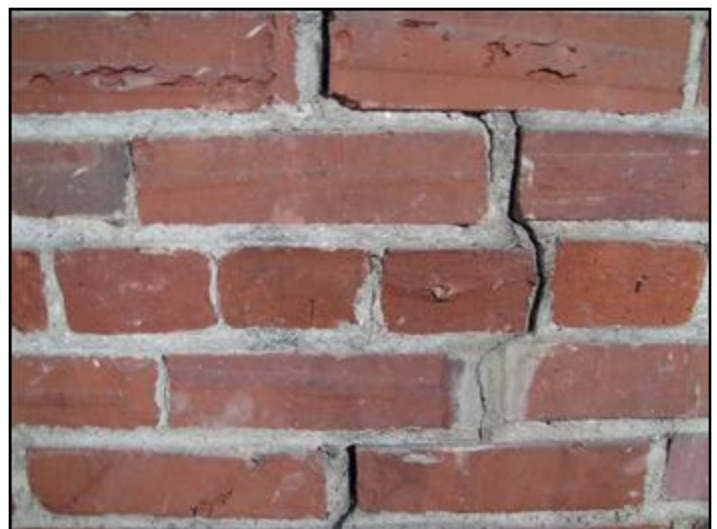
10. repoint

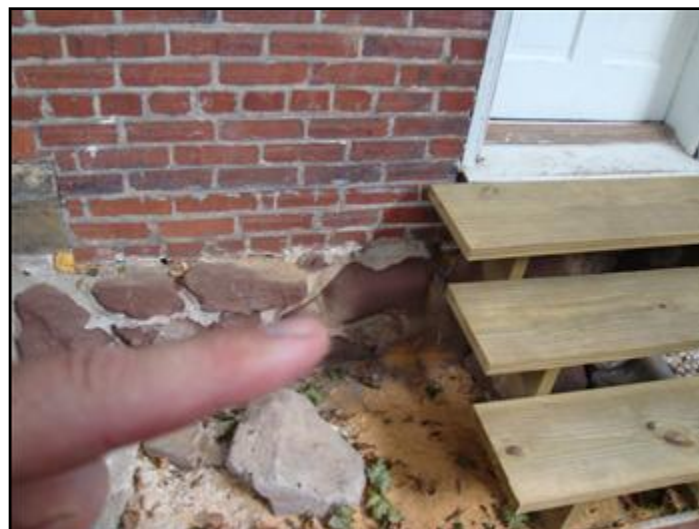
3. Condition: • [Missing](#)

2 steps or more should have a hand rail.

Implication(s): Fall hazard

11. rail needed

Task: Provide

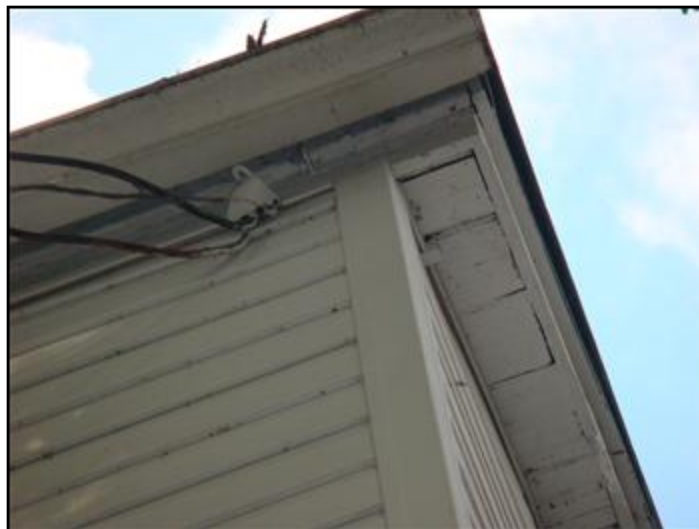
4. Condition: • [Conduit or cable covered by siding](#)

Service entrance cable should not be covered by siding

12. cable covered with siding

Task: Repair

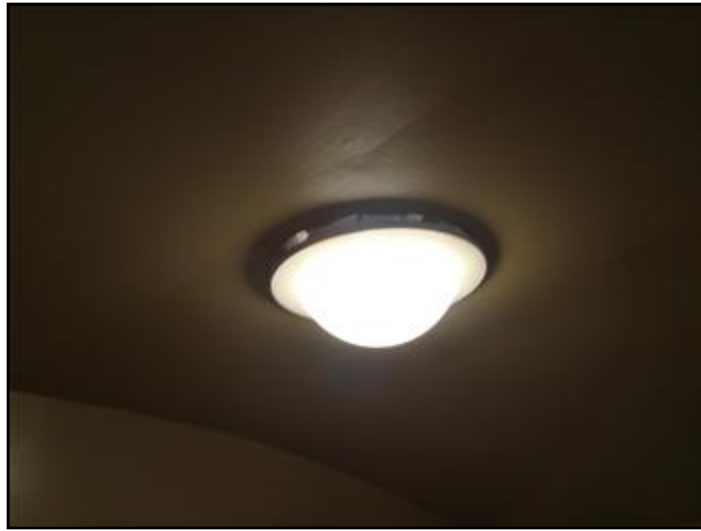
5. Condition: • [Loose](#)

Implication(s): Electric shock | Fire hazard

13. loose light

Task: Repair

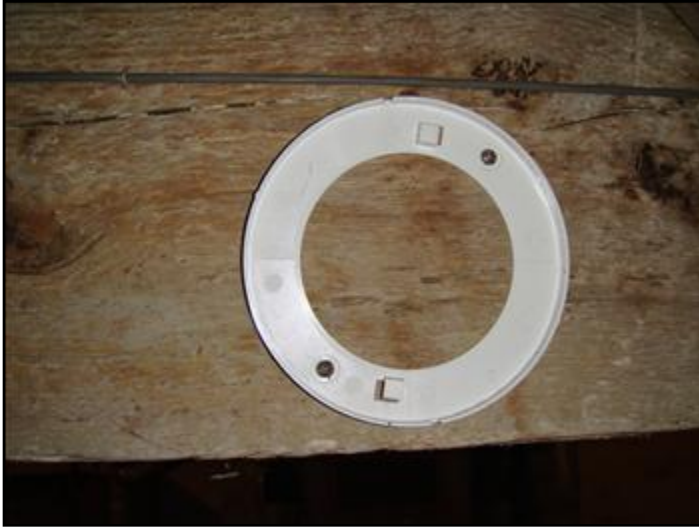
7. Condition: • [Inoperative](#)

15. *missing in basement*

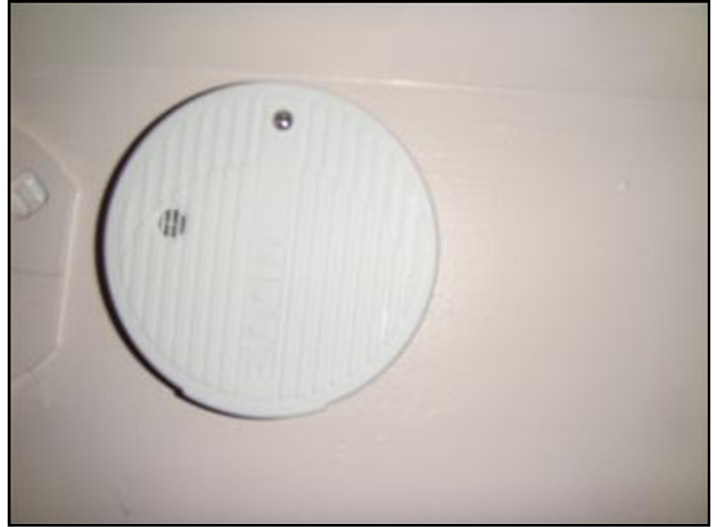
16. *not working 2nd floor*

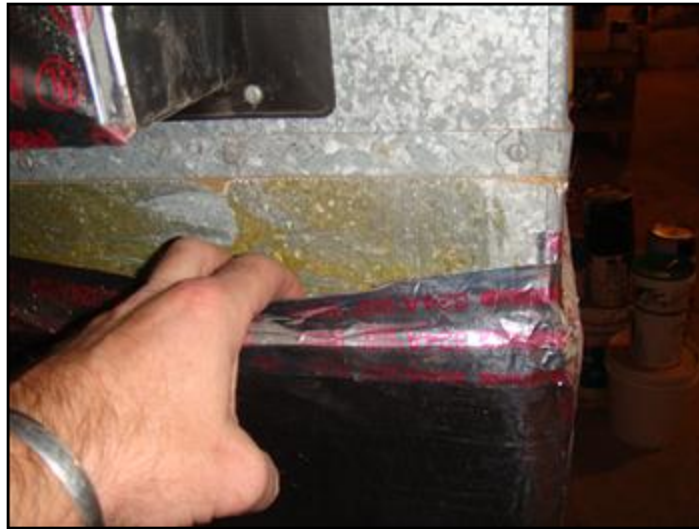
9. Condition: • [Leaky joints](#)

18. leaky joints

Task: Repair

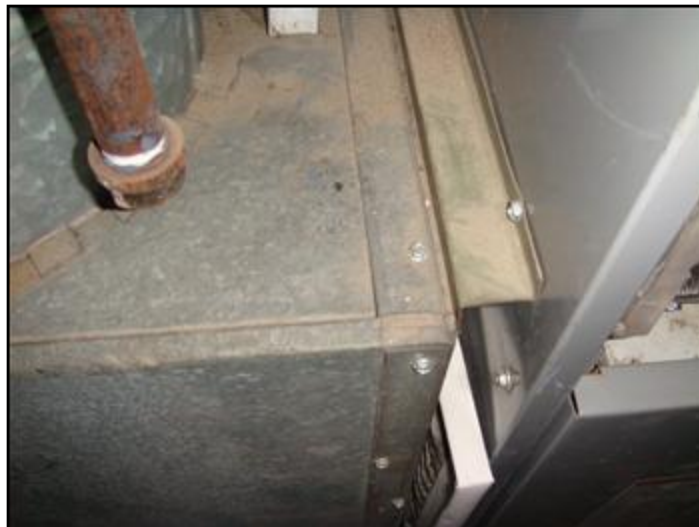
10. Condition: • Filter housing is open which will result in dirty air being sucked into system. Filter is the wrong size for the housing. Recommend repair by an HVAC contractor.

19. open housing

Task: Repair

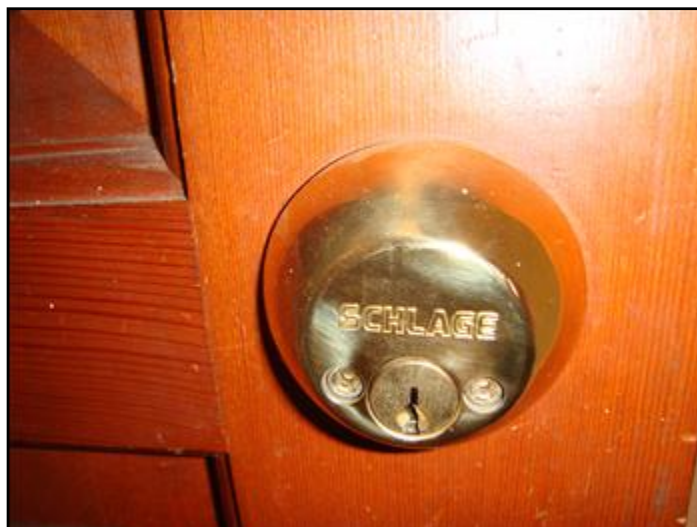
15. Condition: • Lock on the front door; this is dangerous in case emergency exit is needed. Change to a hand turn dead bolt.

22. keyed deadbolt

Task: Replace
