YOUR Inspection Report

37-39 Hwy 11
Fauquier, ON

Saturday, March 14, 2015

RE: Report No. 1067
37-39 Hwy 11
Fauquier, ON

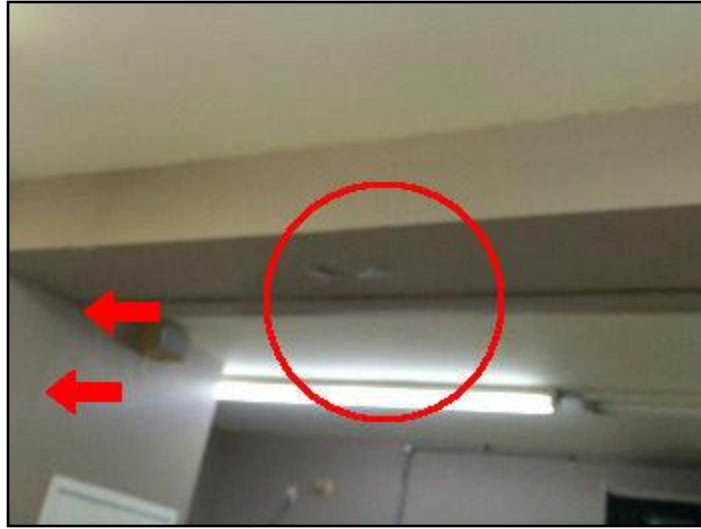
3. Leak

The roof was noted to have an active leak in the kitchen. The area is directly bellow a valley, and is probably a result of water intrusion at this vulnerable area. Further investigation on the roof side, along with temporary repairs should be performed immediately to minimize interior damage. Areas of the bulkhead and wall have water damage and should be repaired soon as possible. The gypsum should be removed at affected areas, roof repairs and the area should be given time to properly dry prior to re installing new gypsum board. This will prevent the growth of organic materials (mould).

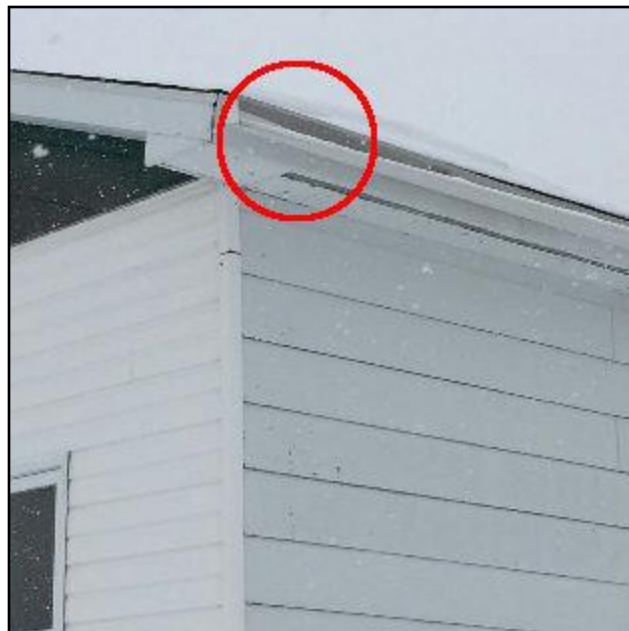
4. Loose or damaged

The gutter is loose and should be re fastened properly to ensure good roof drainage.

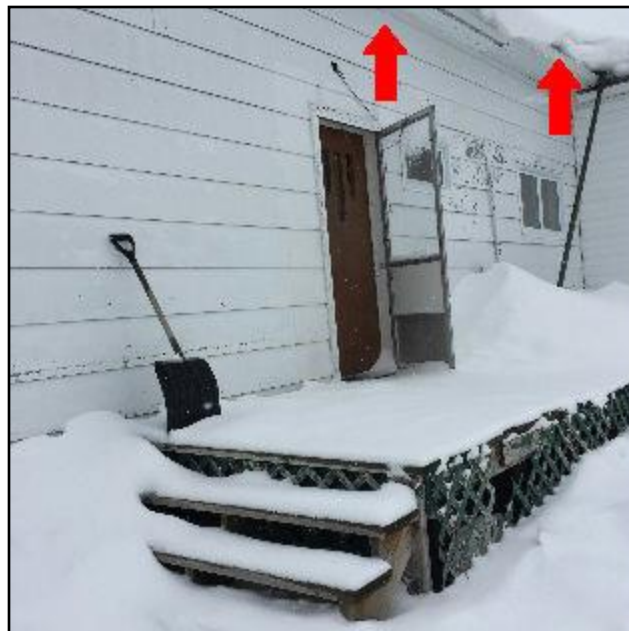
5. Paint or stain needed

Some areas of the wood soffit require some maintenance painting to prevent wood rot. Repair areas as needed.

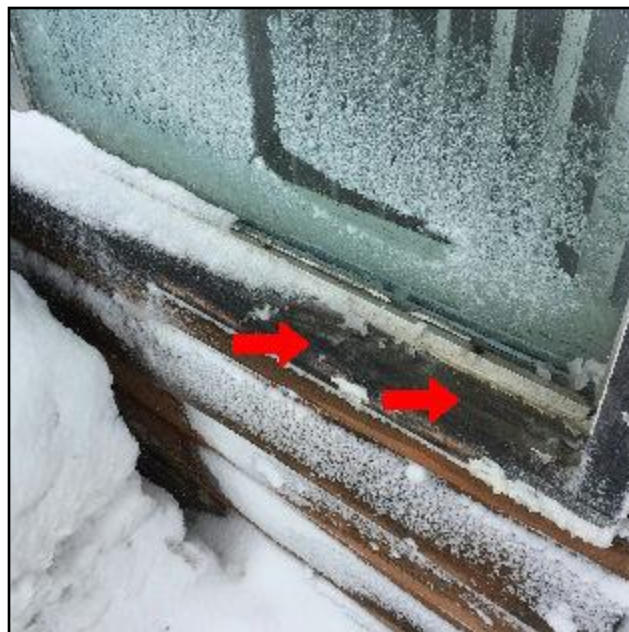
8. Paint or stain needed

The exterior frames of some windows require paint to prevent rot, and / or water damage to the interior of the property. Consider future upgrades to these windows.

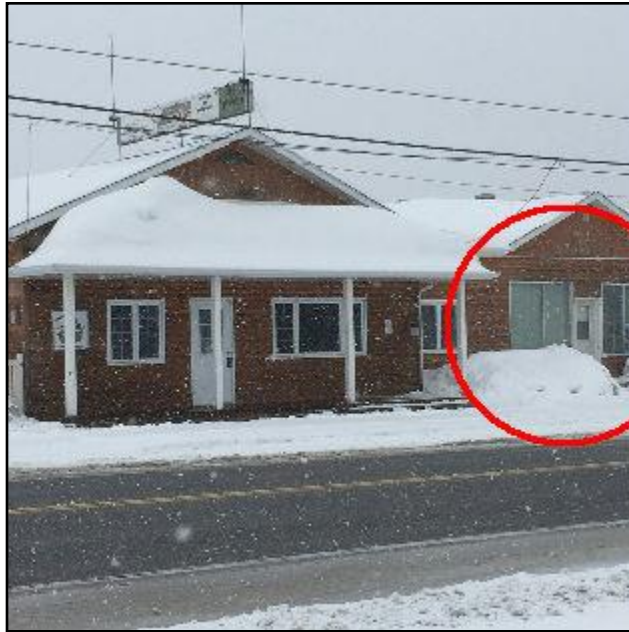
9. Adjust Door

6. Condition: • The entry door to the "center" portion of the building (Not restaurant entrance / Not House entrance) is difficult to open / close. Consider making adjustments to the door to ensure proper closing and easy exit.

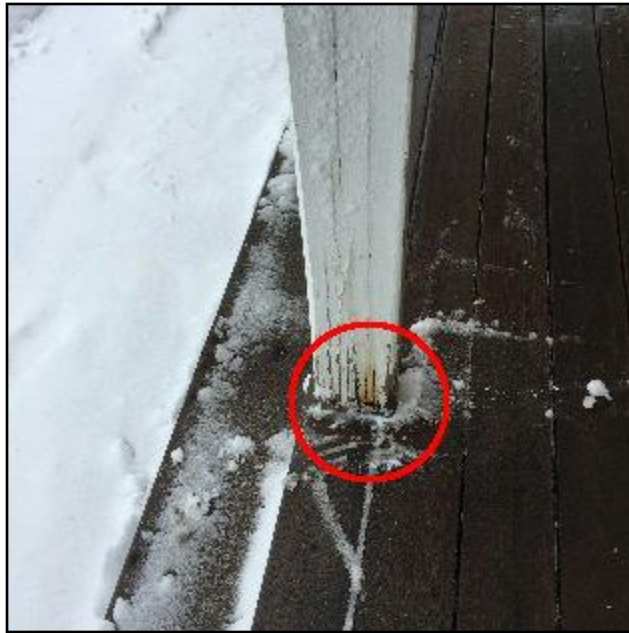
10.

7. Condition: • Paint Required. Ensure continued maintenance painting to the exterior columns to prevent rot. Replacing these in the future could be costly. The columns are in good condition presently, but do require paint.

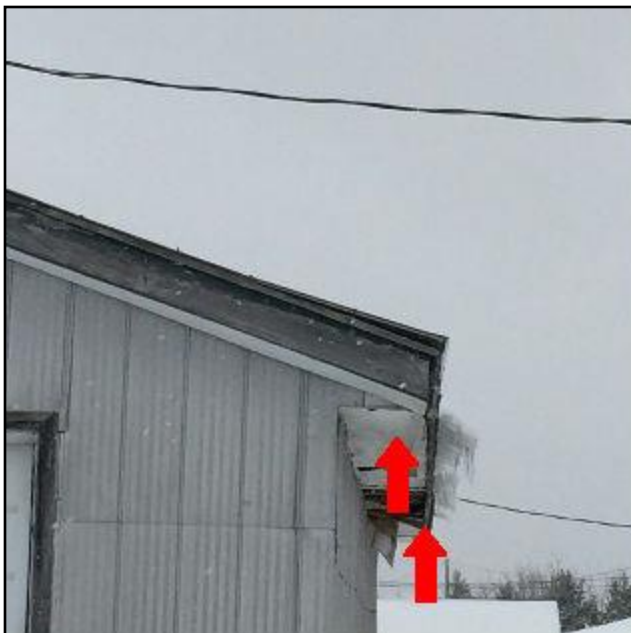
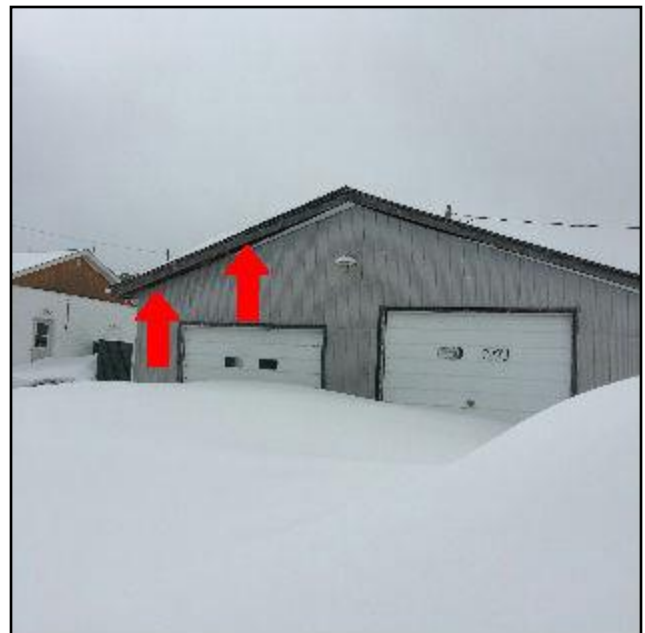
8. Condition: • The interior of the garage / storage shed was unable to be inspected due to no access. The soffit was noted to be damaged and will require repairs in the spring.

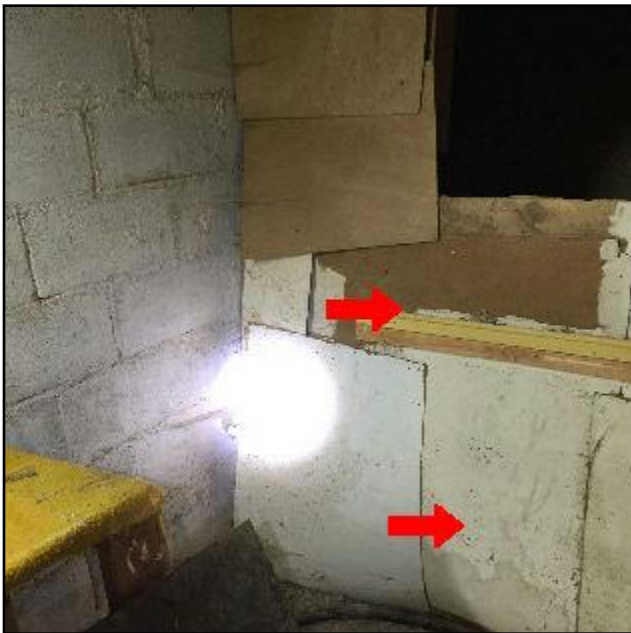
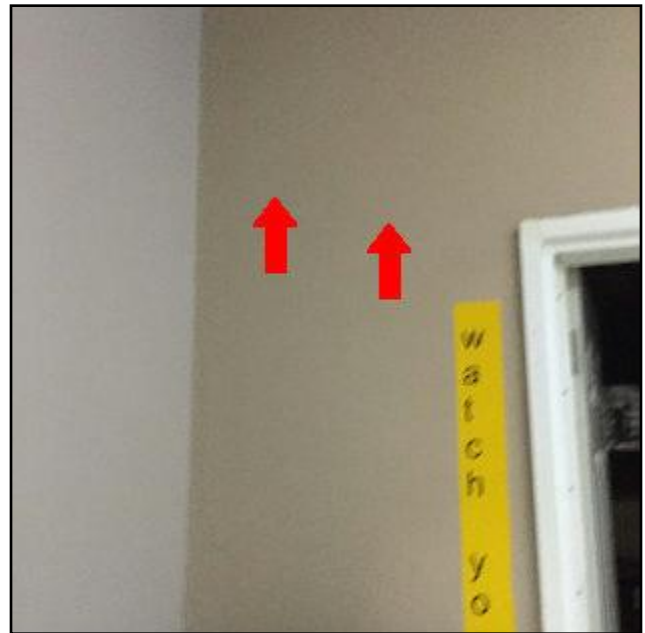
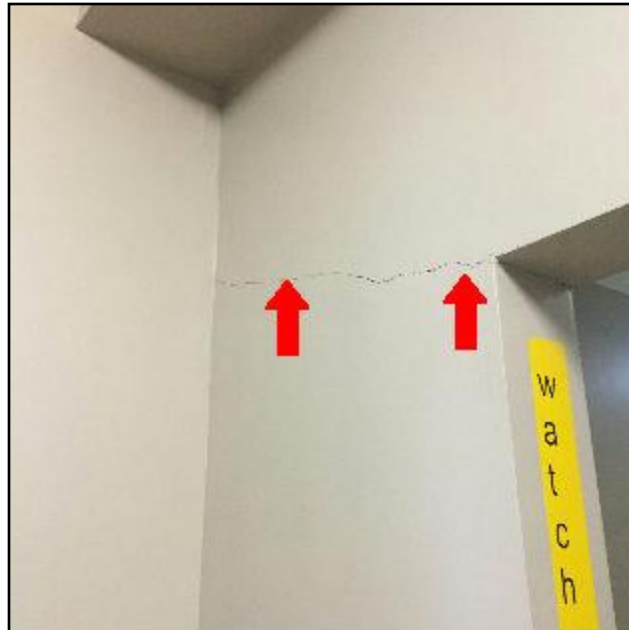
Structural movement has occurred in this areas due to a failure in the supporting wall below. Repairs are required in this area with a combination of posts and beams, or by other means recommended by a professional.

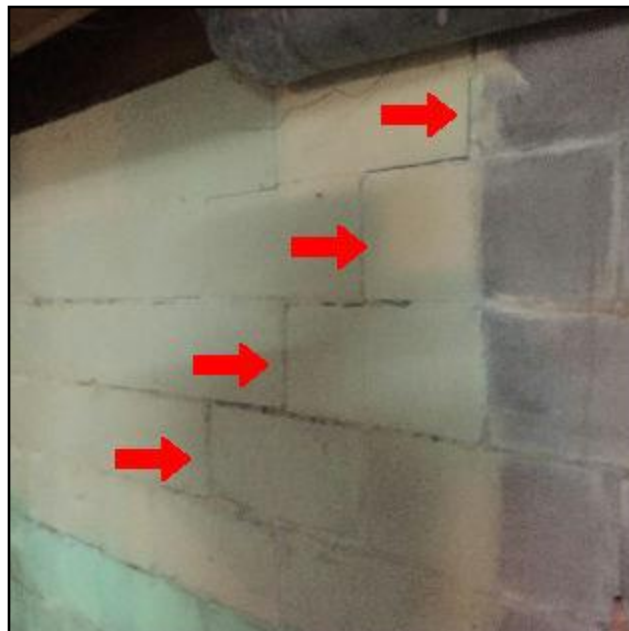
16. Typical minor cracks

10. Condition: • Typical minor cracks

These cracks should be repaired to avoid water damage, and further foundation damage.

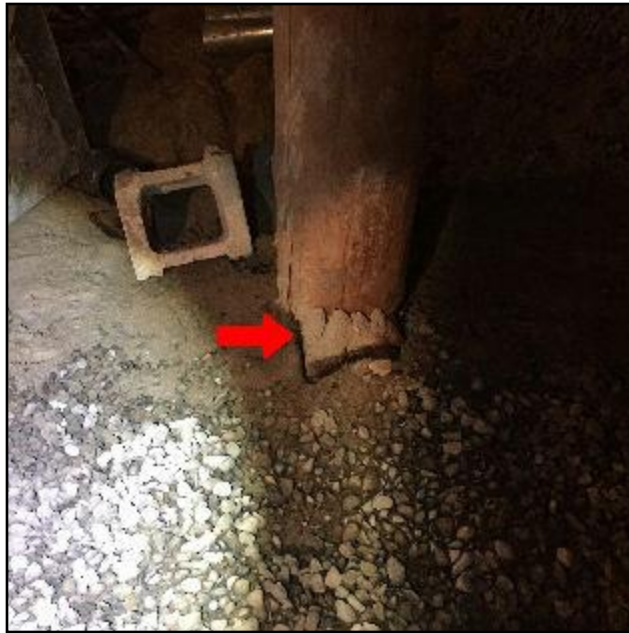
17. Wood/soil contact

Some posts in the crawlspace of the restaurant have wood/soil contact. To prevent rot, ensure this issue is corrected in the future.

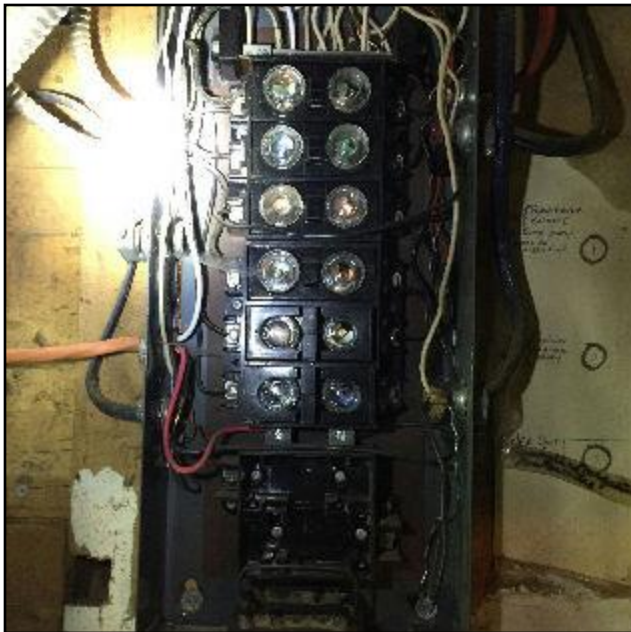
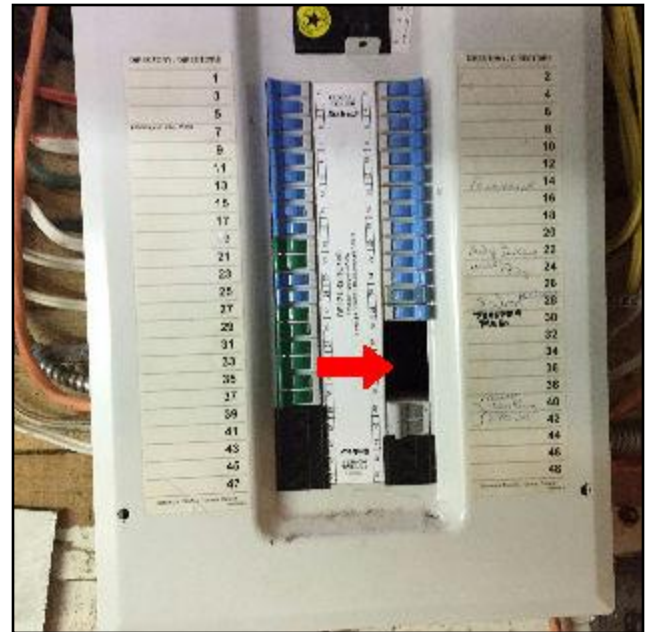
The electrical panels in the basement on the house side have openings which need to be covered. The fuse panel is also missing a cover. Protection from contact should be provided to avoid electric shock. Also, the two panels are fastened to a wall which has kicked out at the base. Future considerations should be made to amalgamate the two panels into one larger service box, and fastened to a secure location.

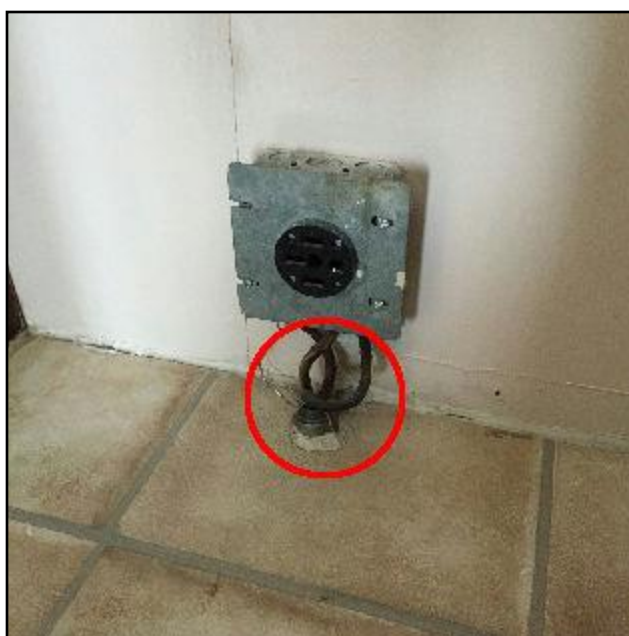
20. Exposed on walls or ceilings

13. Condition: • [Exposed on walls or ceilings](#)

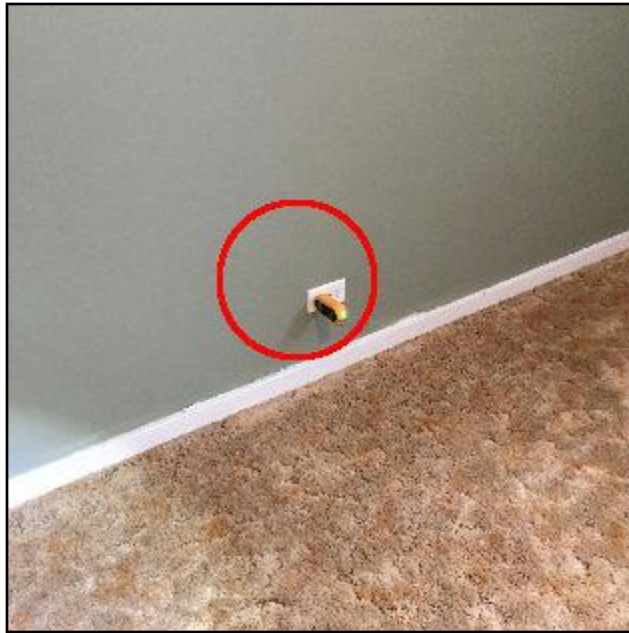
21. Ungrounded

14. Condition: • [Ungrounded](#)

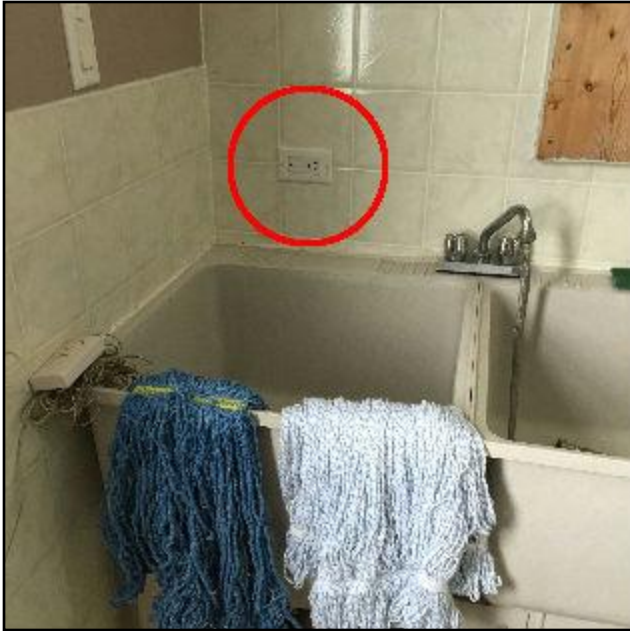
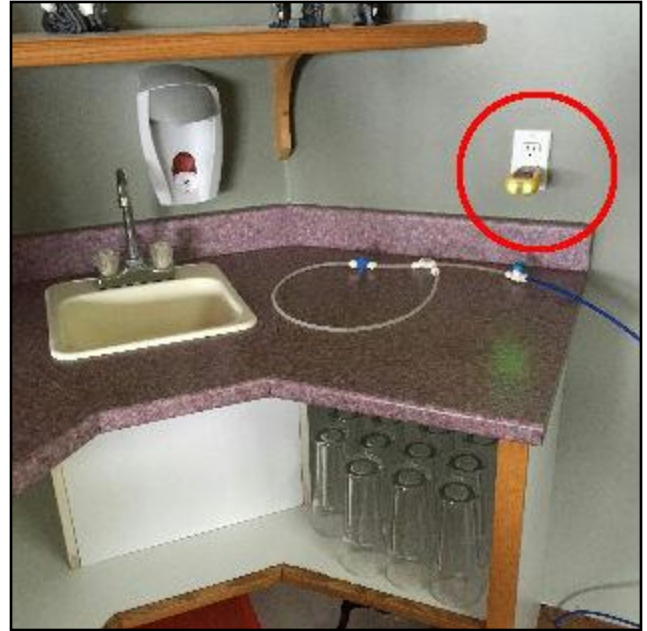
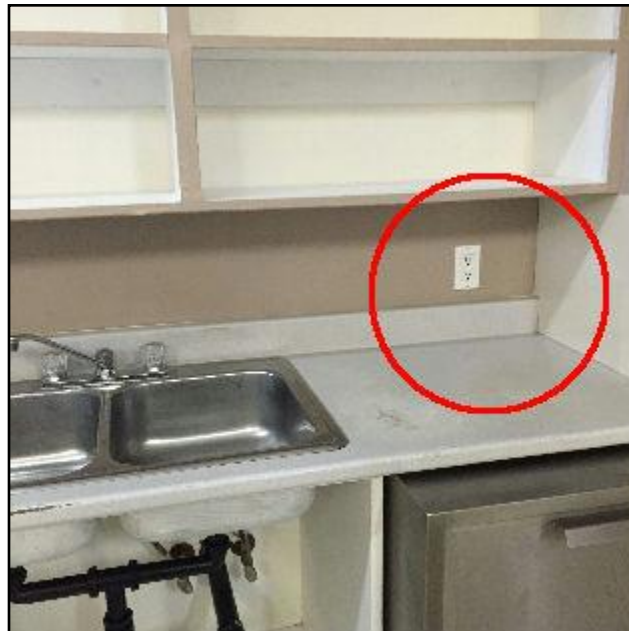
15. Condition: • [Ground Fault Interrupter \(GFI\) needed](#)

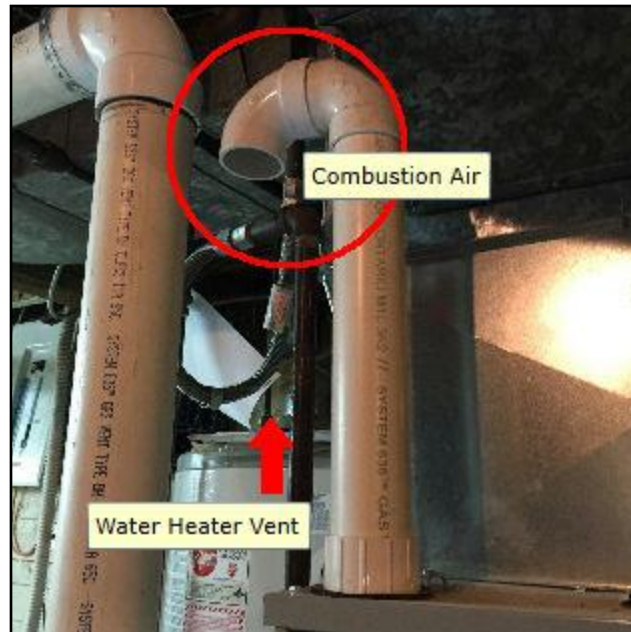
25.

17. Condition: • The combustion air for the furnace in the basement of the house is using indoor air. The furnace is located next to a natural draft gas water heater. This configuration could result in gases being circulated into the home. Have a licensed gas technician evaluate the install, and have proper repairs made.

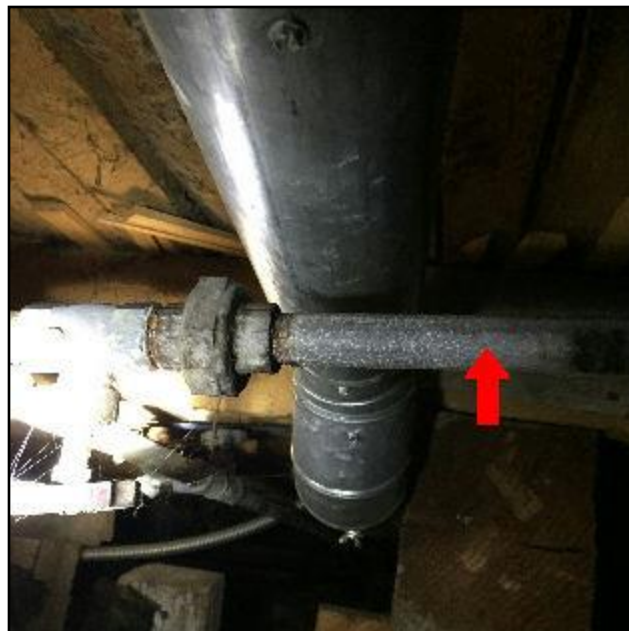
26. Galvanized steel

20. Condition: • [Galvanized steel](#)

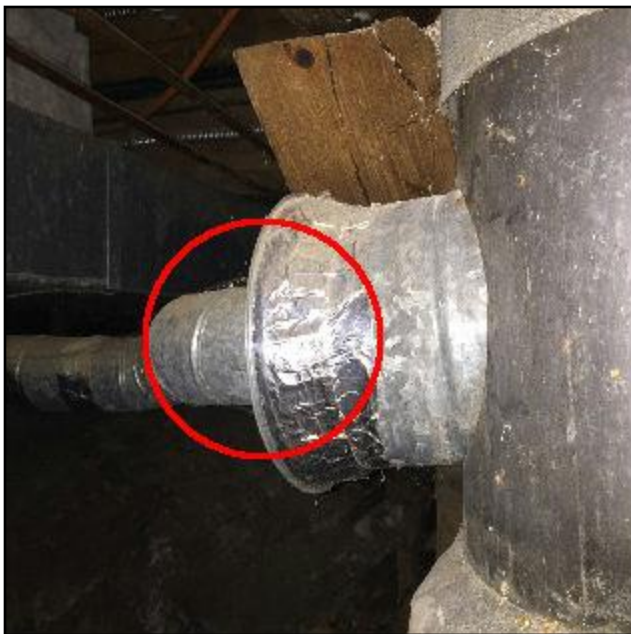
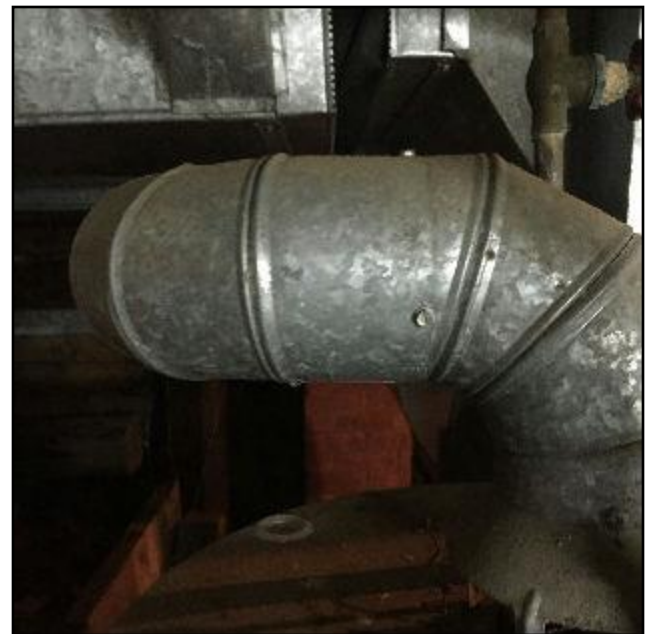
21. Condition: • [Vent connector extends too far into chimney](#)

Implication(s): Equipment not operating properly | Hazardous combustion products entering home

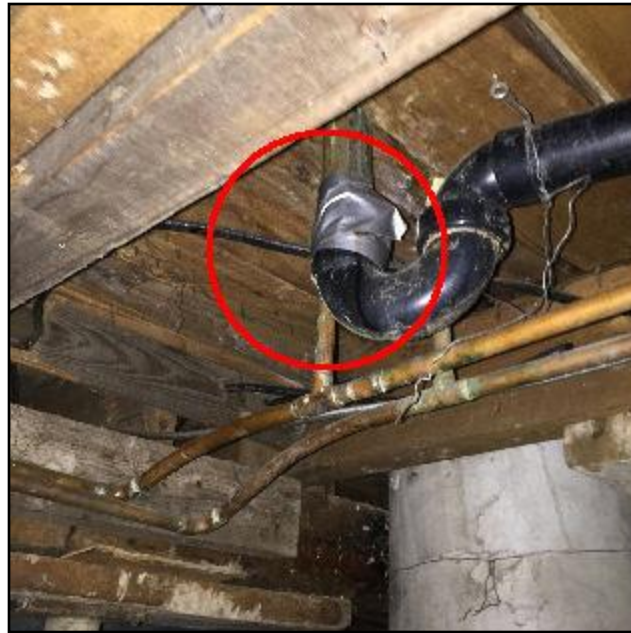
29. Leak

22. Condition: • The trap serving the house kitchen sink is leaking. Repair immediately.

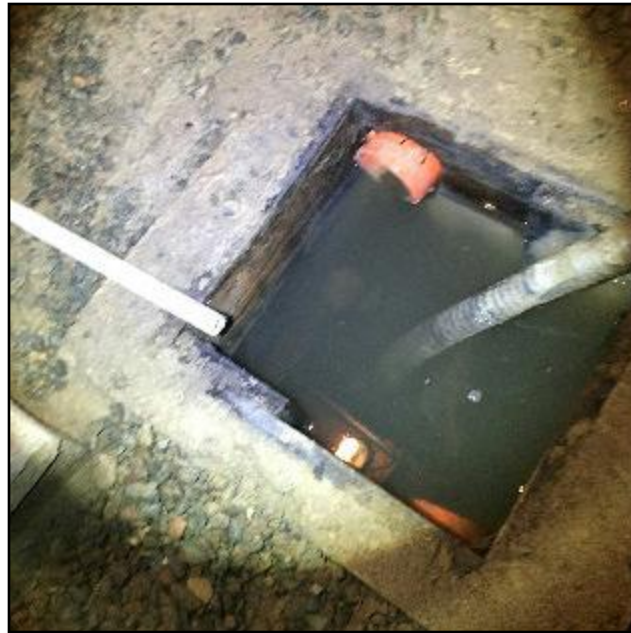
30. Inoperative

The sump pump on the restaurant side is not operating. This is often the result of a damaged float switch. Consider changing the switch prior to replacing the entire pump.

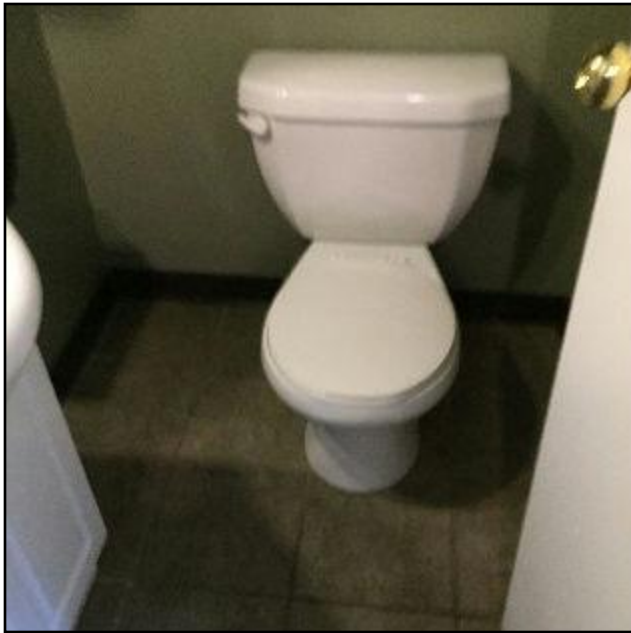
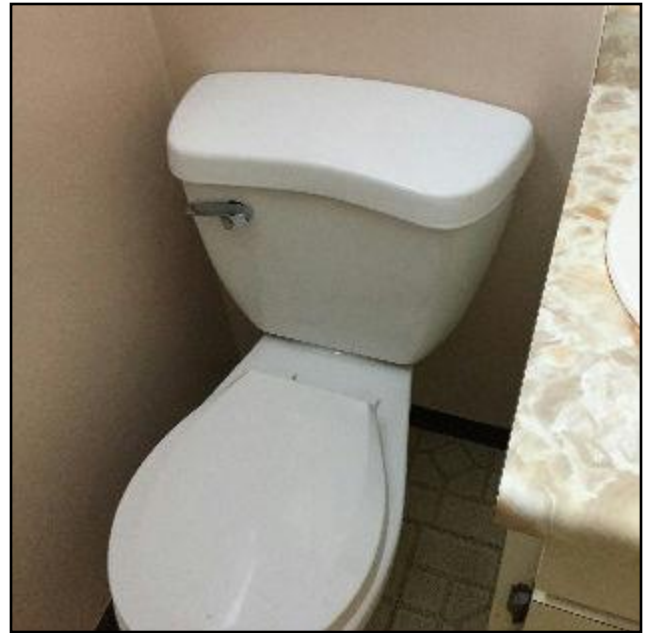
24. Condition: • [Loose](#)

Implication(s): Chance of water damage to contents, finishes and/or structure | Sewage entering the building

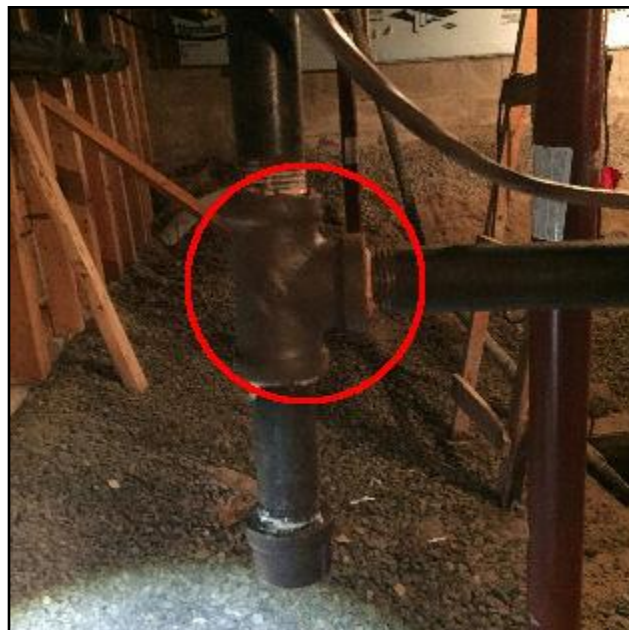
33.

25. Condition: • Teflon tape used on gas pipe threads. Have replaced with proper gas pipe sealant.

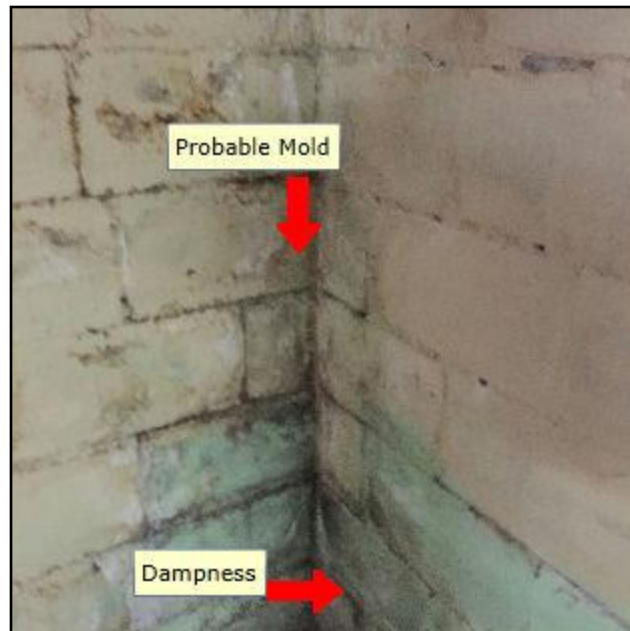
34. Dampness

• Dampness

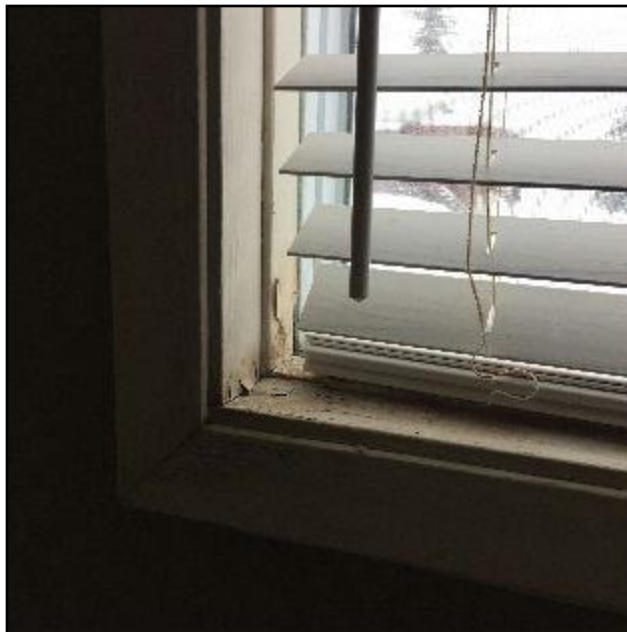
35. *Original lower quality units*

Consider upgrading these windows in the future to improve energy efficiency, comfort and reduce condensation and water damaged frames.

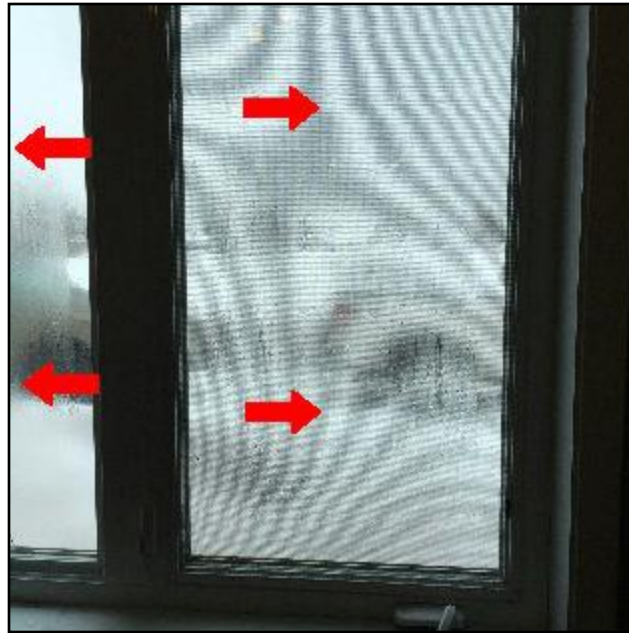
36. Cracked

The glass is broken on this window. Sealed units can be replaced, there is no need to replace the entire window. Have this problem rectified to avoid possible water damage, personal injury, and heat loss.
