Your Inspection Report

1234 Somewhere
Pittsburgh, PA 15206

INSPECTION DATE:
Thursday, April 25, 2013

RE: Report No. 1062, v.4
1234 Somewhere
Pittsburgh, PA
15206

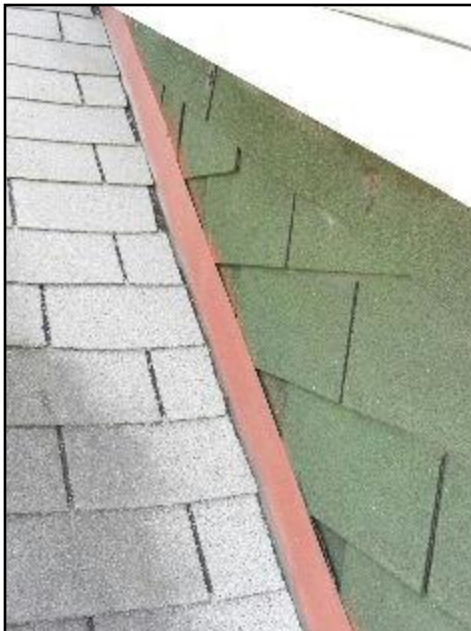
4. Missing base or cap flashings

Task: Monitor for leaks, repair as necessary by qualified contractor

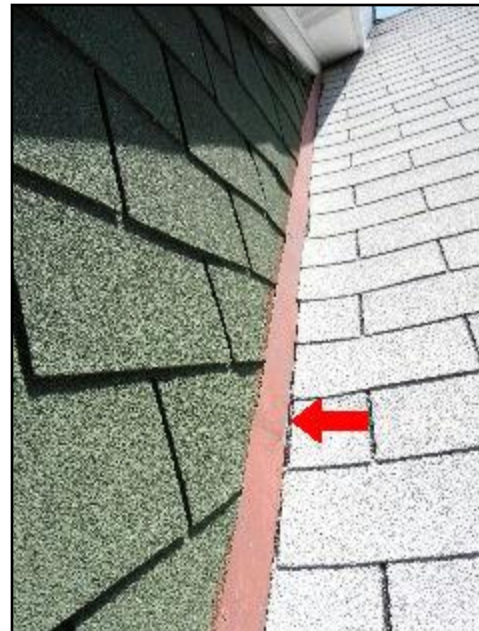
5. Missing cap flashings at rear dormer

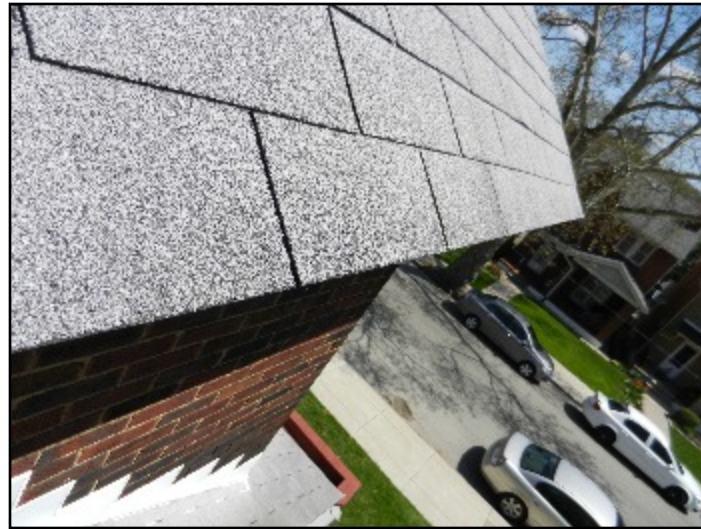
8. Missing gutter on garage.

Task: Repair by qualified contractor

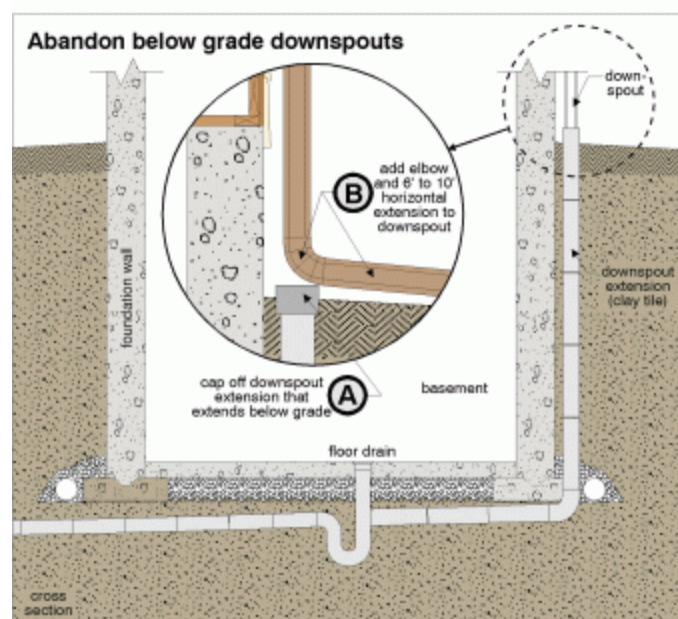
Moisture noted in basement in areas near where downspouts discharge into underground pipes. Damaged storm water pipes could contribute to moisture in basement. Recommend using camera to scope condition of pipes and/or experimenting with diverting the downspouts away from the foundation to see if moisture conditions in basement improve.

9. Downspouts discharging below grade

Task: Repair by qualified contractor

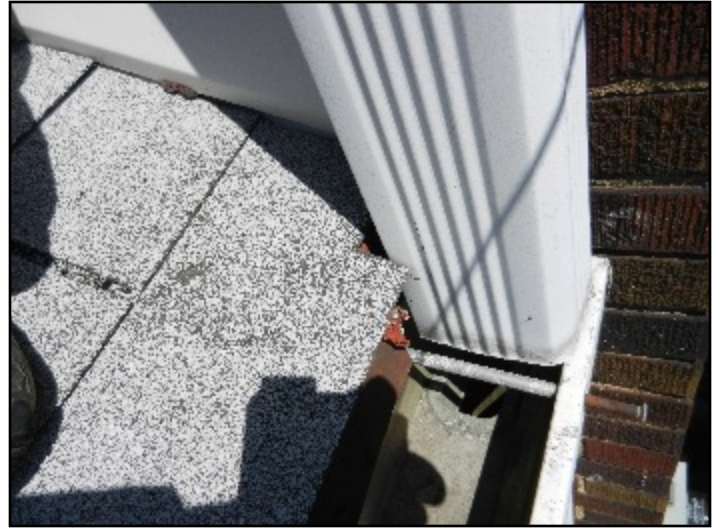
10. Downspouts to back porch roof gutter.

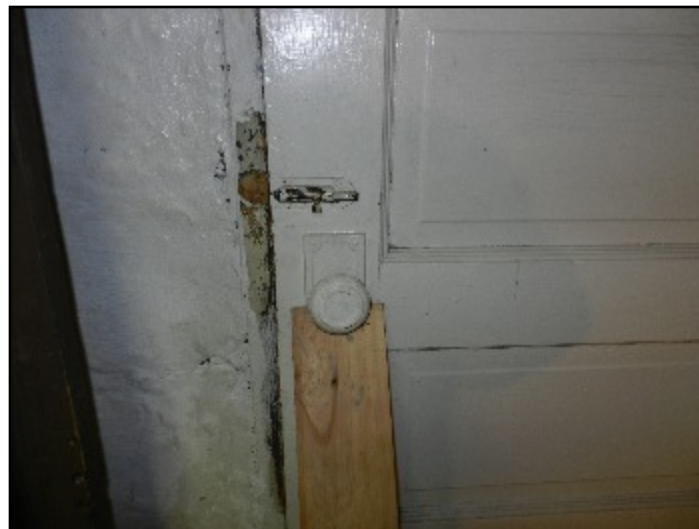
6. Condition: • Doors lack dead bolts.

11. Doors lack dead bolts.

Task: Repair by qualified contractor

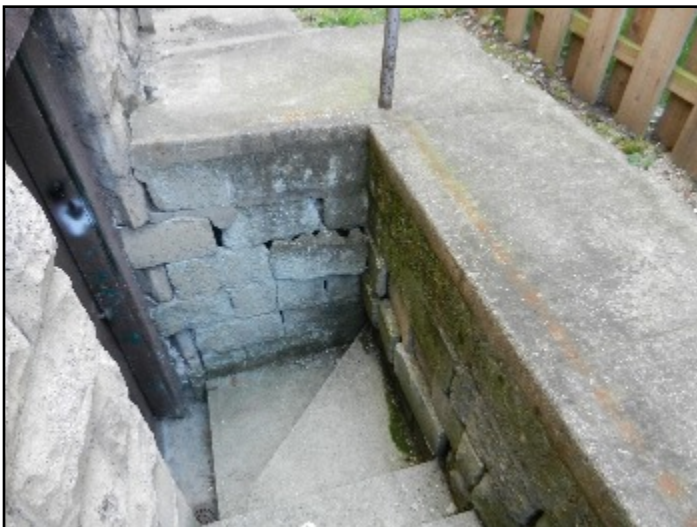
The walls of the basement walkout stair has shifted and shows indications of spalling and deterioration of masonry blocks.

12. Walls cracking, leaning, bowing or spalling

Task: Repair by qualified contractor

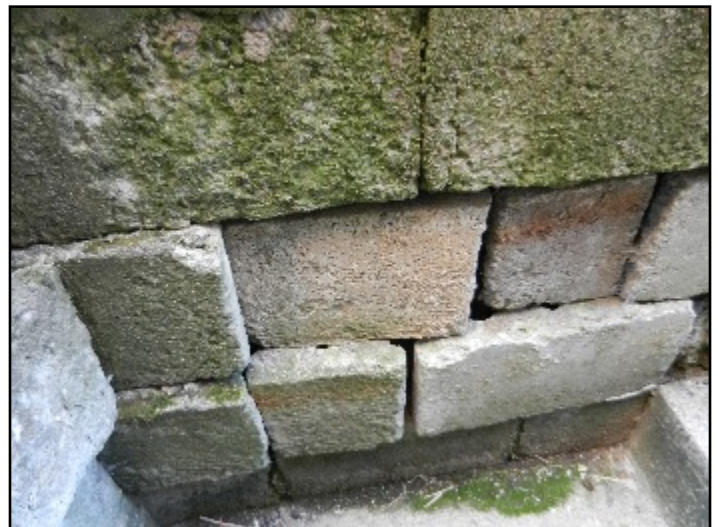
13. Blocks are loose, shifting

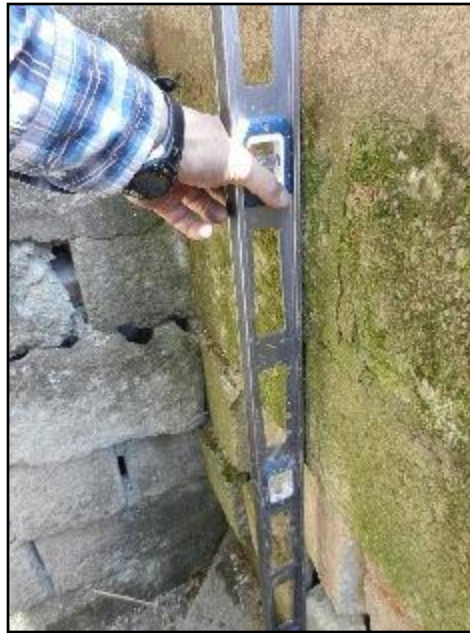
14. Walls cracking, leaning, bowing or spalling

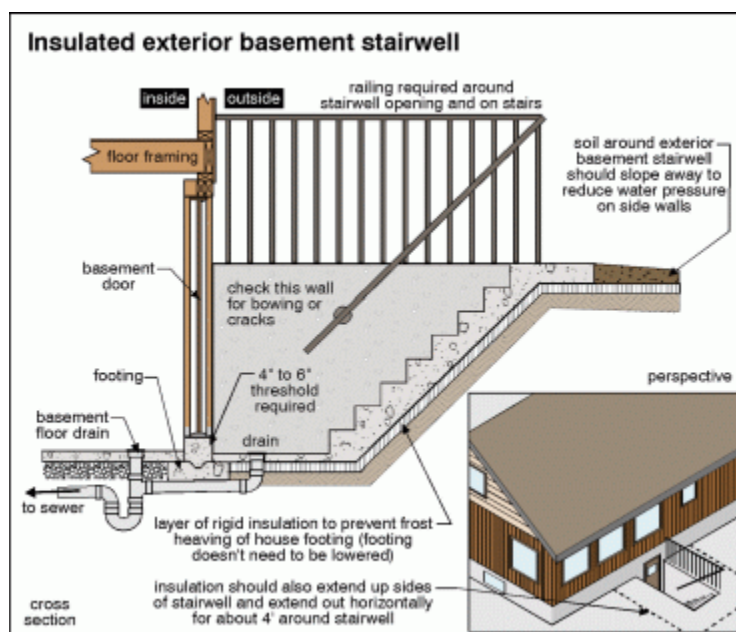
The guardrail to the basement stairs is ineffective as a barrier. It is 28 inches high, should be 36 inches and no vertical slats present to prevent falling under. No hand rail for the steps. Have a qualified contractor repair and upgrade guardrail and railings for safety.

Task: Repair by qualified contractor

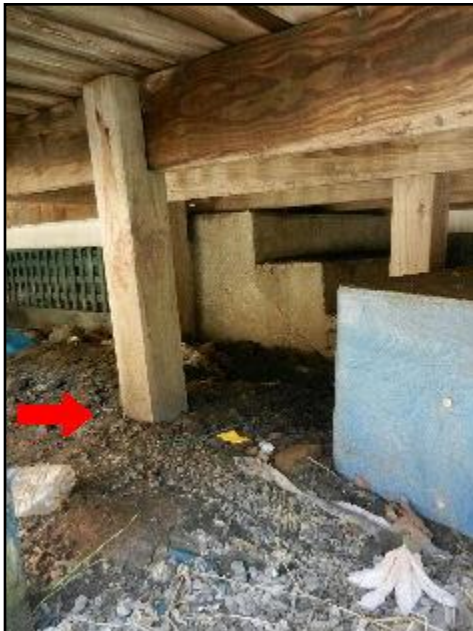
The rear deck is in need of renovation. The decking (covered with carpet and not visible) was loose/soft in places. The recently installed steps to the yard are not properly installed and are sinking. Support posts are in contact with the ground and susceptible to rot or insect damage. The ledger connecting the deck to the house is not bolted to the house framing. The railing is too low to prevent falls. (The deck stands at approximately 24-28 inches off the ground.)

15. Posts in contact with earth

Task: Repair by qualified contractor for safety.

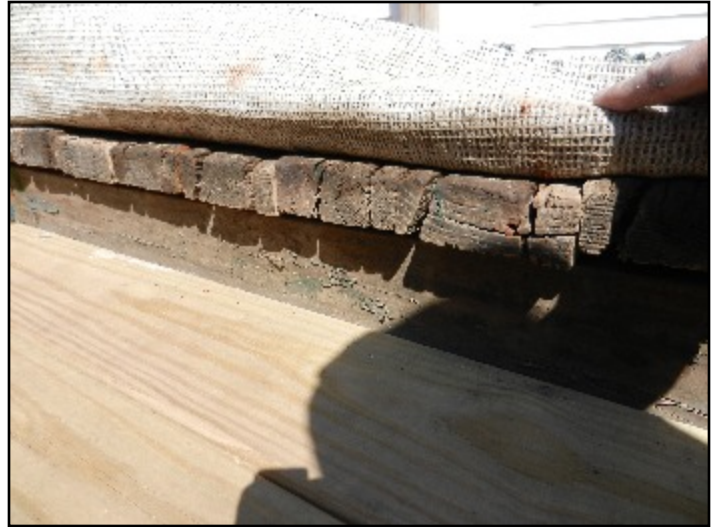
20. Decking is loose, covered with carpet.

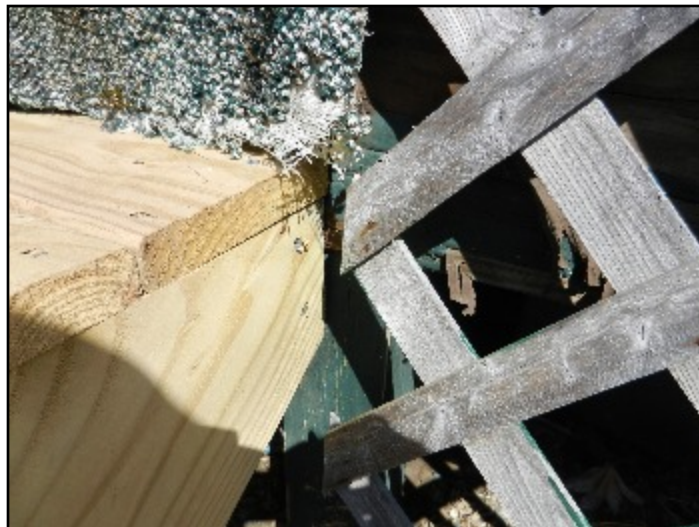
21. Stairs not properly fastened at deck.

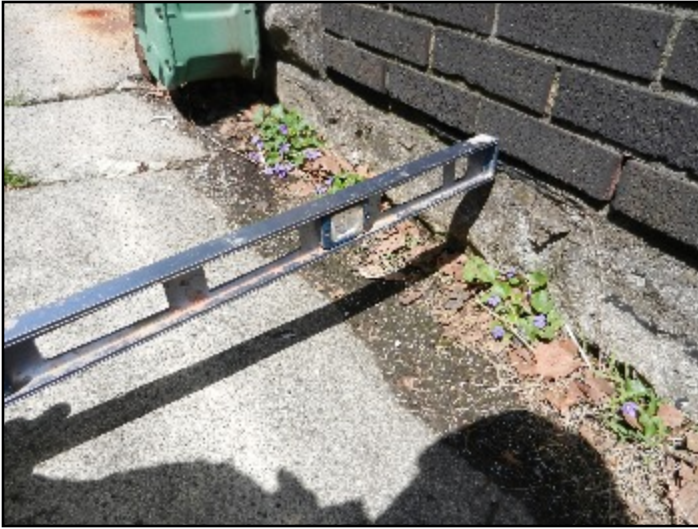
The slope of the ground and sidewalk on the left side is towards the foundation. Poor grading at the foundation can be a significant cause of moisture intrusion into the basement. Moisture was detected in the basement walls adjacent to the area of poor grading. The grade at the foundation should be evaluated and improved as necessary by a qualified landscape or foundation contractor.

22. Improper slope

Task: Repair, rebuild sidewalk and seal at foundation, improving grade

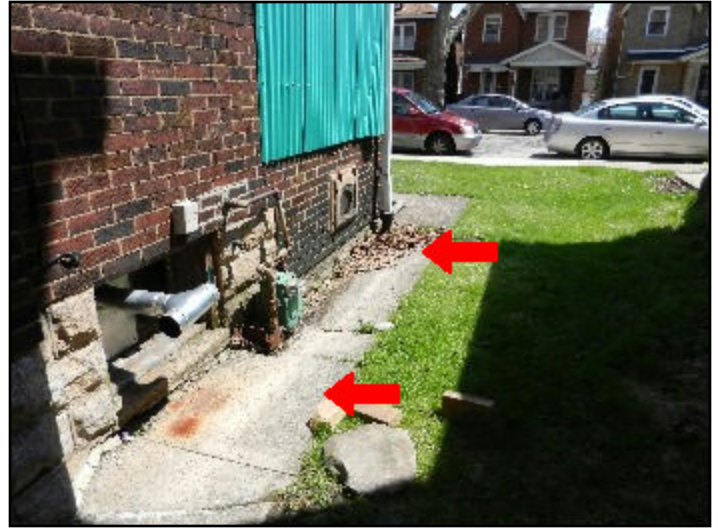
23. Improper slope

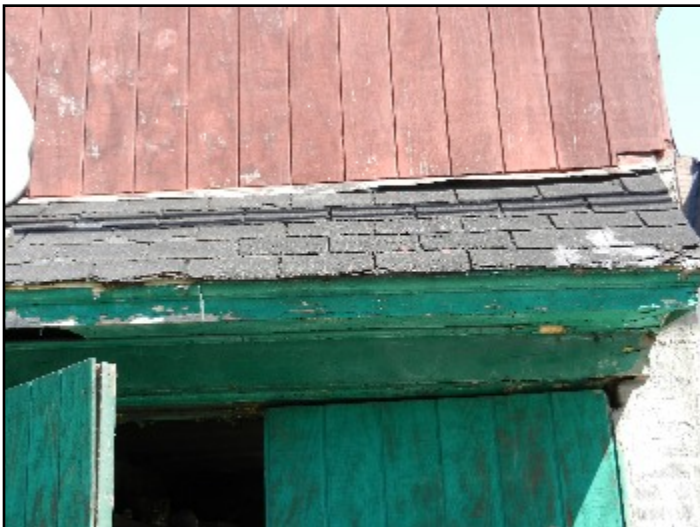
The garage is need of renovation. A new roof (10+ years ago?) and framing has been constructed on top of the old roof which was failing/ collapsing. No access was available to inspect the attic space. One corner at the alley has sustained extensive water and termite damage and is being held up by temporary wooden support post. A crack/separation of mortar joints was noted on the shared interior wall of the garage. The other side of the wall was not accessible to inspect the crack further. Mortar deterioration and erosion was noted on the exterior brick

24. Over hang roof shingles deteriorated.

Task: Evaluation and repair by qualified contractor

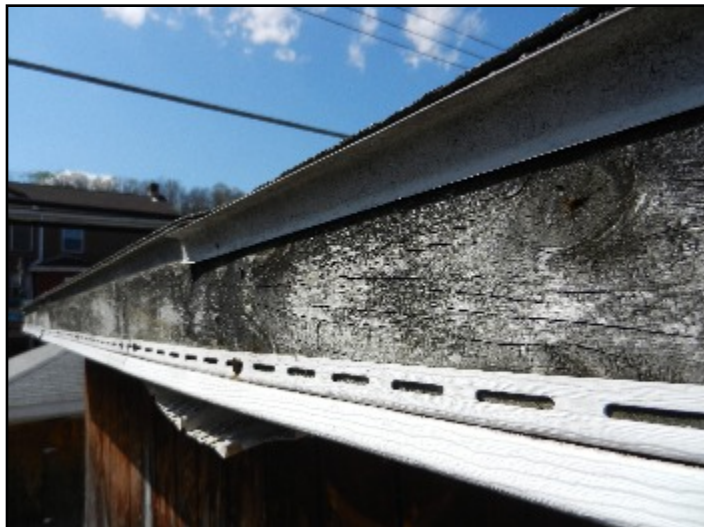
25. Paint fascia at roof line

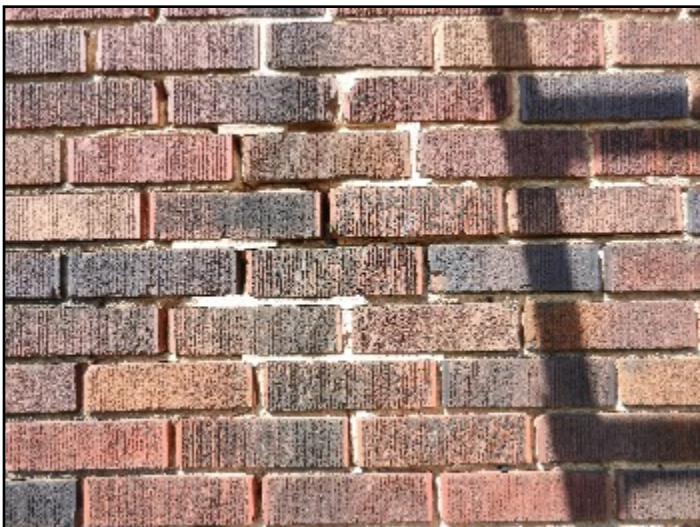
26. Mortar deterioration on garage wall.

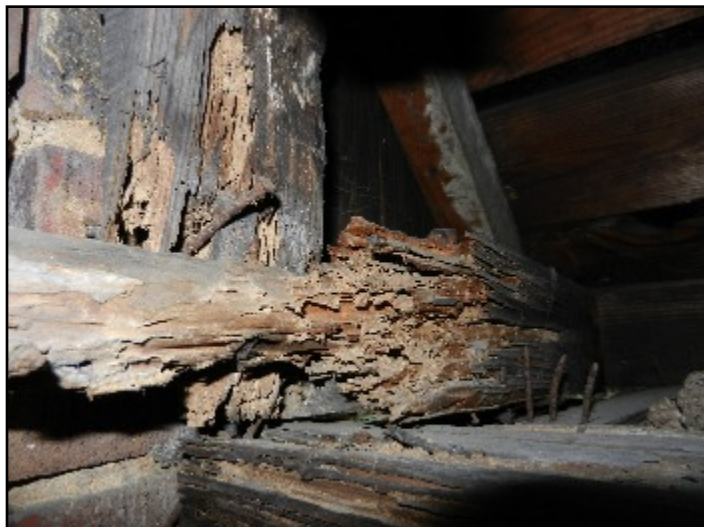
27. Extensive termite damage in back-left corner.

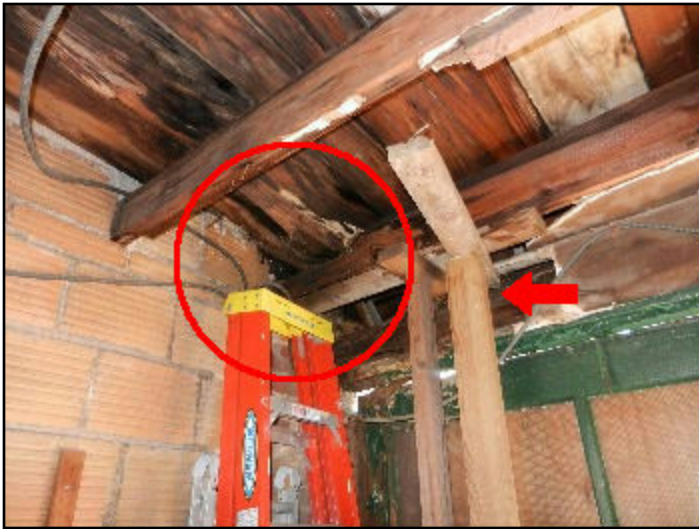
28. Damage to framing, posts holding up corner.

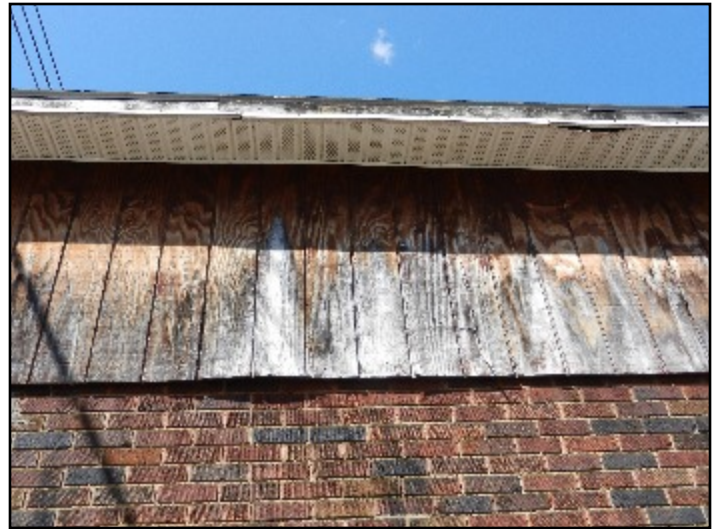
29. Wood siding warping, in need of paint

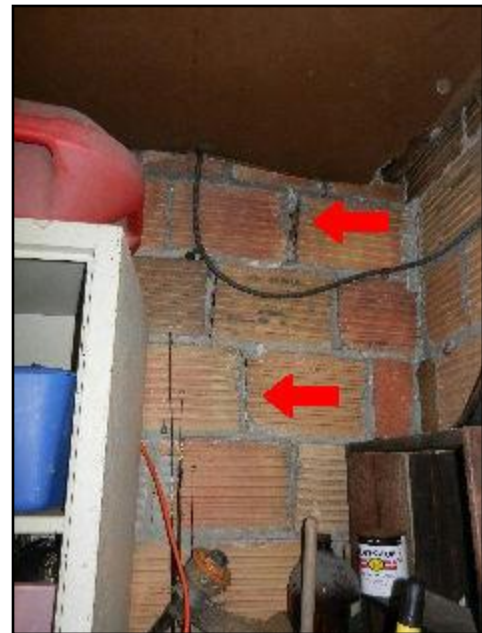
31. Crack/gap in mortar joints

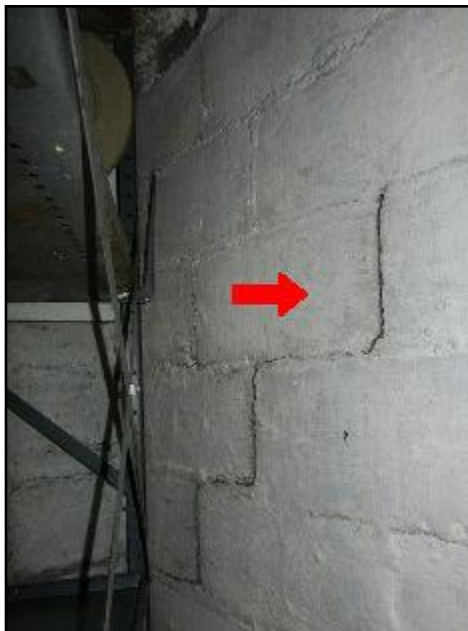
Cracks noted in cement block foundation wall at front of building. Recommend measuring the cracks for movement over time for changes. This crack is in a shared wall with the neighboring duplex. Access to other side of wall was available.

32. *Typical minor cracks*

Location: Front Right Side Basement**Task:** Monitor for movement**Time:** Ongoing

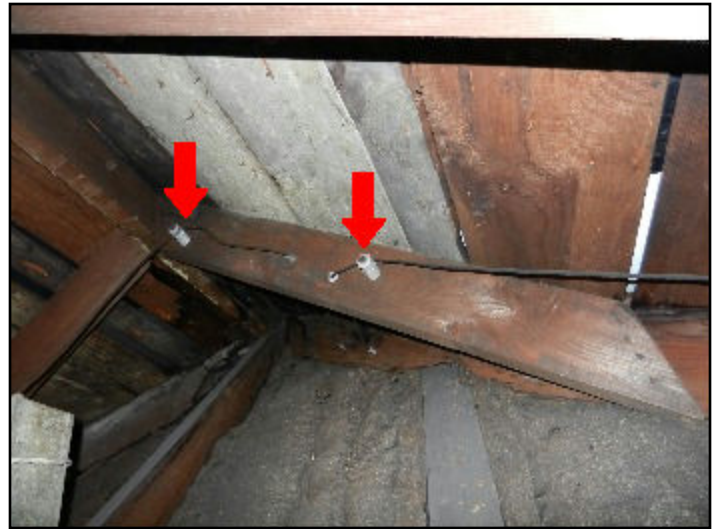
There is knob and tube wiring in the attic. This type of wiring is antiquated and should be replaced or evaluated by a qualified electrician for safety.

34. Outdated

Task: Evaluation and repair/replace as necessary for safety

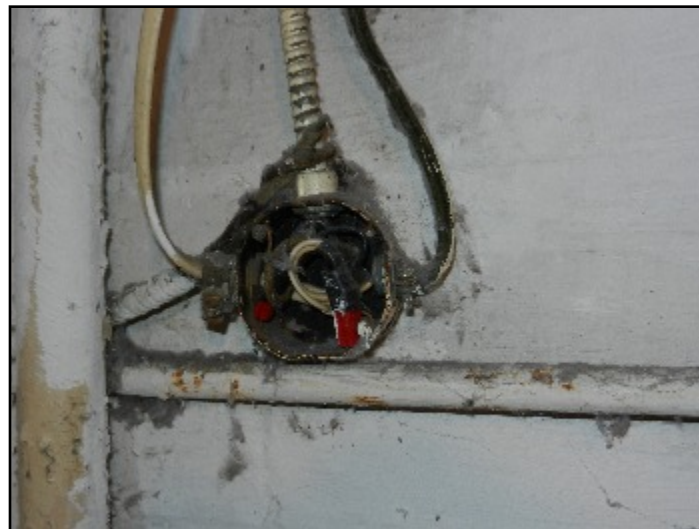
35. Cover loose or missing

Task: Repair by qualified contractor

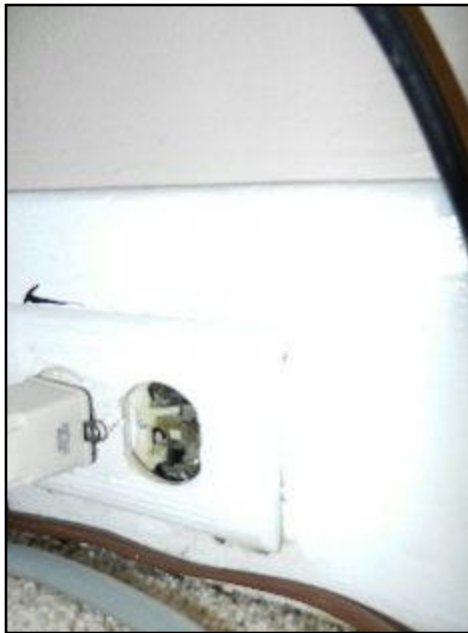
36. *Damaged outlet*

Task: Repair by qualified plumber

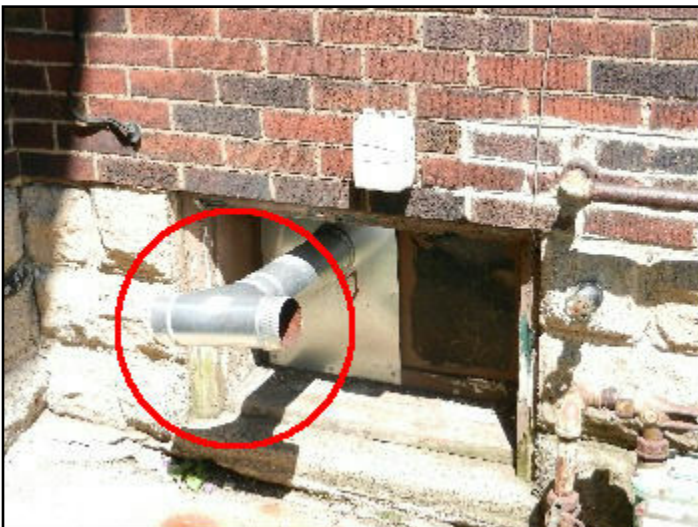
23. Condition: • Conventional boiler was venting out basement window. A booster fan had been installed to the vent connector. Extensive rust, corrosion and signs of condensation noted on vent and vent connector. The chimney terminates just outside the window. This configuration will need to be altered for safe operation of the boiler and to avoid damage to flue and boiler.

37. Boiler vent termination outside.

Task: Repair by qualified HVAC contractor

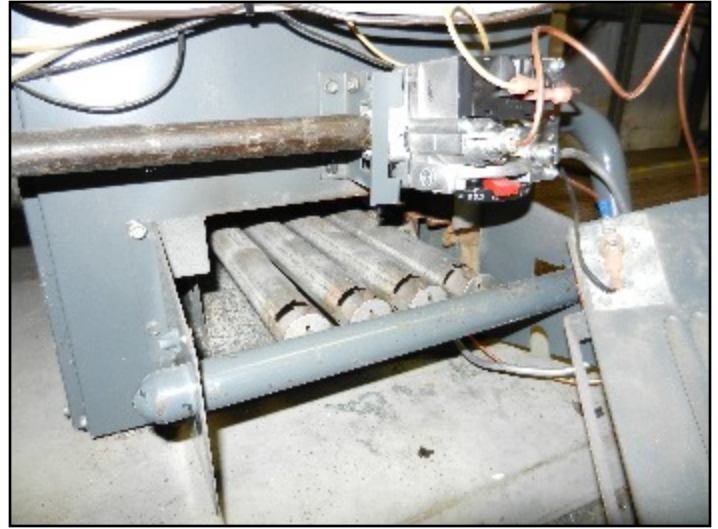
40. Burners, boiler should be serviced.

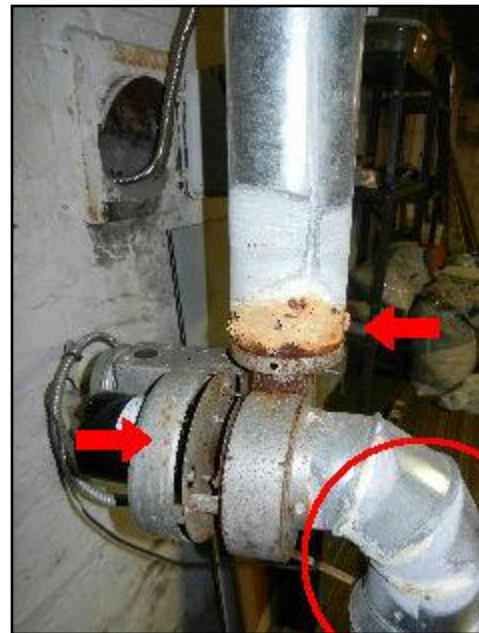
42. Booster fan, rust and condensation on vent.

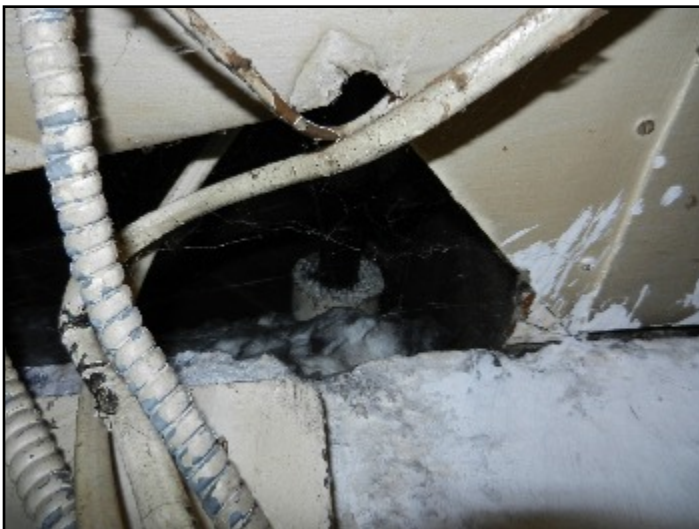
25. Condition: • Asbestos insulation noted on supply lines for boiler. Don't know how extensive this insulation is in areas not accessible to inspect.

44. Back left of basement.

Task: Repair by qualified contractor

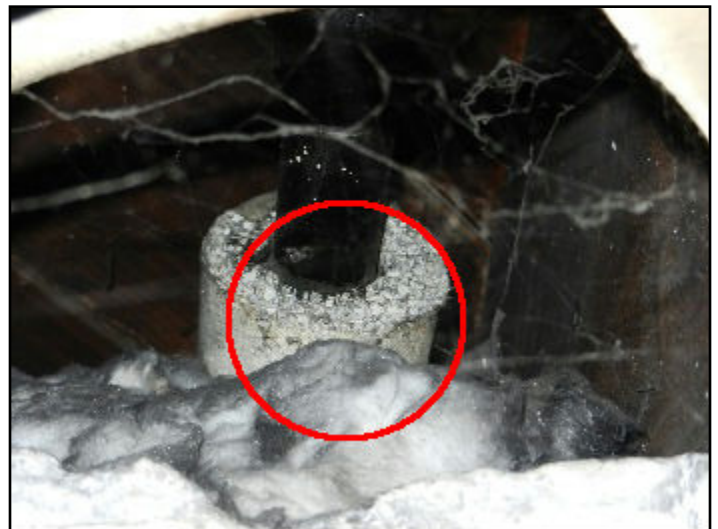
45. Asbestos

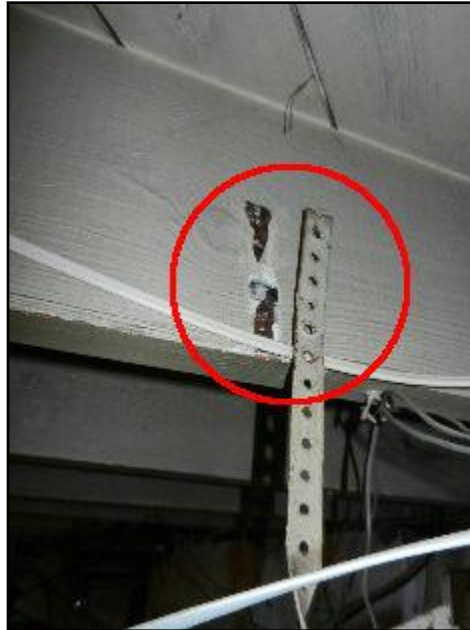
Some pipe supports were detached or missing. Make sure all pipes are supported adequately.

46. Poor support

Task: Repair by qualified contractor

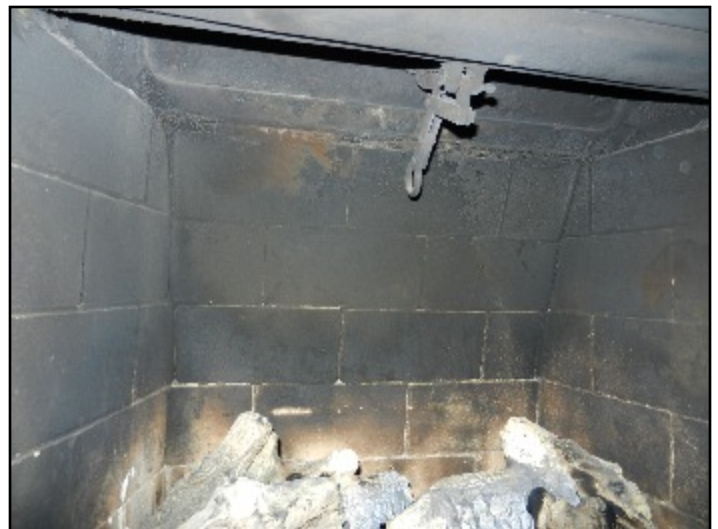
Charring noted on outside of fireplace and on inside firebox. The chimney had ash build-up and should be swept. The hearth extension is short or near the minimum depth. Owner could not get gas burner to light. The gas is supplied through flex line that should not be run through walls or floors. The gas line should be in permanent steel or CSST piping. Have a qualified fireplace technician evaluate and repair fireplace gas insert for safety before use. Damper was closed when inspected.

48. Blackened inside fire box

Task: Evaluation and repair/replace as necessary by a qualified contractor

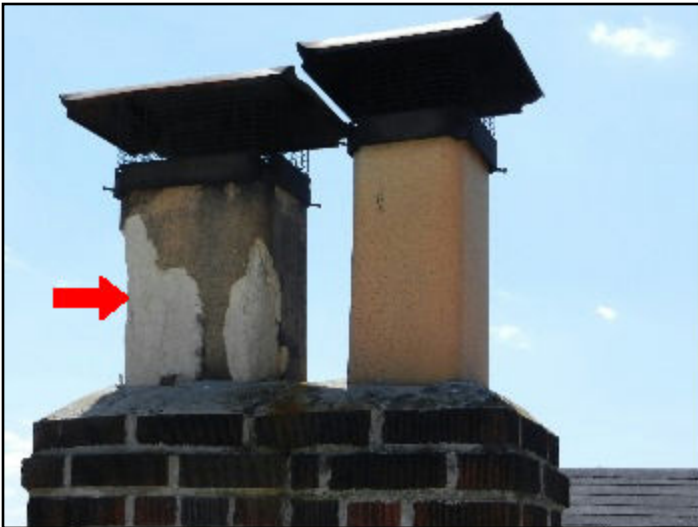
28. Condition: • The clay flue liners of the front chimney is spalling/damaged. The chimney was so high it could only be viewed from a distance. Both chimneys have been repointed but under a thin layer of new mortar is deteriorated mortar. If the clay liners are damaged, metal flue liners should be installed for both the gas fireplace and the boiler. The consulting with qualified HVAC and masonry contractors to shorten the masonry portion of the chimney and add the metal liners.

50. Spalling chimney liner

Task: Repair by qualified contractor

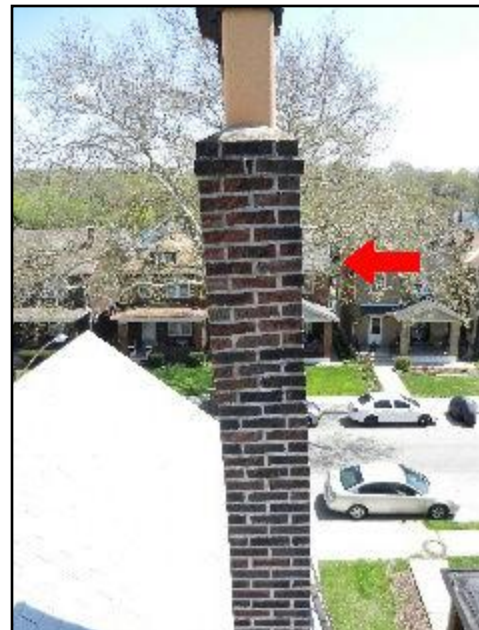
51. chimney is tall, leaning, unsupported.

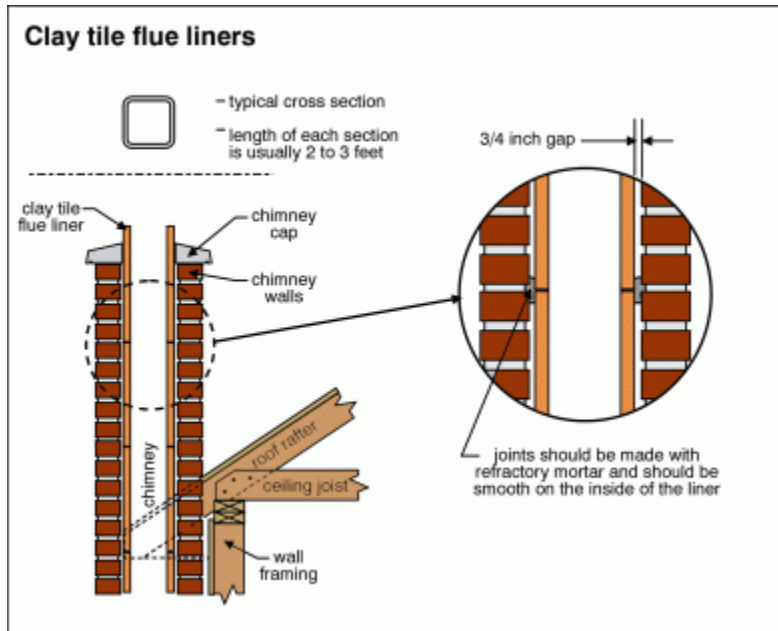
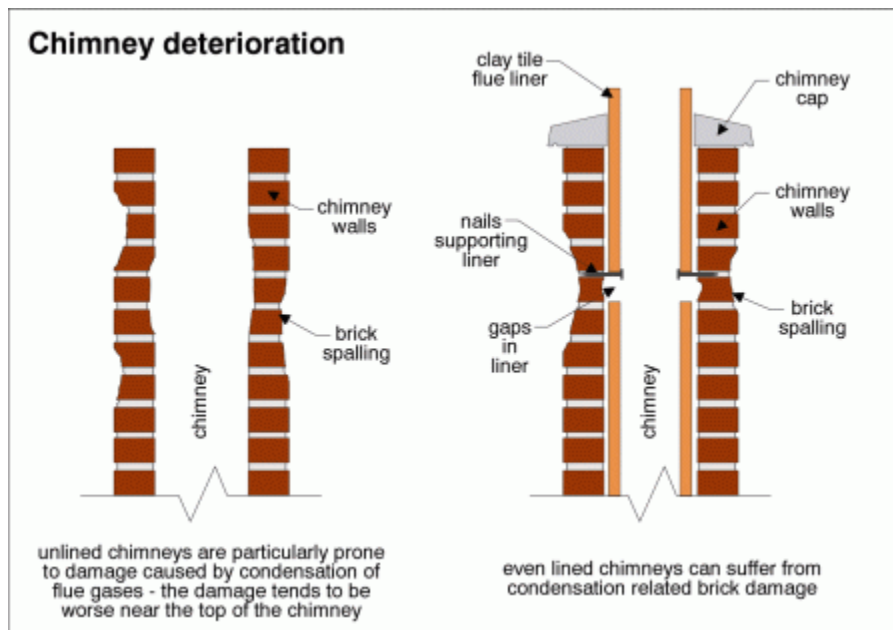
The rear chimney that serves the water heater is unlined and should have appropriate metal flue liner installed for safety and to prevent material deterioration of the masonry chimneys.

Task: Repair by qualified contractor

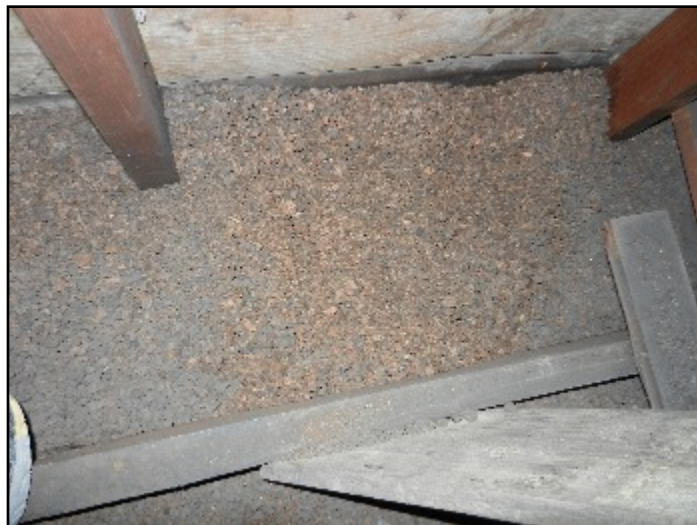
56. Possible Zonolite

Task: Repair by qualified contractor

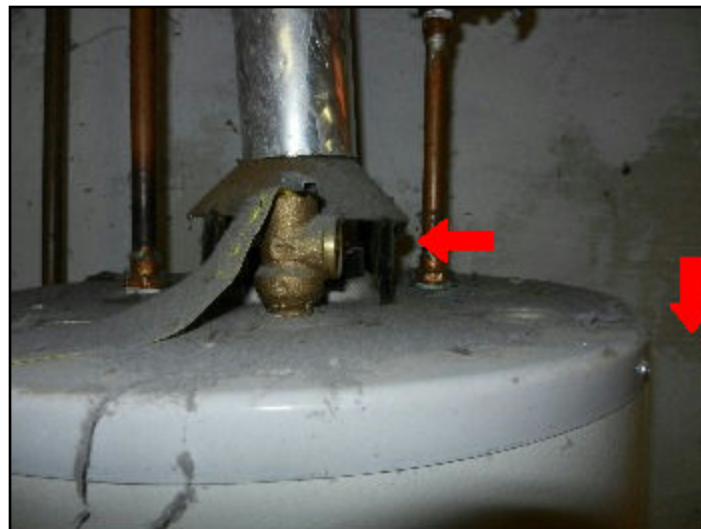
59. Discharge tube missing

Task: Repair by qualified plumber for safety

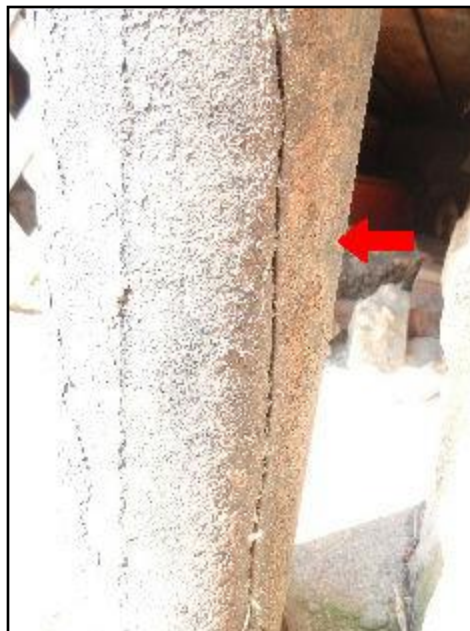
61. Split, pipe, outside at back left corner

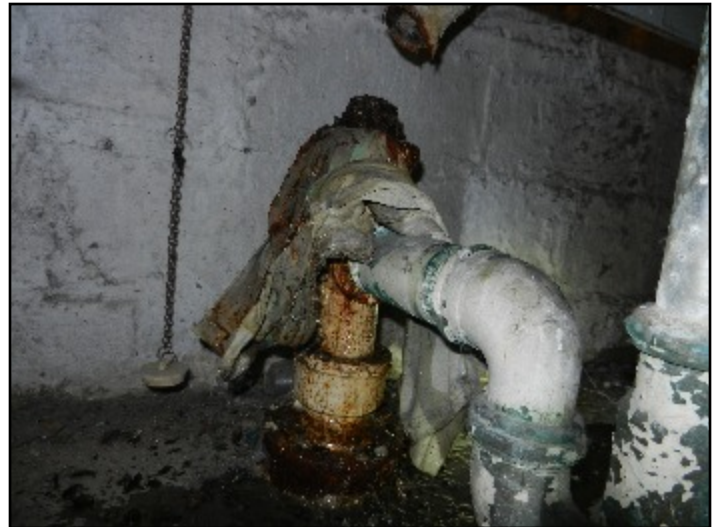
65. Clogged, leaking out of vent fitting

Task: Repair by qualified plumber

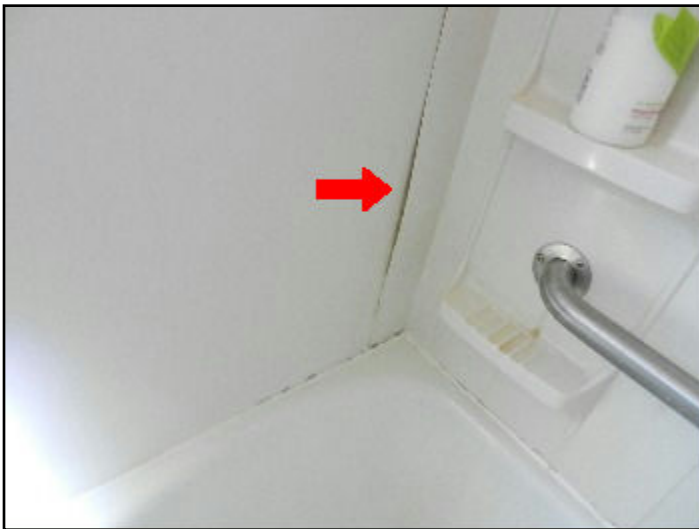
66. Not smooth, impervious or water resistant

Task: Repair by qualified electrician for safety

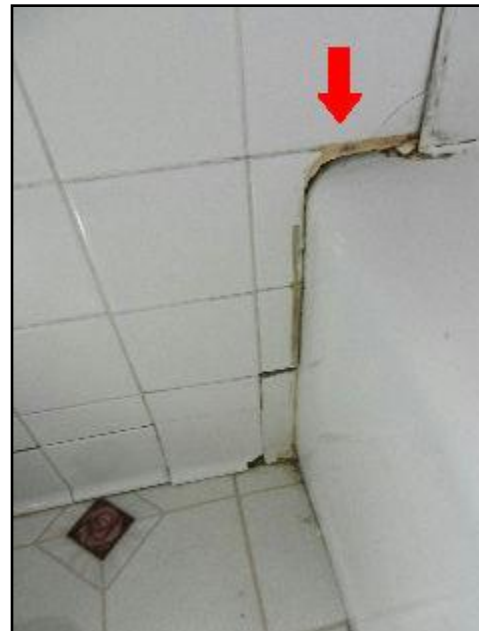
67. Caulking need, loose tiles.

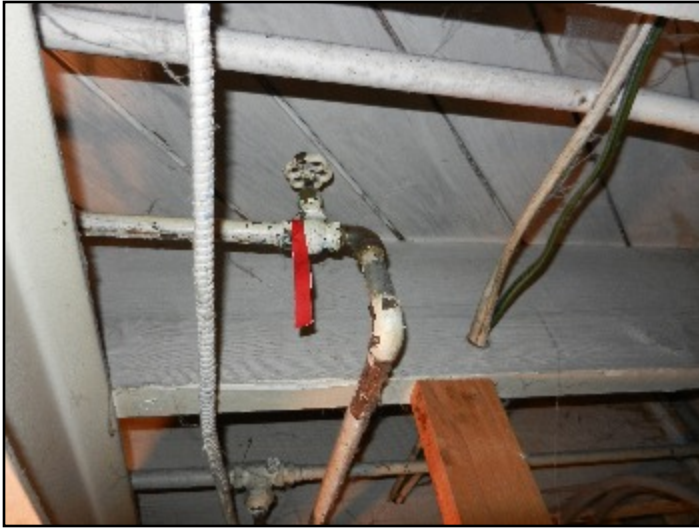
Two gas leaks found at valves in gas supply piping in basement

68. Leak

Task: Repair by qualified plumber for safety.

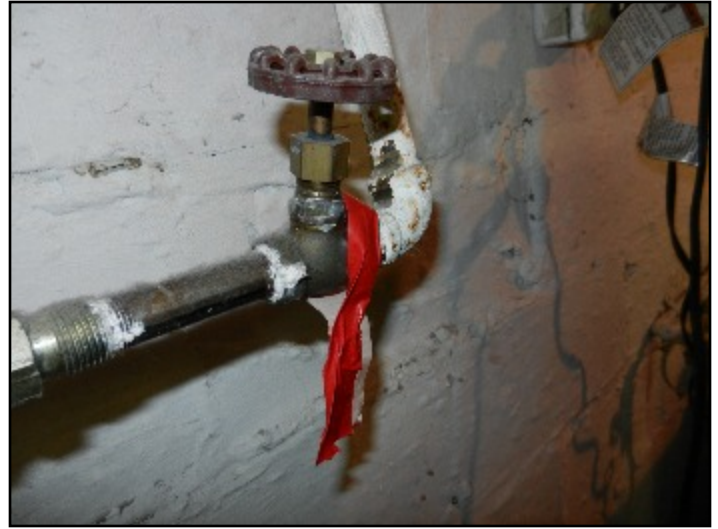
69. Leak

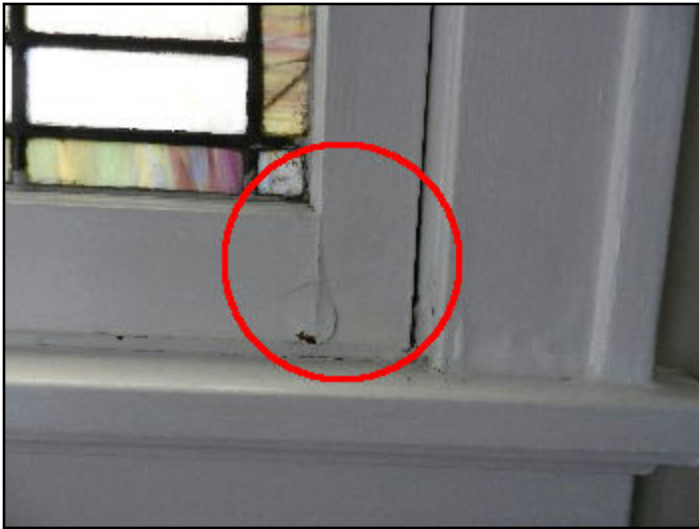
70. Sash cracked.

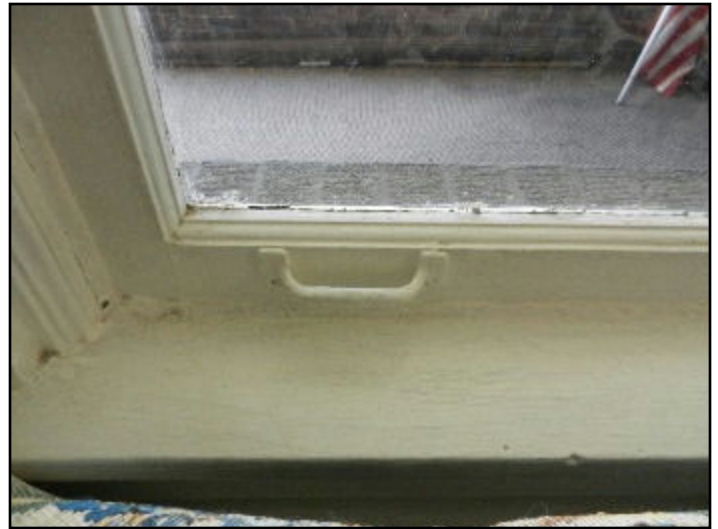
71. Painted shut.

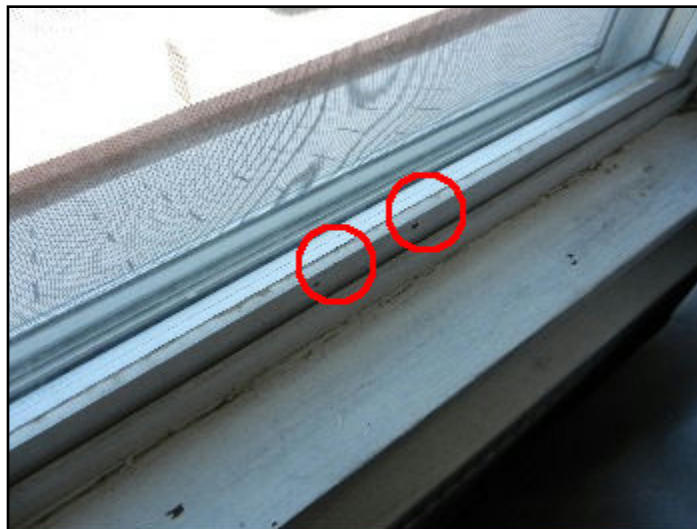
72. Missing

Task: Repair by qualified contractor

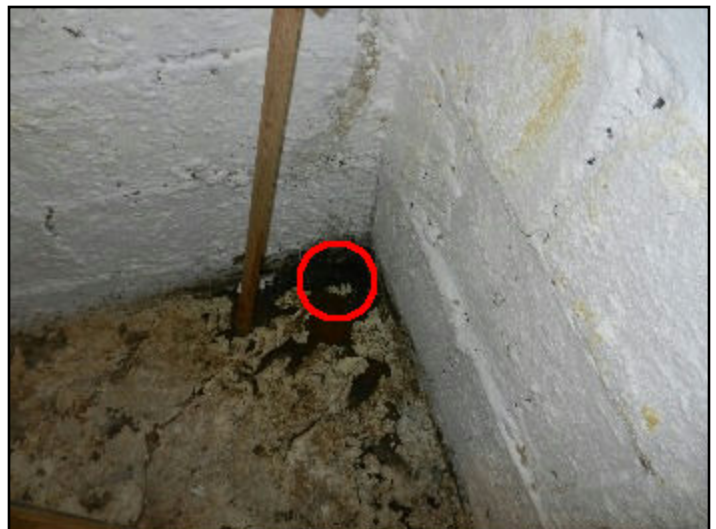
Dampness, efflorescence, staining and noted in basement floors and walls primarily on the front left side. (See exterior section for information on lot slope and downspout placement which can be major factors in basement moisture.)

78. Dampness on floor or walls

Moisture and high humidity levels can promote wood decay/rot, insect damage, mold growth, rust. Monitor the moisture conditions in the basement and consult with qualified moisture intrusion specialists to evaluate and improve where possible.

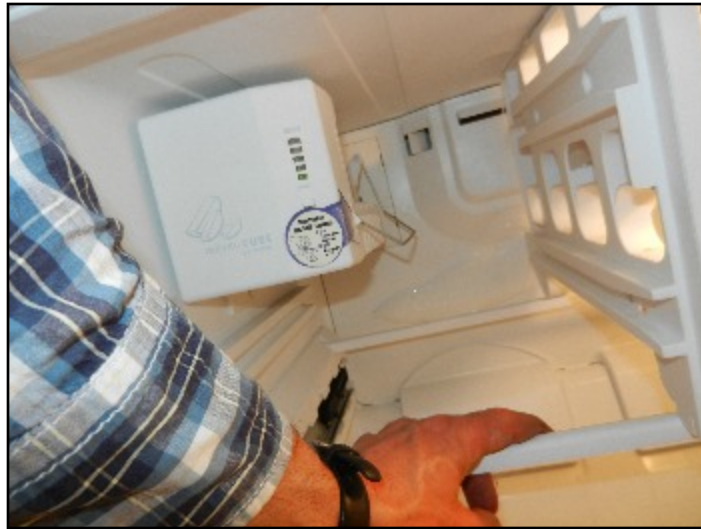
79. *Missing shelving in refrigerator.*
