Your Inspection Report

123 Any St
Thunder Bay, ON

Tuesday, June 18, 2013

RE: Report No. 1004, v.4
123 Any St
Thunder Bay, ON

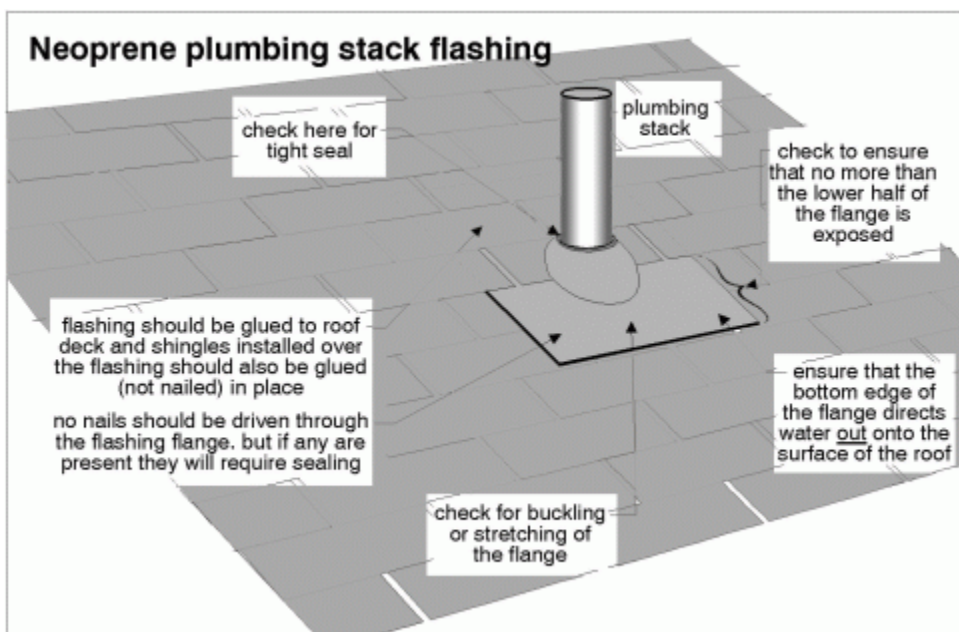
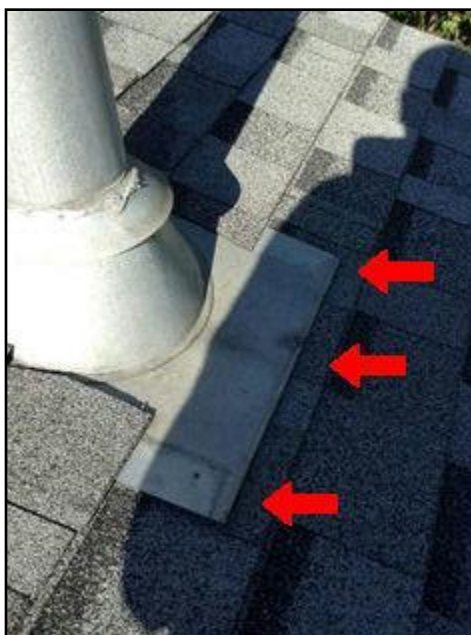
2. Condition: • [Exposed, missing fasteners](#)

Implication(s): Chance of water damage to contents, finishes and/or structure

3. Exposed, missing fasteners

Task: Provide

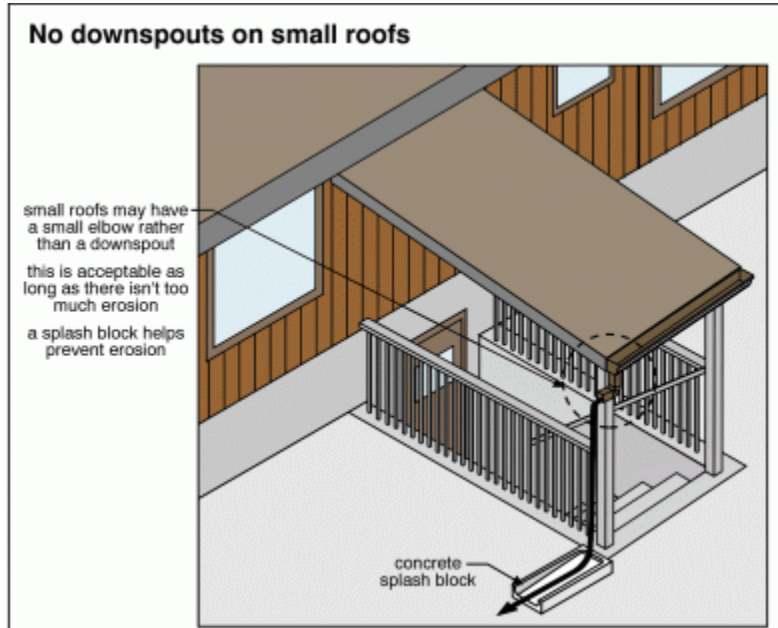
- No gutters or downspouts

Missing gutter and downspout on front entrance overhang. Water running freely down the siding and foundation. Recommend installation

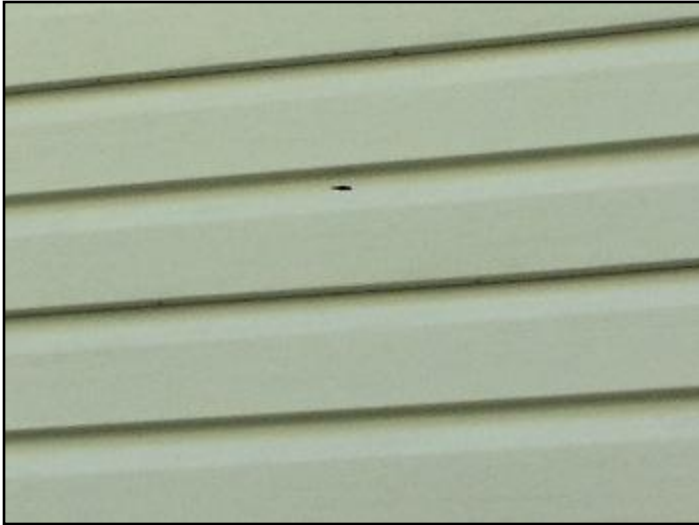
Vinyl siding has discolouration typical to age. Some small areas of mechanical damage

4. Minor Mechanical Damage

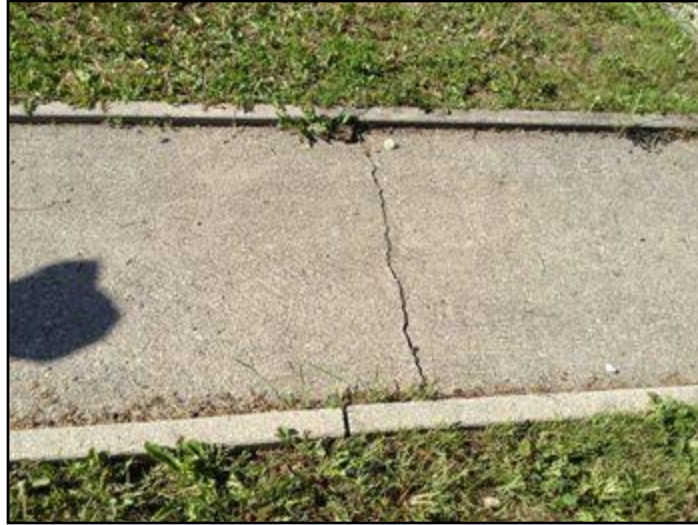
Crack in pathway could be a potential trip hazard

7. Front Pathway

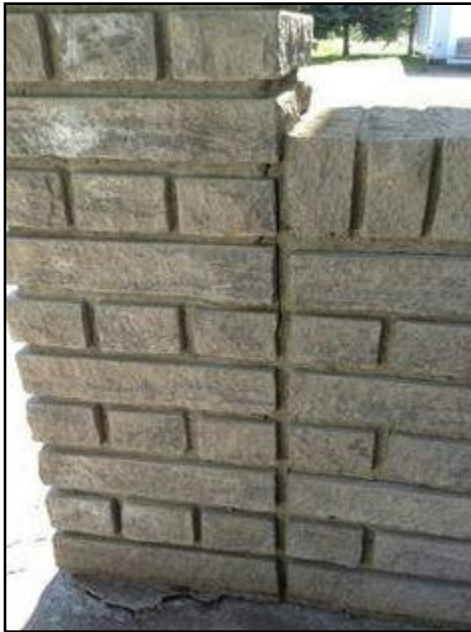
Some settlement of concrete pad under column. Recommend monitoring situation

8. Patio Settlement

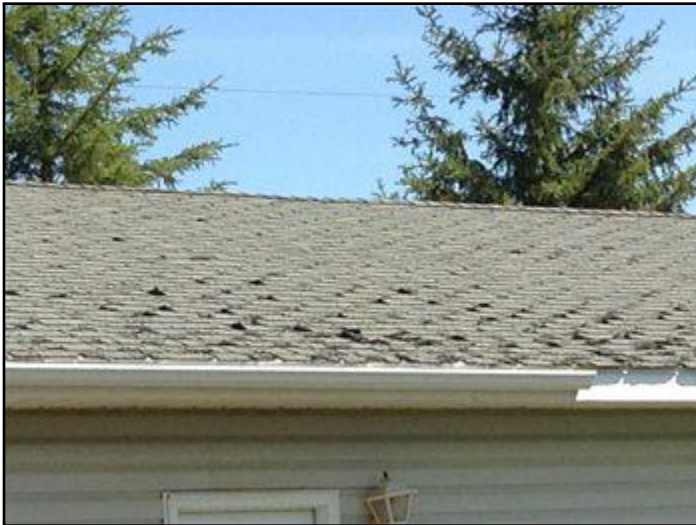
11. Garage shingles require replacement

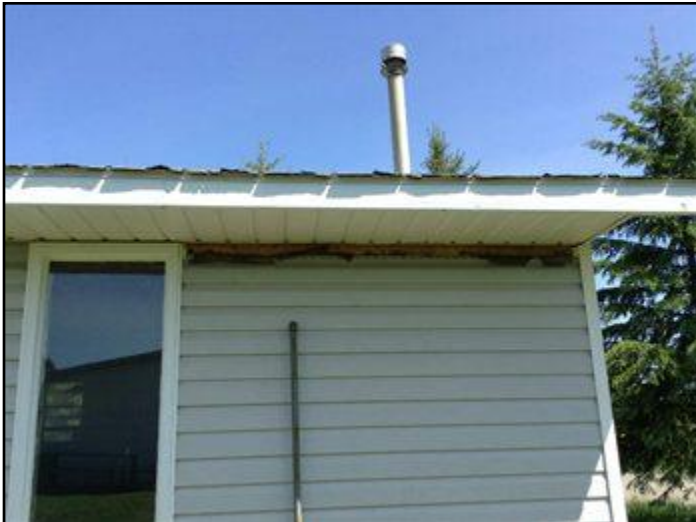
13. Garage wall missing siding

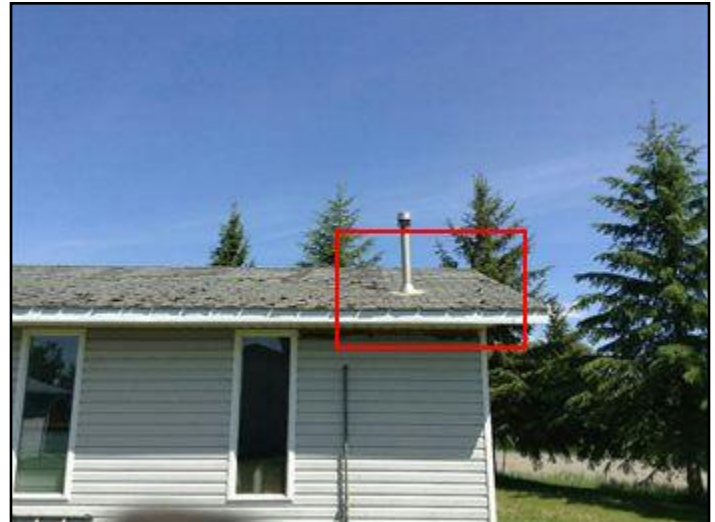
14. Sag noted in garage roof

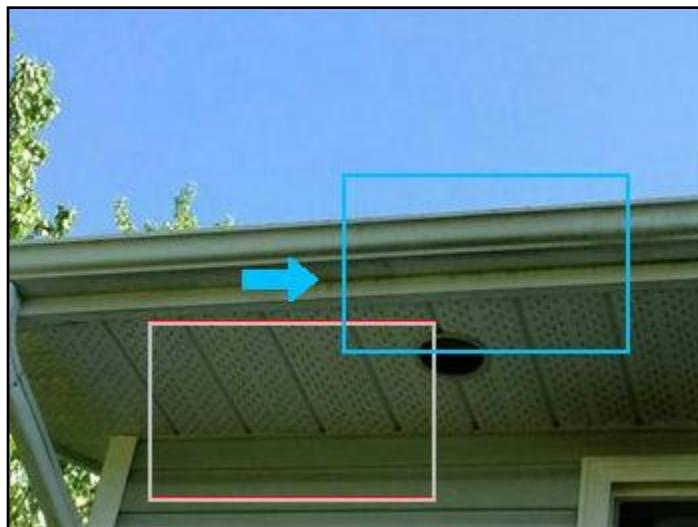
4. Condition: • Mildew on fascia and trough

17. Mildew on fascia and trough

Task: Clean/Improve

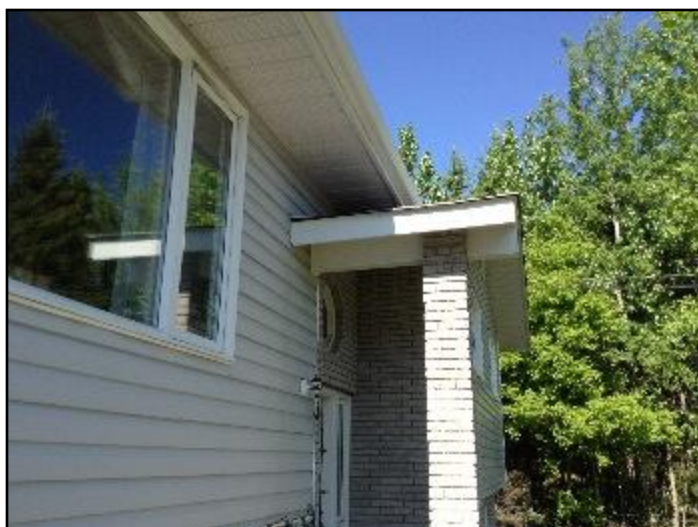
5. Condition: • [Missing](#)

Implication(s): Chance of water damage to contents, finishes and/or structure

18. No gutter or downspout

Task: Provide

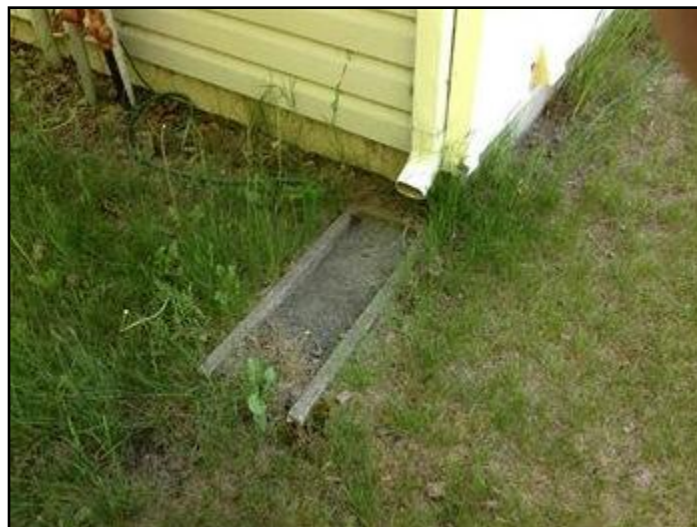
6. Condition: • [Downspouts end too close to building](#)

Implication(s): Chance of water damage to contents, finishes and/or structure

19. *Discharge too close to house*

Task: Improve

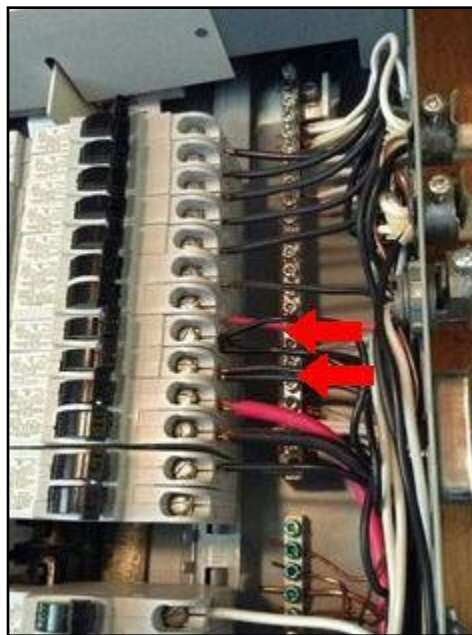
9. Condition: • [Double taps](#)

Implication(s): Fire hazard

24. Double taps

Task: Correct

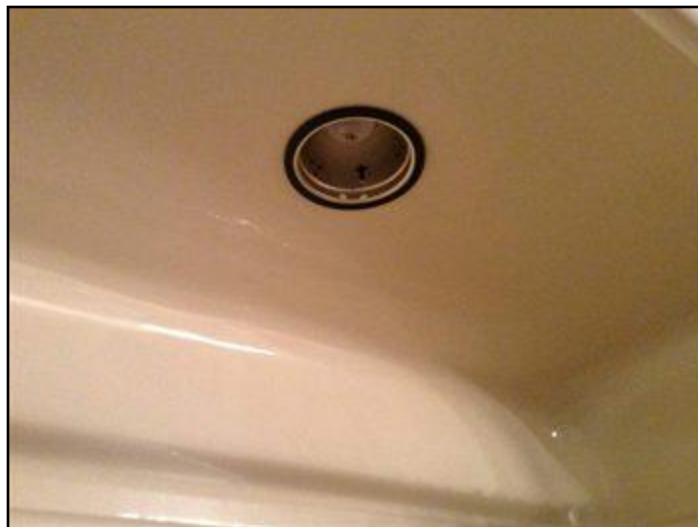
11. Condition: • [Conventional lights in wet areas](#)

Implication(s): Electric shock | Fire hazard

25. Conventional lights in wet areas

Task: Replace

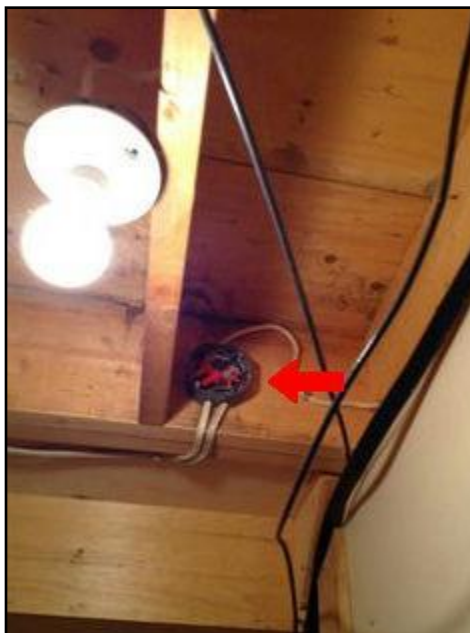
12. Condition: • [Cover loose or missing](#)

Implication(s): Electric shock | Fire hazard

26. Cover loose or missing

Task: Correct

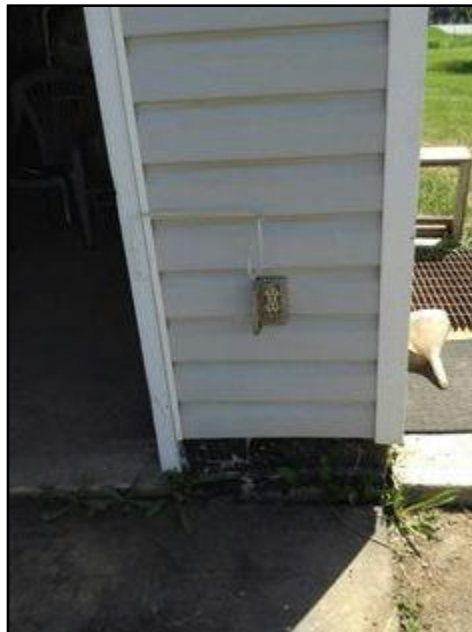
14. Condition: • [No GFI \(Ground Fault Interrupter\)](#)

Lack of GFCI receptacles on exterior outlet locations both on house and garage

Implication(s): Electric shock

27. No GFI (Ground Fault Interrupter)

Task: Provide

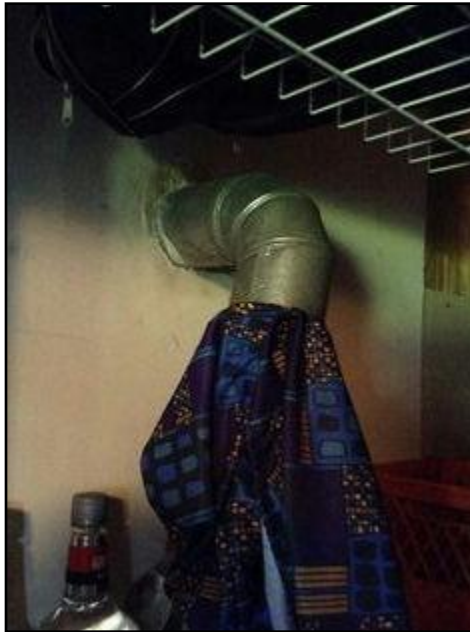
22. Condition: • Unused vent extending to exterior plugged with a rag. Recommend removing vent and repairing hole.

31. Unused Vent

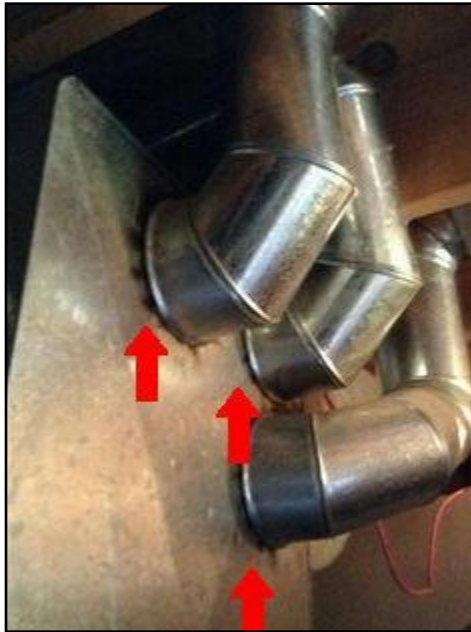
24. Condition: • [Dirty, obstructed or collapsed](#)

Ducts noticeably dirty. Recommend professional duct cleaning when purchasing a new home

32. *Dirty, obstructed or collapsed*

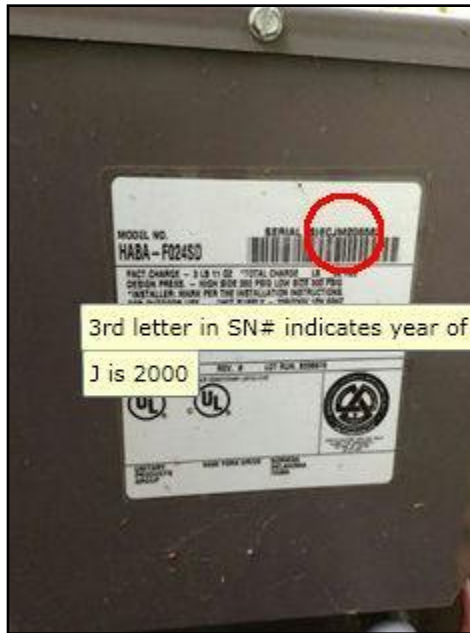
33. 13 years

Typical life expectancy: • 12 to 15 years

26. Condition: • [Near end of life expectancy](#)

Task: Replace

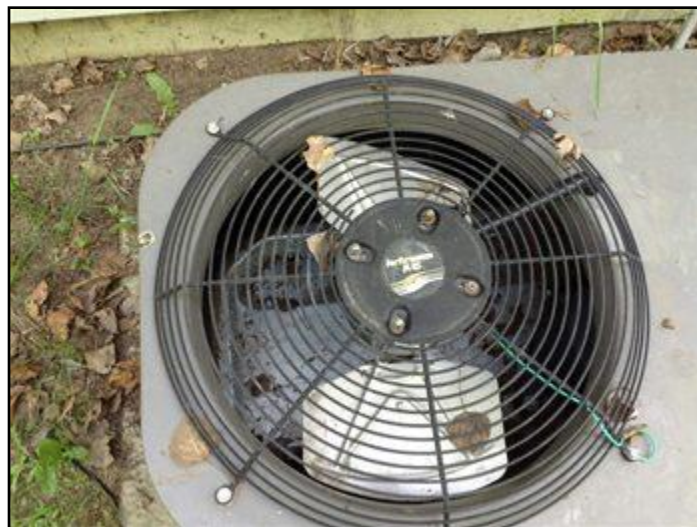
29. Condition: • [Dirty](#)

34. Dirty

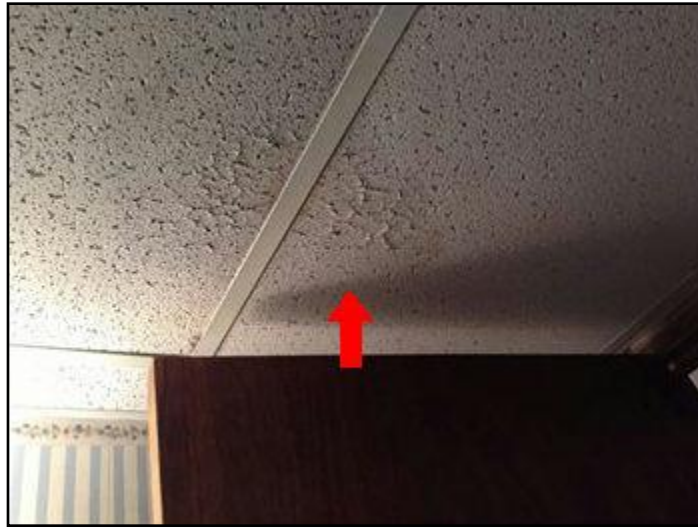
33. Condition: • [Leak](#)

Old water stains detected on ceiling tiles in basement washroom below main bathroom. Suggest monitoring of condition to determine if leak was a solitary event, occasional, or current

38. Leak

Task: Monitor

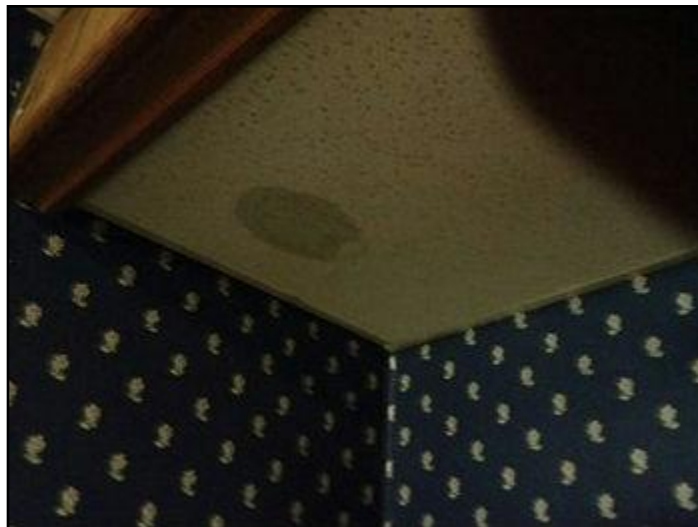
34. Condition: • [Leak](#)

water stain observed on ceiling in basement below kitchen. Stain is still saturated. Recommend immediate repair

39. Leak

Task: Repair

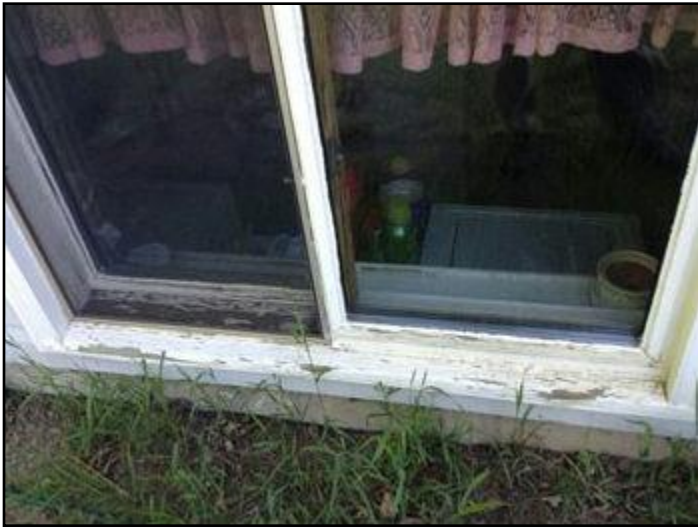
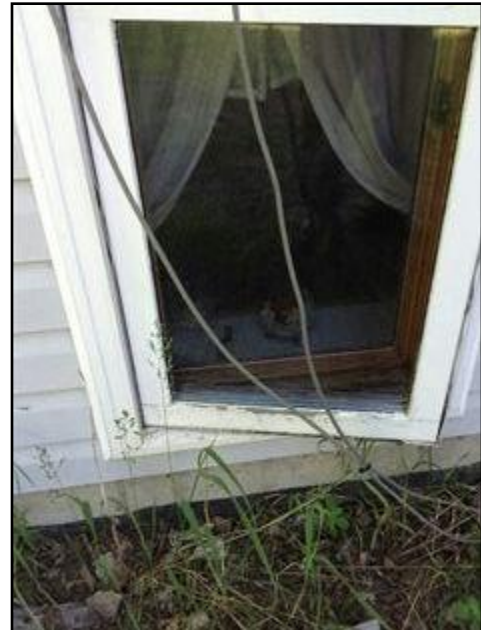
41. Peeling Finish

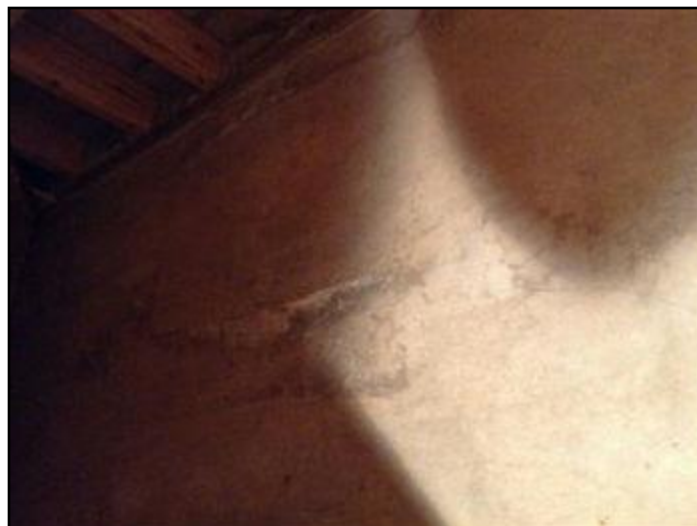
Stains observed on basement floor under stairs near sump pump location. Possible previous overflow of sump pit

43. Stains

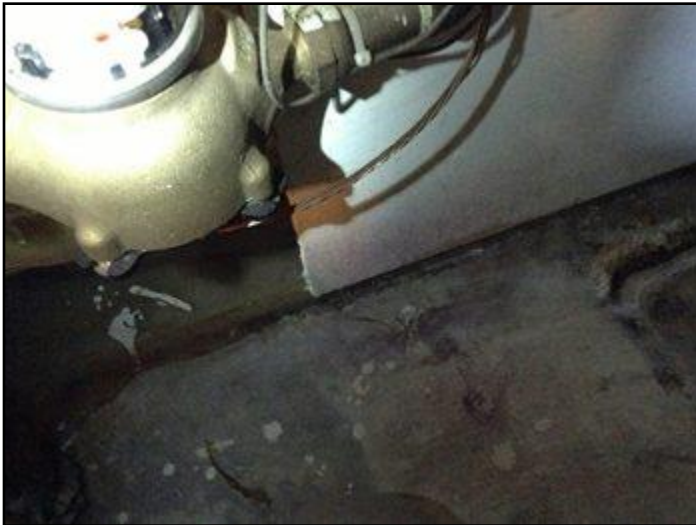
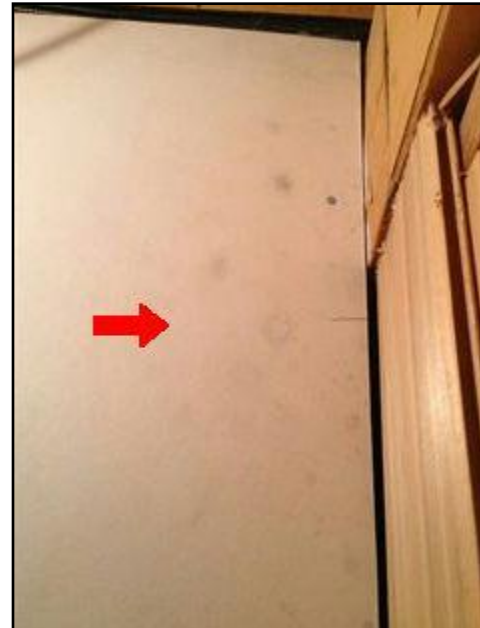
44. Mold
