# INSPECTION REPORT

For the Property at:  
**#81 RIVERPOINTE DRIVE**  
FORT SASKATCHEWAN, AB

Prepared for: PERRY NELSON  
Inspection Date: Friday, July 2, 2010  
Prepared by: Don Schmidt

Report No. 1124

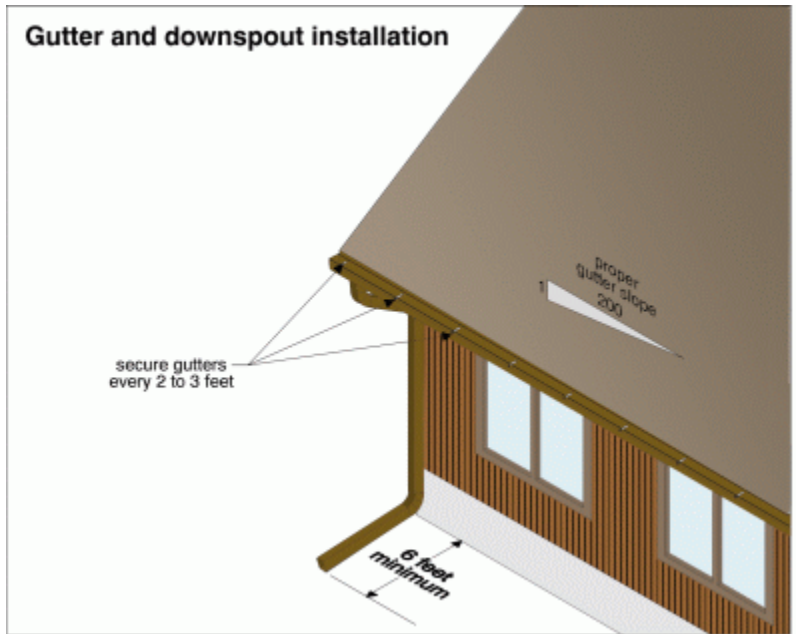
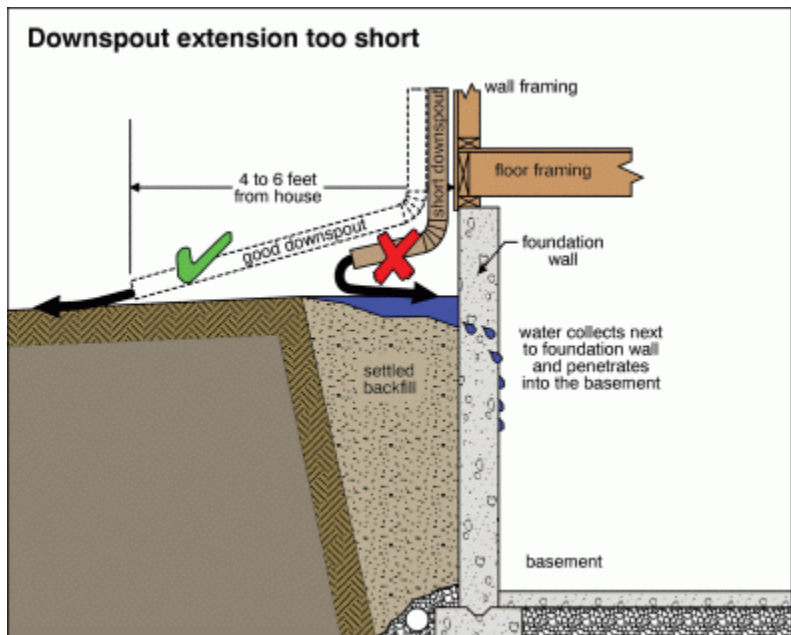
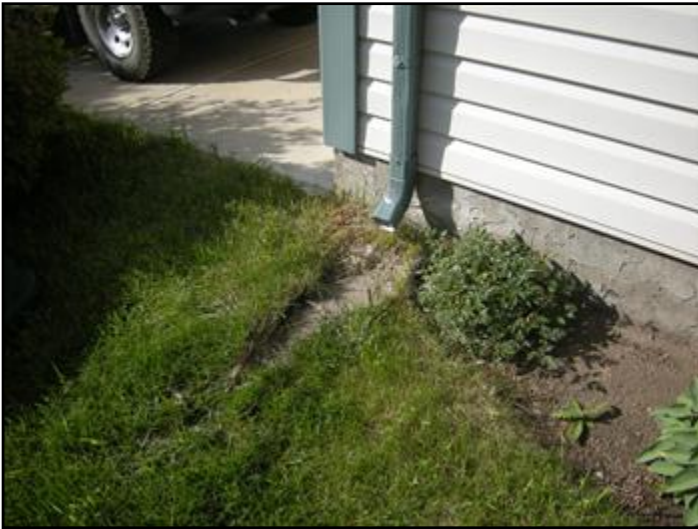
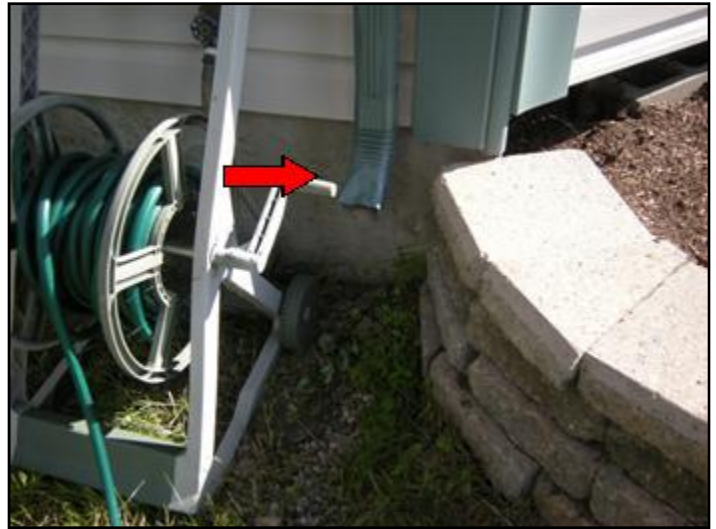
### **ROOF DRAINAGE \ Downspouts**

**Condition:** • Should discharge 6ft. from home

**Implication(s):** Chance of water damage to contents, finishes and/or structure

**Location:** Various Yard

**Task:** Correct

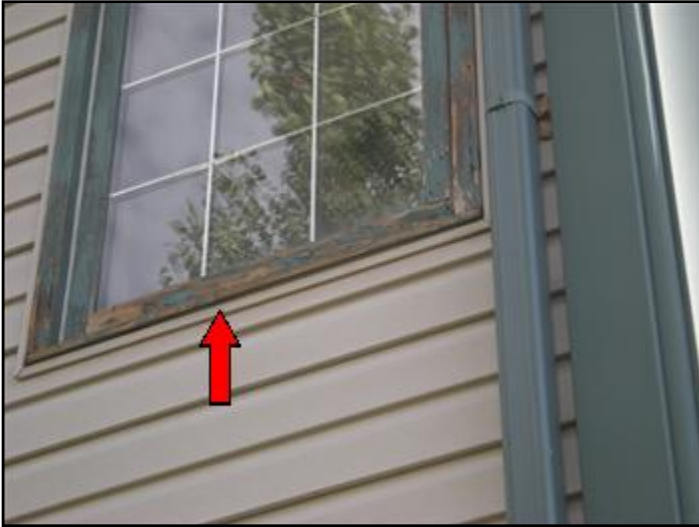
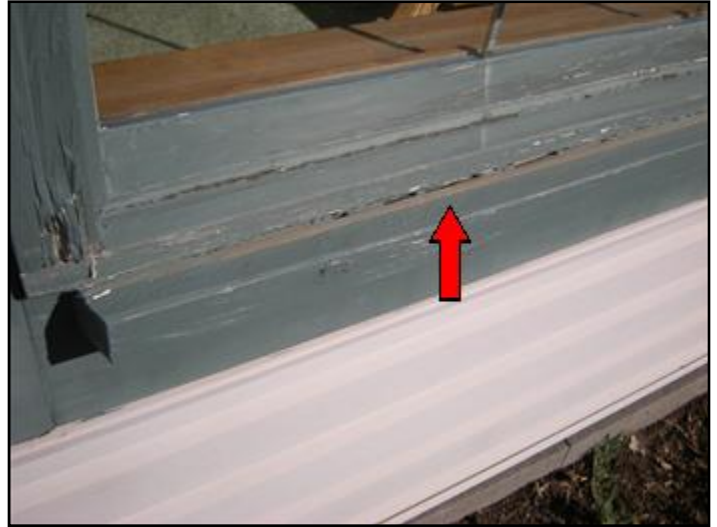
## EXTERIOR GLASS \ Exterior trim

**Condition:** • [Paint or stain needed](#)

**Implication(s):** Chance of water damage to contents, finishes and/or structure | Material deterioration

**Location:** Throughout Exterior Wall

16. left side second storey.

17. Front main floor.

**Task:** Improve

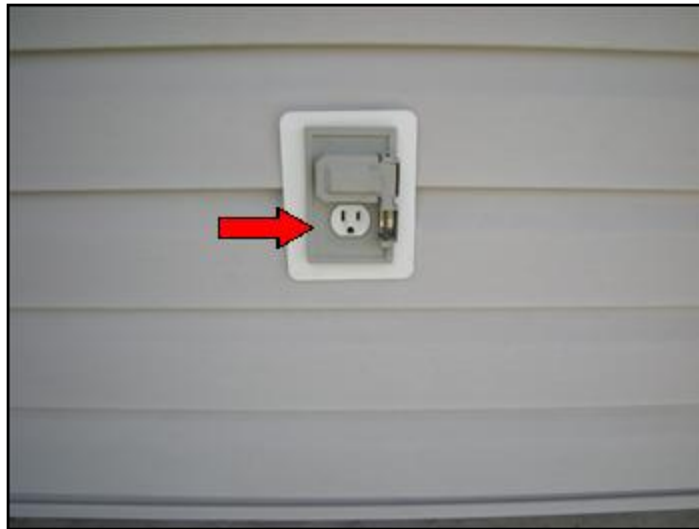
### DISTRIBUTION SYSTEM \ Outlets (receptacles)

**Condition:** • [Damage](#)

**Location:** Front Garage

24. Missing cover.

**Task:** Repair or replace

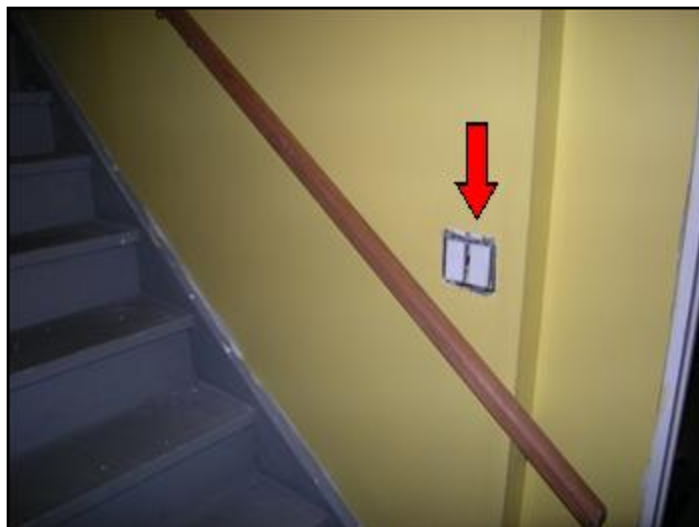
25.

### DISTRIBUTION SYSTEM \ Cover plates

**Condition:** • [Missing](#)

**Implication(s):** Electric shock

**Location:** Basement

**Task:** Correct

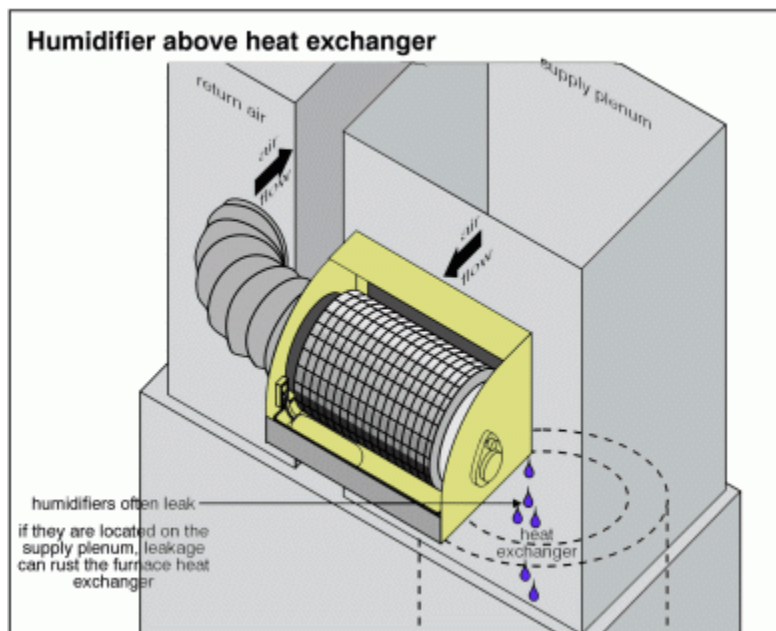
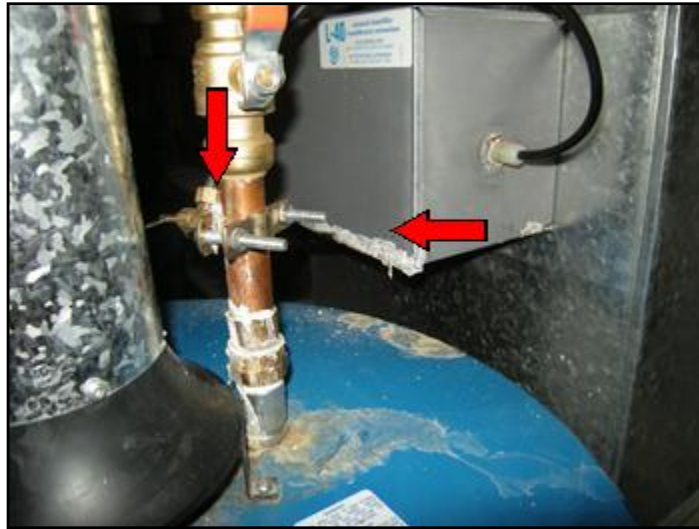
### GAS FURNACE \ Humidifier

Condition: • [Leak](#)

Implication(s): Chance of water damage to contents, finishes and/or structure | Damage to equipment

Location: Basement Furnace Room

Task: Repair or replace

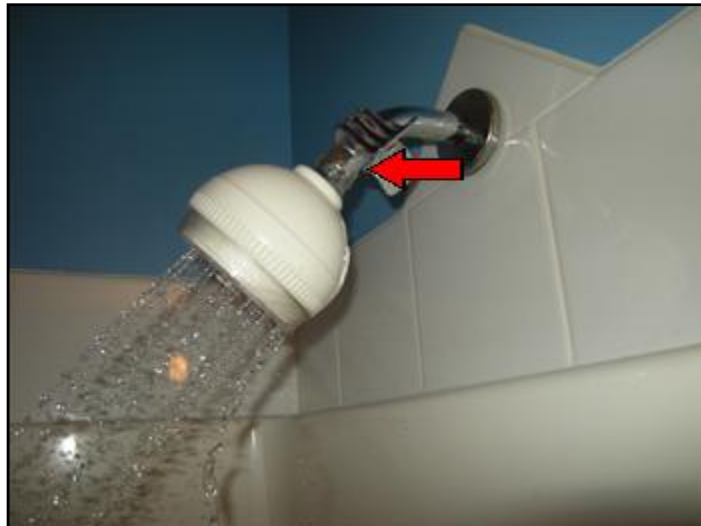
38.

### FIXTURES AND FAUCETS \ Faucet

**Condition:** • [Drip, leak](#)

**Implication(s):** Chance of water damage to contents, finishes and/or structure

**Location:** Second Floor Hallway Bathroom

**Task:** Improve

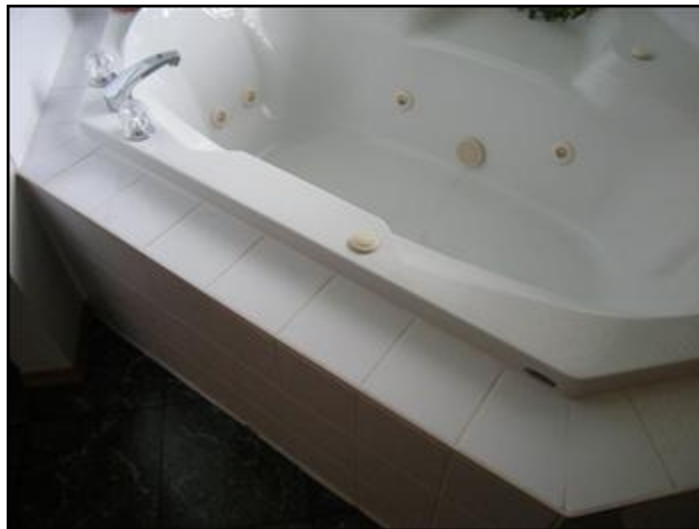
## **FIXTURES AND FAUCETS \ Whirlpool bath pump**

**Condition:** • [Inoperative](#)

**Implication(s):** Equipment failure

**Location:** Second Floor Master Bathroom

**39.** *Tub does not turn on.*

**Task:** Further evaluation

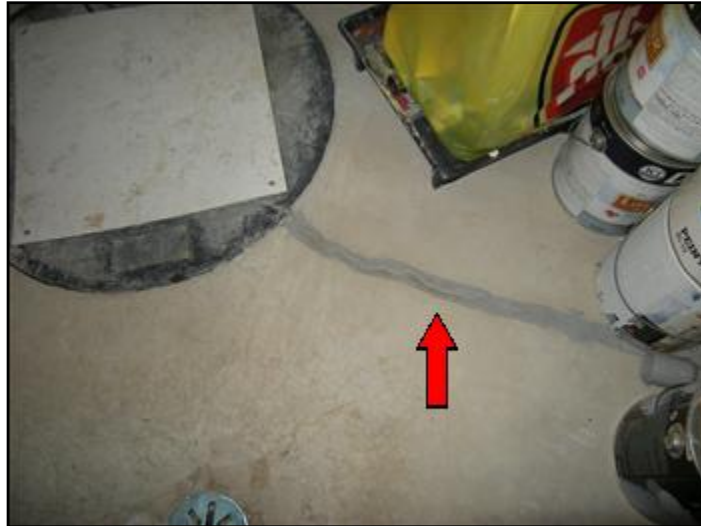
46.

### FLOORS \ Concrete floors

Condition: • [Cracked](#)

Location: Basement Furnace Room

Task: Inspect annually

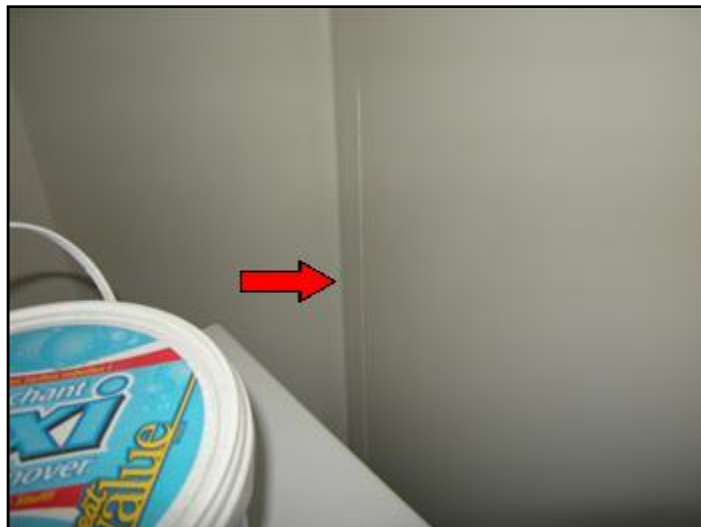
47.

### WALLS \ Plaster or drywall

Condition: • [Poor joints](#)

Implication(s): Cosmetic defects

Location: First Floor Laundry Area

Task: Repair

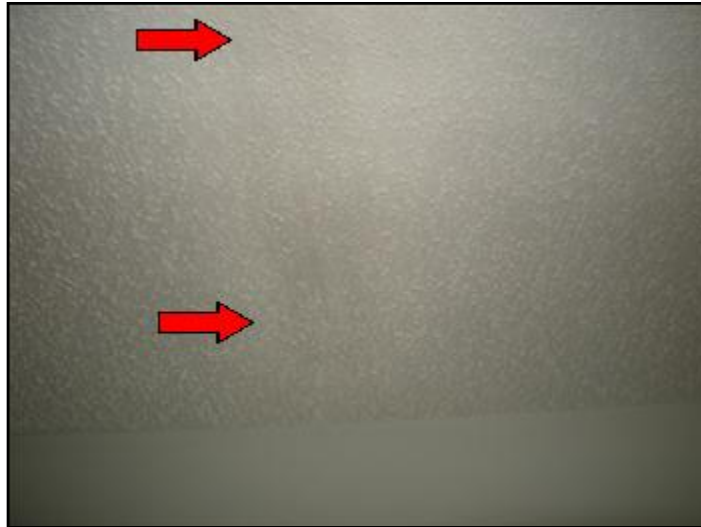
48.

## CEILINGING \ General

**Condition:** • Stains

A ceiling stain was evident and was tested for existing moisture. No moisture was detected at time of inspection.

**Implication(s):** Cosmetic defects

**Location:** First Floor Living Room

**Task:** Improve

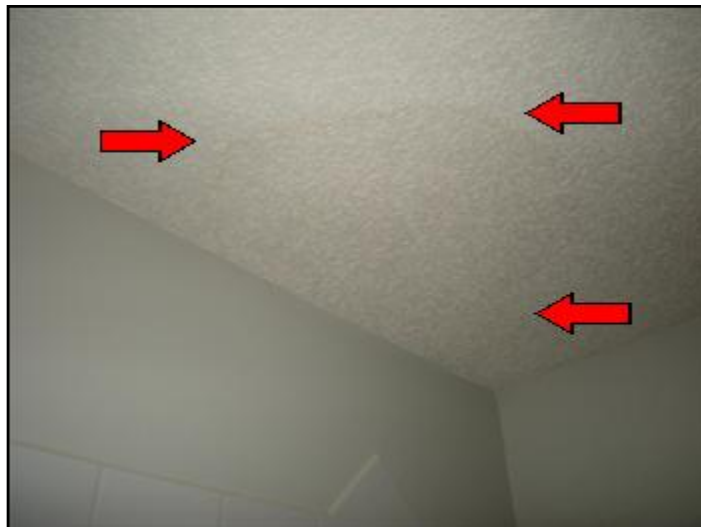
49.

**Condition:** • Stains

A ceiling stain was evident and was tested for existing moisture. No moisture was detected at time of inspection.

**Implication(s):** Cosmetic defects

**Location:** Second Floor Master Bathroom

**Task:** Improve

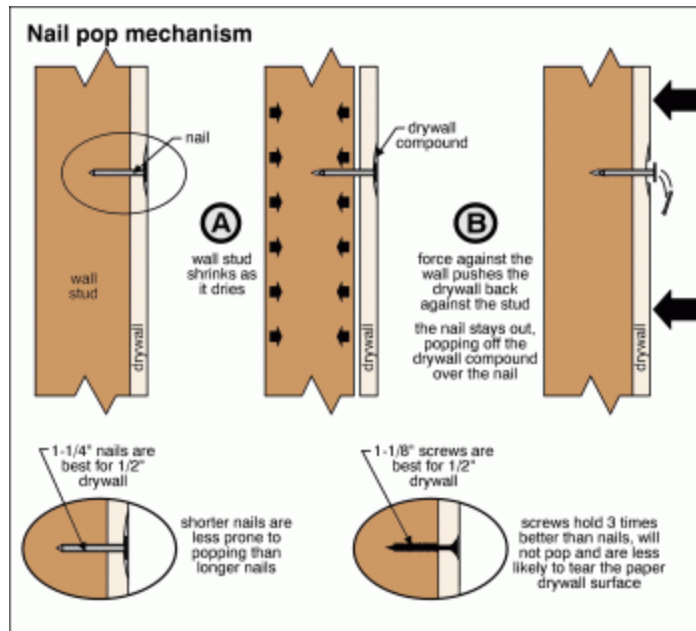
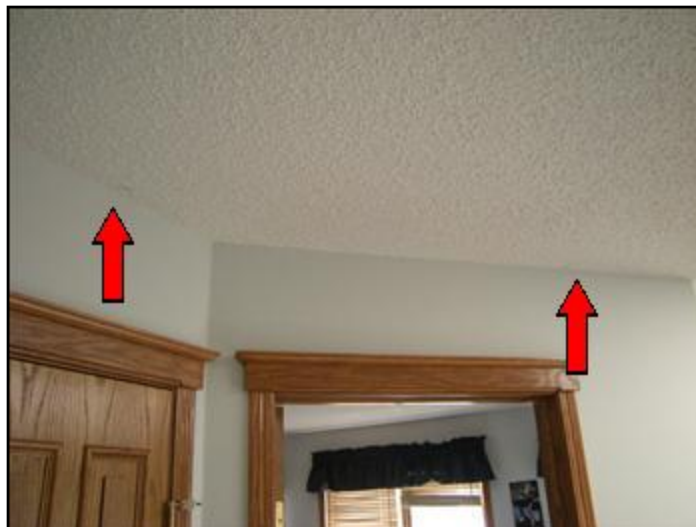
**CEILINGS \ Plaster or drywall**

**Condition:** • [Nail pops](#)

**Implication(s):** Cosmetic defects

**Location:** Second Floor Hall

**Task:** Repair

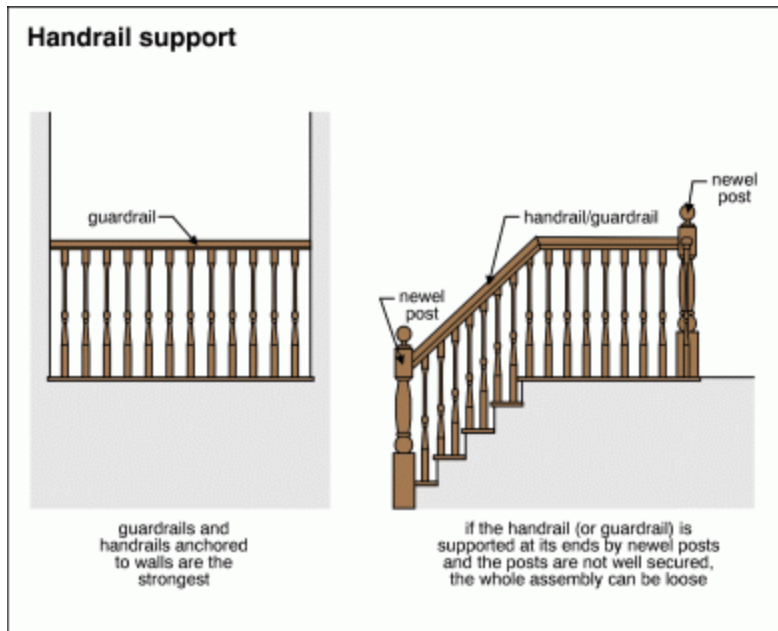
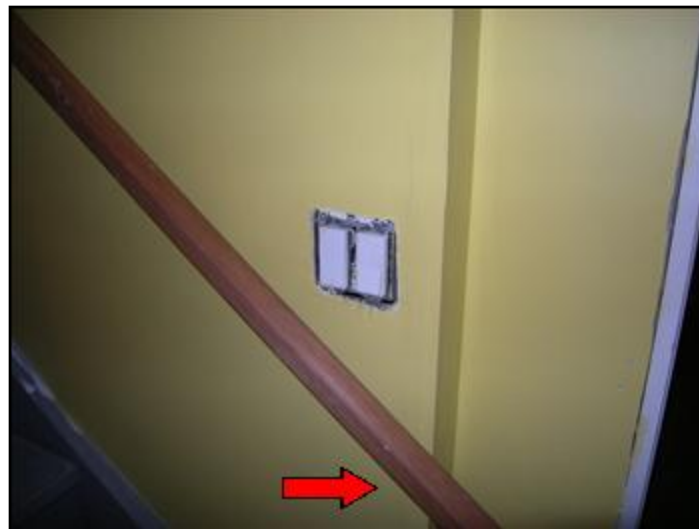
## STAIRS \ Handrails

Condition: • [Loose](#)

Implication(s): Fall hazard

Location: Basement

Task: Correct
