Your Inspection Report

1185 My Street
Wasilla, AK 99655

INSPECTION DATE:
Tuesday, August 4, 2009

RE: Report No. 1008, v.2
1185 My Street
Wasilla, AK
99655

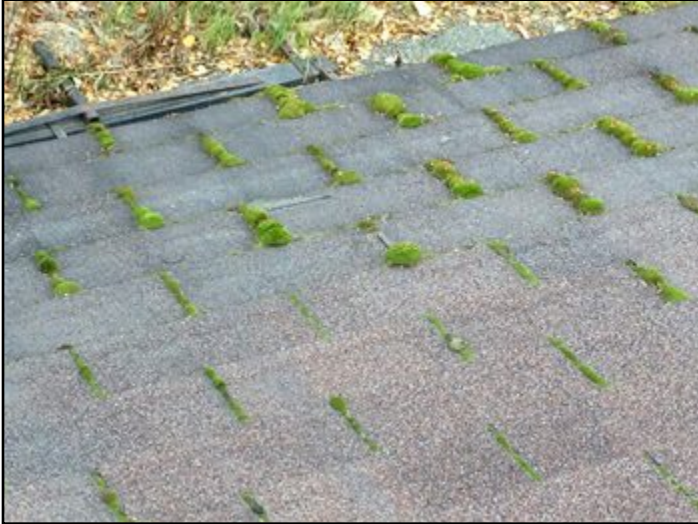
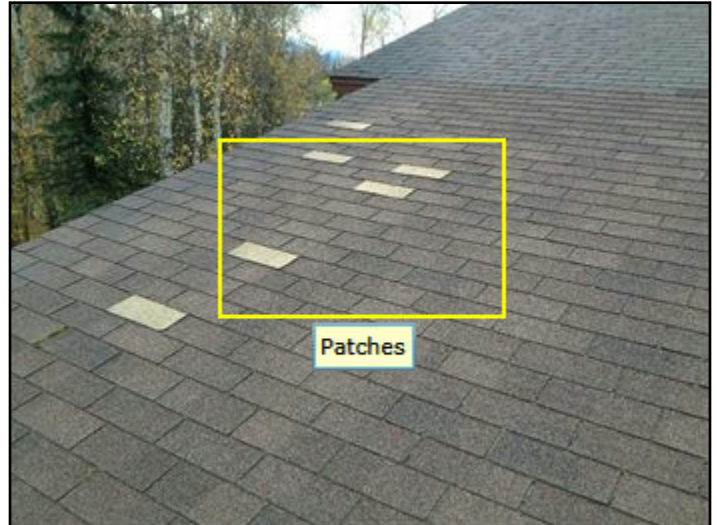
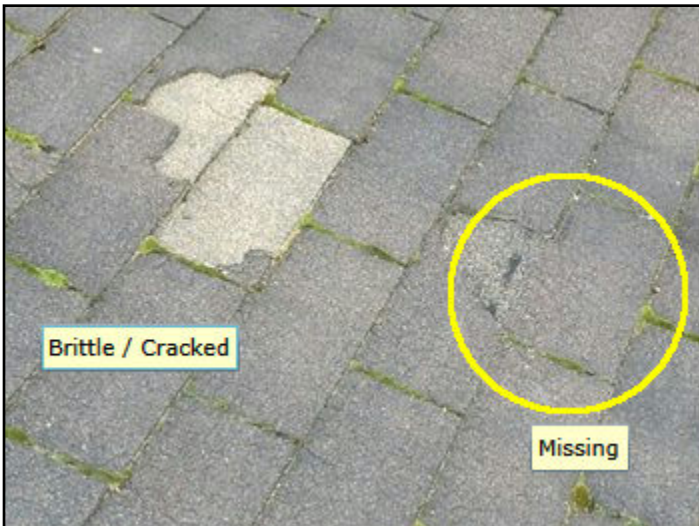
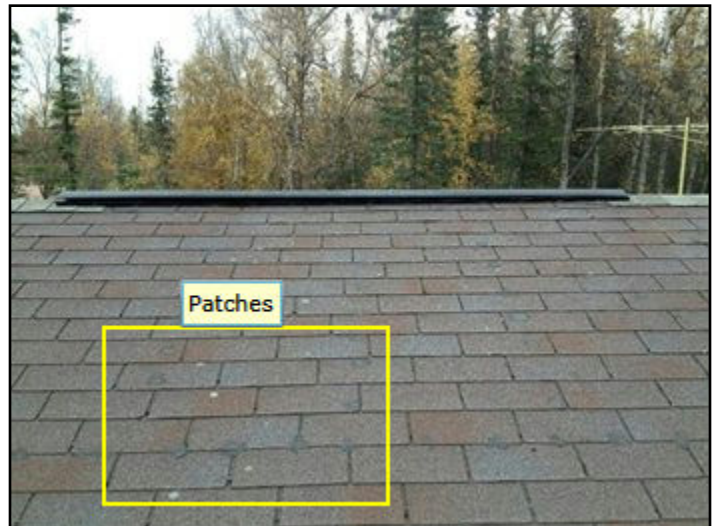
Numerous patches, brittle shingles and cracks. Penetration

Although the roof appears to be functioning well at this time and there was no sign of significant leakage, the roof shingles will probably need to be replaced before long. Owner should be anticipating a major expenditure for reroofing within a few years.

2. Condition: • [Cracked](#)

3. Condition: • [Brittle](#)

Task: Replace

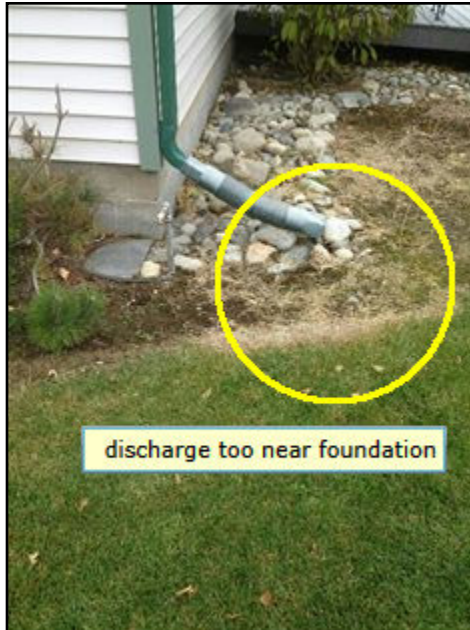
5. Above grade

Downspout discharges above grade too close to the building.

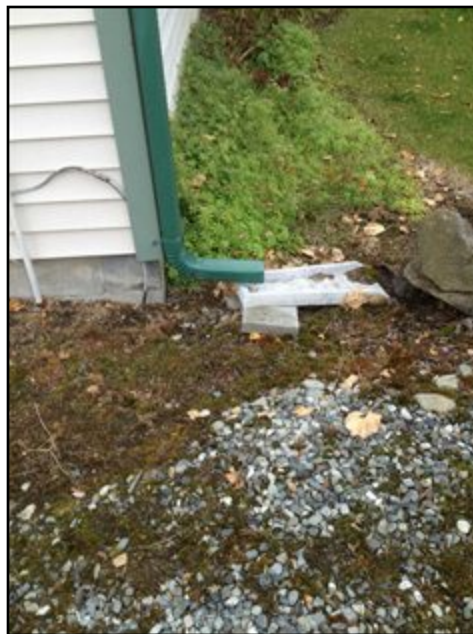
4. Condition: • [Downspouts end too close to building](#)

6. Downspouts end too close to building

5. Condition: • Should discharge 6ft. from home

Task: Improve

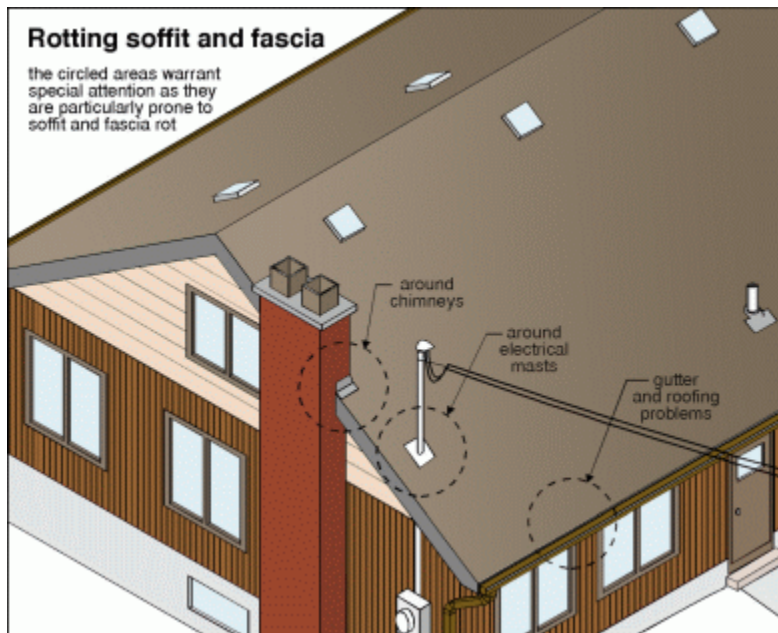
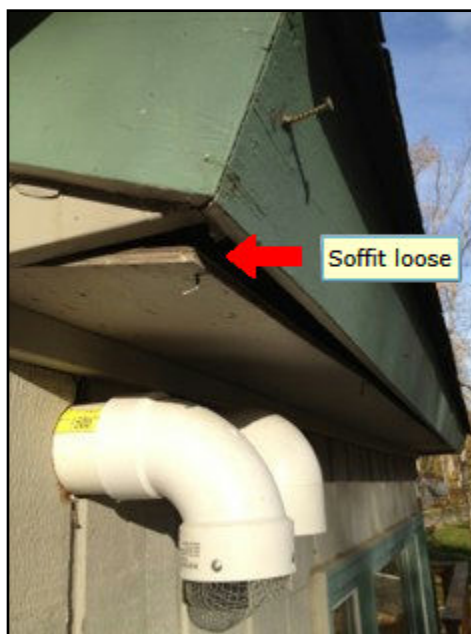
Loose soffit

6. Condition: • [Loose or missing pieces](#)

7. Loose or missing pieces

Task: Repair

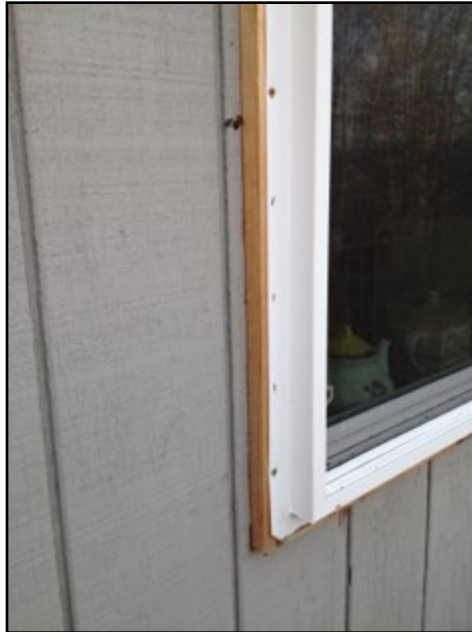
7. Condition: • [Missing](#)

Location: North

8. *Missing*

Task: Install trim around window and caulk.

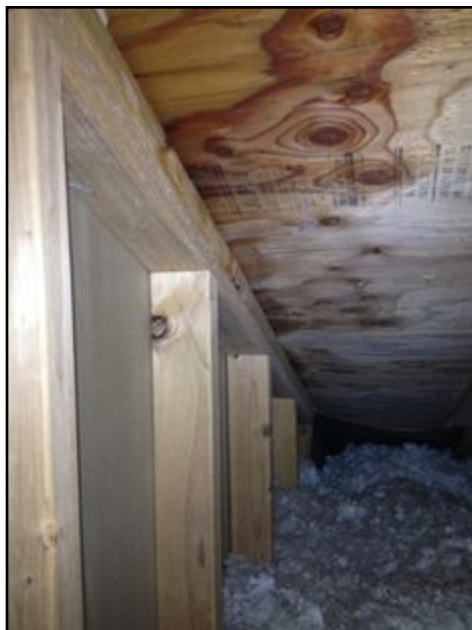
9. Condition: • [Water stains](#)

roof sheathing was wet when inspected

Implication(s): Material deterioration

11. Water stains

Task: Repair

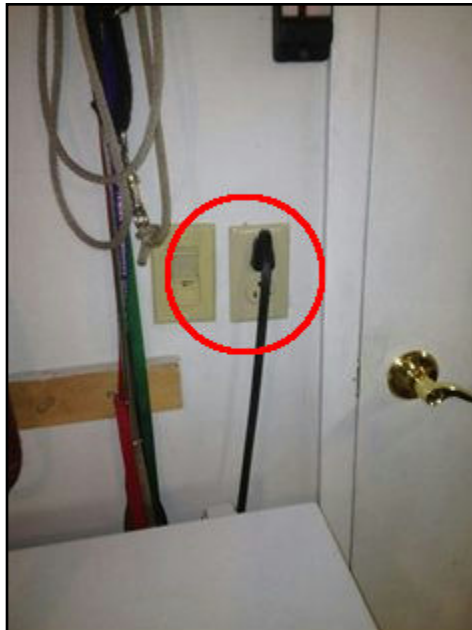
12. No GFCI

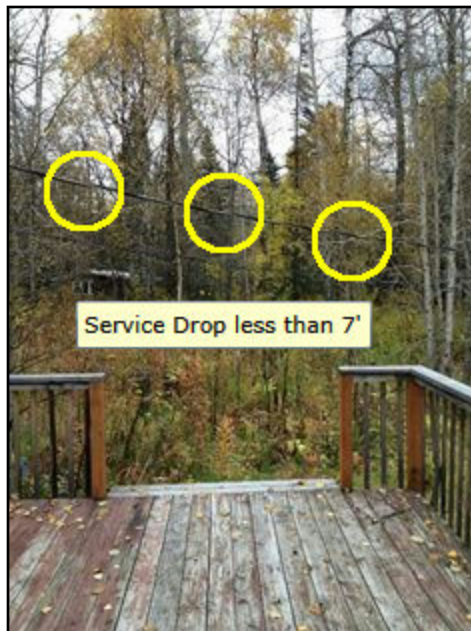
10. Condition: • [Height over walking area](#)

Implication(s): Electric shock

13. Height over walking area

Addition of another pole could possibly fix the problem, but it should be evaluated by an electrician

Task: Further evaluation Upgrade
