Your Inspection Report

82 Dalegrove Cres
Toronto, ON

INSPECTION DATE:
Friday, May 7, 2010

Report No. 9570, v.2
For inspection at:
82 Dalegrove Cres
Toronto, ON

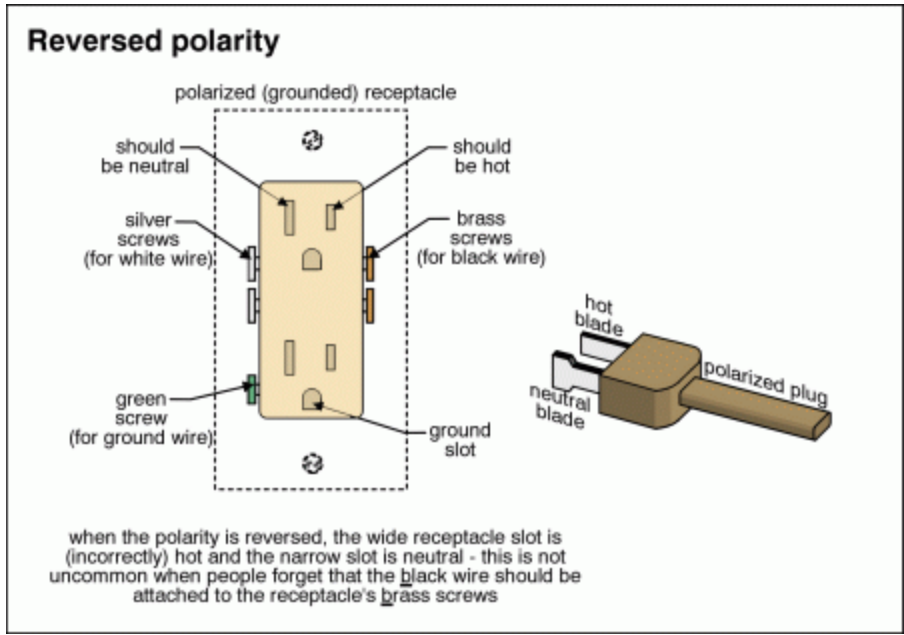
Location: Rear Basement

Condition: • [Reversed polarity - black & white wires reversed \(5.2.4\)](#)

Task: Correct
