# Your Inspection Report

Sample Street  
Atlanta, GA

**INSPECTION DATE:**  
Tuesday, December 18, 2012

Report No. 4455

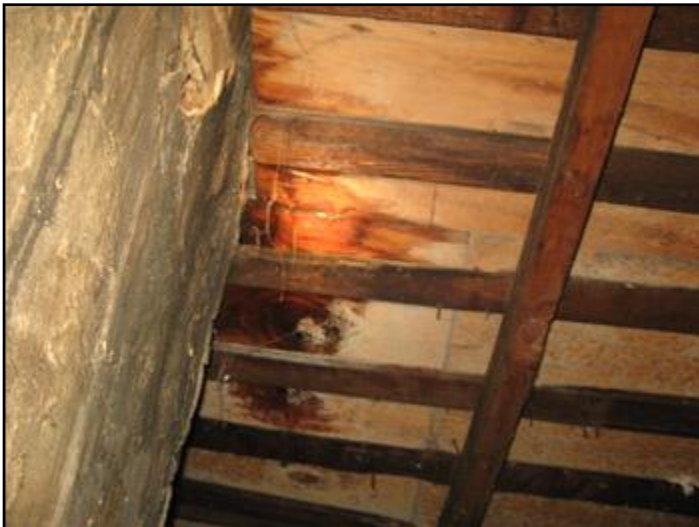
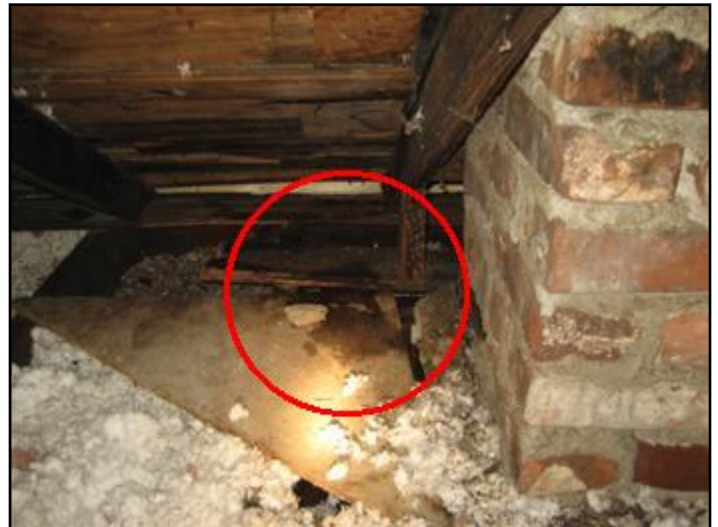
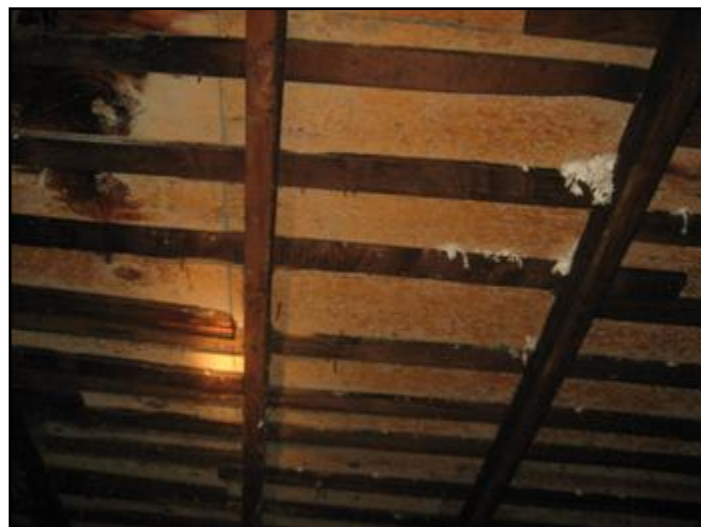
**Condition:** • [Leak](#)

**Implication(s):** Chance of water damage to contents, finishes and/or structure

**Location:** Attic at Chimneys

**Task:** Correct

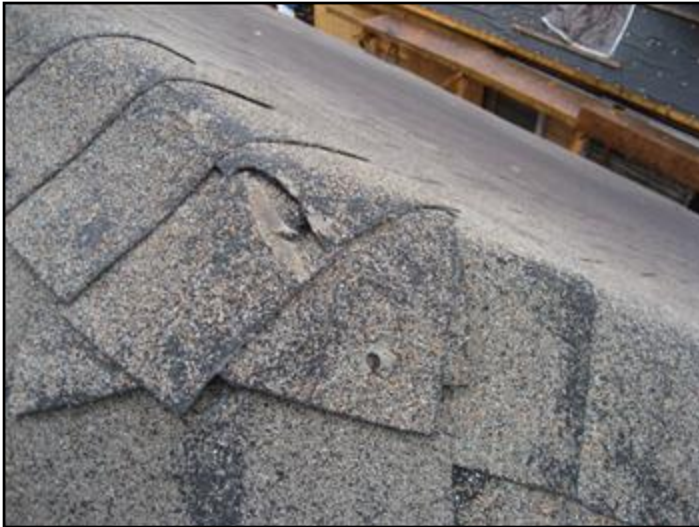
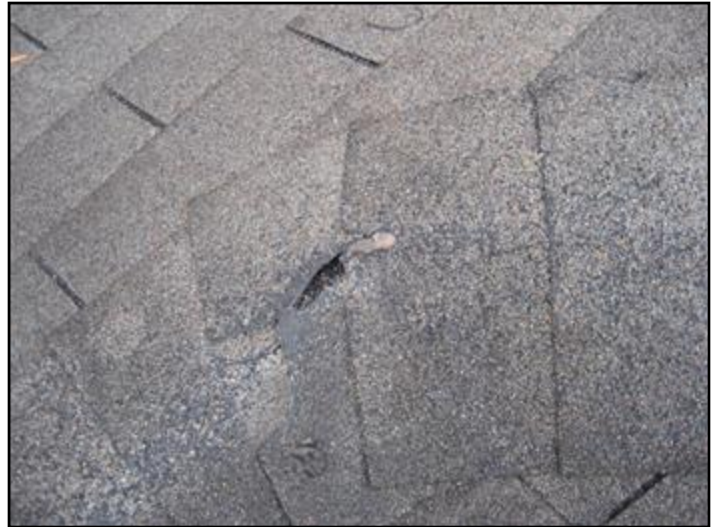
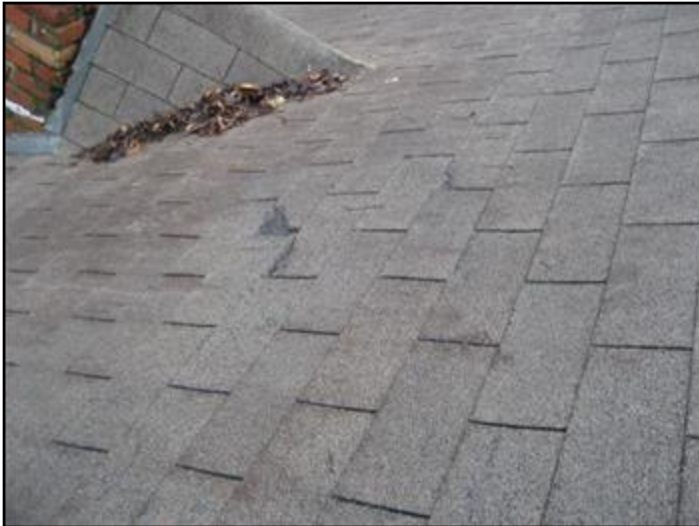
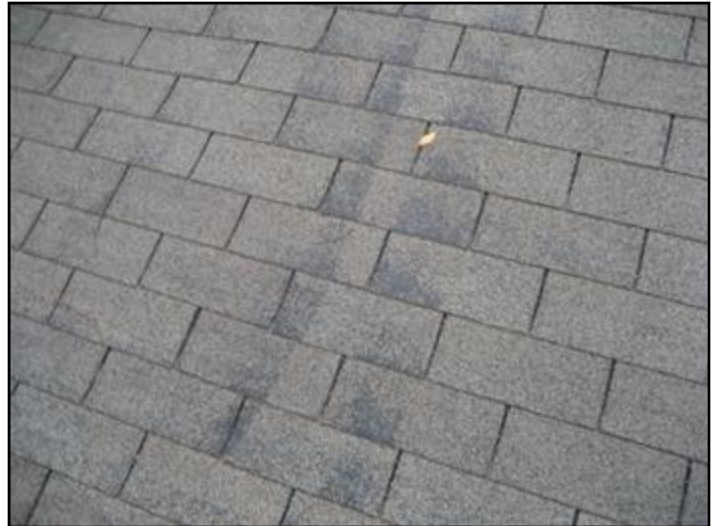
**Condition:** • [Old, worn out](#)

**Implication(s):** Chance of water damage to contents, finishes and/or structure

**Location:** Throughout Exterior Roof

**Task:** Replace

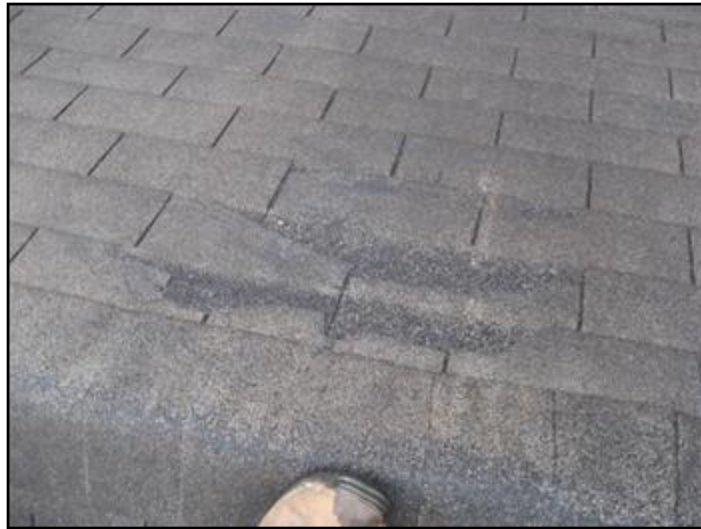
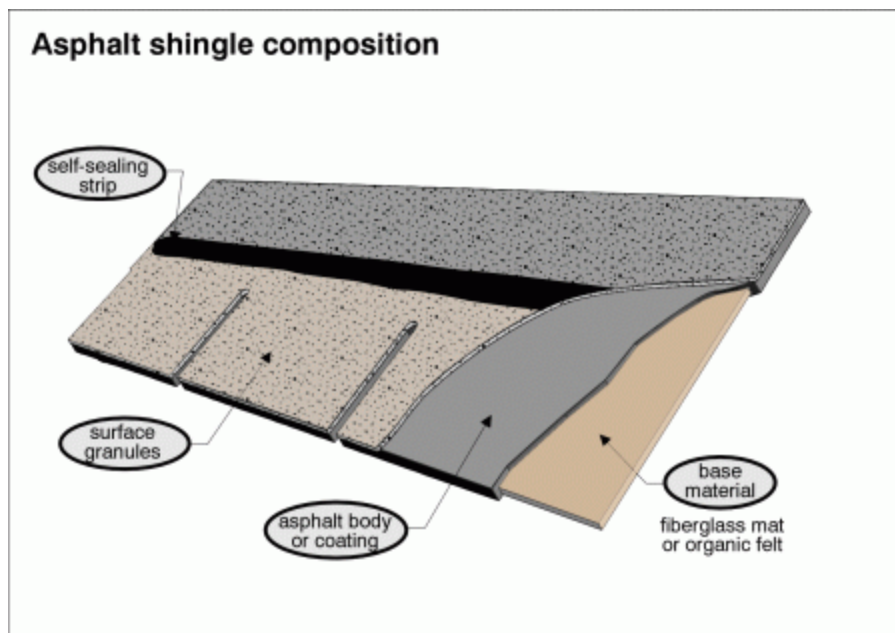
**Condition:** • [Granule loss](#)

**Implication(s):** Chance of water damage to contents, finishes and/or structure

**Location:** Throughout Exterior Roof

**Task:** Replace

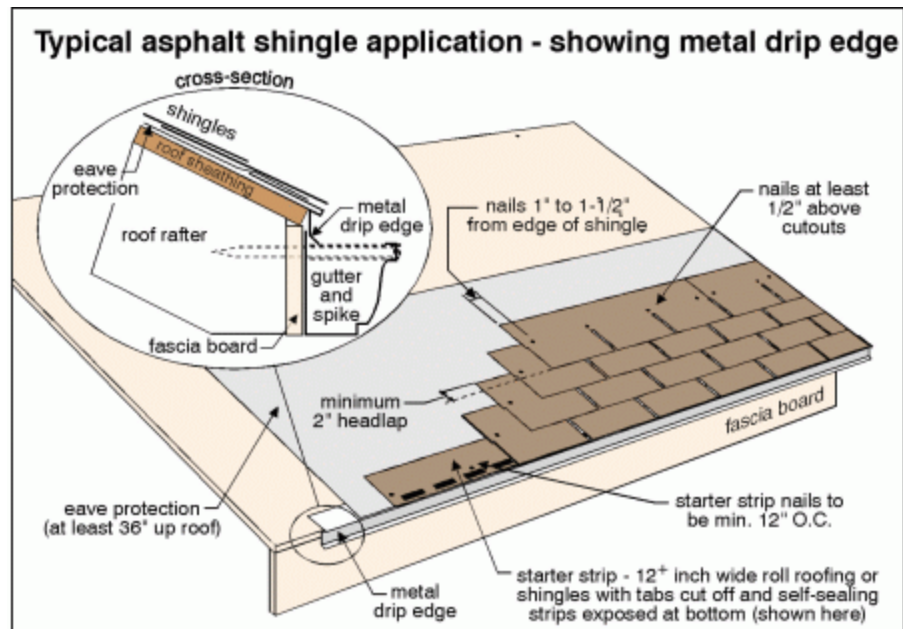
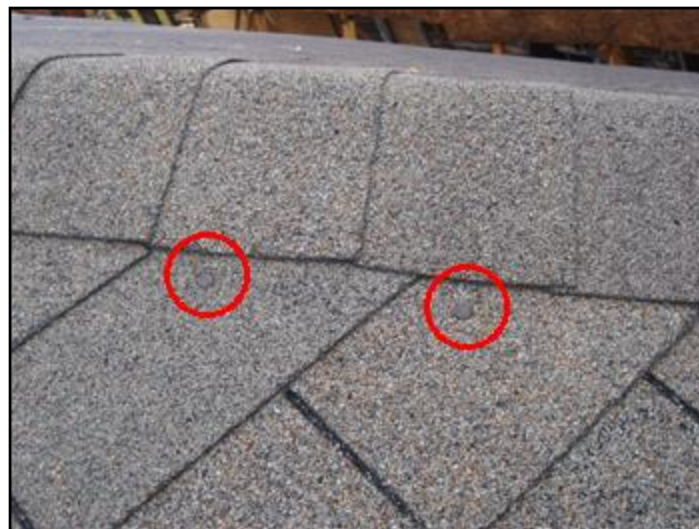
**Condition:** • [Exposed fasteners](#)

**Implication(s):** Chance of water damage to contents, finishes and/or structure

**Location:** Throughout Exterior Roof

**Task:** Correct

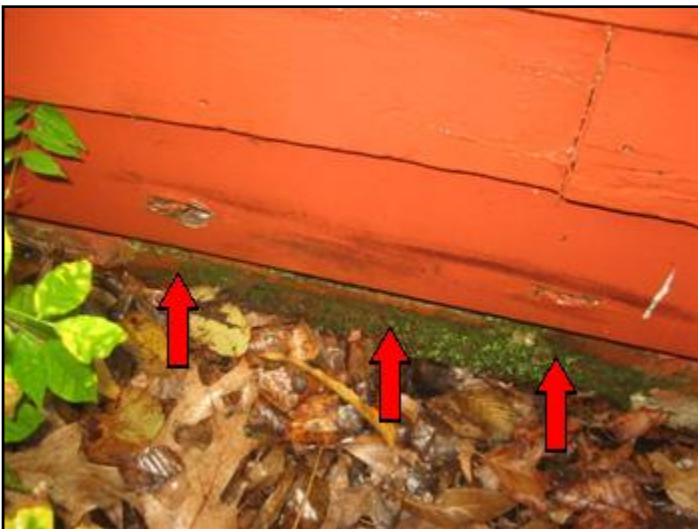
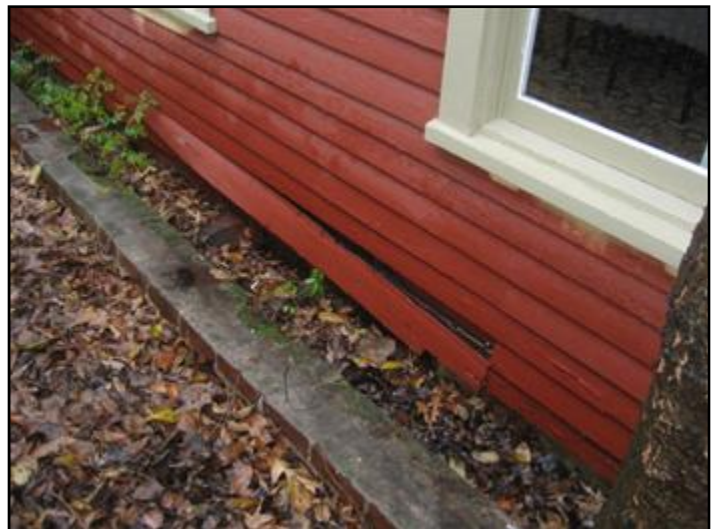
Condition: • [Rot or insect damage](#)

Implication(s): Cosmetic defects | Chance of water damage to contents, finishes and/or structure | Material deterioration

Location: Left Side Exterior Wall

Task: Repair or replace

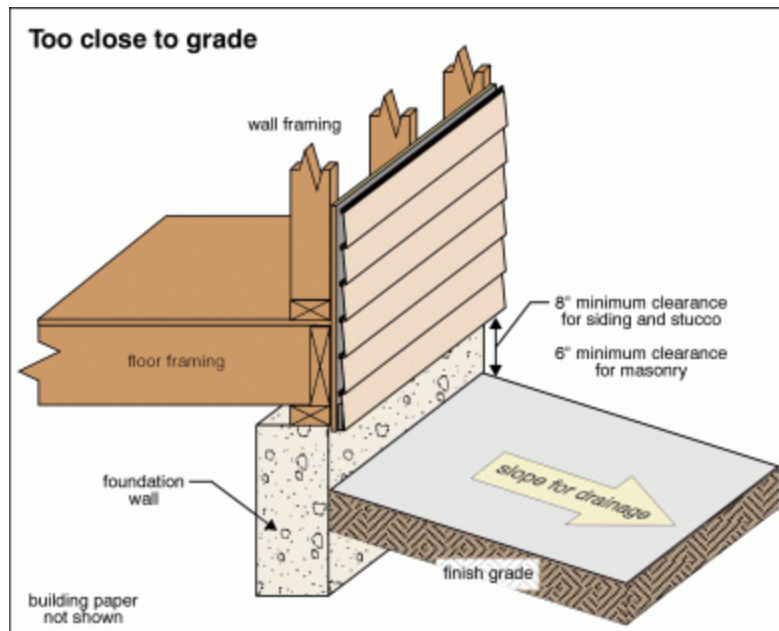
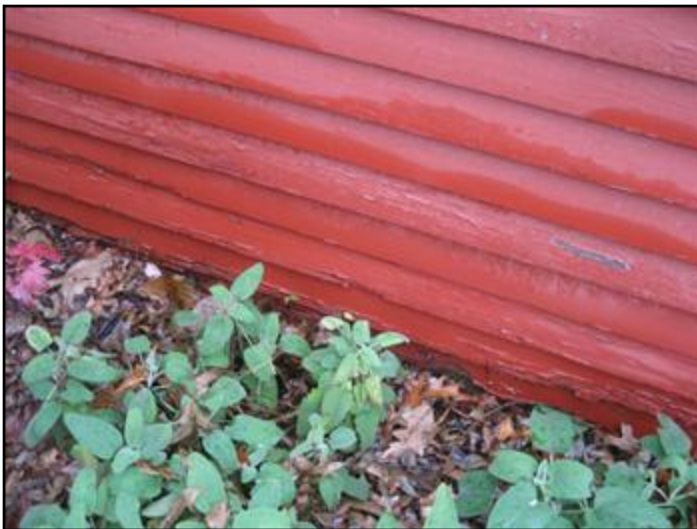
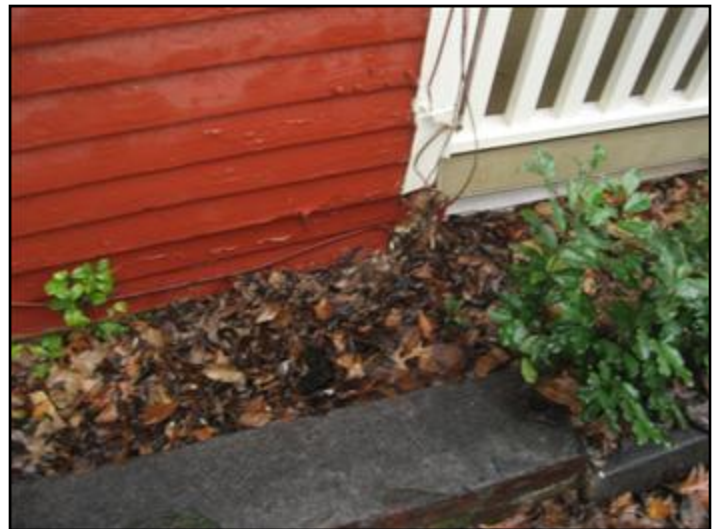
**Condition:** • [Too close to grade](#)

**Implication(s):** Chance of water damage to contents, finishes and/or structure | Material deterioration | Rot | Insect damage

**Location:** Left Side Exterior Wall

**Task:** Improve

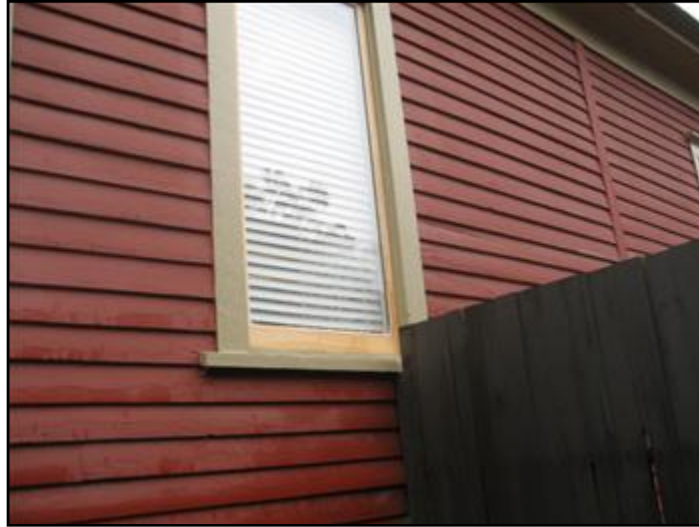
**Condition:** • [Paint or stain needed](#)

**Implication(s):** Chance of water damage to contents, finishes and/or structure | Material deterioration

**Location:** Right Side Exterior Master Bathroom

**Task:** Provide

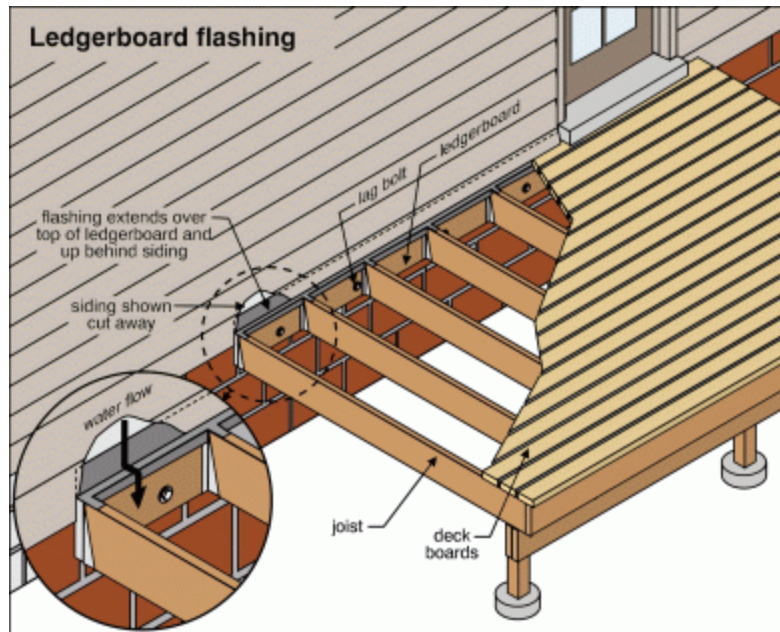
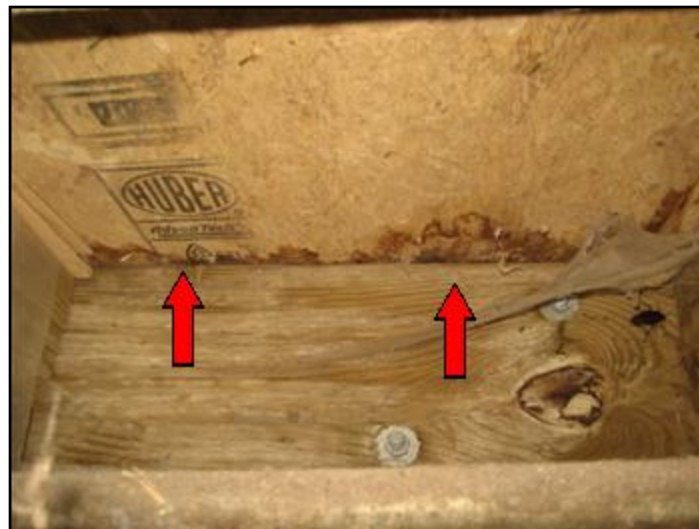
**Condition:** • [Ledgerboard problems](#)

**Implication(s):** Weakened structure | Chance of movement

**Location:** Rear Exterior Deck

**Task:** Improve

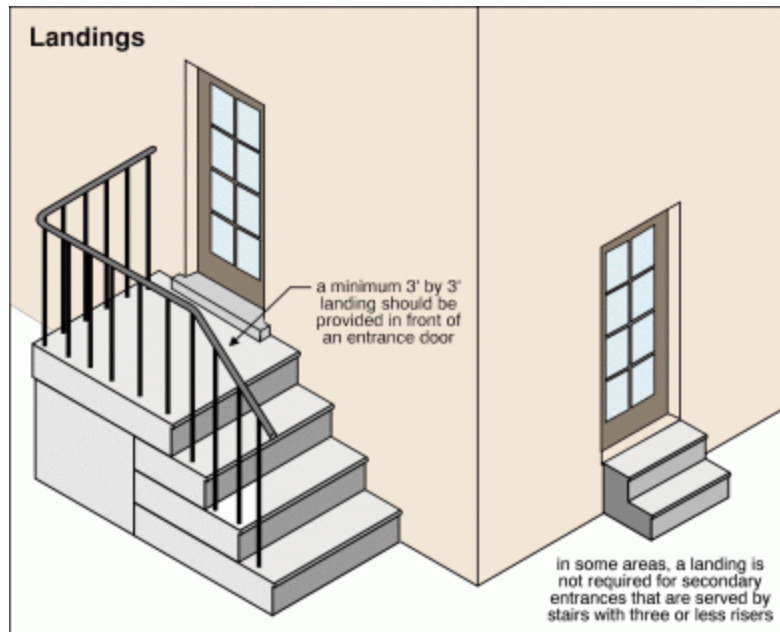
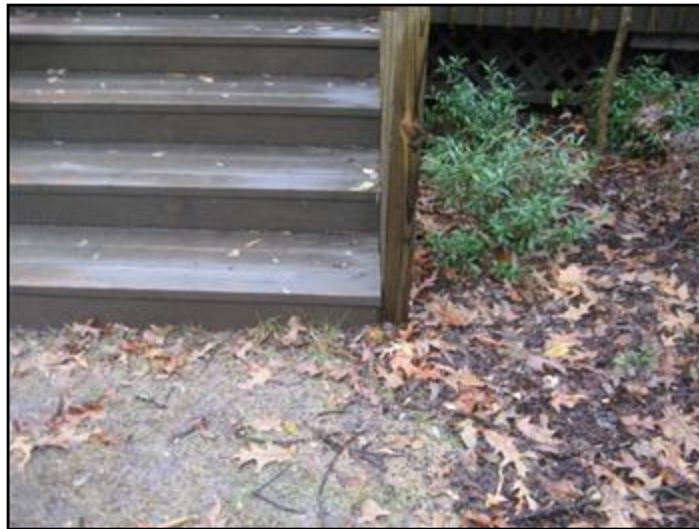
**Condition:** • [Landings missing or undersized](#)

**Implication(s):** Trip or fall hazard

**Location:** Rear Exterior Deck

**Task:** Provide

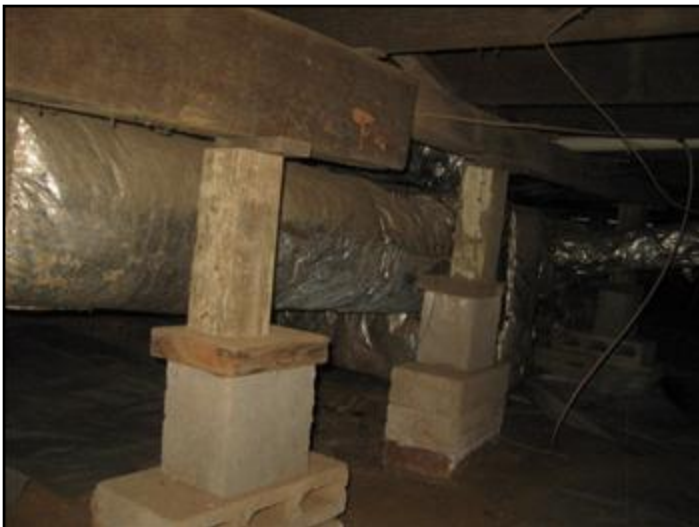
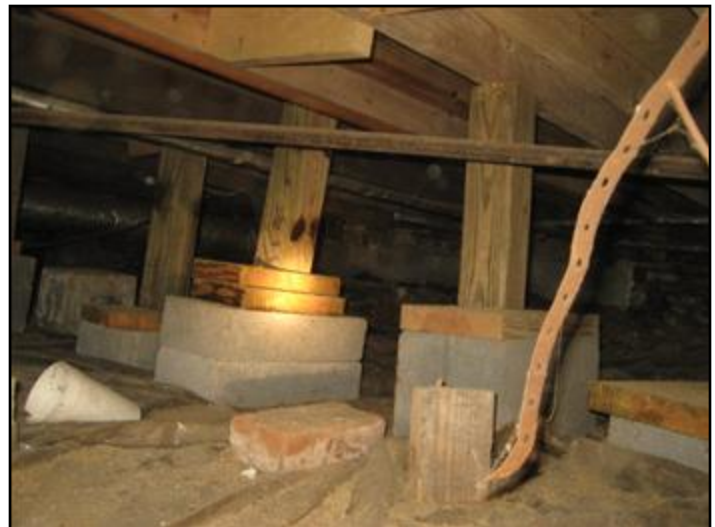
**Condition:** • There are multiple temporary supports installed in the crawlspace that should be replaced with permanent supports.

**Location:** Throughout Crawl Space

Recommend consulting a qualified framing contractor to determine best approach to remedying the support issues in the crawlspace.

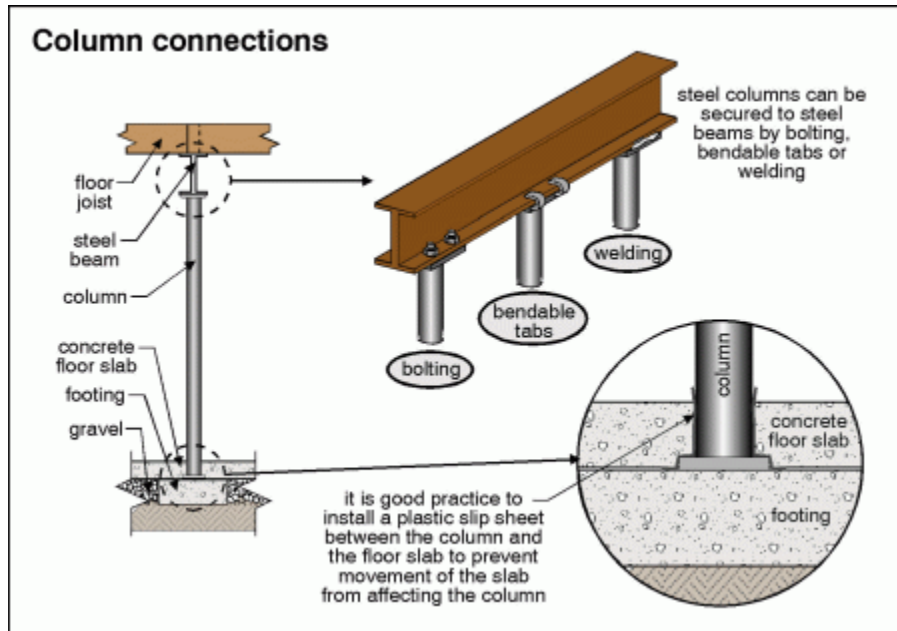
**Condition:** • [Poorly secured at top or bottom](#)

**Implication(s):** Weakened structure | Chance of structural movement

**Location:** Throughout Crawl Space

**Task:** Improve

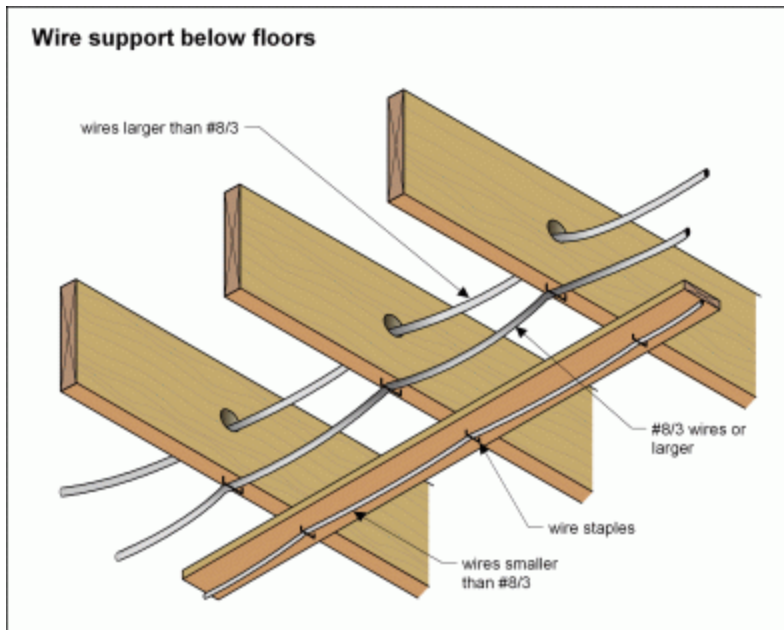
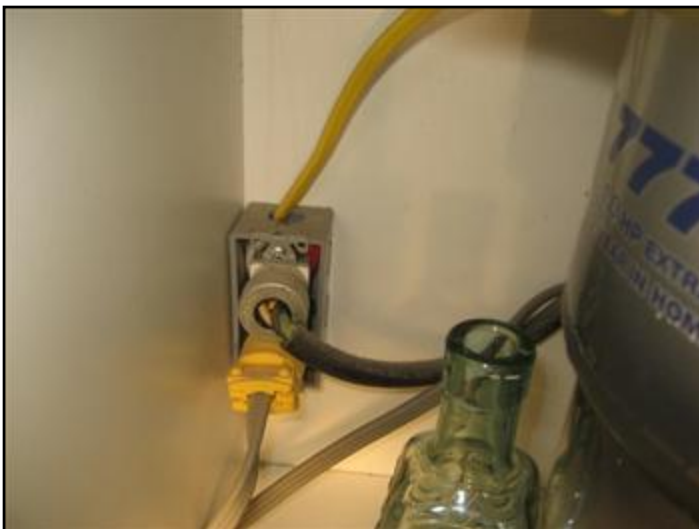
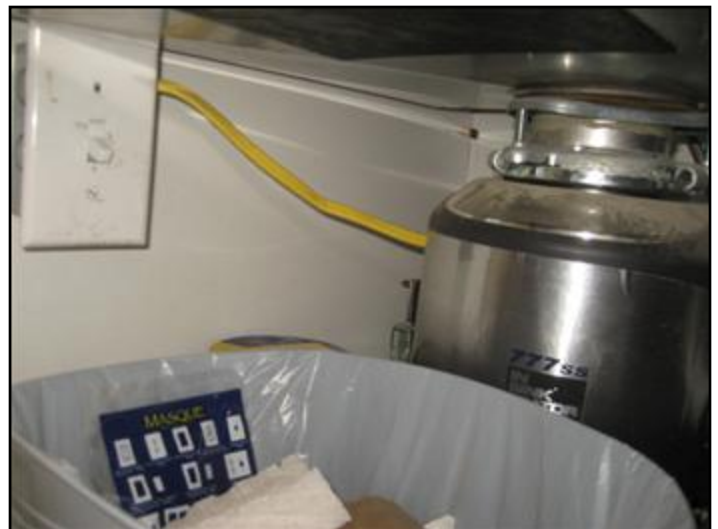
**Condition:** • [Exposed on walls or ceilings](#)

**Implication(s):** Electric shock

**Location:** Under Kitchen Sink

**Task:** Improve

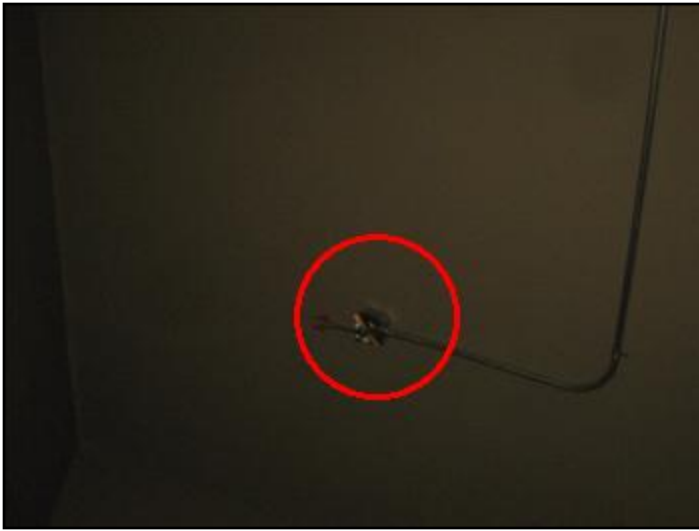
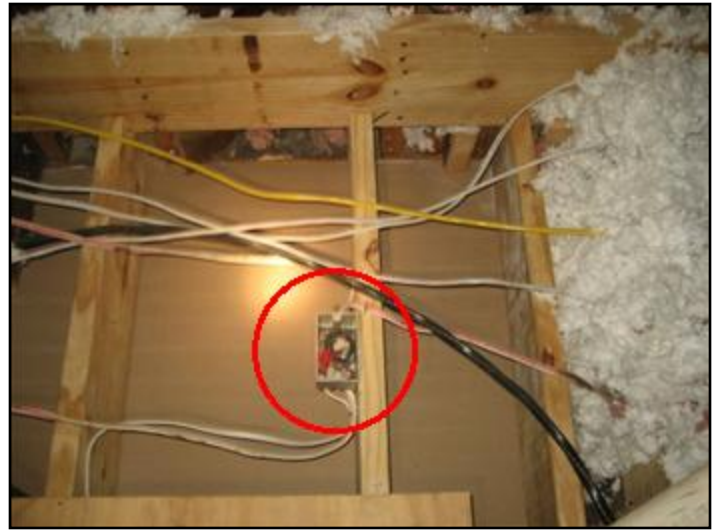
**Condition:** • [Cover loose or missing](#)

**Implication(s):** Electric shock | Fire hazard

**Location:** Throughout Attic

**Task:** Correct

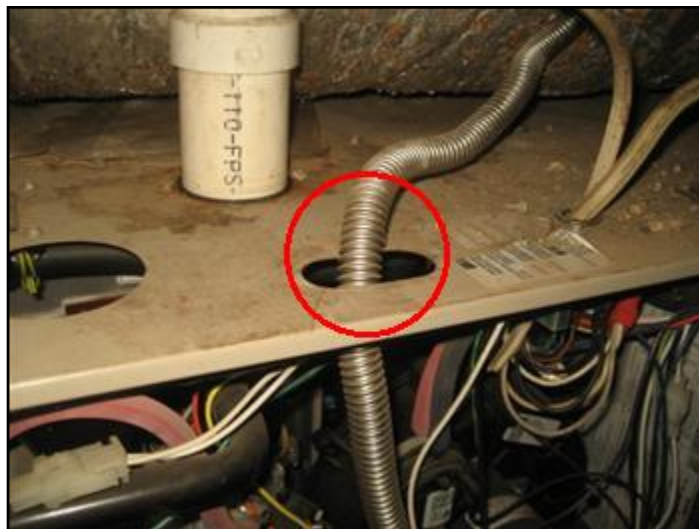
**Condition:** • [Inappropriate materials](#)

Insuflex piping is going through the furnace cabinet.

**Implication(s):** Equipment not operating properly | Fire or explosion

**Location:** Crawl Space

**Task:** Correct

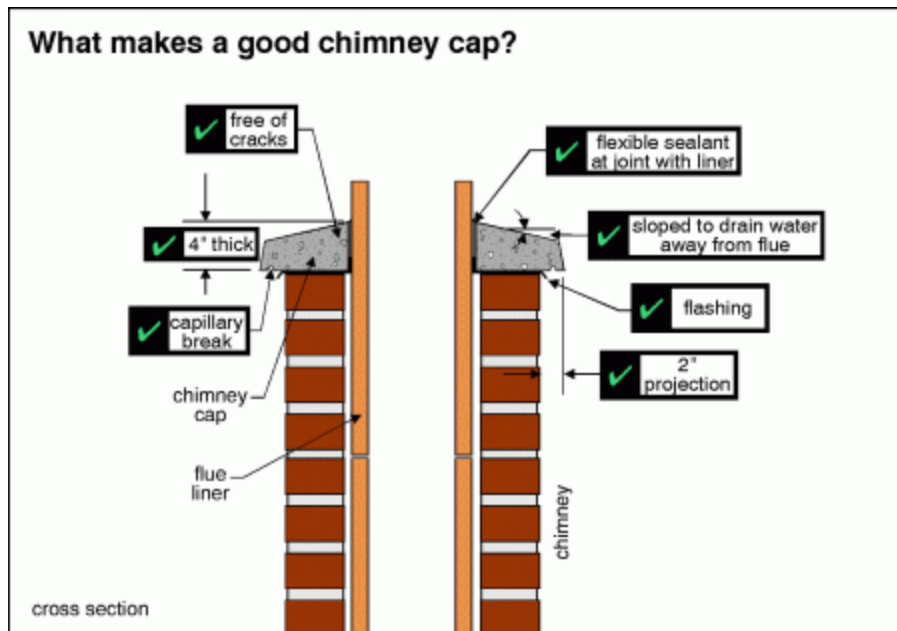
**Condition:** • [Improper slope on cap](#)

**Implication(s):** Shortened life expectancy of material | Material deterioration

**Location:** Exterior Roof

**Task:** Improve

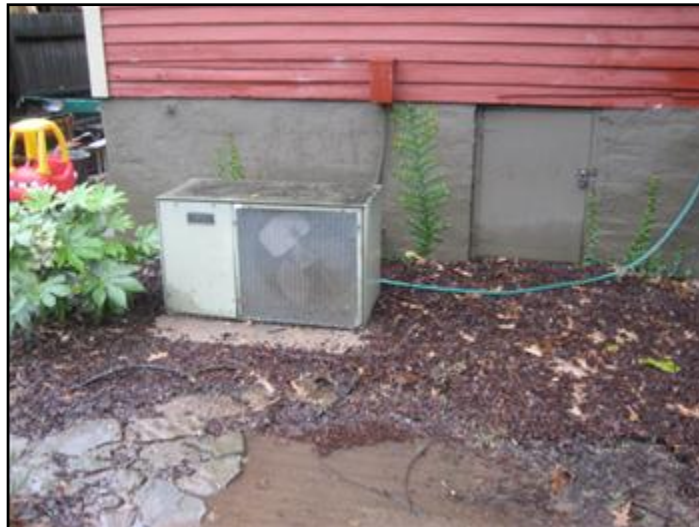
**Air conditioning type:** • [Air cooled](#)

**Compressor approximate age:** • 20+ Years Old • 20+ Years Old

**Typical life expectancy:** • 10 to 15 years

**Failure probability:** • [High](#)

**Condition:** • [Old](#)

**Implication(s):** Equipment failure | Reduced comfort

**Task:** Replace

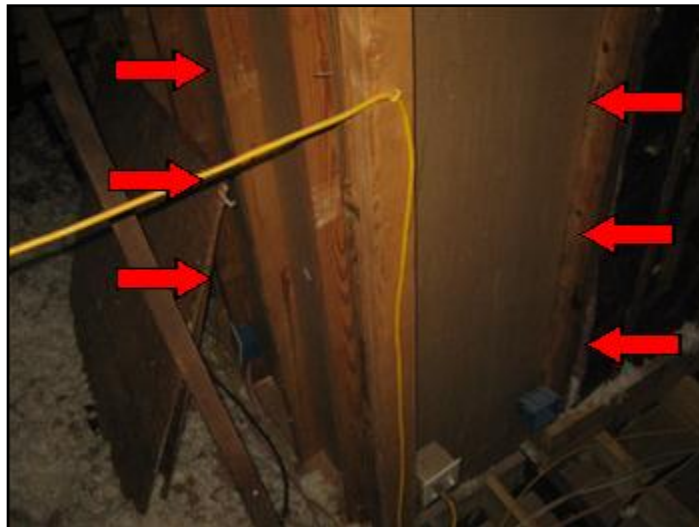
**Condition:** • [Gaps or voids](#)

Section around the kitchen walls and area over laundry room.

**Implication(s):** Increased heating and cooling costs | Reduced comfort

**Location:** Attic Kitchen

**Task:** Provide

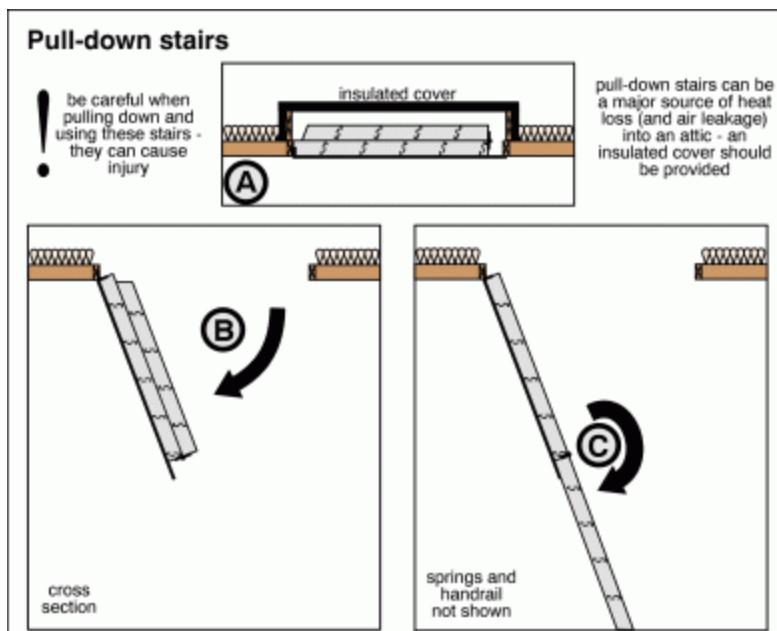
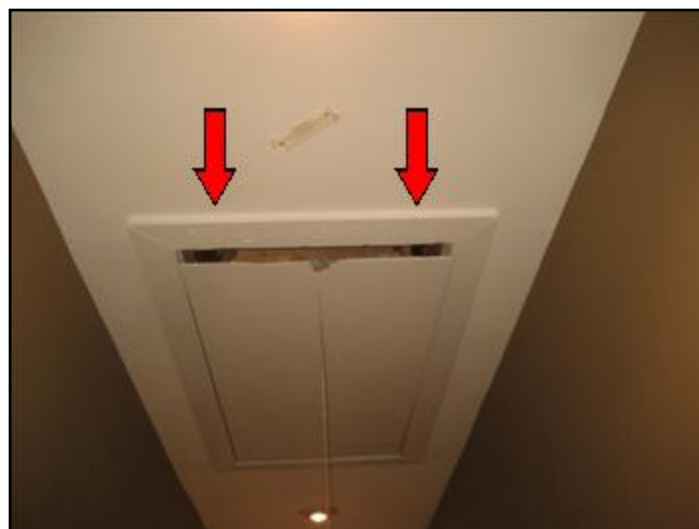
**Condition:** • [Not weatherstripped](#)

**Implication(s):** Chance of condensation damage to finishes and/or structure | Increased heating and cooling costs | Reduced comfort

**Location:** Attic

**Task:** Correct

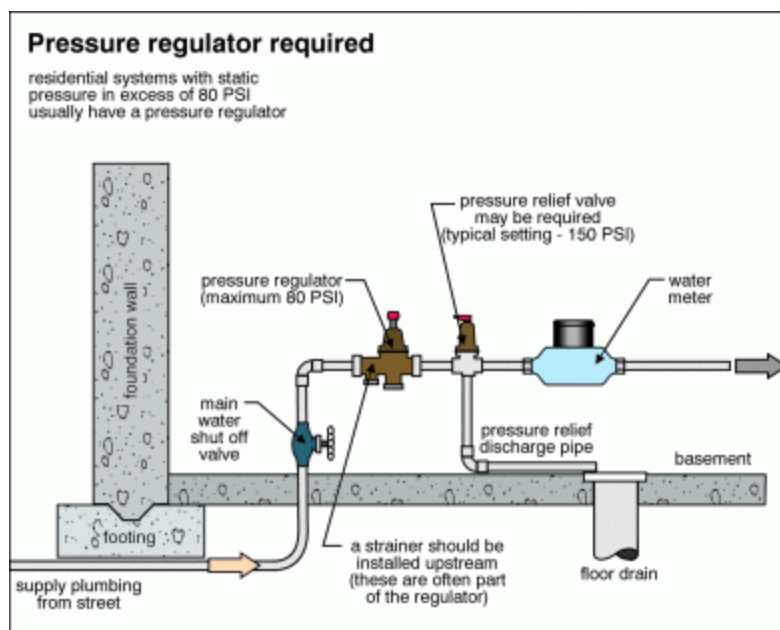
**Condition:** • [Missing](#)

**Implication(s):** Chance of water damage to contents, finishes and/or structure | Leakage | Damage to equipment

**Location:** Crawl Space

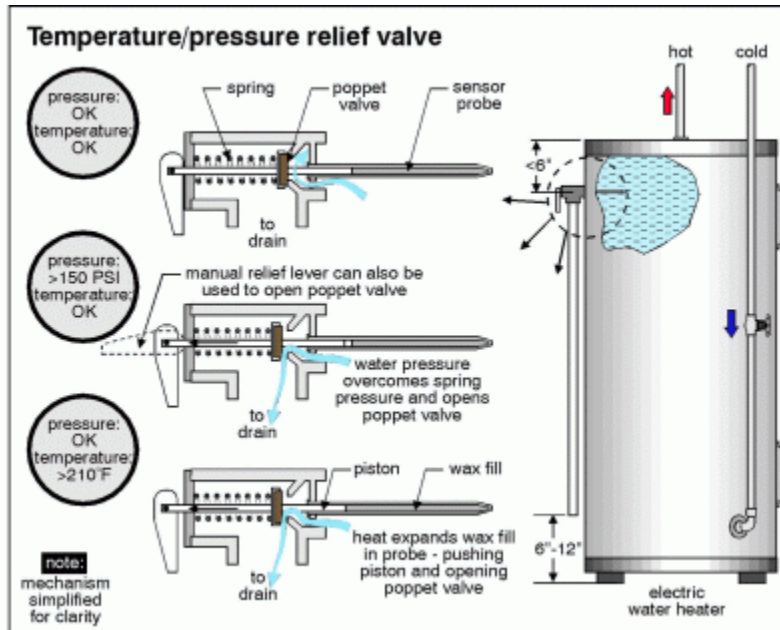
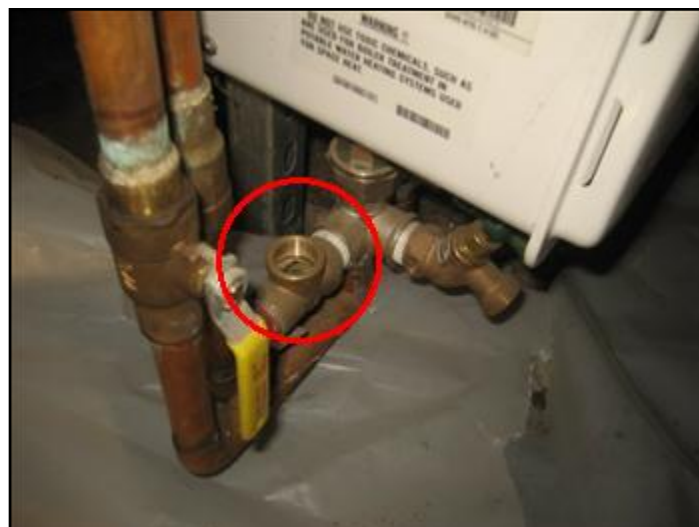
**Condition:** • [Discharge tube missing](#)

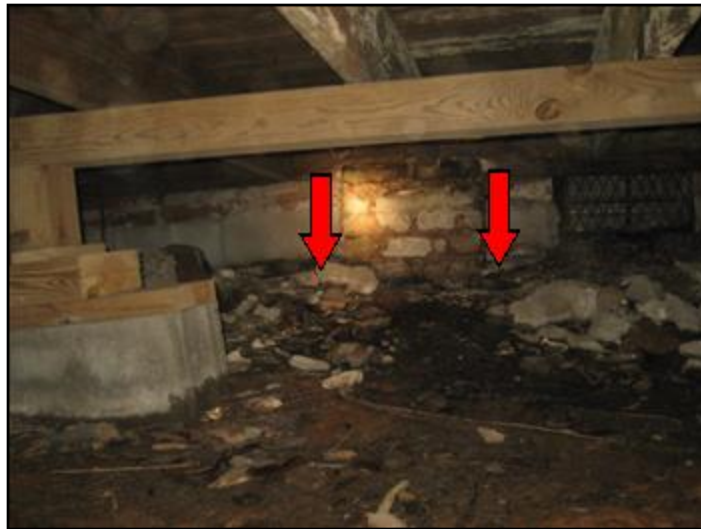
**Evidence of crawlspace leakage:**

- Present
- Water

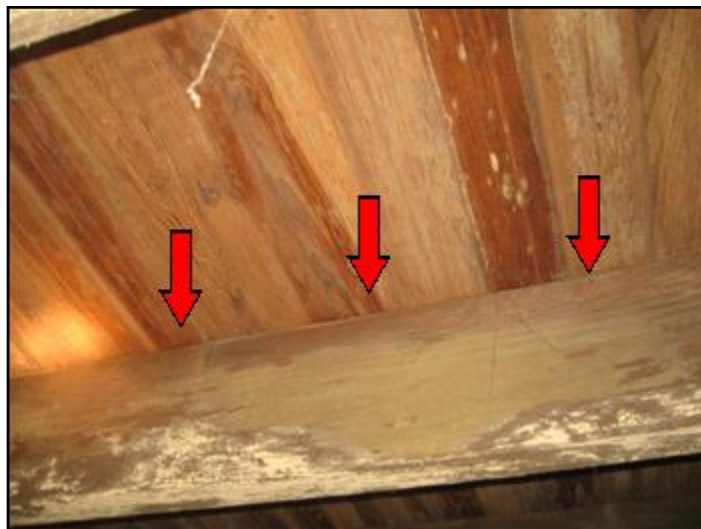
- Mold

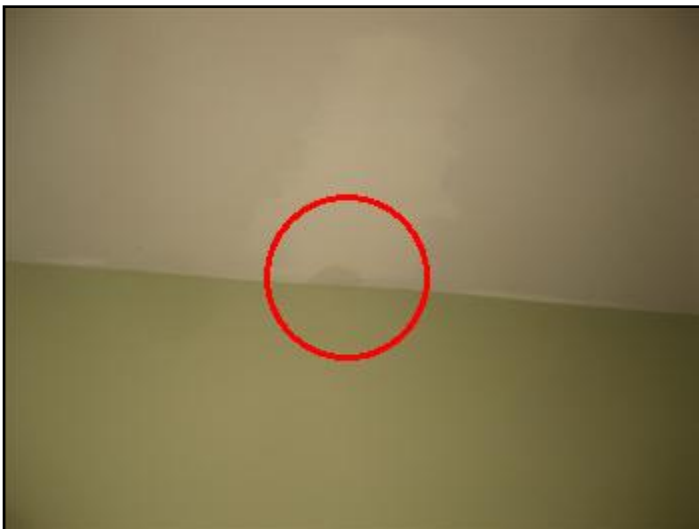
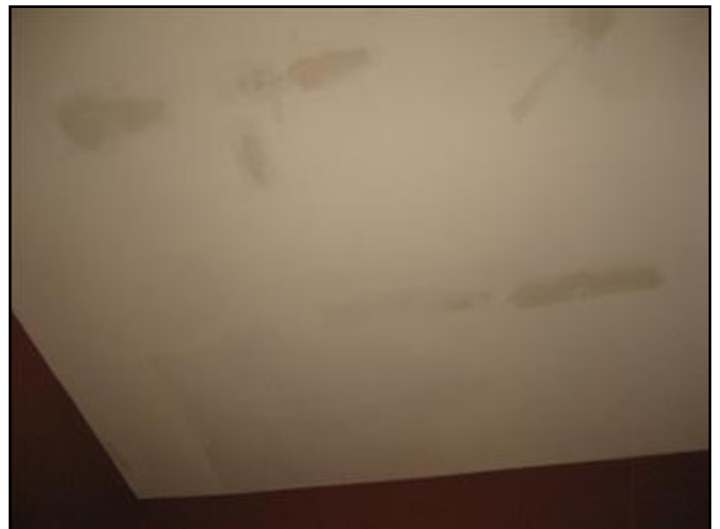
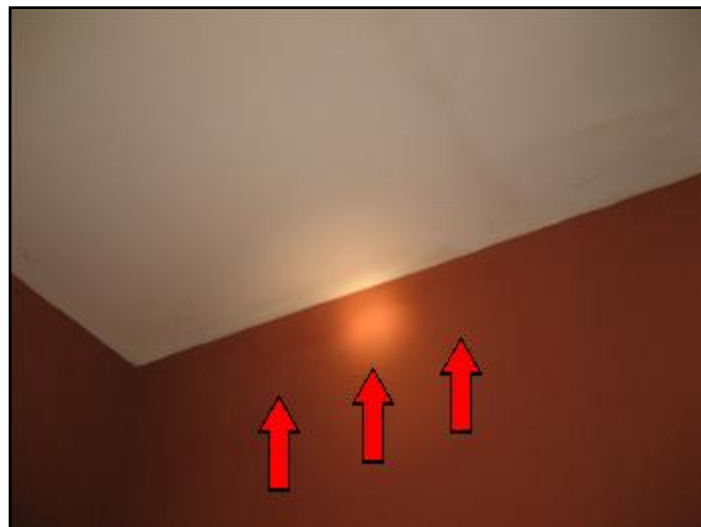
**Condition:** • Stains

Water stains present in front and middle bedrooms from leaks at the chimney in this area. Painting has been done in these areas to conceal stains.

**Implication(s):** Cosmetic defects

**Location:** Front Bedroom

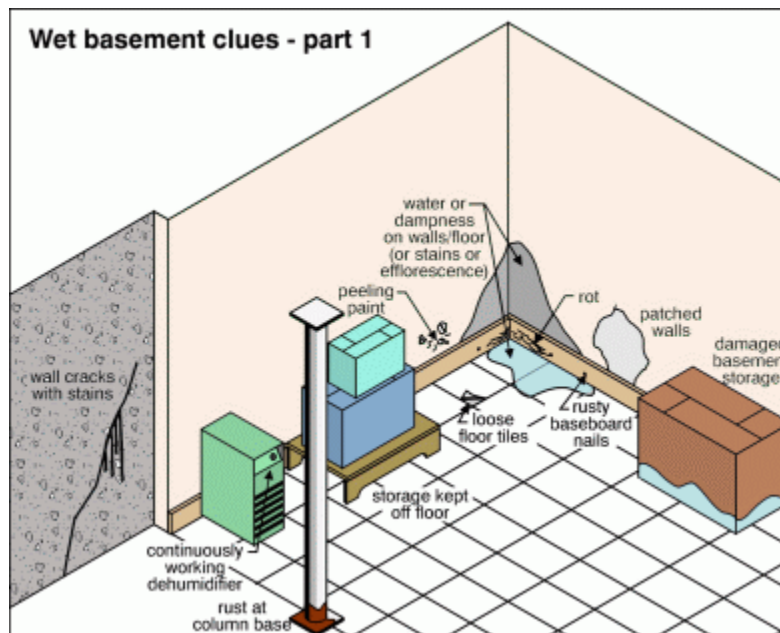
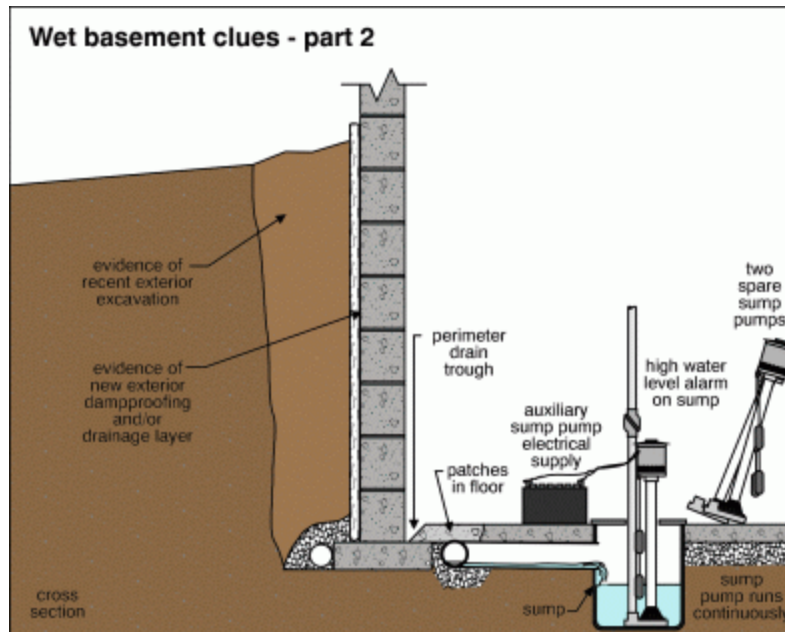
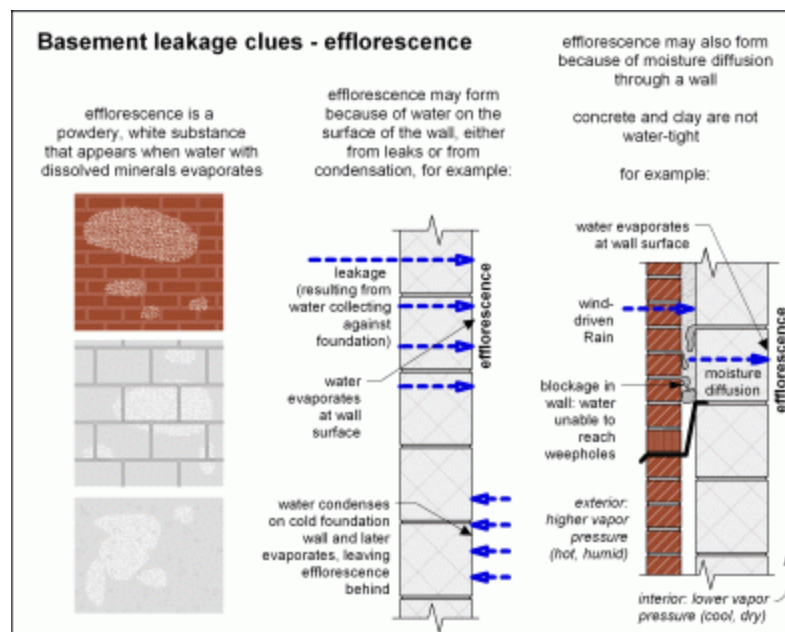
**Condition:** • [Efflorescence](#)

**Implication(s):** Cosmetic defects | Chance of water damage to contents, finishes and/or structure
