INSPECTION REPORT

For the Property at:
123 YOUR ST.
NIAGARA REGION, ON

Prepared for: HOLMES BUYER
Inspection Date: Wednesday, February 7, 2007
Prepared by: Mark Diplock

RE: Report No. 1055
123 Your St.
Niagara Region, ON

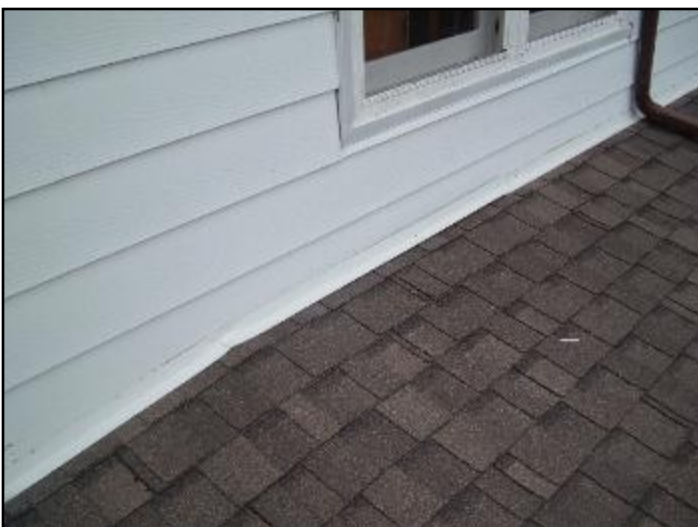
Note: The main roof is in good repair. The roof wall flashings on the back of the home are either missing or installed improperly. These should be repaired immediately in order to prevent the possibility of water damage to the interior of the home.

1. improper installation/open at top

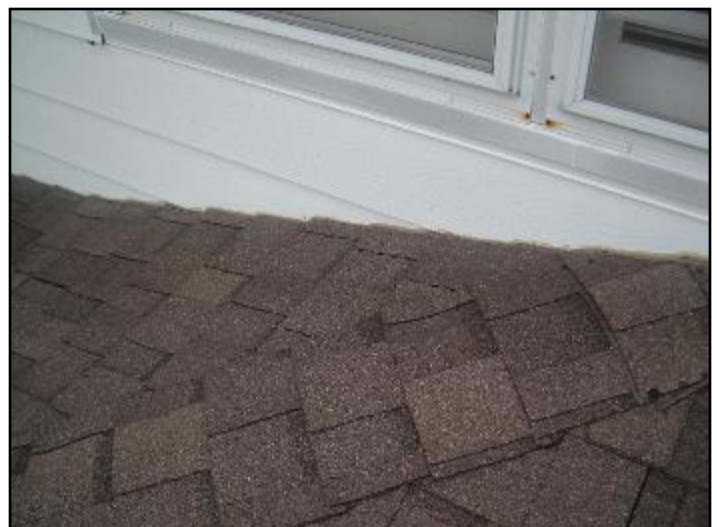
2. missing flashing

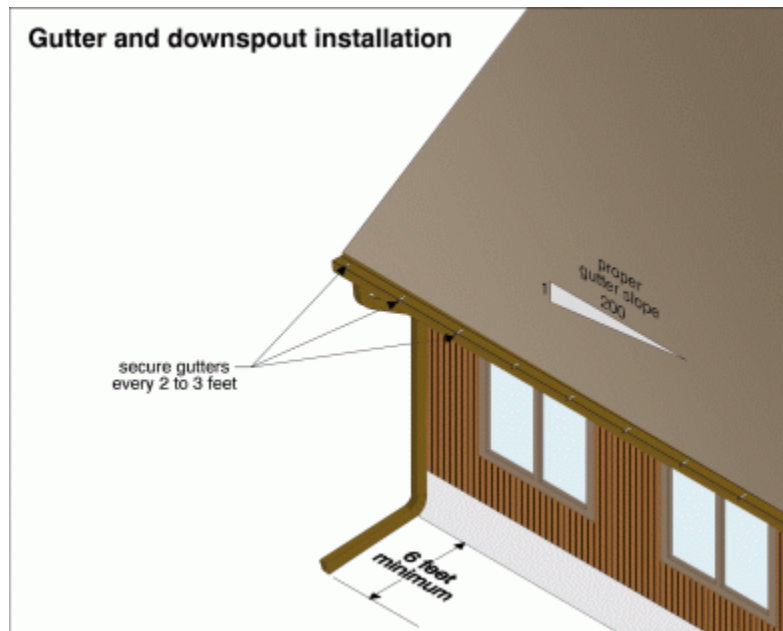
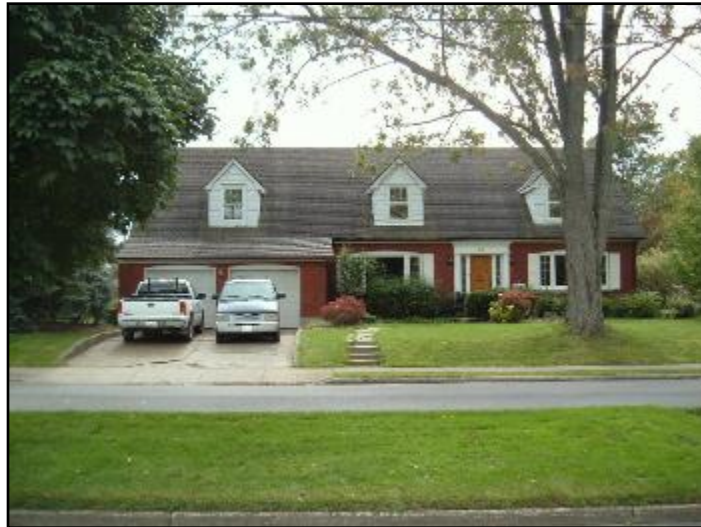
Condition: • [Missing](#)

3. Dormers need gutters

Note: Gutters and downspouts need to be added to dormer roofs. Although not aesthetically pleasing some people, it will prevent wear and costly repairs to the roof.

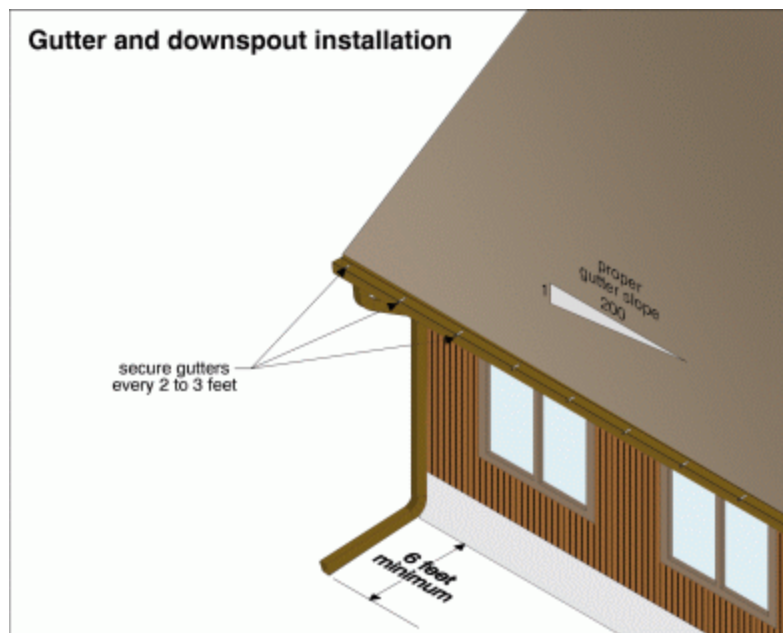
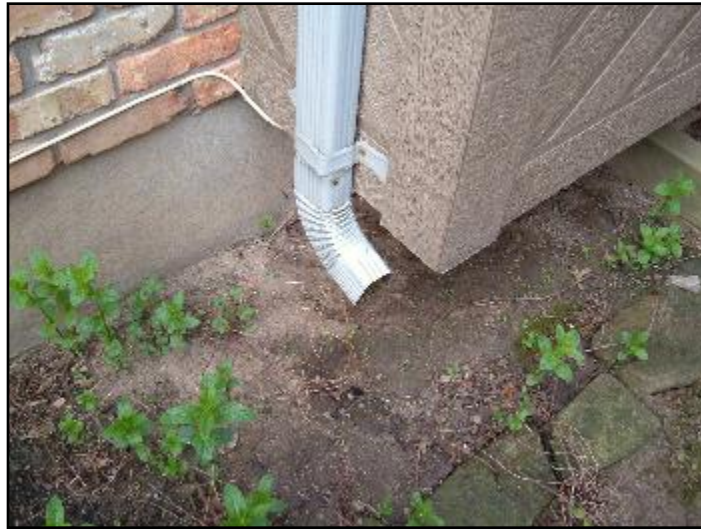
Condition: • [Downspouts end too close to building](#)

Note: Downspouts should be extended at least 6' from building to prevent water buildup near foundation.

4. *Extend downspout 6'*

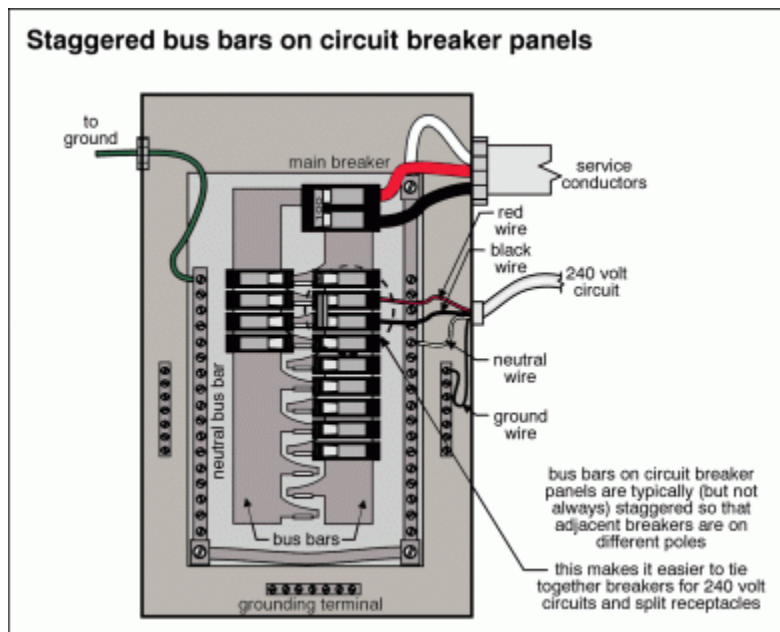
Condition: • [Breaker bridge missing](#)

Note: One of the breakers supplying a split receptacle in the kitchen is missing its bridge. This needs to be in place in order to shut off power to both halves of the receptacles should the breaker trip.

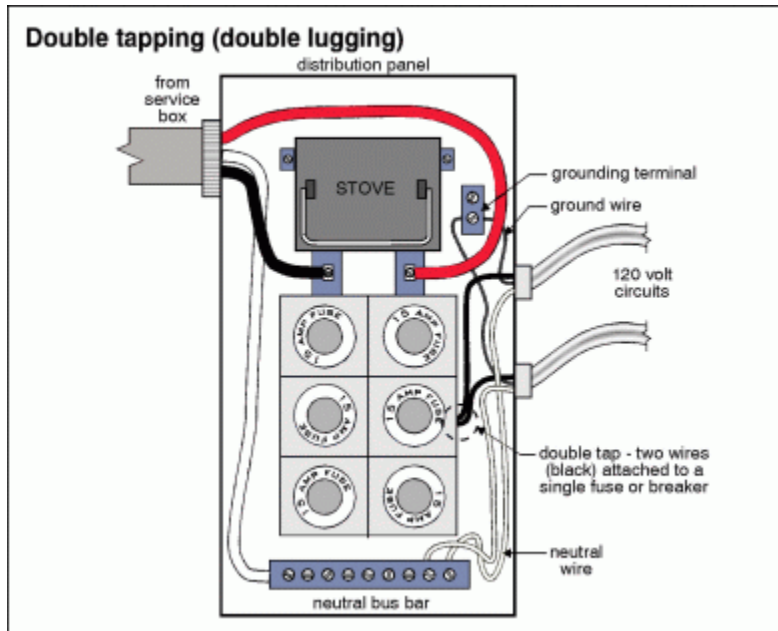
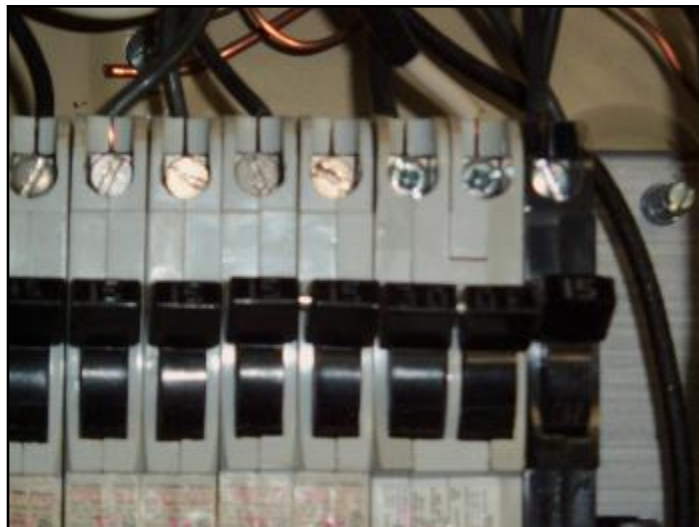
Condition: • [Double taps](#)

Note: There are several double tapped and abandoned wires inside the panel, as well as, signs of over heating on several breakers. This should be cleaned up and inspected by a licensed electrician.

5. Have breakers and panel inspected

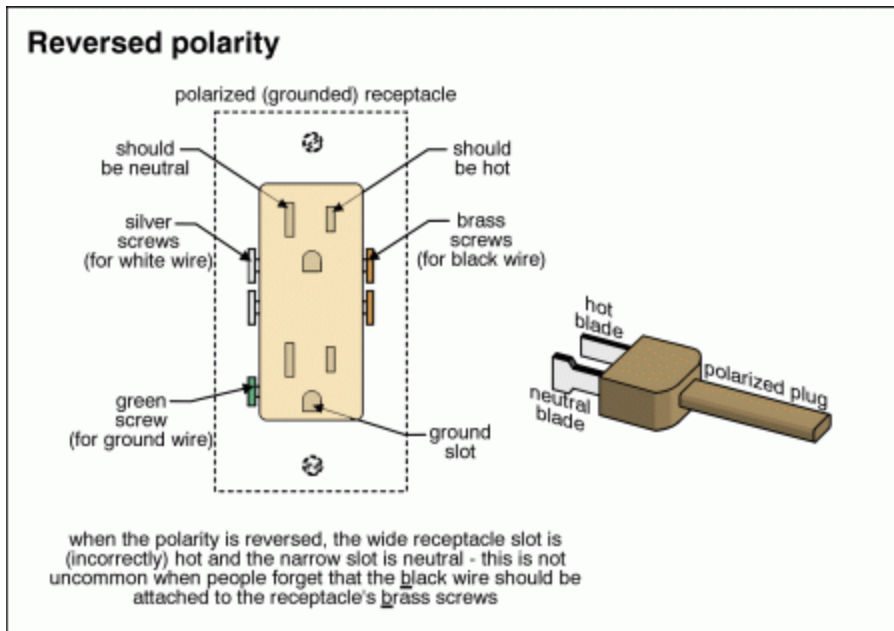
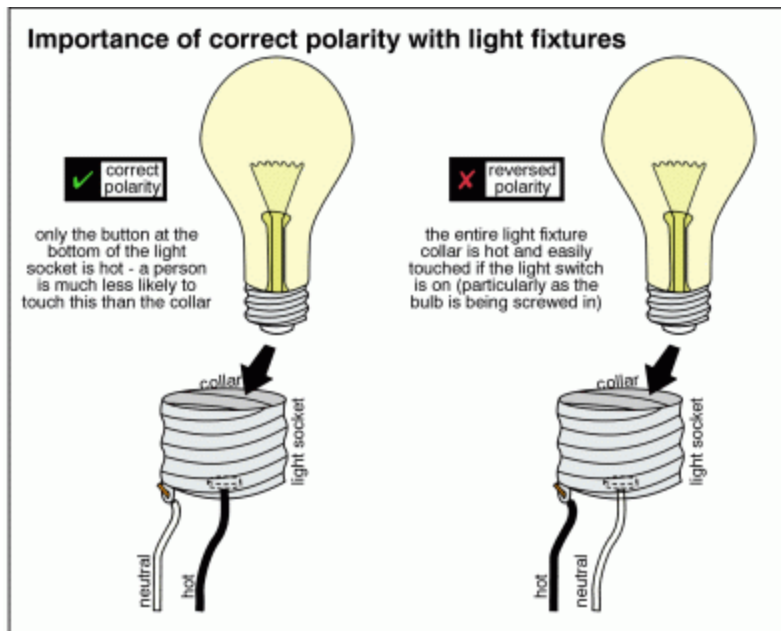
Condition: • [Reversed polarity](#)

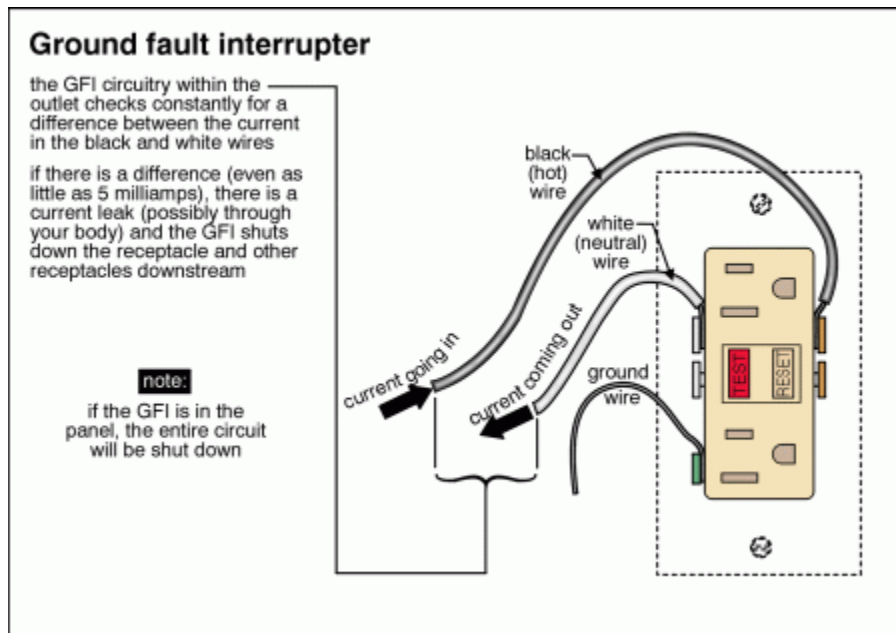
Condition: • [No GFI](#)

Note: Install GFI in this area.

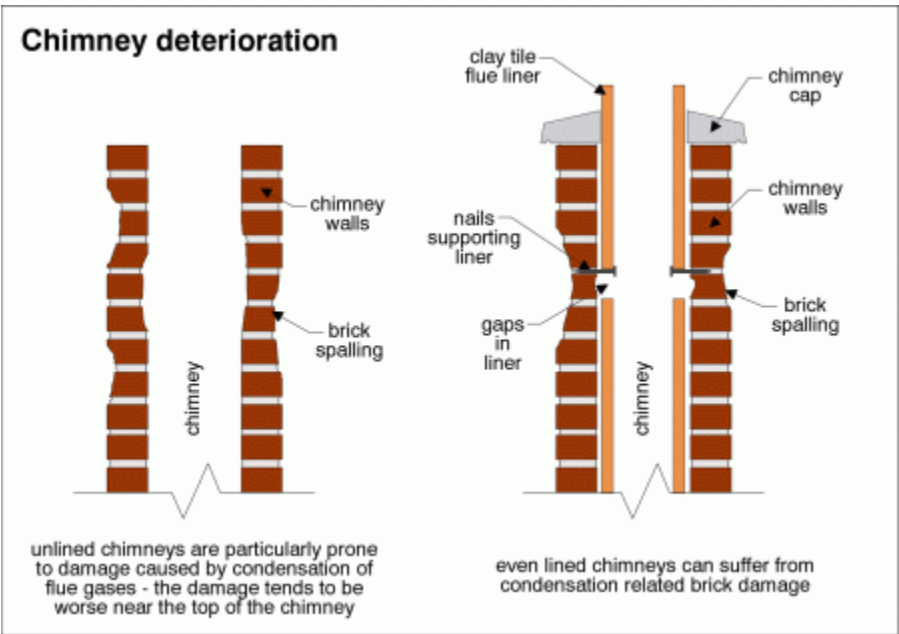
Condition: • [Loose, missing or deteriorated mortar](#)

Note: Some mortar deterioration and spalling are visible. Although deterioration is not excessive at this time, repairs are recommended within the next couple years to prevent further deterioration and costs.

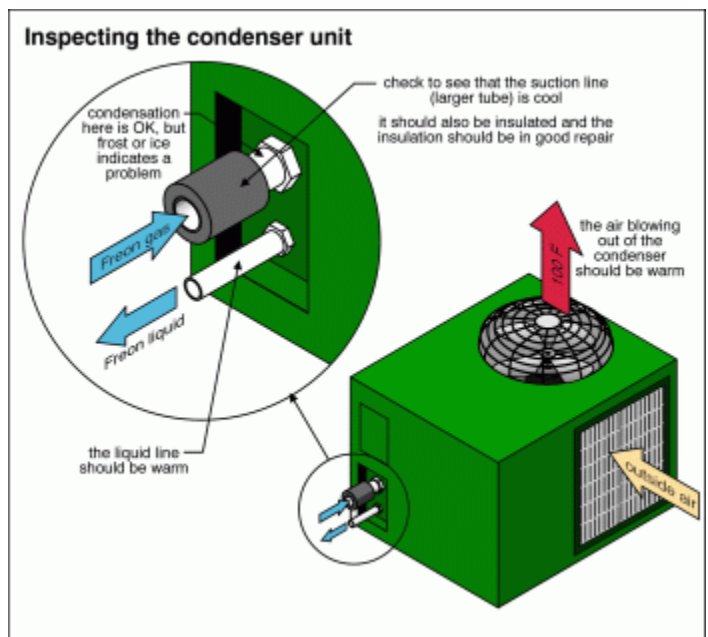
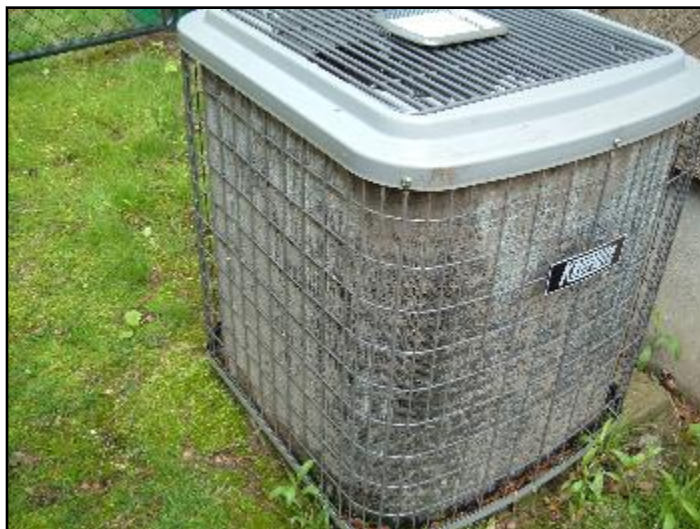
Condition: • [Dirty](#)

Note: Coils need to be unobstructed for proper air flow and cooling and to prevent premature failure of system.

6. *Clean condensing unit immediately*

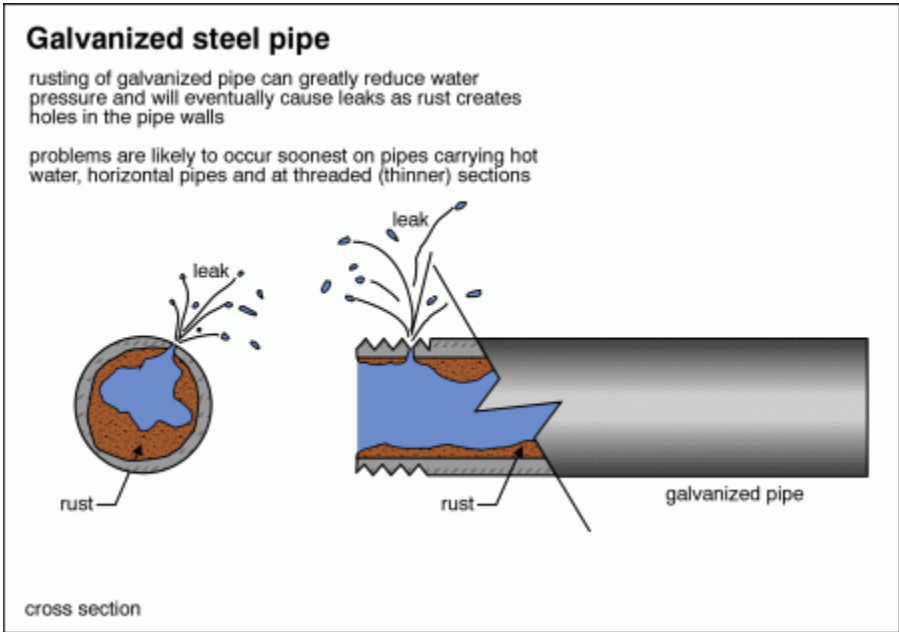
Condition: • [Galvanized steel](#)

Note: A small amount of galvanized piping still remains in the laundry area and should be replaced. This piping has not been used since the early 1950's and had a life expectancy of 50 years. Thus, it is past its life expectancy and poses the potential of severe water damage should a pipe leak.

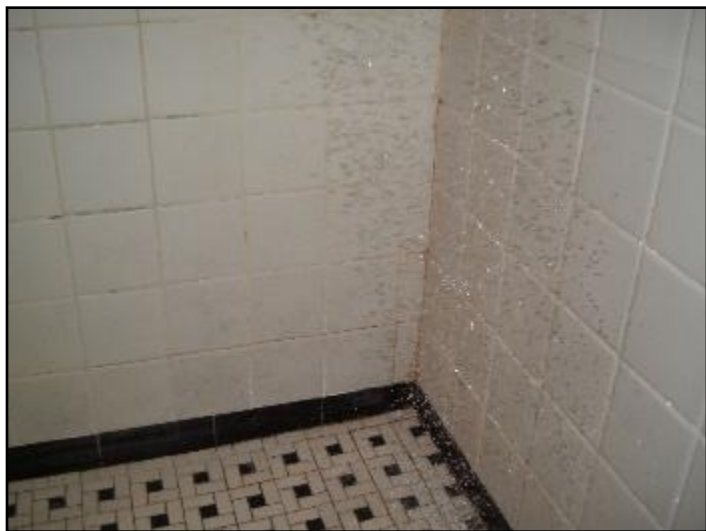
Note: The tile and grout are broken and deteriorated near the sill of this stall. The entire shower enclosure needs to be repaired immediately to avoid significant water damage to interior finishes. There is some water staining visible on the first floor ceiling in this area. Use of this facility should be avoided until repairs are made.

7. Grout broken and deteriorated

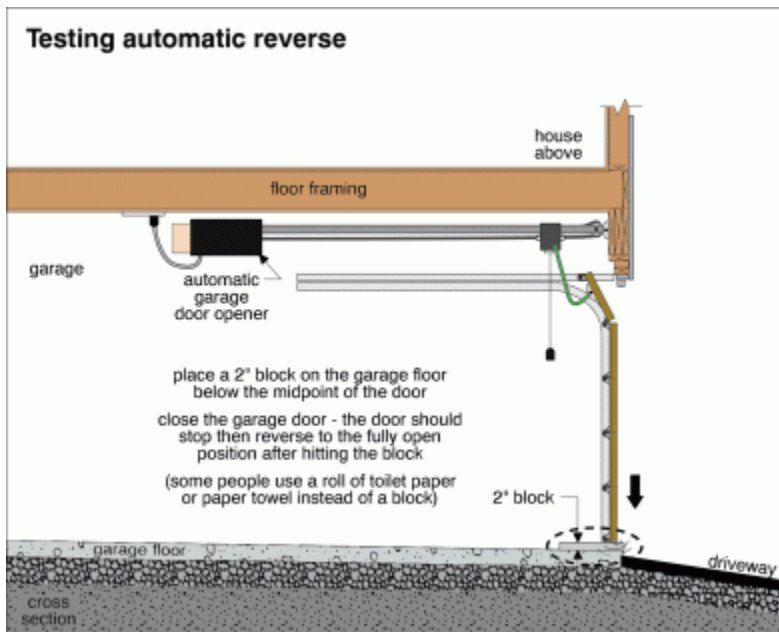
Condition: • [Fails to auto reverse](#)

Note: This is a safety feature that should be dealt with at first opportunity to avoid possible damage to property or injury to persons.

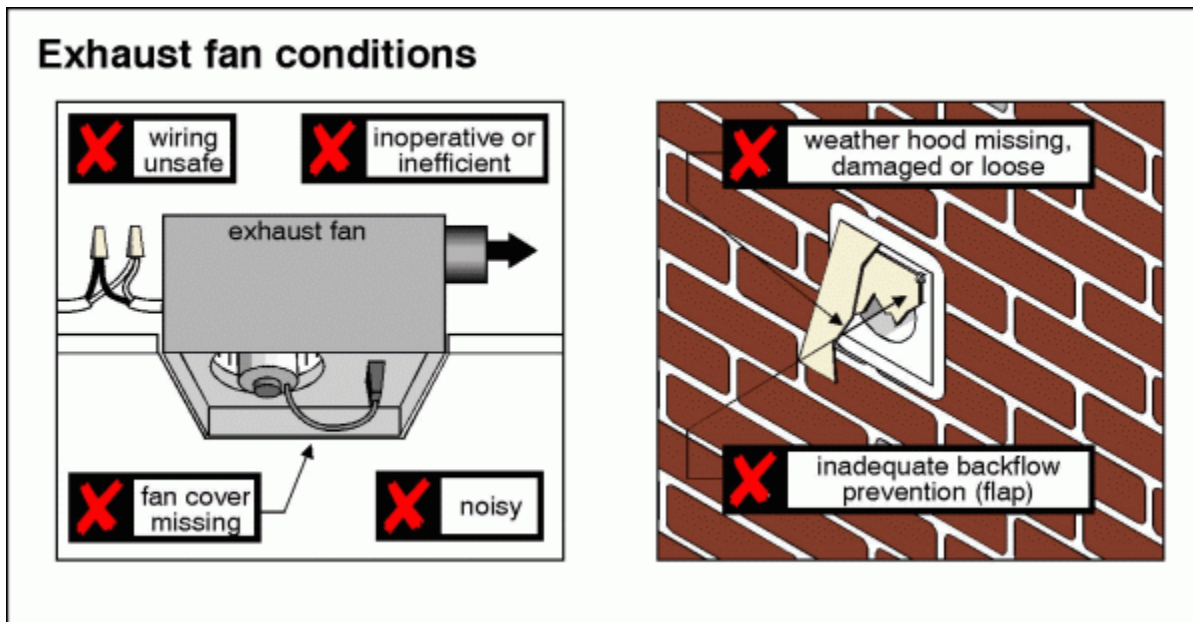
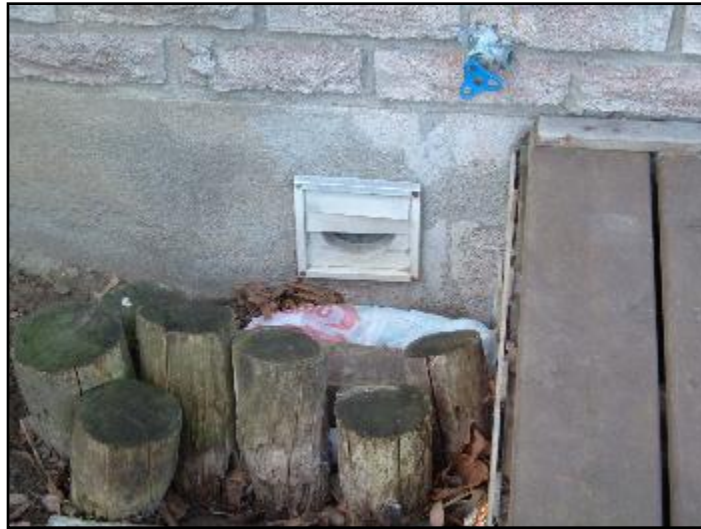
8.

Condition: • [Weather hood missing or loose](#)

Note: Weather hood for dryer vent should be replaced at first opportunity to avoid pest or vermin entering home.
