INSPECTION REPORT

For the Property at:
2533 SE 34TH AVE
PORTLAND, OR 97202

Prepared for: JESSE LICHTENSTEIN
Inspection Date: Monday, December 8, 2014
Prepared by: Shelter Home Inspection

RE: Report No. 1010
2533 SE 34th Ave
Portland, OR
97202

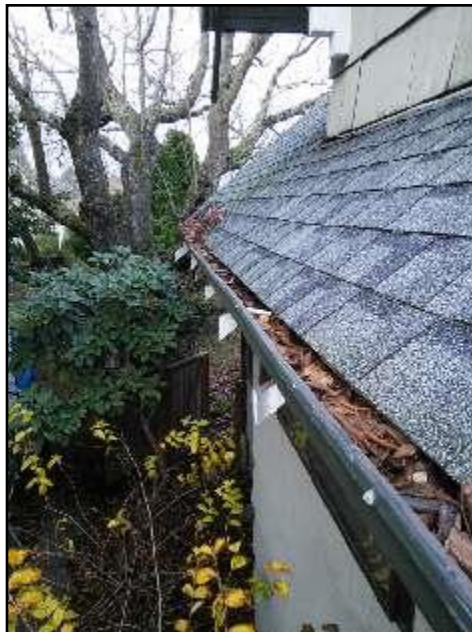
1. • Gutters need to be cleaned out.

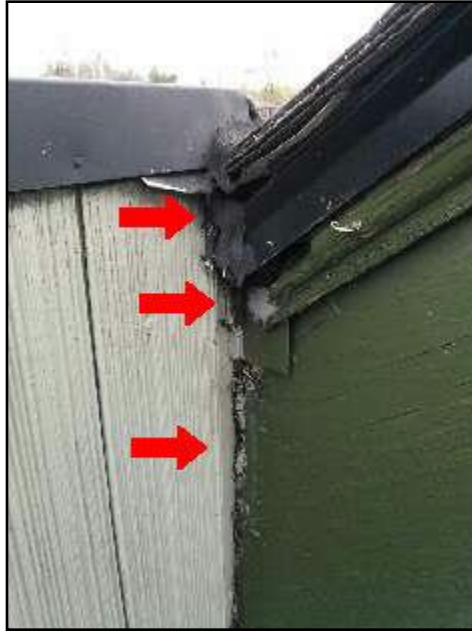
2. Leak

Roof over rear addition is in need of immediate repair. Evidence of water infiltration on interior ceiling and significant rot around the area.

2. **Condition:** • [Leak](#)

Recommend further evaluation by qualified contractor.

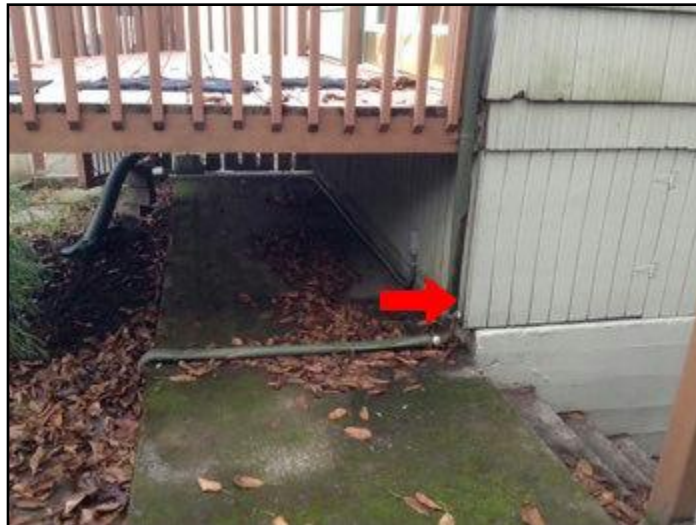
3. West wall

Crawlspace under addition was not accessible.

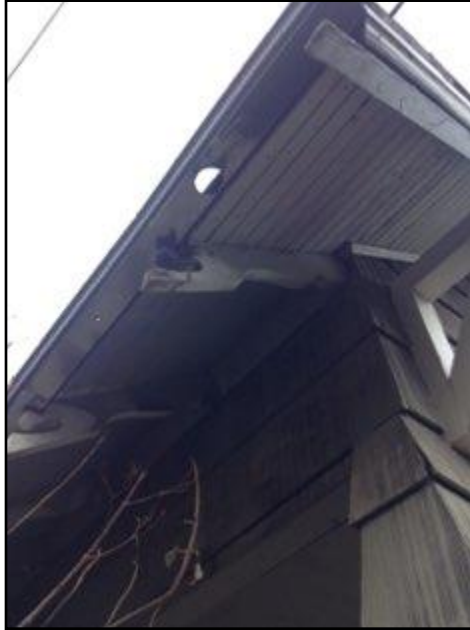
4. Condition: • Hole in gutter from previous downspout

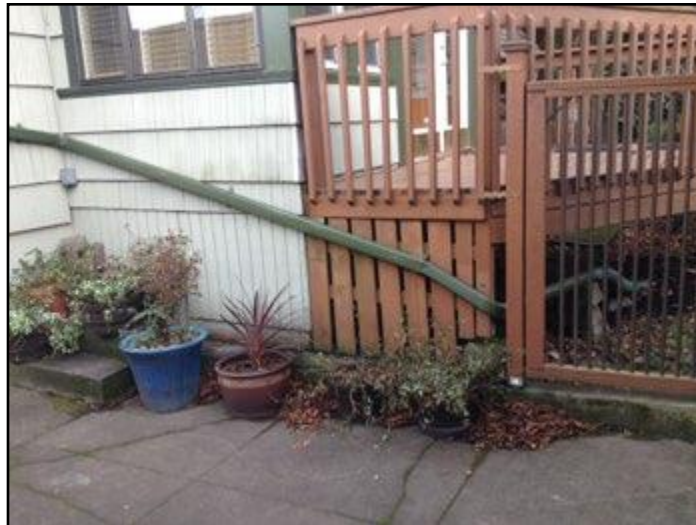
5. Condition: • Downspout in rear, NW corner has very long run and poor slope

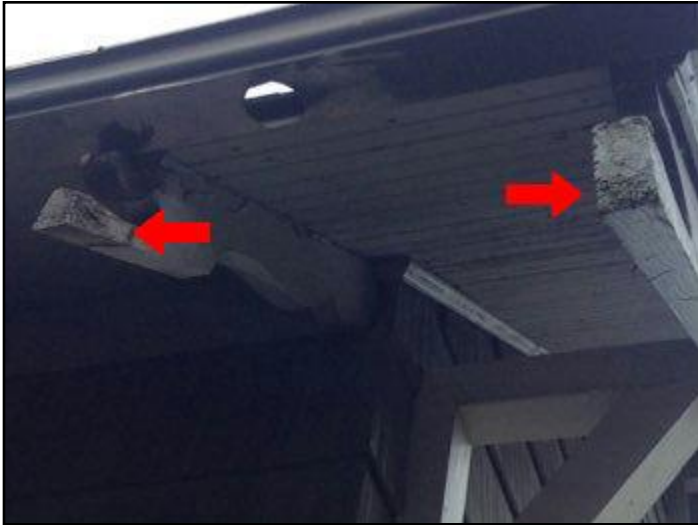
6. Rot

7. Condition: • Rot

Maintenance on wood trim has been neglected over the years. Needs attention. However, the trim on the backside of house has significant rot due to poorly constructed addition and rooftop deck.

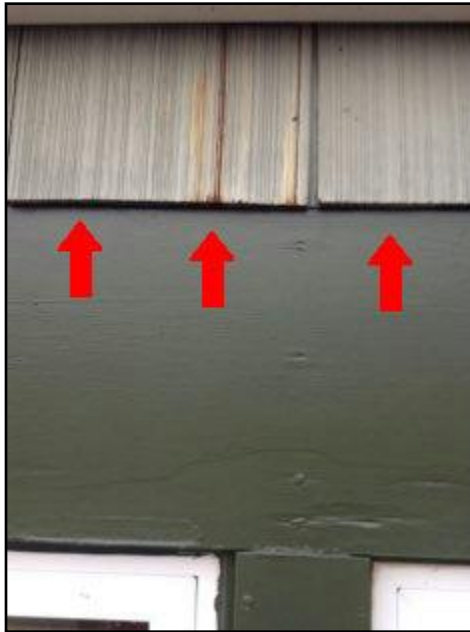
8. *Flashings missing*

8. Condition: • [Flashings missing](#)

Implication(s): Chance of water damage to contents, finishes and/or structure

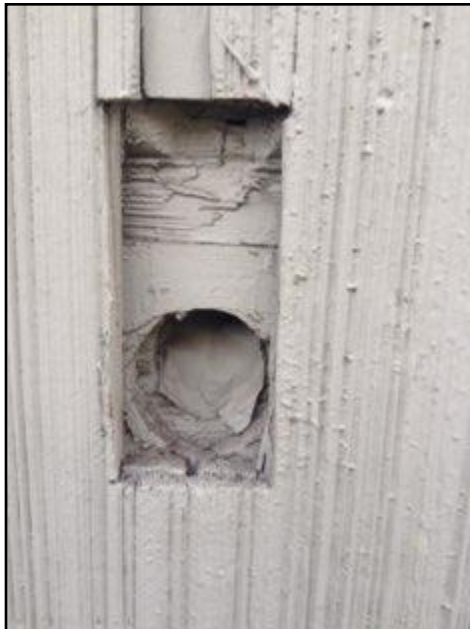
9. *Cracked, split or broken*

10. Condition: • [Cracked, split or broken](#)

Implication(s): Cosmetic defects | Chance of water damage to contents, finishes and/or structure

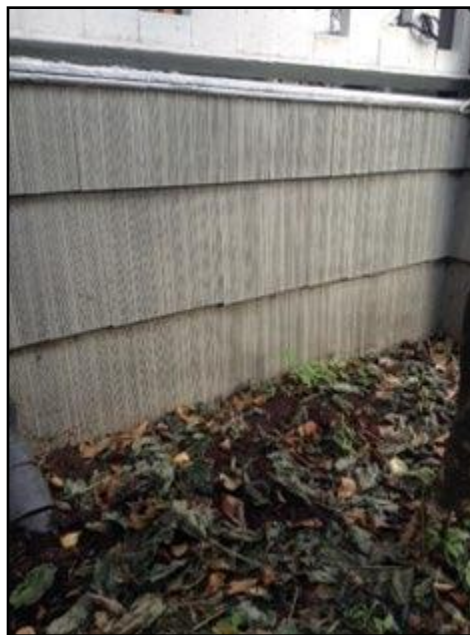
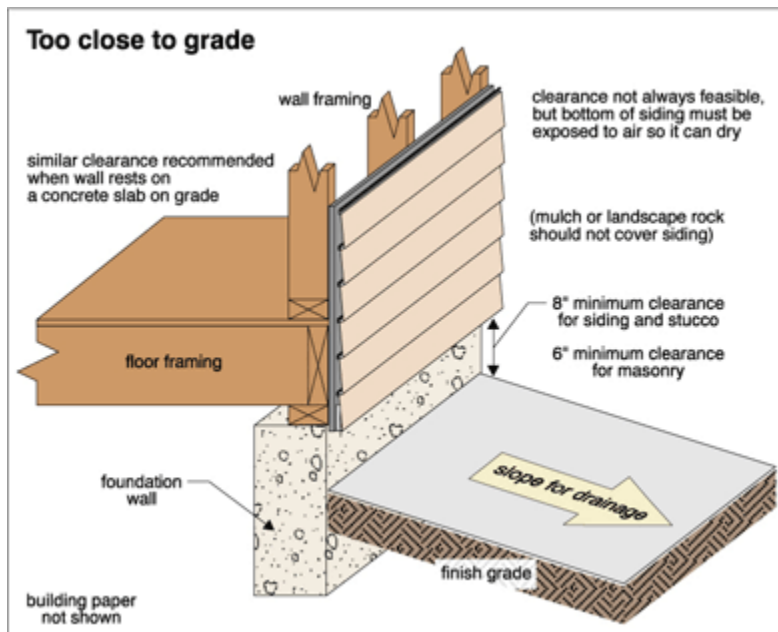
10. Too close to grade

11. Condition: • [Too close to grade](#)

Implication(s): Chance of water damage to contents, finishes and/or structure | Material deterioration | Rot | Insect damage

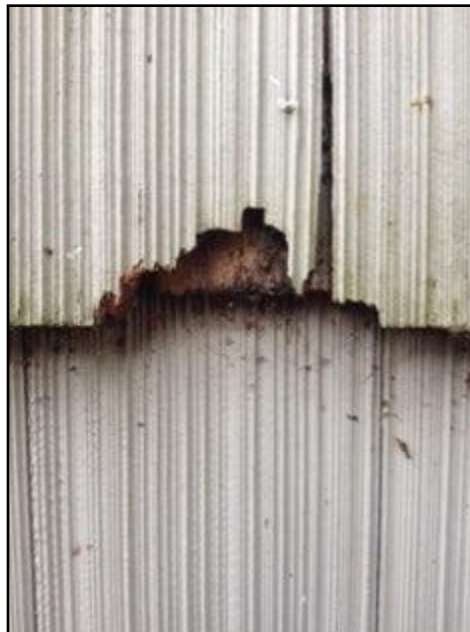
11. Rot

12. Condition: • [Rot](#)

Most notable rot on siding exists around the rear addition. Recommend immediate evaluation by a qualified contractor to determine the amount of water infiltration behind siding and possibility of sheathing and/or structural damage.

Implication(s): Cosmetic defects | Weakened structure | Material deterioration

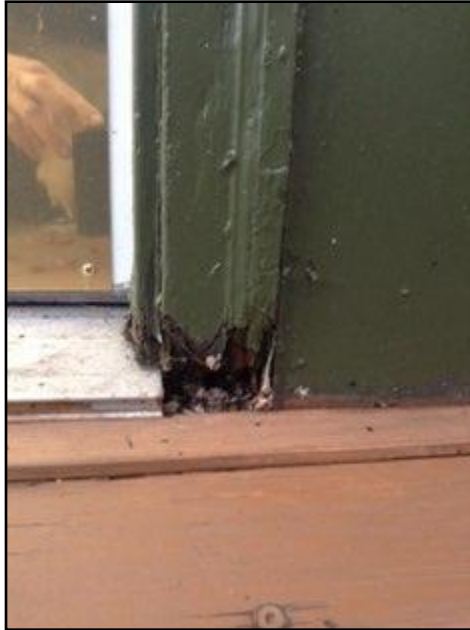
12. Rot

15. Condition: • [Rot](#)

Implication(s): Chance of damage to finishes and structure

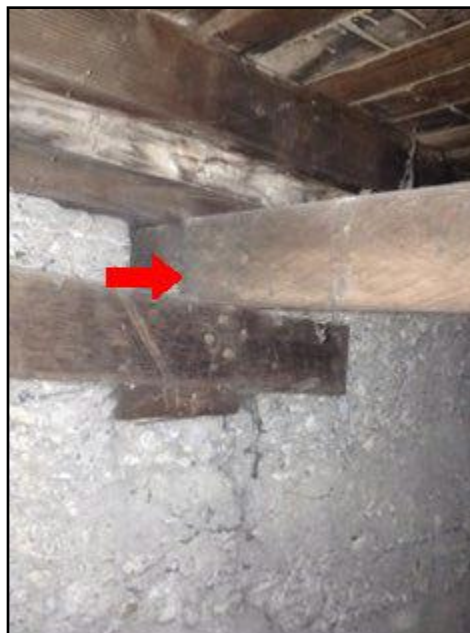
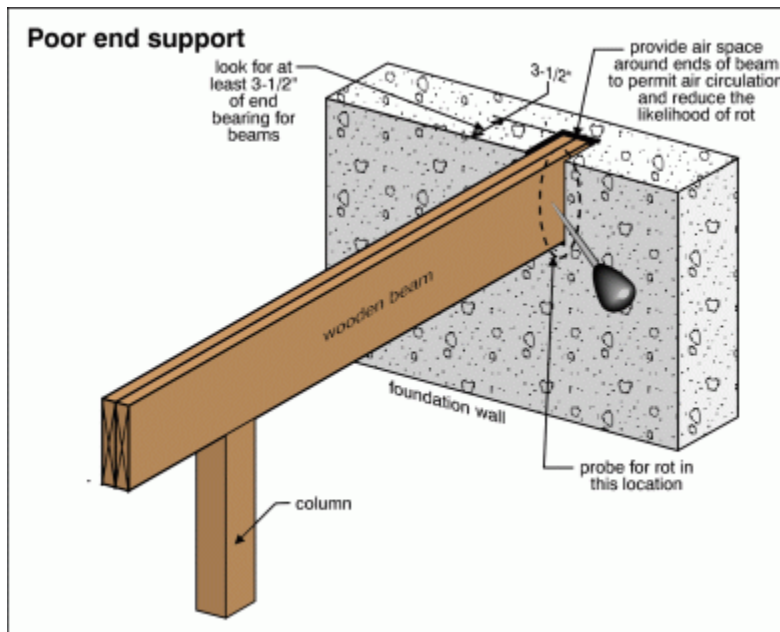
13. End support inadequate

17. Condition: • [End support inadequate](#)

Beam under front porch supported by a 2x4 nailed into the end of the main basement beam.

Implication(s): Weakened structure | Chance of movement

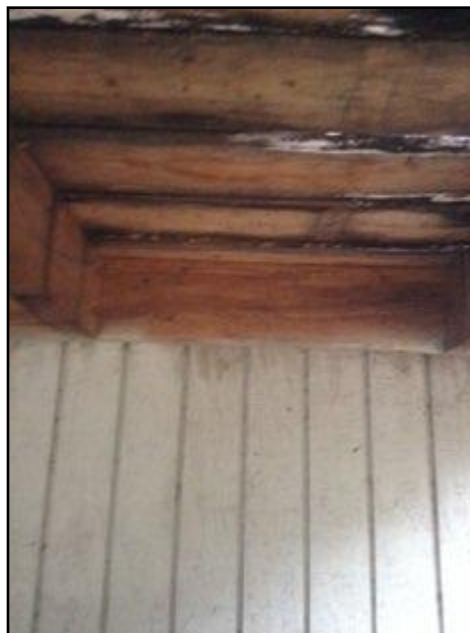
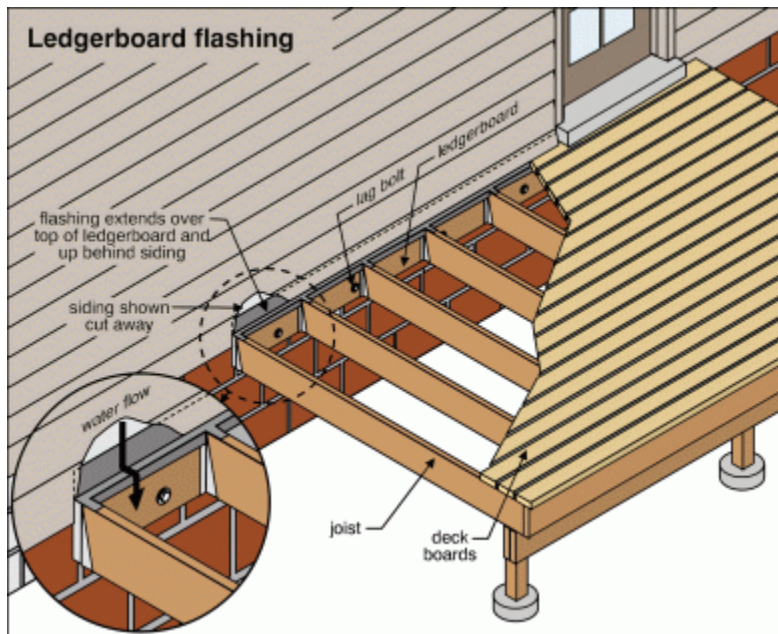
14. Ledgerboard problems

18. Condition: • [Ledgerboard problems](#)

Ledger board on rear deck should be lag bolted to house

Implication(s): Weakened structure | Chance of movement

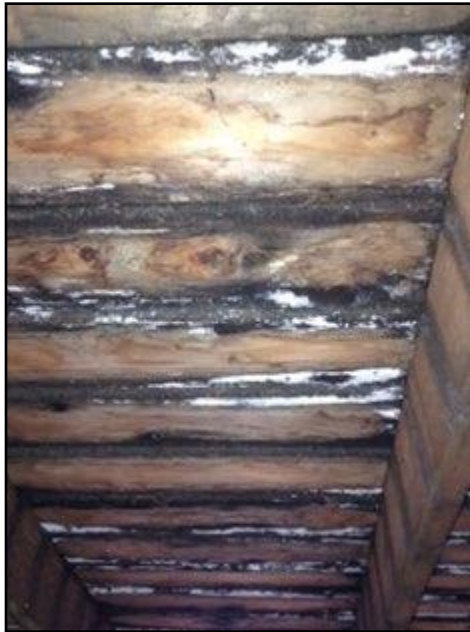
15. Rot or insect damage

20. Condition: • [Rot or insect damage](#)

Decking on rear deck is rotting underneath

Implication(s): Weakened structure | Chance of movement | Material deterioration

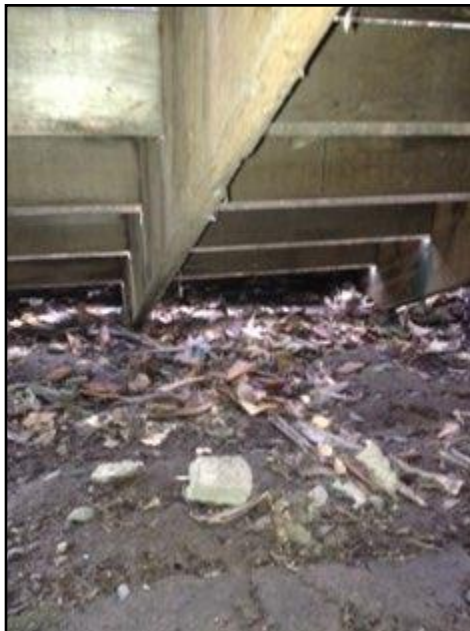
16. Wood/soil contact

21. Condition: • [Wood/soil contact](#)

Implication(s): Shortened life expectancy of material | Material deterioration

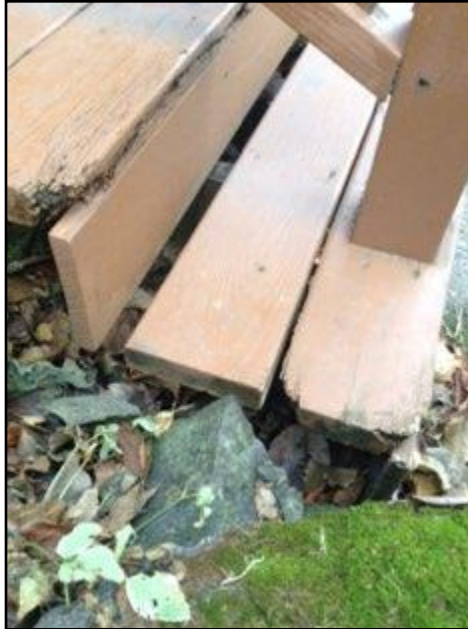
17. Rot

23. Condition: • [Rot](#)

Implication(s): Weakened structure

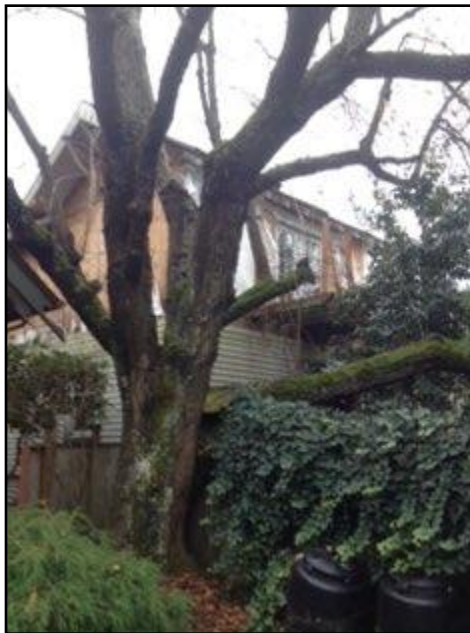
18. Trees or shrubs too close to building

27. Condition: • [Trees or shrubs too close to building](#)

Large tree in back yard too close to house and neighbors house. Could be a liability.

Implication(s): Chance of water damage to contents, finishes and/or structure | Chance of pests entering building |

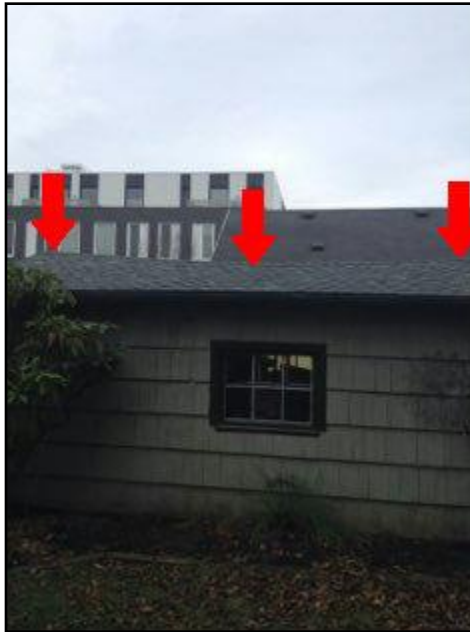
19.

28. Condition: • Significant settling of garage structure

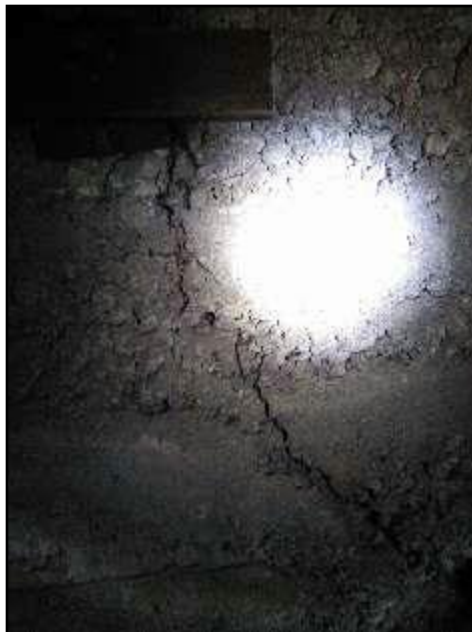
20. *Typical minor settlement*

29. Condition: • [Typical minor settlement](#)

1/8th inch crack in foundation under front porch. I recommend further evaluation by qualified contractor.

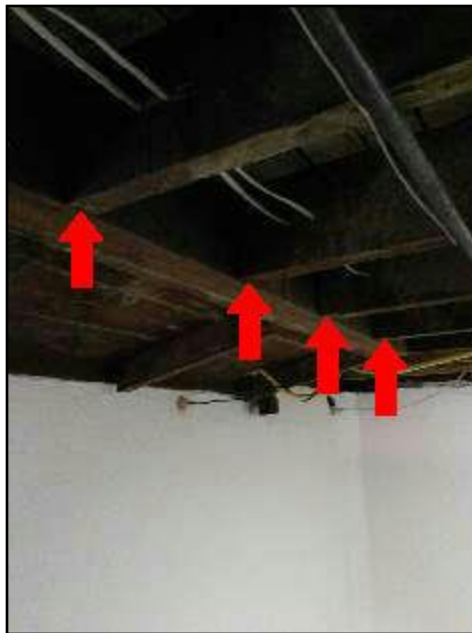
21. *Missing hangers*

30. Condition: • [Missing](#)

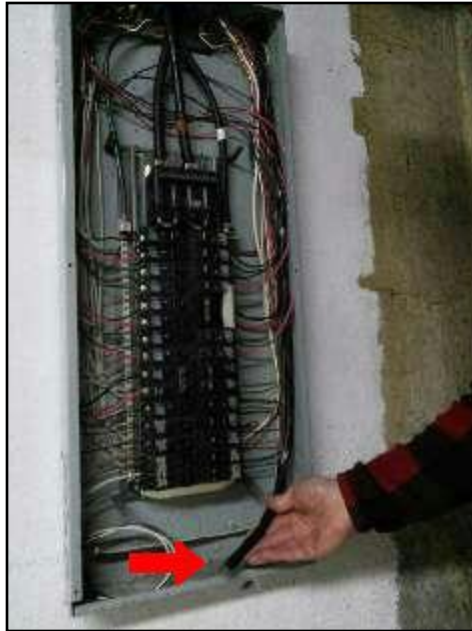
24. *Abandoned wires in panel*

31. Condition: • [Abandoned wires in panel](#)

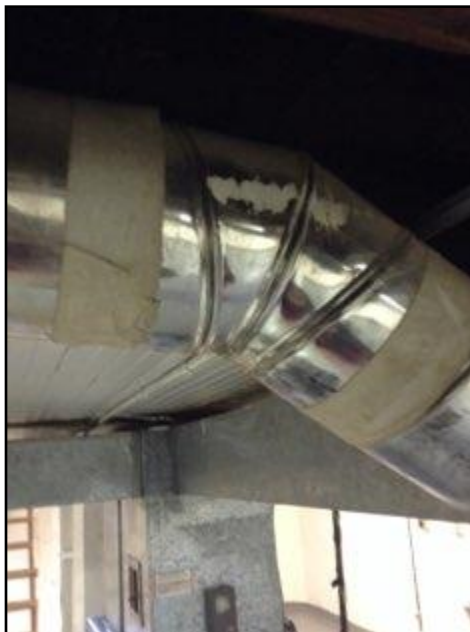
26.

34. Condition: • Asbestos tape on ducts in basement

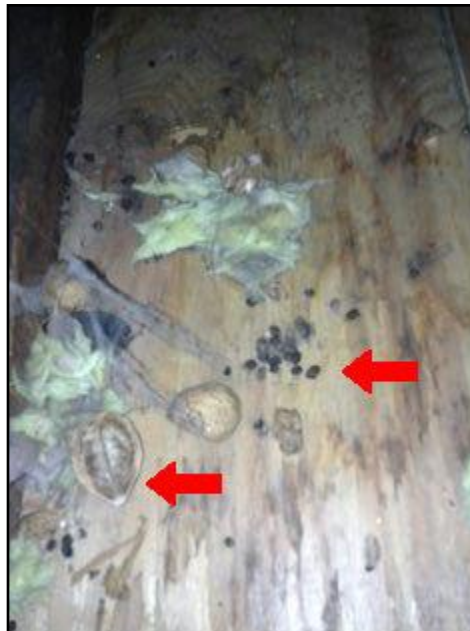
28.

36. • Evidence of pests behind knee walls. Further evaluation by qualified exterminator recommended.

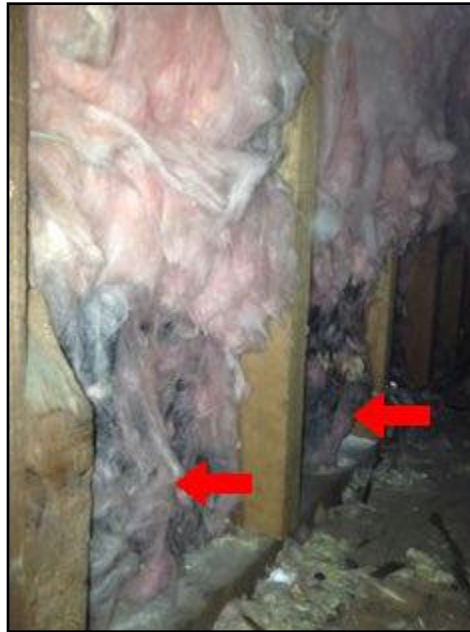
29. Amount inadequate

37. Condition: • [Amount inadequate](#)

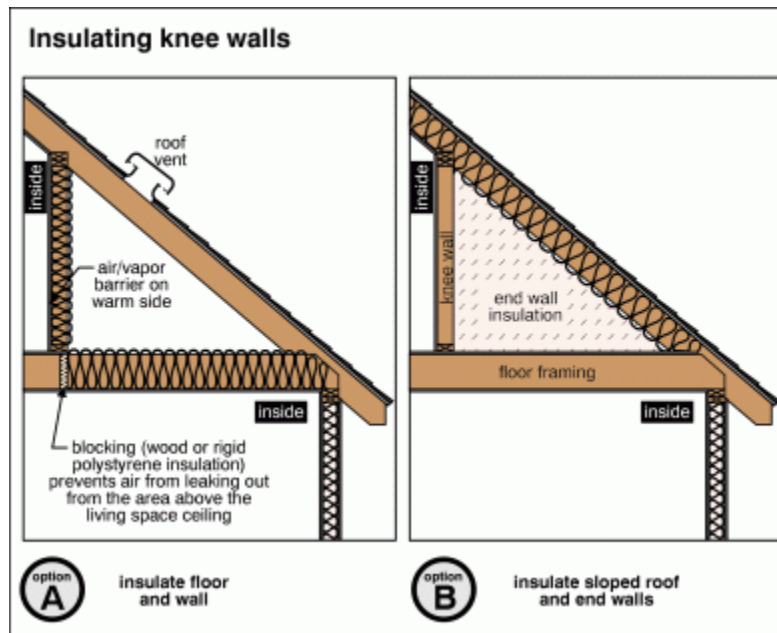
38. Condition: • [Inadequate in knee wall areas](#)

Implication(s): Increased heating and cooling costs | Reduced comfort

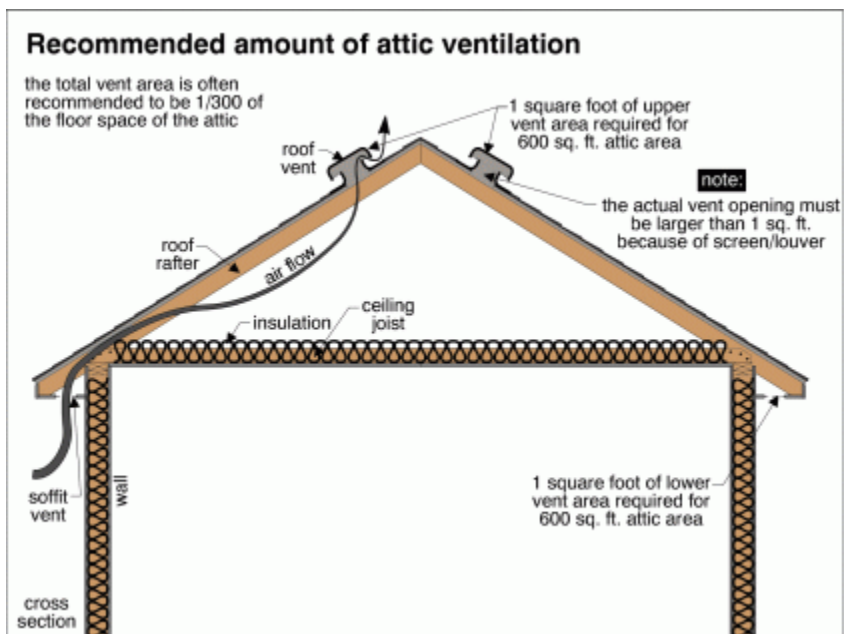
39. Condition: • [Inadequate](#)

Implication(s): Chance of condensation damage to finishes and/or structure

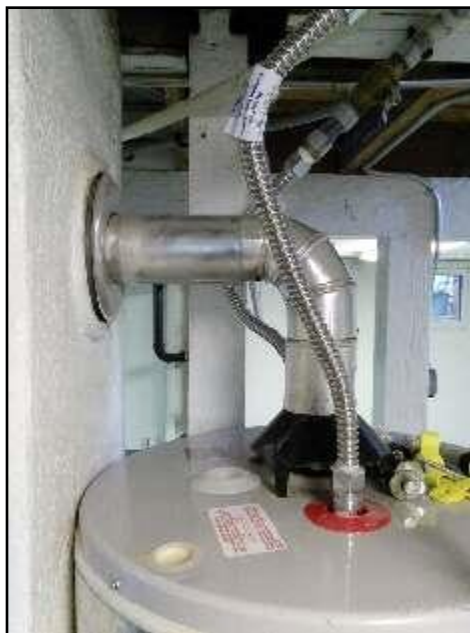
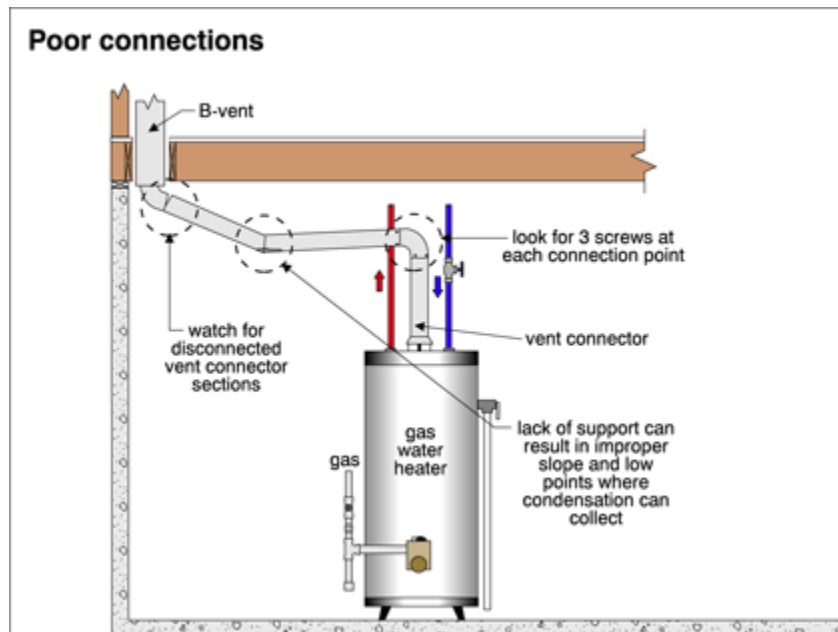
32. Poor slope

40. Condition: • [Poor slope](#)

Vent pipes should slope up toward chimney.

Implication(s): Equipment not operating properly | Hazardous combustion products entering home

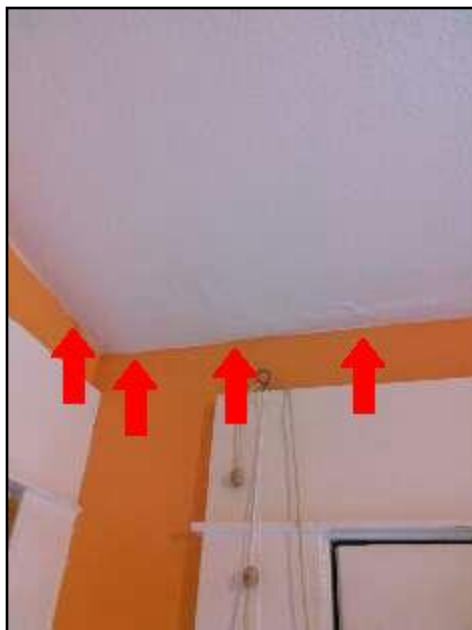
33. Water damage

43. Condition: • [Water damage](#)

Interior water damage. Recommend further evaluation by qualified contractor.

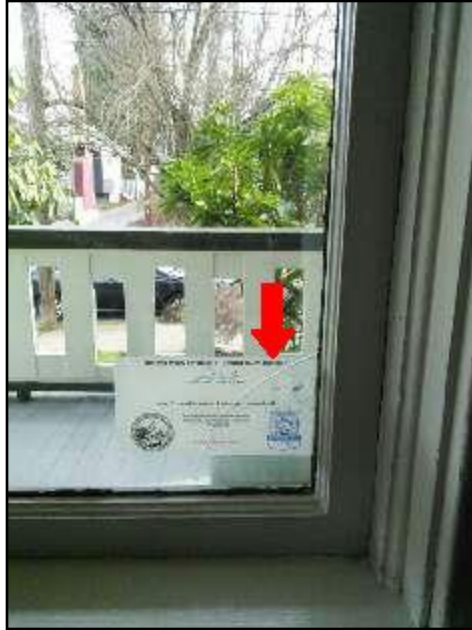
34. Cracked

44. Condition: • [Cracked](#)

Implication(s): Cosmetic defects | Physical injury

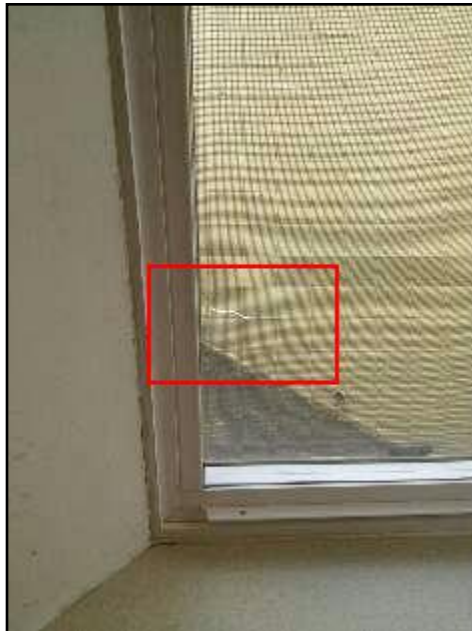
35. Cracked

45. Condition: • [Cracked](#)

Implication(s): Cosmetic defects | Physical injury

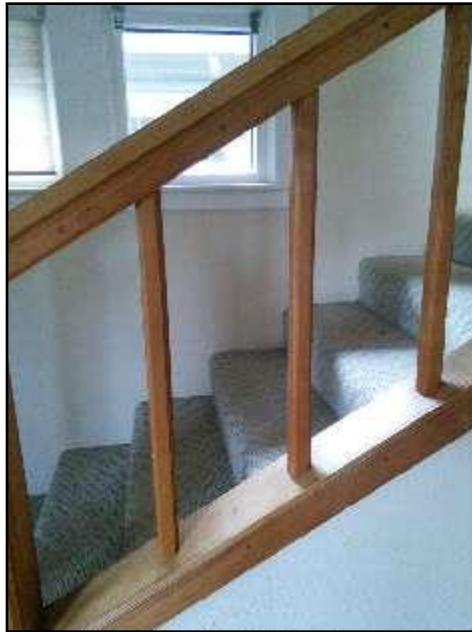
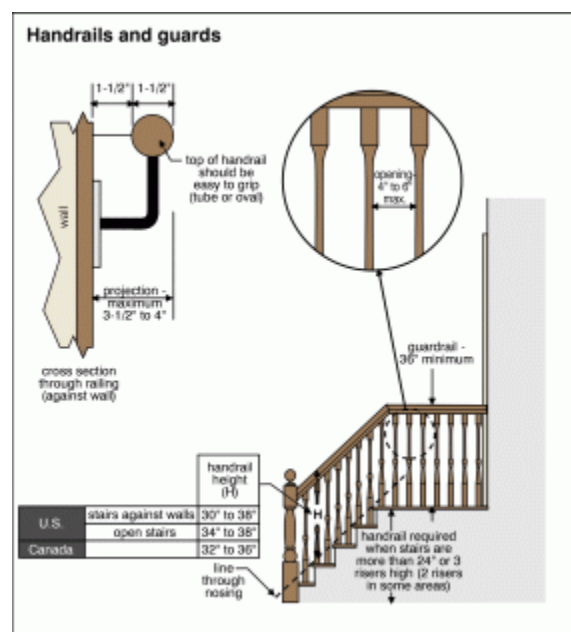
37. Missing

Staircase balusters are too far apart. 4" is the maximum between balusters. This is a safety issue for young children.

47. **Condition:** • [Missing](#)
