INSPECTION REPORT

33824 NE KALE ST
SCAPPOSE, OR 97056

Inspection Date: Wednesday, December 3, 2014

Prepared by: Shelter Home Inspection

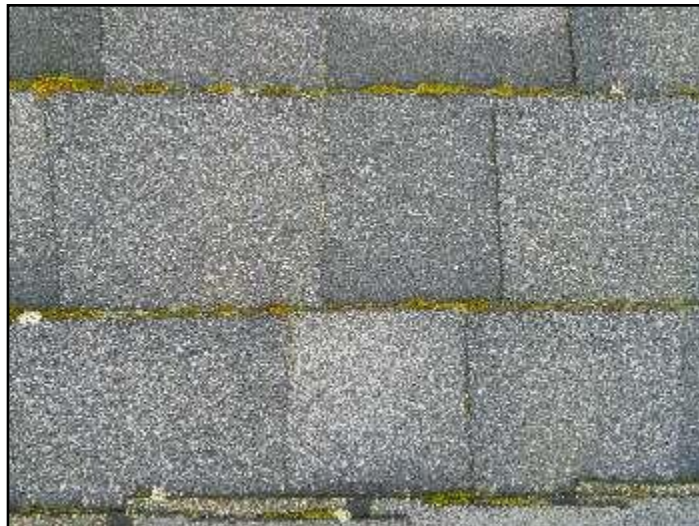
1. **Condition:** • Moss accumulation on comp shingles. Recommend removing.

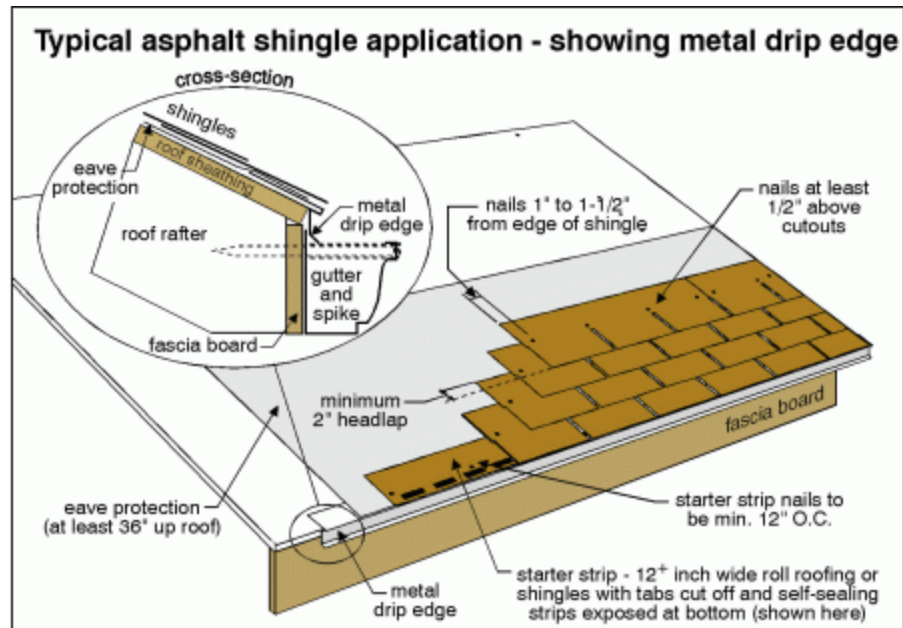
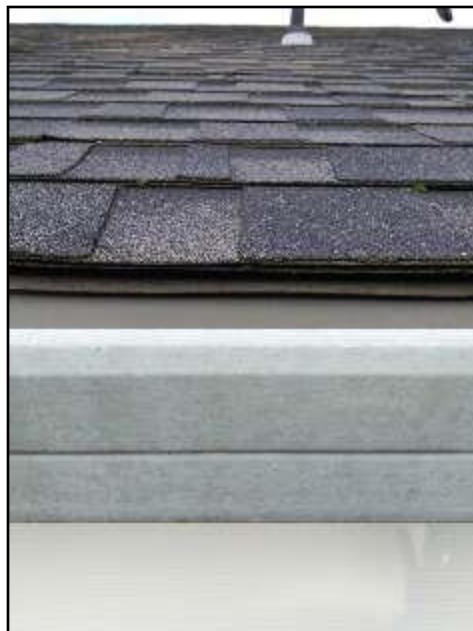
2. Missing

2. **Condition:** • [Leak](#)

Vent stack at NW corner of roof is allowing water to penetrate. Signs of water damage below on sheetrock in laundry room.

3. **Condition:** • [Missing](#)

Recommend installing drip edge flashing along eaves.

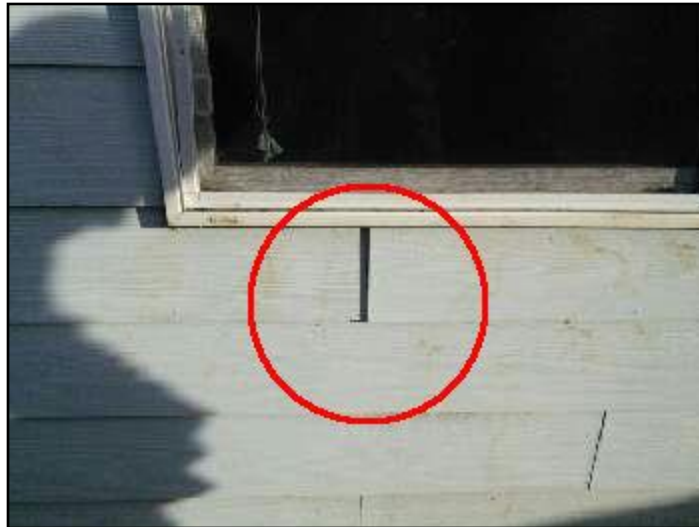
5. Loose

5. Condition: • [Loose or missing pieces](#)

Windows and slider on south side of house allowing water penetration. Recommend immediate repair.

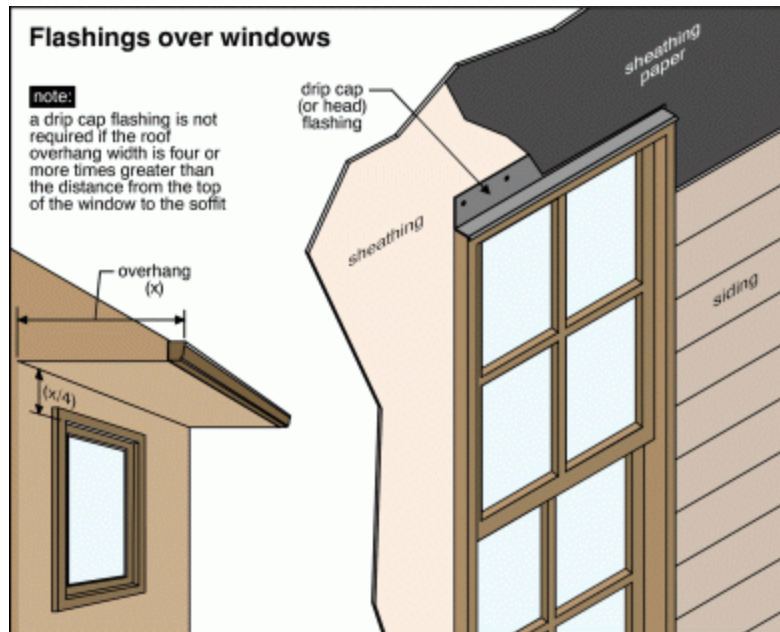
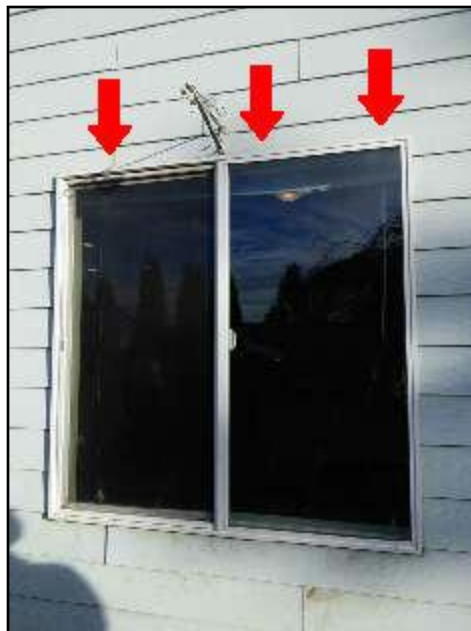
6. Missing

6. Condition: • [Missing](#)

Missing drip cap above window on south side of 1st floor

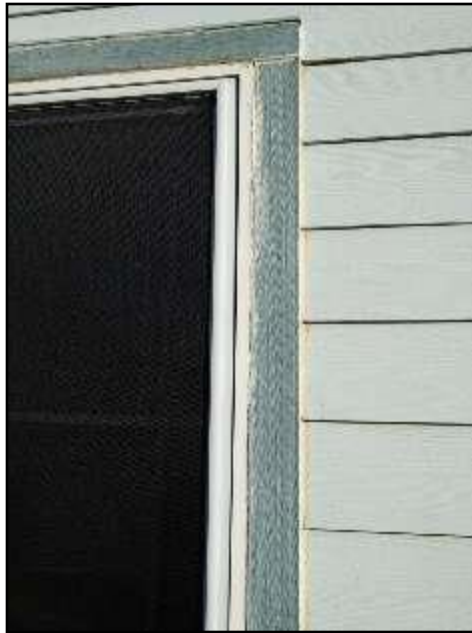
7. Condition: • [Rot](#)

Rear slider was improperly installed and flashed. Has caused visible water damage.

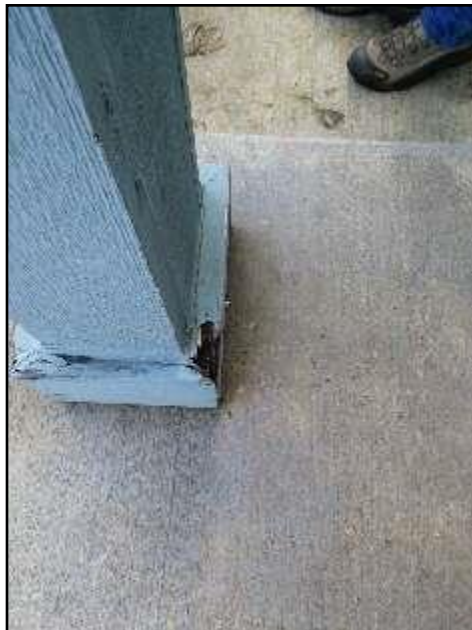
8. Rot

8. Condition: • [Rot](#)

Implication(s): Weakened structure | Chance of movement

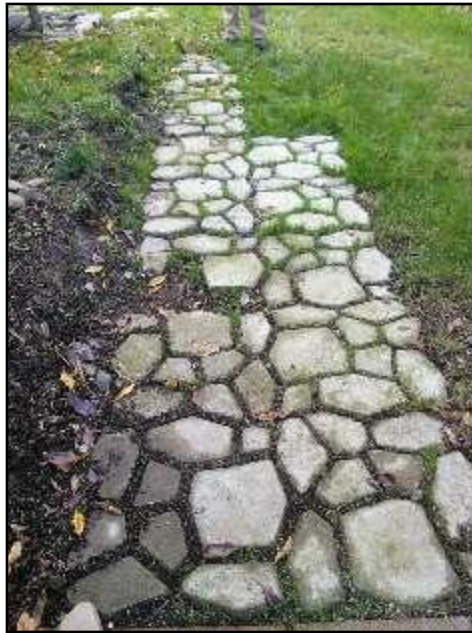
9. Stone

9. Condition: • Stone walkway is missing some stones and could be a tripping hazard.

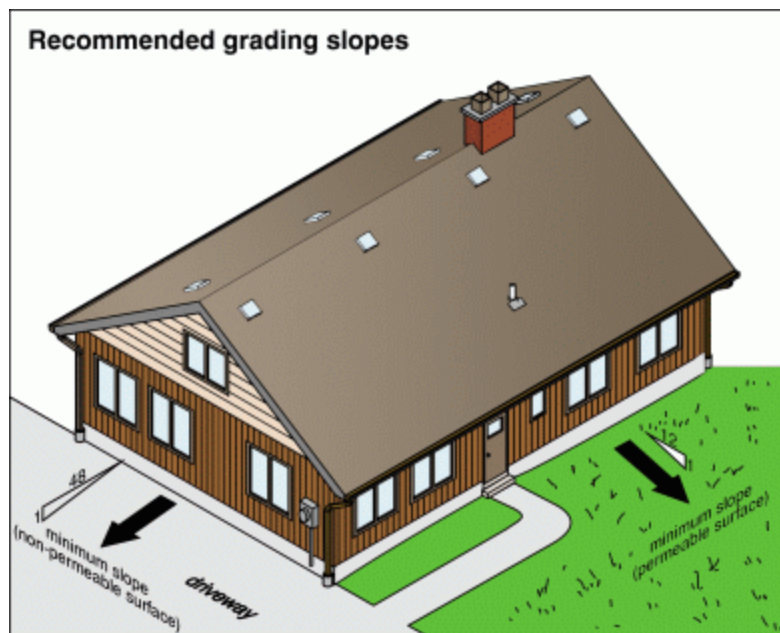
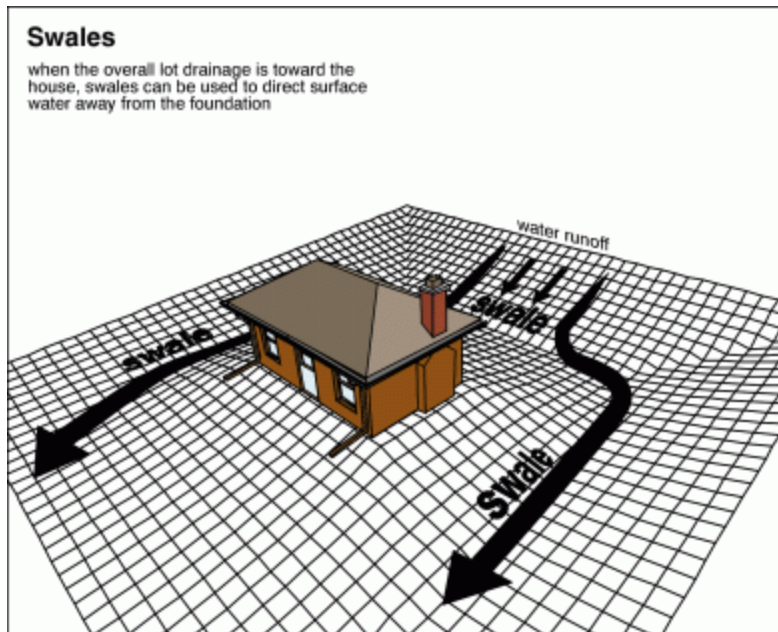
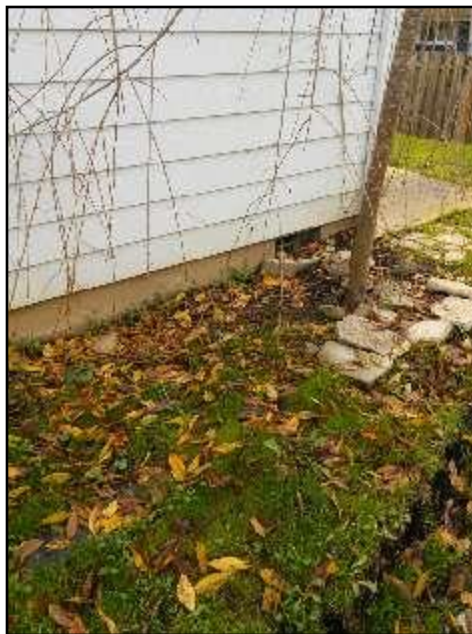
10. Improper slope

10. Condition: • [Improper slope](#)

Slope should be away from house

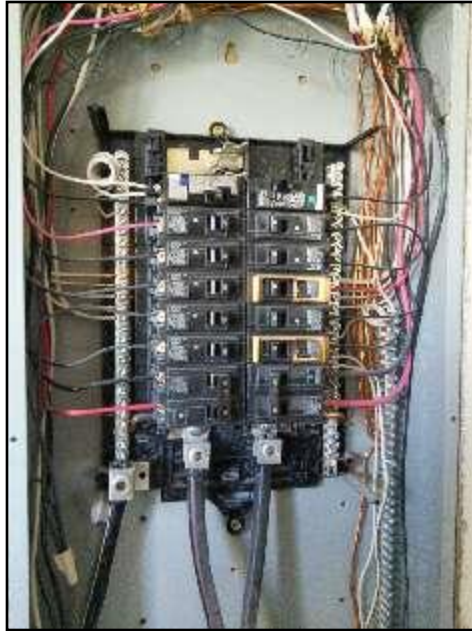
14.

11. • Upstairs, distribution panel does not have a main shut off.

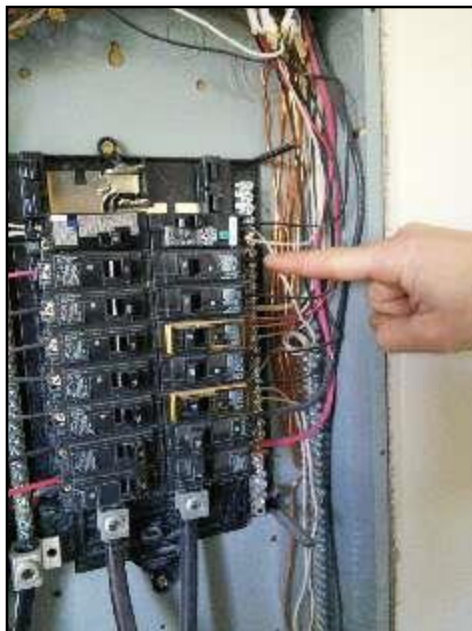
15. Loose connections

12. Condition: • [Loose connections](#)

Hot wire to 15amp breaker is loose.

Implication(s): Electric shock | Fire hazard

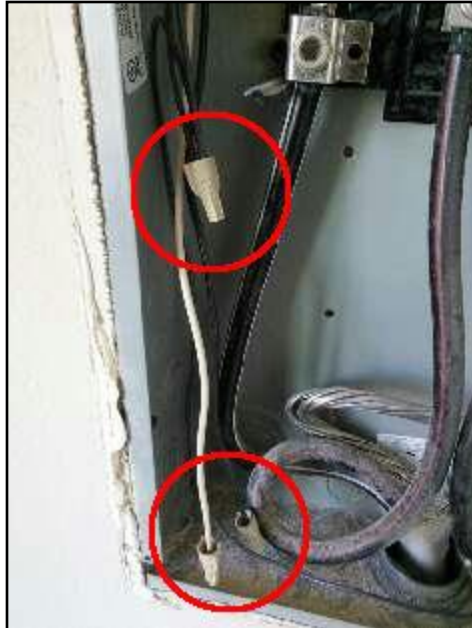
16. Abandoned wires in panel

13. Condition: • [Abandoned wires in panel](#)

Abandoned wires in panel and pig tail connections.

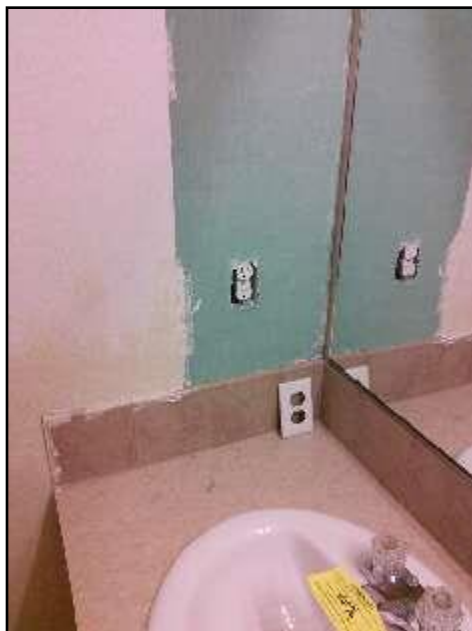
17.

14. Condition: • [Missing](#)

Several outlets throughout house missing covers

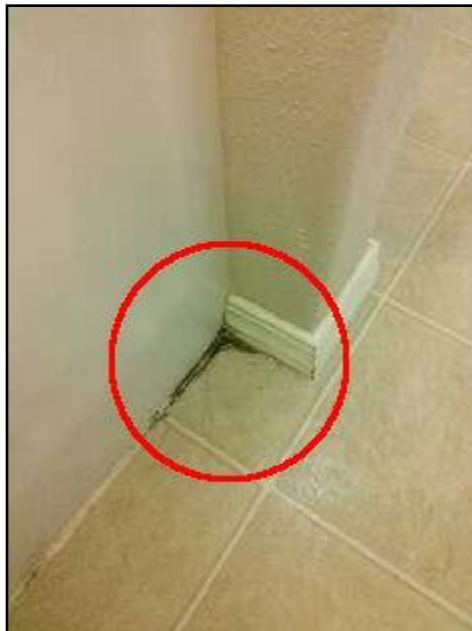
27.

17. Condition: • Evidence of water damage and potential of water penetration through floor.

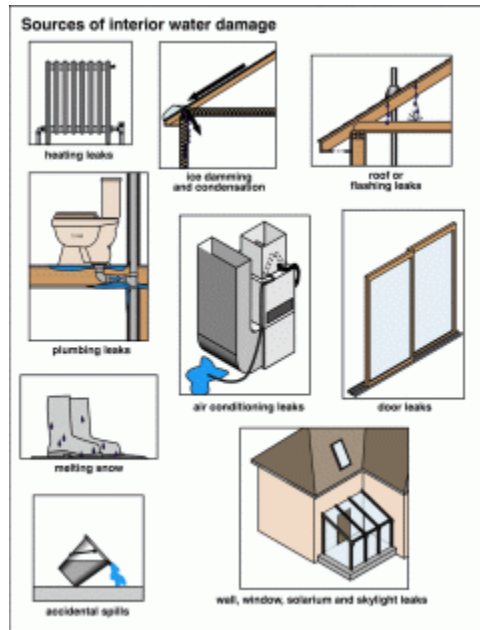
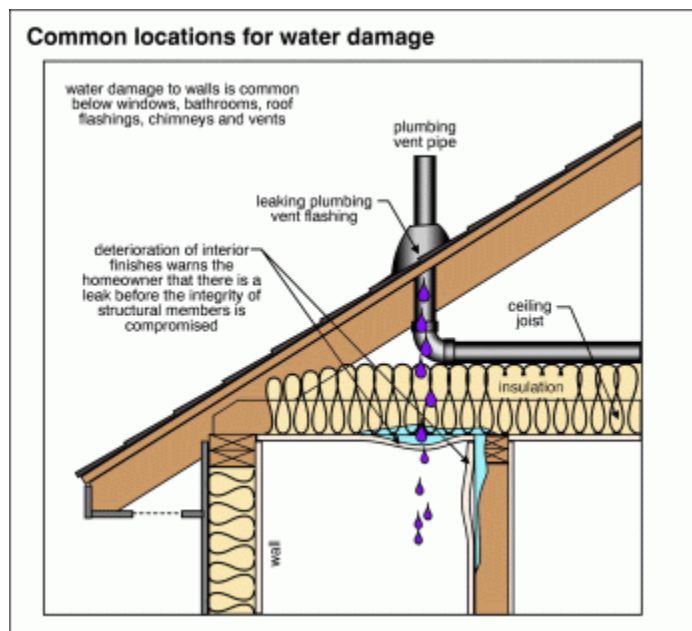
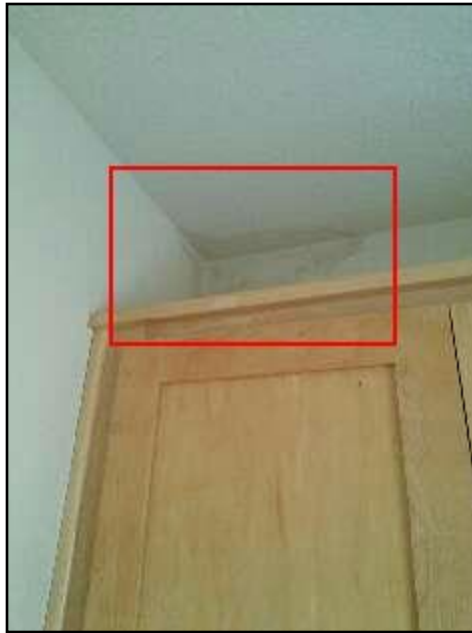
28. Water damage

18. Condition: • [Water damage](#)

Vent stack improperly installed allowing water penetration.

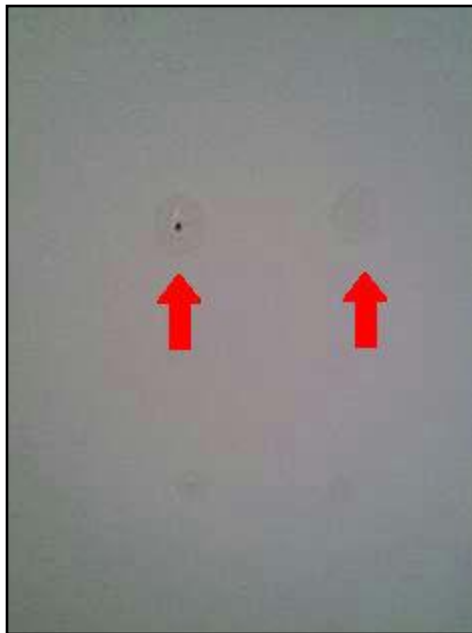
29.

19. Condition: • Evidence of possible water penetration from 2nd floor bathroom

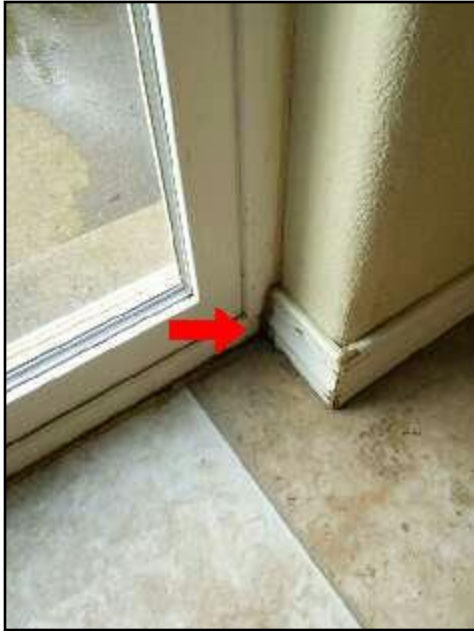
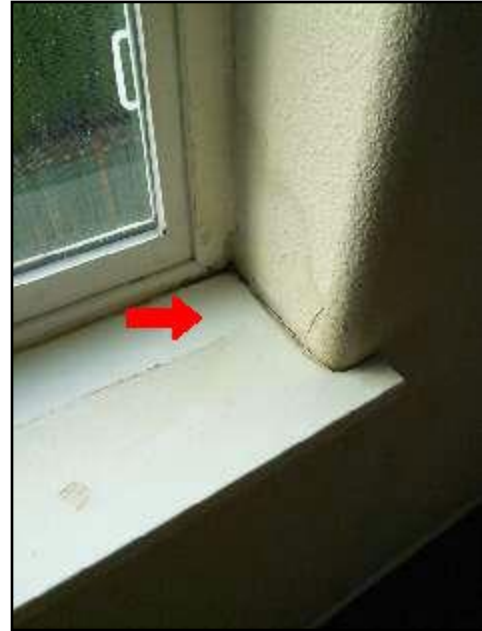
20. Condition: • [Water leaks](#)

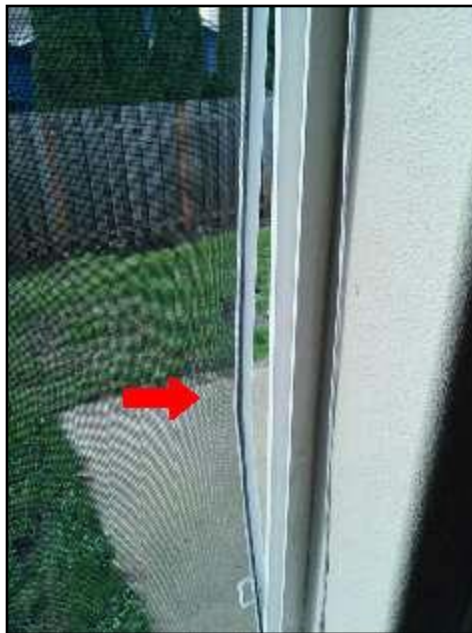
32.

21. Condition: • Damaged window screen

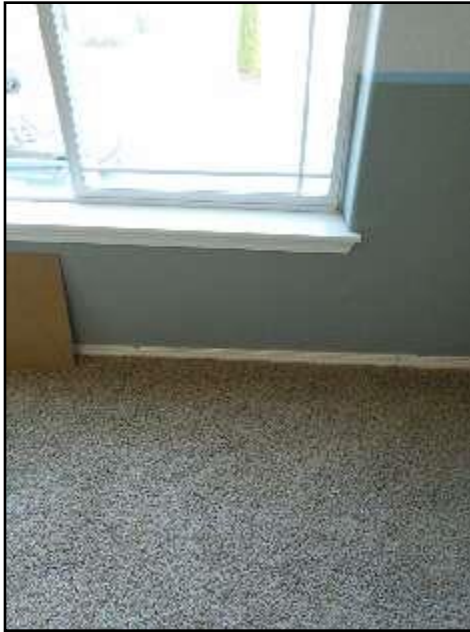
33.

22. Condition: • Window sill is too low. Potential safety hazard
