# YOUR INSPECTION REPORT

321 S. Pine St  
Richmond, VA 23220

**INSPECTION DATE:**  
Thursday, January 8, 2015

RE: Report No. 1004  
321 S. Pine St  
Richmond, VA  
23220

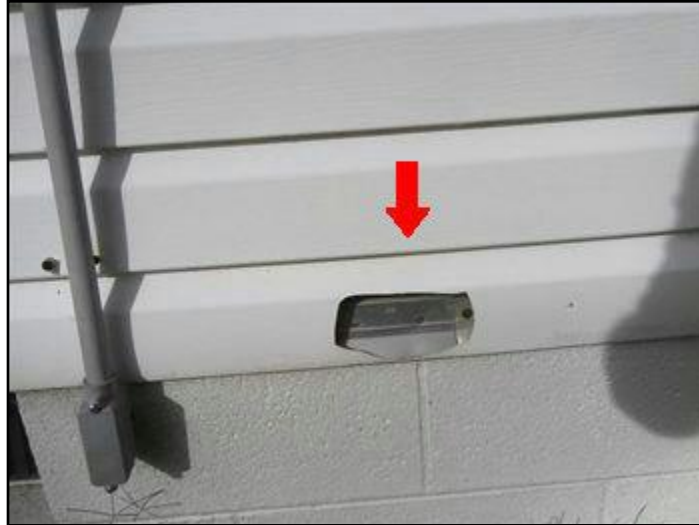
5. Vinyl siding

Broken siding

1. Condition: • [Mechanical damage](#)

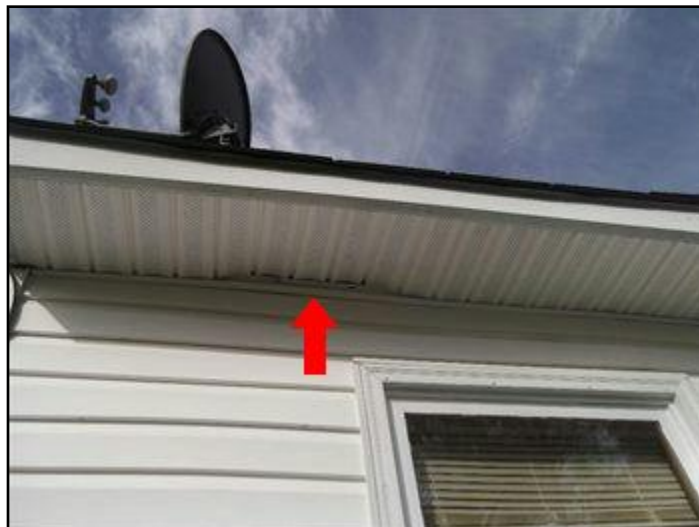
6. Vinyl siding

Soffit vent pushed up. Pull down into channel.

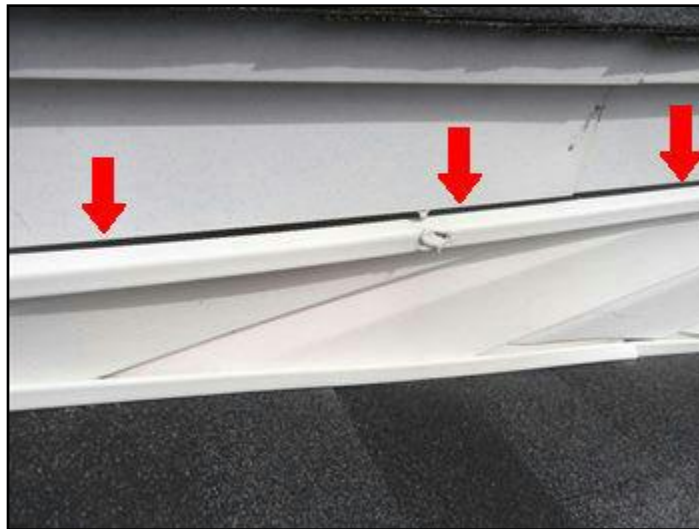
7. Gap between aluminum and vinyl

Gap between fascia and siding that could allow water to leak into walls. Needs to be sealed. Estimate \$100 - 200 to do this and repair other defects in vinyl. Estimate included in summary.

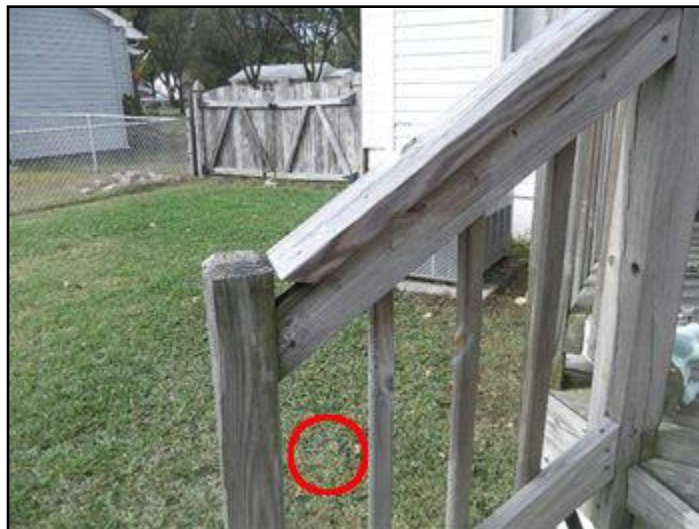
8. Railings

Spindles/balusters on handrail and deck are spaced more than 4 inches apart. This creates a hazard because children can get their head between these and potentially choke.

Spindles/balusters should be removed and spaces less than 4 inches. Use link in the recommendation section to view more information about this.

Install spindles/balusters so they are less than 4 inches apart. You should not be able to get a ball 4 inches in diameter to go between the spindles/balusters.

The estimate is for resetting or replacing these on the steps and the deck.

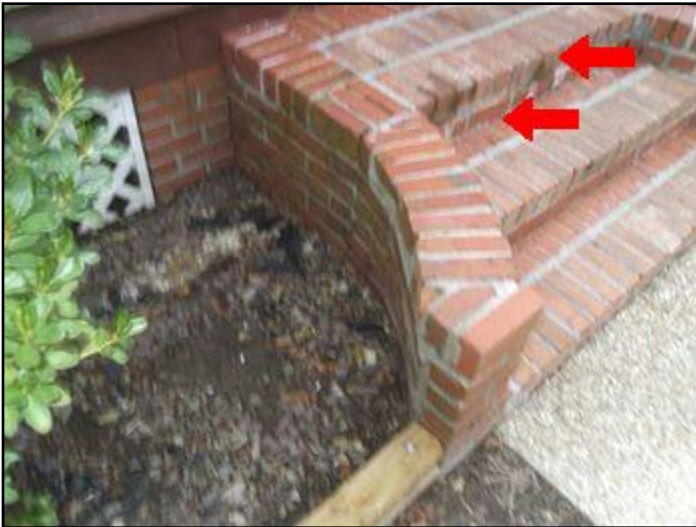
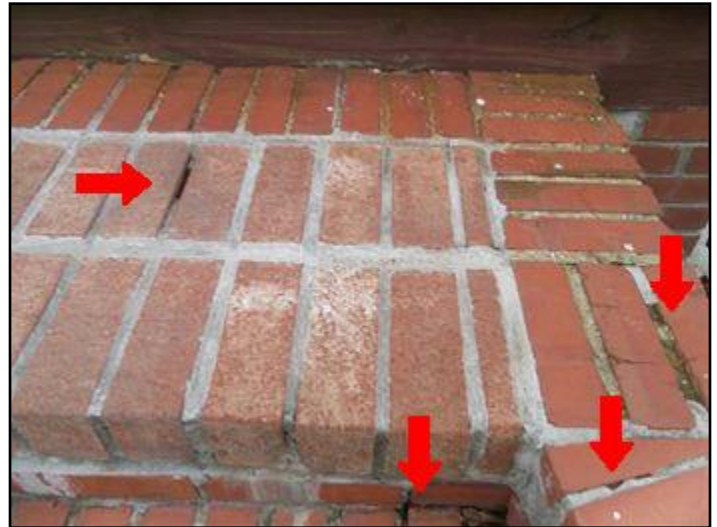
9. Brick front steps

Bricks need to be repointed to stabilize. Estimate \$300

Mortar needs to be repointed in brick step in front of house.

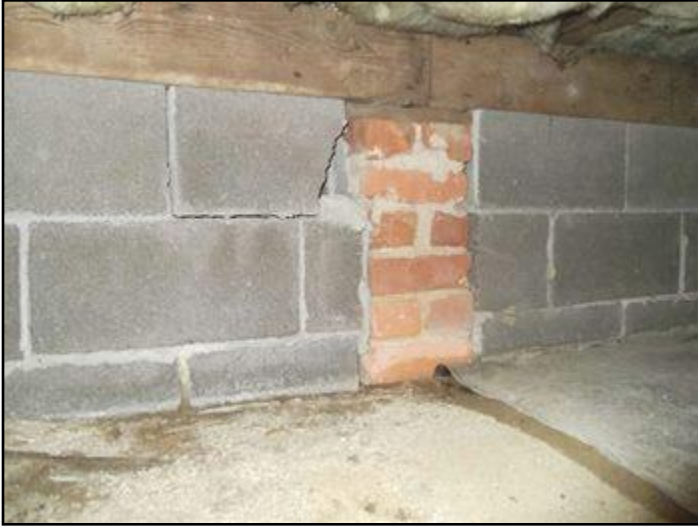
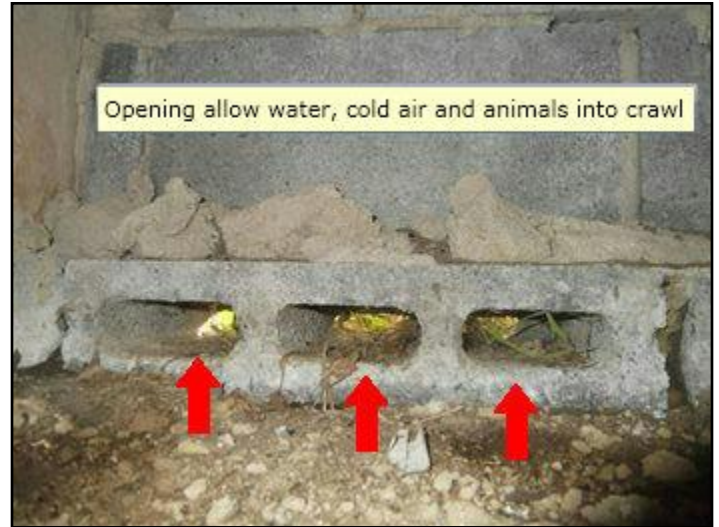
Most of the house is built on brick piers and then the open spaces between were filled with block. The blocks closest to the ground were laid on their side with the opening horizontal to the outside. This could allow water to get under the house. Recommend filling these with mortar to prevent water from entering the crawl space. These opening could also allow small animals to get under the house. It is also not good in the winter when cold air could cause pipes to freeze.

The estimate includes the following, repointing brick piers where mortar is missing, replacing wood piers with block/brick piers, filling openings in the blocks laid on their side to prevent water, air and animals from getting into the crawl space, properly supporting joists that are on the ledger that is not supported well.

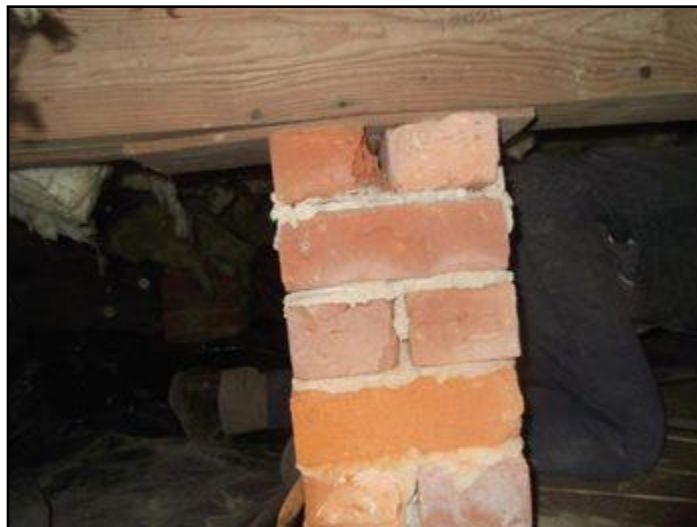
13. Brick repoint

Some brick piers need some repointing to prevent deterioration.

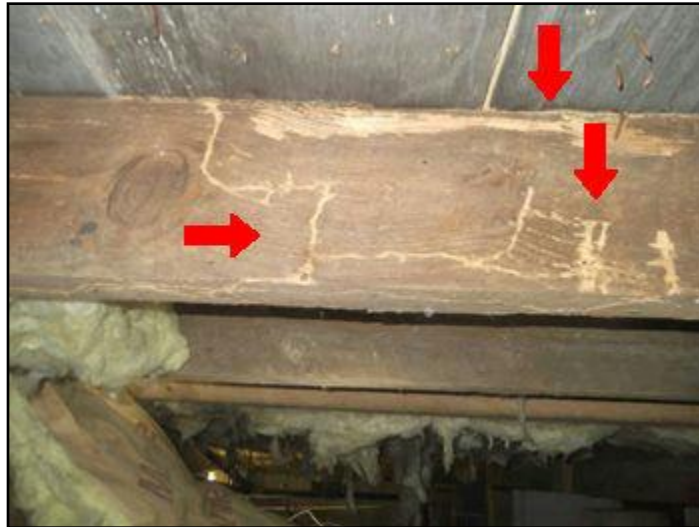
14. Insect evidence

Only spot we saw that has evidence of insects in the past.

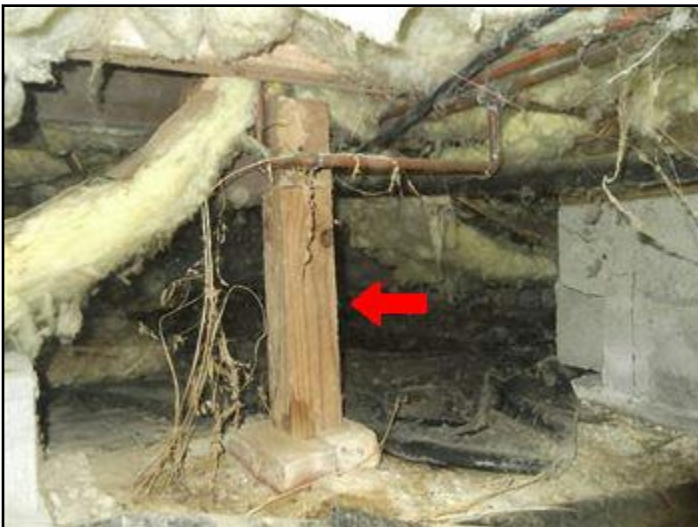
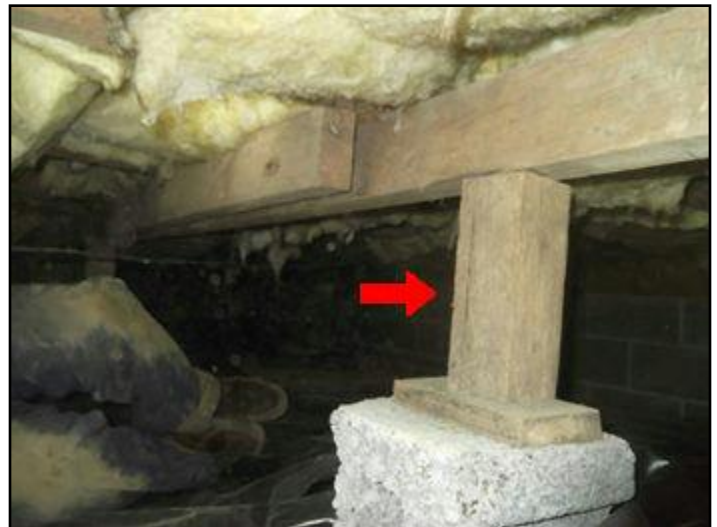
Wood columns are more prone to deteriorate than using brick or block piers.

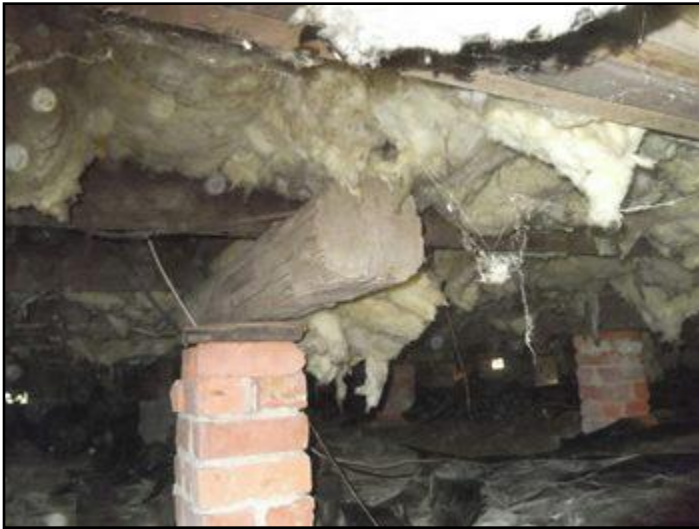
17. Log beam

Log used as a beam to support some floor joists. Another set of joists are not supported properly. A ledger strip is not adequately secure that a number of joists are resting on.

The ledger is partially supported by a small block on top of a pier. This should be corrected with a ledger that is wide enough to support the bottoms of the joists and also rest on top of the pier.

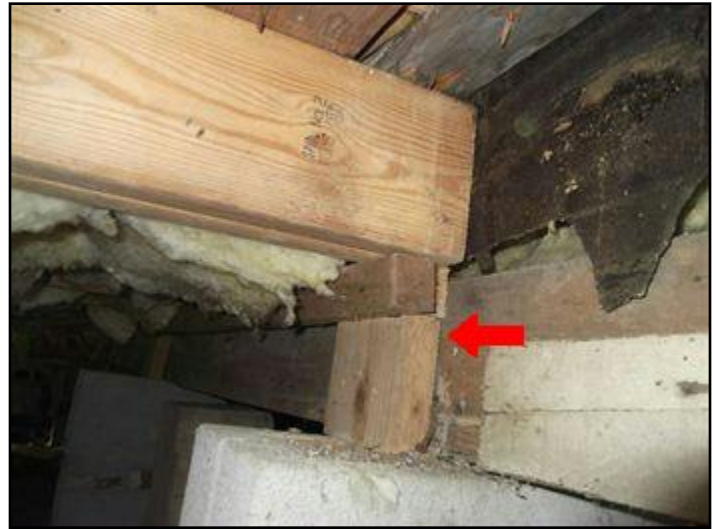
18. Wood joist not supported properly

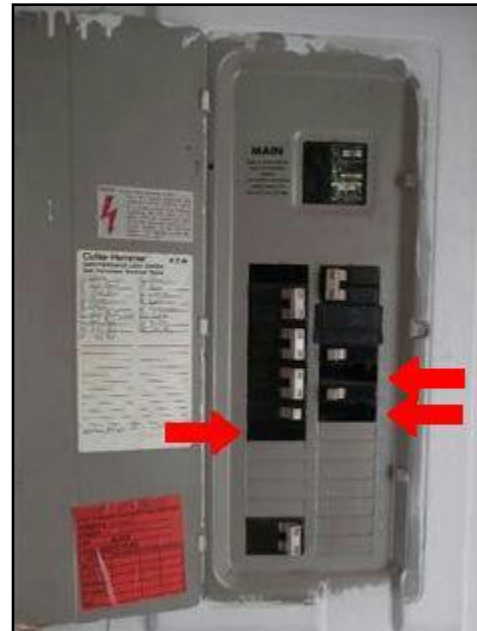
21. 200 amp panel -util rm.

There are three breaker spaces in panel that are not covered - pic 12. Conduit to meter base is not secure to the metal base pic 13. Call Dominion Power to look at this. It should be their responsibility and expense to correct.

5. Condition: • [Unprotected openings](#)

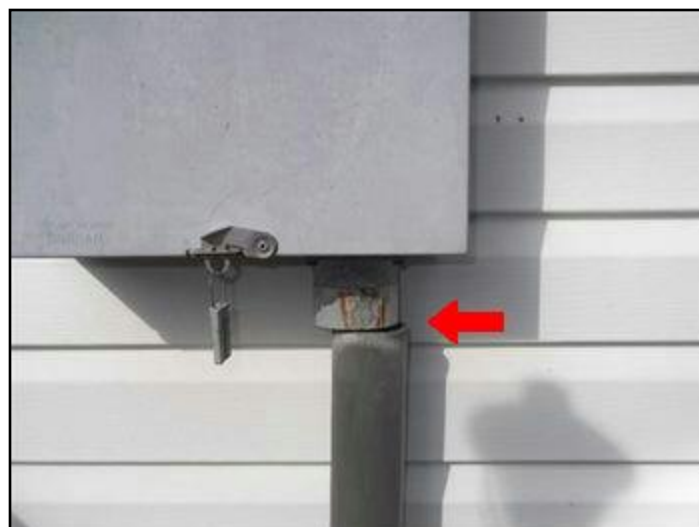
22. Supply to meter base- conduit not secure

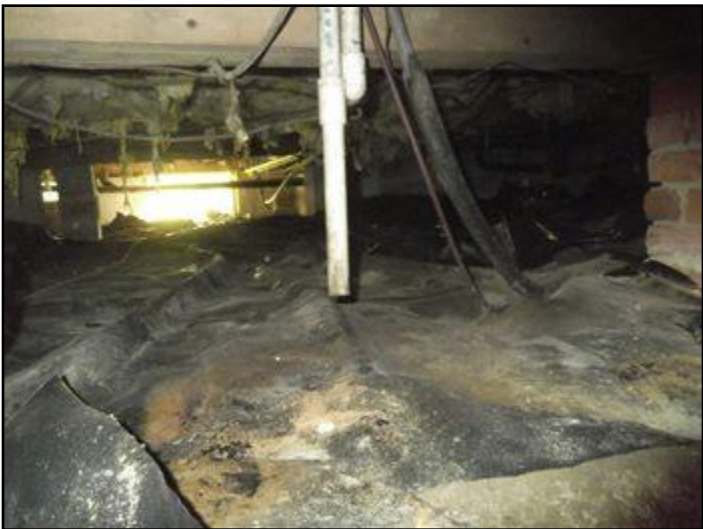
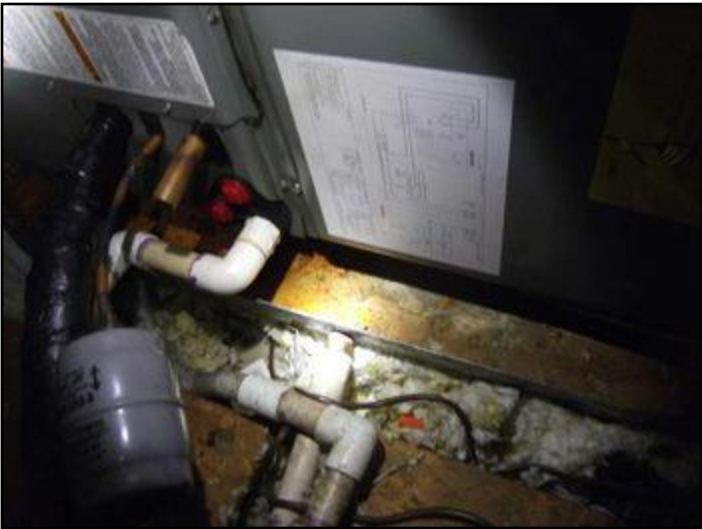
HVAC unit in attic was manufactured in 2008. It has a drain pan under it with a main drain to outside and a back-up that drains into the crawl space (correcting this is included in the cooling recommendations/summary).

27. Hvac attic unit drains into crawl.

6. Condition: • [Improper discharge point](#)

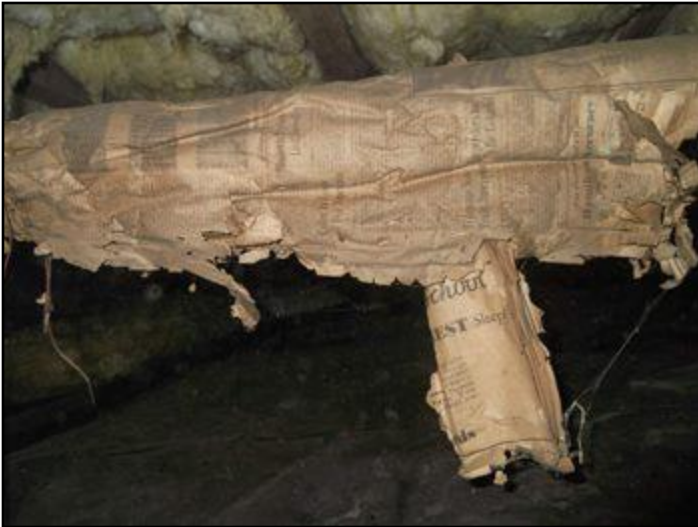
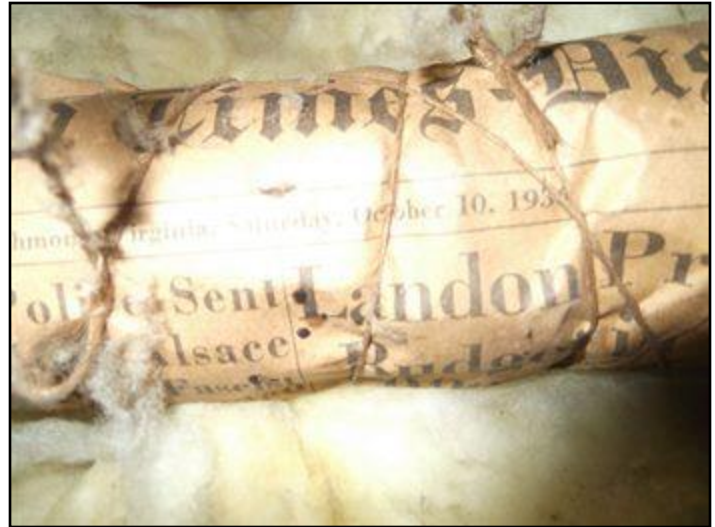
A considerable amount of the copper pipe in the crawl space has old newspaper for insulation. You can see on the one picture a date that appears to be October 10, 1939.

In areas where it is deteriorated it should be replaced with foam insulation.

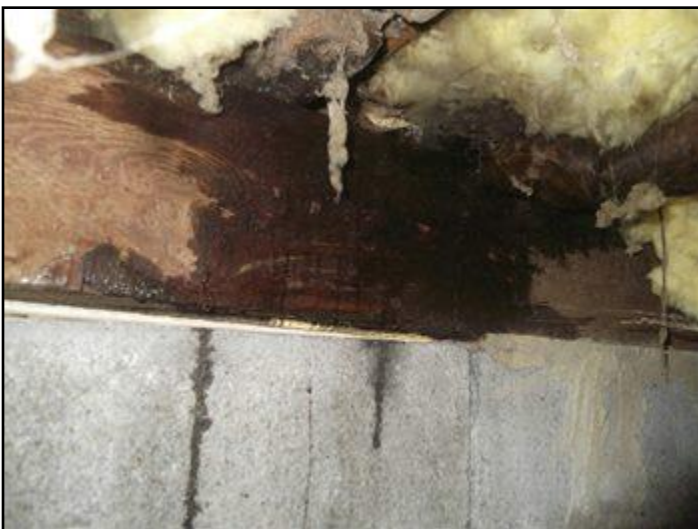
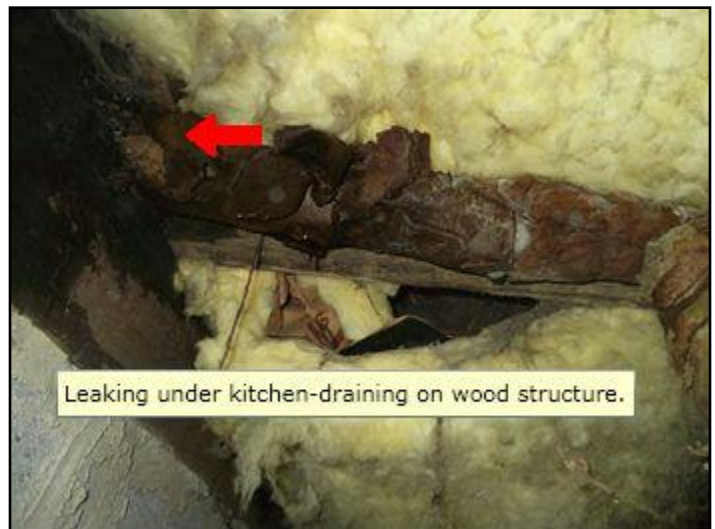
Under the kitchen there is a pipe that has a slow leak. If it continues it will cause damage to the wood floor structure. Estimate it will cost between \$200 - 300.

34. leaking pipe under kitchen

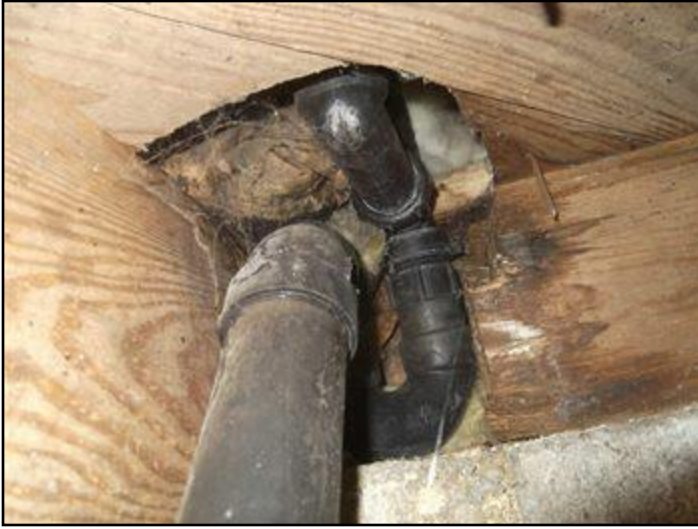
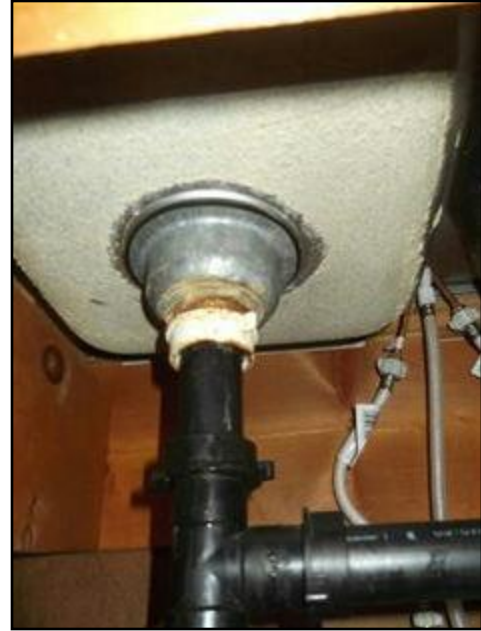
Part of the joist has been cut to get the drain pipe into this tight area. Since the joist is on a pier then it has minimal effect

on the support structure.

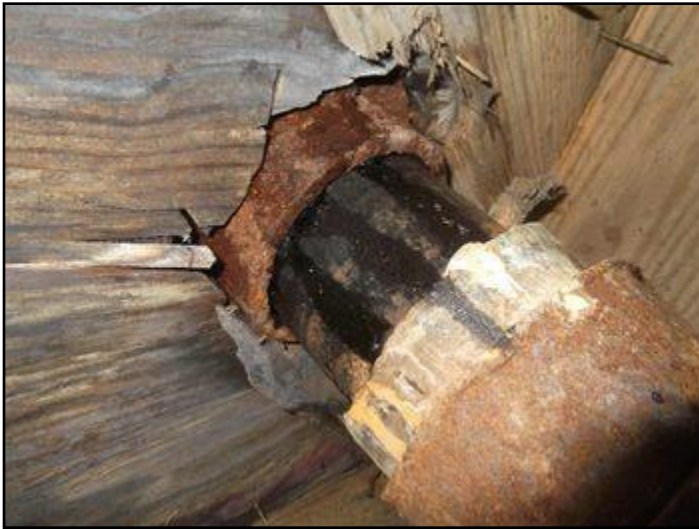
Vinyl is discolored around the toilet. In the crawl space there is a little water around the drain pipe. This cast iron joint is not done properly and has begun to leak. The wood around the joint shows evidence of water damage. The vinyl floor needs to be replaced after repair of wood under the toilet.

40. Area under toilet showing some leakage.

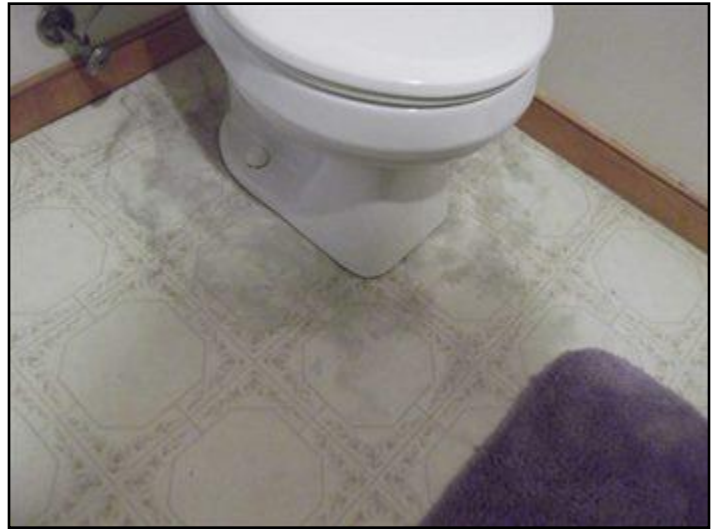
41. Floor damage suspected

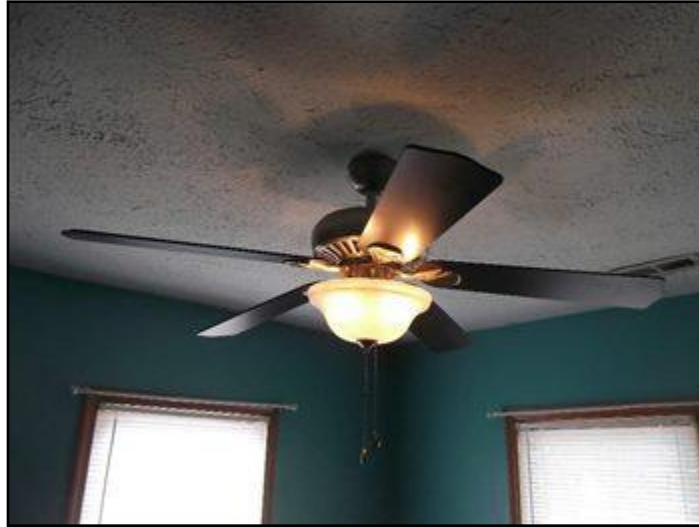
42.

**General:** • Fan in downstairs right side bedroom did not work when the switch or chain was activated. Have an electrician evaluate and fix.

**Task:** Repair or replace

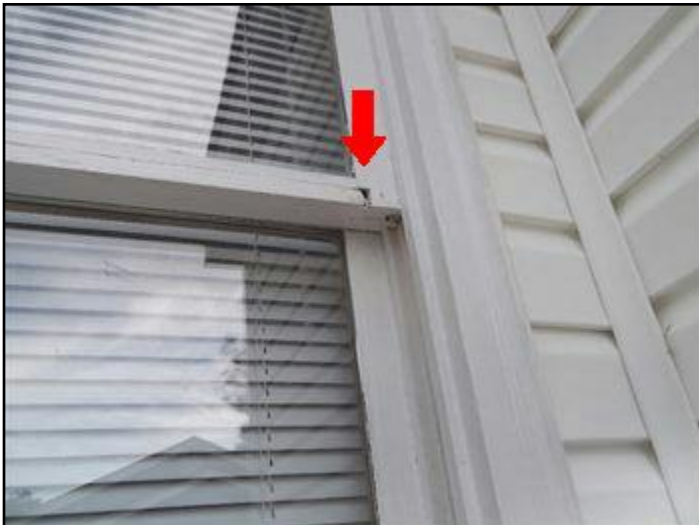
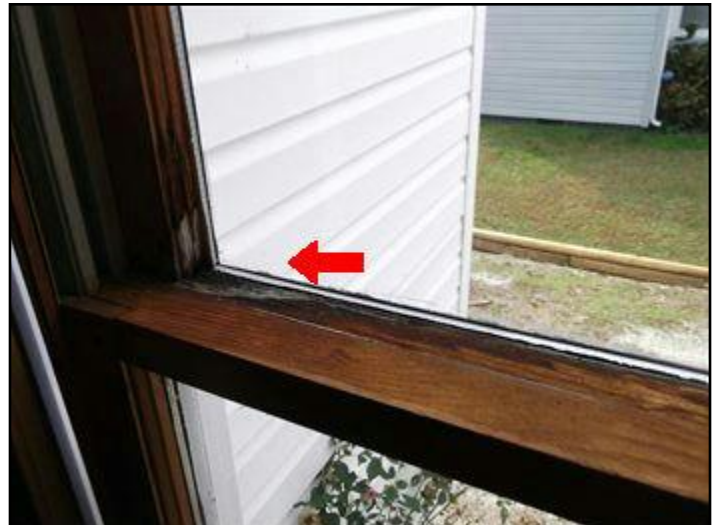
Water has been getting into the joint on this wood sash. Seal the exterior and keep sash painted to prevent water infiltration.

43. Water damage

The window in the downstairs right side of the house has a window that needs the glass sealed and wood repairs so water can not further damage the wood sash.
