YOUR INSPECTION REPORT

demo
demo, VA 11111

Thursday, April 12, 2012

Report No. 1010, v.3

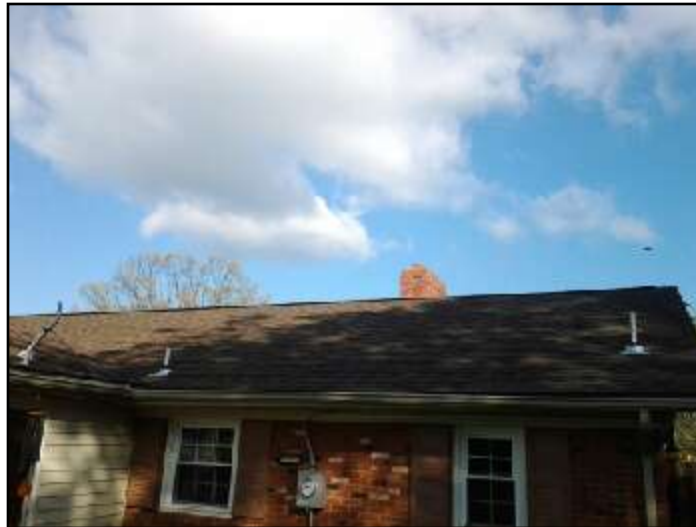
1. Asphalt shingles

1. Condition: • The roof covering material is in a condition that is consistent with its age and method of installation.

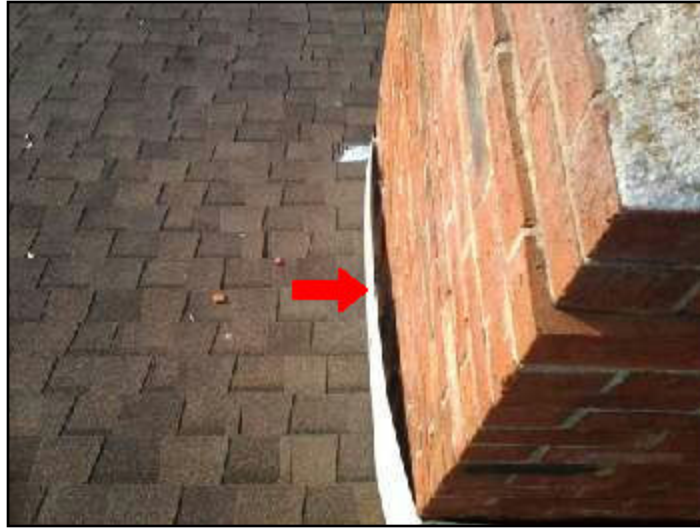
1. Decorative cover flashing not secured properly @ Chimney

2. Condition: • Decorative cover flashing not secured properly

2. Decorative cover flashing not secured...

A licensed and insured contractor should be called to make further evaluation and repairs as needed.

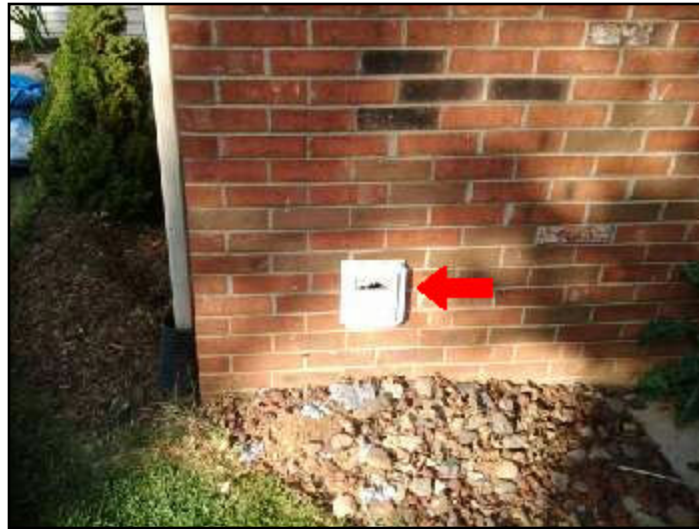
2. Missing dryer vent cover to external exhaust ducting. Repair as needed to prevent nesting or water entry.

3. Condition: • There are missing vent cover(s) to external exhaust ducting at the siding. Repair as needed to prevent nesting or water entry.

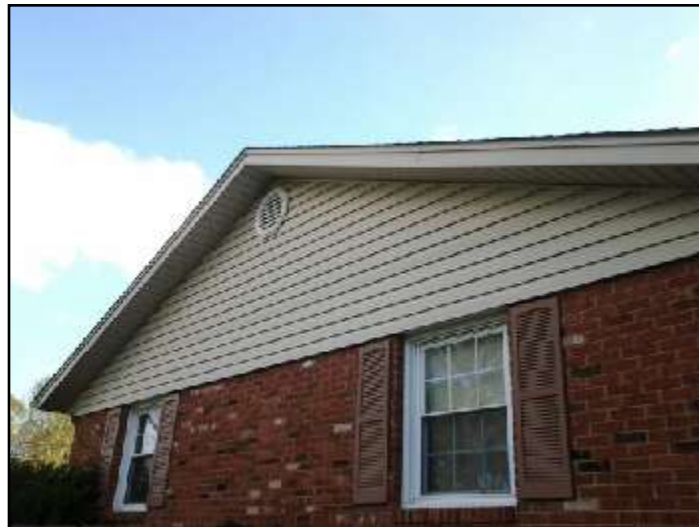
4.

5. Condition: • The siding has been installed properly and is located on both gables of this home.

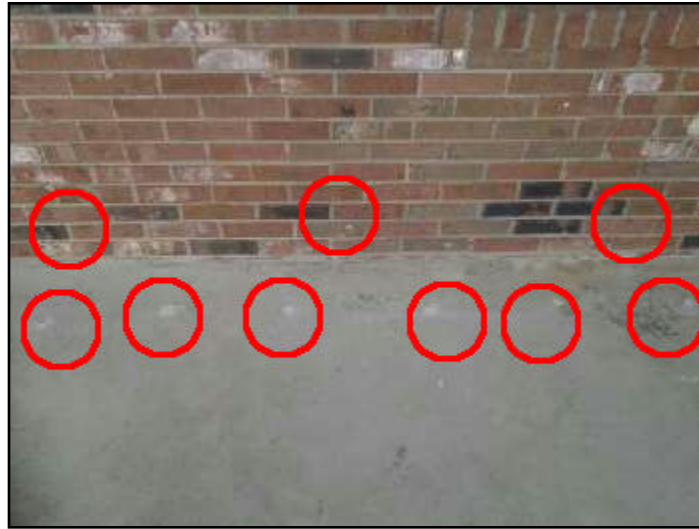
5.

6. Condition: • There is evidence of a termite treatment to the house. Inquire with owner about time and date and warranties if available and applicable. as viewed there are several holes that have been drilled in the brick left of the front door and in the concrete patio.

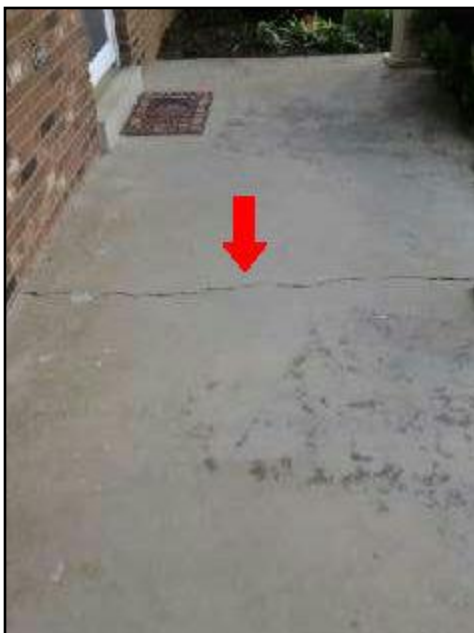
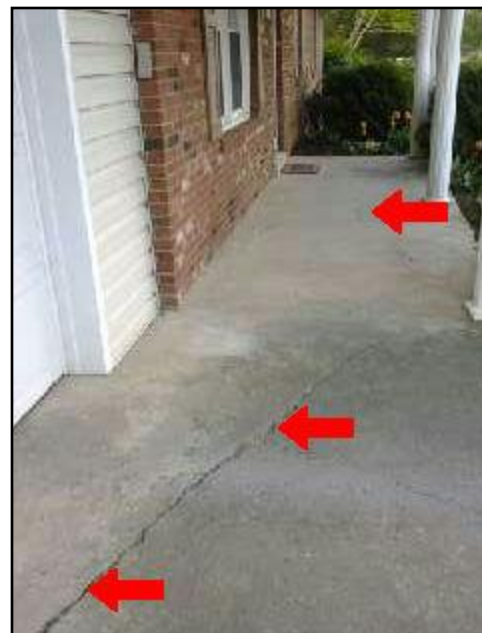
7. Condition: • The patio has cracked and settled. The amount of settlement does not present a safety hazard at this time but does bear monitoring for further settlement. Repairs or replacement of the patio may be required in the future if movement is ongoing.

6. Concrete cracked

7. Concrete cracked

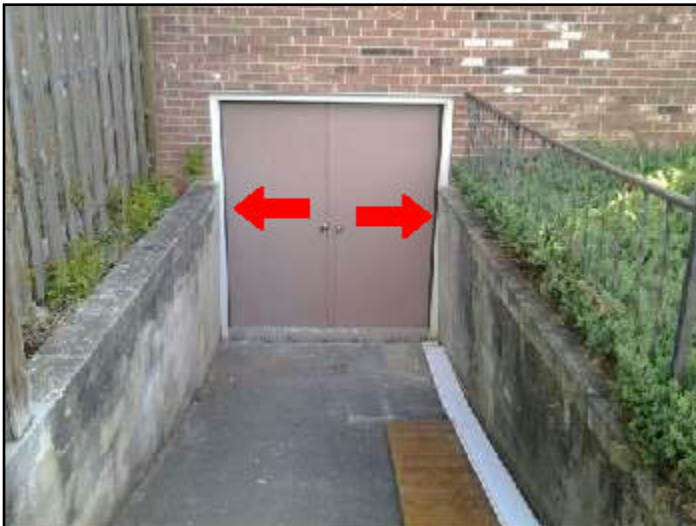
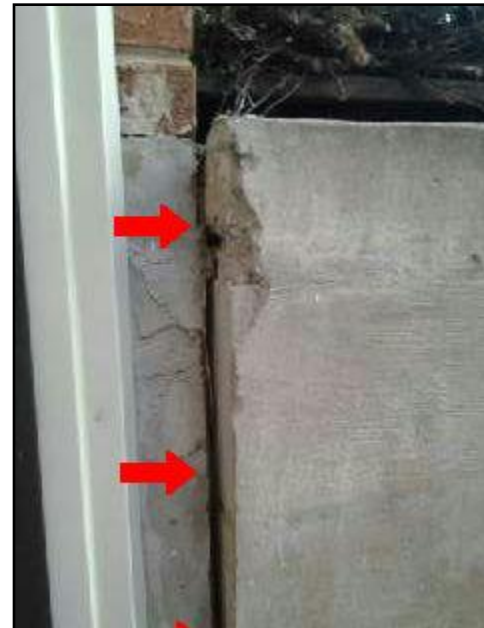
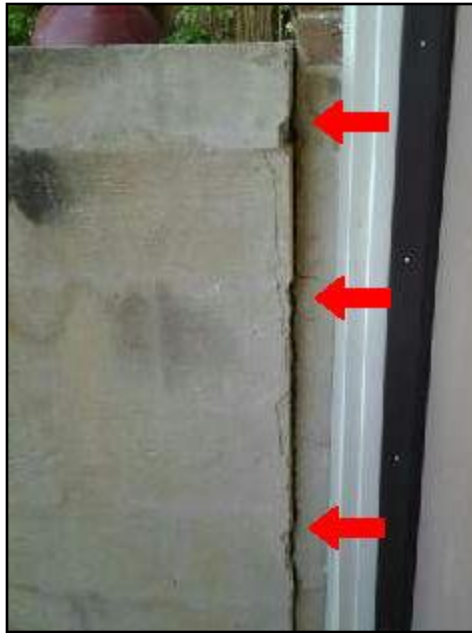
3. Varying settlement conditions exist i.e. rotation, bulging, or settlement present in areas of retaining wall @ Areaway

9. Condition: • Varying settlement conditions exist i.e. rotation, bulging, or settlement present in areas of retaining wall.

8. Concrete

9. Concrete

10. Concrete

A licensed and insured contractor should be called to make further evaluation and repairs as needed.

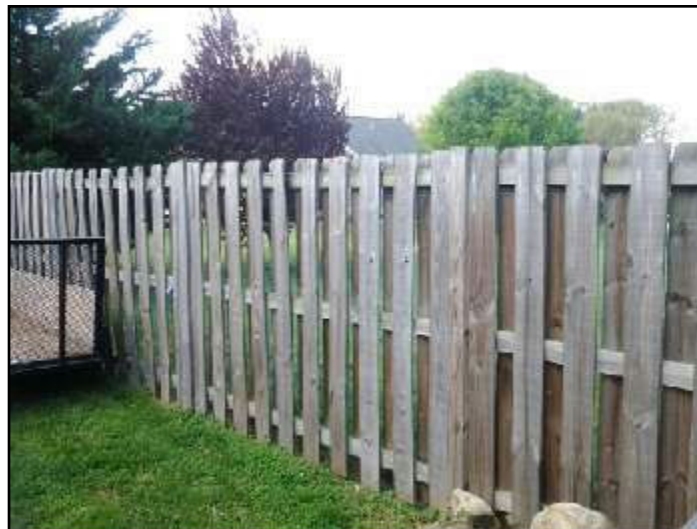
11.

10. Condition: • Deteriorated

Minor defects present in fencing represents the need for regular maintenance now and annually.

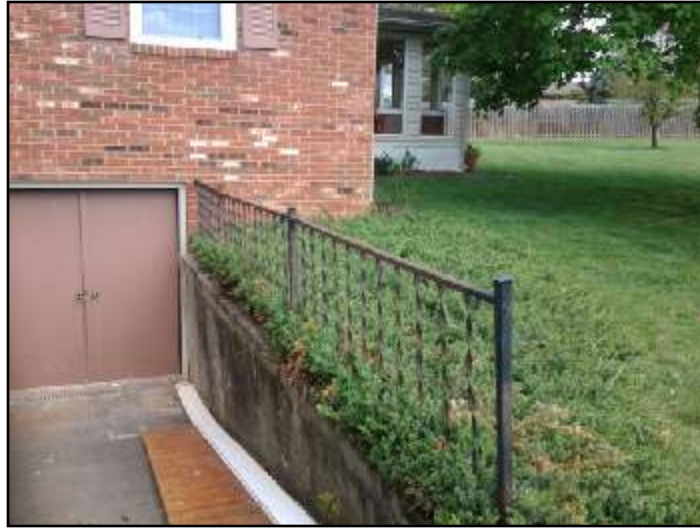
12.

11. Condition: • Rust

Wrought iron rails exhibit rust. Rails need wire-brushing and painting with a rust-inhibiting paint.

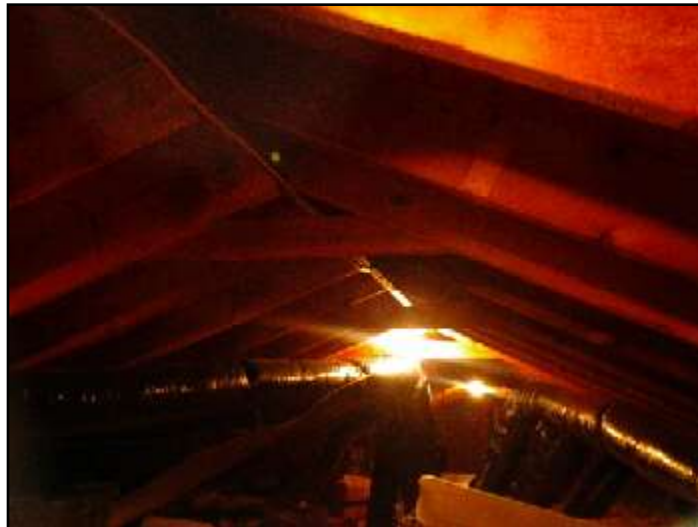
13.

15. Condition: • The attic cavity is large enough and sheathed so that a large amount of storage is available. Be sure to contact an engineer or licensed contractor for a thorough evaluation of feasibility as the flooring may not be able to hold large loads.

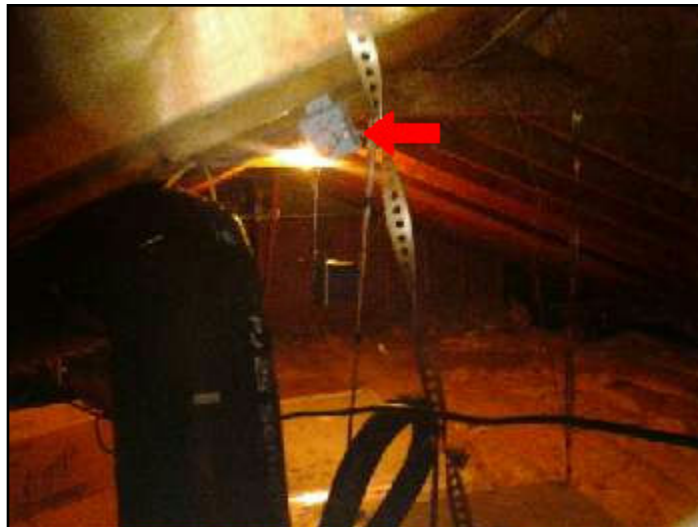
14.

4. There are exposed connections in the attic over the A/C unit. All electrical connections should be done inside a protective junction box.

16. • There are exposed connections in the attic over the A/C unit. All electrical connections should be done inside a protective junction box.

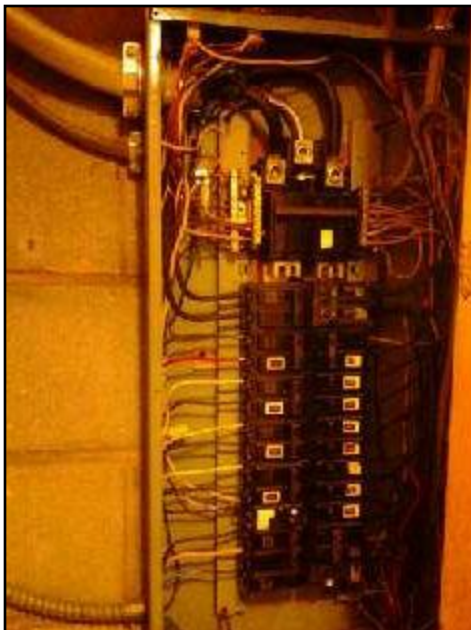
15.

17. Condition: • Breakers - The structure is equipped with a breaker type main power panel. This is the desirable type; when a breaker trips off, it can easily be reset.

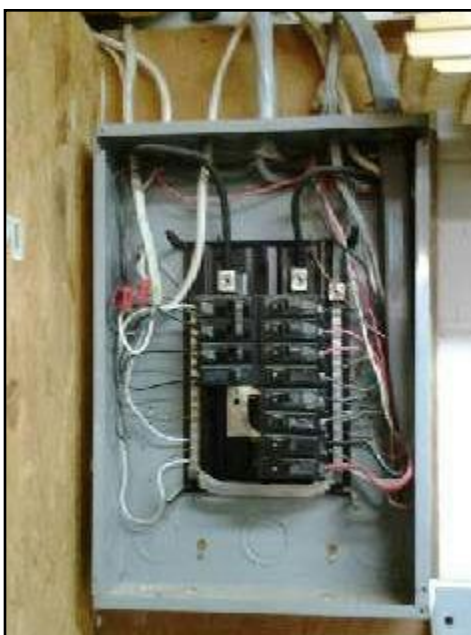
16.

18. Condition: • The service panel located in the workshop is listed and marked for the basement areas and hot tub breaker

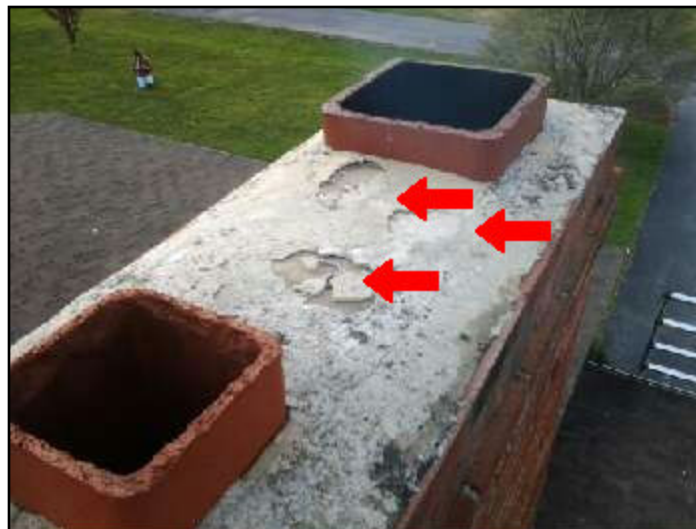
6. Attention Needed - This masonry cap has cracks and aged conditions that require repair or replacement to function as intended, which is to keep water from entering the masonry stack causing deterioration.

23. Condition: • Attention Needed - This masonry cap has cracks and aged conditions that require repair or replacement to function as intended, which is to keep water from entering the masonry stack causing deterioration.

17. Cracked

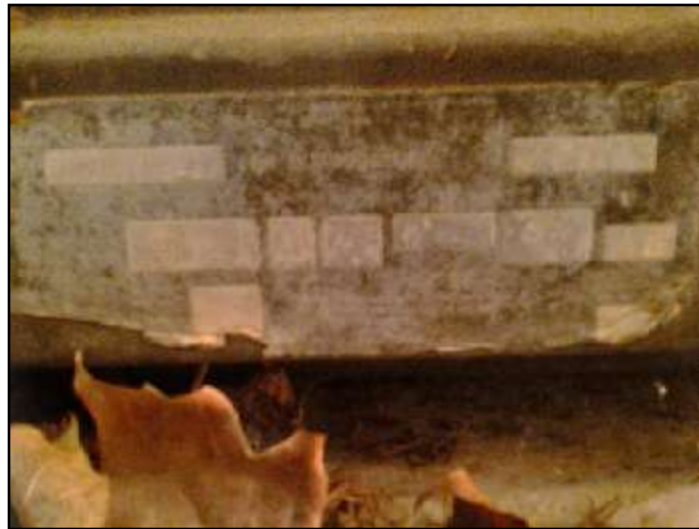
System data plate:

18. Not legible

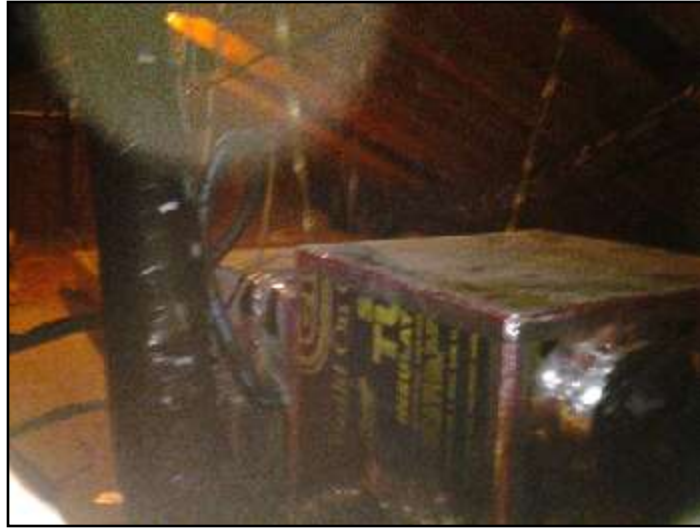
19.

The A/C unit did not function using normal controls. Evaluation of the air conditioning system for repair or replacement is indicated. The non functioning system prohibited a complete inspection of the air conditioning system.

26. Condition: • The A/C unit did not function using normal controls. Evaluation of the air conditioning system for repair or replacement is indicated. The non functioning system prohibited a complete inspection of the air conditioning system.

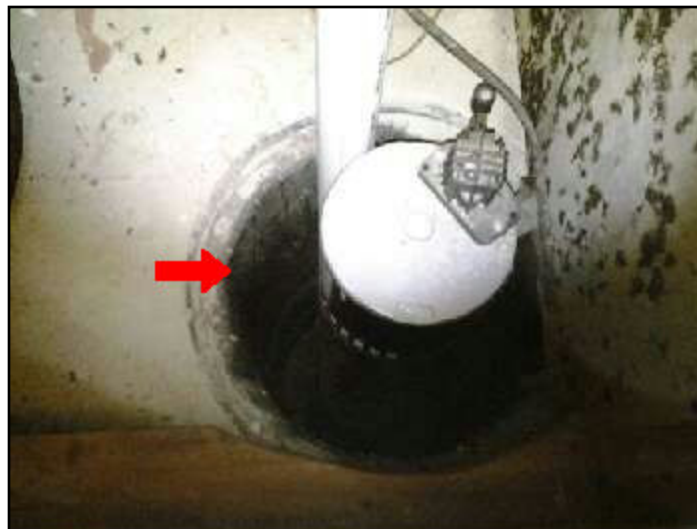
28. Condition: • Lid missing, rotted or not secure

The lid for the sump pump is not installed and can cause a damp area such as seen in the photo with mildew present at time of inspection

20. Lid missing, rotted or not secure

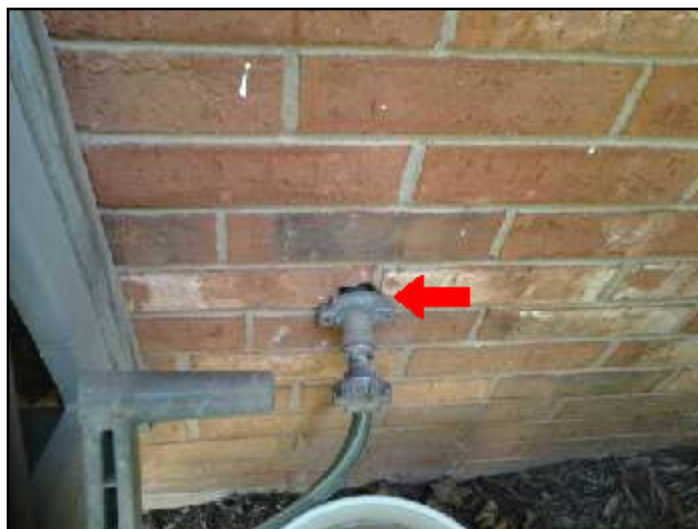
21.

8. The hose-bib(s) is loose at the wall and needs to be properly secured & sealed to the wall

29. Condition: • The hose-bib(s) is loose at the wall and needs to be properly secured & sealed to the wall

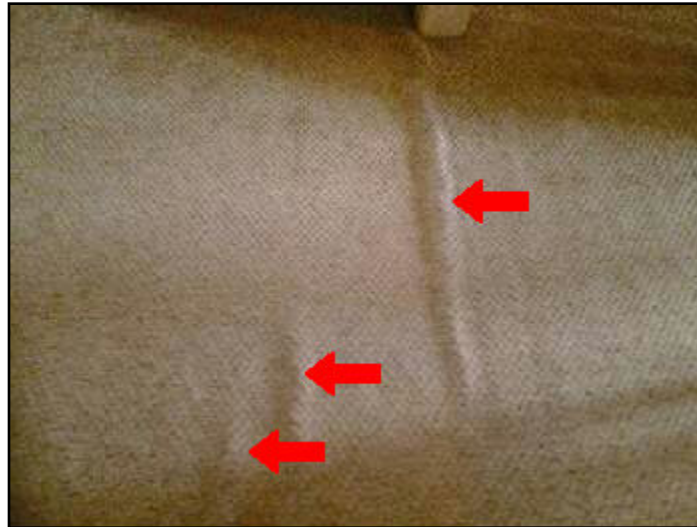
9. Carpet - There is a considerable sag or movement noted in the floors that needs to have a determination of the cause and the course of action. Repairs are needed.

30. Condition: • Buckled

Action Necessary - There is a considerable sag or movement noted in the floors that needs to have a determination of the cause and the course of action. Repairs are needed.

22. Buckled

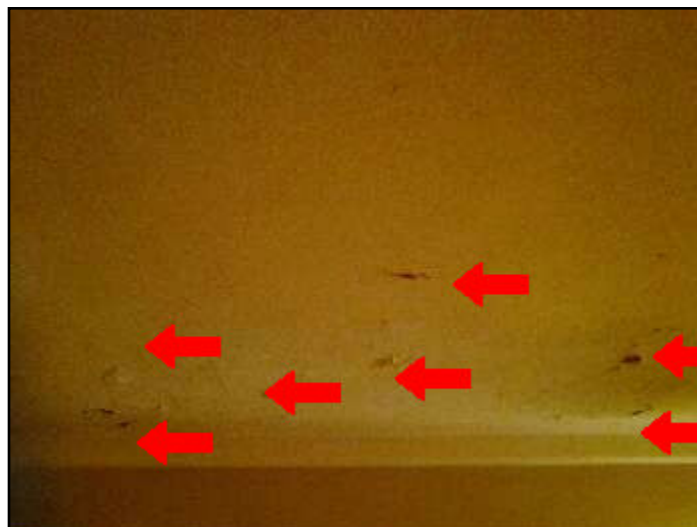
10. The Ceiling in the master bedroom near the master bath texture is crumbling as due to moisture coming out of the bathroom - Recommend installing a fan in the master bath to prevent further moisture damage to the ceilings

31. Condition: • Crumbly or powdery

The Ceiling in the master bedroom near the master bath texture is crumbling as due to moisture coming out of the bathroom - Recommend installing a fan in the master bath to prevent further moisture damage to the ceilings

23. Stucco/texture/stipple

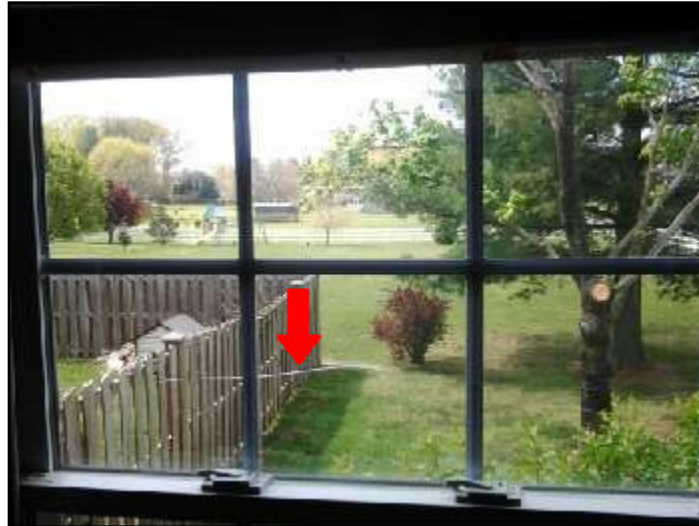
11. There is at least one broken window pane. Repair as needed. @ Front right bedroom.

32. Condition: • There is at least one broken window pane. Repair as needed.

24. Broken
