INSPECTION REPORT

For the Property at:
123 ANY ST.
ANY TOWN, ON

Prepared for: SAMPLE REPORT
Inspection Date: Tuesday, March 4, 2008
Prepared by: Wayne Fulton

RE: Report No. 1483
123 Any St.
Any Town, ON

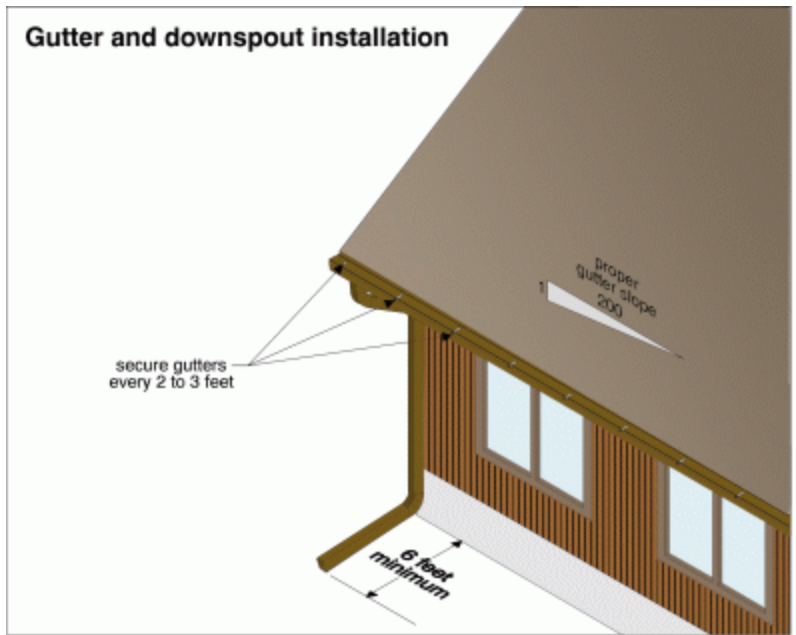
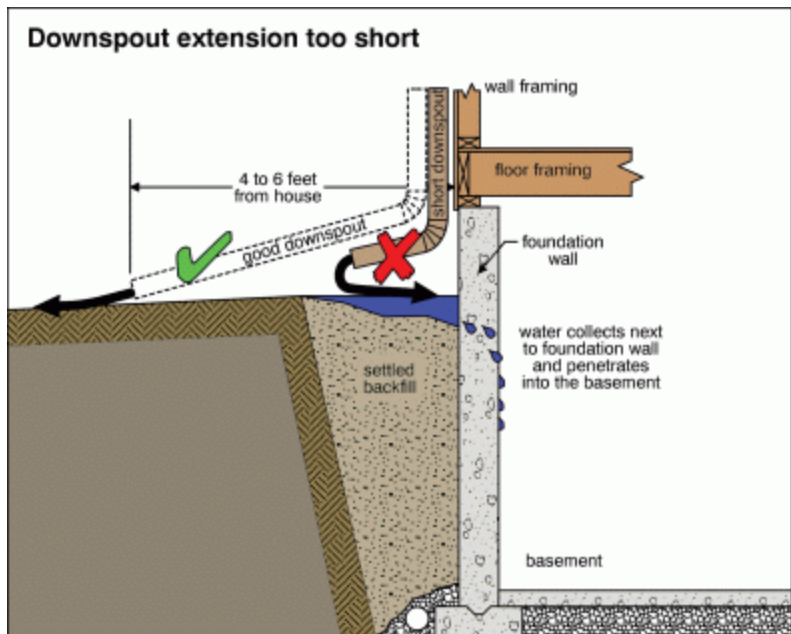
Condition: • [Downspouts end too close to building](#)

Implication(s): Chance of water damage to contents, finishes and/or structure

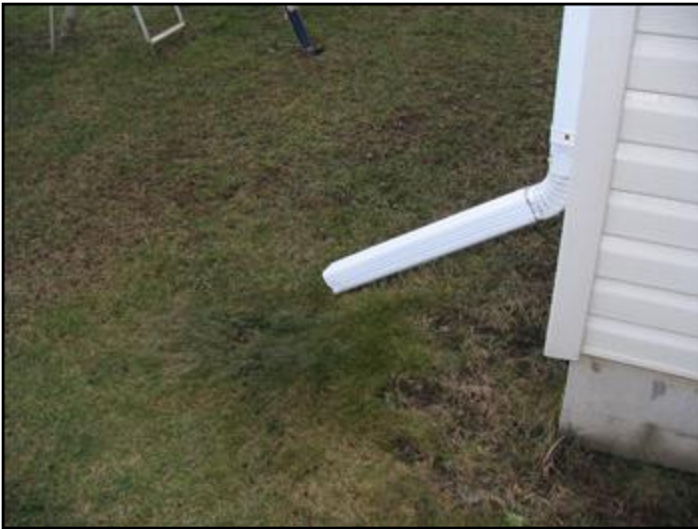
1. Extend away from home

Condition: • Should discharge 6ft. from home

Implication(s): Chance of water damage to contents, finishes and/or structure

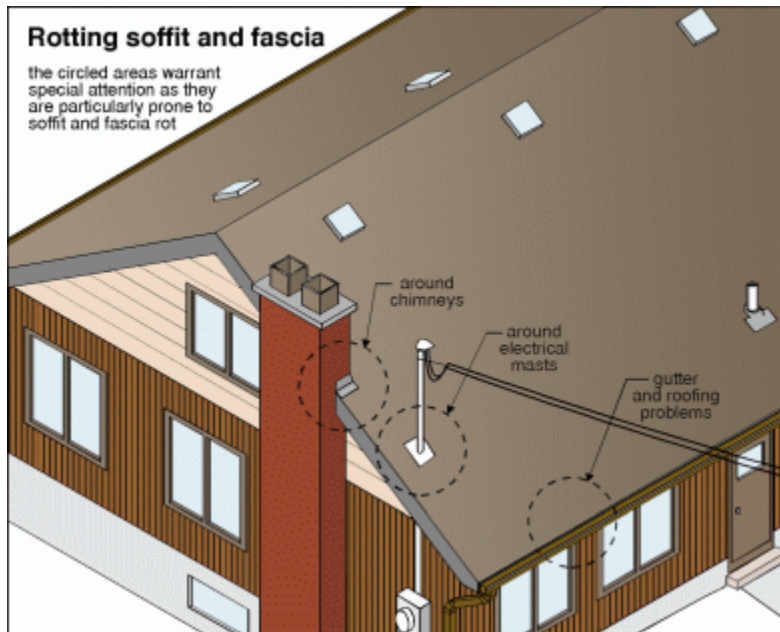
Condition: • [Loose or missing pieces](#)

Implication(s): Cosmetic defects | Chance of water damage to contents, finishes and/or structure | Chance of pests entering house

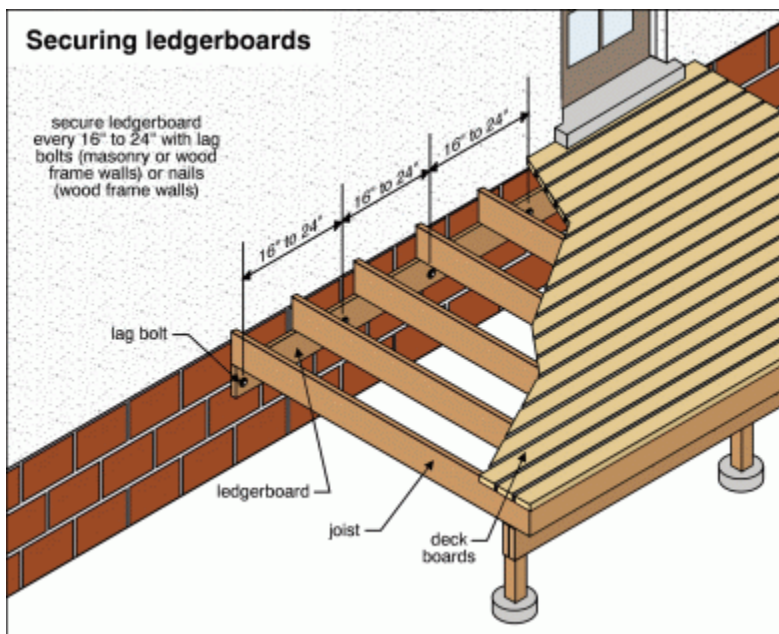
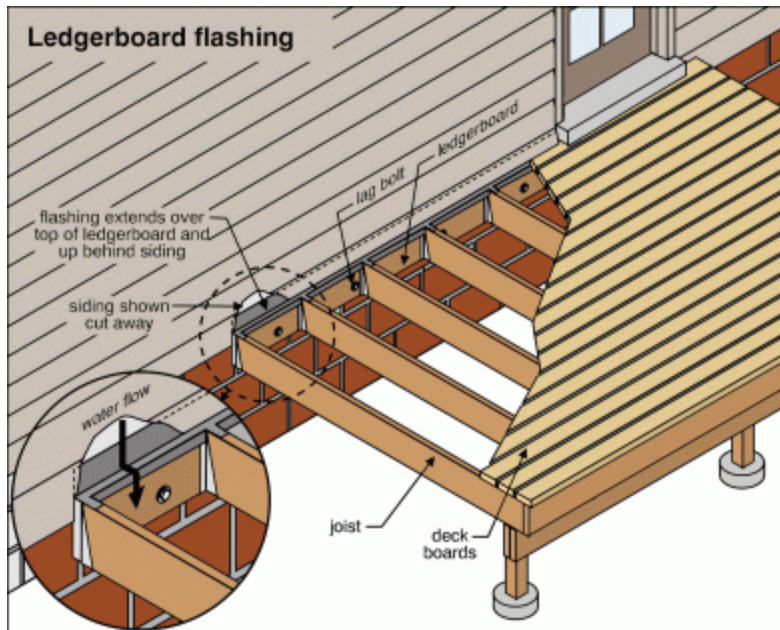
Condition: • The ledger board of the elevated deck has been poorly attached to the house. This type of installation is considered unsafe. Every year, hundreds of people in the U.S.A. and Canada are injured, and some killed, when poorly secured elevated decks detach and collapse with large group of people standing on them, such as at parties. Deck ledgers need to be attached directly to the band joist, not the siding, with lag bolts and washers. I recommend having this installation corrected by a competent carpenter.

Condition: • [Ledgerboard problems](#)

Implication(s): Weakened structure | Chance of movement

Note: Ledgerboards are required to be bolted or lagged to structure; Correct upon taking possession.

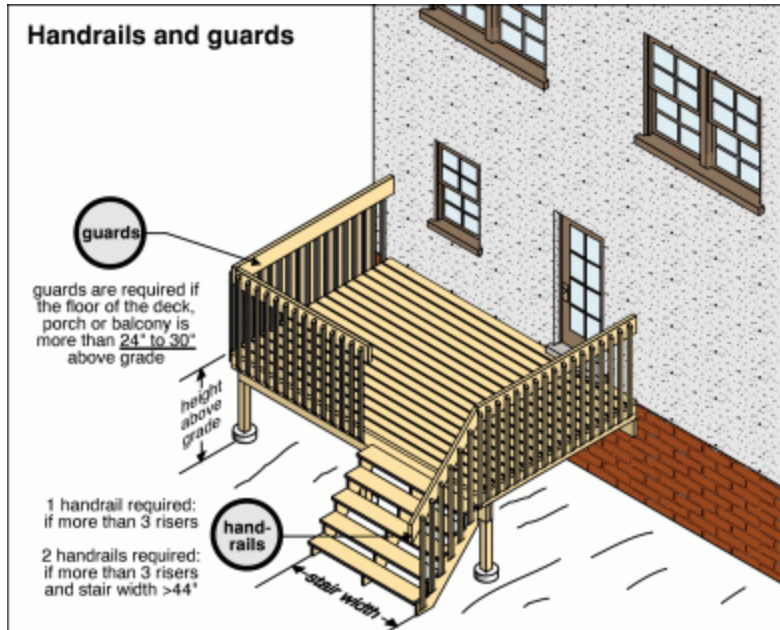
Condition: • [Missing](#)

Implication(s): Fall hazard

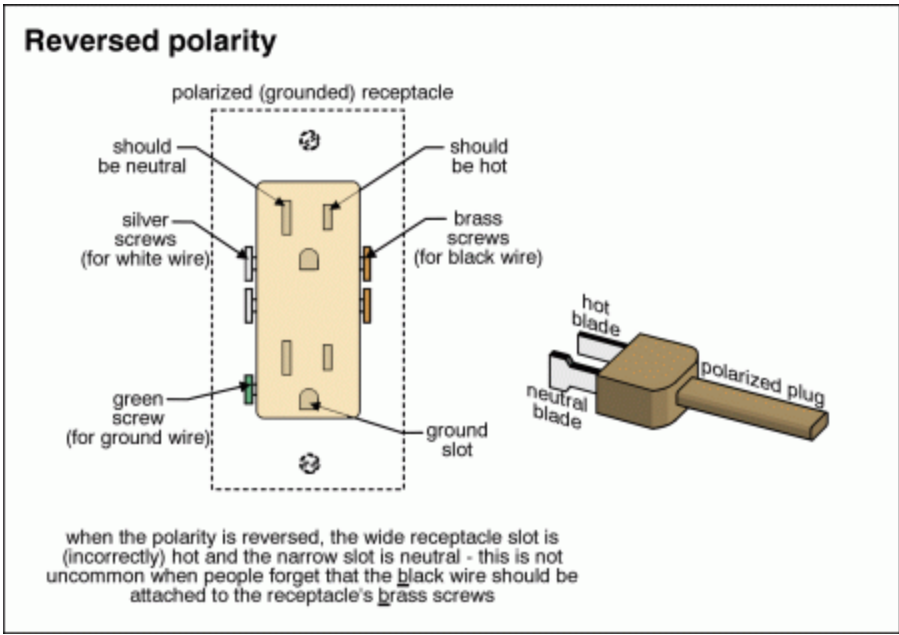
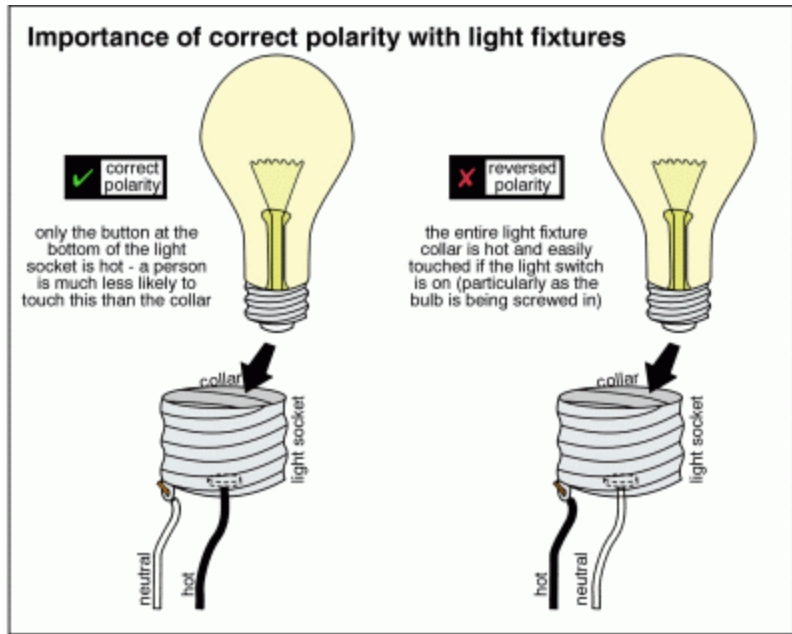
Distribution system \ Outlets
Condition: • GFCI's are recommended in all bathrooms, laundry area, pump outlets. outside outlets and where outlets in kitchen are within 24" of sink.
Condition: • There is one or more outlets in this home that when tested had reversed polarity. Reversed polarity is a life/safety hazard. It means that any appliance plugged into an outlet with reversed polarity has power passing through the device before reaching the on/off switch. Under certain conditions, anyone touching a device with reversed polarity can inadvertently provide a ground path for current and be electrocuted. I recommend immediate correction by an electrician. And, until this is corrected, I dont recommend plugging any device into any effected receptacle.
Condition: • [Reversed polarity](#)
Implication(s): Electric shock
Location: Basement work shop
Task: Correct
Time: Immediate

Condition: • [No GFI \(Ground Fault Interrupter\)](#)

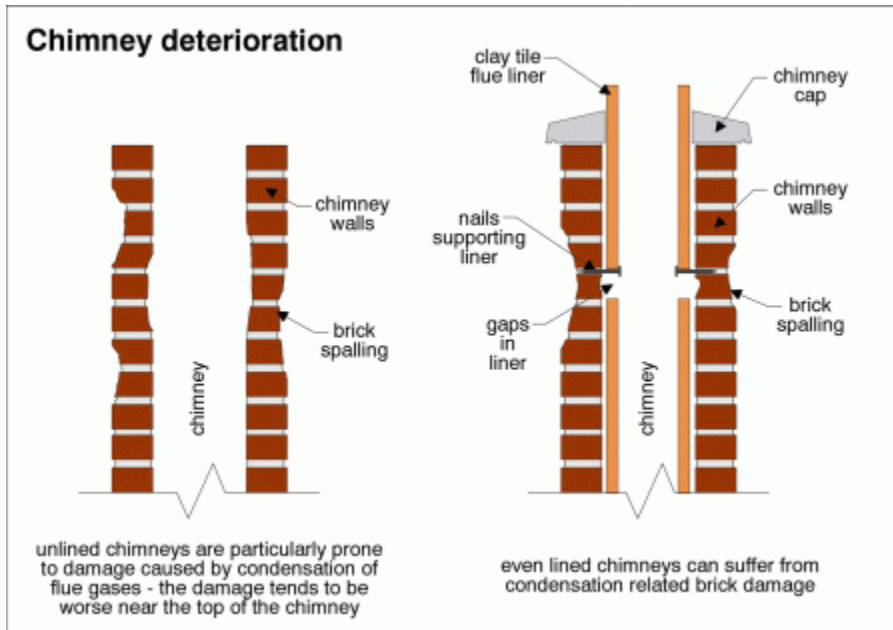
Condition: • [Spalling](#)

Implication(s): Material deterioration

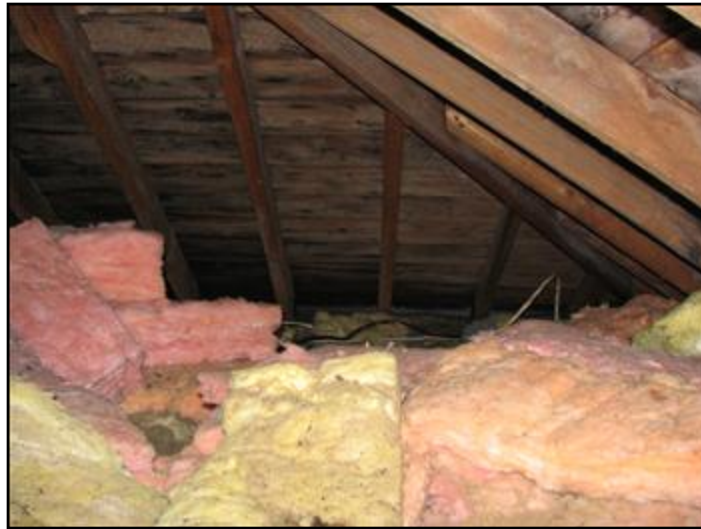
9. Correct

Condition: • [Gaps or voids](#)

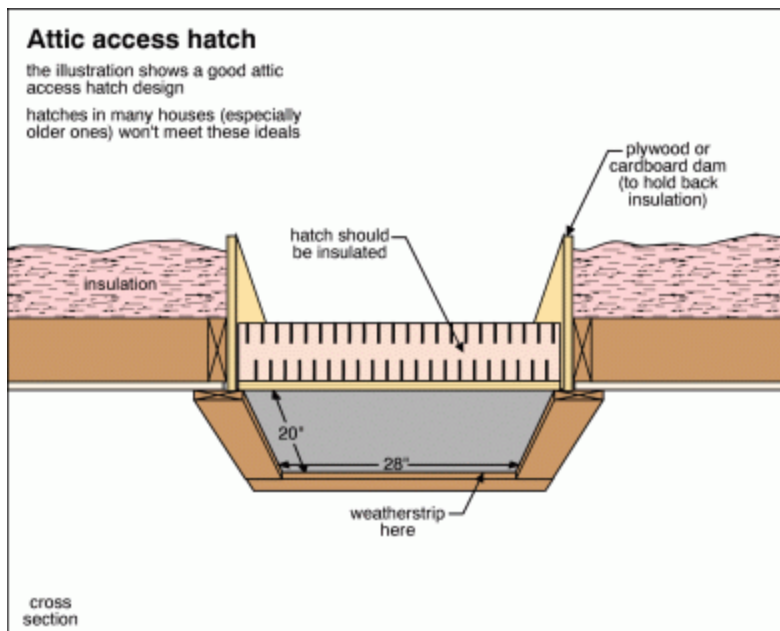
Condition: • [Not insulated and not weatherstripped](#)

Implication(s): Chance of condensation damage to finishes and/or structure | Increased heating and cooling costs | Reduced comfort

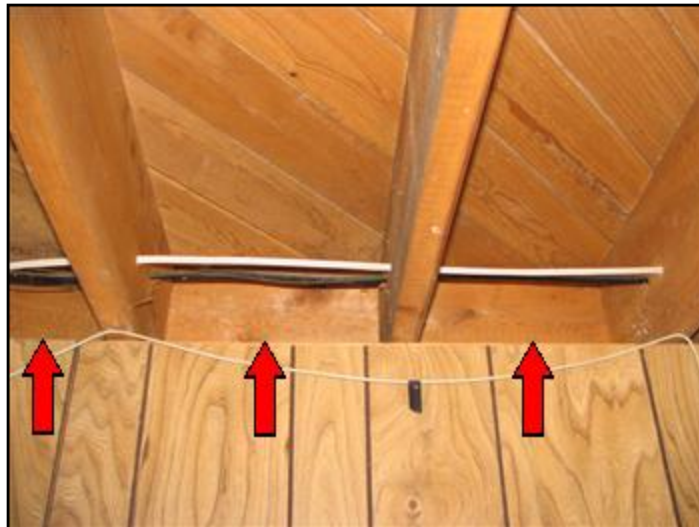
Condition: • [None at rim joist](#)

10. *Insulate this area*

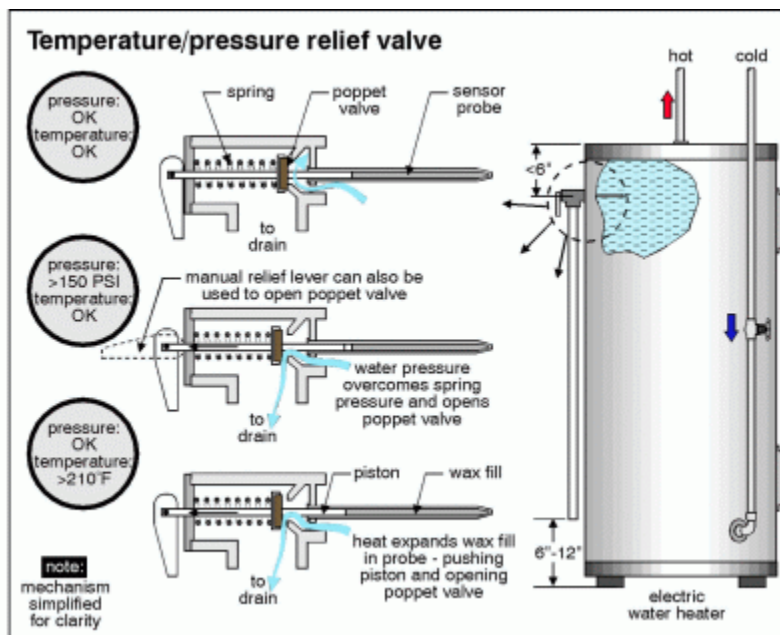
Condition: • [Discharge tube missing](#)

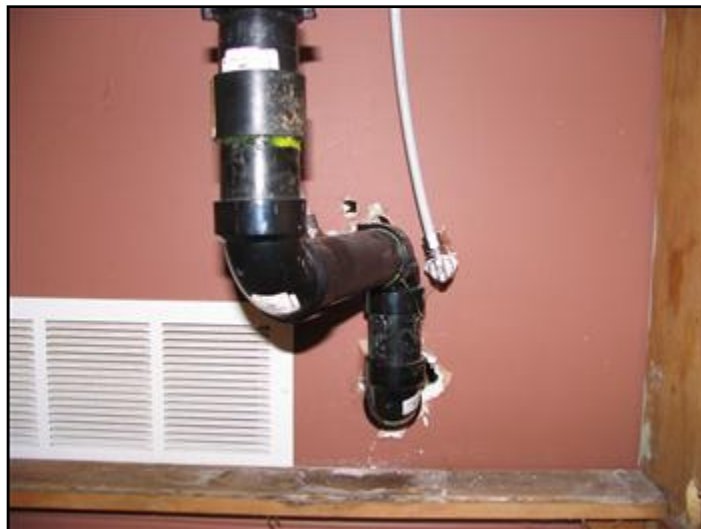
Condition: • [Missing](#)

12. Trap required

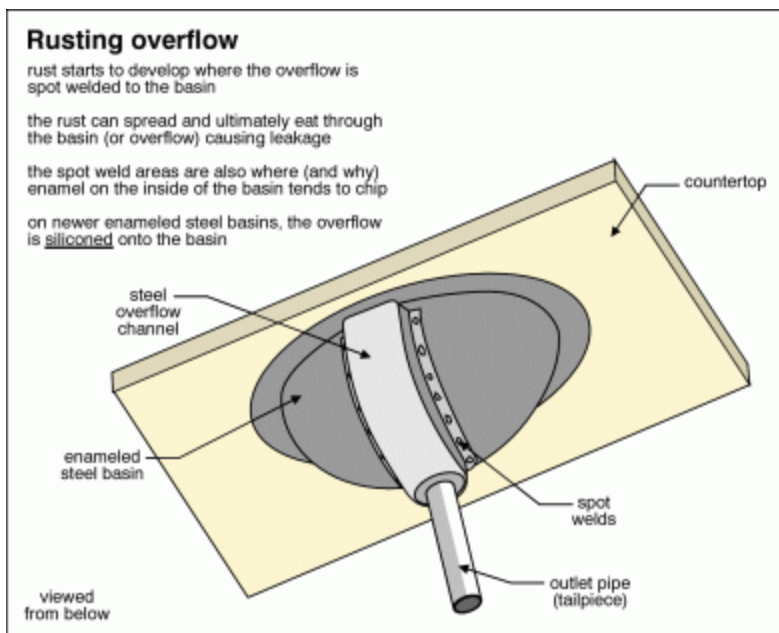
Condition: • [Overflows missing, leak, rust or inappropriate](#)

Implication(s): Chance of water damage to contents, finishes and/or structure

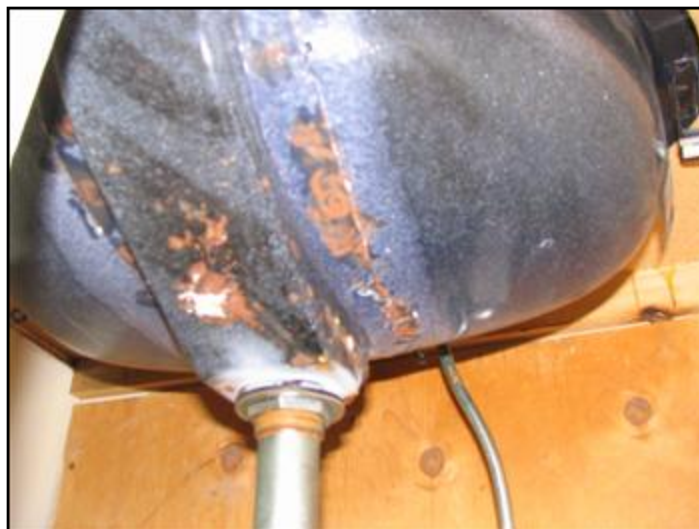
13. Replacement recommended

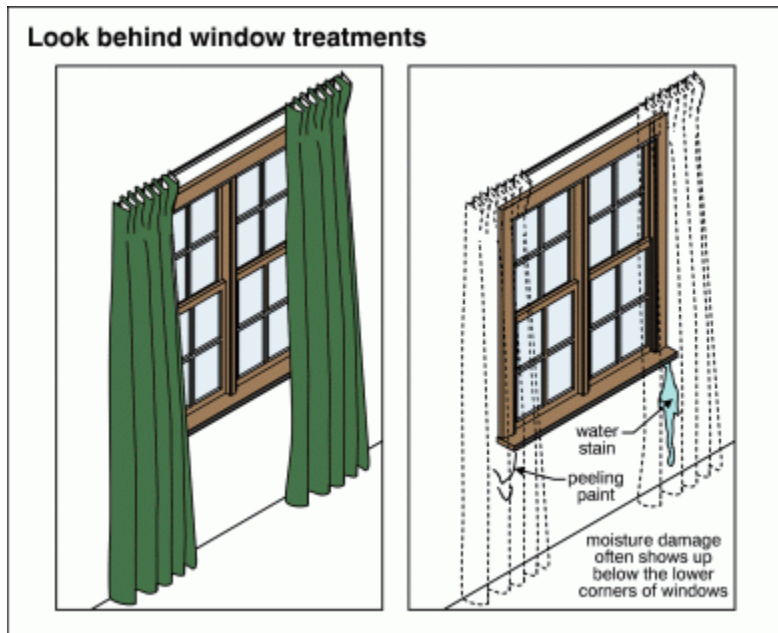
Condition: • [Stained](#)

Note: The dining room windows have excessive staining, there is no evidence of rot or deterioration, cleaning is recommended.

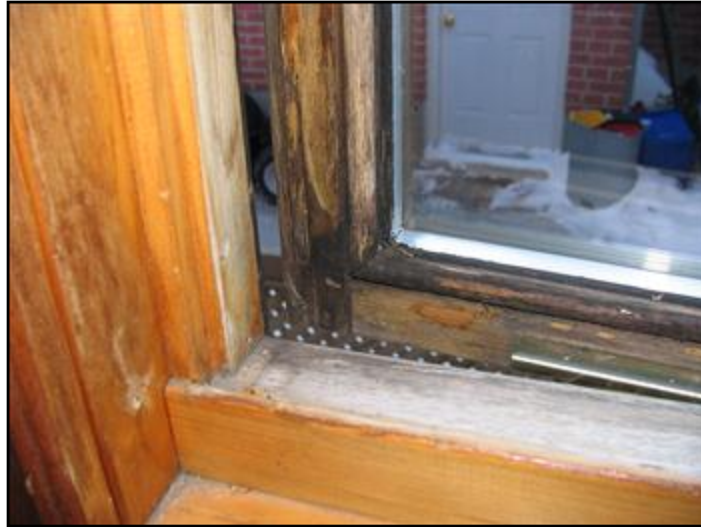
14. Stain damage

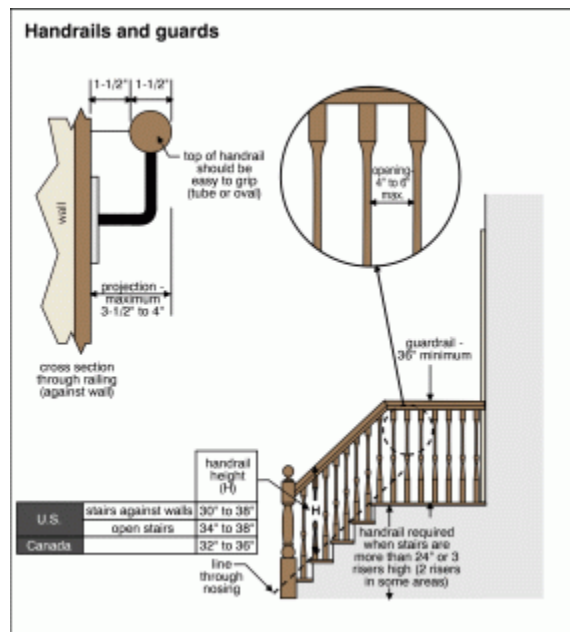
Condition: • [Missing](#)

Implication(s): Fall hazard

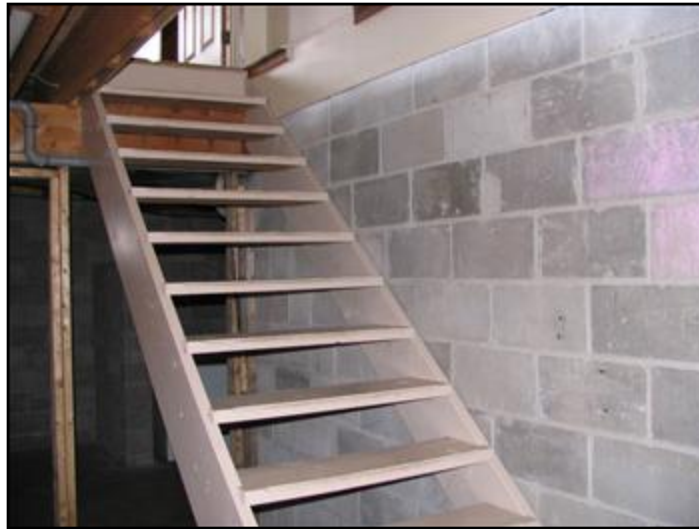
15. Handrail required

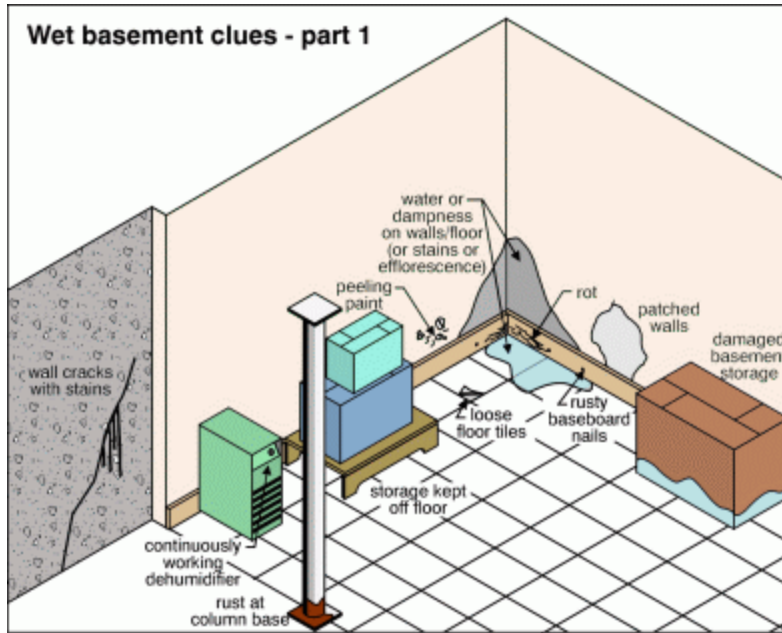
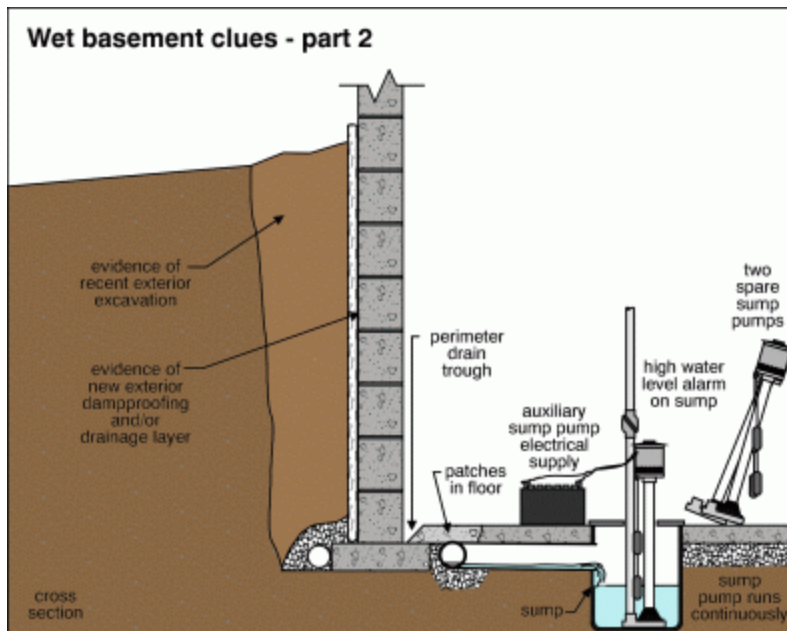
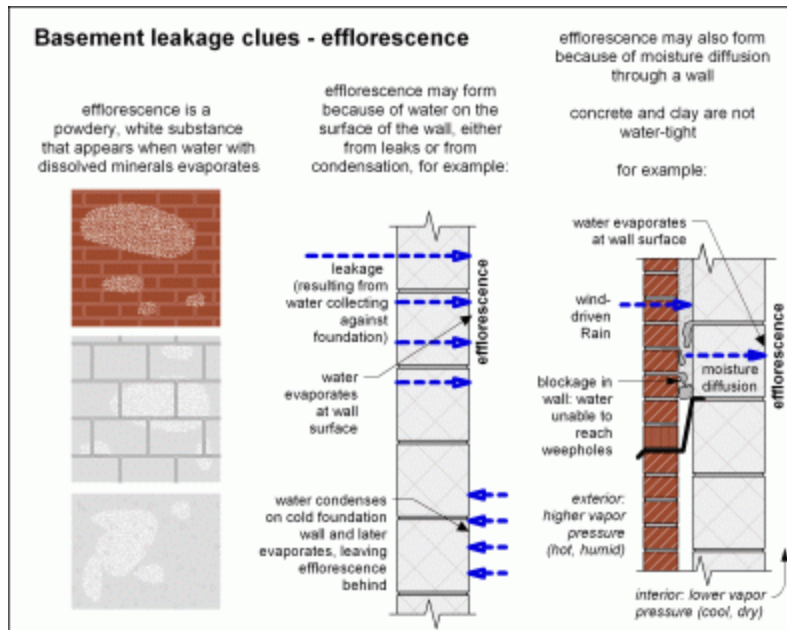
Condition: • [Efflorescence](#)

Implication(s): Cosmetic defects | Chance of water damage to contents, finishes and/or structure

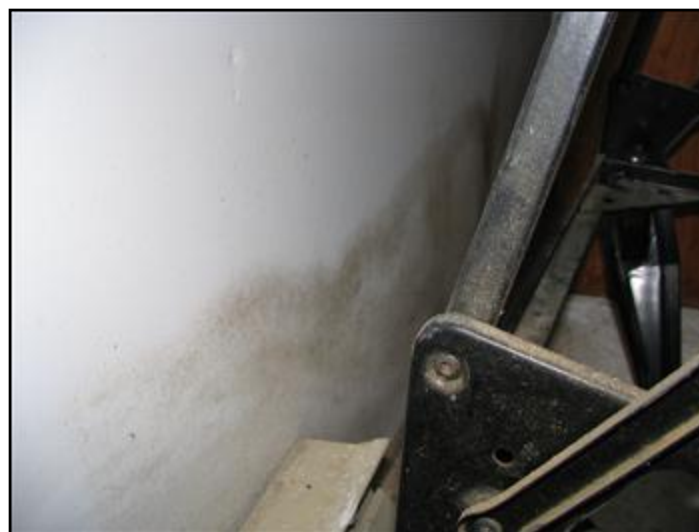
16. Efflorescence and staining

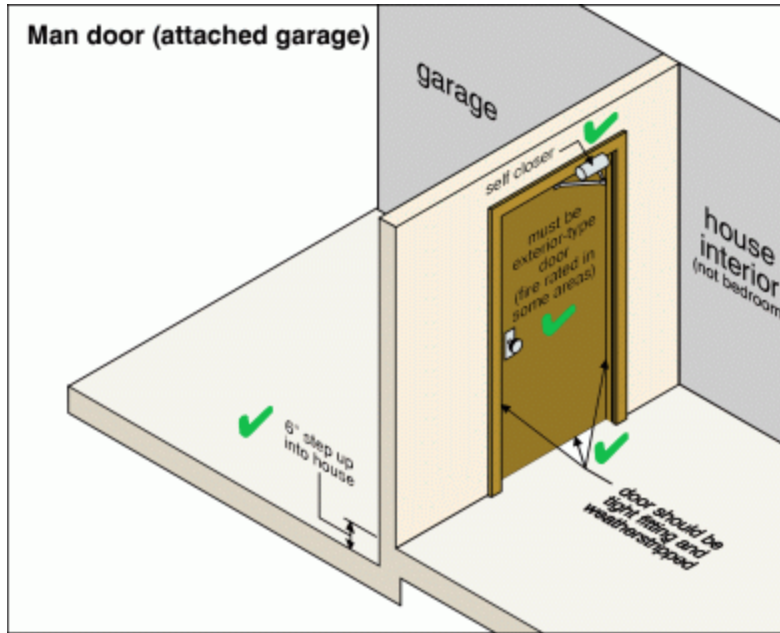
Condition: • [No self closer](#)

Implication(s): Hazardous combustion products entering home

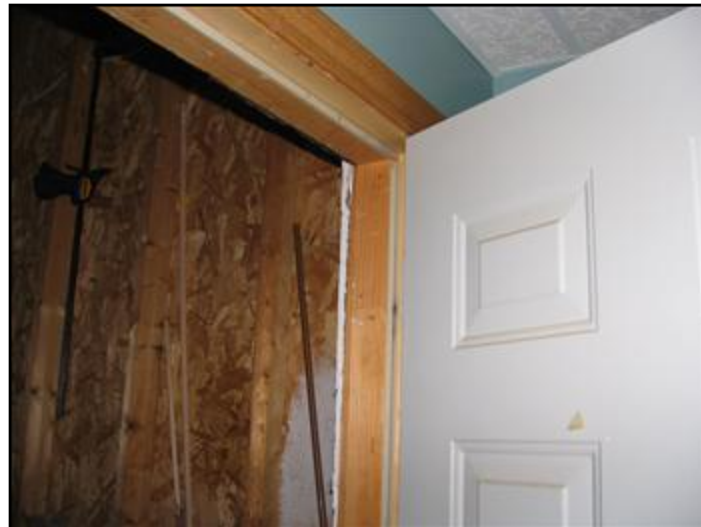
17. Self Closer Required

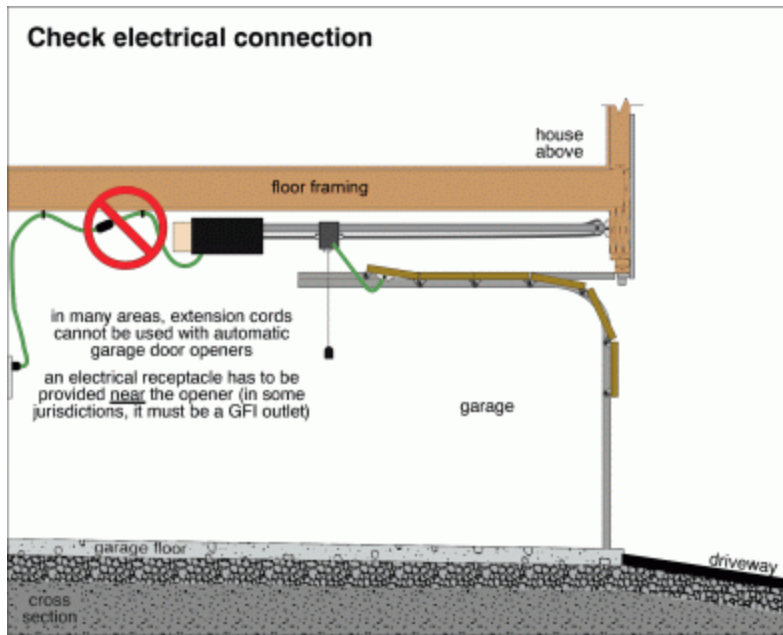
Condition: • [Extension cord for opener](#)

Note: The wiring in the garage can only be described as amateur contact a licensed electrician for upgrades and repairs.

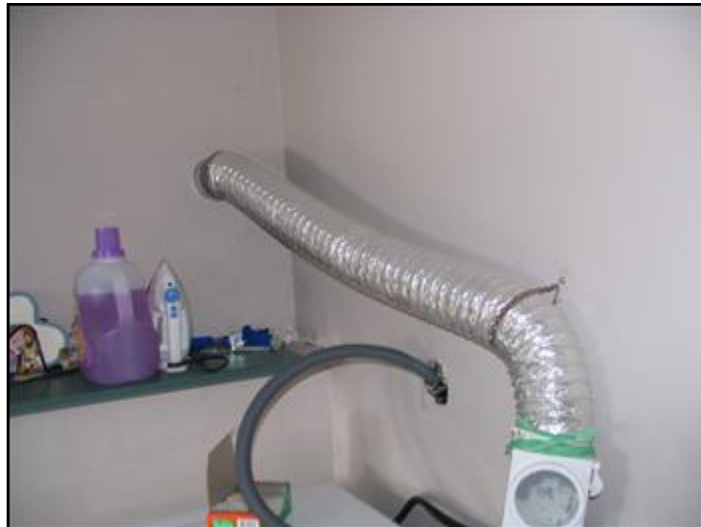
20. Improvements are recommended

Condition: • Dryer Duct;

The duct for the clothes dryer is routed a considerable distance through the home. This will typically cause moisture-laden air to cool before it reaches the end of the duct and depositing lint, which will gradually accumulate and occlude the duct, on the inside of the duct. Besides the flammable lint being a potential fire hazard, this will increase drying time and represent an increased cost factor. It is recommended that the dryer vent be re-routed and reconfigured to a shorter length. Additionally, the duct should be insulated to at least an R7 to lessen the likelihood of condensation occurring inside of the duct.

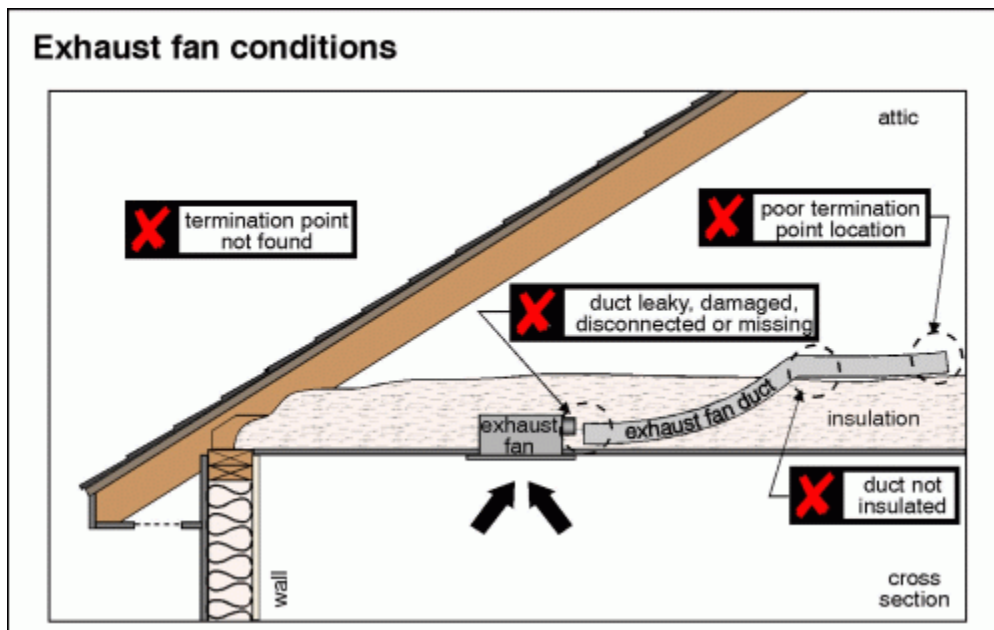
Condition: • [Not insulated in unconditioned space](#)

Implication(s): Chance of condensation damage to finishes and/or structure

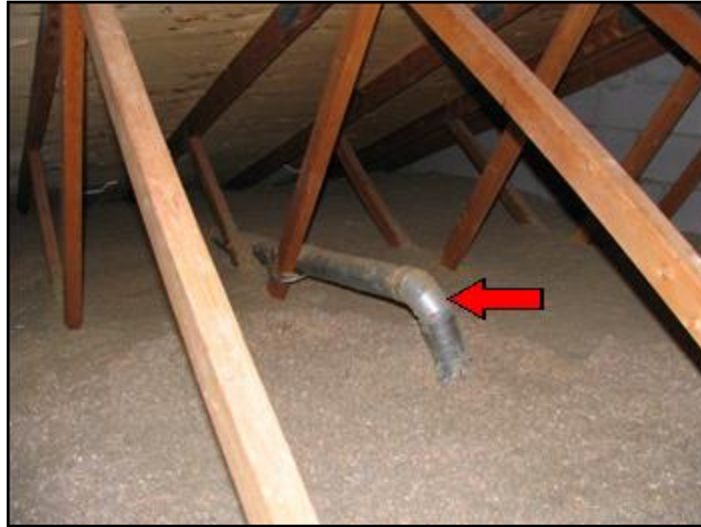
21. *Insulate duct work*
