Your Inspection Report

230 Chaplin Cres
Toronto, ON

INSPECTION DATE:
Wednesday, May 12, 2010

Report No. 21565

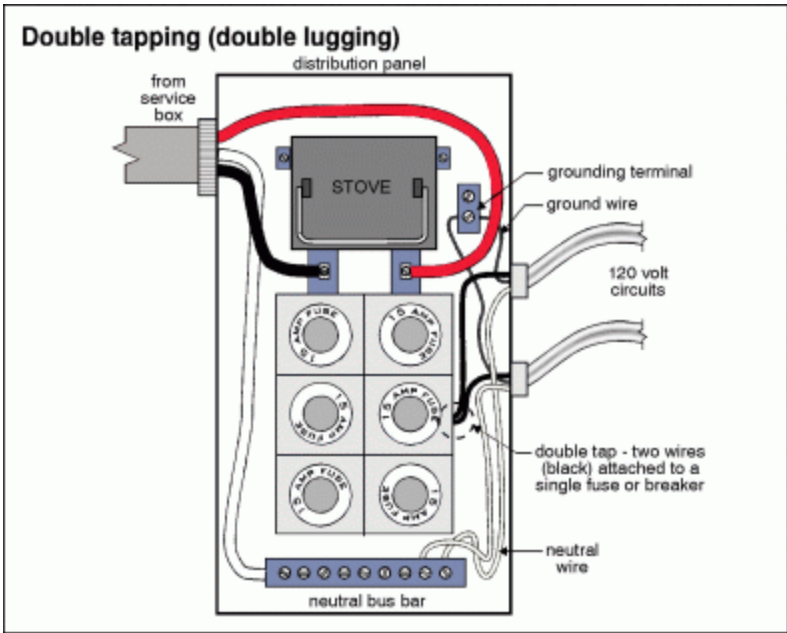
Condition: • [Double tap \(two wires on one breaker or fuse\)](#)

Location: Basement Panel

Task: Correct: Double tap with transformer

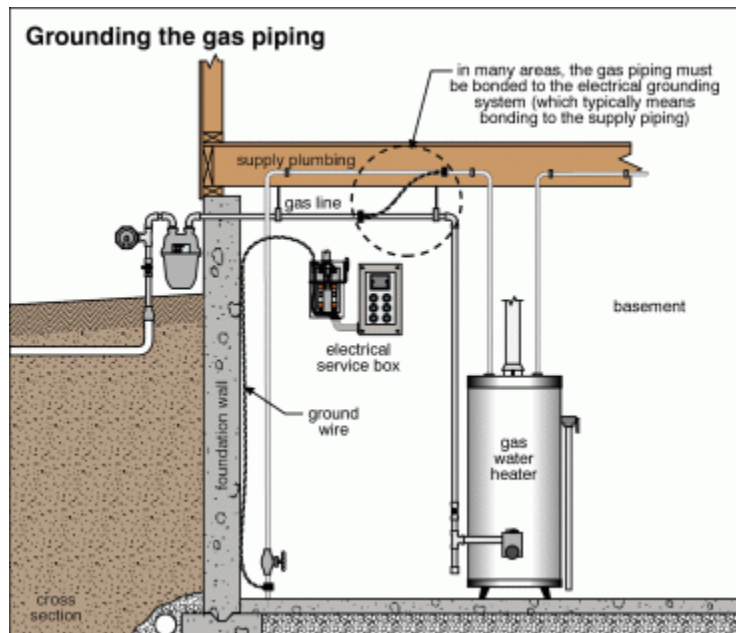
Condition: • [Bonding of gas piping not confirmed](#)

Location: Basement Boiler Room

Task: Provide: Bond between gas and water pipe.
