INSPECTION REPORT

For the Property at:
10672 PONDEROSA WAY
NEVADA CITY, CA 95959

Prepared for: FRED BUYER
Inspection Date: Tuesday, December 29, 2009
Prepared by: Daniel Bertsch CCI

RE: Report No. 1004, v.6
10672 Ponderosa Way
Nevada City, CA
95959

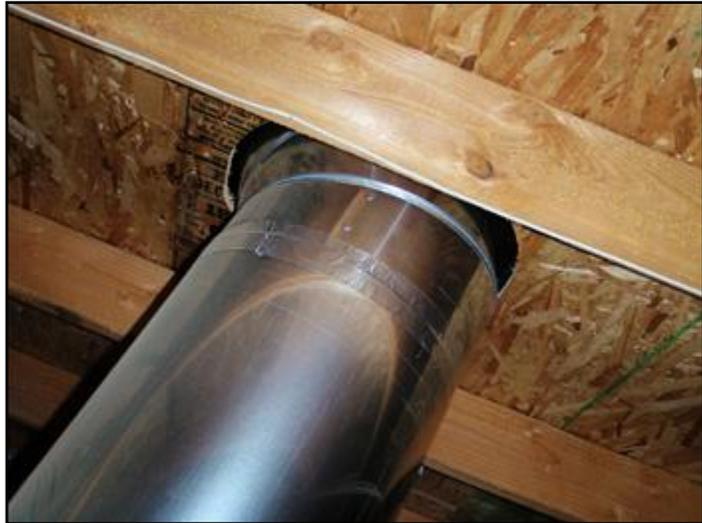
SLOPED ROOFING \ Asphalt shingles
1. Condition: • [Leak](#)
Leak noted by solar tube skylight. Recommend review and repair by Qualified Roofing Contractor.
Implication(s): Chance of water damage to contents, finishes and/or structure
Location: Attic above bathroom
Task: Correct
Time: Immediate

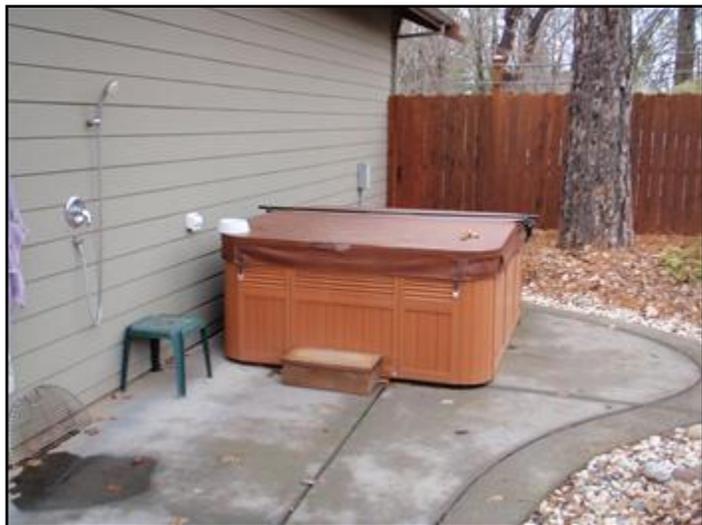
2. • Spa safety notice: Children should be monitored closely around the spa. Recommend locking cover and use of alarms on doors leading directly to the spa.

Implication(s): Possible safety issue, drowning

Location: Back patio

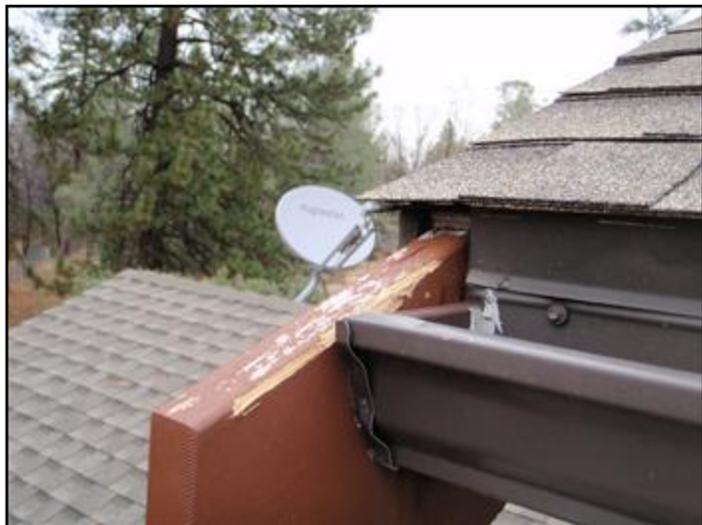
Top of barge rafter

3. • Exterior in need of paint maintenance and caulking

Implication(s): Lack of paint may lead to wood deterioration

Location: Tops of barge rafters and knee braces throughout

Task: Paint and caulk

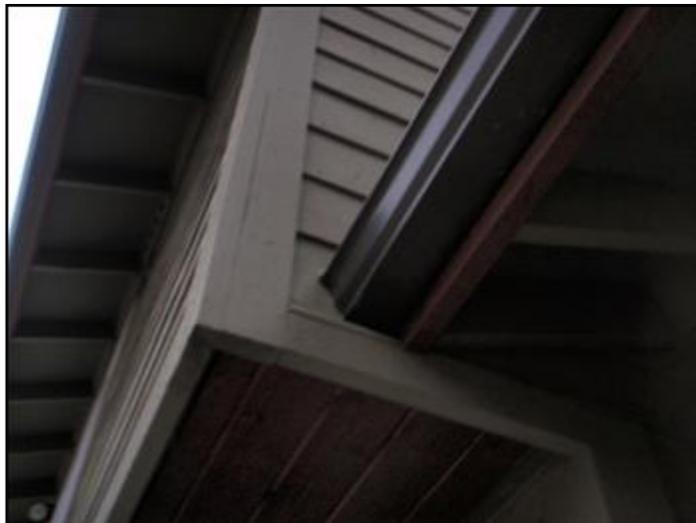
4. Condition: • [Leak](#)

Gutter leaks at rear of garage in several location. Caulk as necessary to prevent moisture intrusion and water damage.

Implication(s): Chance of water damage to contents, finishes and/or structure

Location: Rear

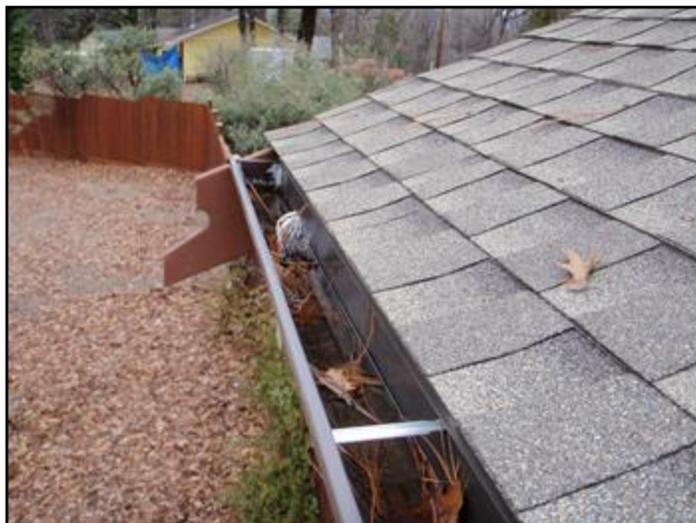
5. Condition: • [Clogged](#)

Ponding noted in gutters. This is a typical condition on newer homes that have gutters set level for improved appearance.

Location: Throughout

Task: Clean

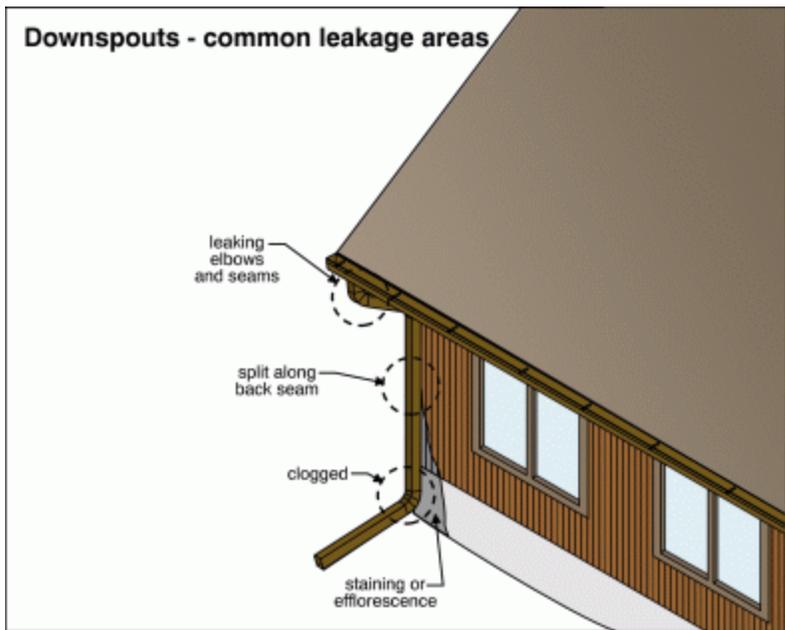
7. Condition: • [Damage](#)

Downspout drain pipe damage. Repair with new section.

Implication(s): Chance of water damage to contents, finishes and/or structure

Location: Left rear corner of building.

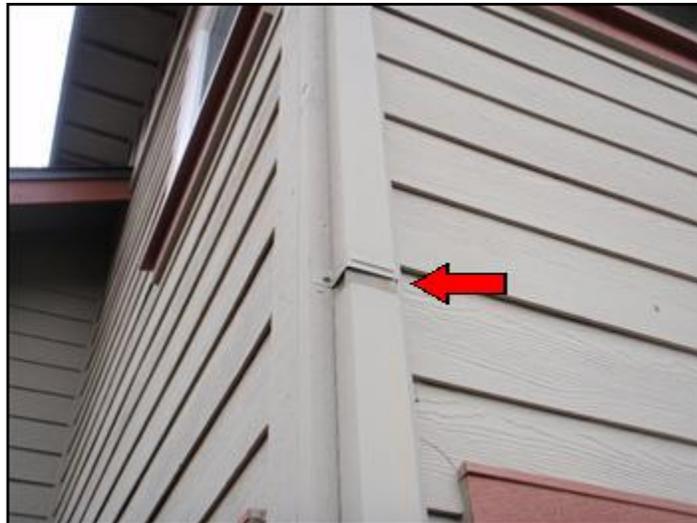
8. Condition: • [Loose connections](#)

Implication(s): Leakage

Location: Right rear corner of building

Task: Correct

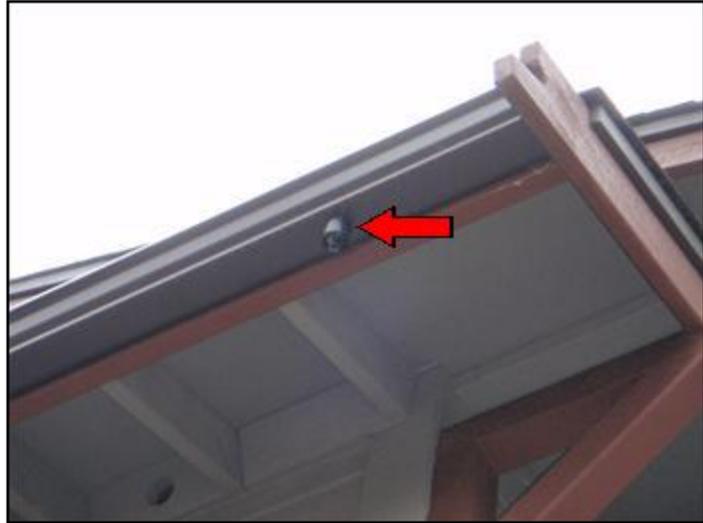
9. Condition: • [Missing](#)

Implication(s): Chance of water damage to contents, finishes and/or structure

Location: Noted at upper right side of building

Task: Correct

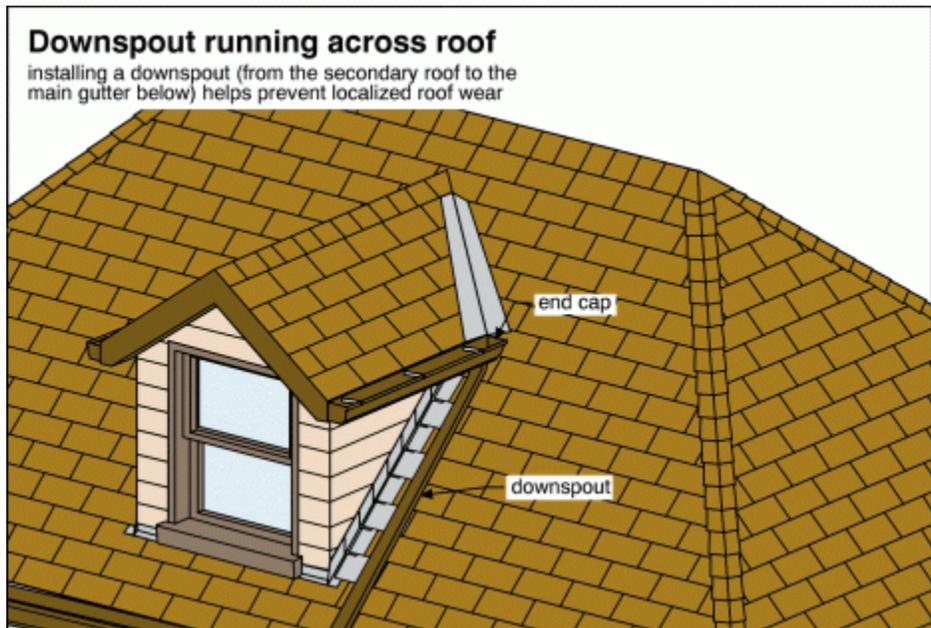
10. Condition: • [Downspouts discharging onto roofs](#)

Implication(s): Chance of water damage to contents, finishes and/or structure

Location: Front and rear roof section of garage

Install downspout section to remedy

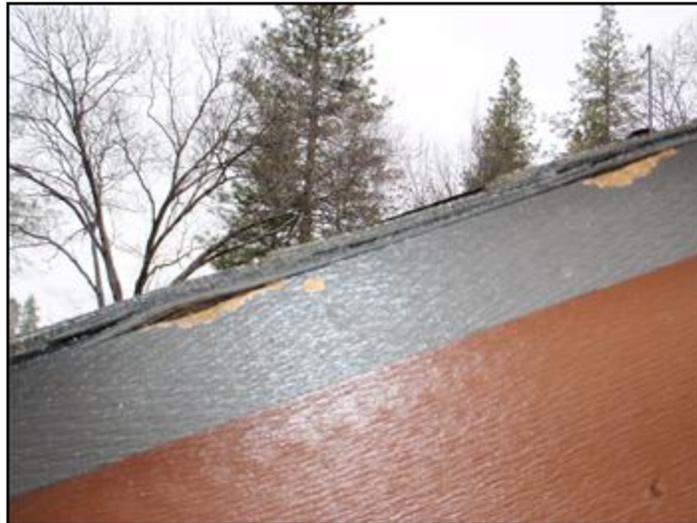
11. Condition: • [Damage](#)

Bird damage noted on shingle molding. Installation of 2"x2" sheet metal drip edge may discourage wood peckers.

Implication(s): Cosmetic defects | Chance of water damage to contents, finishes and/or structure

Location: Second Floor Left Side Above the Garage

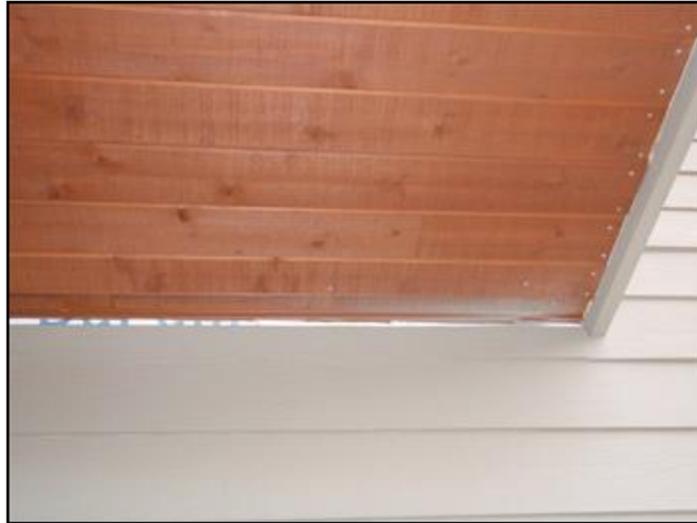
12. Condition: • [Missing](#)

Implication(s): Cosmetic defects | Chance of water damage to contents, finishes and/or structure

Location: Under the right cantilever and rear cantilever

Task: Correct

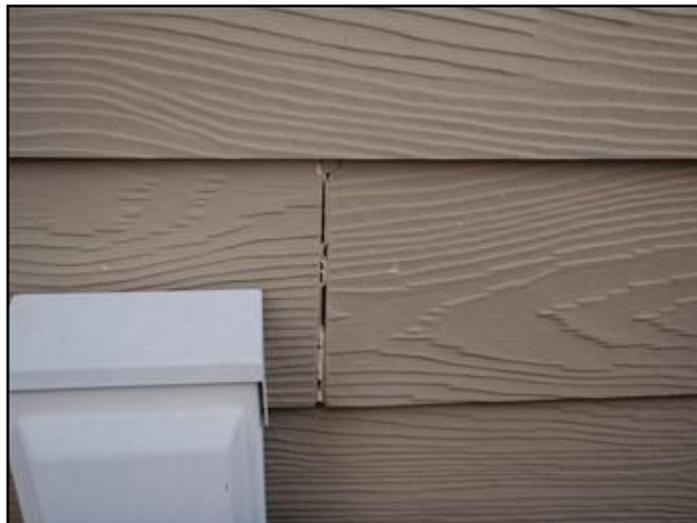
13. Condition: • [Missing paint or caulking](#)

Implication(s): Cosmetic defects | Chance of water damage to contents, finishes and/or structure

Location: Throughout on siding joints

Task: Service annually

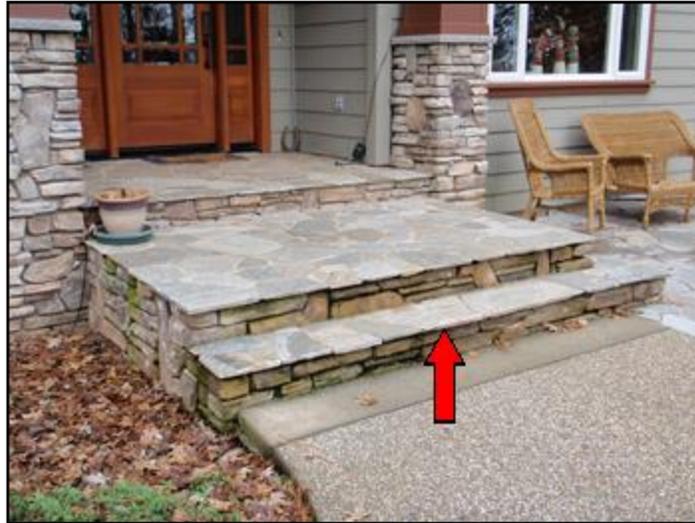
14. Condition: • [Stair rise too big or not uniform](#)

Implication(s): Trip or fall hazard

Location: Front Exterior

Task: Use caution when traversing

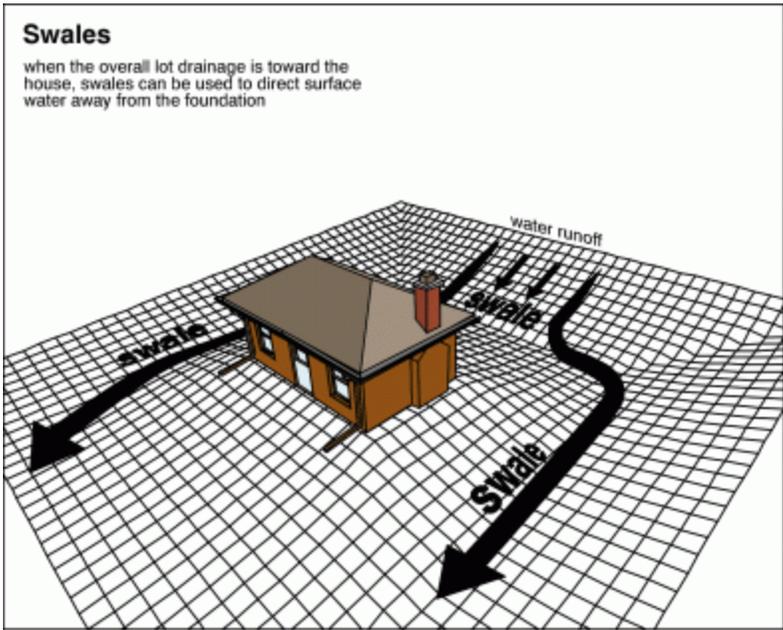
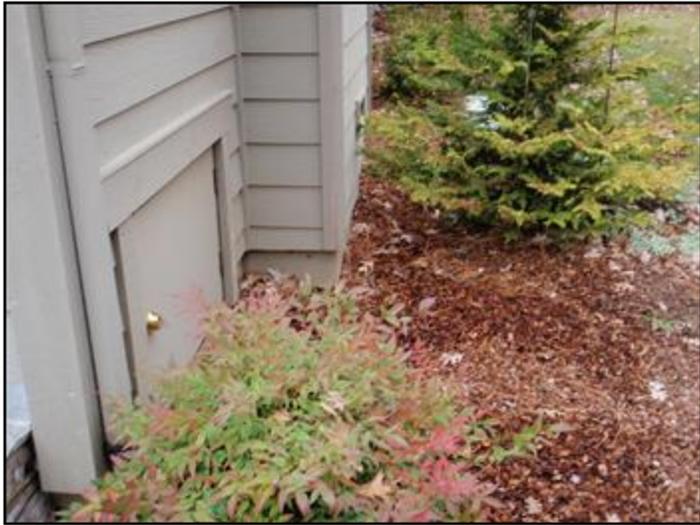
Right front corner of building

15. Condition: • [Improper slope](#)

Implication(s): Chance of water damage to contents, finishes and/or structure

Location: Right side of garage and right front corner of the house

Task: Monitor

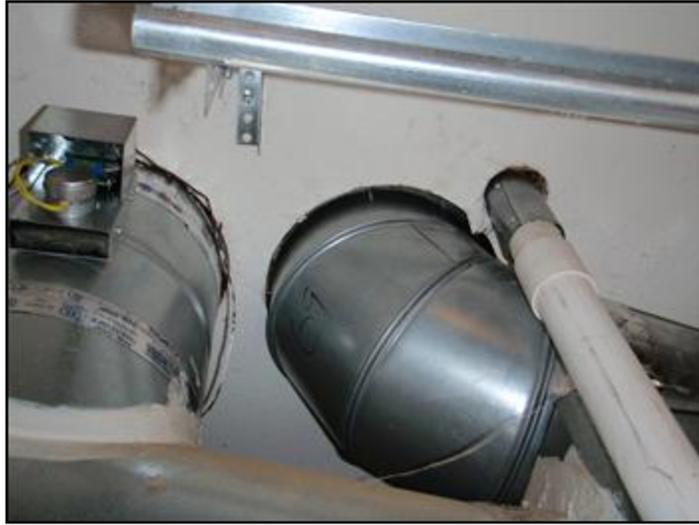
- 16. Condition:** • Not fireproof
- Roof penetrations should be closed off with sheet metal to improve performance of the firewall.
- Implication(s):** Fire hazard
- Location:** Garage
- Task:** Correct
- Time:** Immediate

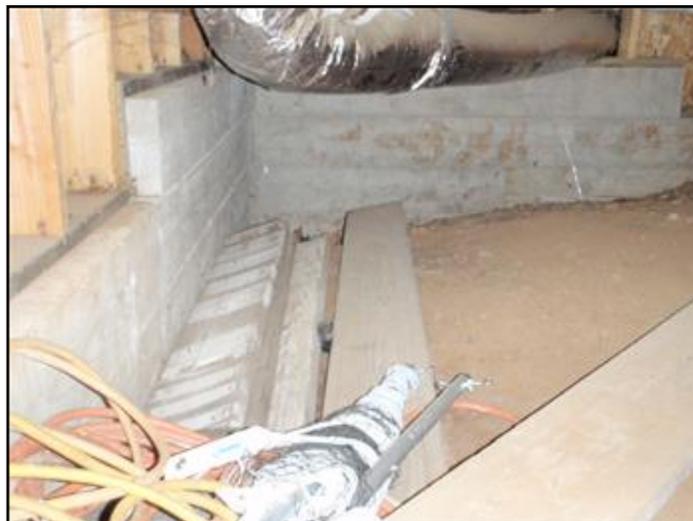
17. • Cellulose debris noted. Boards and other debris should be removed

Task: Correct

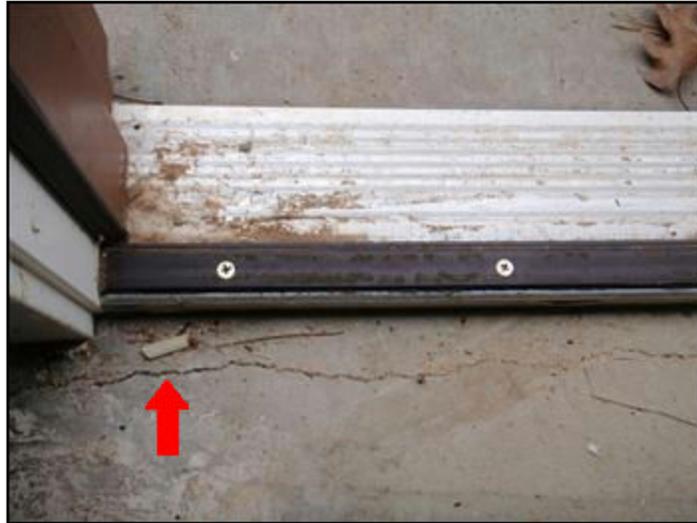
18. Condition: • Typical shrinkage crack noted

Implication(s): Possible moisture intrusion.

Task: Monitor

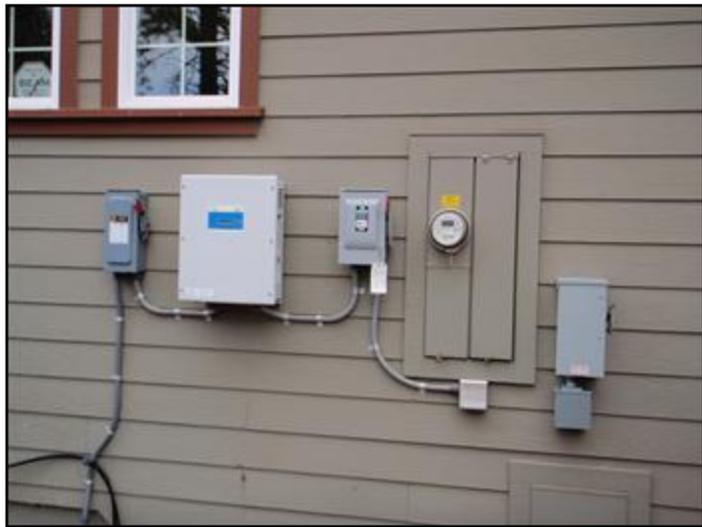
View of solar, main, and generator panel

General**19.** • Solar power and auxiliary generator panels were noted. Consult with current property owners for information and operation of these systems.**Implication(s):** Positive finding, energy savings**Location:** Left side of garage

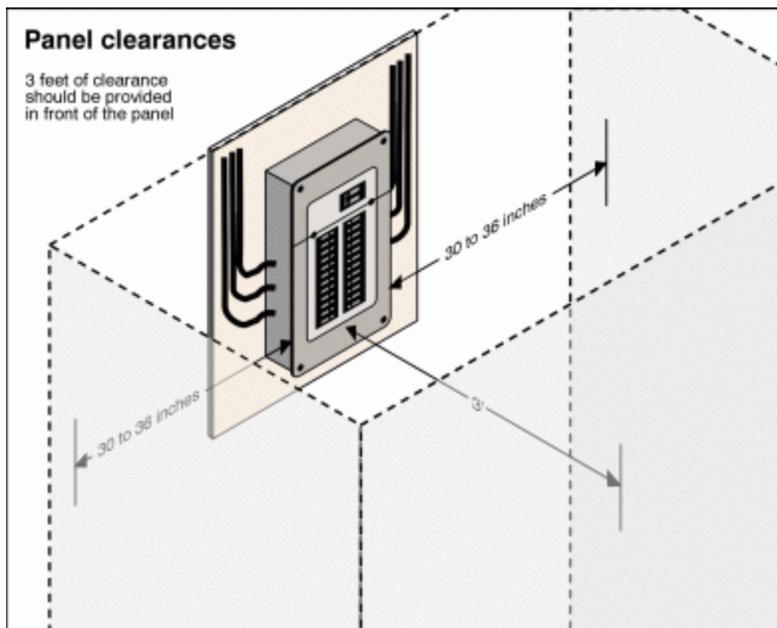
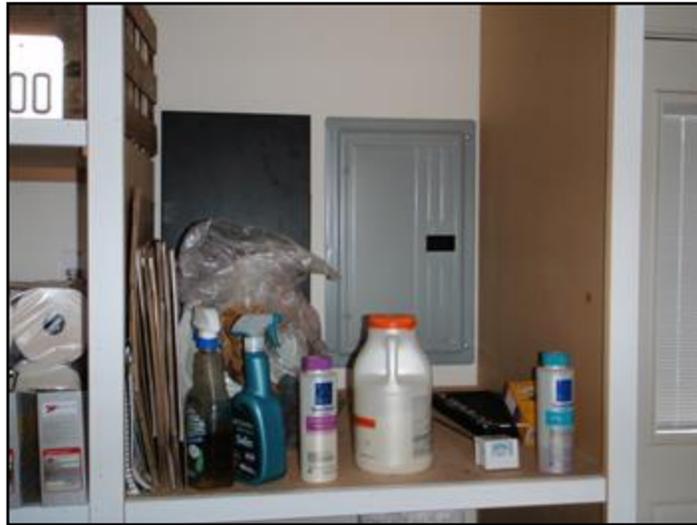
Sub panel in cabinet

20. Condition: • [Box location poor](#)

Task: Correct

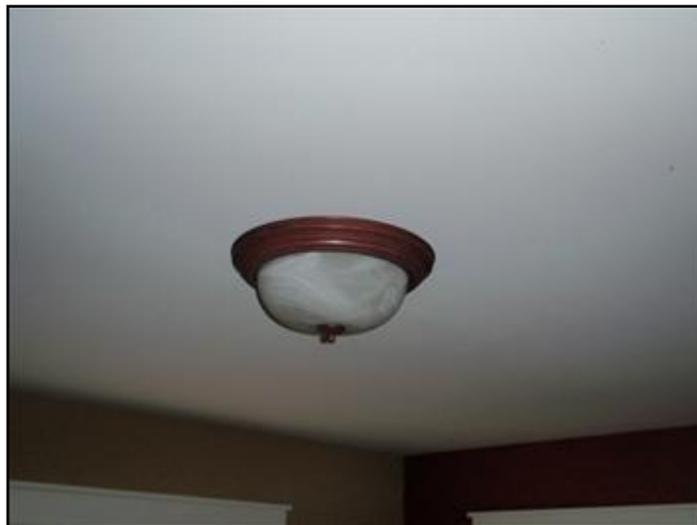
21. Condition: • [Inoperative](#)

Burned out bulb most likely

Implication(s): Inadequate lighting

Location: Bedroom #1

Task: Replace bulb

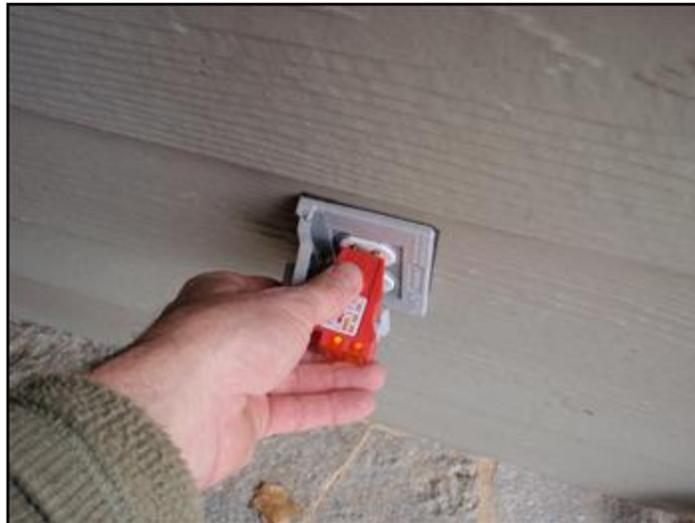
22. Condition: • [GFI test faulty](#)

Task: Correct

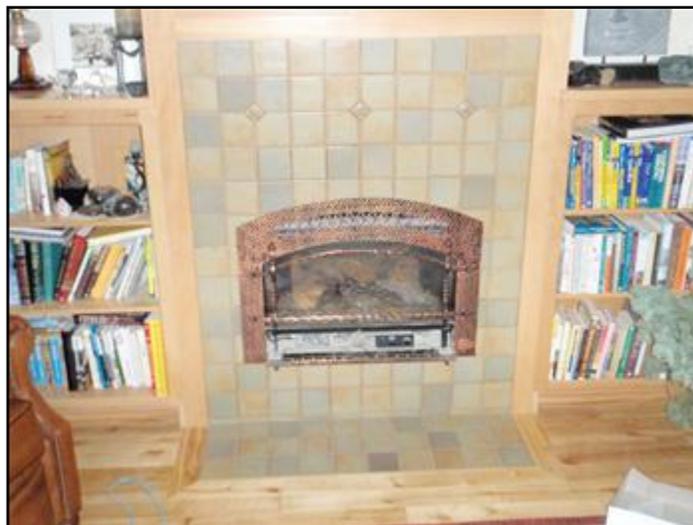
Inspection prevented/limited by: • Pilot light not lit. Noted in the family room. Recommend demonstration of proper operation prior to the close of escrow

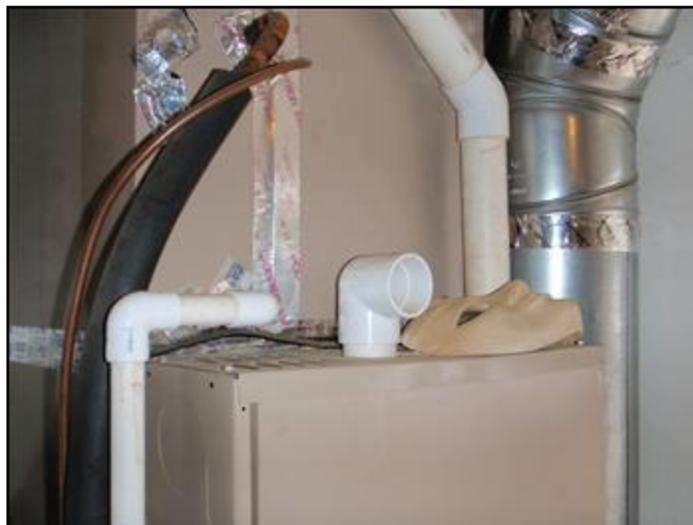
23. Condition: • [Inadequate combustion air](#)

Inspector could not view a typical foundation type vent in garage that is for combustion air. Recommend review by a Qualified Licensed HVAC contractor

Implication(s): Equipment not operating properly | Hazardous combustion products entering home | Increased heating costs | Reduced comfort | Increased operating costs

Task: Correct

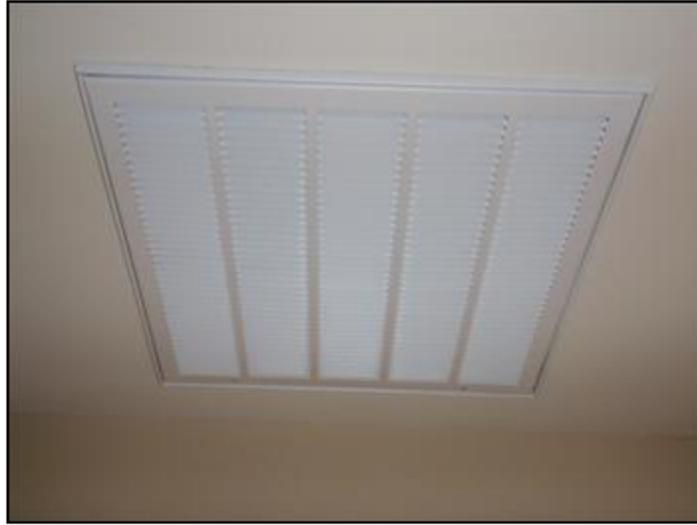
24. Condition: • Air filter dirty.

Task: Replace filter

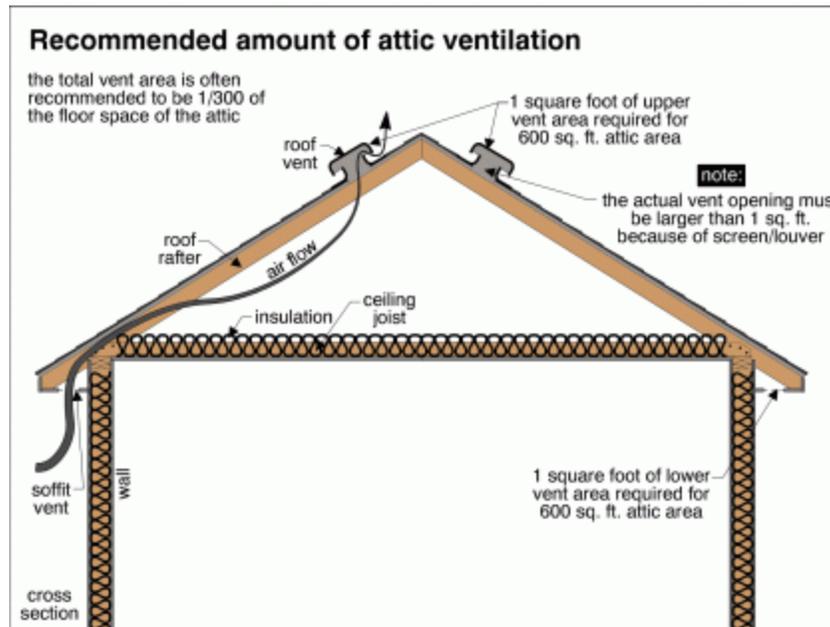
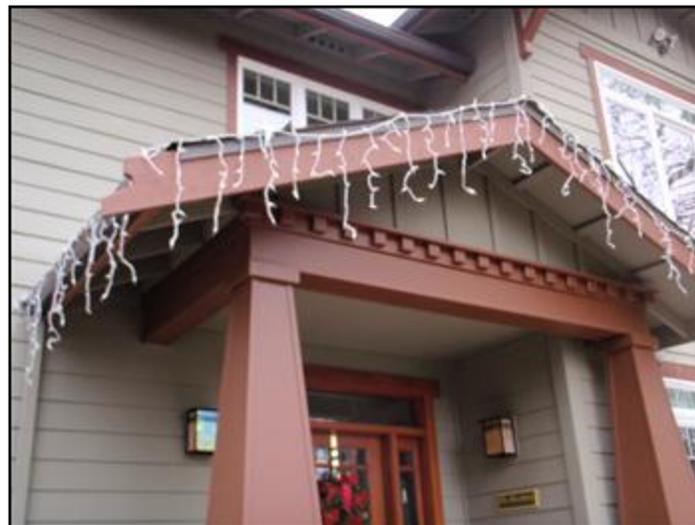
View of porch roof

- ATTIC/ROOF \ Roof vents**
- 26. Condition:** • [Missing](#)
No visible ventilation on entry porch roof
- Implication(s):** Chance of condensation damage to finishes and/or structure
- Location:** Front
- Task:** Improve
- Time:** As Needed

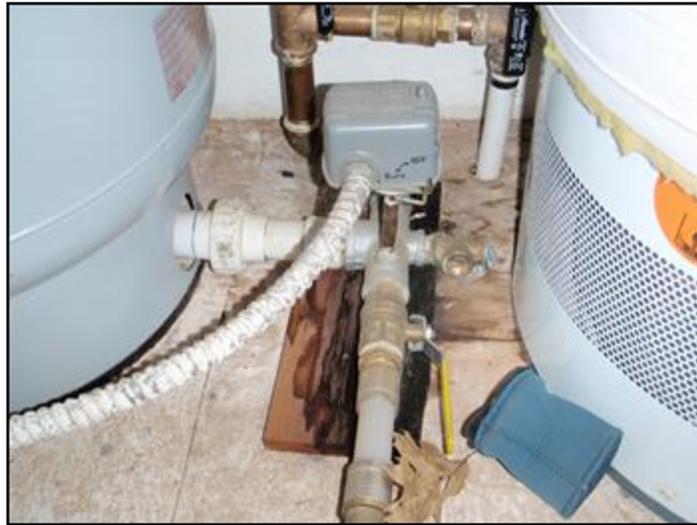
View of leak

28. Condition: • [Leak](#)

Implication(s): Chance of water damage to contents, finishes and/or structure | Reduced system life expectancy | No domestic water

Task: Correct / Repair by qualified licensed plumbing contractor or well technician recommended

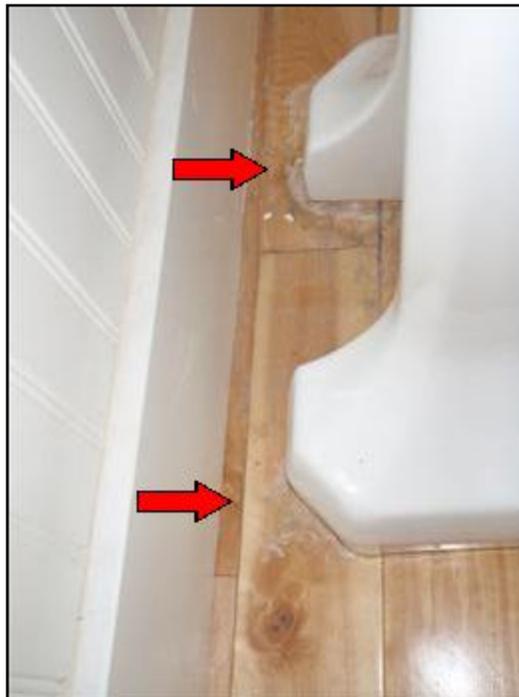
29. Condition: • [Leak](#)

Prior leak evidence.

Implication(s): Chance of water damage to contents, finishes and/or structure | System inoperative

Task: Monitor

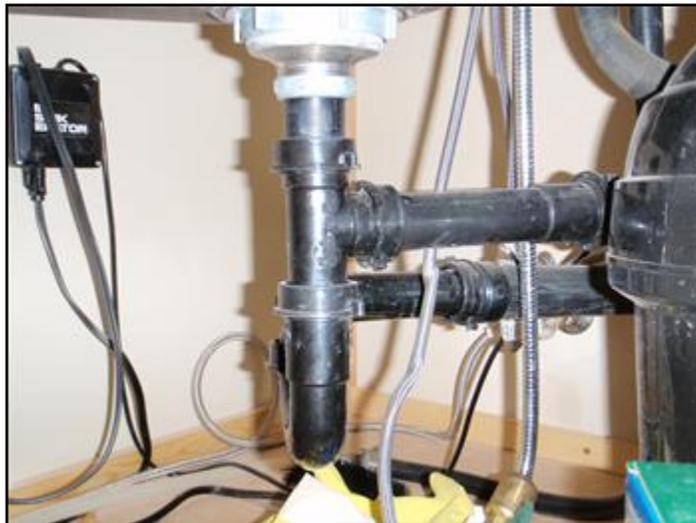
30. Condition: • [Leak](#)

Task: Correct

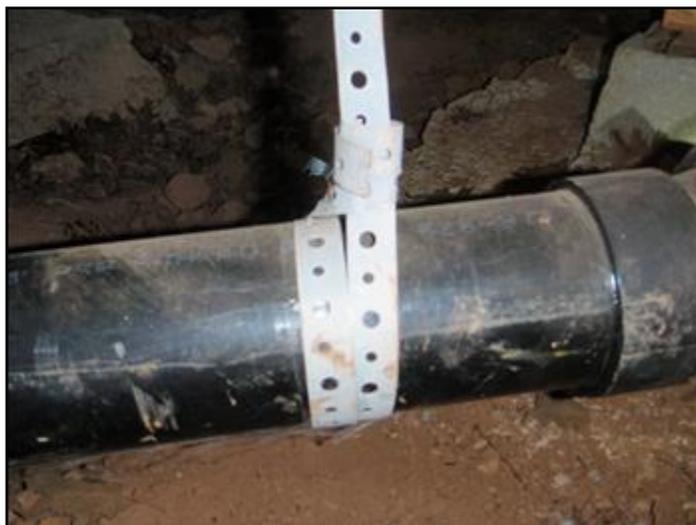
31. Condition: • [Poor support](#)

Waste lines have improper support. Support should restrict upward movement.

Implication(s): Chance of water damage to contents, finishes and/or structure | Sewage entering the house

Install wood block to prevent movement

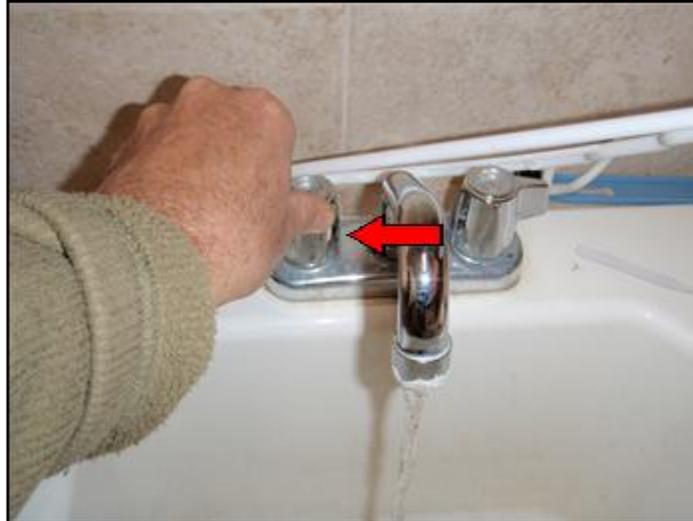
32. Condition: • [Drip, leak](#)

Leaks around the hot faucet

Implication(s): Chance of water damage to contents, finishes and/or structure

Task: Repair

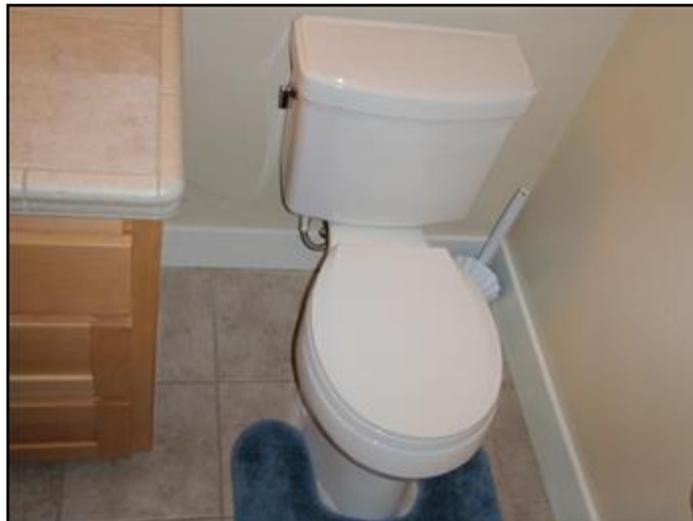
33. Condition: • Toilet loose on floor. Install new wax ring and tighten

Implication(s): Water damage to sub floor

Task: Correct

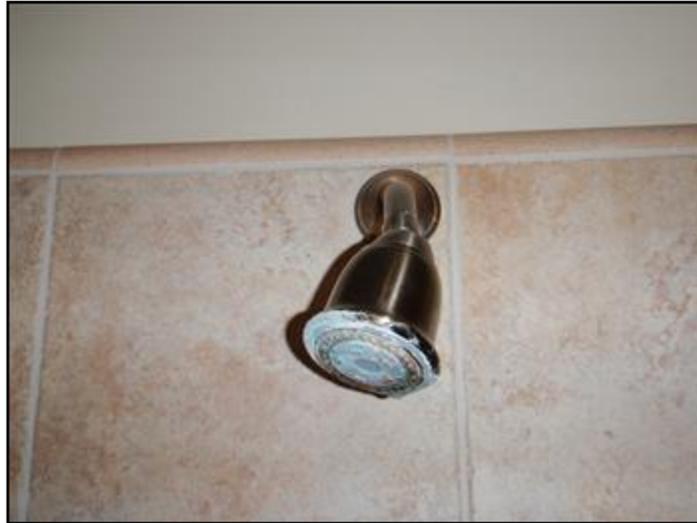
34. Condition: • [Leak](#)

Task: Correct

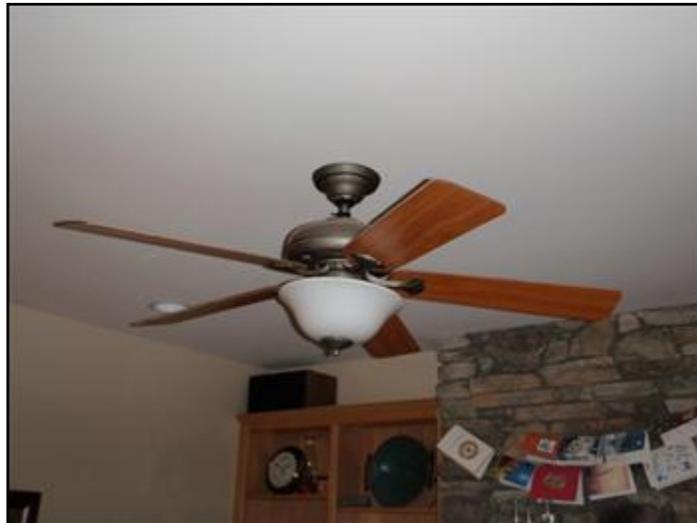
36. • Ceiling fan noisy, wobbles

Implication(s): Nuisance

Task: Monitor

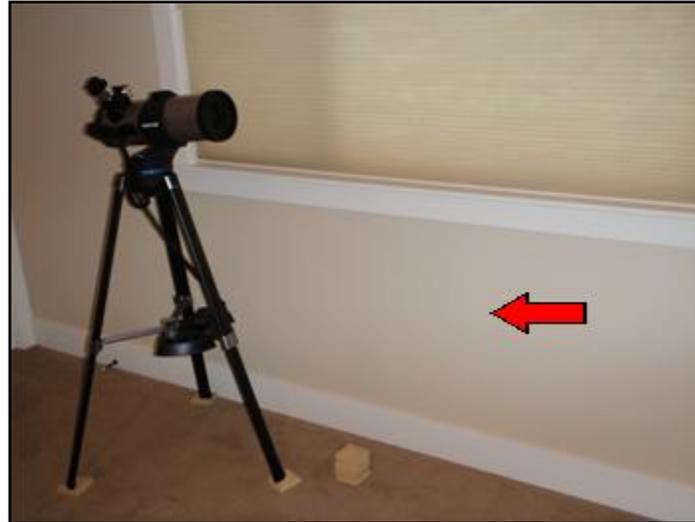
38. Condition: • [Cracked](#)

Typical shrinkage crack

Implication(s): Cosmetic defects

Location: Bonus room

Task: Monitor

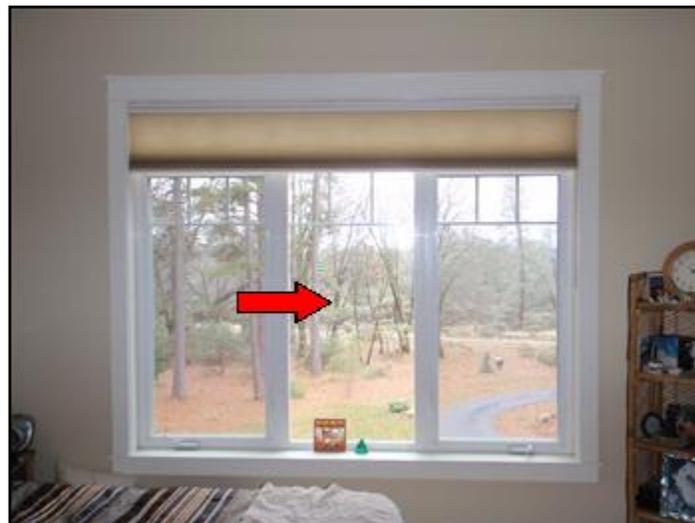
39. Condition: • [Lost seal on double or triple glazing](#)

Implication(s): Cosmetic defects

Task: Improve

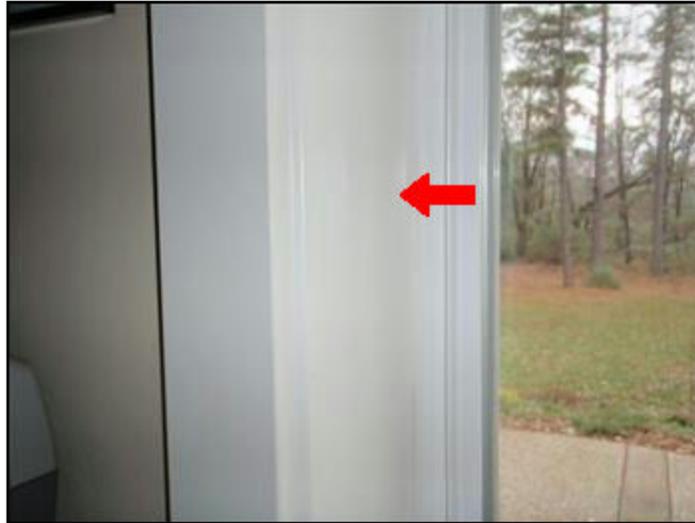
40. Condition: • Moisture intrusion evidence.

Implication(s): Possible hidden damage

Task: Monitor / Repair as necessary

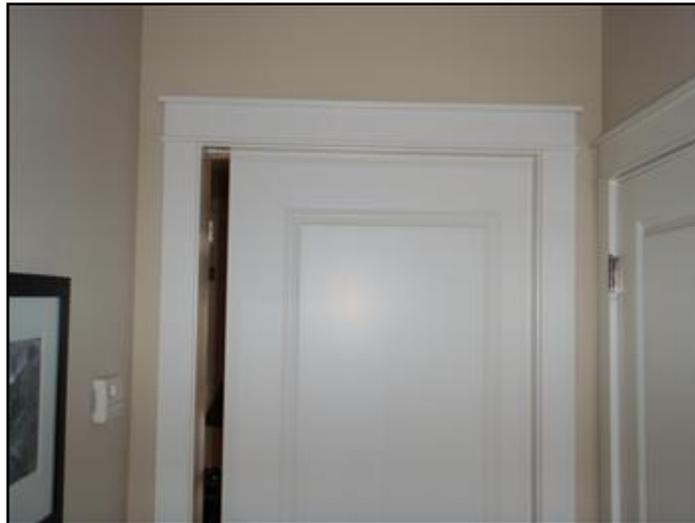
41. Condition: • [Stiff](#)

Task: Improve

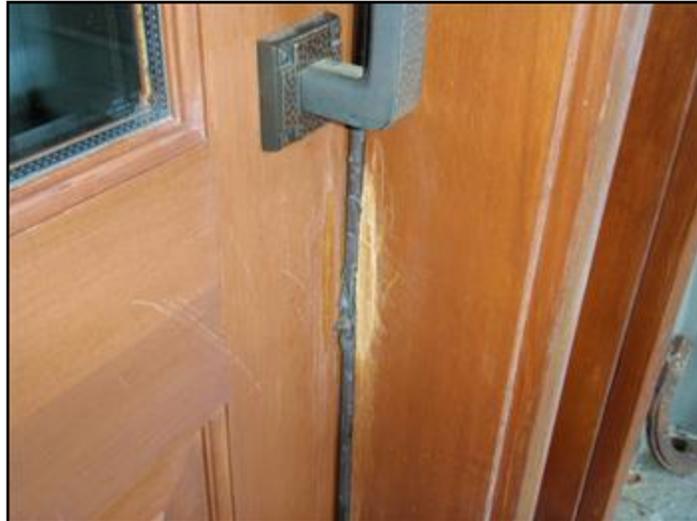
42. Condition: • [Weatherstripping missing or ineffective](#)

Dog or cat damage suspected

Task: Correct

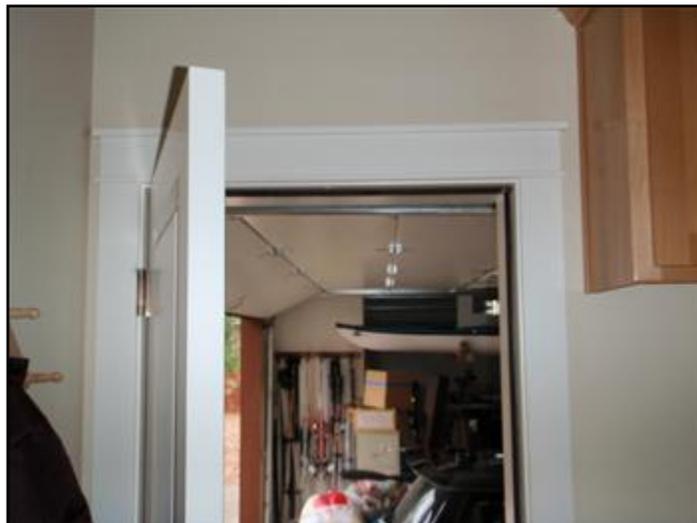
43. Condition: • [No self closer](#)

Implication(s): Hazardous combustion products entering home

Task: Correct

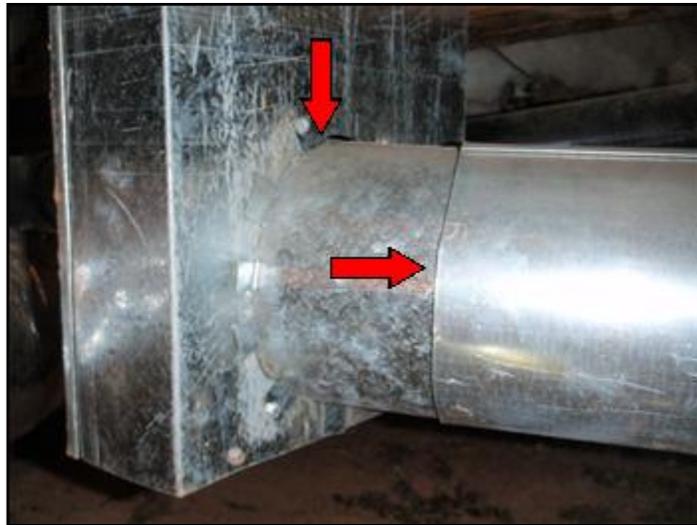
45. Condition: • Down draft vent in need of sealant

Implication(s): Air infiltration issues

Task: Correct

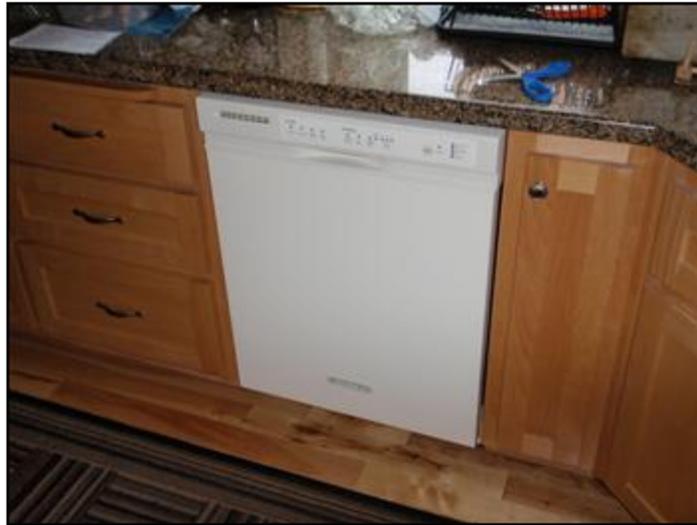
46. Condition: • Loose
