Your Inspection Report

123 Main St
Hamilton, ON

RE: Report No. 1011, v.3
123 Main St
Hamilton, ON
L1L 1L1

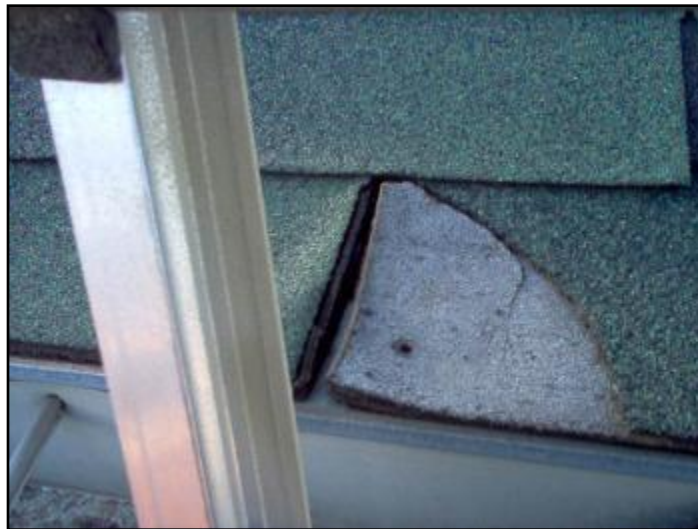
Condition: • [Missing, loose or torn](#)

Implication(s): Chance of water damage to contents, finishes and/or structure

Location: East Exterior

1. Broken shingle, exposed sheathing.

Task: Repair

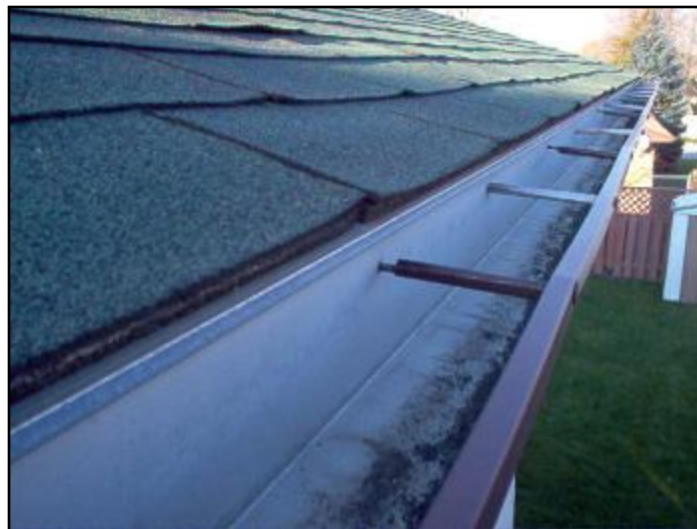
Condition: • [Overhangs too big or too small](#)

Implication(s): Chance of water damage to contents, finishes and/or structure

2. Shingles not extended into trough.

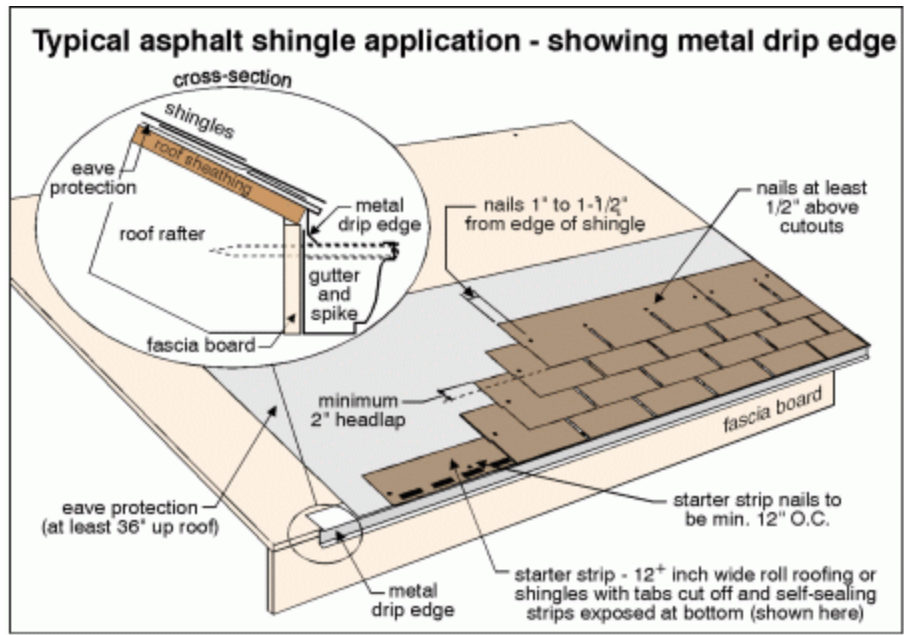
Condition: • [Exposed fasteners](#)

Implication(s): Chance of water damage to contents, finishes and/or structure

Location: East Exterior

Task: Repair

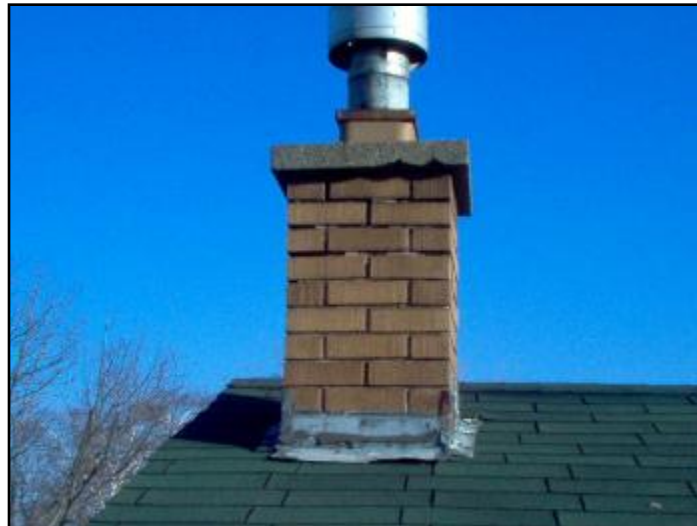
Condition: • [Damage, loose, open seams, patched](#)

Implication(s): Chance of water damage to contents, finishes and/or structure

3. Damaged chimney flashing.

Task: Repair

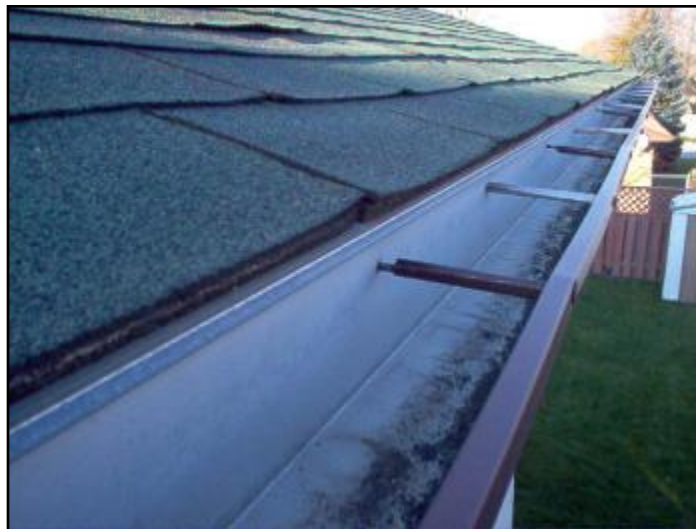
Condition: • [Loose or damaged](#)

Implication(s): Chance of water damage to contents, finishes and/or structure

4. Loose troughs.

Task: Repair

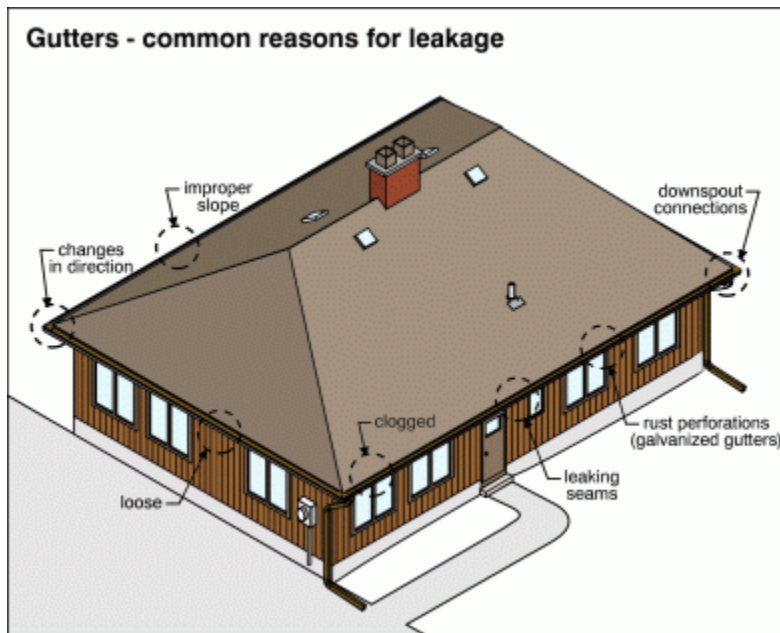
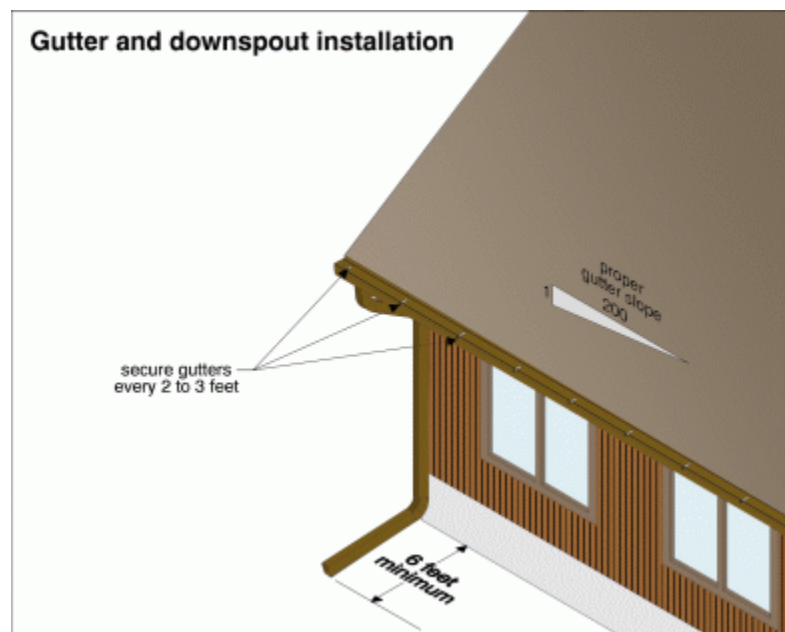
Condition: • [Improper slope, ponding](#)

Implication(s): Chance of water damage to contents, finishes and/or structure

Location: Exterior - west side

Task: Repair

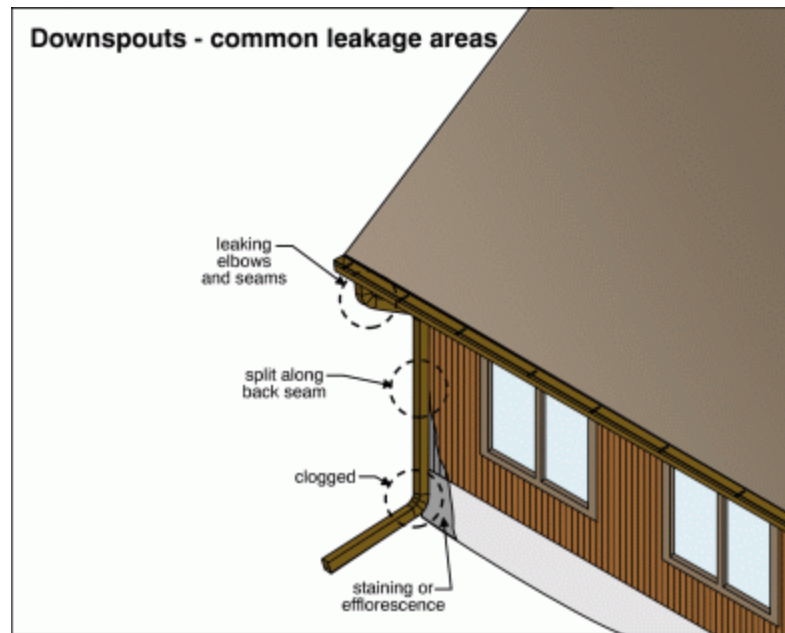
Condition: • [Clogged](#)

Implication(s): Chance of water damage to contents, finishes and/or structure

Location: West Exterior

Task: Clean

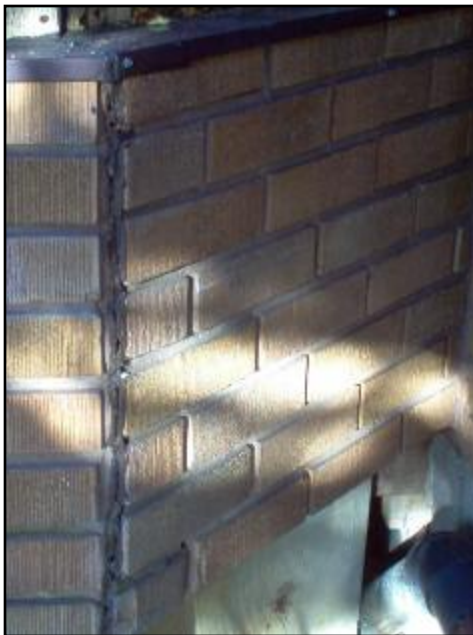
Condition: • [Cracked](#)

Implication(s): Chance of water entering house | Weakened structure | Chance of movement

Location: Front Exterior

5. Crack along mortar joint at bay window.

Task: Repair

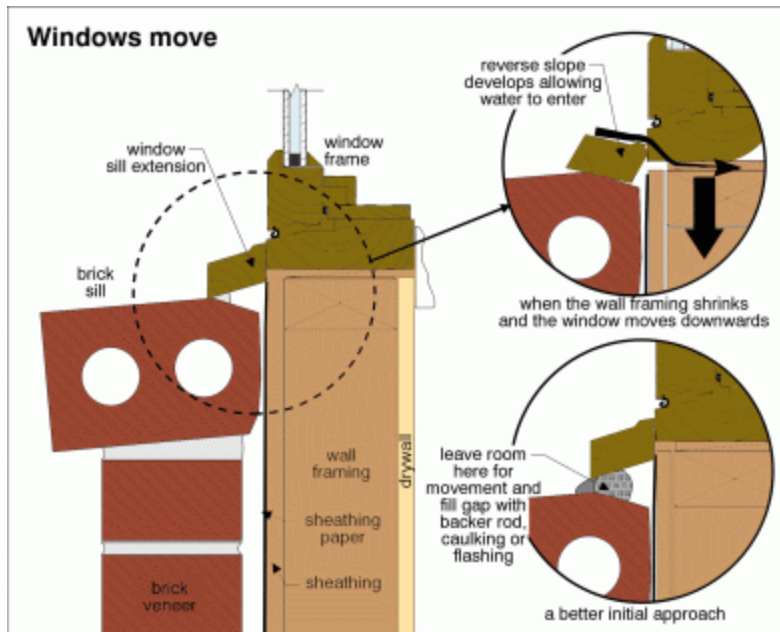
Condition: • [Sills with reverse slope](#)

Implication(s): Chance of water damage to contents, finishes and/or structure | Material deterioration

Location: West Exterior

Task: Repair

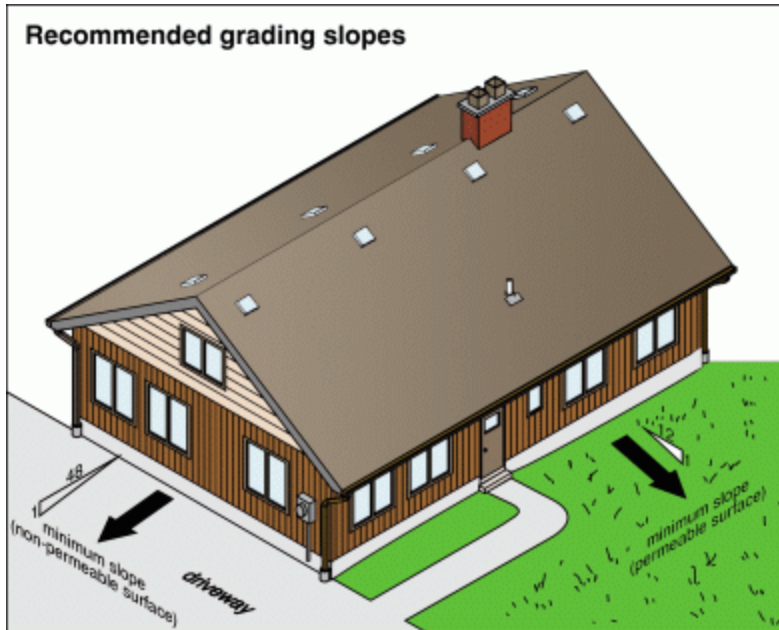
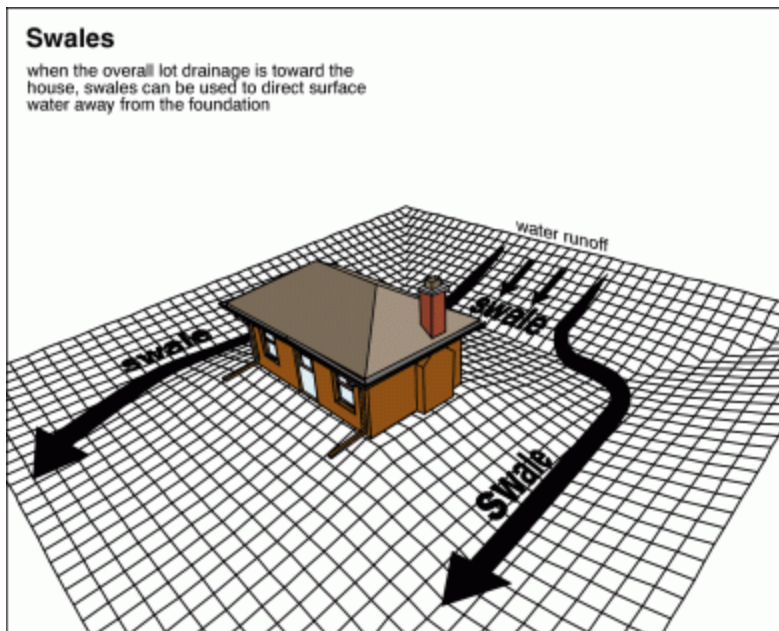
Condition: • [Improper slope](#)

Implication(s): Chance of water damage to contents, finishes and/or structure

Location: West & Front

Task: Improve

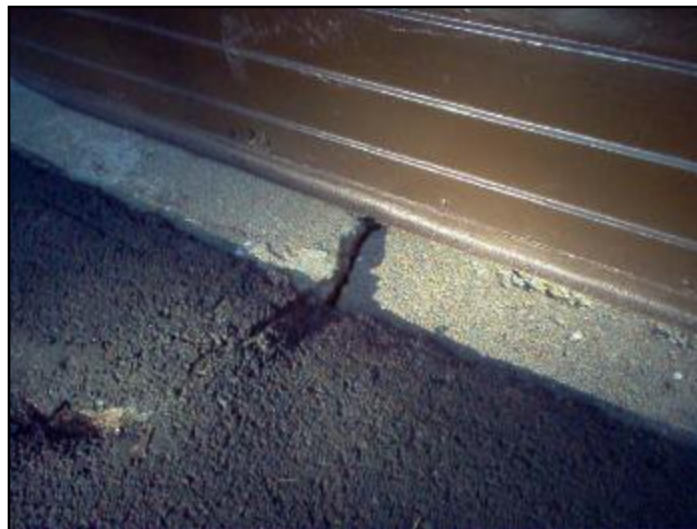
Condition: • [Improper slope or drainage](#)

Implication(s): Chance of water damage to contents, finishes and/or structure

Location: Front - driveway

6. Poor slope at driveway/garage slab.

Task: Repair

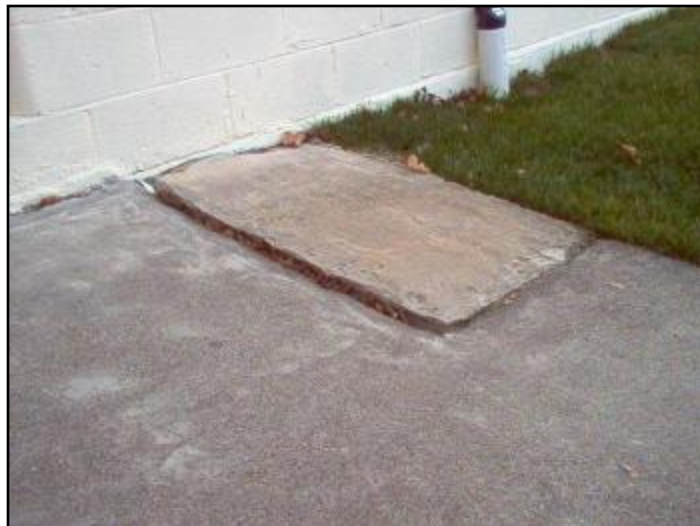
Condition: • [Uneven \(trip hazard\)](#)

Implication(s): Physical injury

Location: East - rear patio

7. Trip hazard at rear patio.

Task: Repair

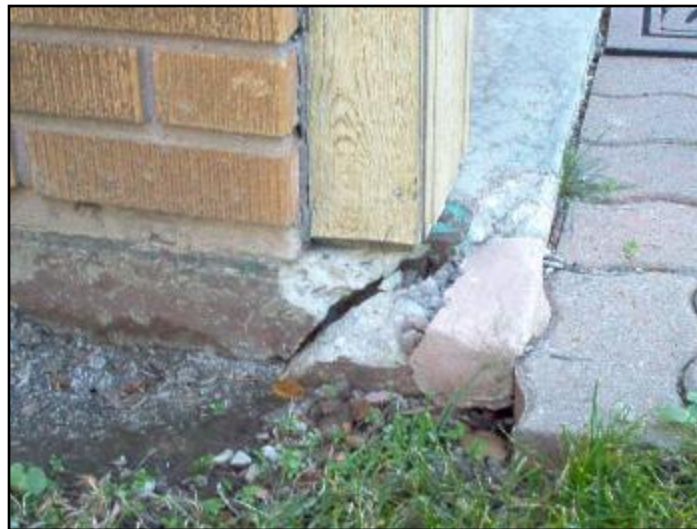
Condition: • [Cracked](#)

Implication(s): Cosmetic defects | Chance of water damage to contents, finishes and/or structure | Trip or fall hazard

Location: Exterior - front entrance

8. Concrete damage at front entrance.

Task: Repair

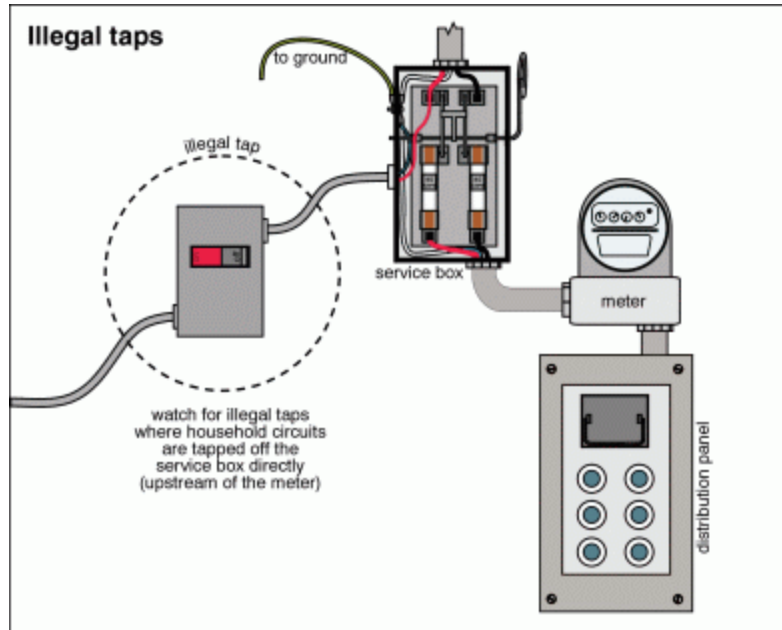
Condition: • [Illegal taps](#)

Implication(s): Electric shock | Fire hazard

Task: Further evaluation

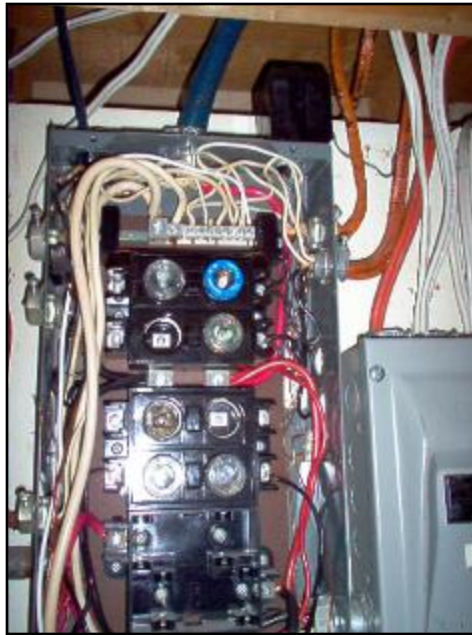
Condition: • [No fuses or breakers for subpanel](#)

Implication(s): Electric shock | Fire hazard

9. Missing fuses in auxiliary panel.

Task: Provide

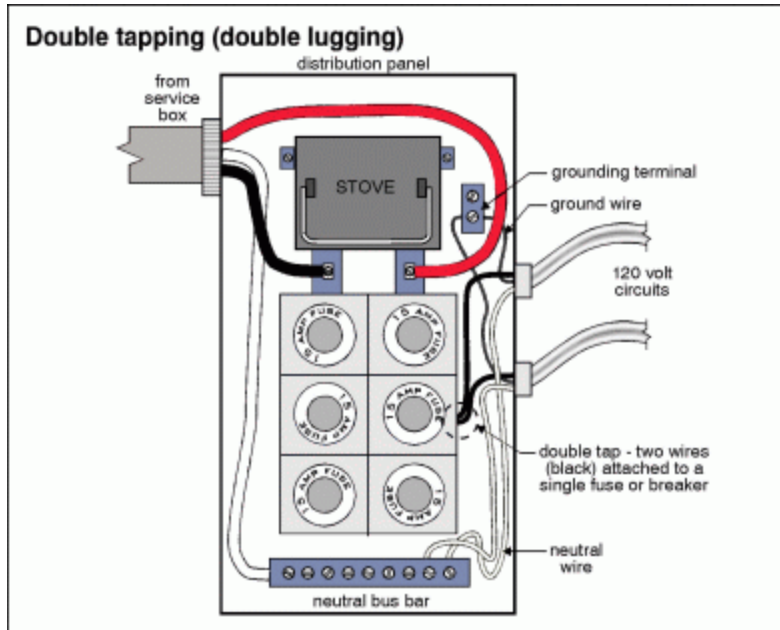
Condition: • [Double taps](#)

Implication(s): Fire hazard

Task: Repair

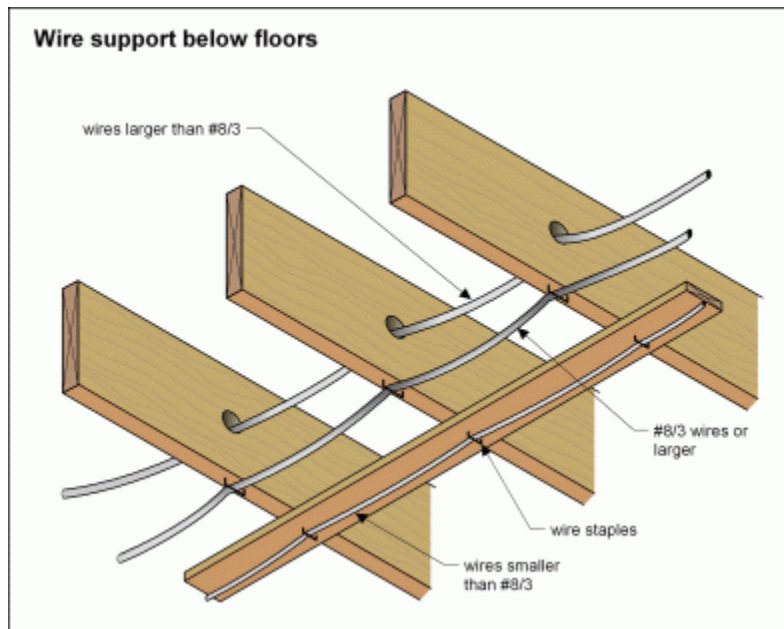
Condition: • [Exposed on walls or ceilings](#)

Task: Repair

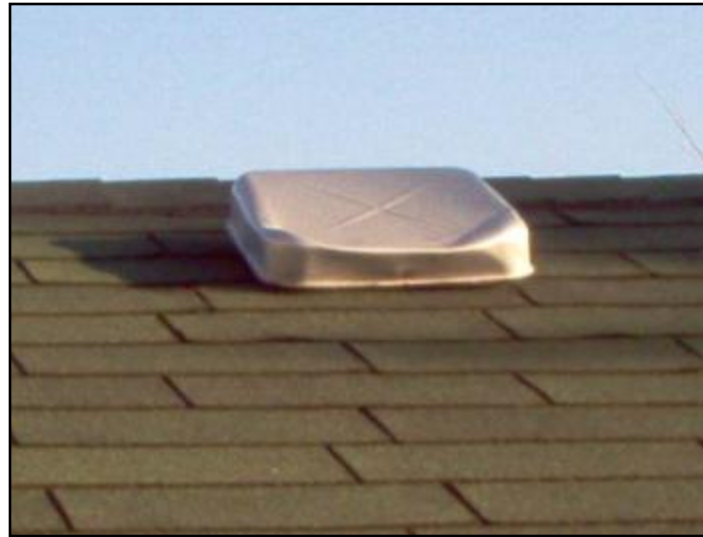
Condition: • [Damage](#)

Implication(s): Chance of condensation damage to finishes and/or structure

10. Damaged roof vent.

Task: Repair or replace

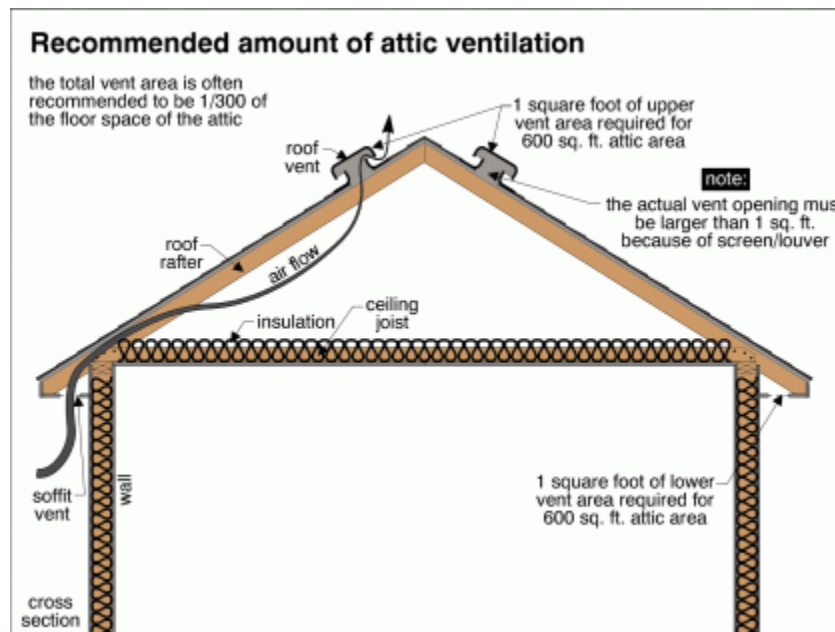
Condition: • [Obstructed](#)

Implication(s): Chance of condensation damage to finishes and/or structure

Task: Improve

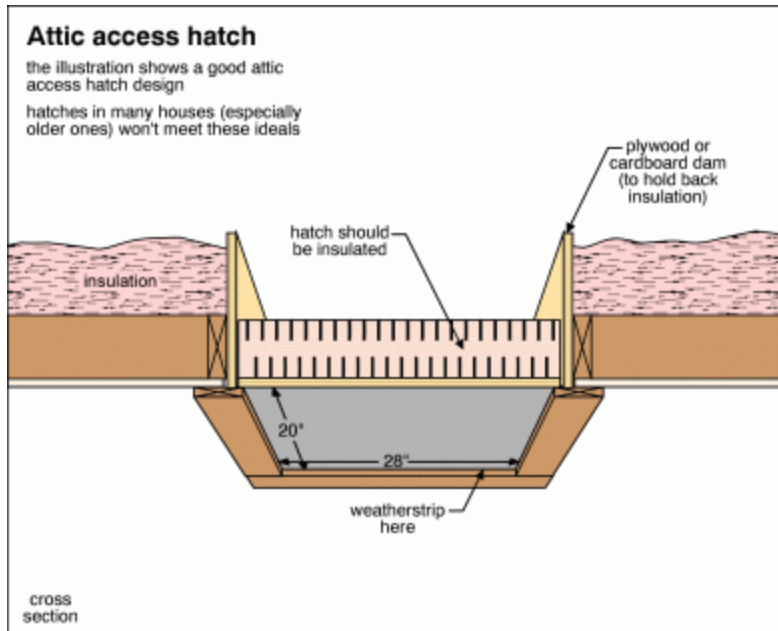
Condition: • [Not weatherstripped](#)

Implication(s): Chance of condensation damage to finishes and/or structure | Increased heating and cooling costs

Task: Provide

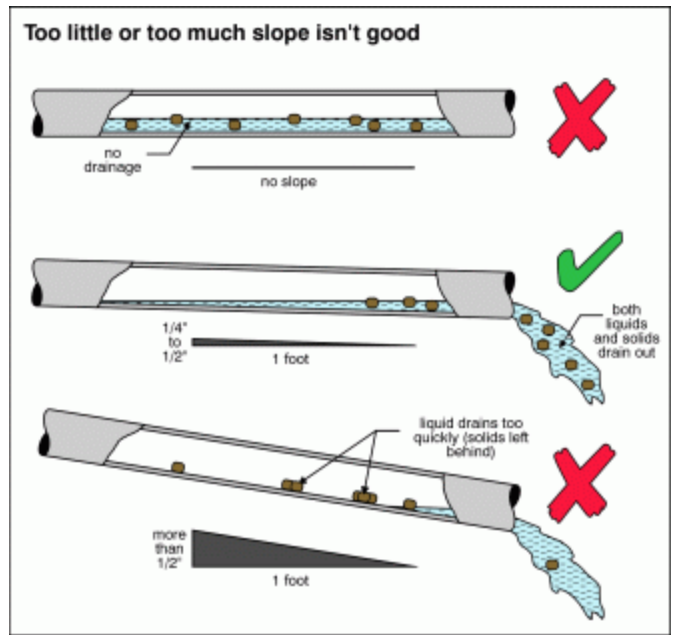
Condition: • [Poor slope](#)

Task: Repair

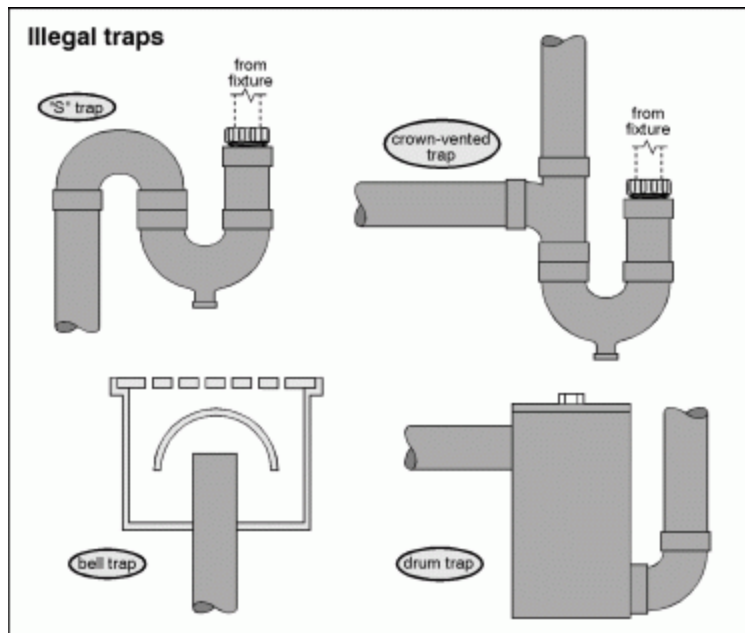
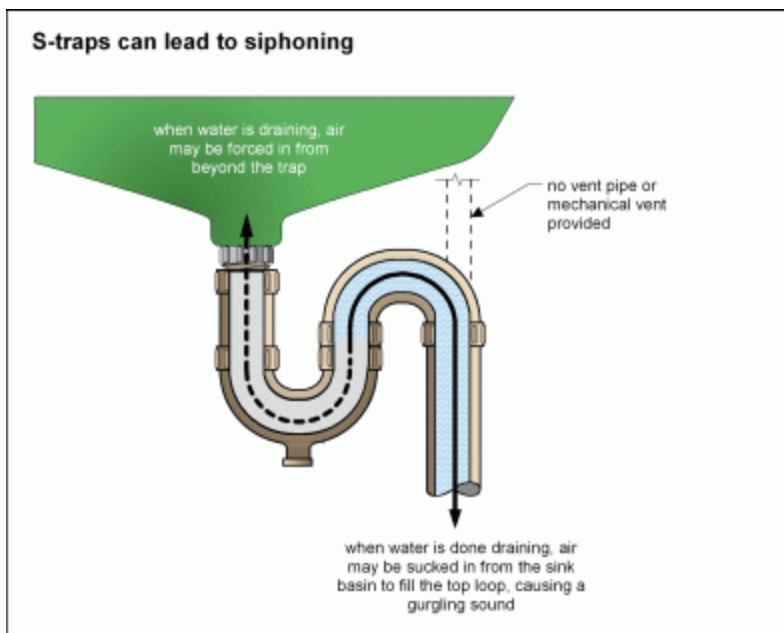
Condition: • [Wrong type](#)

Air vent missing.

Task: Repair or replace

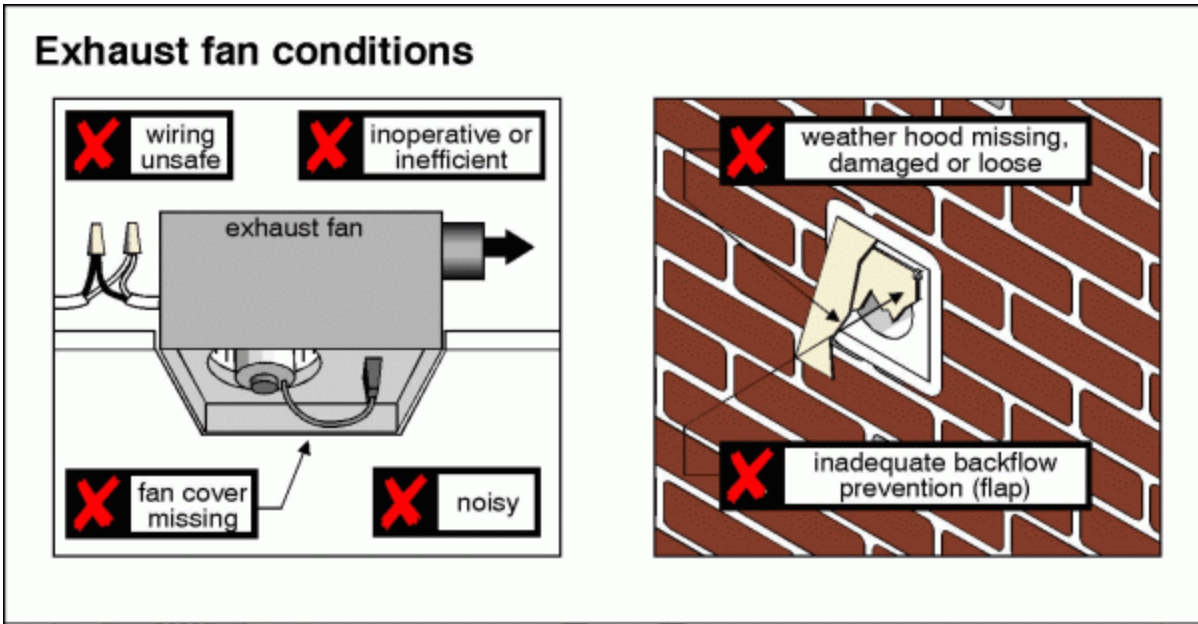
Condition: • [Weather hood missing or loose](#)

Dryer vent cover broken.

Implication(s): Chance of water damage to contents, finishes and/or structure | Chance of pests entering house

Task: Replace

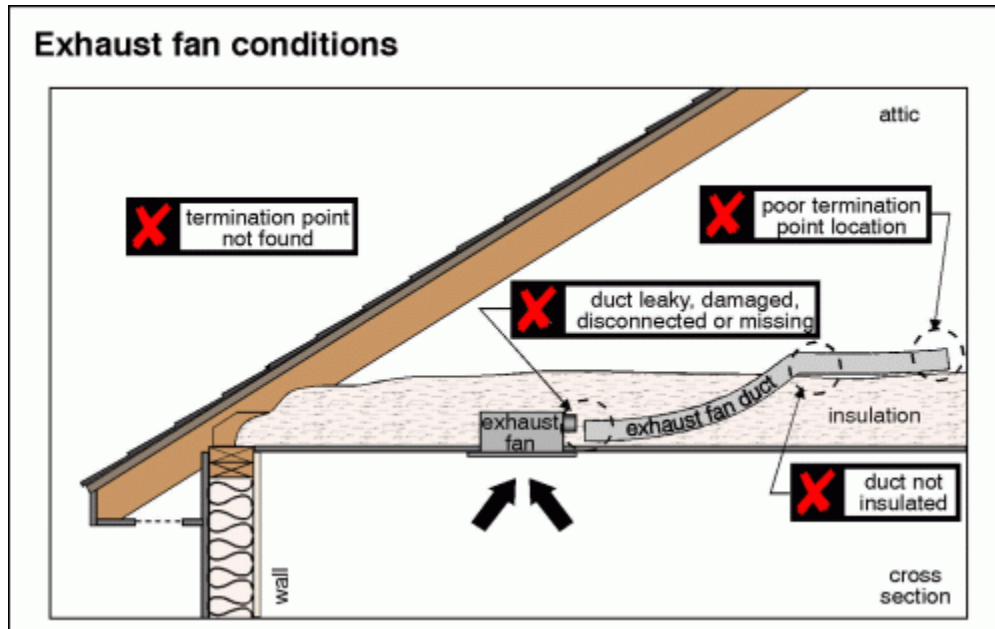
Condition: • Not vented to exterior

Implication(s): Chance of condensation damage to finishes and/or structure

Task: Repair
