# YOUR Inspection Report

123 Any Street  
Kitchener, ON

Thursday, May 13, 2010

RE: Report No. 1062  
123 Any Street  
Kitchener, ON

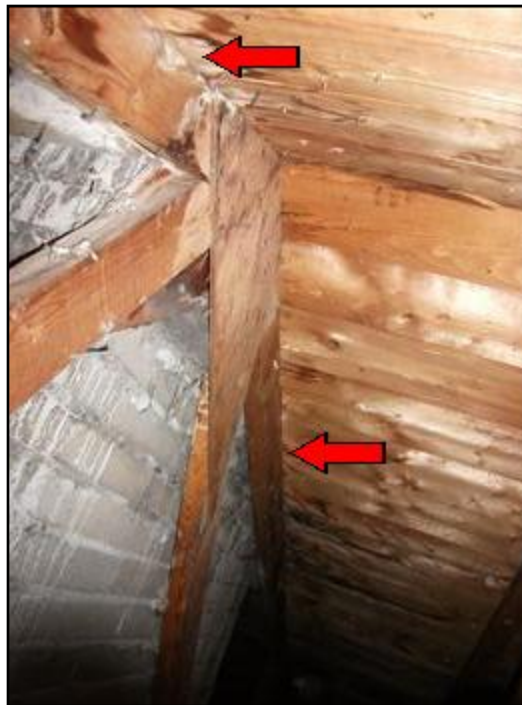
1. Signs of Past Leak

**Condition:** • [Leak](#)

Chimney flashings at one time leaked water into the attic. No signs of leaking at time of inspection.

**Implication(s):** Chance of water damage to contents, finishes and/or structure

**Location:** Attic

**Task:** Correct

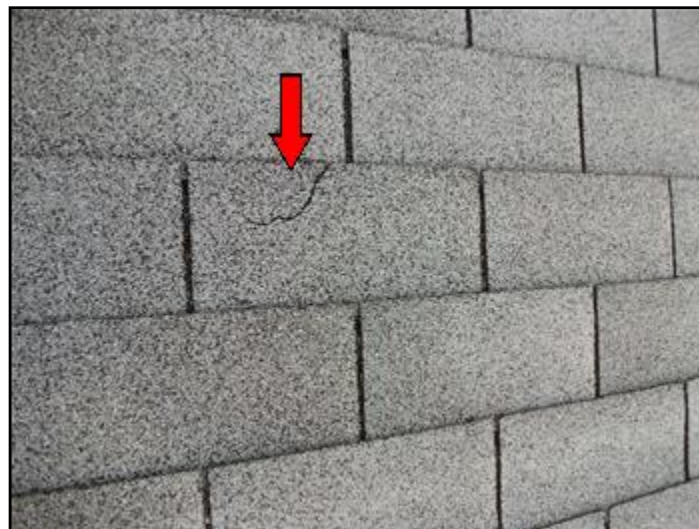
2. Roof Shingle Cracked

**Condition:** • [Cracked](#)

A few shingles on the roof were cracked.

**Implication(s):** Chance of water damage to contents, finishes and/or structure

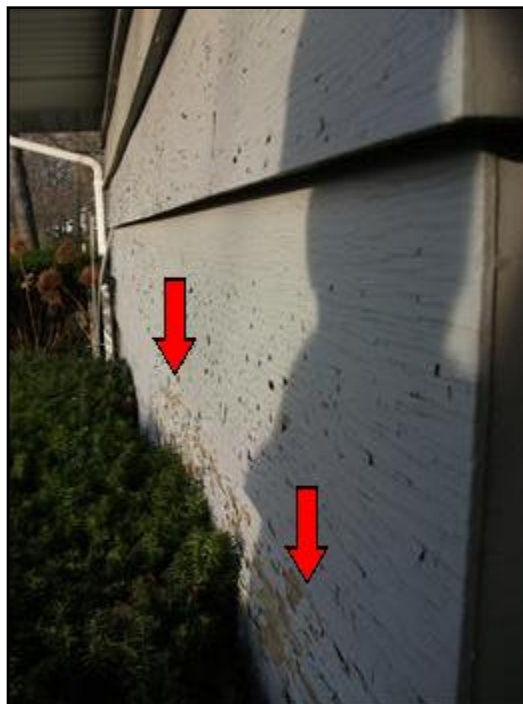
3. Wood Siding

**Condition:** • [Paint or stain - needed](#)

Paint on wood siding was cracked and flaking.

**Location:** Throughout Exterior

**Task:** Correct

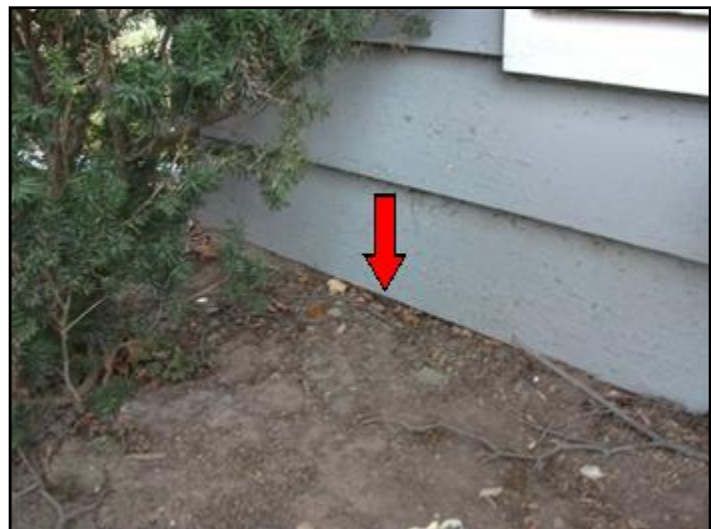
4. Wood Siding in Contact With Ground

**Condition:** • [Too close to grade or wood/soil contact](#)

**Implication(s):** Chance of water entering house | Weakened structure | Rot | Insect damage

**Location:** Throughout Exterior Wall

**Task:** Correct

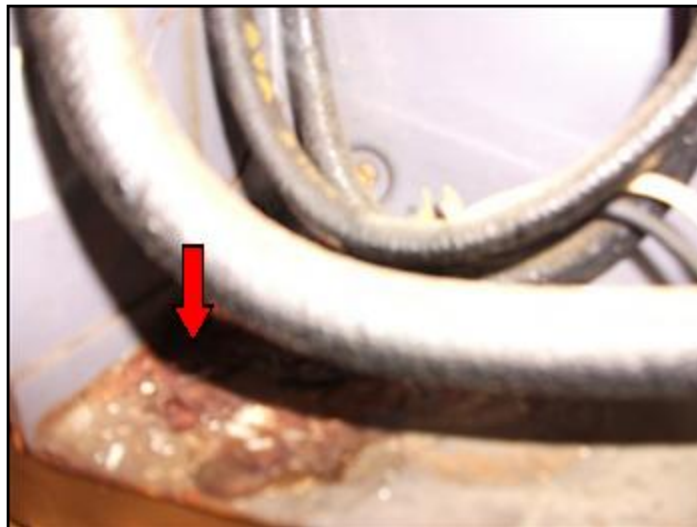
5. Rust in Panel

**Condition:** • [Rust](#)

Rust in panel and grommet missing where wire enters service box.

**Implication(s):** Electric shock | Increased fire hazard

**Task:** Further evaluation

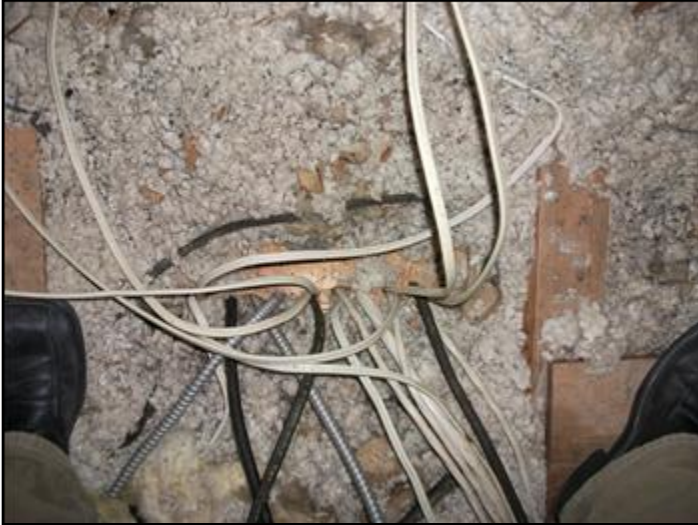
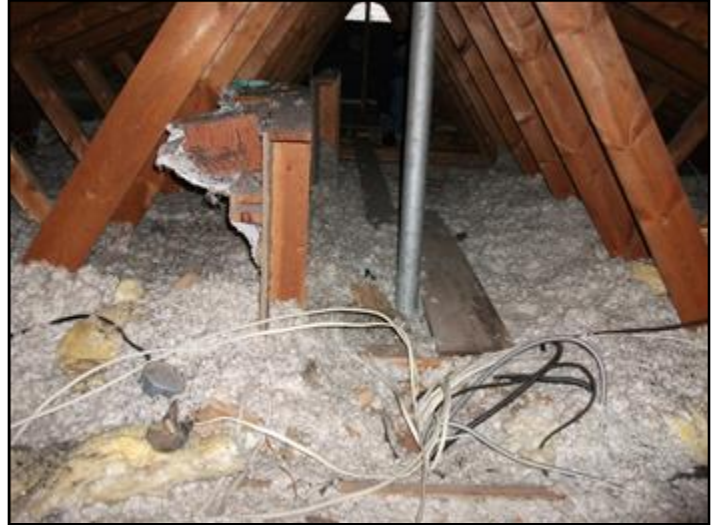
6. Wiring in Attic

**Condition:** • [Not well secured](#)

**Implication(s):** Electric shock | Fire hazard

**Location:** Attic

**Task:** Correct

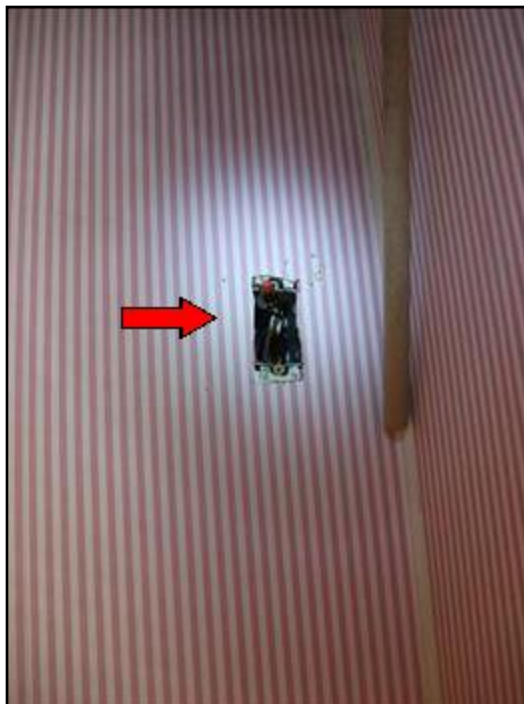
8. Laundry Outlet

**Condition:** • [Missing](#)

**Location:** Laundry Area

**Task:** Correct

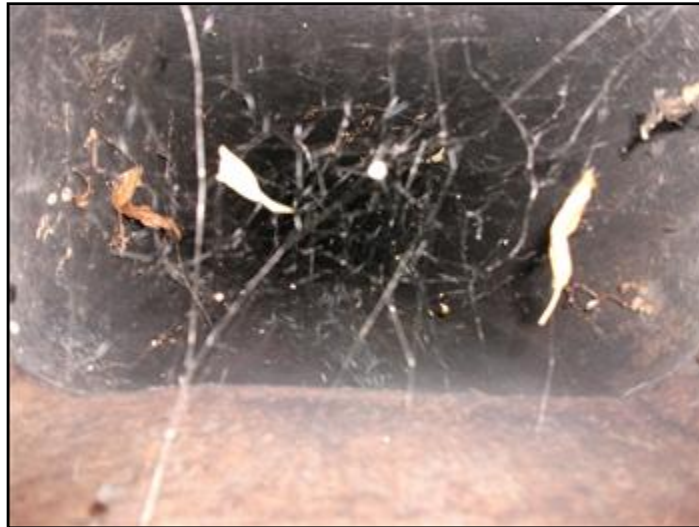
9. Chimney Flue

**Condition:** • [Inspect \(and/sweep if needed\) before using](#)

**Implication(s):** Fire hazard

**Task:** Correct

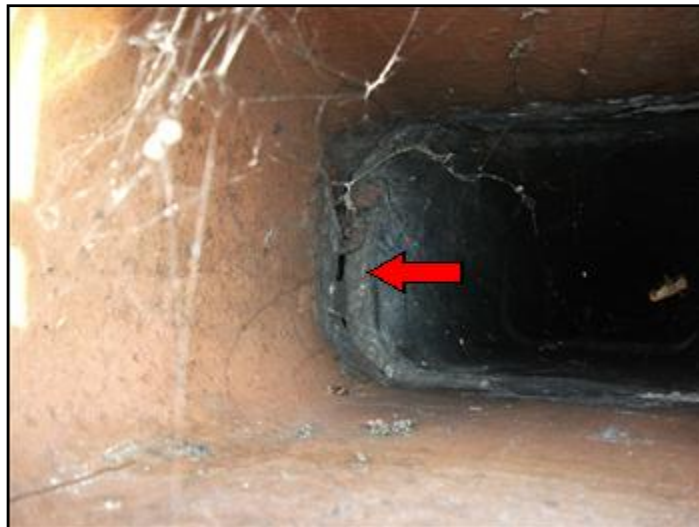
10. Opening and Crack in Flue

**Condition:** • [Cracked](#)

Chimney flue is not smoke tight. This hole and crack must be repaired by a WETT certified Chimney installer.

**Implication(s):** Chance of water damage to contents, finishes and/or structure | Shortened life expectancy of material

**Task:** Correct

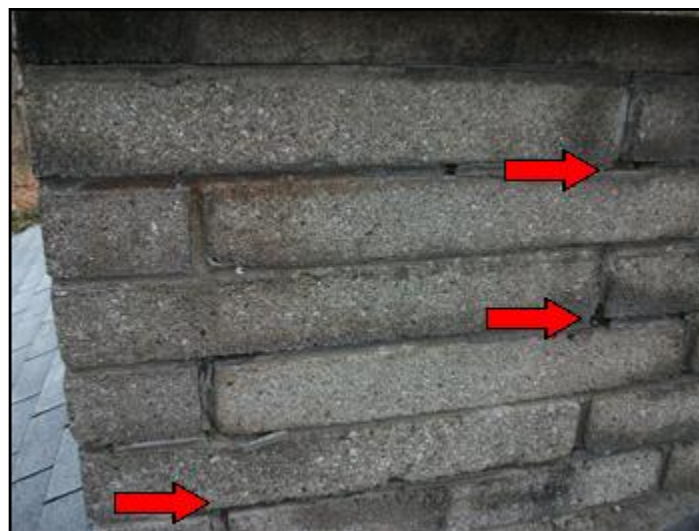
11. Chimney

**Condition:** • [Loose, missing or deteriorated mortar](#)

Repair mortar joints to ensure chimney stays water tight.

**Implication(s):** Material deterioration

**Task:** Correct

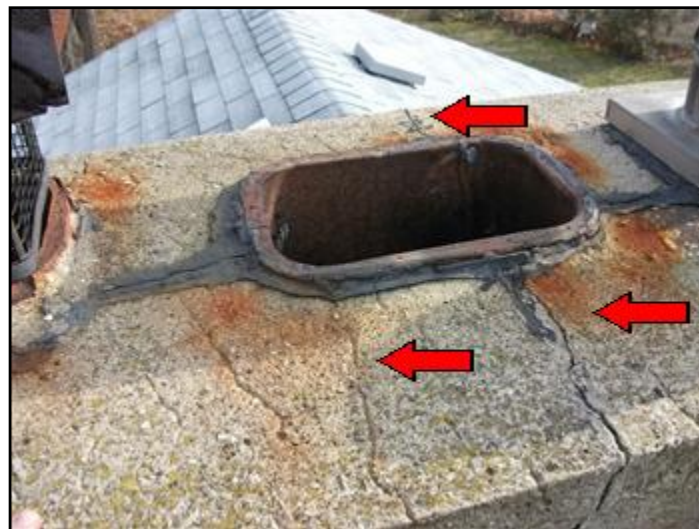
12. Chimney Crown

**Condition:** • [Cracked](#)

Chimney crown has cracks allowing moisture into the chimney. This will cause damage to the chimney during the freeze / thaw cycles.

**Implication(s):** Chance of water damage to contents, finishes and/or structure | Shortened life expectancy of material

**Task:** Correct

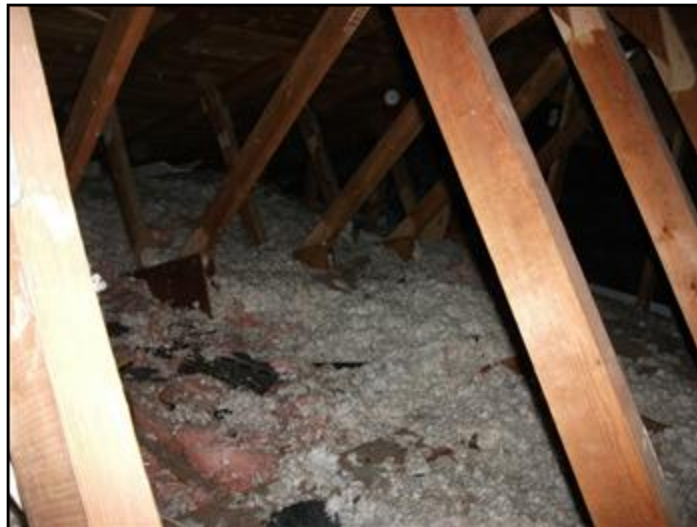
13. Attic Insulation

**Condition:** • [Amount inadequate](#)

Insulation is not consistent over ceiling. Some areas only have 4" whereas 10" or more is recommended.

**Location:** Throughout Attic

**Task:** Correct

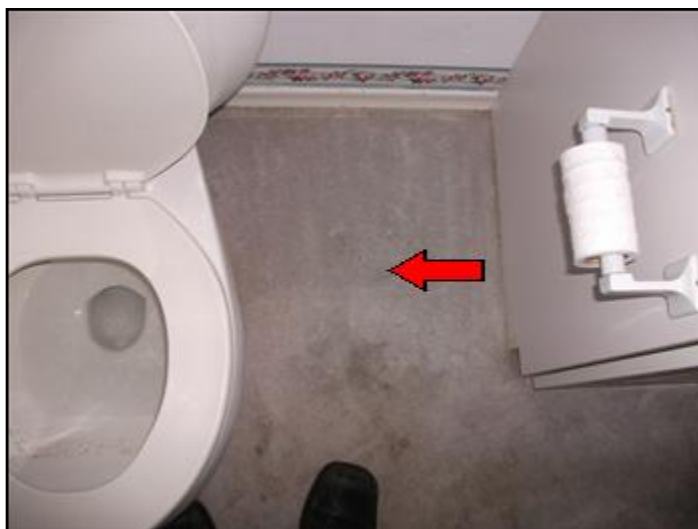
14. Carpet in Bathroom

**Condition:** • [Absorbent materials in wet areas](#)

Carpet not recommended in bathrooms as they absorb moisture.

**Implication(s):** Cosmetic defects | Hygiene issue

**Task:** Correct

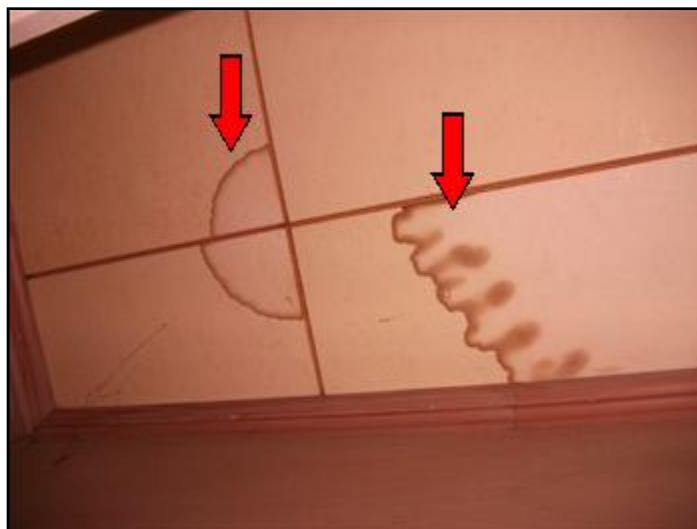
15. Ceiling Stains

**Condition:** • [Water damage](#)

Staining in front closet from previous roof leak.

**Implication(s):** Cosmetic defects | Chance of movement

**Task:** Monitor

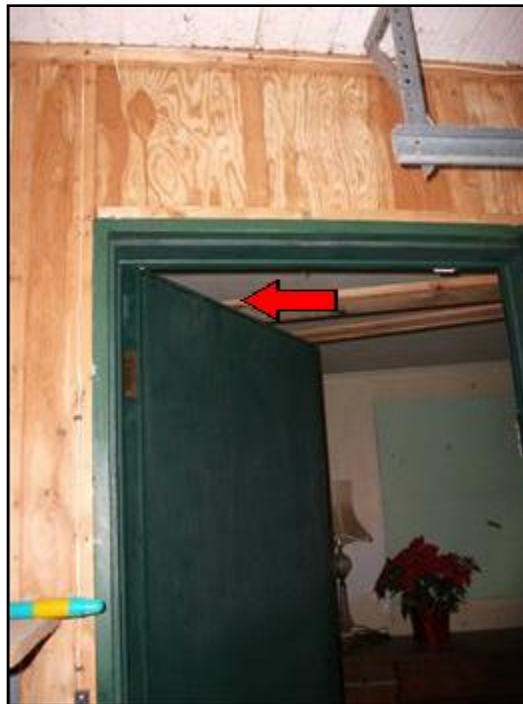
16. Garage Door to House

**Condition:** • [No self closer](#)

**Implication(s):** Hazardous combustion products entering home

**Task:** Correct

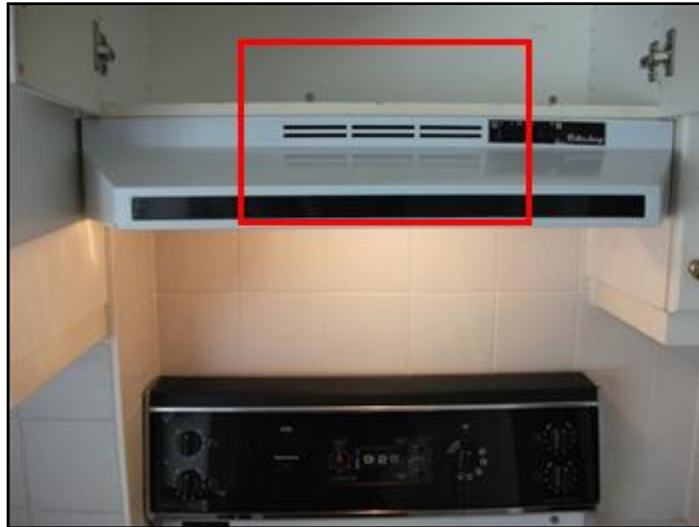
17. Kitchen Hood Fan

**Condition:** • Not vented to exterior

Although not required at time of construction. This fan vented to the exterior would improve indoor air quality by removing excess moisture from cooking.

**Implication(s):** Chance of condensation damage to finishes and/or structure

**Task:** Improve

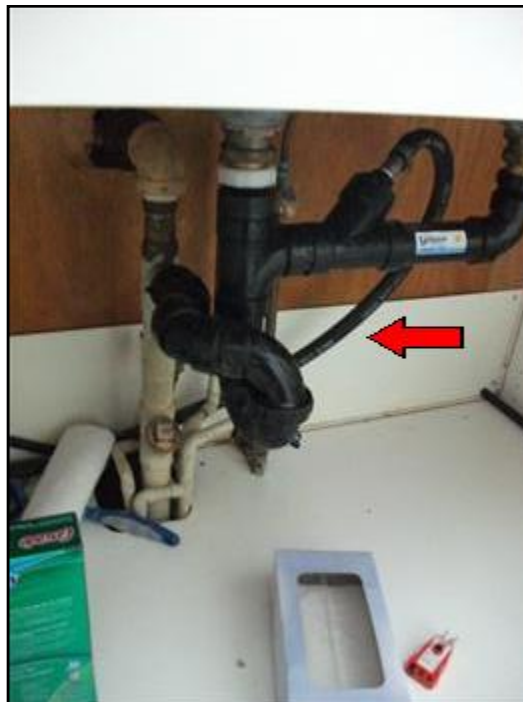
18. Dishwasher Discharge Hose

**Condition:** • Backflow prevention missing

**Task:** Correct

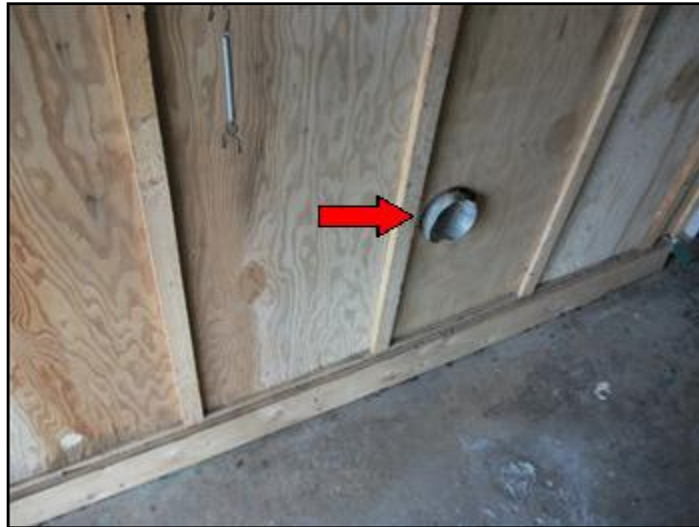
19. Dryer Vent Termination in Garage

**Condition:** • Not vented to exterior

**Implication(s):** Chance of condensation damage to finishes and/or structure

**Task:** Correct
