Your Inspection Report

123 Main Street
Harrisburg, PA

INSPECTION DATE:
Friday, September 19, 2008

RE: Report No. 1483, v.5
123 Main Street
Harrisburg, PA
17102

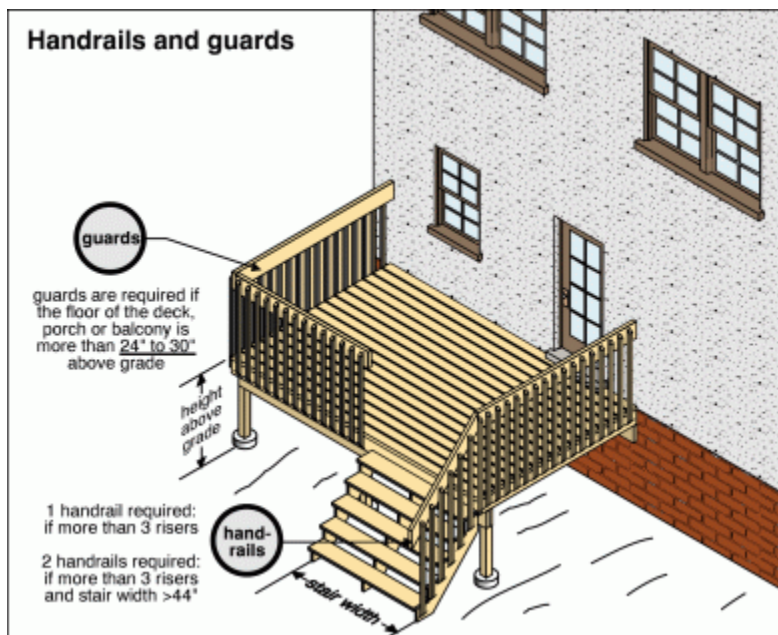
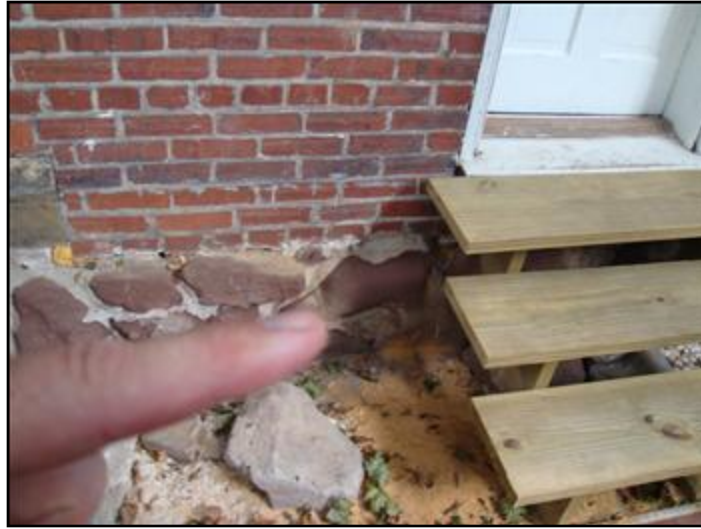
Condition: • [Missing](#)

Implication(s): Fall hazard

Location: Rear Exterior

Note: 2 steps or more should have a hand rail.

1. rail needed

Task: Provide

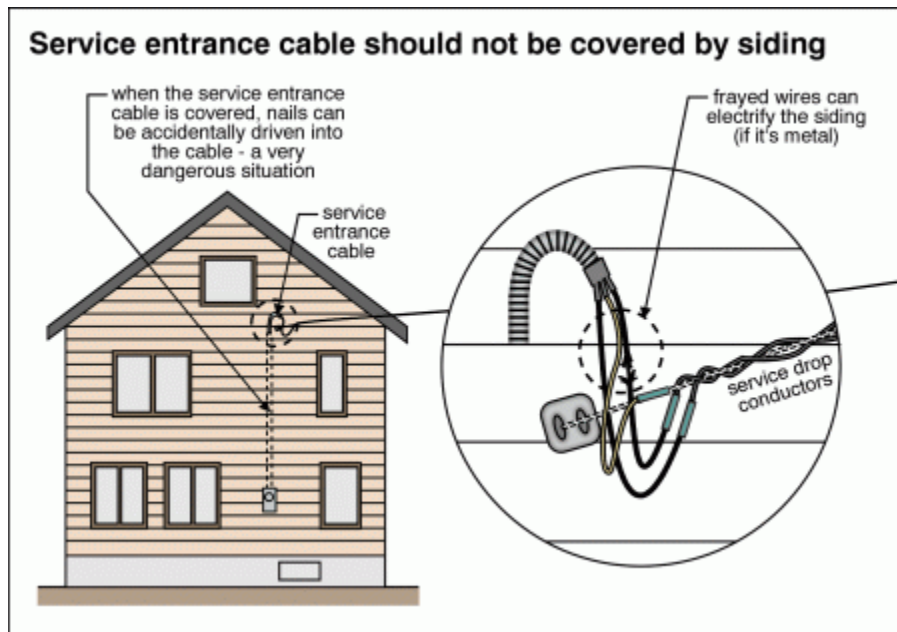
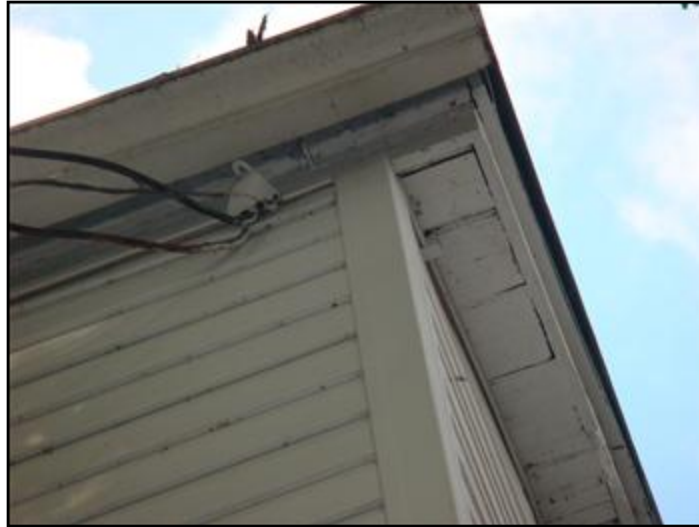
Condition: • [Conduit or cable covered by siding](#)

Implication(s): Electric shock

Location: Rear Exterior

2. cable covered with siding

Task: Repair

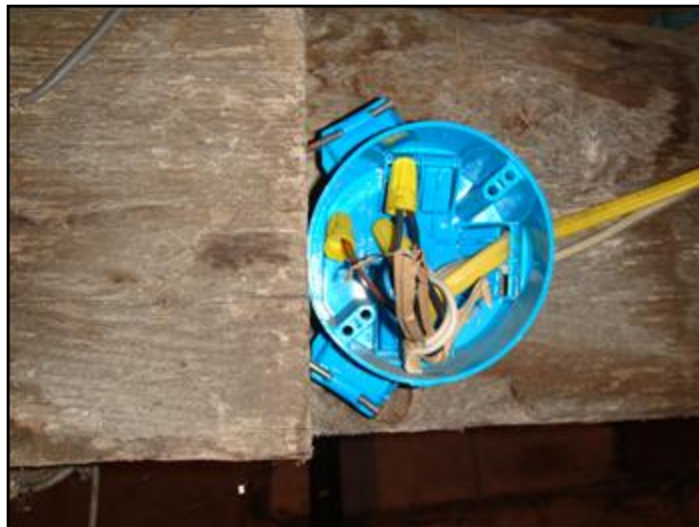
Condition: • [Cover loose or missing](#)

Implication(s): Electric shock | Fire hazard

Location: Basement

3. cover j box

Task: Repair

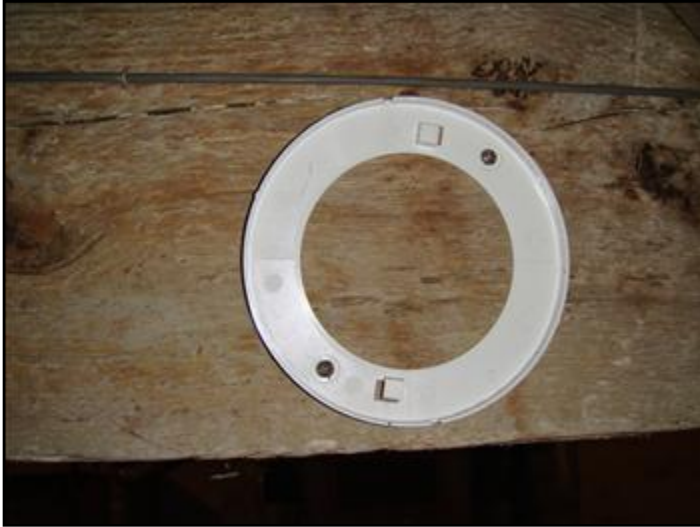
Condition: • [Inoperative](#)

4. missing in basement

Task: Correct

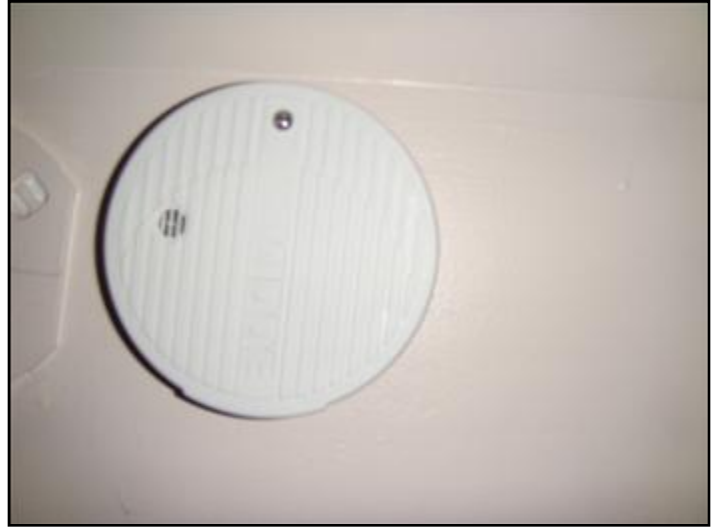
5. not working 2nd floor

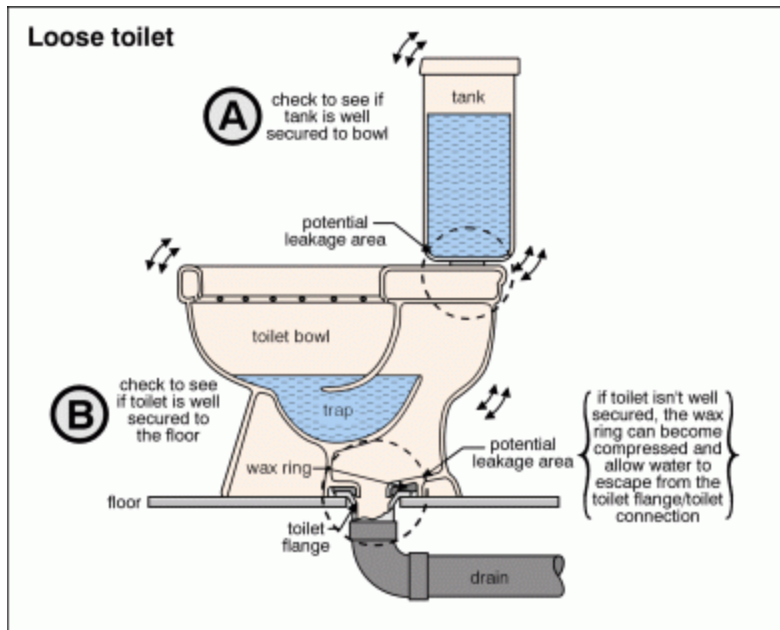
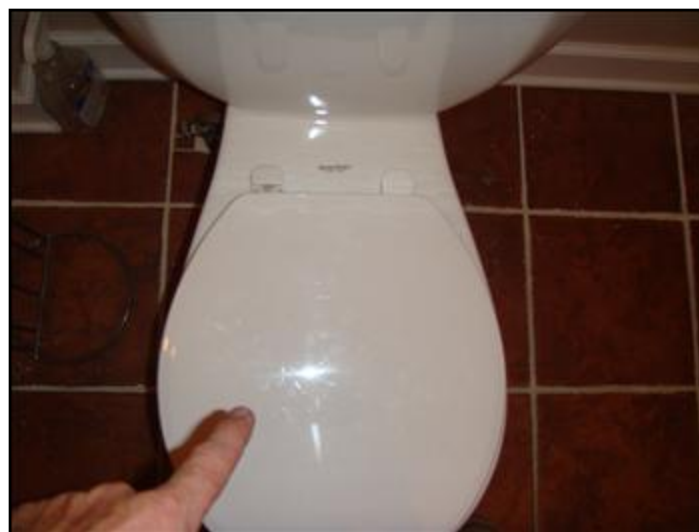
Condition: • [Loose](#)

Implication(s): Chance of water damage to contents, finishes and/or structure | Sewage entering the house

Location: Third floor Bathroom

6. loose toilet

Note: Re install toilet.

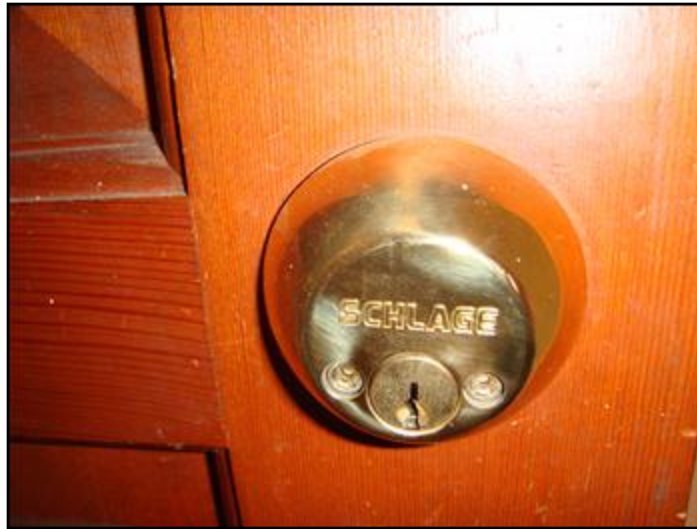
Condition: • Lock on the front door; this is dangerous in case emergency exit is needed. Change to a hand turn dead bolt.

7. *keyed deadbolt*

Task: Replace

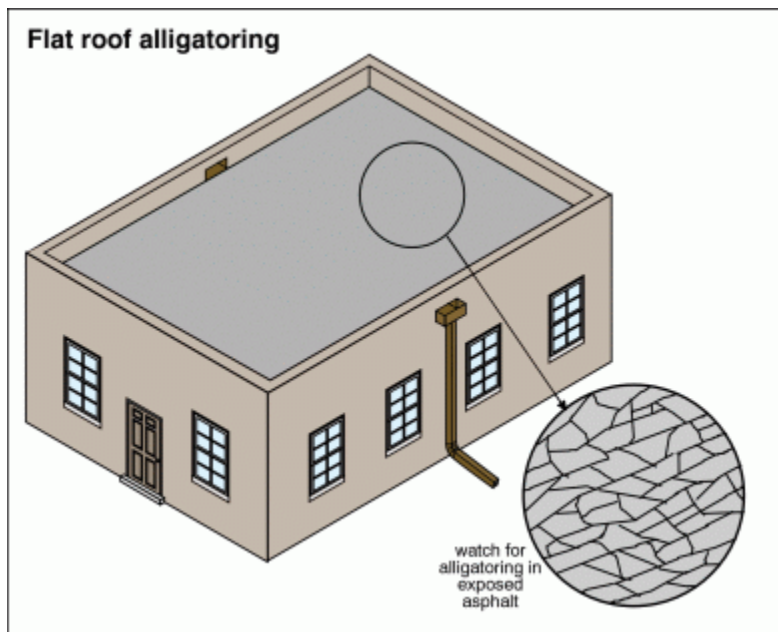
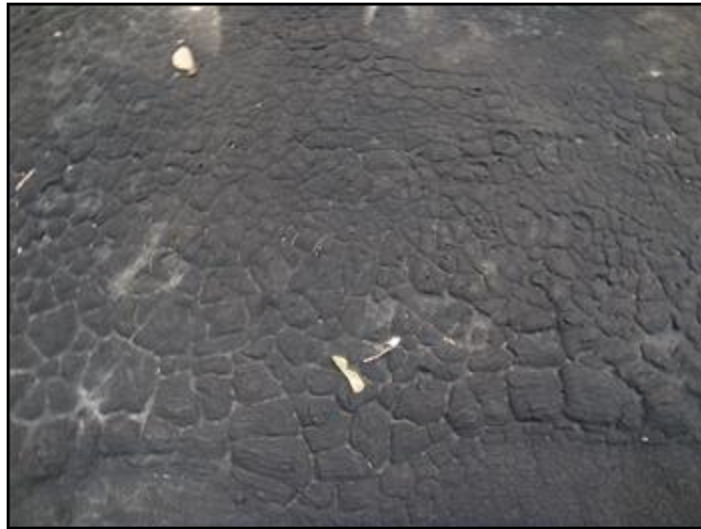
8.

Condition: • [Alligatoring](#)

Implication(s): Chance of water damage to contents, finishes and/or structure | Material deterioration

Location: Rear Second floor

Note: No evidence of current leakage; monitor, keep roof coated (suggest elastomeric coating) or replace as necessary.

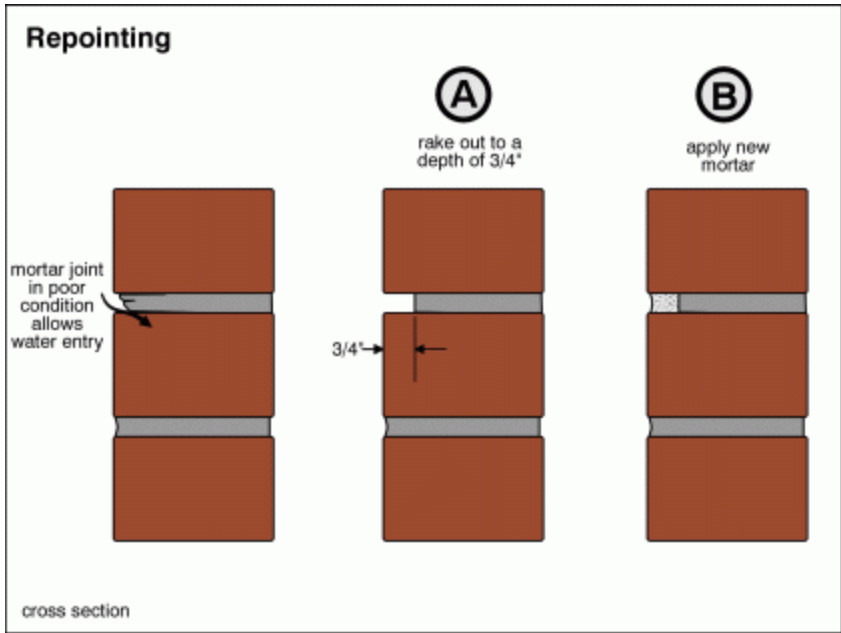
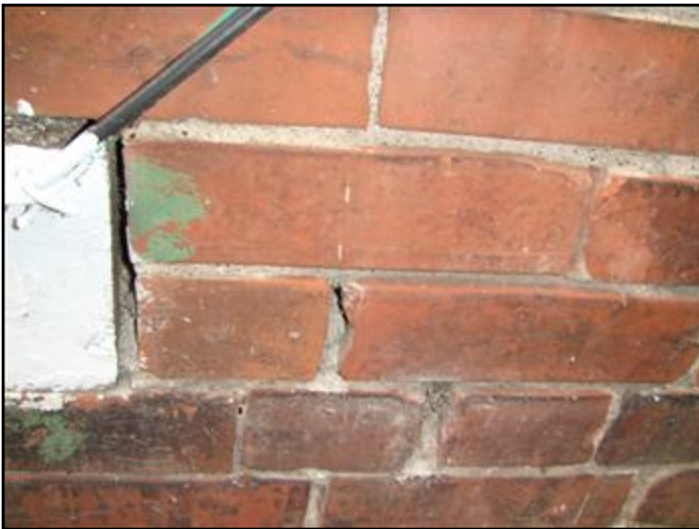
Condition: • [Mortar deterioration](#)

Implication(s): Chance of water entering house | Weakened structure | Chance of structural movement

Location: Rear Exterior

Note: Some minor brick repairs are needed at the rear of the property.

9. repoint

Task: Repair

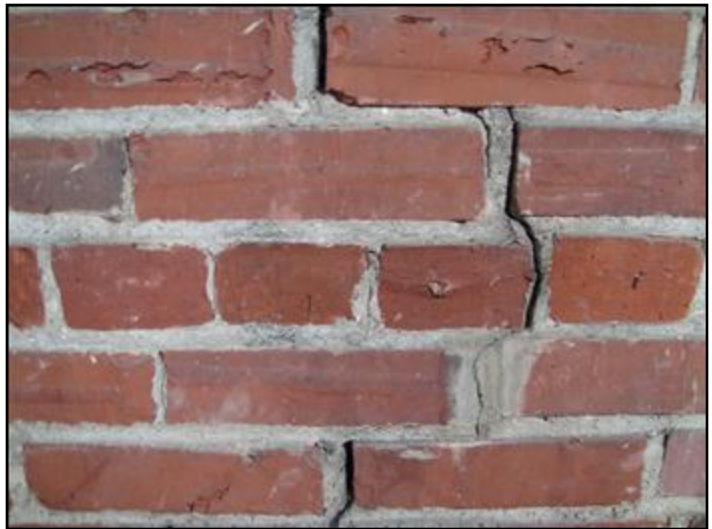
10. repoint

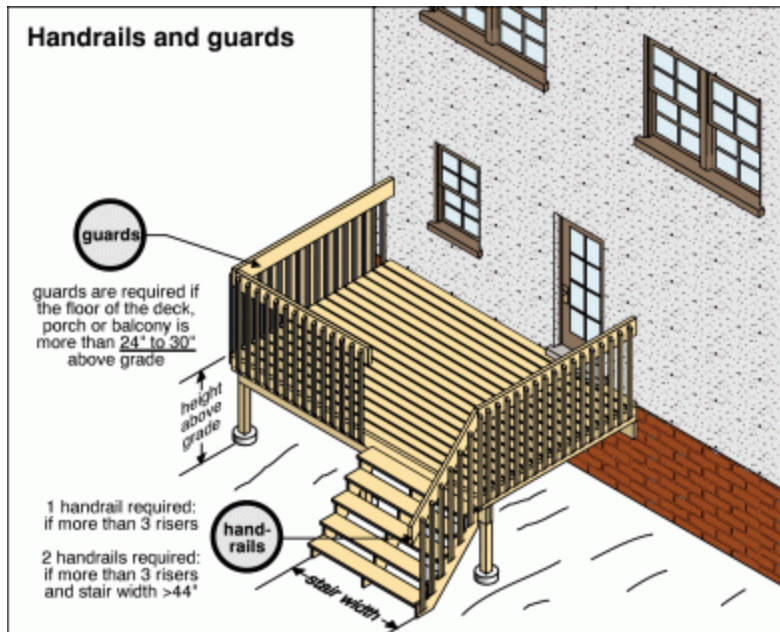
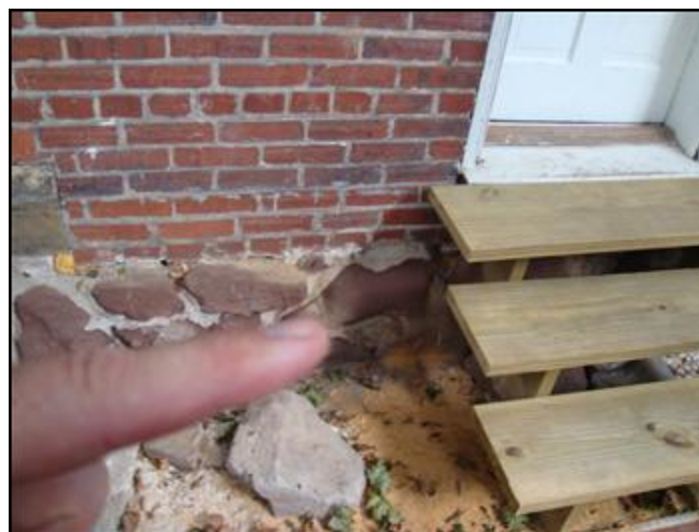
Condition: • [Missing](#)

Implication(s): Fall hazard

Location: Rear Exterior

Note: 2 steps or more should have a hand rail.

11. rail needed

Task: Provide

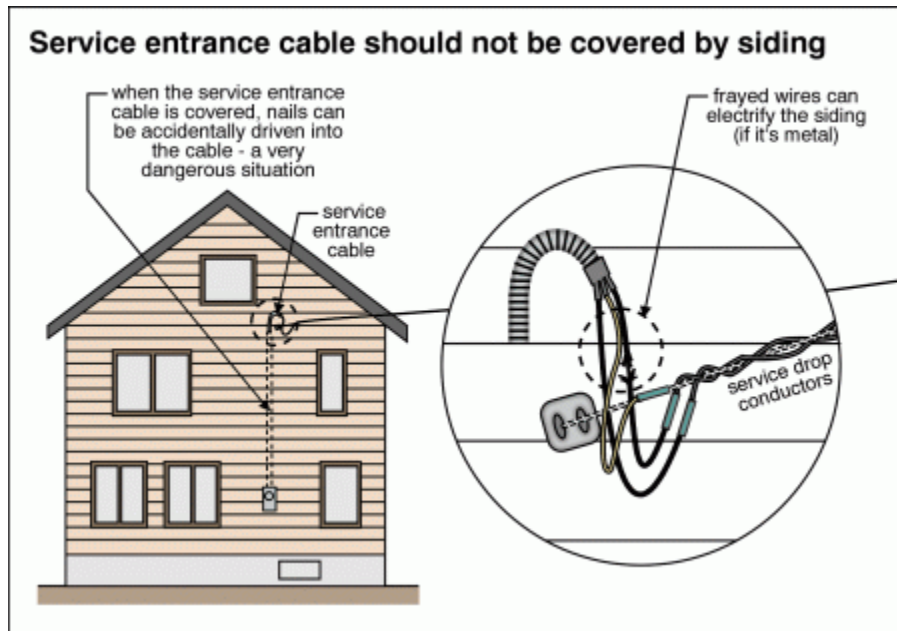
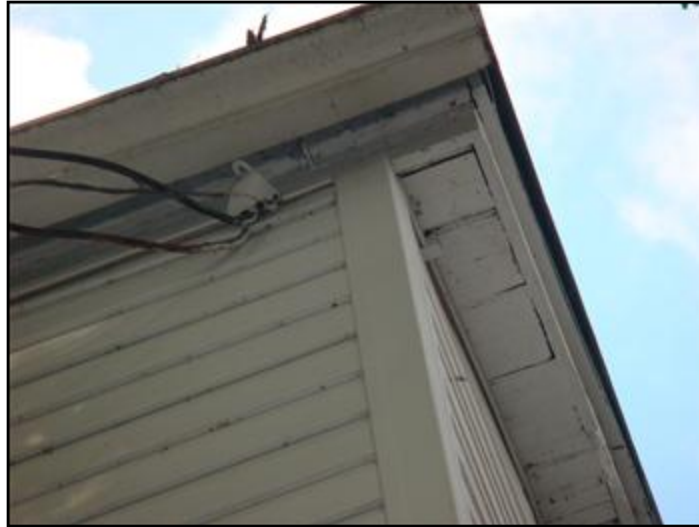
Condition: • [Conduit or cable covered by siding](#)

Implication(s): Electric shock

Location: Rear Exterior

12. cable covered with siding

Task: Repair

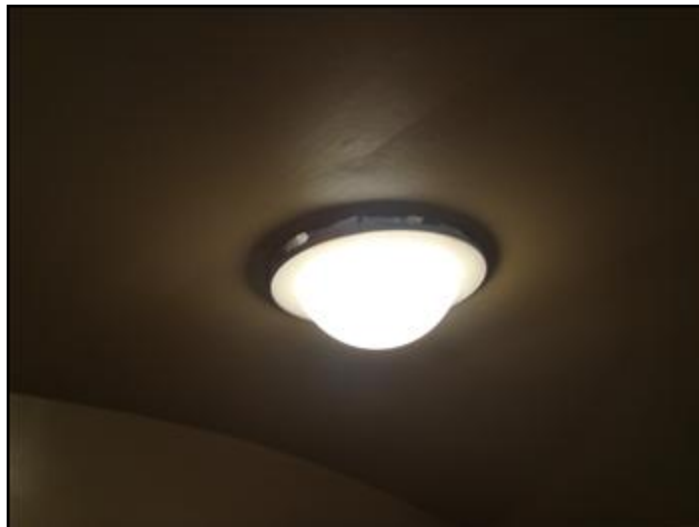
Condition: • [Loose](#)

Implication(s): Electric shock | Fire hazard

Location: Second floor Bathroom

13. loose light

Task: Repair

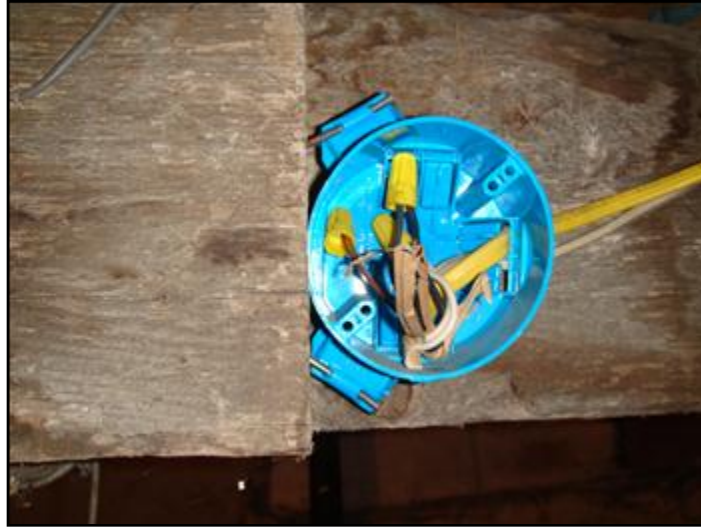
Condition: • [Cover loose or missing](#)

Implication(s): Electric shock | Fire hazard

Location: Basement

14. cover j box

Task: Repair

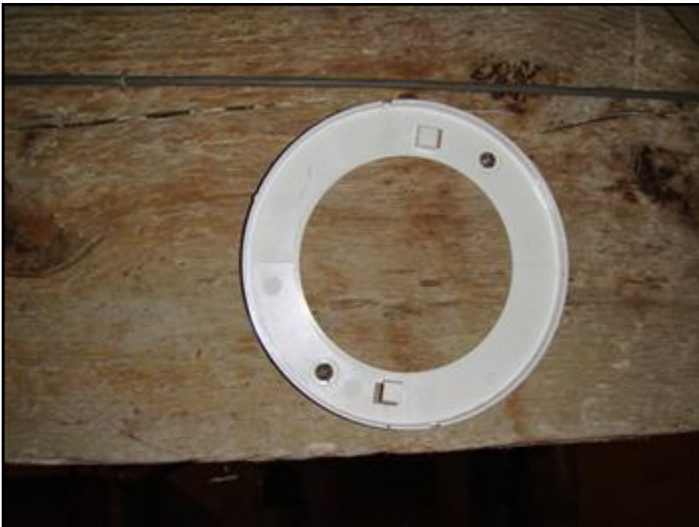
Condition: • [Inoperative](#)

15. missing in basement

Task: Correct

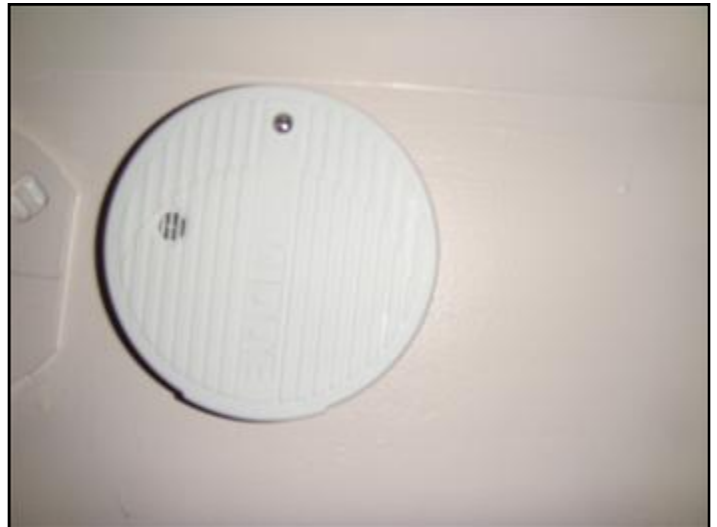
16. not working 2nd floor

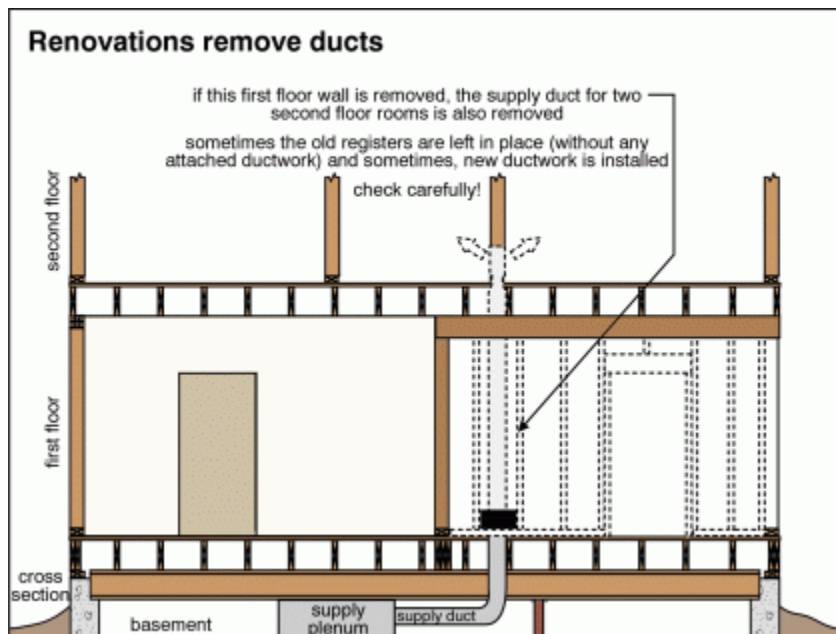
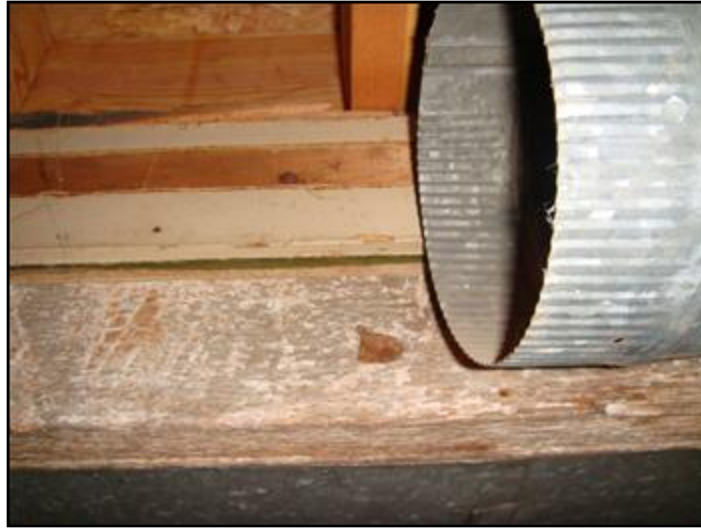
Condition: • [Disconnected ducts](#)

Implication(s): Increased heating costs | Reduced comfort

Location: Basement

Note: This dumps heat into the basement. Close off asap to save gas.

17. supply duct

Task: Repair

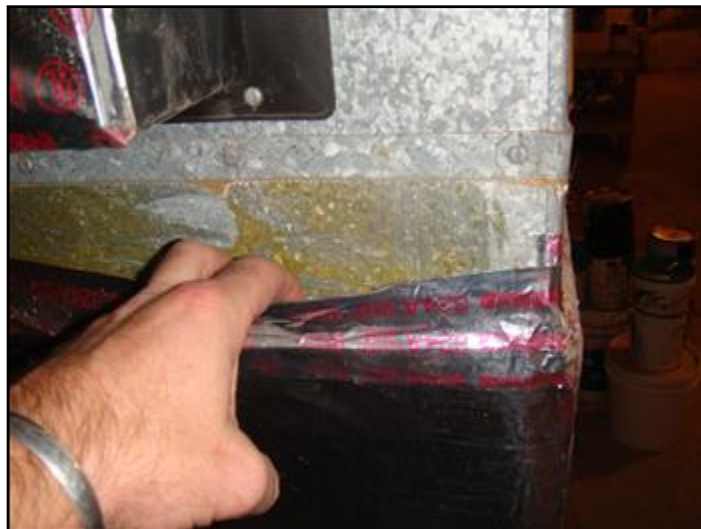
Condition: • [Leaky joints](#)

Implication(s): Increased heating costs | Reduced comfort

Location: Basement

18. leaky joints

Task: Repair

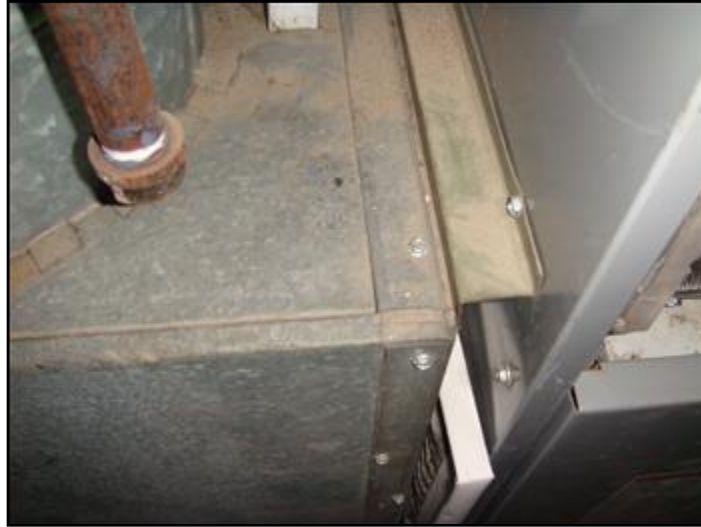
Condition: • Filter housing is open which will result in dirty air being sucked into system. Filter is the wrong size for the housing. Recommend repair by an HVAC contractor.

Location: Basement

19. open housing

Task: Repair

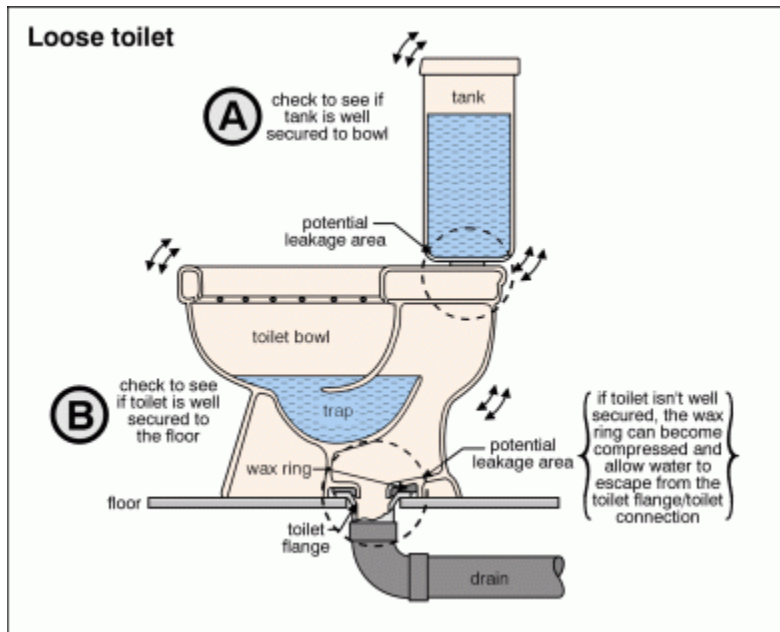
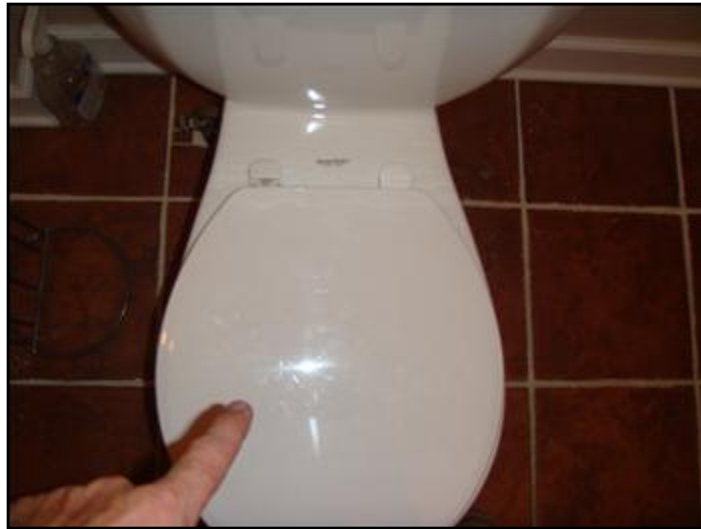
- Condition: • [Loose](#)
- Implication(s): Chance of water damage to contents, finishes and/or structure | Sewage entering the house
- Location: Third floor Bathroom
- Task: Repair
- Time: Immediate
- Cost: Less than \$100
- Note: Re install toilet.

20. loose toilet

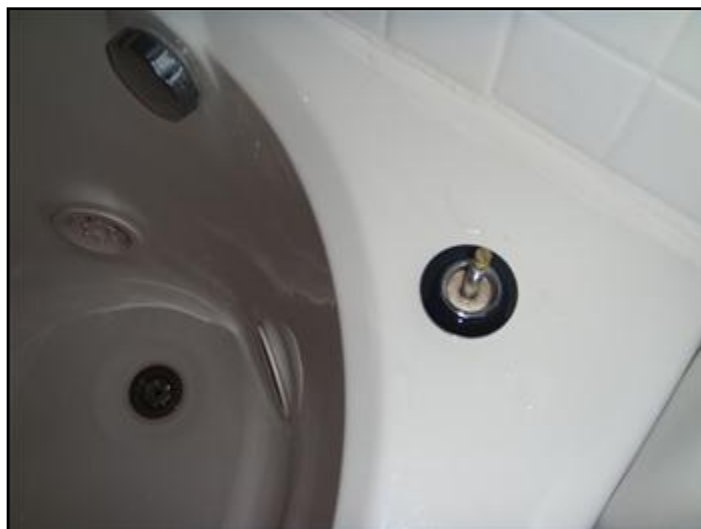
Condition: • Drain stop ineffective

Location: Second floor Bathroom

21. stopper broken

Task: Repair

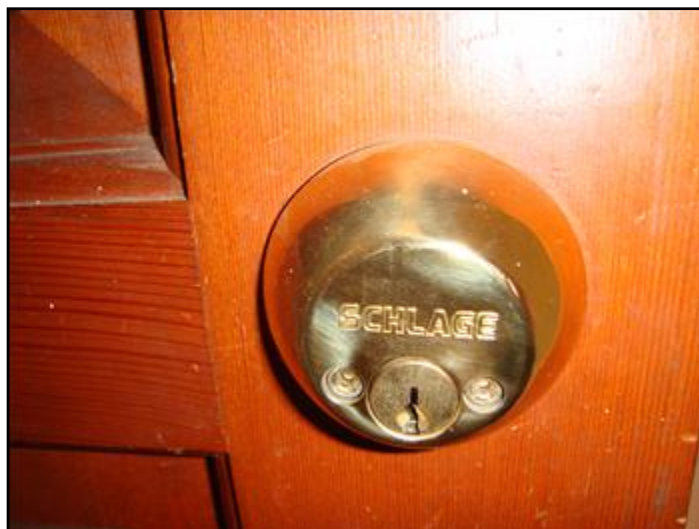
Condition: • Lock on the front door; this is dangerous in case emergency exit is needed. Change to a hand turn dead bolt.

Location: Front First floor

22. keyed deadbolt

Task: Replace
