Your Inspection Report

247 Fairglen Ave
Toronto, ON

INSPECTION DATE:
Thursday, March 4, 2010

Report No. 8900

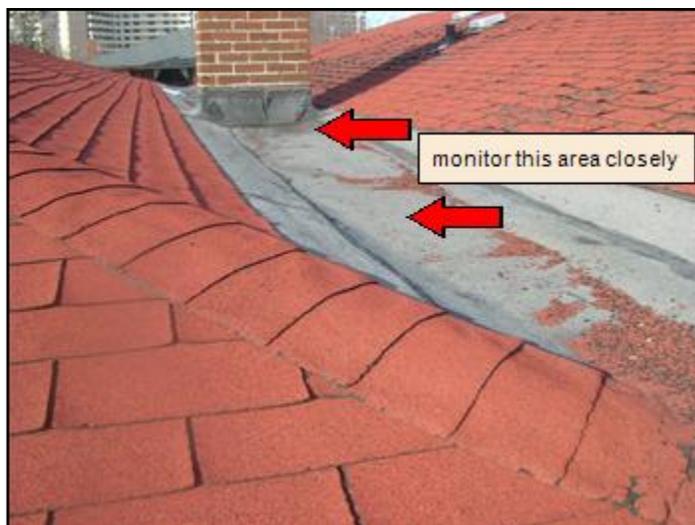
VULNERABLE AREAS \ 1.13, 1.14 & 1.15

Condition: • [Valleys converging creates a vulnerable area for roof leaks](#)

The valley between the two houses should be inspected and maintained yearly.

Task: Service annually

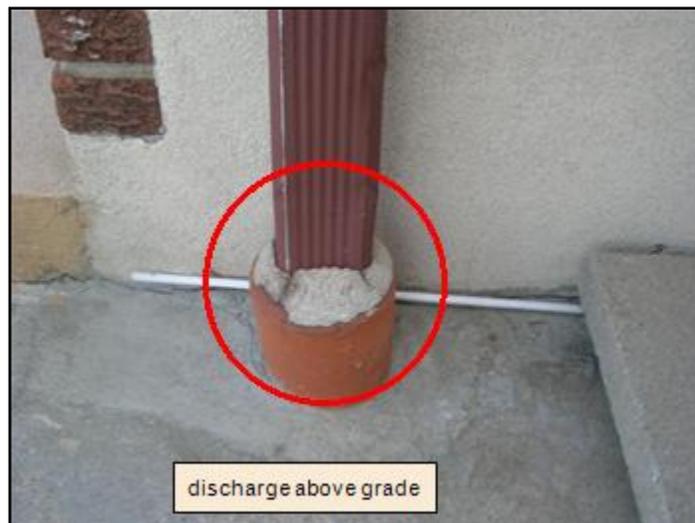
DOWNSPOUTS \ 1.0

Condition: • The City of Toronto requires downspouts be disconnected from the city sewers. Why? The sewers handle both storm water and waste from houses. Waste has to go through the sewage treatment system, which is very expensive. Storm water does not have to be treated, and should not go into city sewers. Downspouts should discharge above grade onto the lawn at least 6 feet from the home. This may require relocating downspouts and re-sloping gutters.

Location: Front

Task: Improve

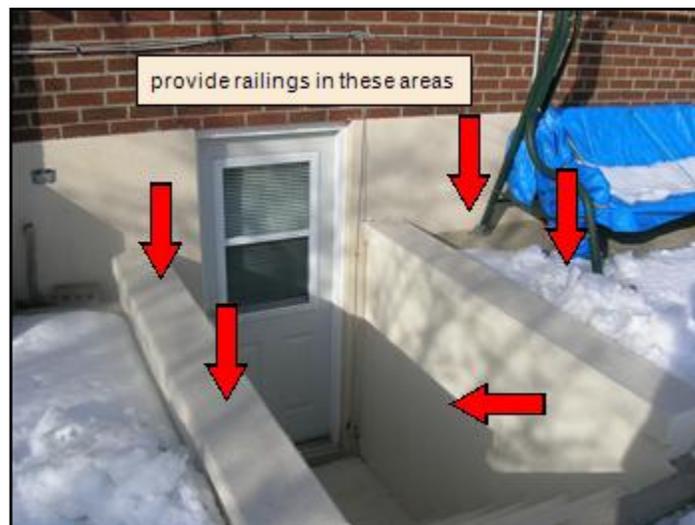
BASEMENT WALK-OUT \ 7.0

Condition: • [Railing missing \(7.3\)](#)

Location: Rear

Task: Provide
