Your Inspection Report

4321 Any Street
Lower Mainland, BC

Thursday, March 21, 2013

RE: Report No. 1632, v.4
4321 Any Street
Lower Mainland, BC

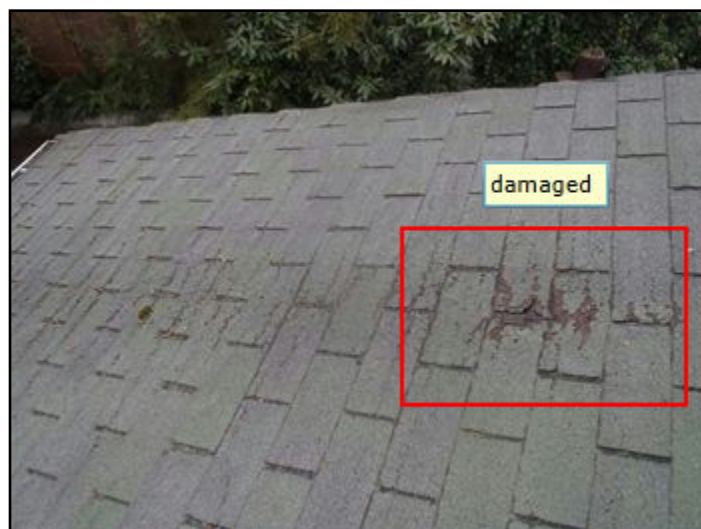
1.

Condition: • [Granule loss](#)

This high flow area has worn out and will need to be repaired/replaced in the near future.

Implication(s): Chance of water damage to contents, finishes and/or structure

Location: Throughout Exterior Roof

Task: Repair

Time: Less than 2 years

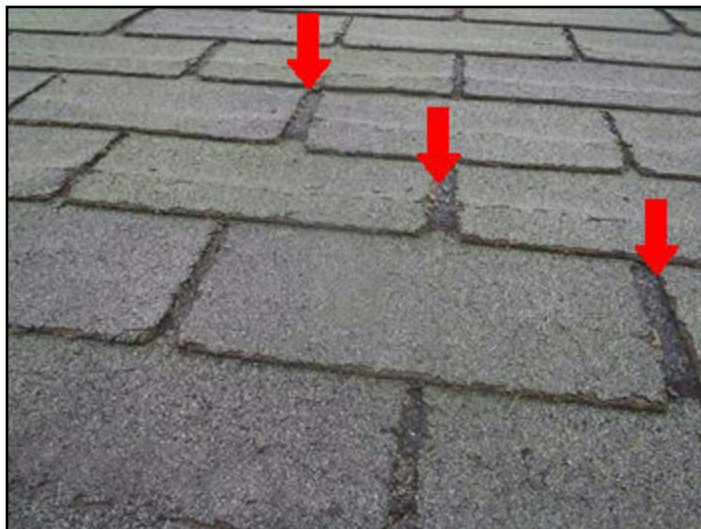
2.

Condition: • [Slots wide](#)

Widened slots increase the chance of leakage

Implication(s): Chance of water damage to contents, finishes and/or structure

Location: Various Exterior Roof

Task: Replace

Time: Less than 2 years

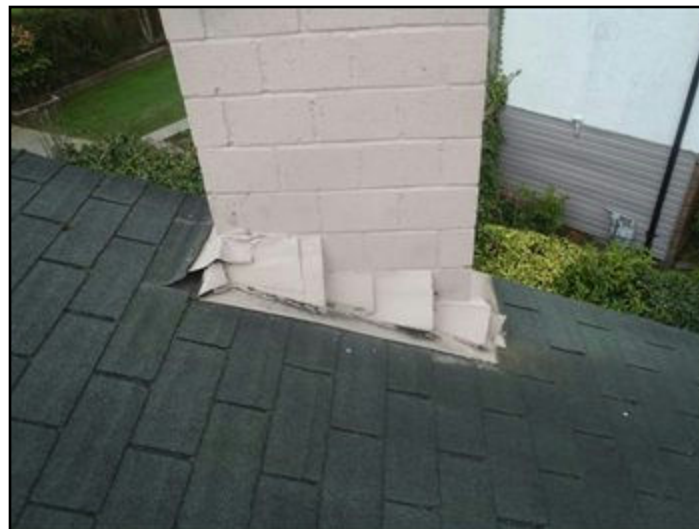
3.

Condition: • [Overlap inadequate on base or cap flashings](#)

The flashing appears to be functioning correctly but I recommend that you improve the arrangement when re-roofing.

Implication(s): Chance of water damage to contents, finishes and/or structure

Location: West Exterior

Task: Repair

Time: When Re Roofing

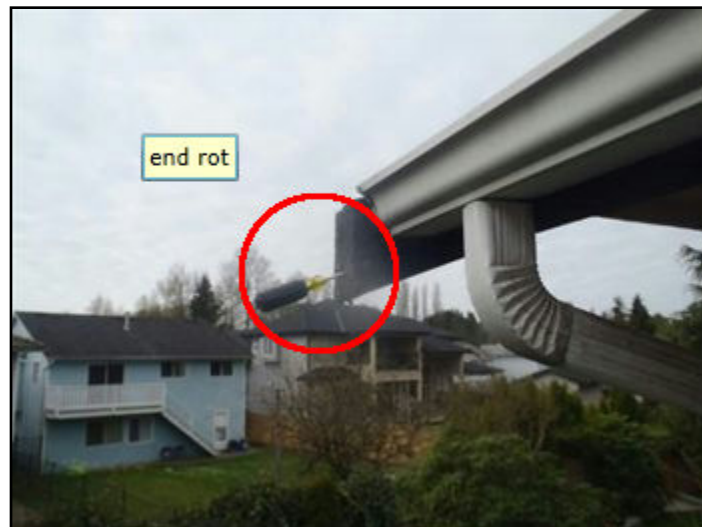
4.

Condition: • [Rot or insect damage](#)

Implication(s): Cosmetic defects | Chance of water damage to contents, finishes and/or structure | Material deterioration

Location: Various Exterior

Task: Repair

Time: Less than 3 years

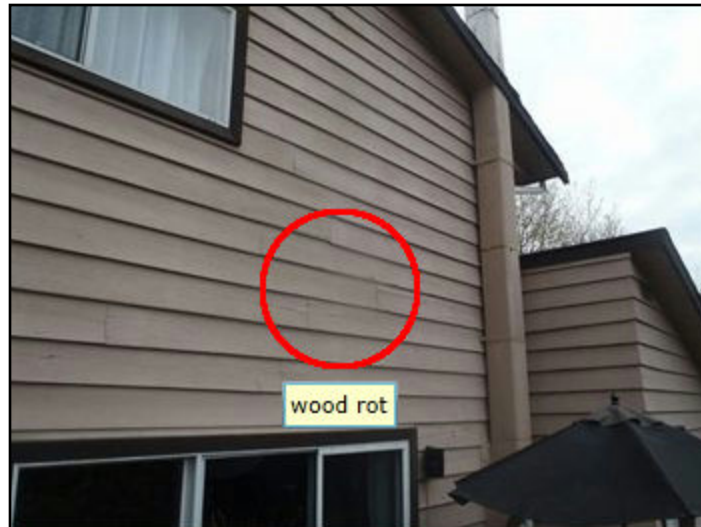
5.

Condition: • [Rot or insect damage](#)

Implication(s): Cosmetic defects | Chance of water damage to contents, finishes and/or structure | Material deterioration

Location: South Exterior

Task: Repair

Time: If necessary

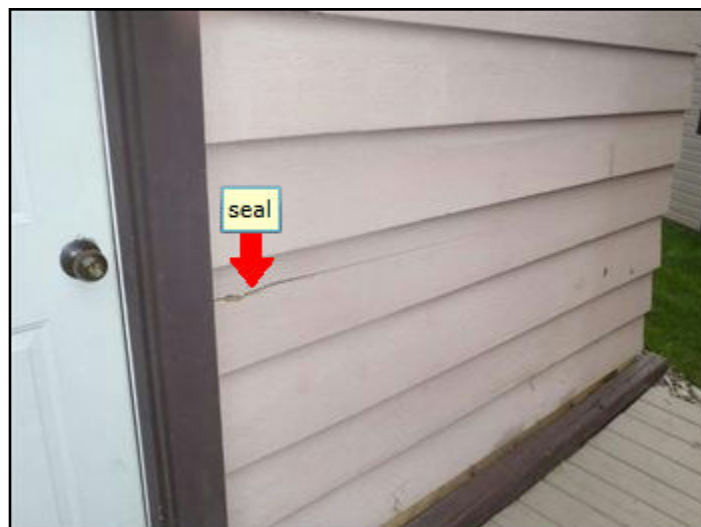
6.

Condition: • [Cracked, split or broken](#)

Implication(s): Cosmetic defects | Chance of water damage to contents, finishes and/or structure

Location: Southeast Exterior

Task: Repair

Time: Less than 1 year

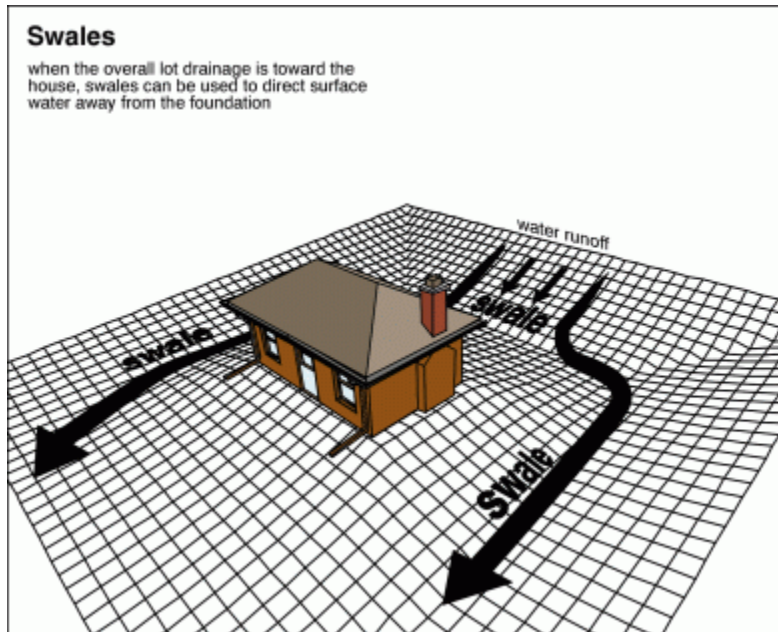
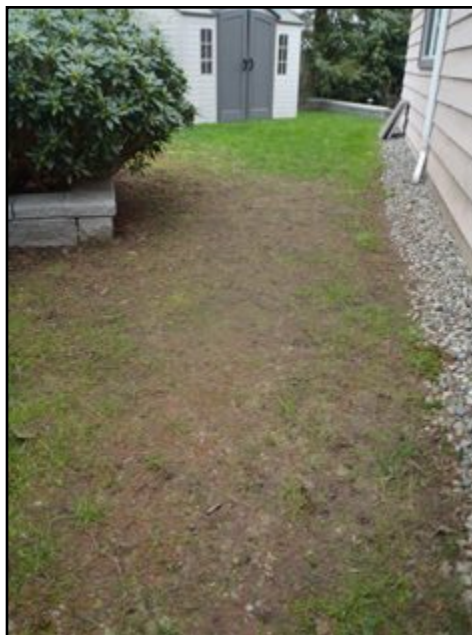
7.

Condition: • [Improper slope](#)

There is no slope in the yard and pooling water could be an issue.

Implication(s): Chance of water damage to contents, finishes and/or structure

Location: East Exterior

Task: Improve

Time: If necessary

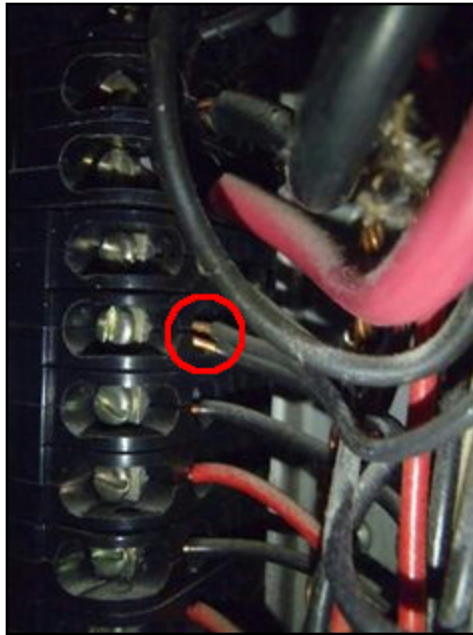
8.

Condition: • [Double taps](#)

Implication(s): Fire hazard

I recommend that you bring in an electrician to repair the condition

Task: Repair

Time: Immediate

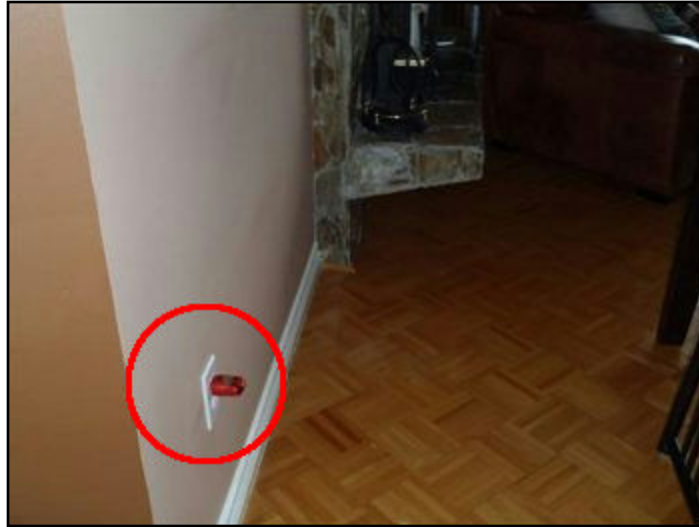
9.

Condition: • [Reversed polarity](#)

Task: Repair

Time: Immediate

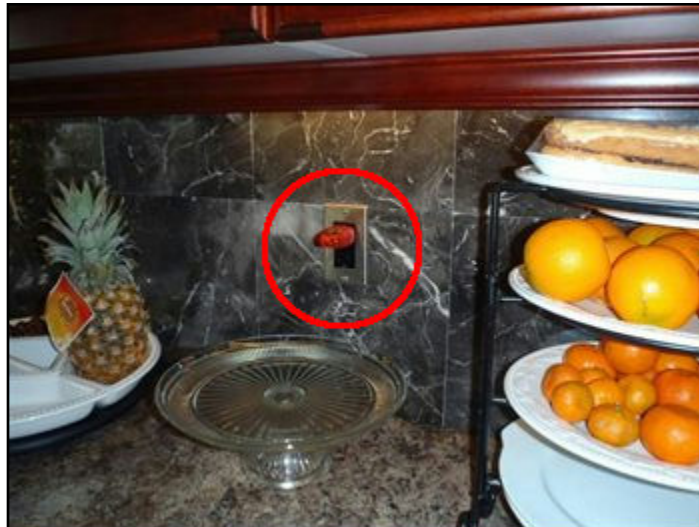
10.

Condition: • [Reversed polarity](#)

Task: Repair

Time: Immediate

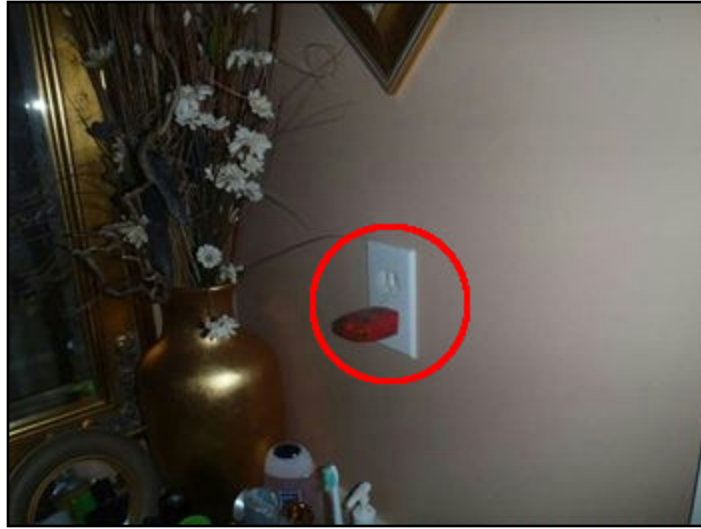
11.

Condition: • [Reversed polarity](#)

Task: Repair

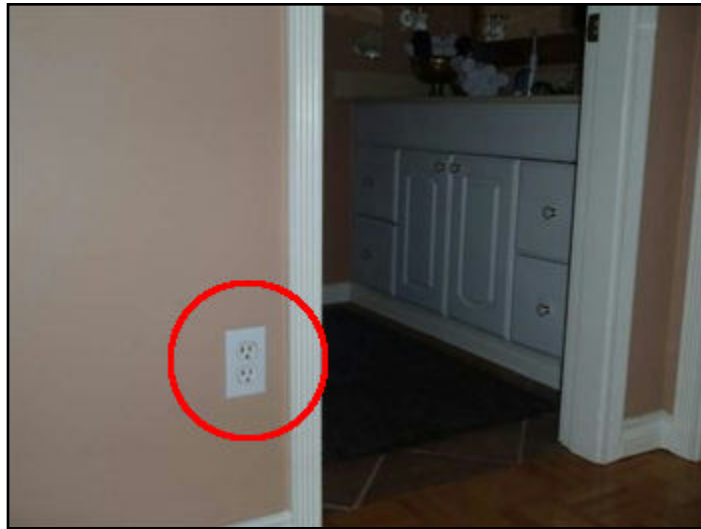
12.

Condition: • [Loose](#)

Implication(s): Electric shock | Fire hazard

Task: Repair

Time: Less than 1 year

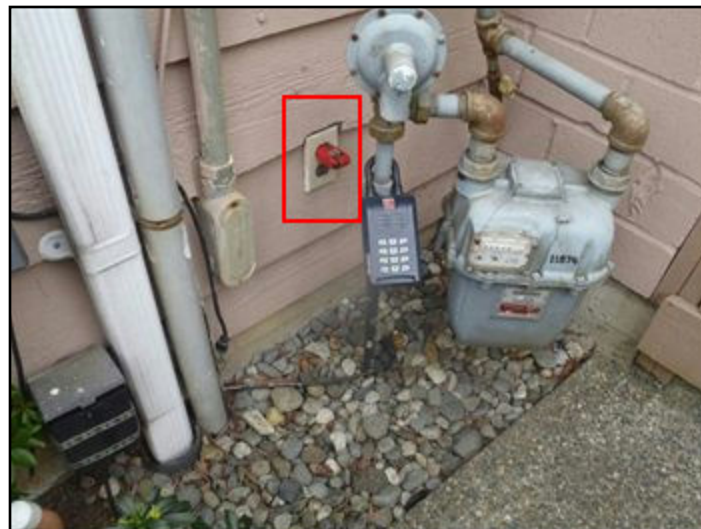
13.

Condition: • [Ground Fault Interrupter \(GFI\) needed](#)

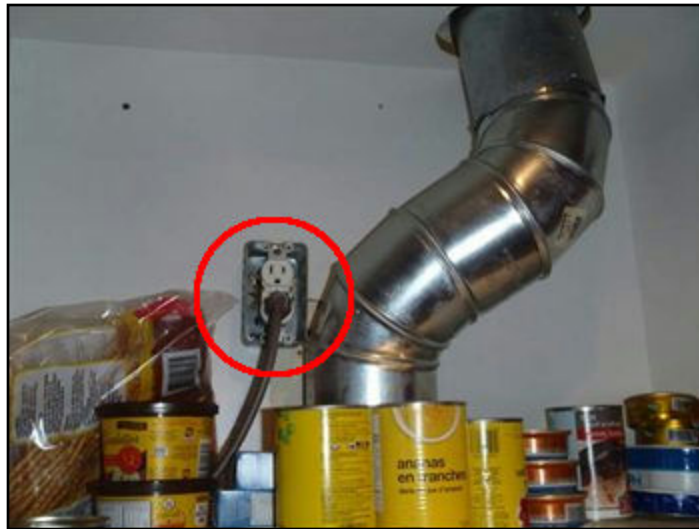
14.

Condition: • [Missing](#)

Task: Provide

Time: Less than 1 year

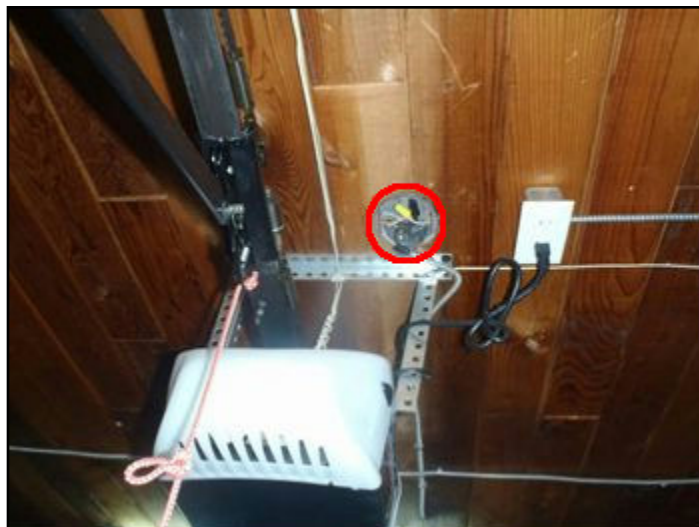
15.

Condition: • [Missing](#)

Task: Provide

Time: Less than 1 year

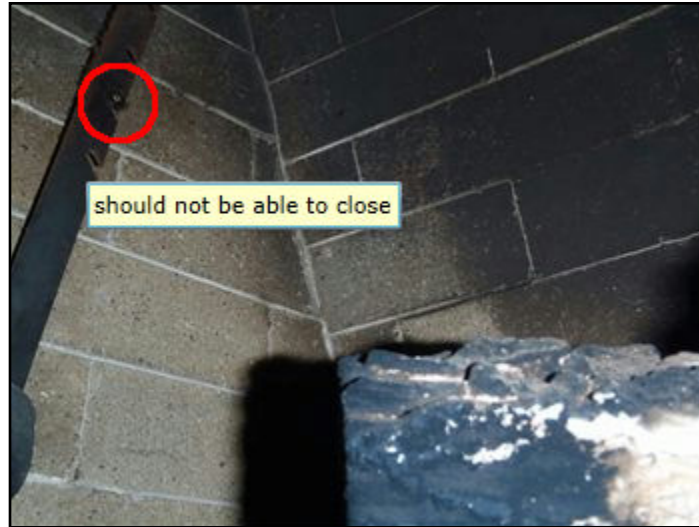
16.

Condition: • [Damper in existing fireplace not fixed open](#)

Implication(s): Hazardous combustion products entering home

I recommend that you have the damper fixed open to prevent hazardous gases from entering the home

Task: Improve

Time: Immediate

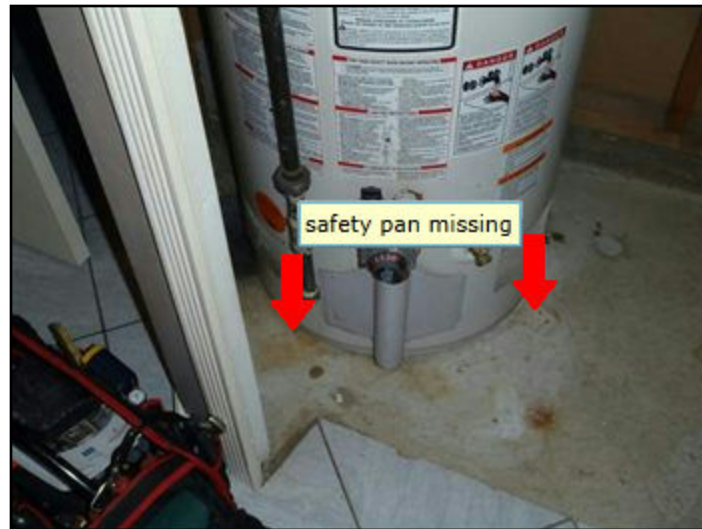
17.

Condition: • Safety pan and drain missing

Implication(s): Chance of water damage to contents, finishes and/or structure

Task: Provide

Time: Discretionary

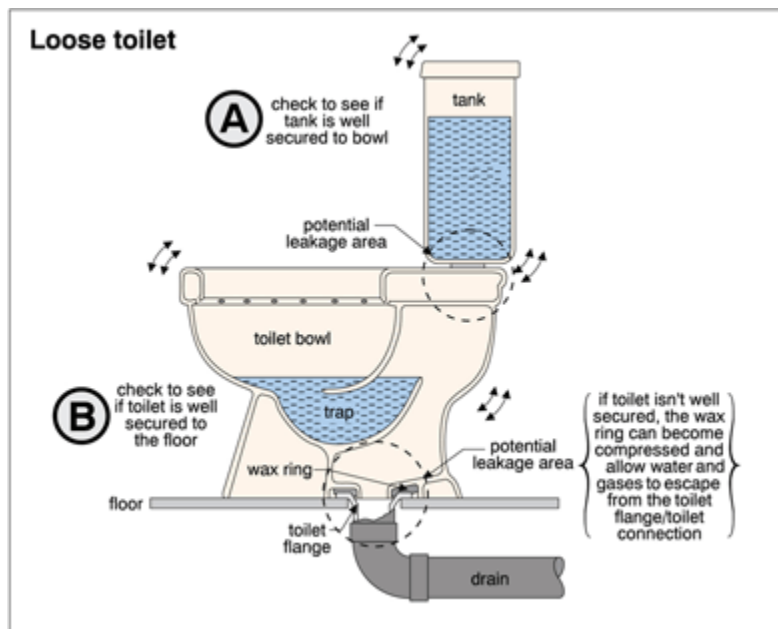
Condition: • [Loose](#)

The base to flange connection is loose and needs to be tightened. No leakage was detected in the sub floor during the inspection

Implication(s): Chance of water damage to contents, finishes and/or structure | Sewage entering the house

Task: Repair

Time: Immediate

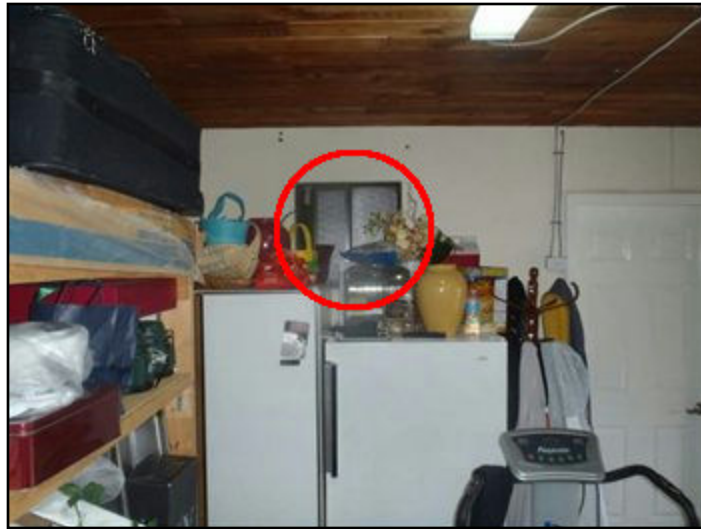
18.

Condition: • [Not gastight](#)

Implication(s): Hazardous combustion products entering home

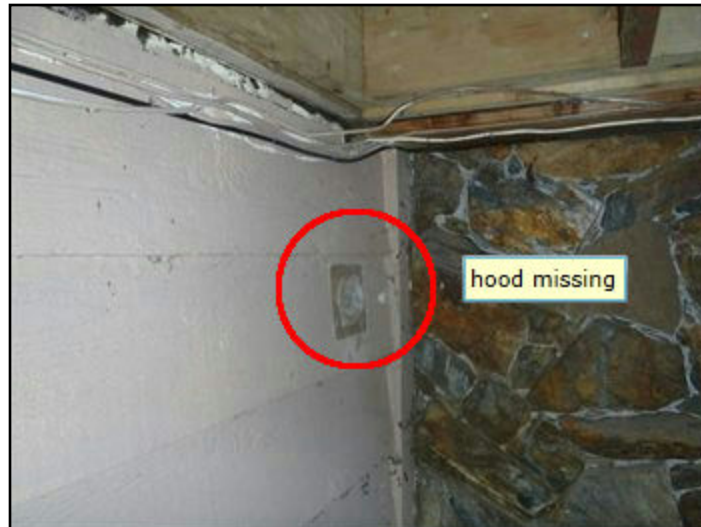
19.

Condition: • [Weather hood missing or loose](#)

Implication(s): Chance of water damage to contents, finishes and/or structure | Chance of pests entering house

Task: Provide

Time: Less than 1 year
