YOUR INSPECTION REPORT

631 Hudson Ave
Albany, NY

Sunday, January 17, 2010

Report No. 1001

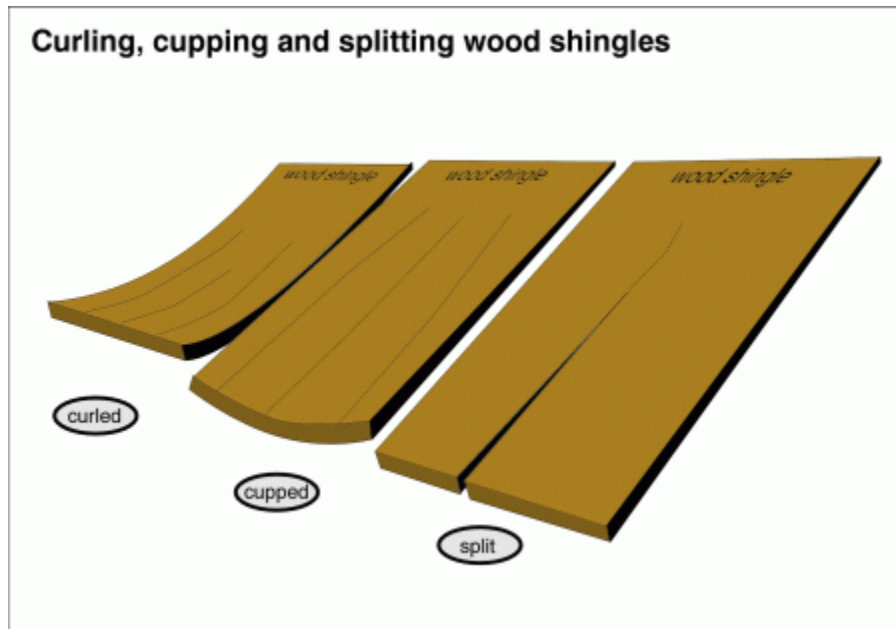
SLOPED ROOFING \ Wood shingles and shakes

Condition: • [Old, worn out](#)

Implication(s): Chance of water damage to contents, finishes and/or structure

Location: Throughout

Task: Replace

Time: Less than 1 year

Cost: Major

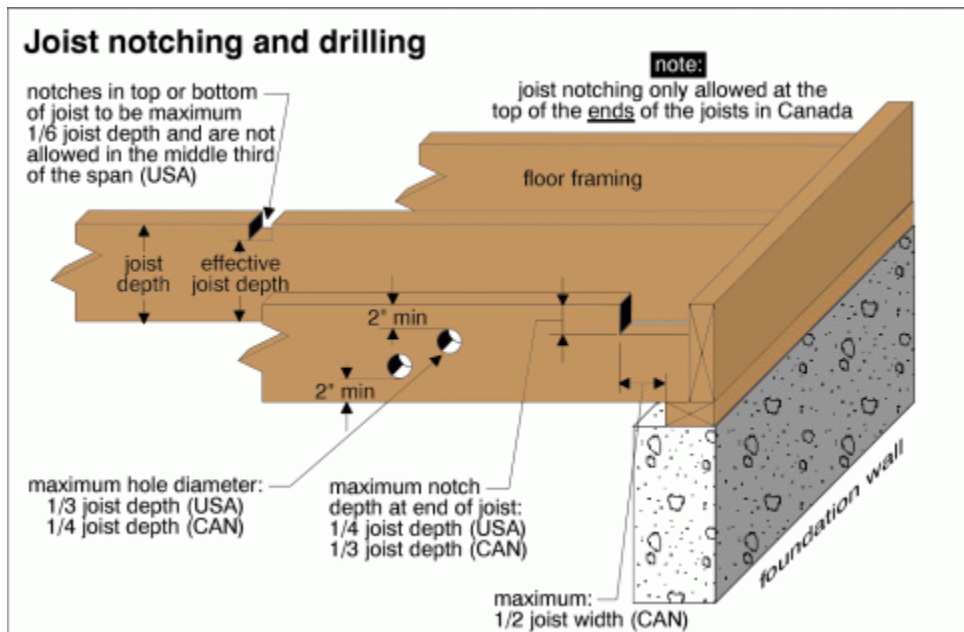
FLOORS \ Joists

Condition: • [Notches or holes](#)

Implication(s): Weakened structure

Location: West Basement

Task: Repair or replace

Time: Less than 1 year

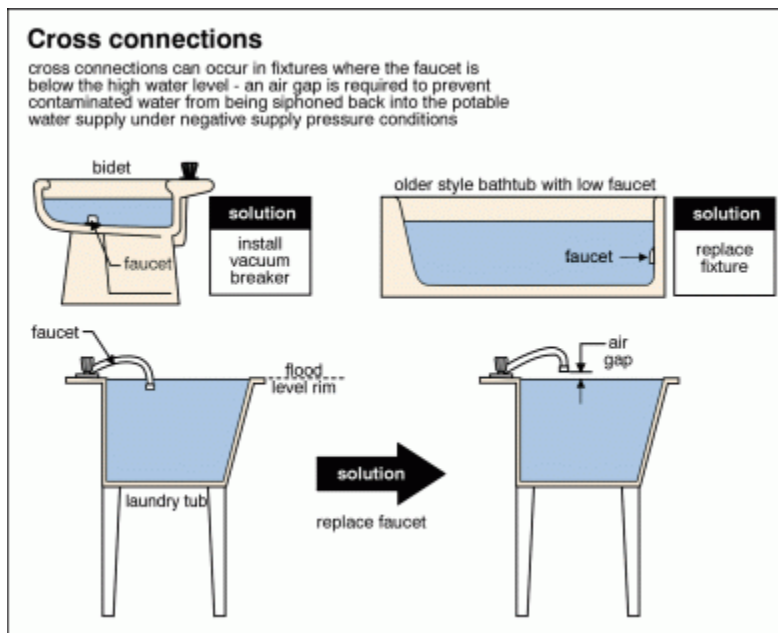
SUPPLY PLUMBING \ Supply piping in house

- Condition: • [Cross connections](#)
- Implication(s): Contaminated drinking water
- Location: Front Basement Bathroom
- Task: Repair
