# INSPECTION REPORT

**123 SAMPLE STREET**  
BAY AREA, MD

Inspection Date: Monday, September 1, 2014

Report No. 1011

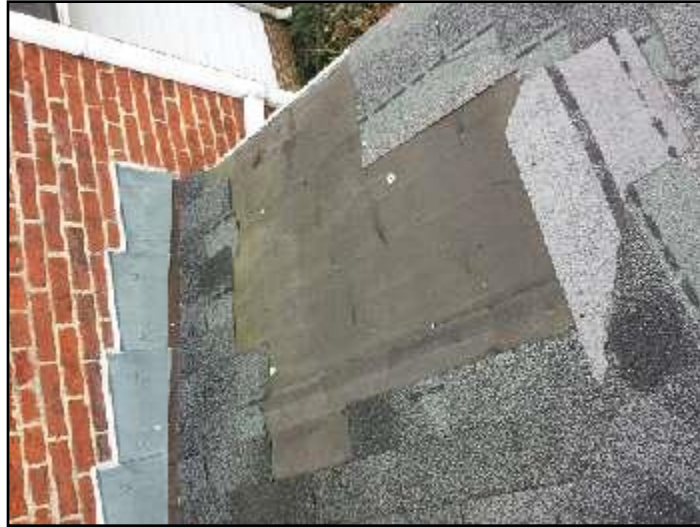
**2. Condition:** • [Missing, loose or torn](#)

**Implication(s):** Chance of water damage to contents, finishes and/or structure

**Location:** Various

2. Missing, loose or torn

**Task:** Repair or replace

**Time:** Immediate

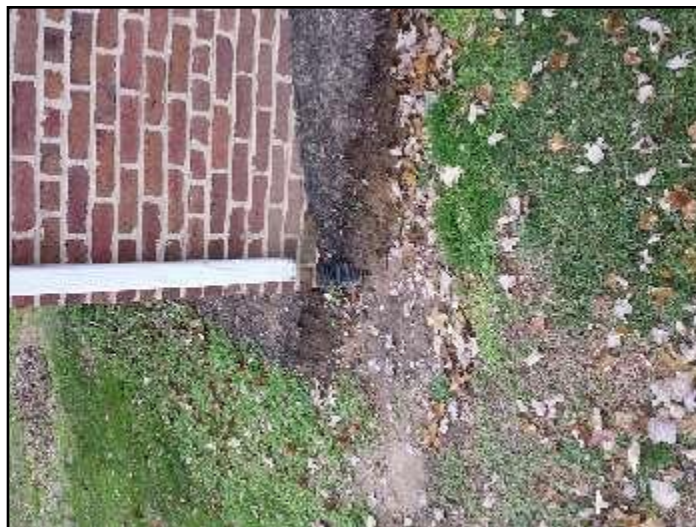
3. Condition: • [Loose connections](#)

Implication(s): Leakage

Location: Rear

3. *Loose connections*

Task: Repair

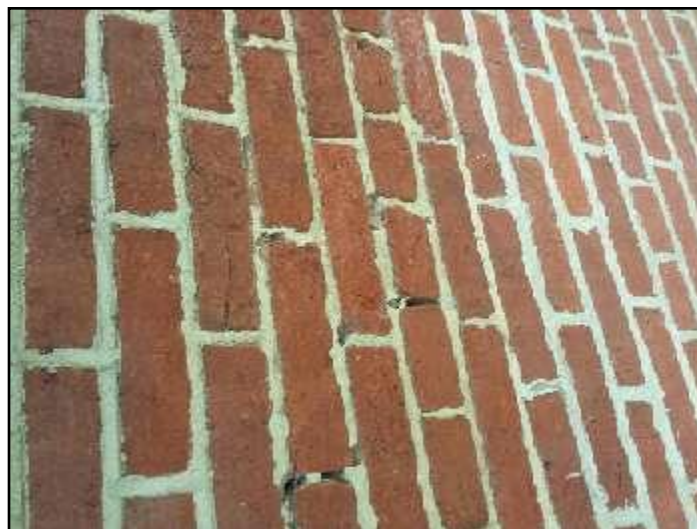
### 5. Condition: • [Mortar deterioration](#)

**Implication(s):** Chance of water entering building | Weakened structure | Chance of structural movement

**Location:** Front First Floor

4. Mortar deterioration

rake and point

**Task:** Repair

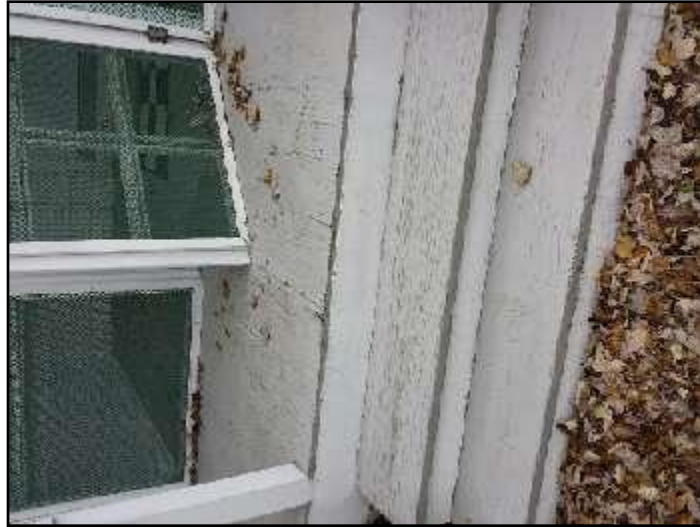
### 6. Condition: • [Paint or stain needed](#)

**Implication(s):** Cosmetic defects | Shortened life expectancy of material

**Location:** Rear Porch

*5. Paint or stain needed*

**Task:** Protect

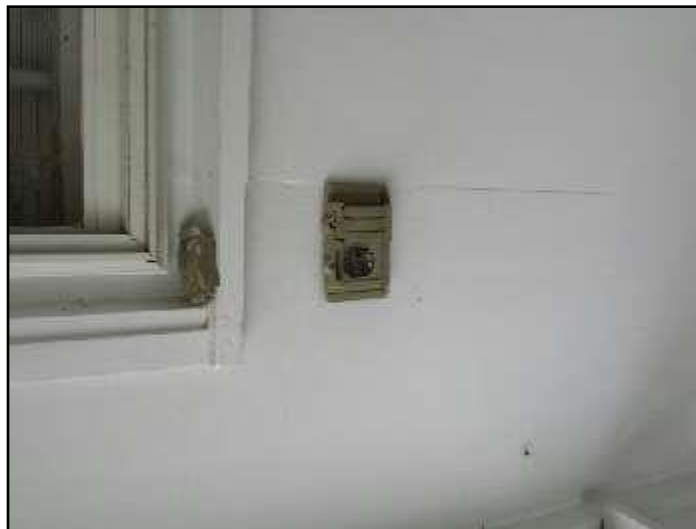
**11. Condition:** • [Damaged](#)

**Implication(s):** Electric shock

**Location:** Rear porch

7. Damaged

**Task:** Replace

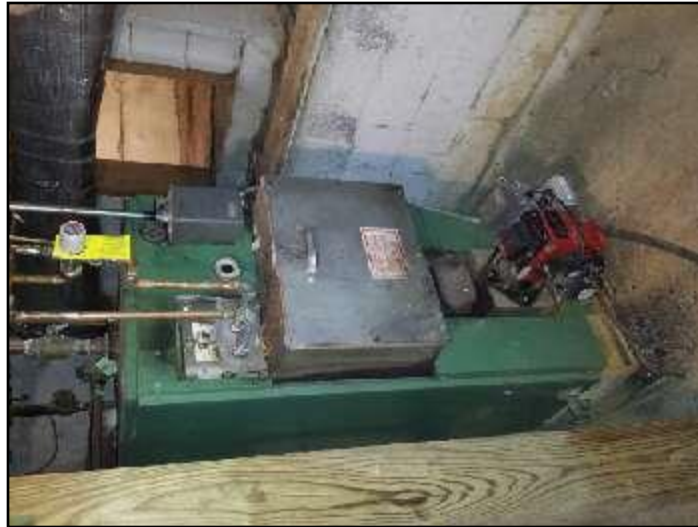
8. Boiler

**Approximate age:** • [35 years](#) • Near end of life expectancy

**13. Condition:** • [Near end of life expectancy](#)

various rust and signs of age.

**Implication(s):** Equipment failure | No heat for building

**Task:** Further evaluation

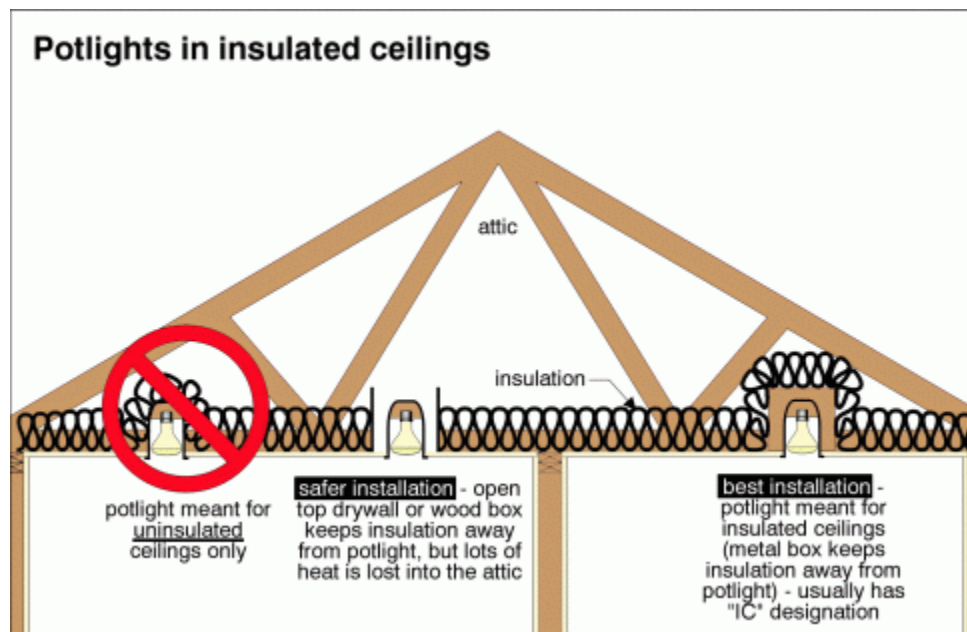
**16. Condition:** • [Covering recessed lights](#)

**Implication(s):** Increased fire hazard

**Location:** Attic

**Task:** Correct

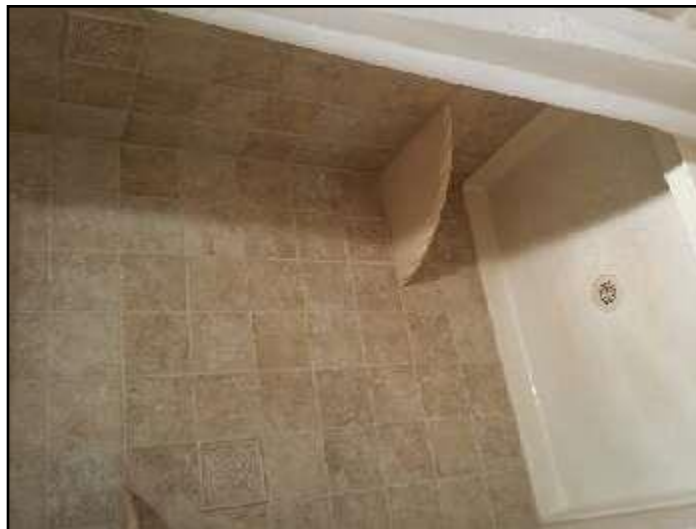
9.

17. • caulk or grout matter shower tile

**Location:** Master Bathroom

**Task:** Repair

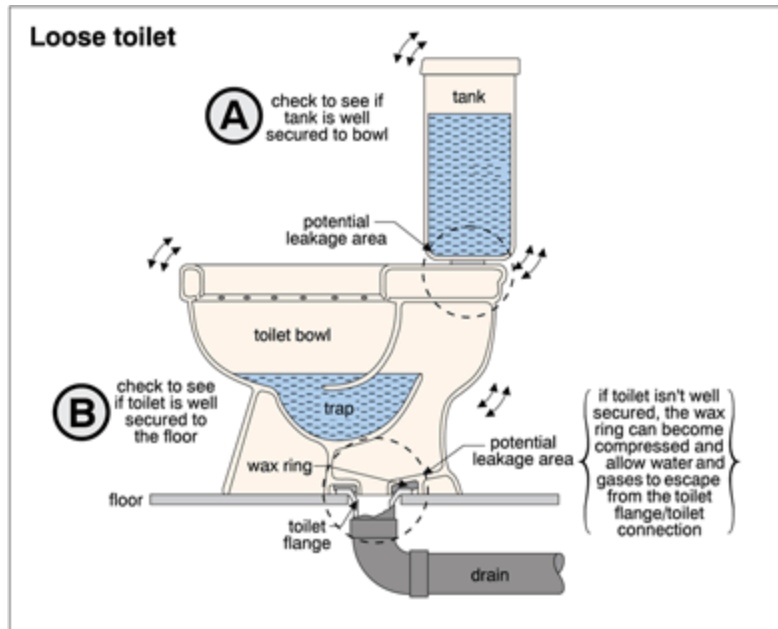
18. **Condition:** • [Loose](#)

**Implication(s):** Chance of water damage to contents, finishes and/or structure | Sewage entering the building

**Location:** Bathroom Master Bedroom

**Task:** Repair

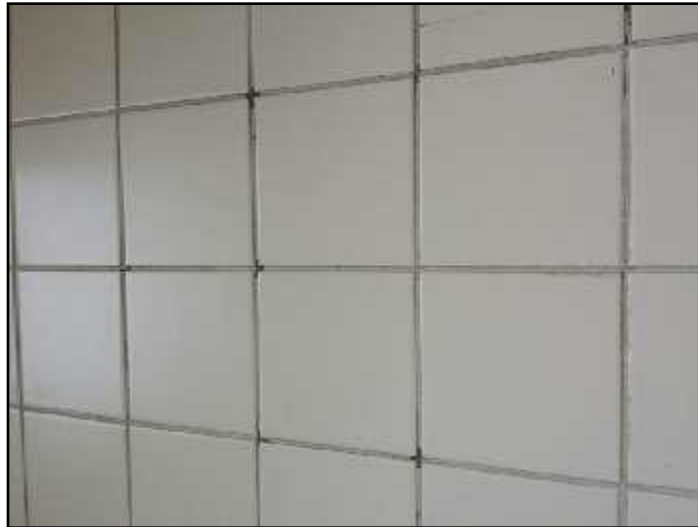
**20. Condition:** • [Grout missing](#)

**Implication(s):** Cosmetic defects | Trip or fall hazard

**Location:** Second Floor Hallway Bathroom

10. Grout missing

**Task:** Repair

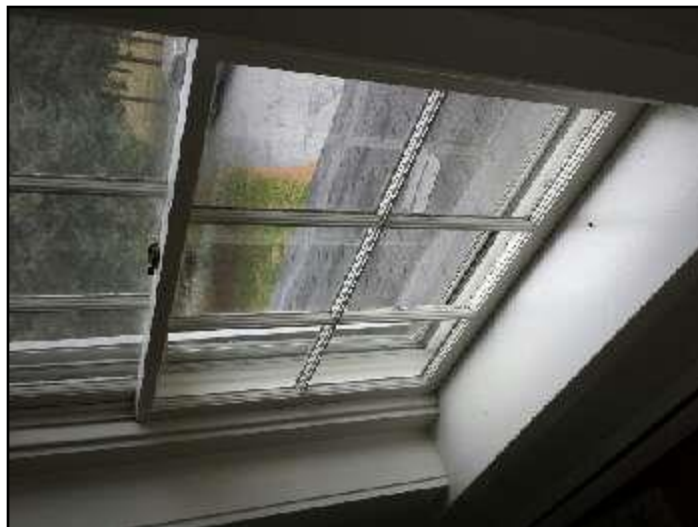
21. Condition: • [Missing](#)

**Implication(s):** Cosmetic defects | Chance of water entering building | Increased heating and cooling costs | Reduced comfort

**Location:** Front Second Floor Hall

11. Missing

**Task:** Repair

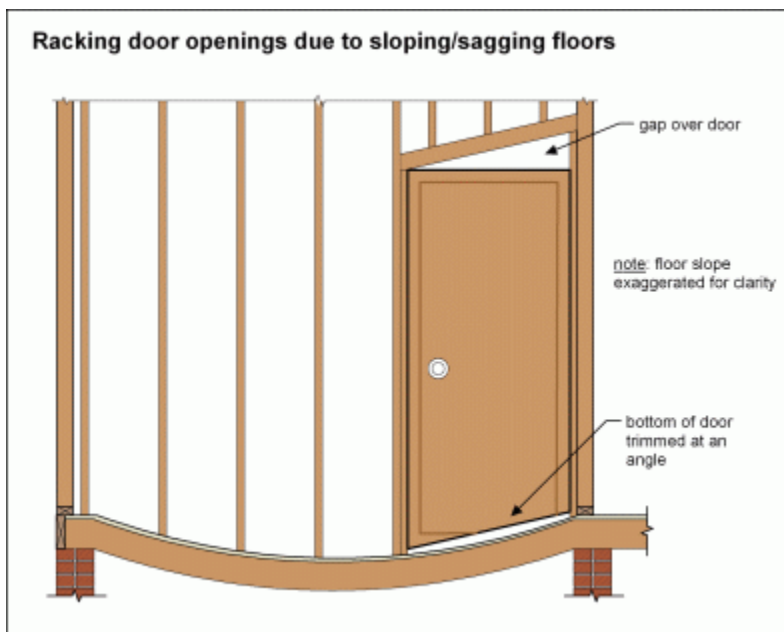
22. Condition: • [Racked/out-of-square](#)

**Implication(s):** Cosmetic defects | Chance of damage to finishes and structure

**Location:** Second Floor Bathroom Hallway Bathroom

**Task:** Repair

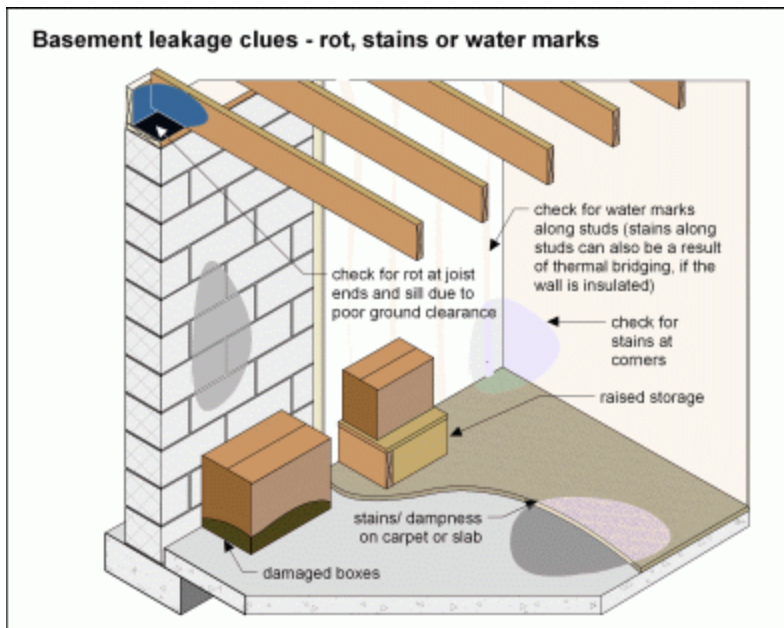
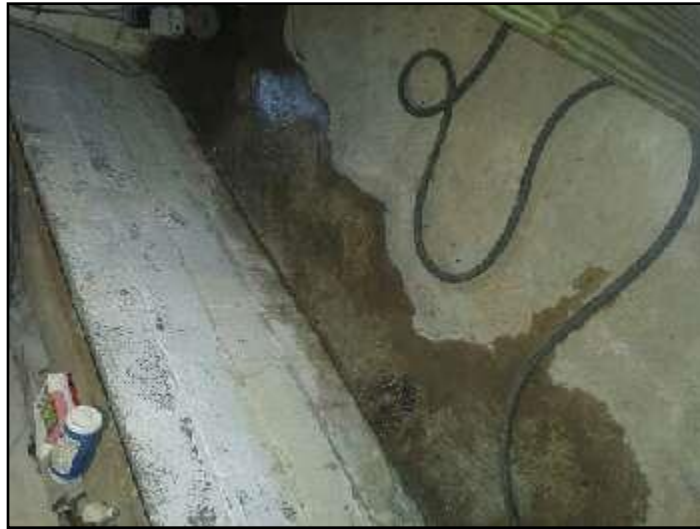
**23. Condition:** • [Water on floor](#)

**Implication(s):** Chance of water damage to contents, finishes and/or structure

**Location:** Basement

12. *Water on floor*

**Task:** further evaluation
