# YOUR Inspection Report

2720 H Street  
Sacramento, CA 95816

Friday, September 10, 2010

RE: Report No. 1298  
2720 H Street  
Sacramento, CA  
95816

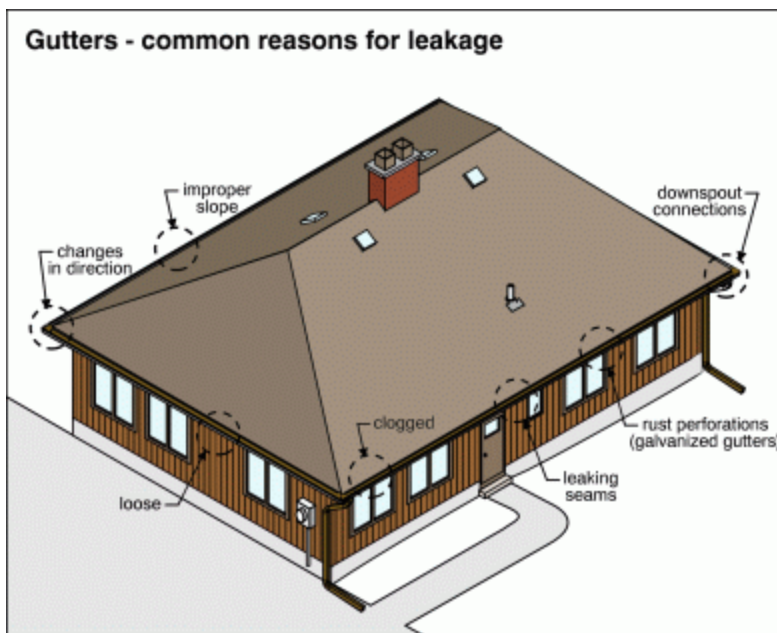
**ROOF DRAINAGE \ Gutters**

**Condition:** • [Clogged](#)

**Implication(s):** Chance of water damage to contents, finishes and/or structure

**Location:** Various Exterior Roof

**Task:** Clean

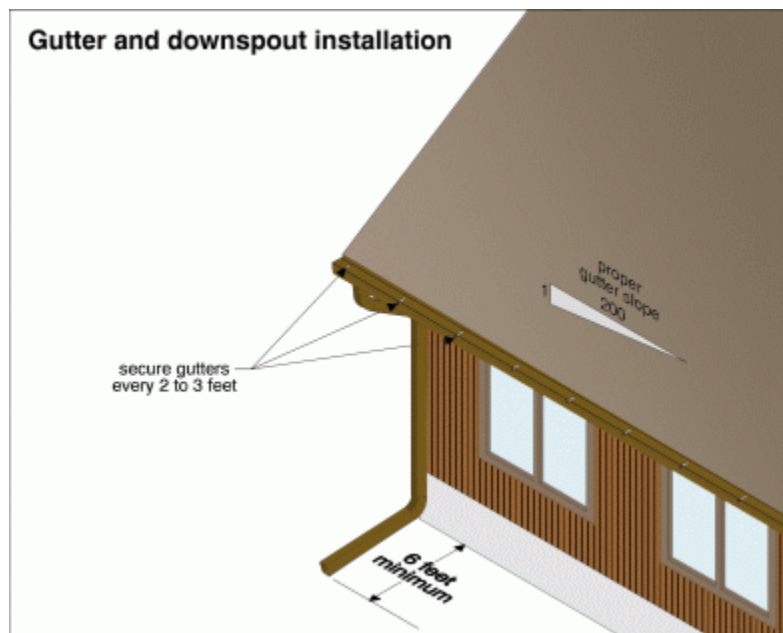
## ROOF DRAINAGE \ Downspouts

**Condition:** • Should discharge 6ft. from home

**Implication(s):** Chance of water damage to contents, finishes and/or structure

**Location:** Various Exterior

**Task:** Improve

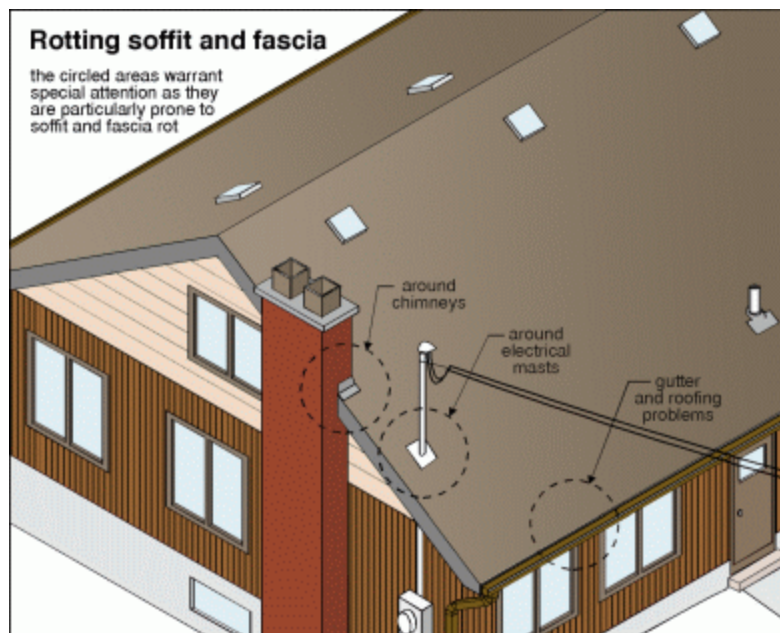
## WALLS \ Soffits and fascia

**Condition:** • [Paint or stain needed](#)

**Implication(s):** Cosmetic defects | Chance of water damage to contents, finishes and/or structure | Shortened life expectancy of material

**Location:** Front Exterior Roof

**Task:** Improve

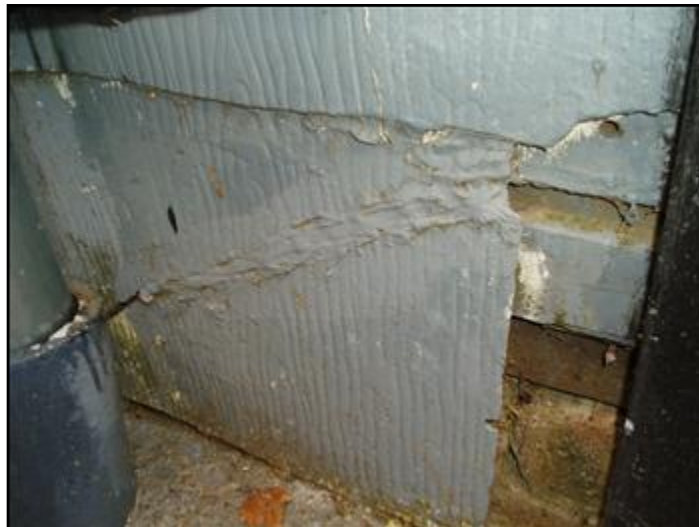
**Condition:** • [Mechanical damage](#)

**Implication(s):** Cosmetic defects | Chance of water damage to contents, finishes and/or structure

1. CRACKED DAMAGED SHINGLES

RECOMMEND EVALUATION AND REPAIRS BY A LICENSED CONTRACTOR OR APPROPRIATE TRADESMAN DEALING WITH THAT ITEM OR SYSTEM.

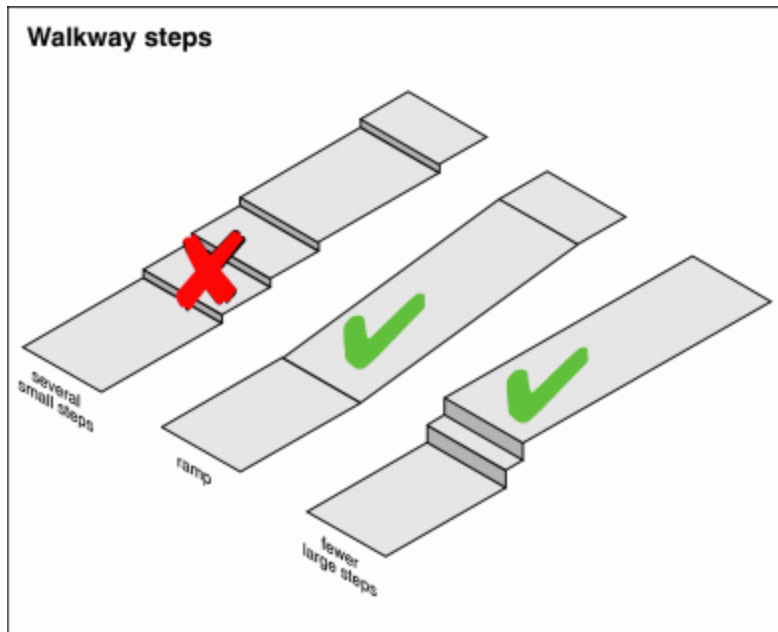
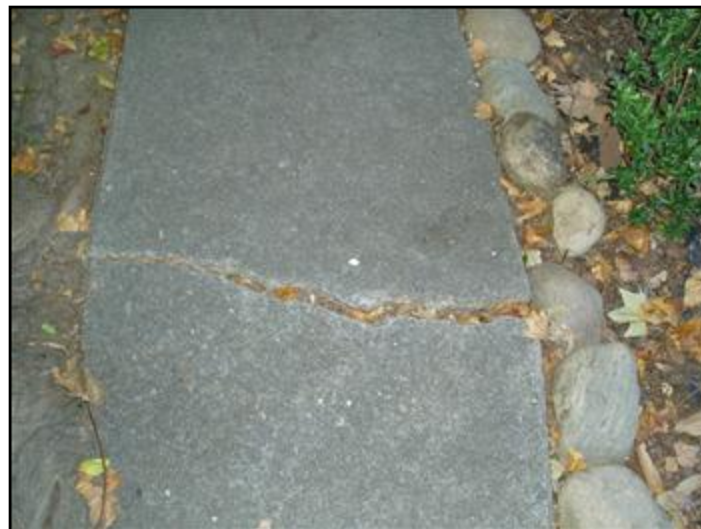
## LANDSCAPING \ Walk and driveway

Condition: • [Uneven \(trip hazard\)](#)

2. TRIP HAZARD

THIS ITEM OR COMPONENT WARRANTS ADDITIONAL ATTENTION , REPAIR OR MONITORING.

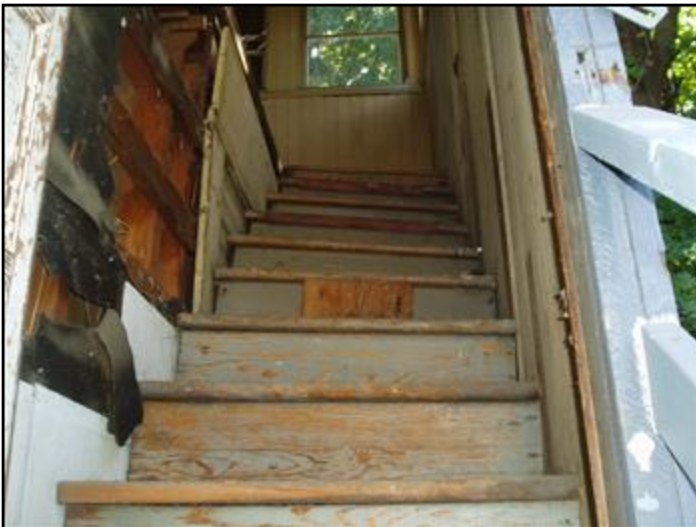
**Condition:** • [Sag or springy](#)

3. SAG/LEANING STAIRWELL

RECOMMEND EVALUATION AND REPAIRS BY A LICENSED CONTRACTOR OR APPROPRIATE TRADESMAN DEALING WITH THAT ITEM OR SYSTEM. (STATE LICENSED GENERAL CONTRACTOR) AND (STATE LICENSED STRUCTURAL ENGINEER)

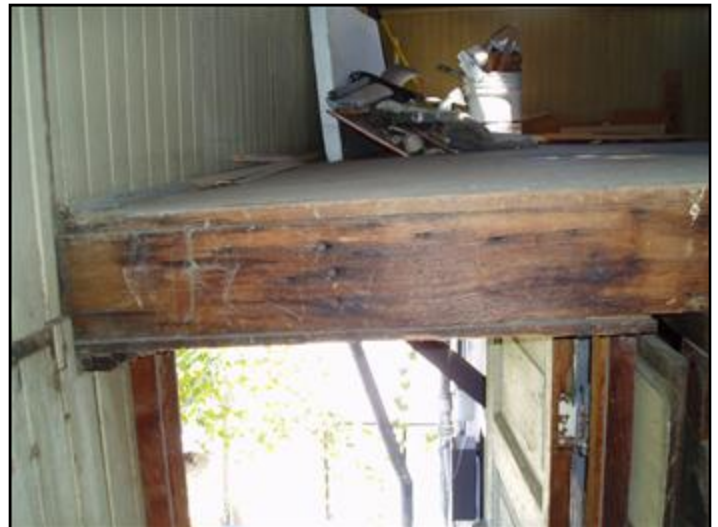
4. SAG LEANING FLOOR

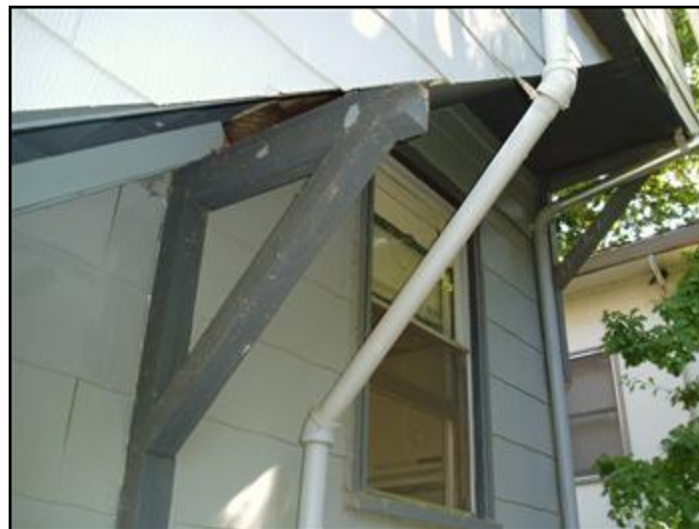
**Condition:** • [Poor end bearing, joist hanger connections](#)

5. POOR SUPPORT OF ATTIC AREA

RECOMMEND EVALUATION AND REPAIRS BY A LICENSED CONTRACTOR OR APPROPRIATE TRADESMAN DEALING WITH THAT ITEM OR SYSTEM. (STATE LICENSED GENERAL CONTRACTOR) AND (STATE LICENSED STRUCTURAL ENGINEER)

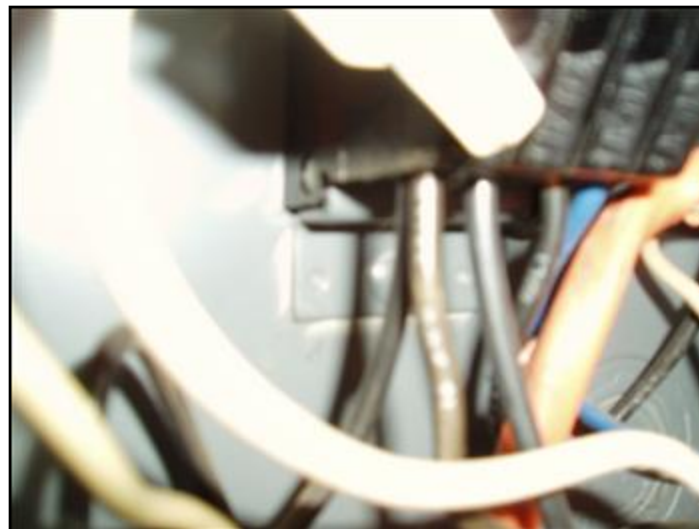
**Condition:** • [Double taps](#)

**Implication(s):** Fire hazard

6. DOUBLE TAP WIRES

RECOMMEND EVALUATION AND REPAIRS BY A LICENSED CONTRACTOR OR APPROPRIATE TRADESMAN DEALING WITH THAT ITEM OR SYSTEM. (STATE LICENSED ELECTRICIAN)

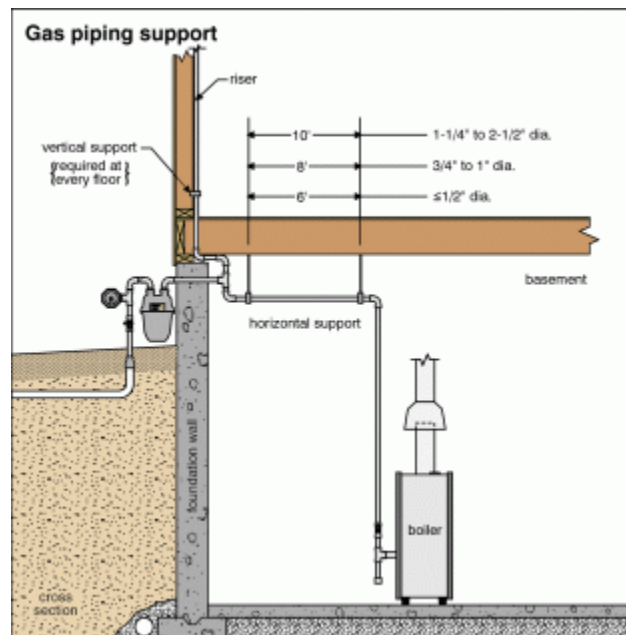
Condition: • [Inadequate support](#)

RECOMMEND EVALUATION AND REPAIRS BY A LICENSED CONTRACTOR OR APPROPRIATE TRADESMAN DEALING WITH THAT ITEM OR SYSTEM.

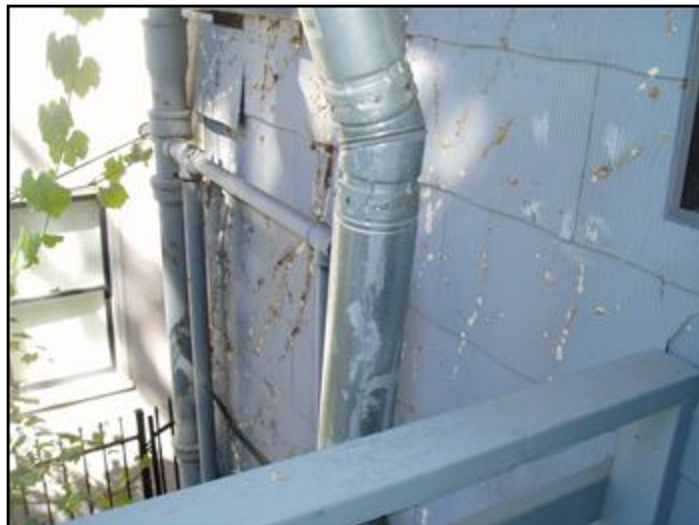
**Condition:** • THE WATER HEATER FLUE IS IN REACH OF THE REAR SECOND FLOOR DECK. THE FLUE IS HOT AND CAN BE A SAFETY CONCERN. RECOMMEND COVERING OR RELOCATING FLUE.

7. THE WATER HEATER FLUE

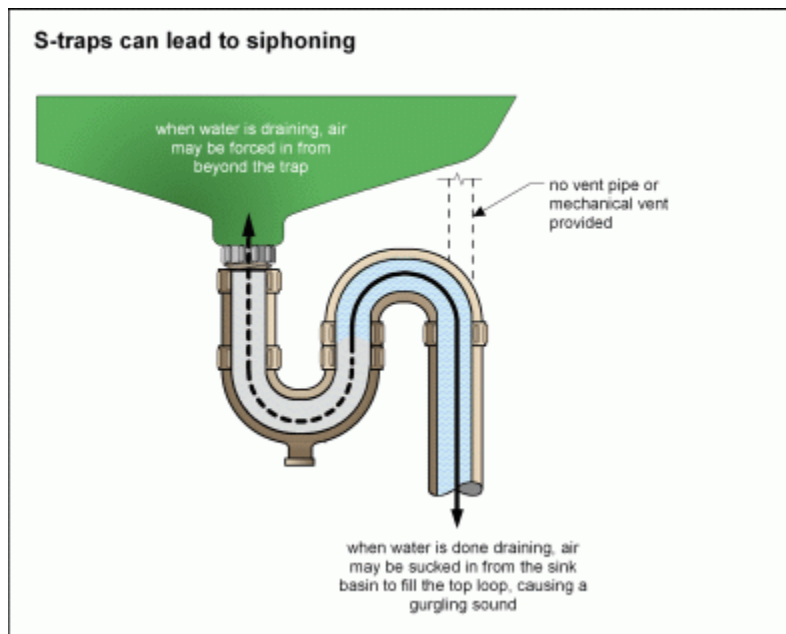
## WASTE PLUMBING \ Traps - installation

**Condition:** • [Nonstandard shape or material](#)

CORRUGATED DRAIN PIPING IS MORE PRONE TO CLOGGING AND LEAKING. RECOMMEND REPLACING WITH A SMOOTH WALL DRAIN PIPE.

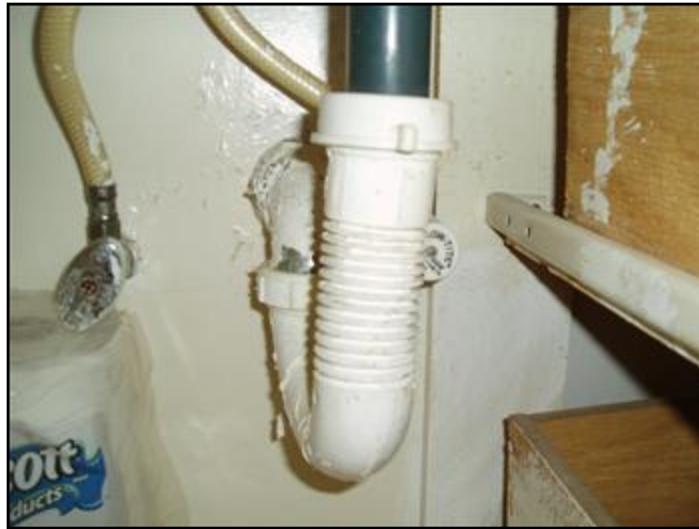
**Condition:** • [Leak](#)

APPEARS THERE IS A LEAK UNDER THE KITCHEN SINK. RECOMMEND MONITORING AND CONSULTING A LICENSED PLUMBER FOR FURTHER EVALUATION.

**Implication(s):** Chance of water damage to contents, finishes and/or structure | Sewage entering the house

8. DRAIN LEAK

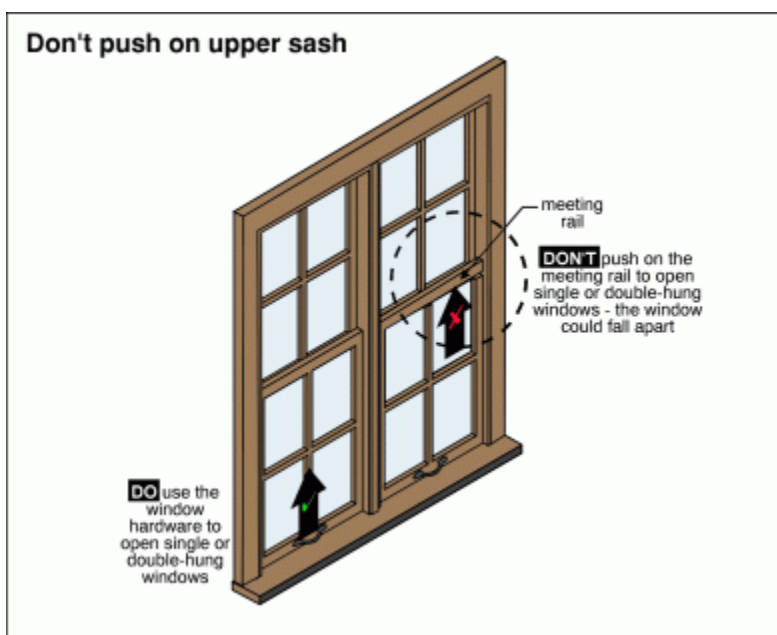
**Condition:** • [Inoperable](#)

RECOMMEND EVALUATION AND REPAIRS BY A LICENSED CONTRACTOR OR APPROPRIATE TRADESMAN DEALING WITH THAT ITEM OR SYSTEM.
