INSPECTION REPORT

For the Property at:
123 ANY STREET
TAVERNIER, FL 33070

Prepared for: JOHN DOE
Inspection Date: Thursday, November 21, 2013
Prepared by: Mark Hall

Report No. 4911, v.3

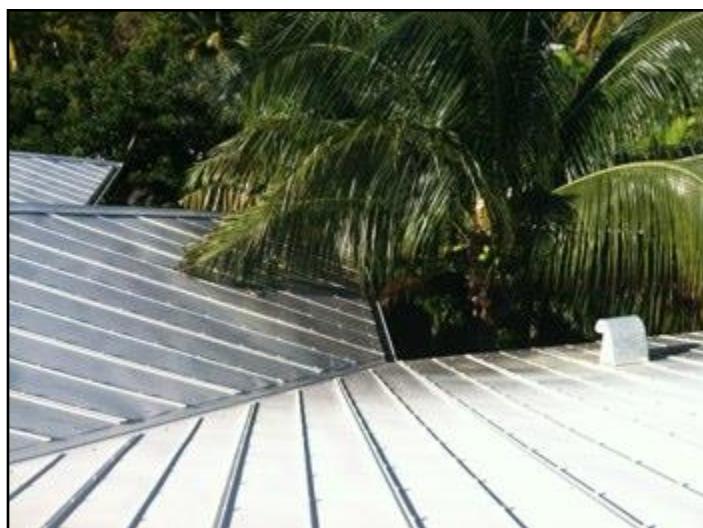
- Trim the trees away from the roof to prevent roof damage and rodent access.

Implication(s): Potential damage to roof panels.

Trim Trees Away From Roof Panels

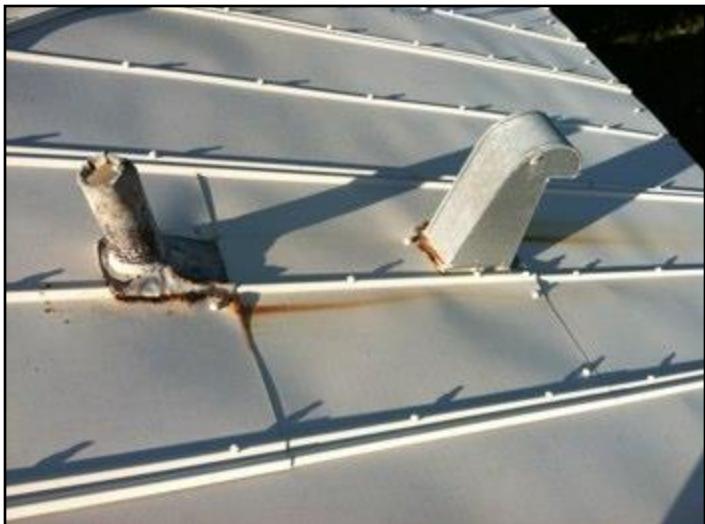
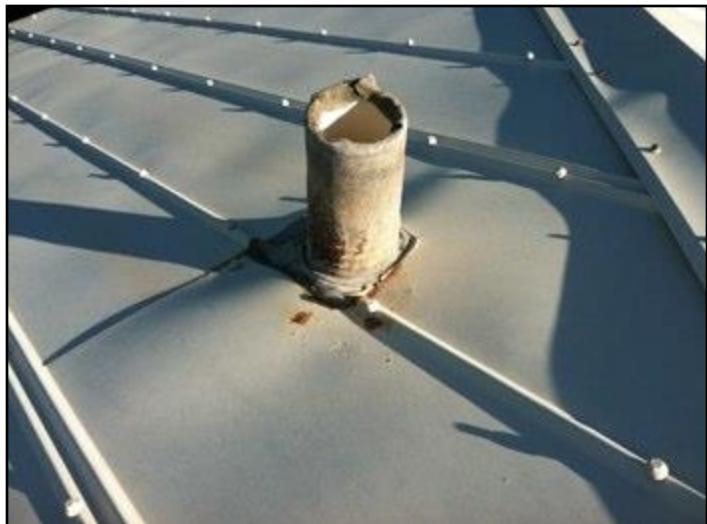
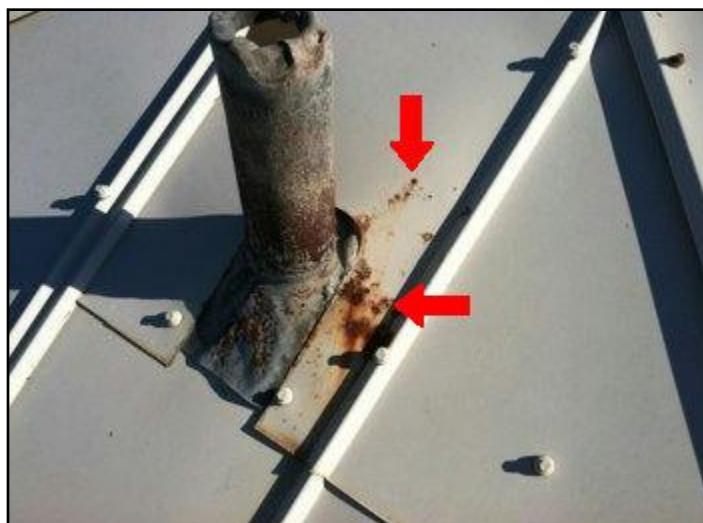
The metal roof panels are rusted at the lead plumbing vent flashings. The vent flashings are lead and the lead is reacting with the steel roof panels causing rust. Replace the rusted panels and replace the roof jack flashings with metal compatible flashings.

Implication(s): Chance of water damage to contents, finishes and/or structure

Rusted Roof Panels

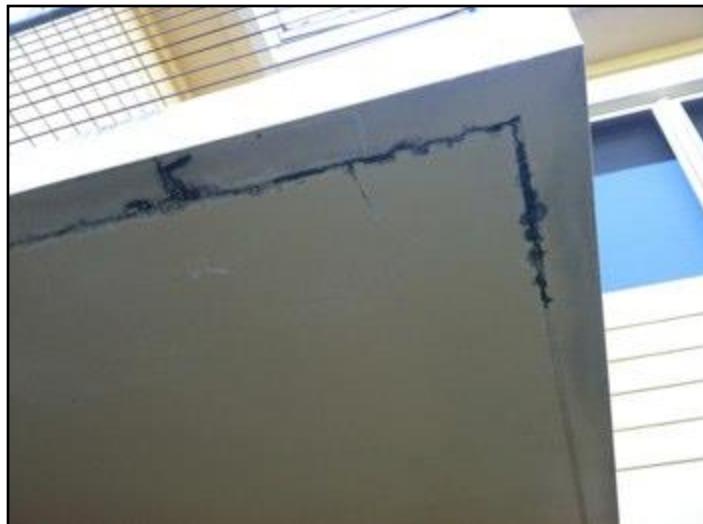
Moisture is getting trapped in the stucco on the underside of the deck below the front A/C condenser unit. Caulking & painting recommended soon to prevent damage to the stucco. The stucco may need to be patched soon otherwise.

Implication(s): Chance of water damage to contents, finishes and/or structure | Material deterioration

Moisture In Stucco Under Deck

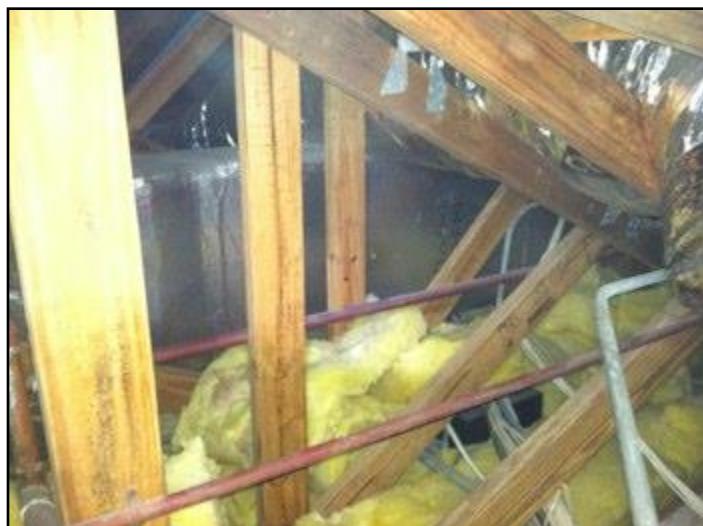
Note: Unable to get to the front A/C air-handler. Restricted space in the attic and blocked by electronics equipment at the Bedroom-2 attic access.

No Attic Access To Front A/C AHU

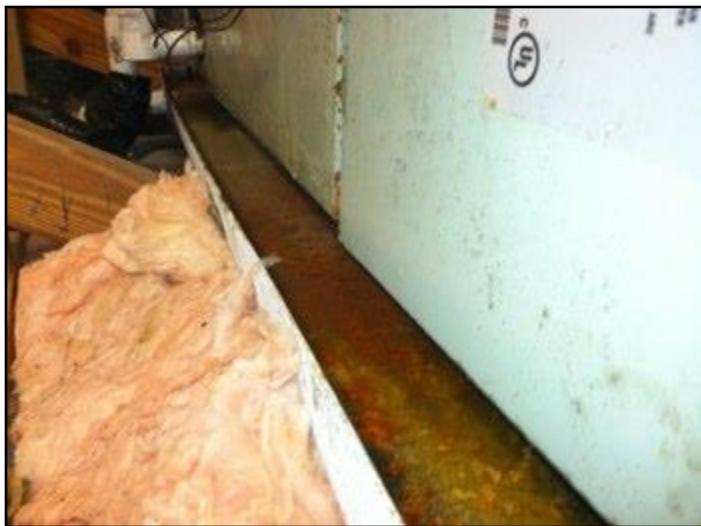
Condensation is running from the rear air-handler indicating a clogged condensate drain.; No condensate water is dripping from the front exterior drain discharge pipe, this drain may be clogged as well. Service both A/C systems. Consult an A/C Contractor

Clogged Condensate Drain(s)

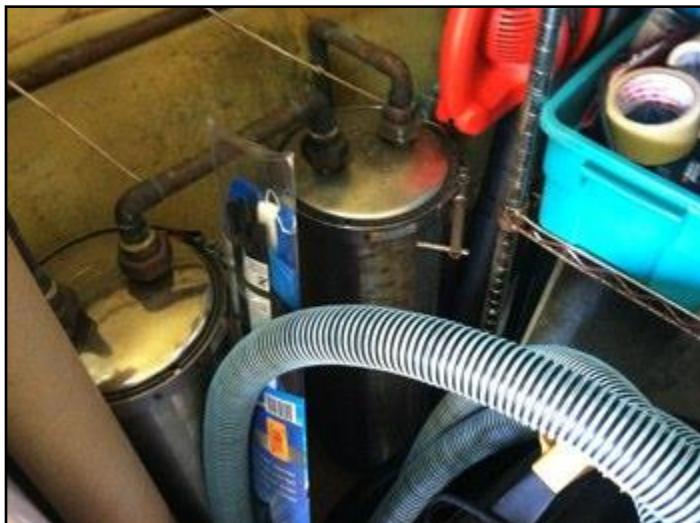
Note: Service Filters.

Service Water Filters

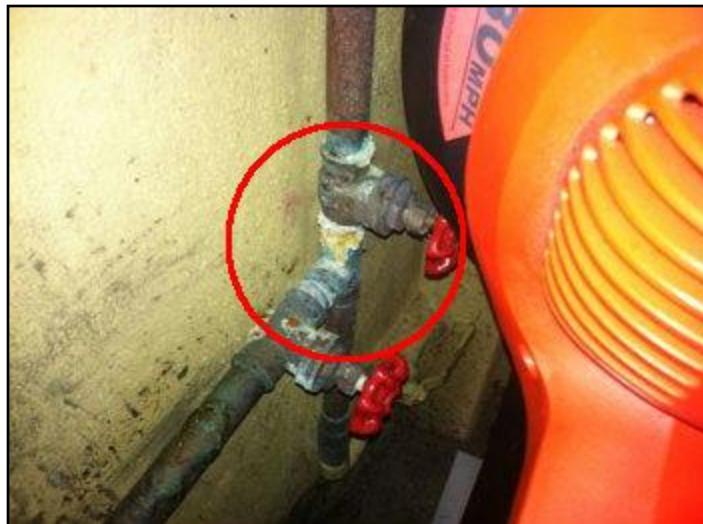
Condition: • Corroded copper pipes at the filtration system in the rear Storage Room. Clean the corrosion & monitor.

Implication(s): Could cause pipes to corrode and leak.

Corroded Pipes

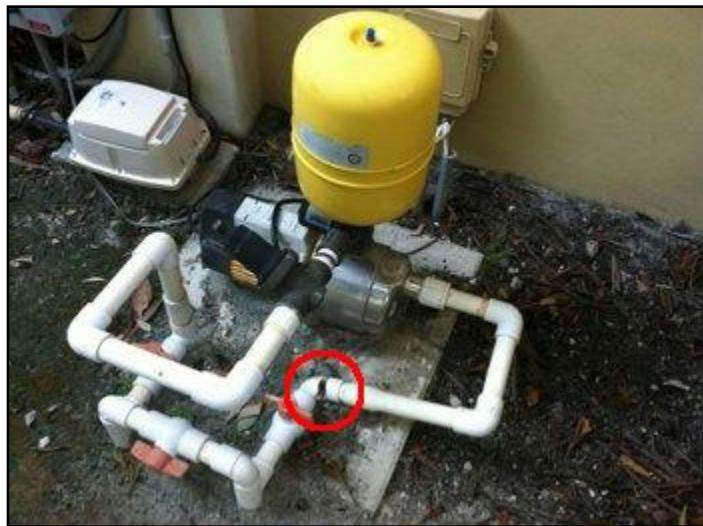
Condition: • The pipes at the pressure tank are broken and the pressure tank system may not function. Consult a Plumber

Broken Pressure Tank System

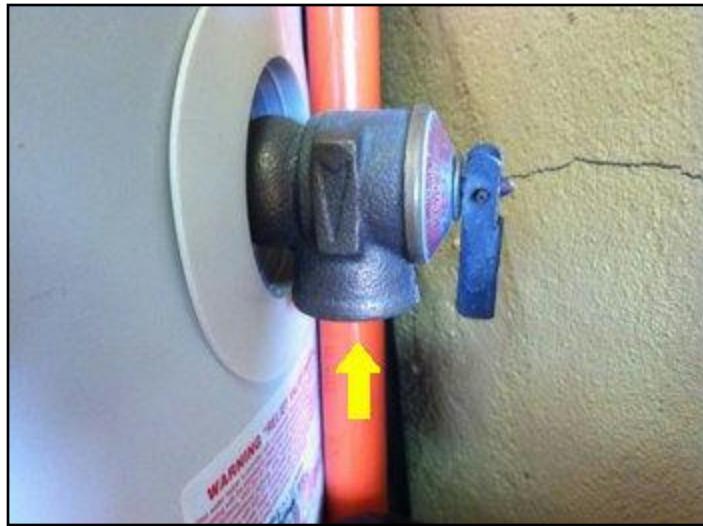
Condition: • [Discharge tube missing](#)

No Discharge Pipe @ TP Valve

Install a 3/4" discharge pipe at the downstairs water heater to within 6" of the floor. Safety Concern

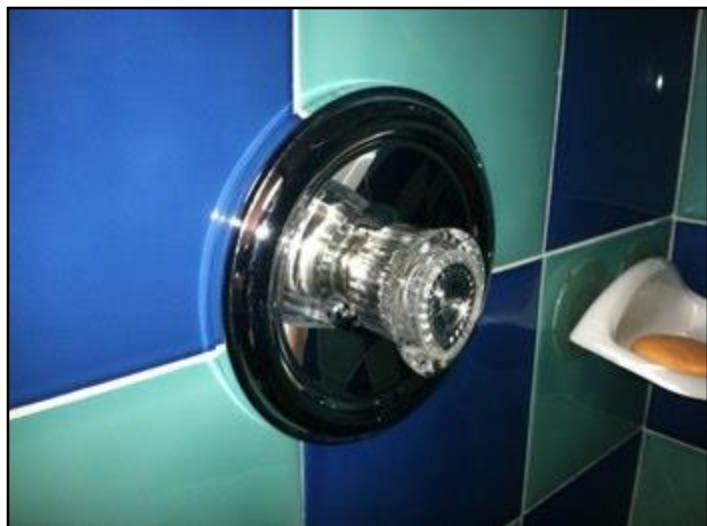
Condition: • The water flow becomes restricted when the downstairs graduated shower valve is turned into the HOT zone of the valve. The internal mixing cartridge may be defective. (This is most likely caused by lack of use)

Downstairs Shower Valve

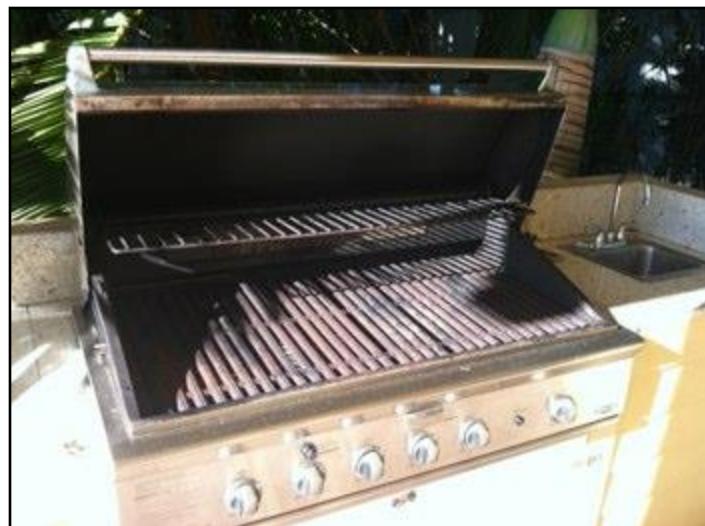
The electric igniters for the barbecue are not working. (HomePro cannot test appliances if the igniters do not work.
Repair, then test)

Barbecue Igniters Not Working

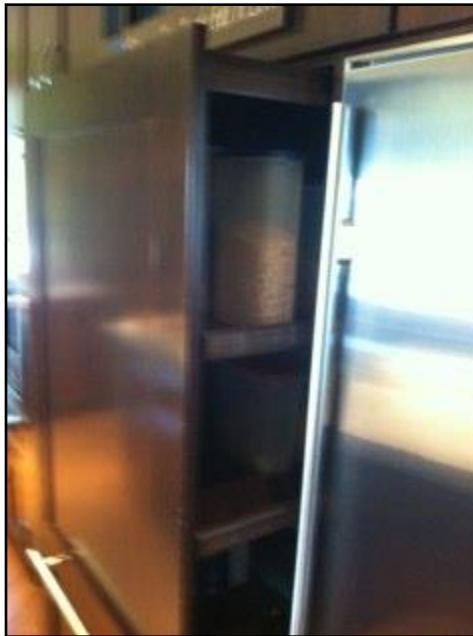
Condition: • Doors do not close properly

Adjust Pull Out Pantry Cabinet

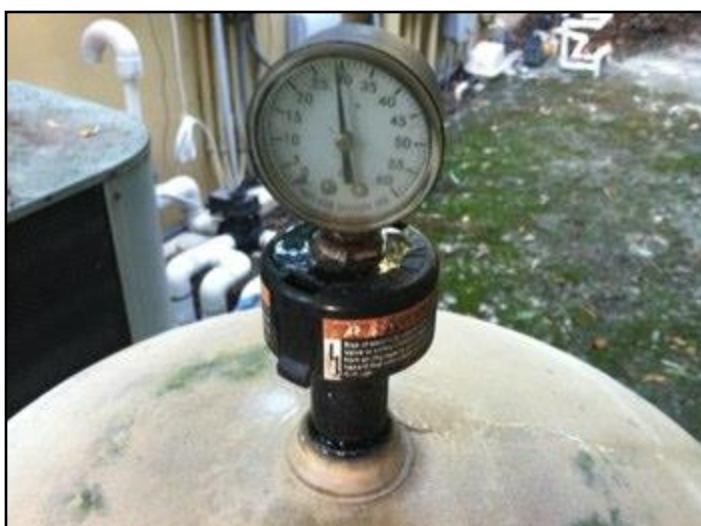
Condition: • The filter pressure gauge is working fine but leaking. Repair recommended.

Leaking Pressure Gauge

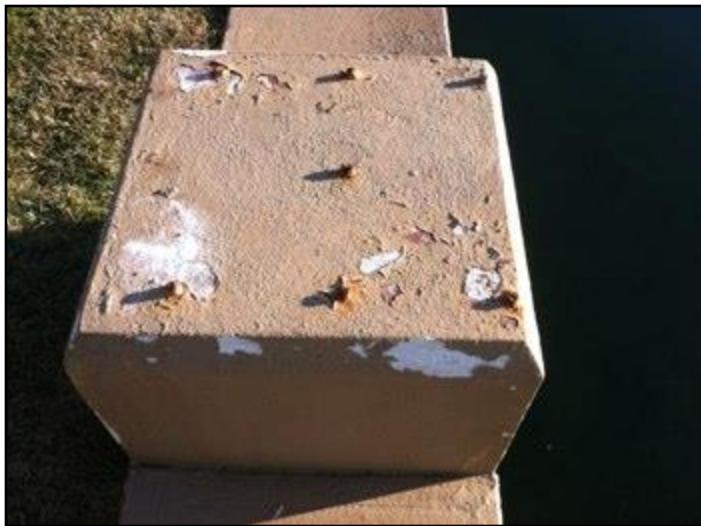
General: • Note: The existing davit based may not be useable, the bolts have been cut off or are too short for proper davit installation.

Davit Bases

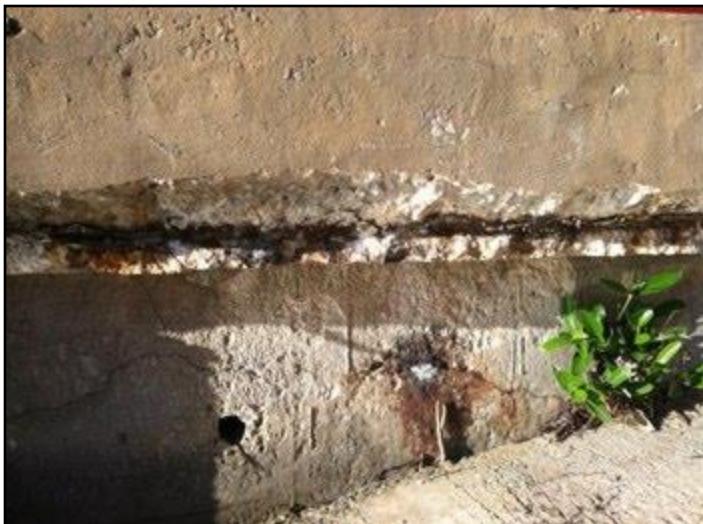
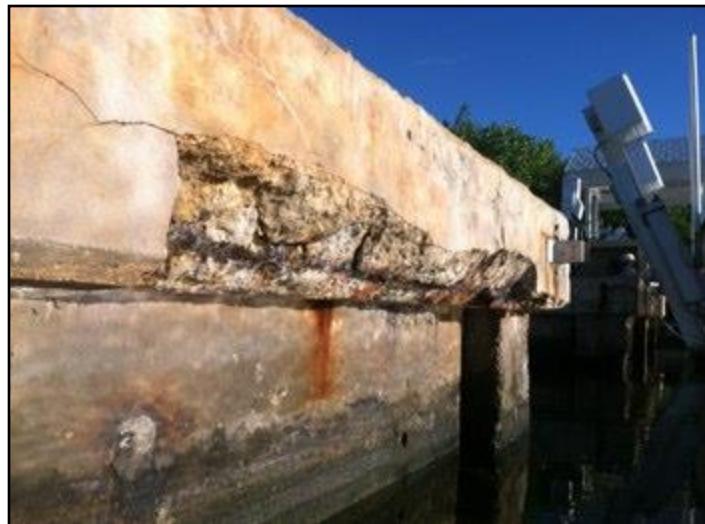
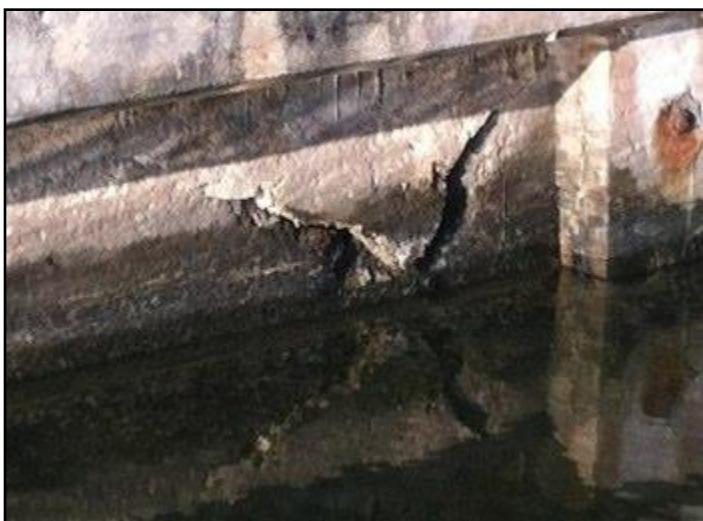
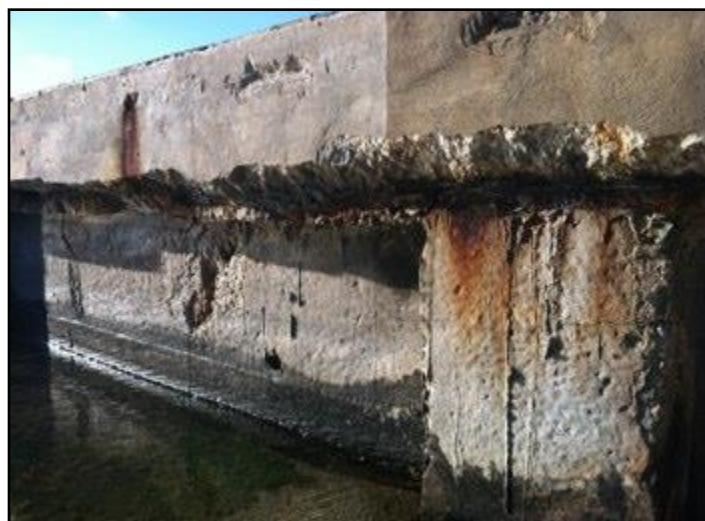
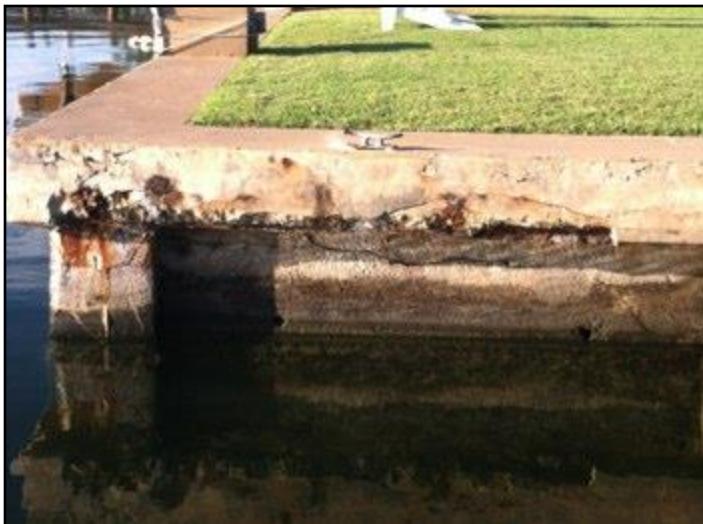
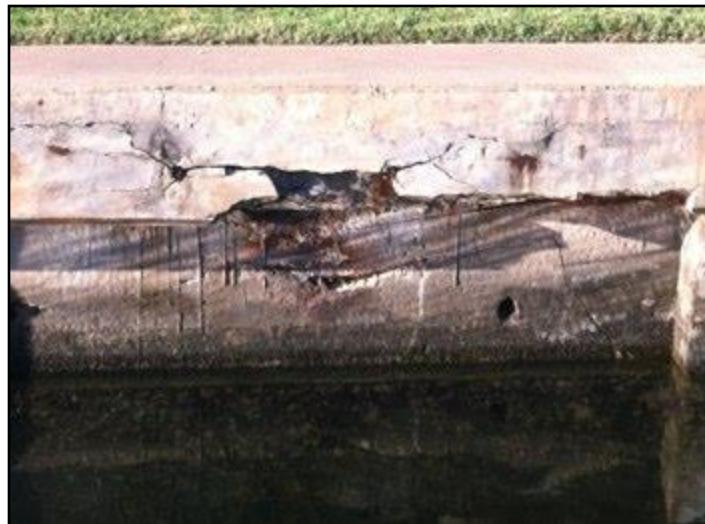
The concrete seawall cap, panels and pilings are badly spalled. Consult a Marine/Concrete Repair Contractor

Note: The seawall seems to be stable although not in good condition. If repairs are desired, it would be costly but the structure should remain stable for many years and remain functional without repair. At some point though, repair or replacement will be necessary.

Spalled Concrete

Condition: • Cracked pilings

Condition: • Spalled pilings

Condition: • Major repairs needed

Condition: • Consult a Marine Contractor for further evaluation

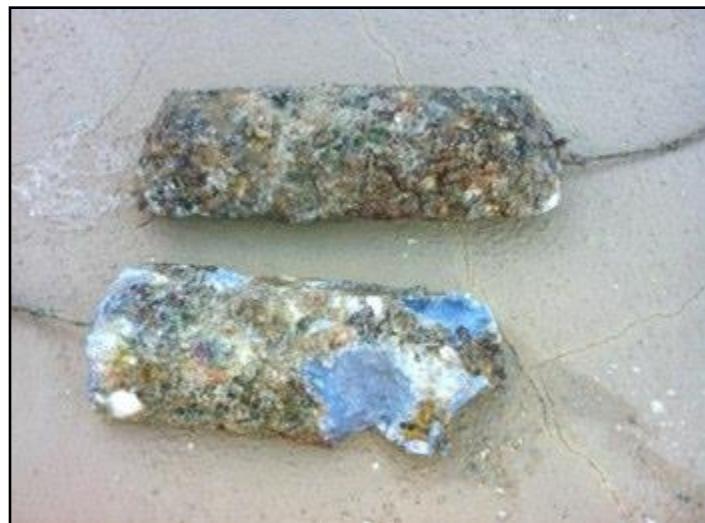
Still in good condition. Replace once 75% depleted.

Zinc Anodes
