# INSPECTION REPORT

For the Property at:  
**#2 CENTURY VILLAS CLOSE**  
FORT SASKATCHEWAN, AB

Prepared for: CHARLIE HEBERT  
Inspection Date: Sunday, June 7, 2009  
Prepared by: Don Schmidt

Report No. 1007

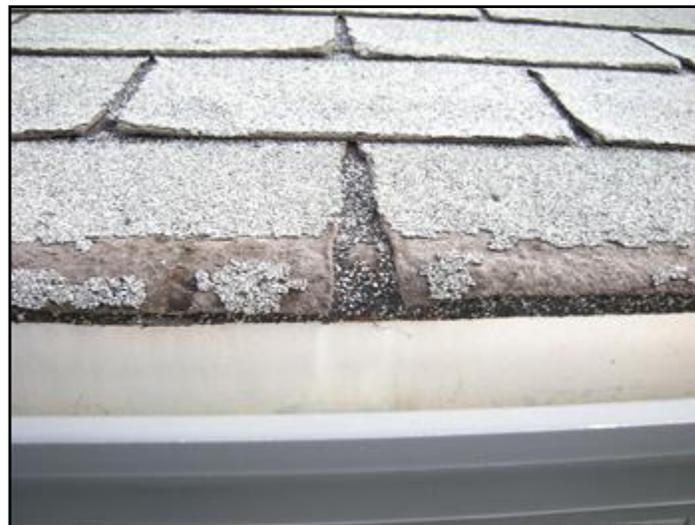
**Condition:** • [Granule loss](#)

**Location:** South Roof

**Note:** Granule loss is a sign of roof deterioration.

1. Granule loss

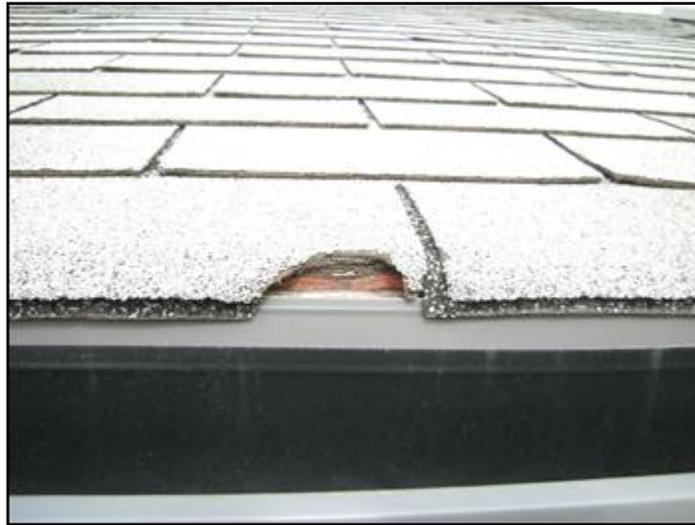
**Note:** West side shingle torn.

2. Shingle torn.

**Task:** Repair

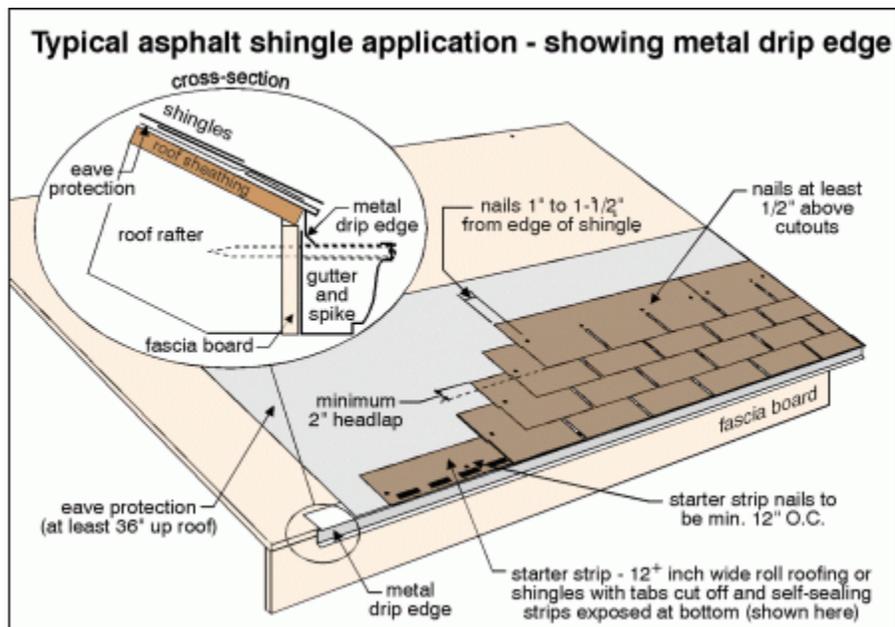
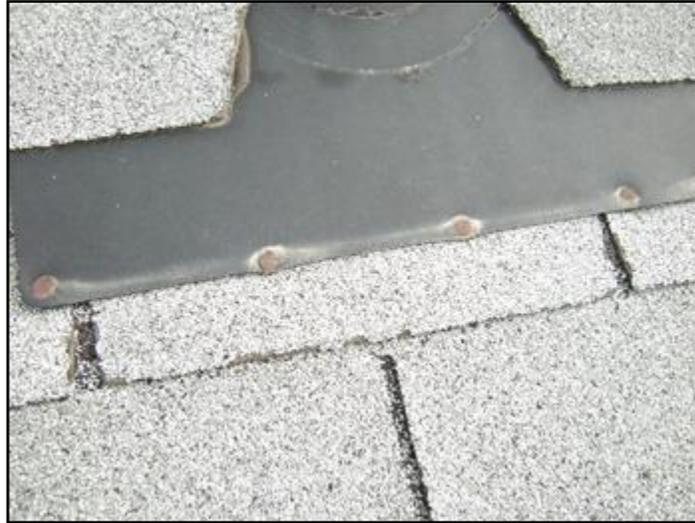
**Note:** Most of the flashings on the roof have exposed fasteners or nail heads visible. These should be sealed with caulking.

3. Exposed fasteners

**Task:** Correct

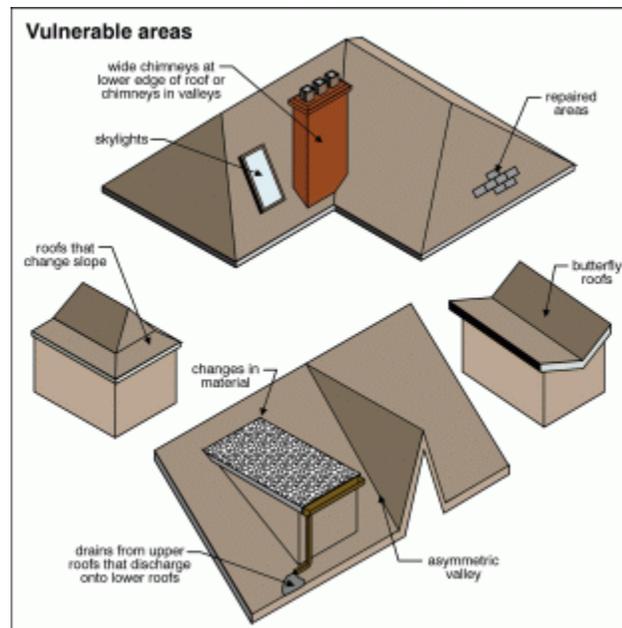
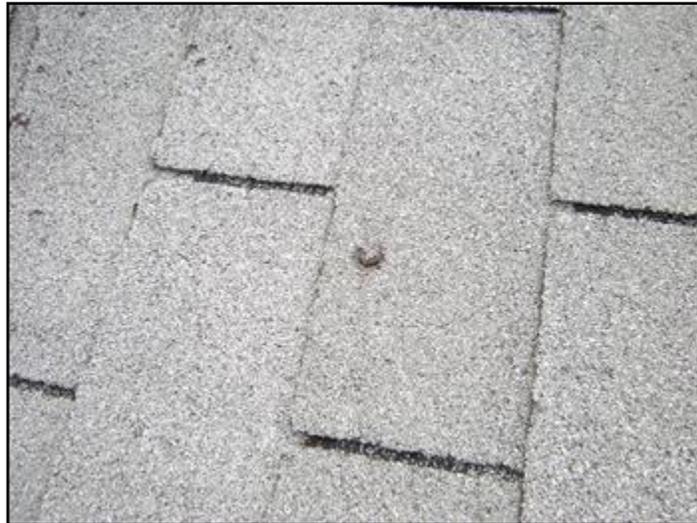
**Note:** Upon inspection it was noted that there are a number of nail pops that should be sealed.

4. *Nail pops*

**Task:** Repair

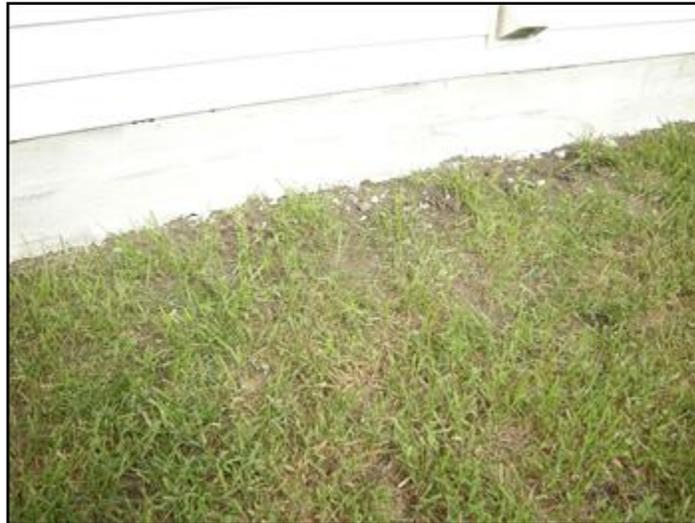
*Note:* The slope in a few areas on the south side of the house slope toward the house.

9. Slope south side.

**Note:** The slope of the grade in a few areas on the south side of the house should be improved to ensure water flows away from the home.

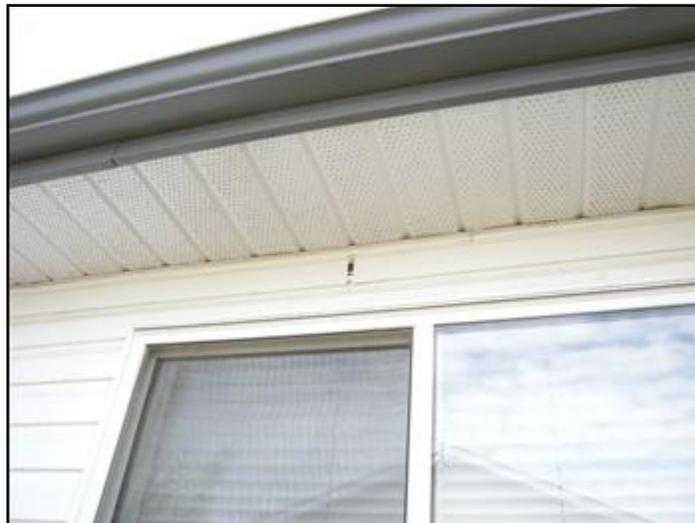
*Note:* Siding separation above window.

10. Siding separation.

**Condition:** • Gap in vinyl siding.

**Task:** Correct

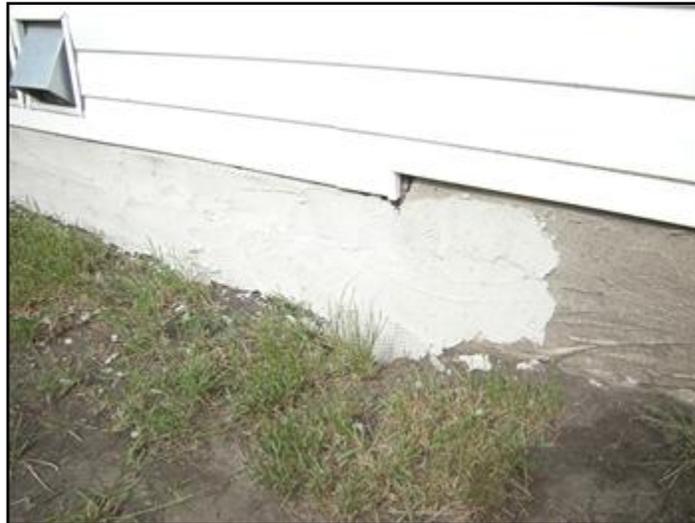
- There are a number of previous parking repairs noted on the home.

12. Previous repair.

**Task:** Monitor

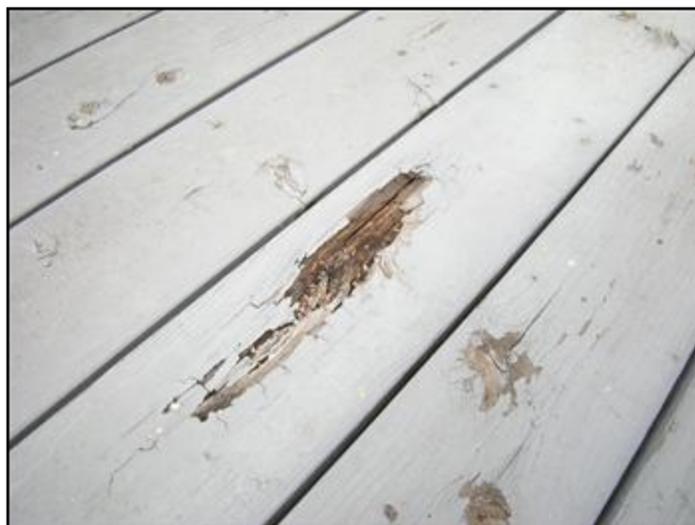
**Note:** The rear deck is showing wood rot in one specific area.

13. Rot deck board.

**Task:** Inspect annually

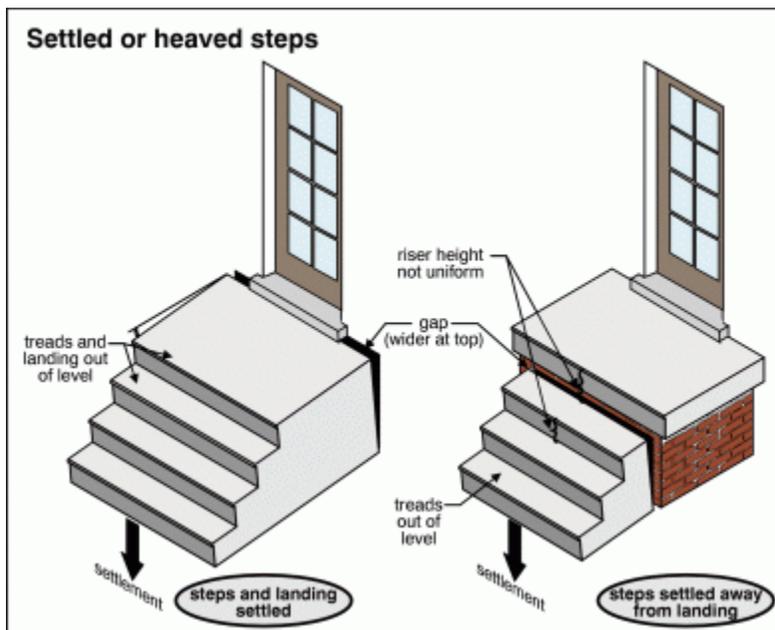
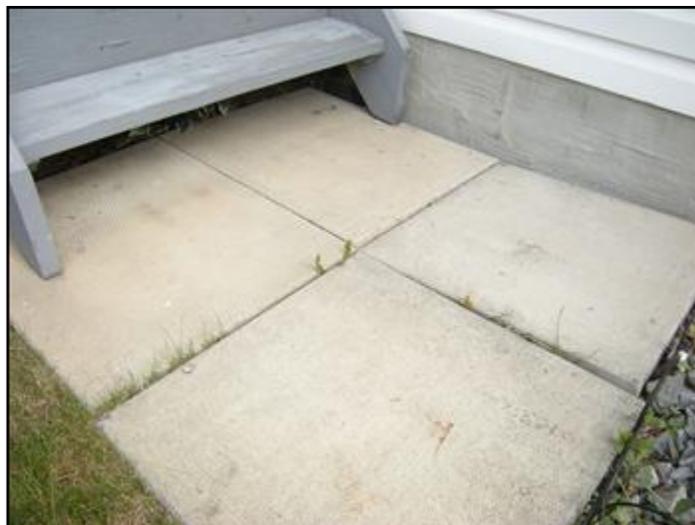
**Note:** The concrete block making up the landing for the deck steps are uneven and present a trip hazard.

14. Rear steps landing.

**Task:** Correct

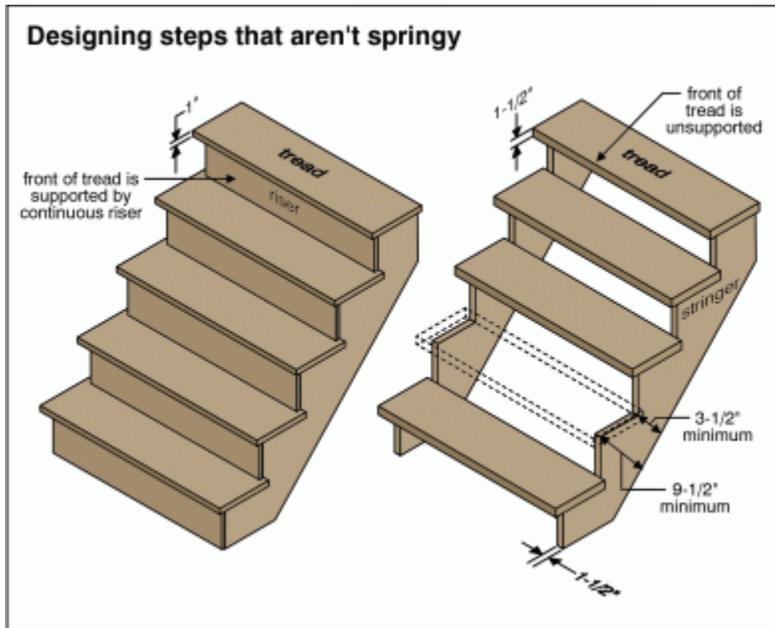
**Note:** The rear deck steps net to be re-secured.

**Task:** Repair

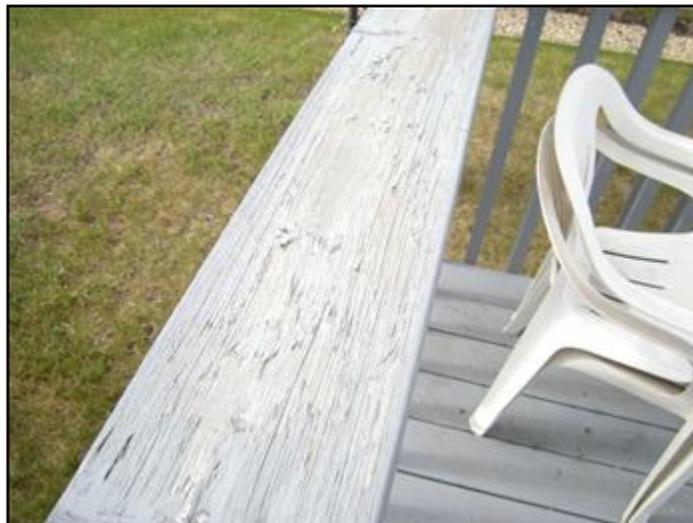
**Condition:** • Repaint the rear deck handrail to prevent further deterioration.

15. Handrail deck.

**Task:** Repair

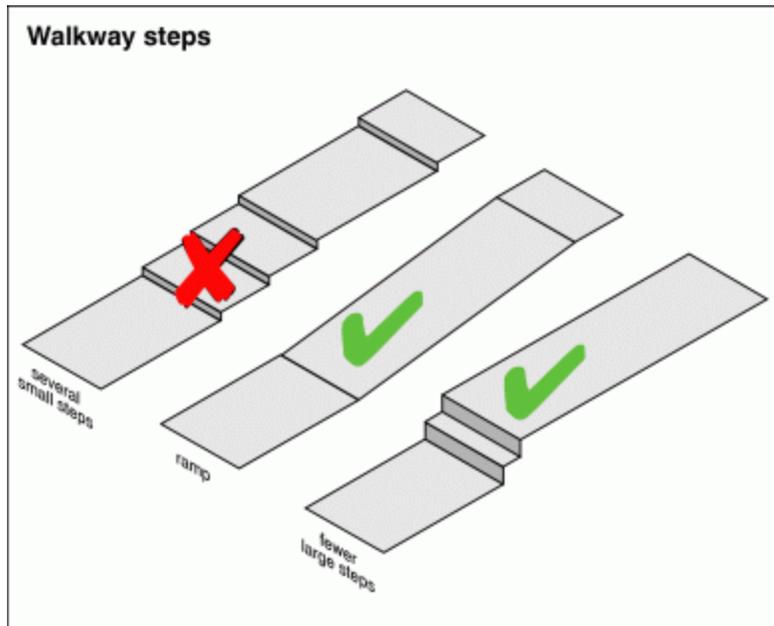
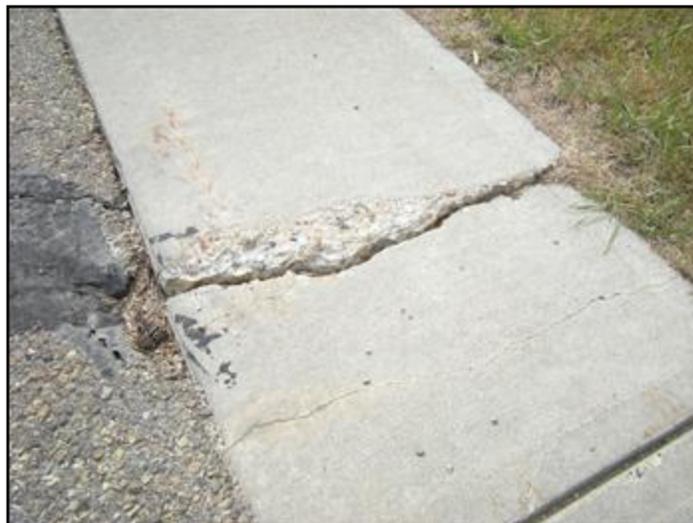
Note: There is a trip hazard in the front side walk.

16. Front side walk.

Task: Correct

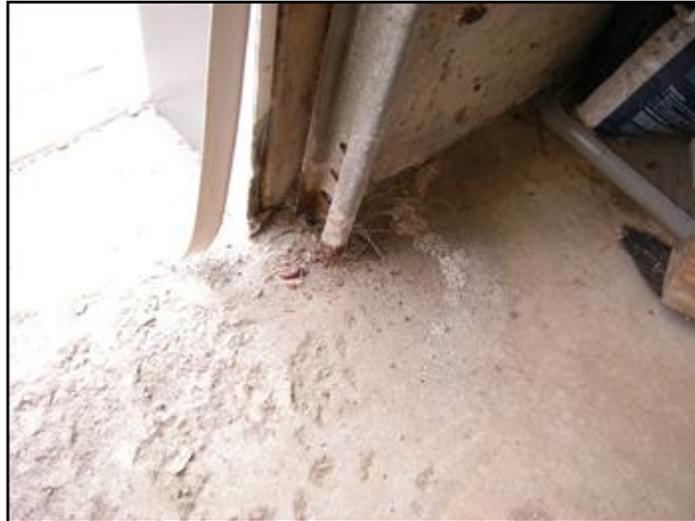
**Condition:** • Both garage tracks are showing deterioration from water.

17. Garage door track.

**Task:** Repair

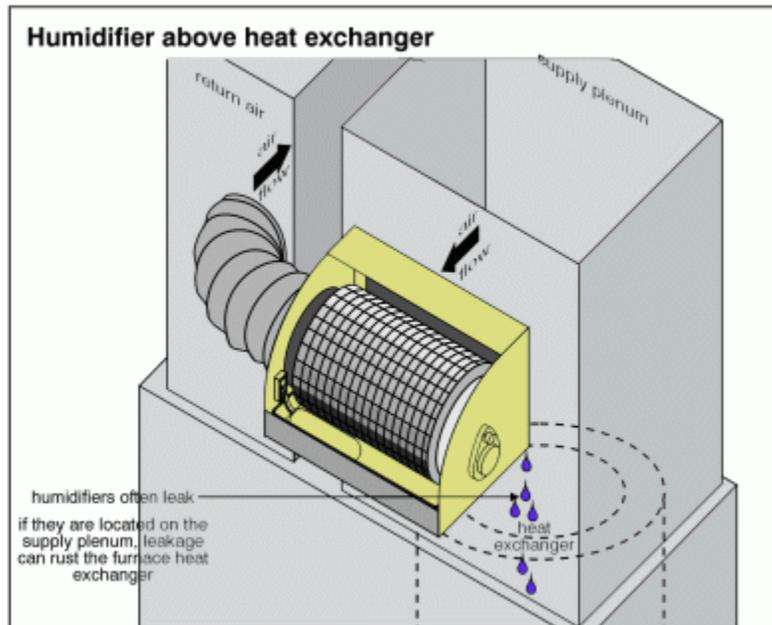
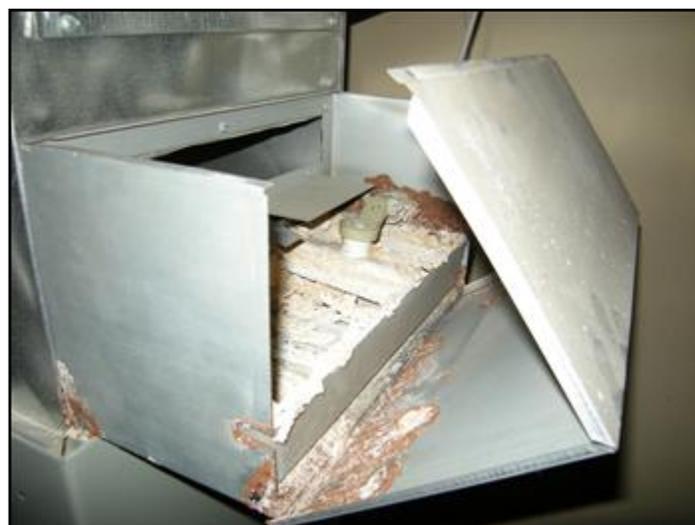
**Note:** The humidifier is not operational and shows signs of previous leakage.

30. Humidifier

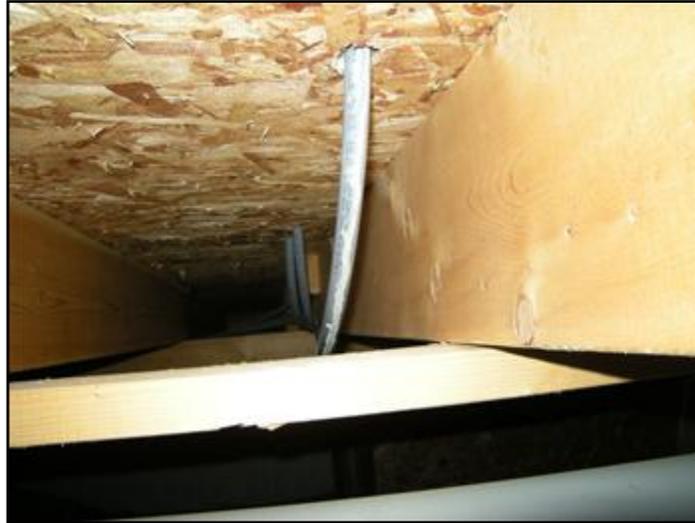
**Note:** Evidence of leak in crawl space on supply line to the master ensuite. Not wet at time of inspection.

36. Evidence of leak.

**Task:** Monitor

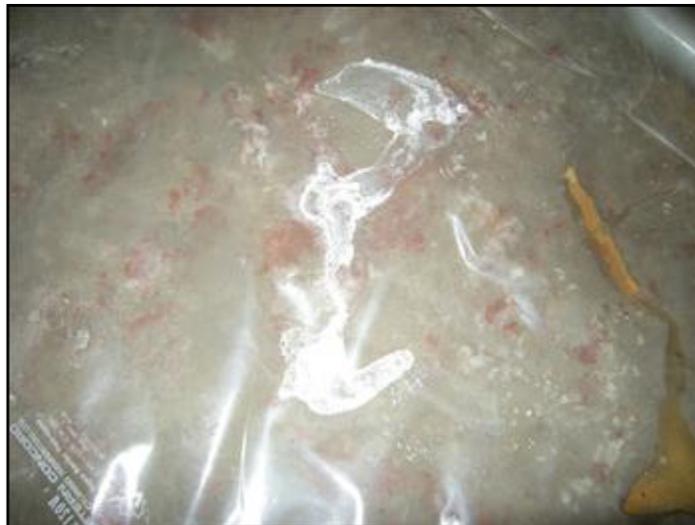
**Note:** Evidence of water leak in crawl space at some point. Not present at time of inspection.

37. Evidence of leak.

**Task:** Monitor

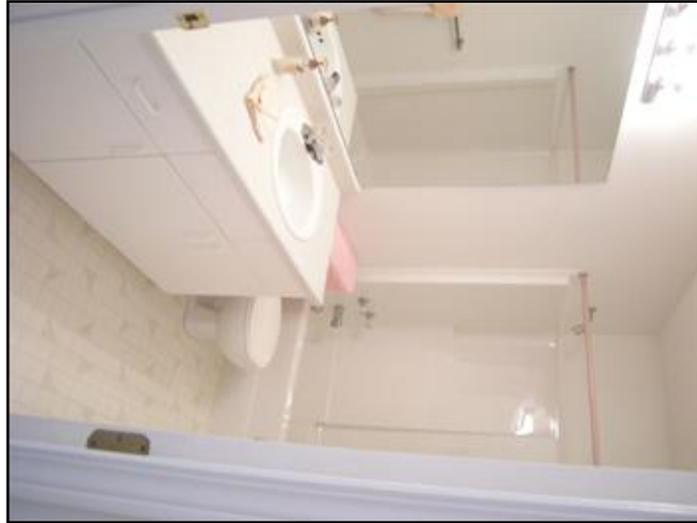
**Condition:** • The hot water tap for the hall way bathroom shower is not functional. Cold water is fine.

38. Hot water tap.

**Task:** Repair

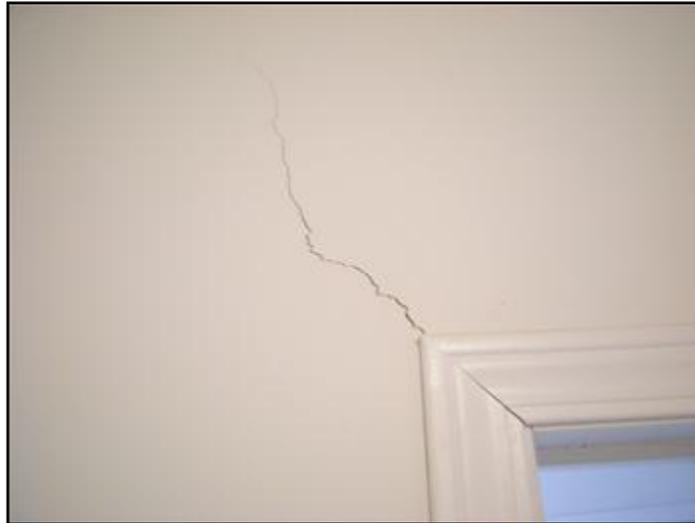
**Note:** Crack in drywall plaster leading into the utility room.

43. Cracked plaster.

**Task:** Repair
