YOUR Inspection Report

9300 NEWFOUND WAY
ELK GROVE, CA

INSPECTION DATE:

RE: Report No. 1003
9300 NEWFOUND WAY
ELK GROVE, CA
95758

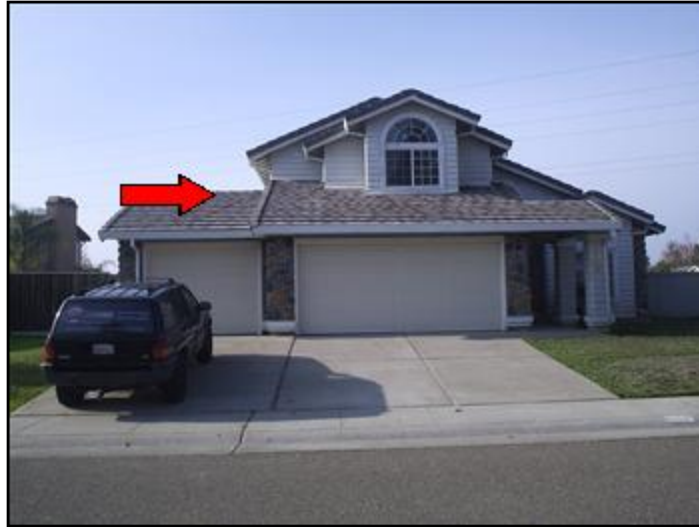
1.

General: • Roof Moss Covered

Inspection performed: • Roof is 18 years old recommend roof inspection to ensure there is no leaks.

General: • Recommend Roof Inspection

Recommended evaluation and repairs by a licensed contractor or appropriate tradesman dealing with that item or system.(Roofer)

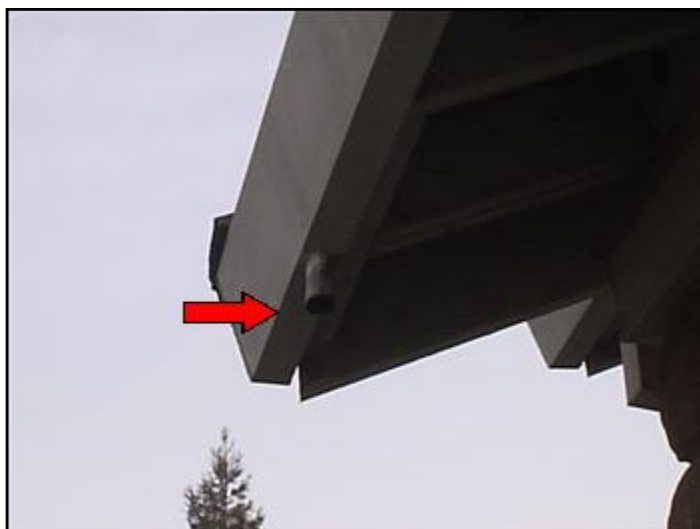
2.

Note: Disconnected downspout right. Recommend repairs.

This item or component warrants additional attention , repair or monitoring.

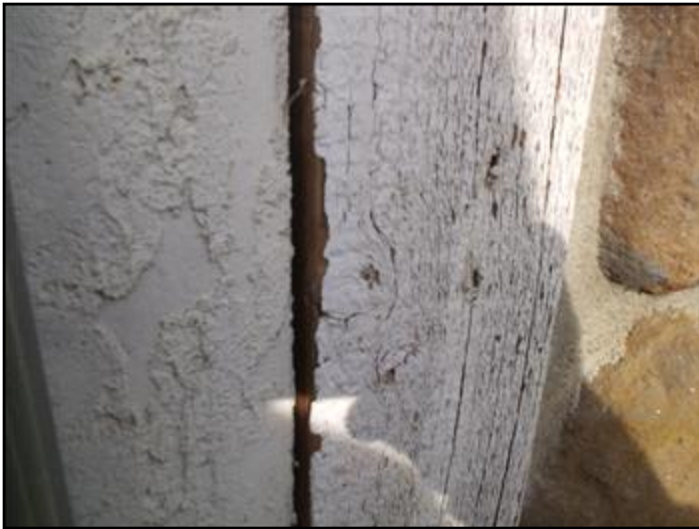
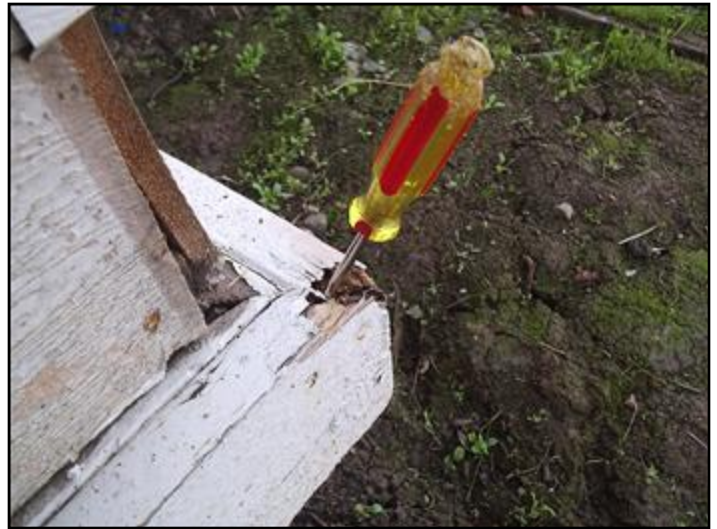
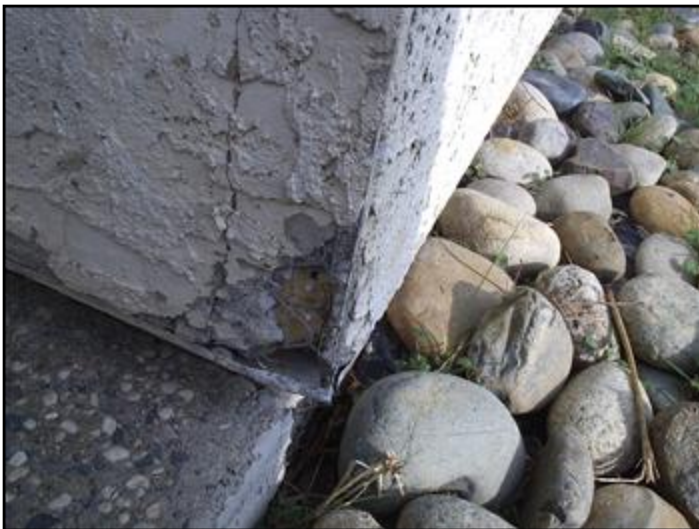
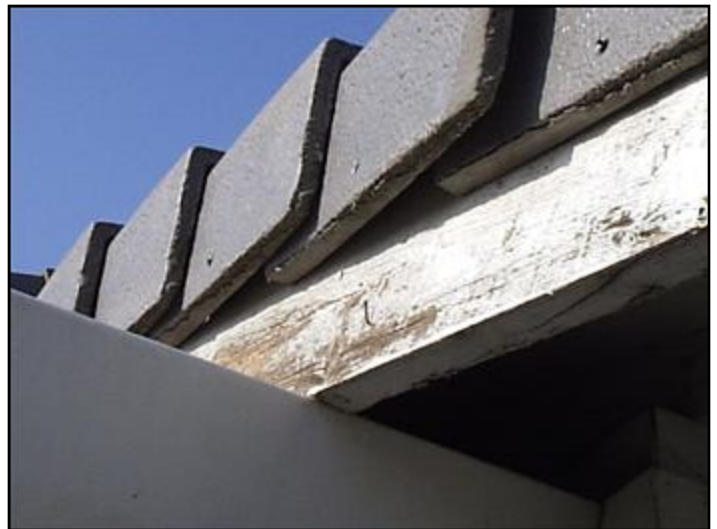
Note: Siding / Common Cracks , Openings. Recommend repairs to avoid further water intrusion.

Recommended evaluation and repairs by a licensed contractor or appropriate tradesman dealing with that item or system.

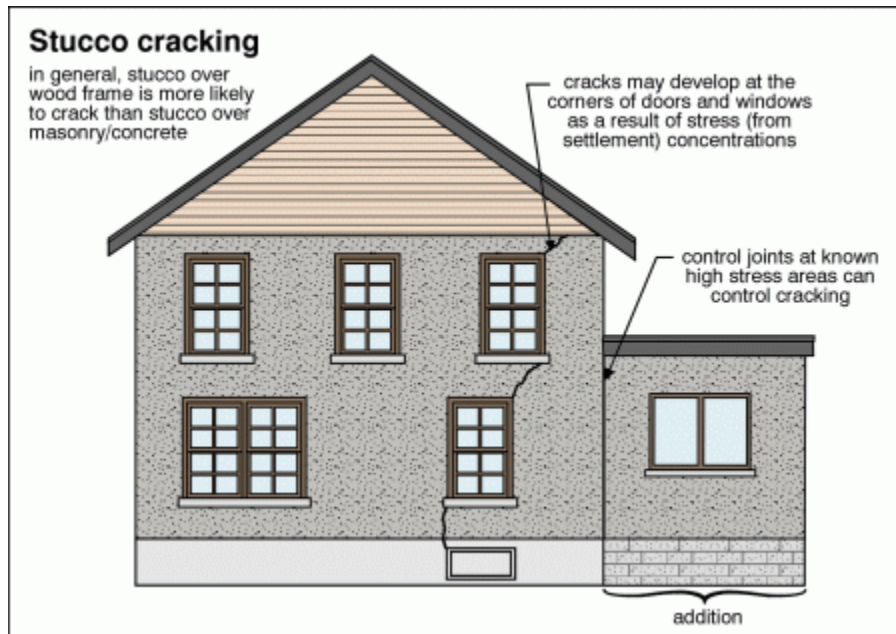
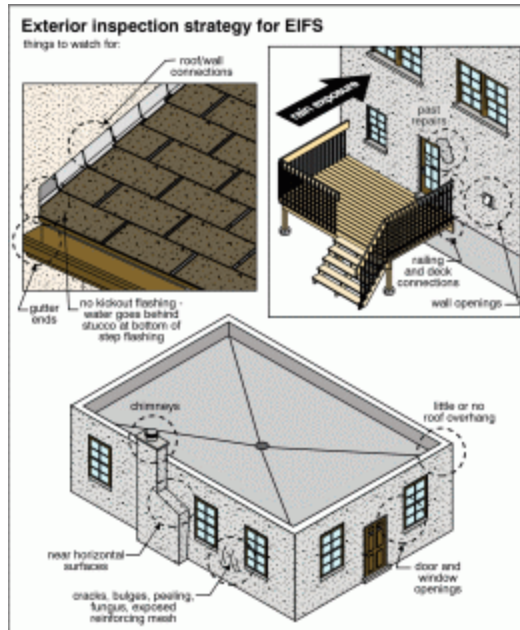
Condition: • [Cracked](#)

Implication(s): Chance of water damage to contents, finishes and/or structure | Material deterioration

Location: Various

Task: Correct

Time: Immediate

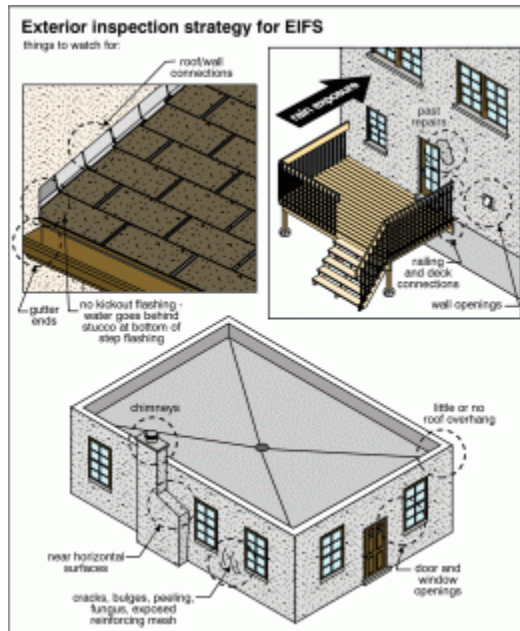
Condition: • [Crumbling](#)

Implication(s): Chance of water damage to contents, finishes and/or structure | Material deterioration

Location: Various Exterior Wall

Task: Correct

Time: Immediate

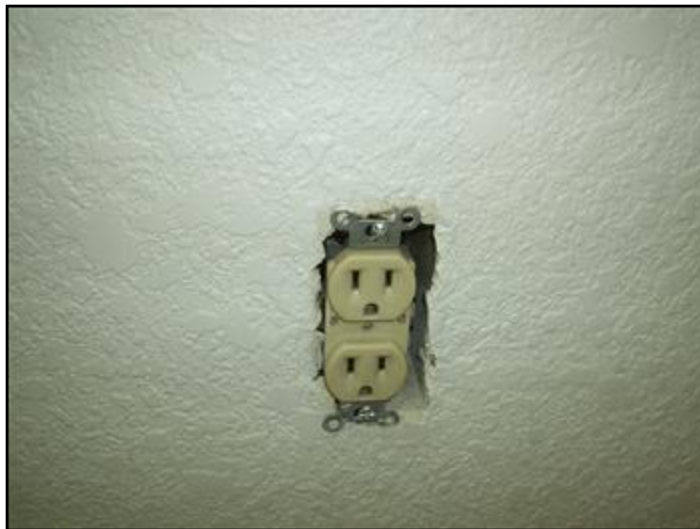
8.

General: • Varies areas of the home and garage are missing outlet covers.

This item or component warrants additional attention , repair or monitoring.

Condition: • [Missing](#)

Implication(s): Electric shock

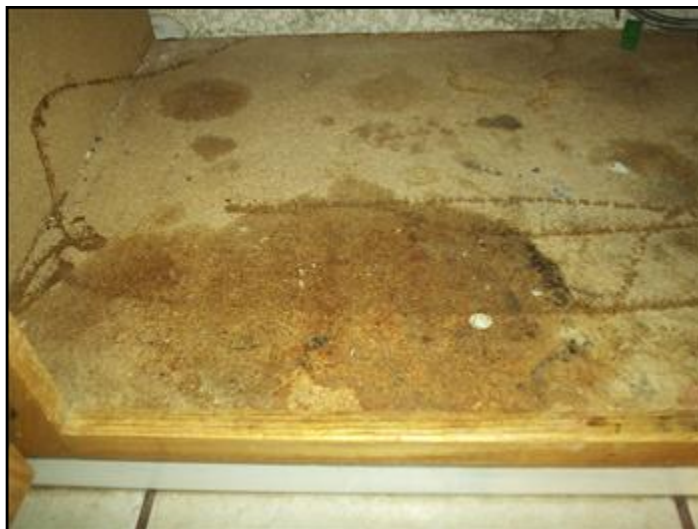
9.

General: • Shower water will not turn on mst bath, (Replace Cartridge)

There was a past leak under kitchen sink no leak at time of the inspection.

This item or component warrants additional attention , repair or monitoring.

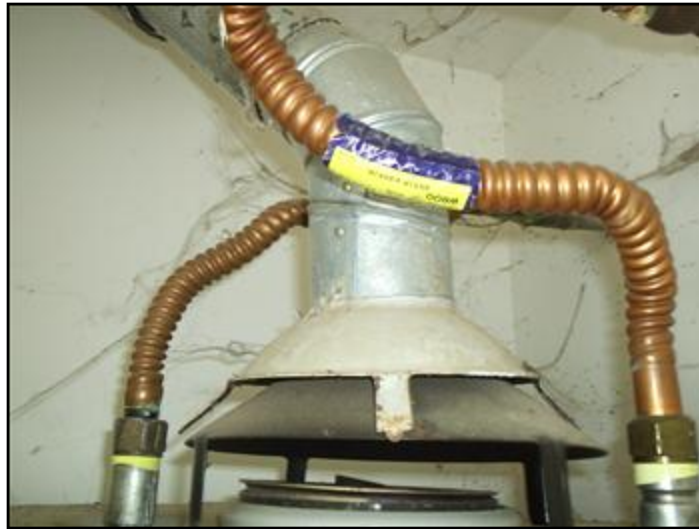
10.

Note: Draft diverter is loose and double b venting needs to secured.

Recommended evaluation and repairs by a licensed contractor or appropriate tradesman dealing with that item or system.(Plumber)

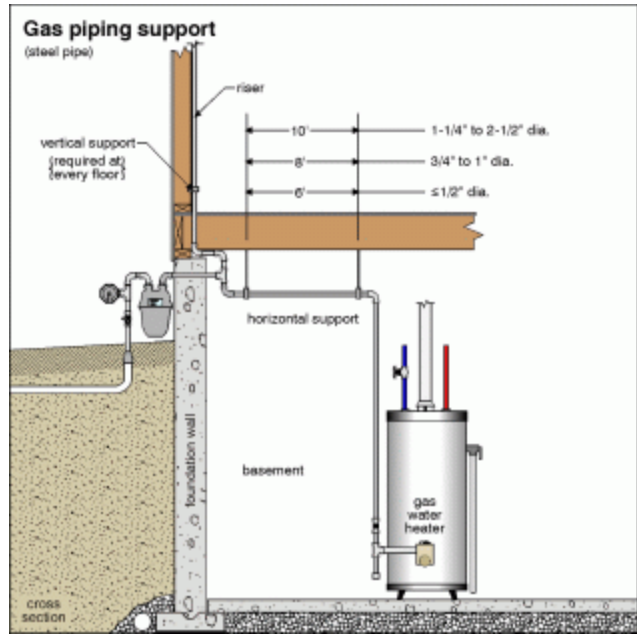
Condition: • [Inadequate support](#)

Implication(s): Fire or explosion

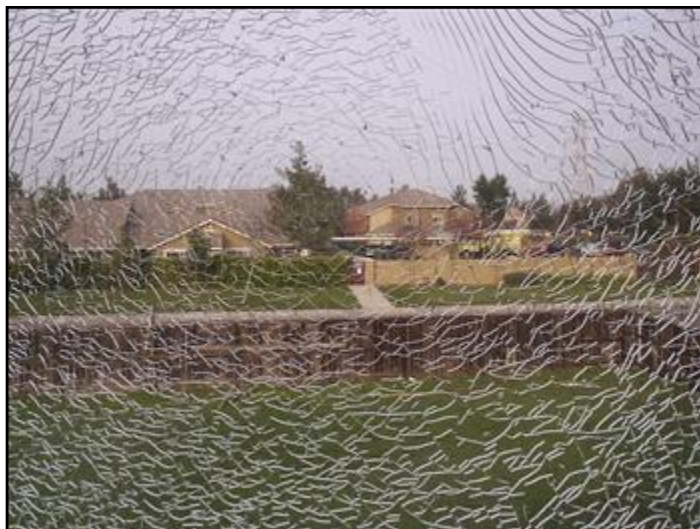
11.

Windows: • Dual pane , mst bath one of the dual panes is broken.

Condition: • [Broken](#)

Implication(s): Cosmetic defects | Chance of water entering house | Physical injury | Increased heating and cooling costs | Reduced comfort

Location: Second Floor Master Bathroom

Recommended evaluation and repairs by a licensed contractor or appropriate tradesman dealing with that item or system. (Glazer)

Task: Correct

Time: Immediate
