# INSPECTION REPORT

For the Property at:  
**4209 JEFFERSON PLACE**  
NEW ORLEANS, LA 70187

Prepared for: ROBERT SMITH  
Inspection Date: Tuesday, April 27, 2010  
Prepared by: Tom Axelrad

RE: Report No. 1426, v.3  
4209 Jefferson Place  
New Orleans, LA  
70187

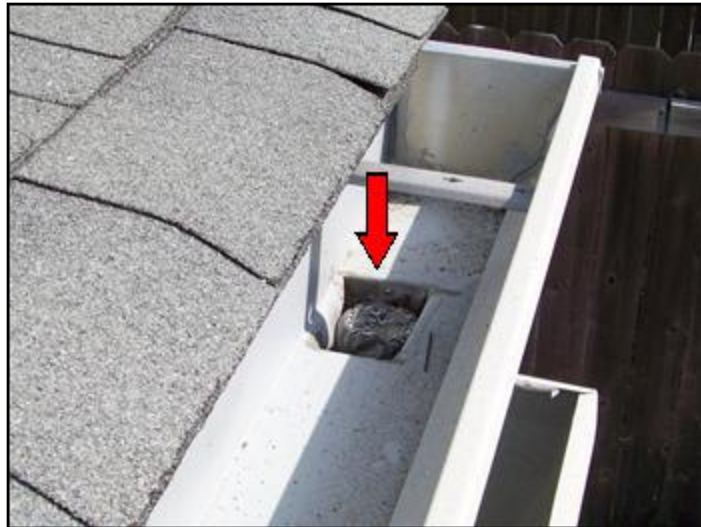
#### **4. Condition:** • [Clogged](#)

**Implication(s):** Chance of water damage to contents, finishes and/or structure

5. Clogged downspout (bottle)

**Task:** Remove

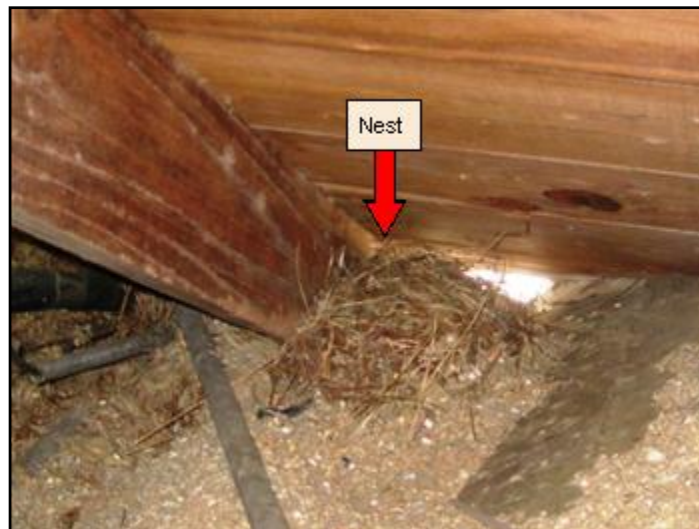
#### **5. Condition:** • Soffit vent screen missing or broken - birds or other unwanted pests in attic. Nest visible.

6. Animal or bird nest in attic - open soffit

**Task:** Correct

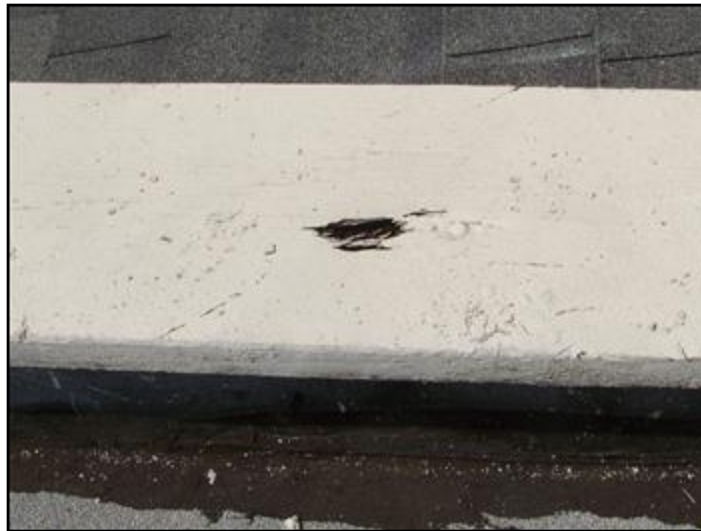
Small amount of rot (hole) on wood trim around flat roof platform. Because this is exposed to direct water intrusion, this will deteriorate rapidly unless repaired. The rot goes quite deep.

**Implication(s):** Chance of water damage to contents, finishes and/or structure | Material deterioration

7. Wood rot on roof trim

**Task:** Repair

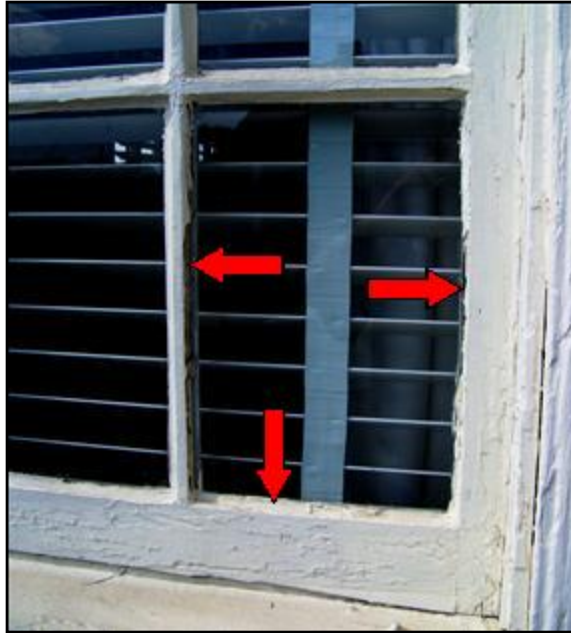
2nd floor rear right bedroom window - glass was replaced and putty is missing or deteriorated.

**Implication(s):** Chance of water entering house | Increased heating and cooling costs

8. Window putty missing

**Task:** Replace putty, paint

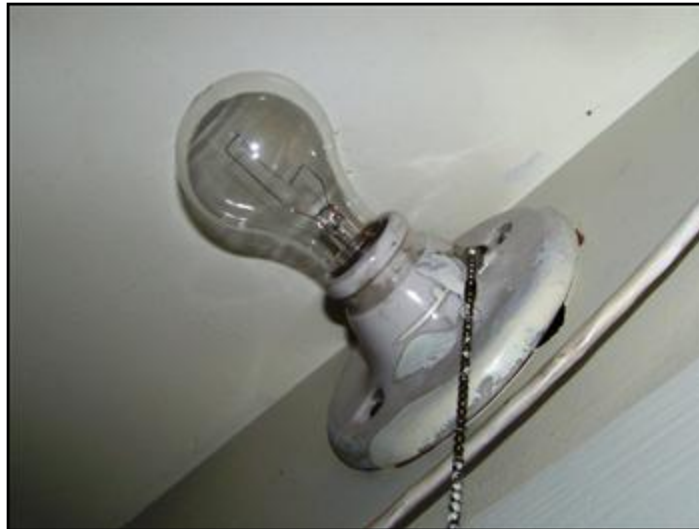
Incandescent bulb in closet too close to sheetrock. Fire hazard - safety issue

**Implication(s):** Fire hazard

*17. Closet light too close to ceiling*

**Task:** Recommend converting to florescent bulb

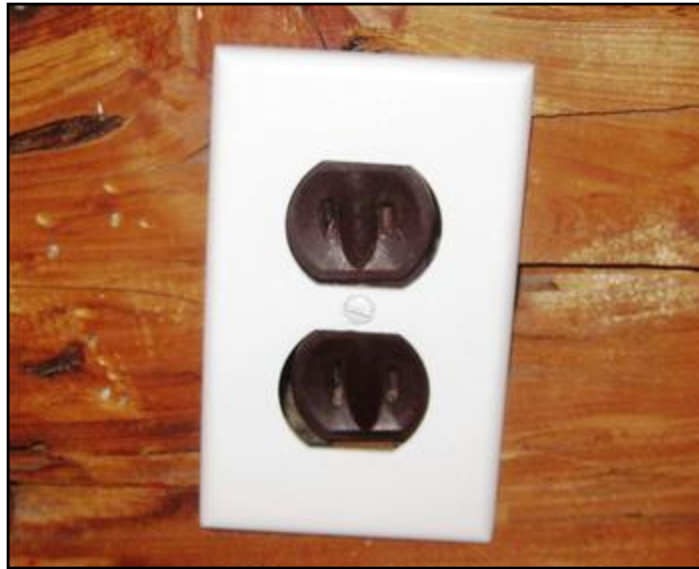
Entire 3rd floor has ungrounded, 2 slot outlets.

18. Two slotted outlet (ungrounded) 3rd floor

**Task:** Correct if desired.

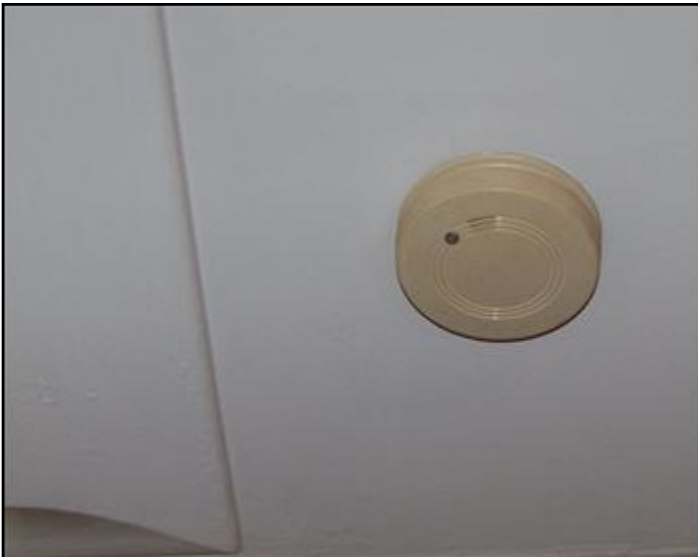
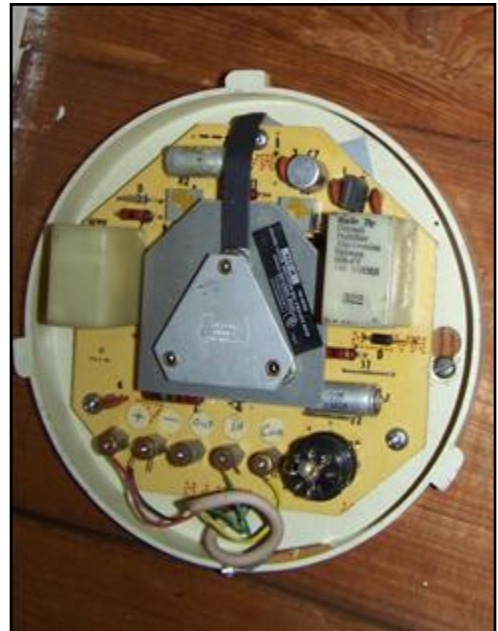
**Implication(s):** Failure or malfunction of smoke alarm(s). SAFETY ISSUE

19. Smoke detector appears old

20. Smoke detector - no date, appears old

**Task:** Replace

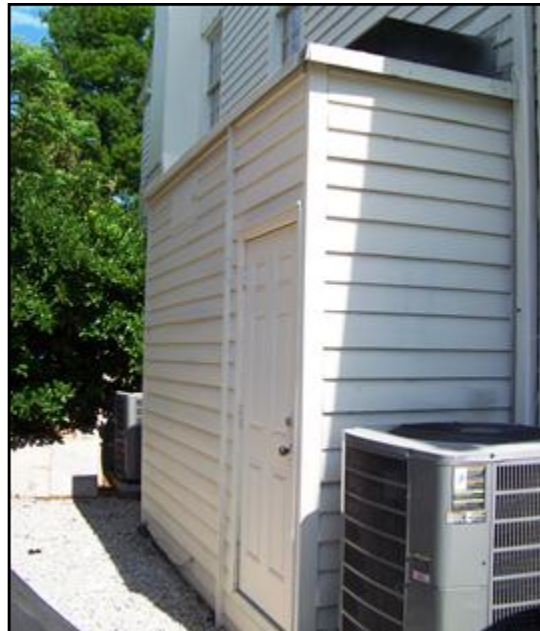
One furnace located in storage shed built onto the right side of the house. The shed was locked. No access to this furnace.

22. Outside building with furnace - no access

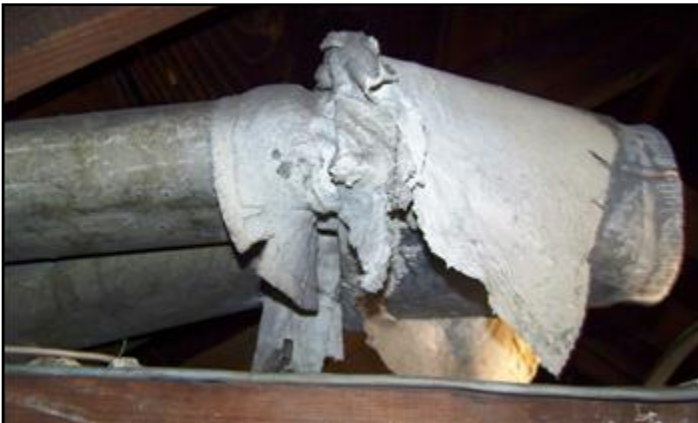
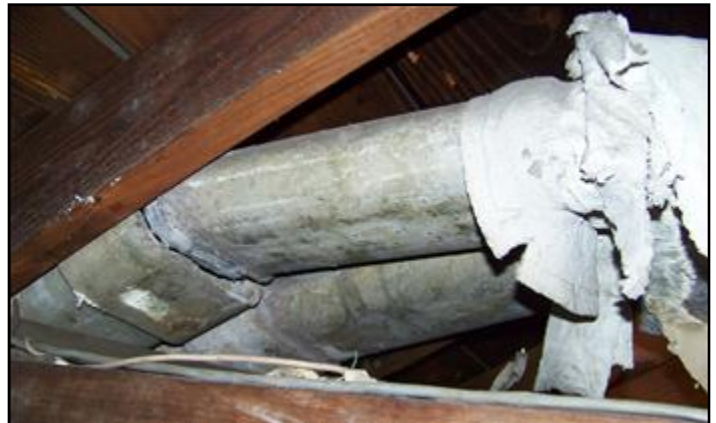
**17. Condition:** • There are two vent pipes that are in the wall toward the front of the house and exit to the left of the upper attic hatch. It appears that they originally connected with a metal vent pipe and penetrated the roof, but no longer. These can also be seen to the right of the center door in the upper front attic. These appear to be old wall heater transite pipe, which is usually an indication of asbestos. The loose insulation around the pipes is also suspect.

**23.** *Suspect material and pipes in upper attic*

**24.** *Suspect material and pipes in upper attic*

**Task:** Further evaluation and testing is recommended. Please refer to the two articles on asbestos and transite pipe in the Appendix of this report for additional information.

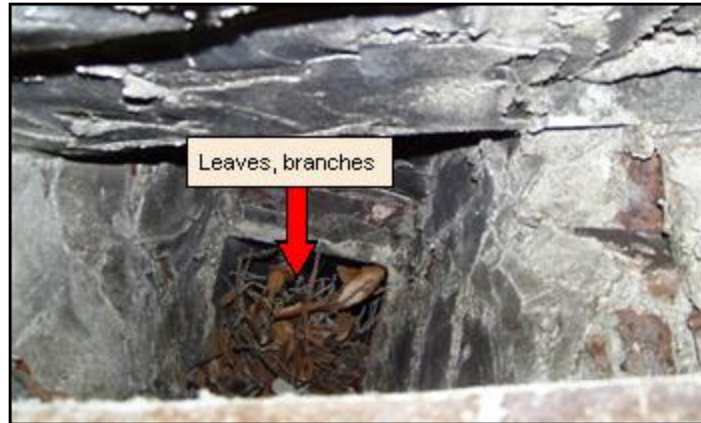
**25.** *2nd floor fireplace chimney - debris*

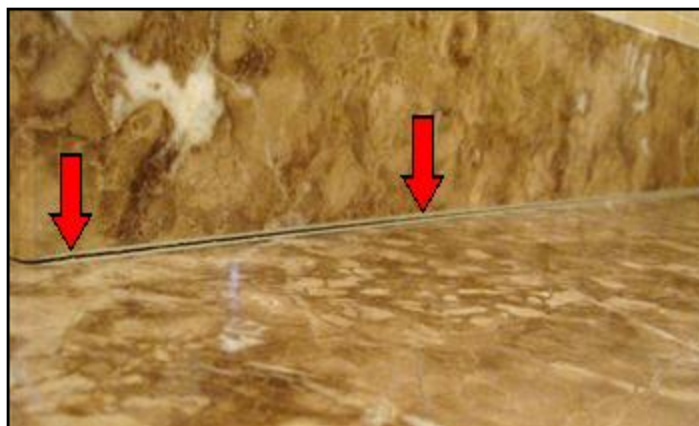
**Implication(s):** Chance of water damage to contents, finishes and/or structure

33. Caulk needed

**Task:** Correct to prevent water intrusion and damage

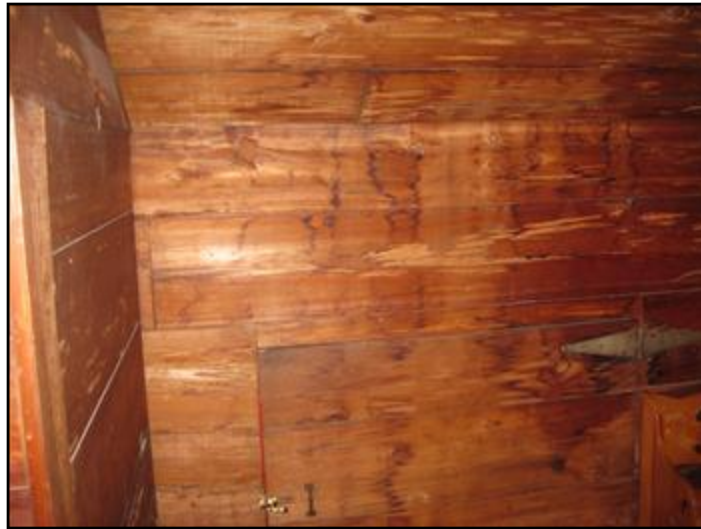
34. Third floor water stains (typical)

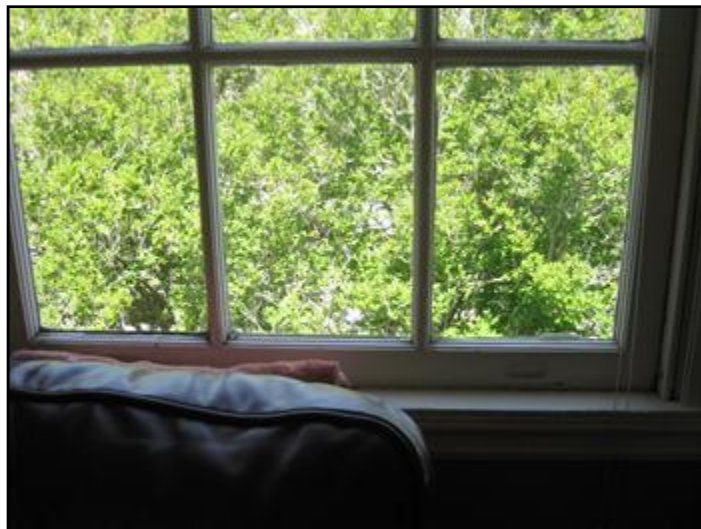
**Implication(s):** Chance of damage to finishes and structure | Chance of damage to structure

35. Bedroom window, possible leak.

**Task:** Monitor. Further investigation.

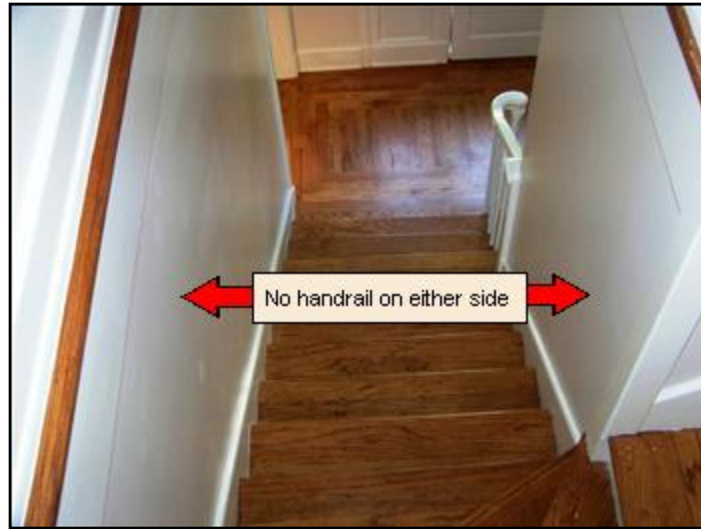
**Implication(s):** Fall hazard

36. Handrail missing - between 1st and 2nd floor

**Task:** Install a handrail on either side for safety

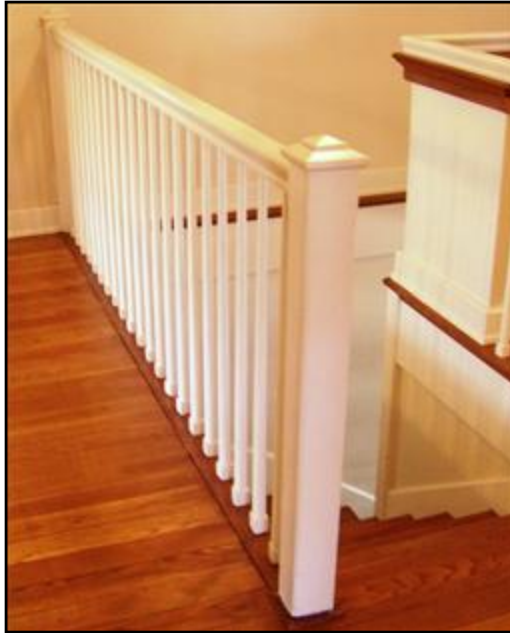
**Implication(s):** Fall hazard

37. Loose guardrail - 2nd floor

**Task:** Repair, tighten
