Your Inspection Report

66 Highfield Rd
Toronto, ON

INSPECTION DATE:
Wednesday, September 30, 2009

Report No. 7896, v.2
www.boulevardinspection.com

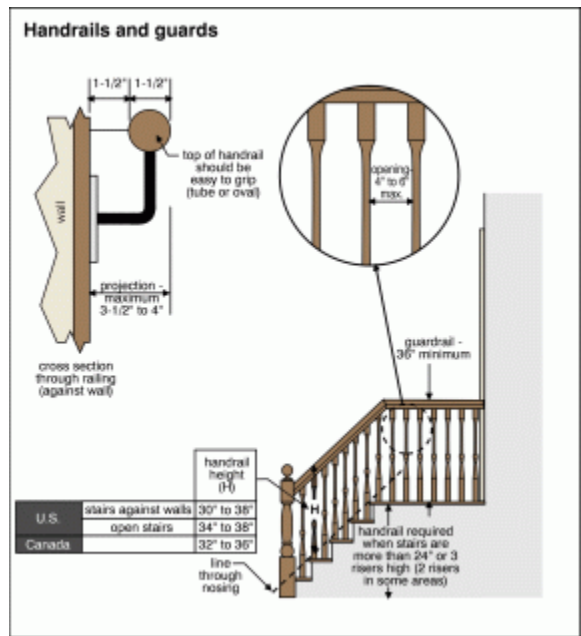
Location: Second Floor

Condition: • [Railing missing](#)
