INSPECTION REPORT

For the Property at:
10672 PONDEROSA WAY
NEVADA CITY, CA 95959

Prepared for: FRED BUYER
Inspection Date: Tuesday, December 29, 2009
Prepared by: Daniel Bertsch CCI

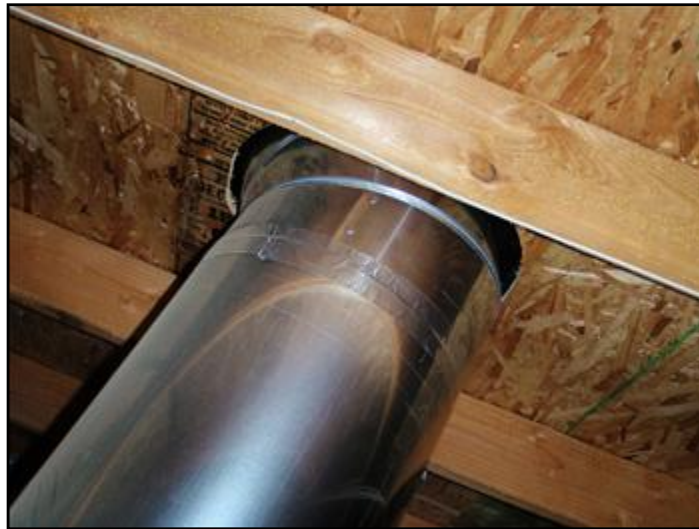
1. Condition: • [Leak](#)

Leak noted by solar tube skylight. Recommend review and repair by Qualified Roofing Contractor.

Implication(s): Chance of water damage to contents, finishes and/or structure

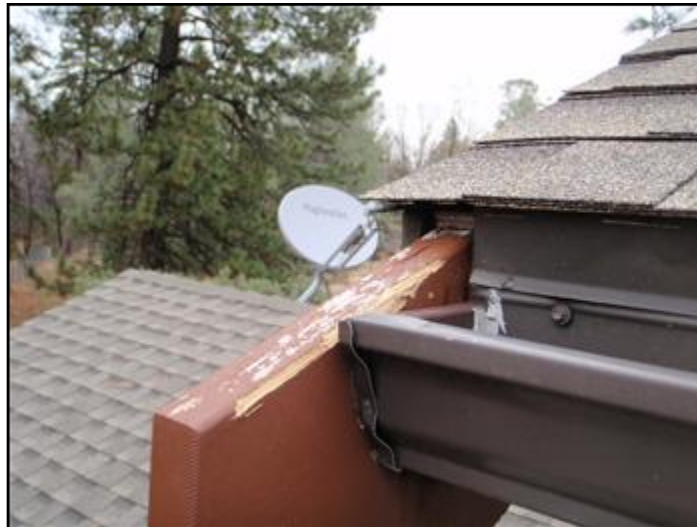
Top of barge rafter

3. • Exterior in need of paint maintenance and caulking

Implication(s): Lack of paint may lead to wood deterioration

Task: Paint and caulk

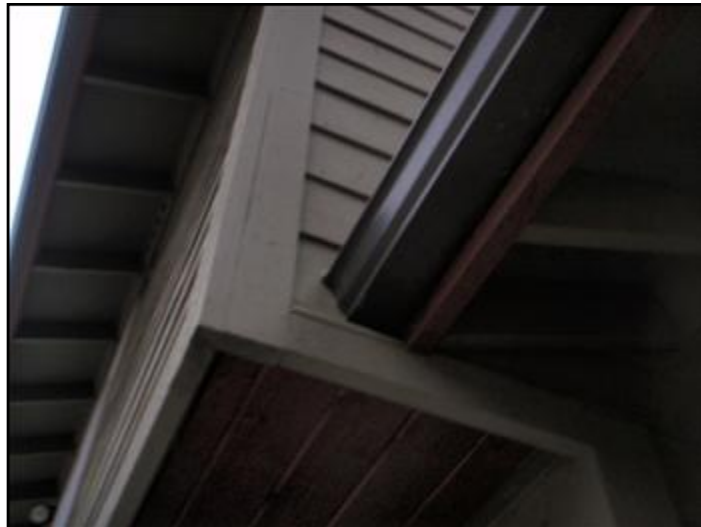
4. **Condition:** • [Leak](#)

Gutter leaks at rear of garage in several location. Caulk as necessary to prevent moisture intrusion and water damage.

Implication(s): Chance of water damage to contents, finishes and/or structure

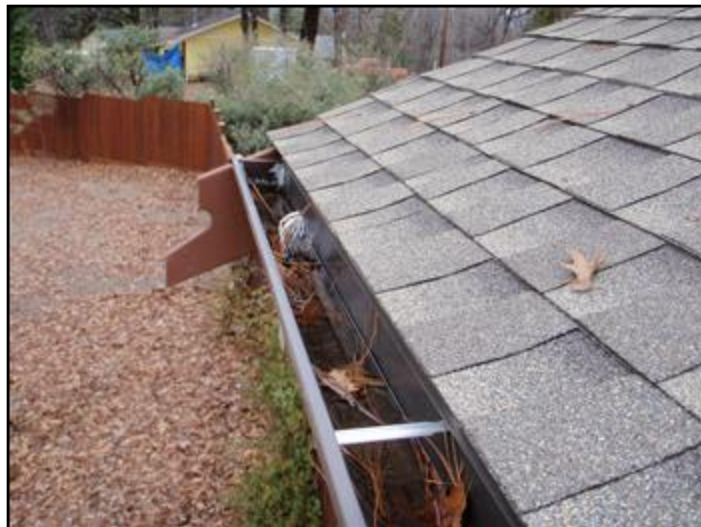
5. Condition: • [Clogged](#)

Ponding noted in gutters. This is a typical condition on newer homes that have gutters set level for improved appearance.

Task: Clean

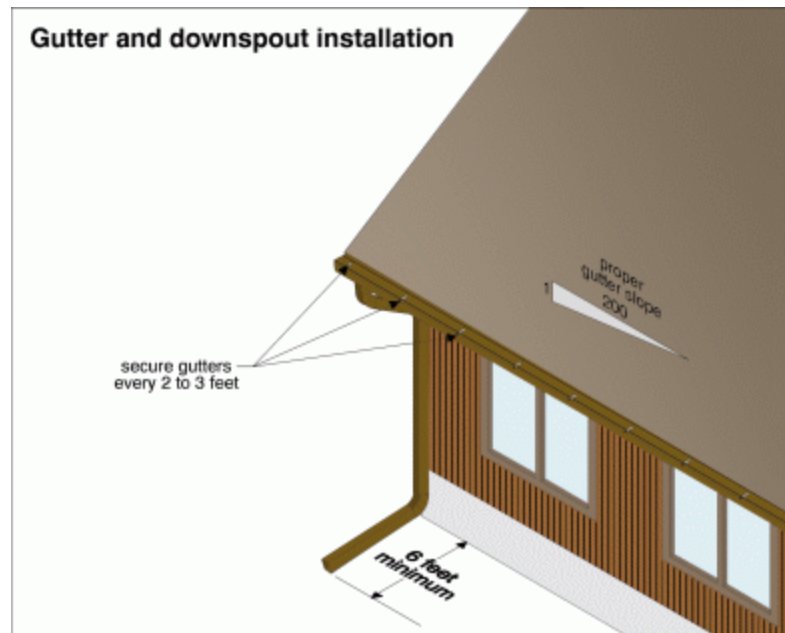
6. Condition: • [Improper slope, ponding](#)

Implication(s): Chance of water damage to contents, finishes and/or structure

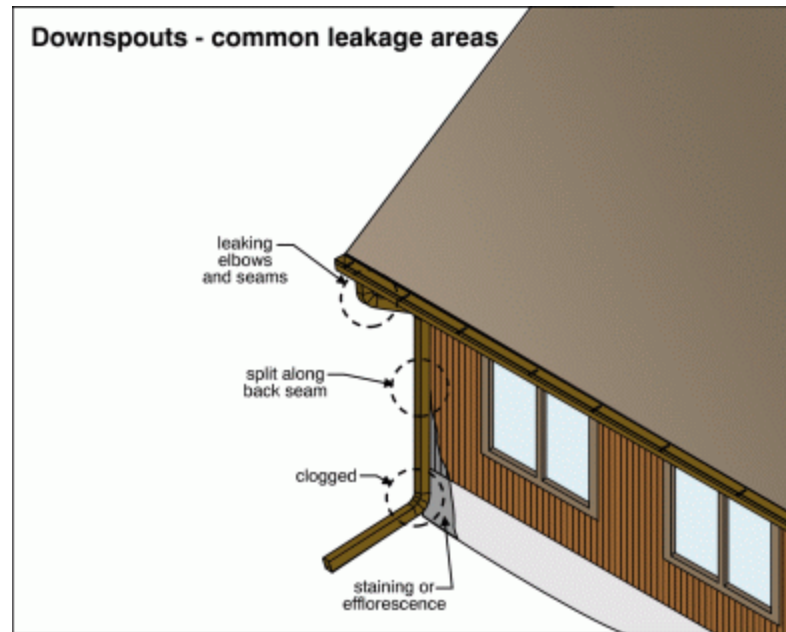
7. Condition: • [Damage](#)

Downspout drain pipe damage. Repair with new section.

Implication(s): Chance of water damage to contents, finishes and/or structure

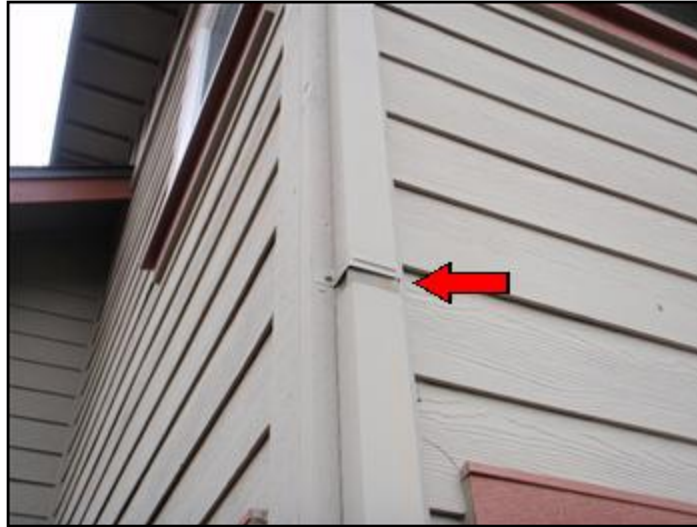
8. Condition: • [Loose connections](#)

Implication(s): Leakage

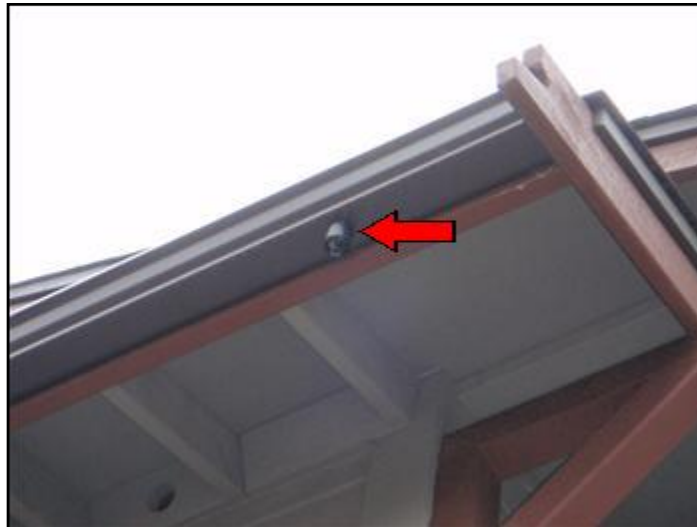
9. Condition: • [Missing](#)

Implication(s): Chance of water damage to contents, finishes and/or structure

Location: Noted at upper right side of building

Task: Correct

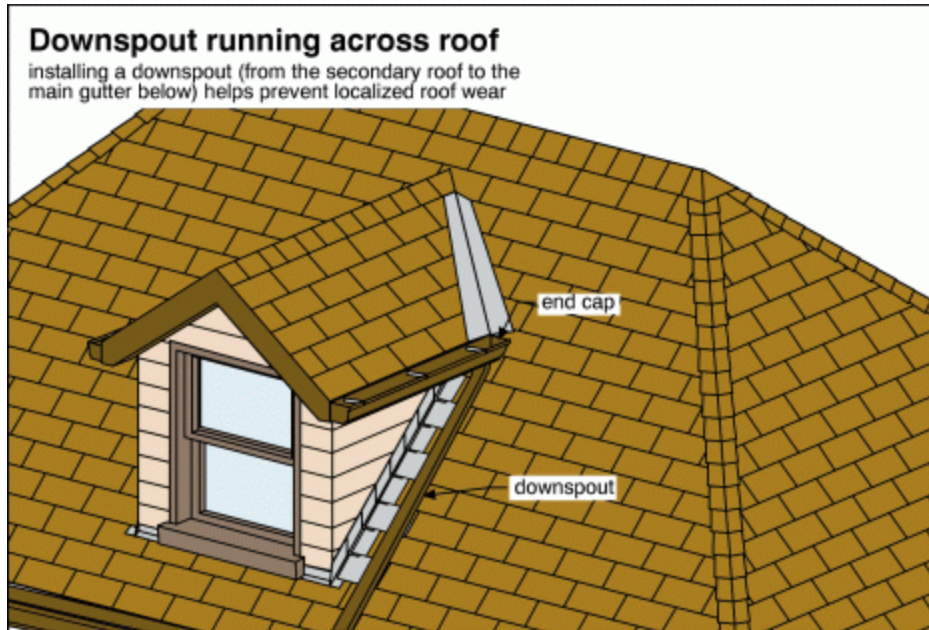
10. Condition: • [Downspouts discharging onto roofs](#)

Implication(s): Chance of water damage to contents, finishes and/or structure

Install downspout section to remedy

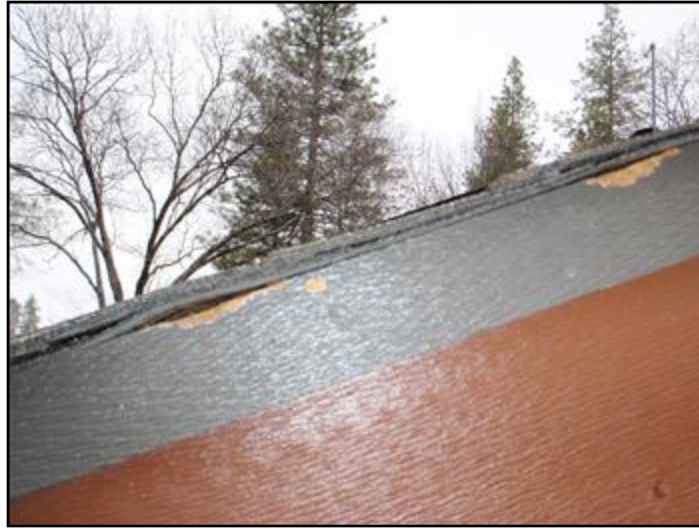
11. Condition: • [Damage](#)

Bird damage noted on shingle molding. Installation of 2"x2" sheet metal drip edge may discourage wood peckers.

Implication(s): Cosmetic defects | Chance of water damage to contents, finishes and/or structure

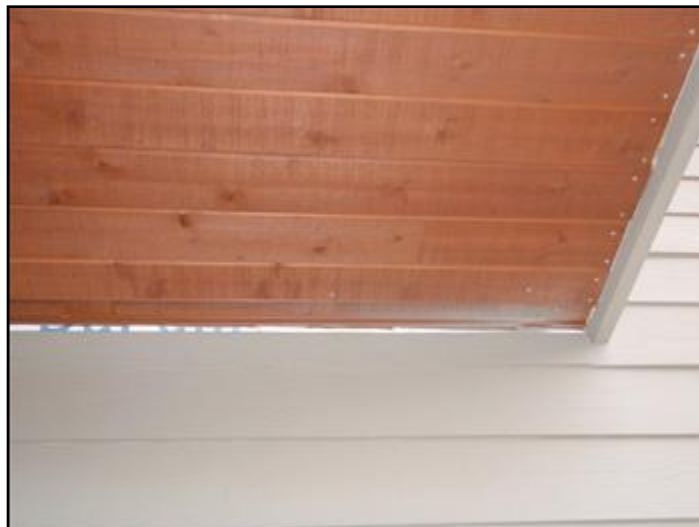
12. Condition: • [Missing](#)

Implication(s): Cosmetic defects | Chance of water damage to contents, finishes and/or structure

Task: Correct

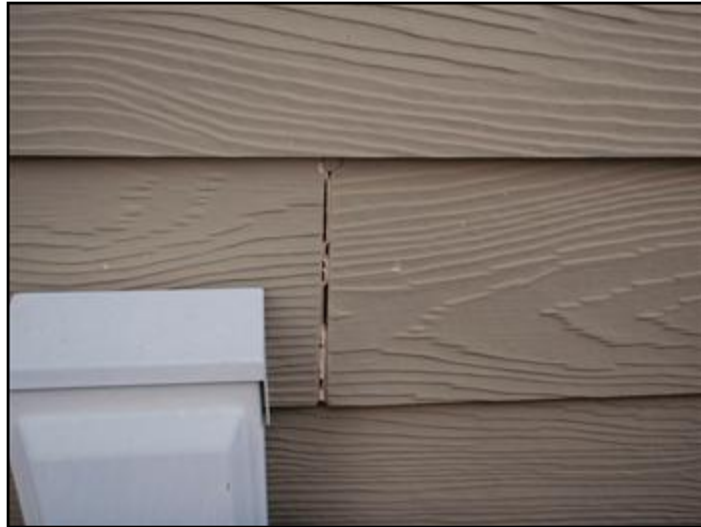
13. Condition: • [Missing paint or caulking](#)

Implication(s): Cosmetic defects | Chance of water damage to contents, finishes and/or structure

Task: Service annually

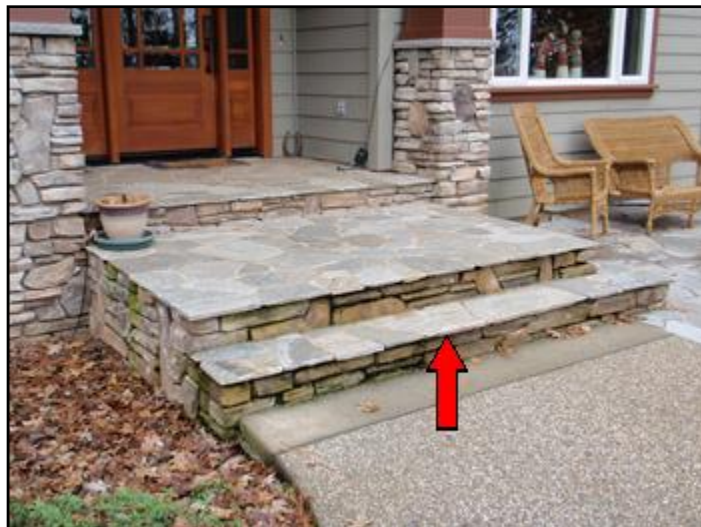
14. Condition: • [Stair rise too big or not uniform](#)

Implication(s): Trip or fall hazard

Task: Use caution when traversing

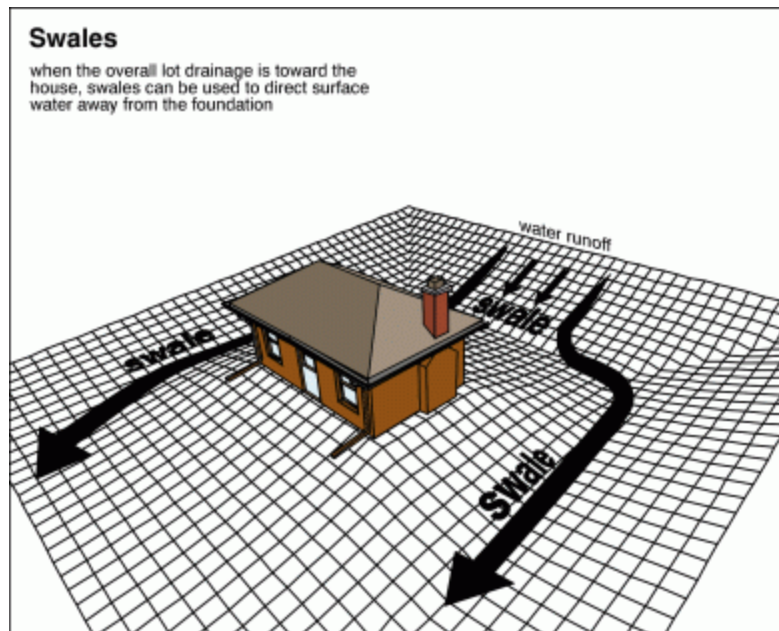
15. Condition: • [Improper slope](#)

Implication(s): Chance of water damage to contents, finishes and/or structure

Task: Monitor

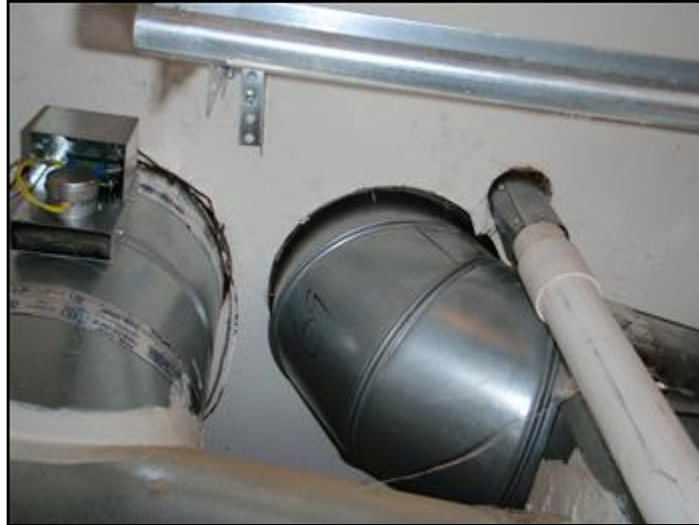
16. Condition: • Not fireproof

Implication(s): Fire hazard

Task: Correct

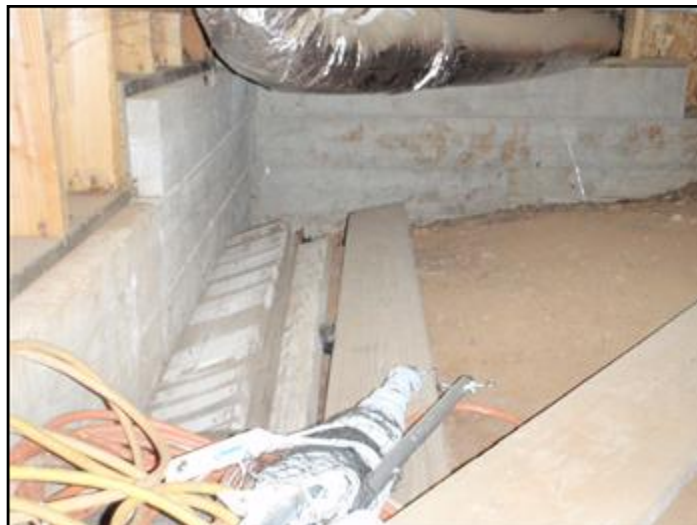
17. • Cellulose debris noted. Boards and other debris should be removed

Task: Correct

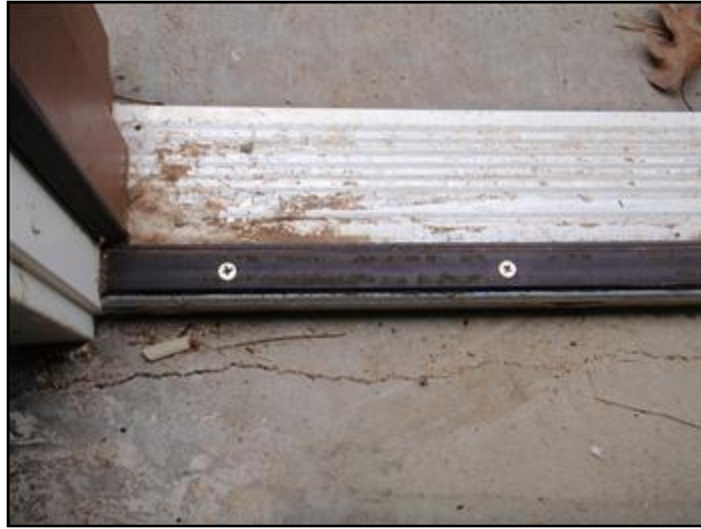
18. Condition: • Typical shrinkage crack noted

Implication(s): Possible moisture intrusion.

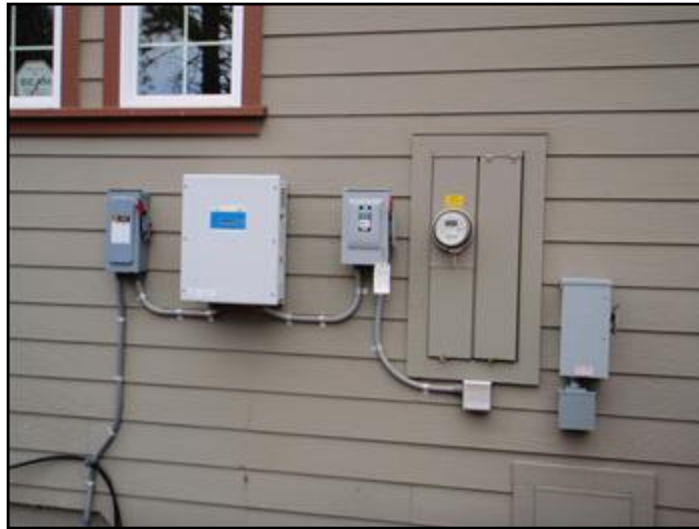
19. • Solar power and auxiliary generator panels were noted. Consult with current property owners for information and operation of these systems.

Location: Left side of garage

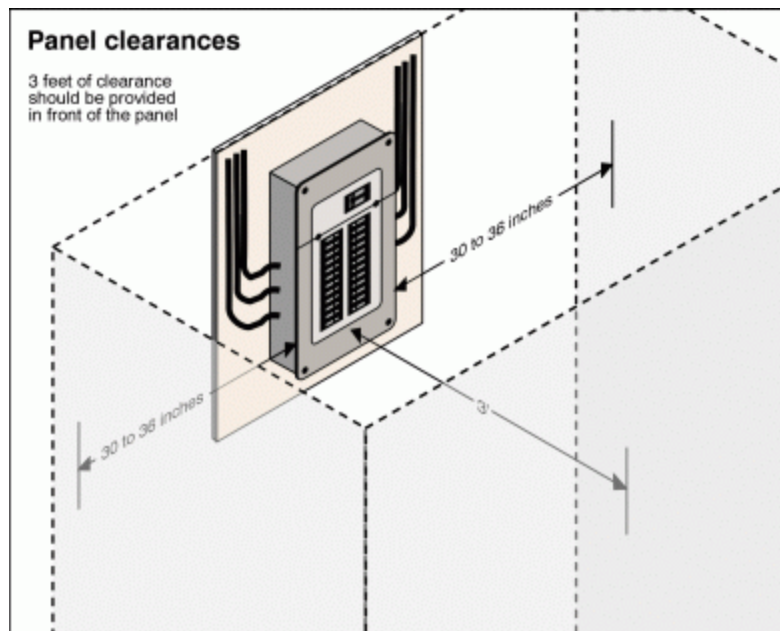
20. Condition: • [Box location poor](#)

Task: Correct

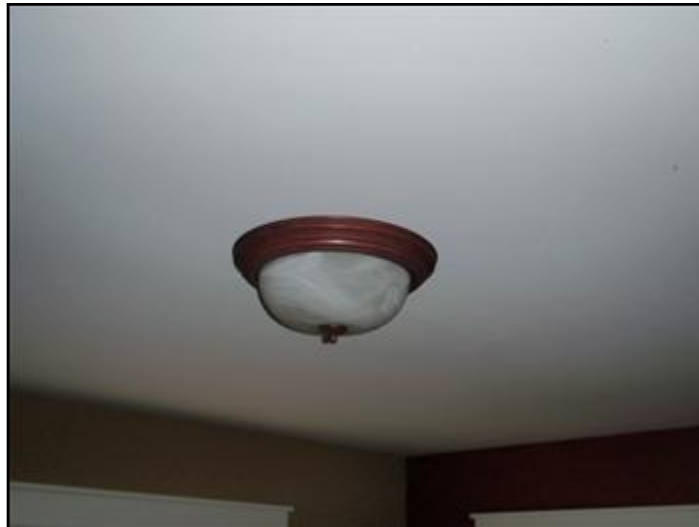
21. Condition: • [Inoperative](#)

Implication(s): Inadequate lighting

Location: Bedroom #1

Task: Replace bulb

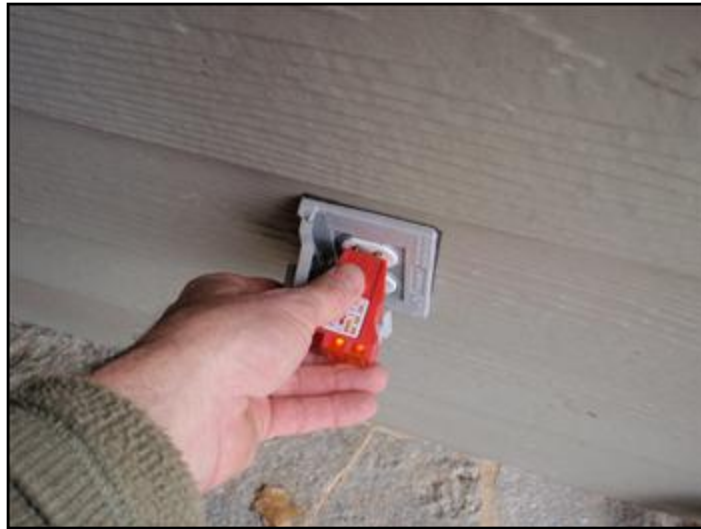
22. Condition: • [GFI test faulty](#)

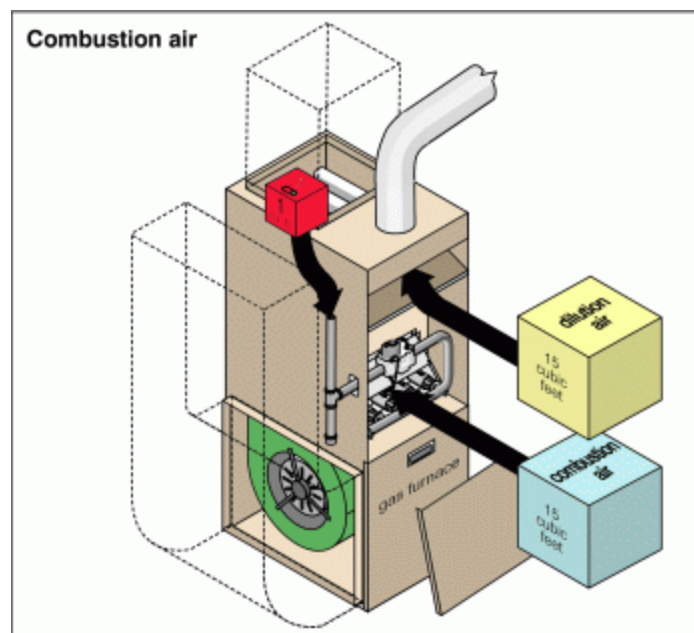
23. Condition: • [Inadequate combustion air](#)

Inspector could not view a typical foundation type vent that is for combustion air. Recommend review by a Qualified Licensed HVAC contractor

Implication(s): Equipment not operating properly | Hazardous combustion products entering home | Increased heating costs | Reduced comfort | Increased operating costs

Task: Correct

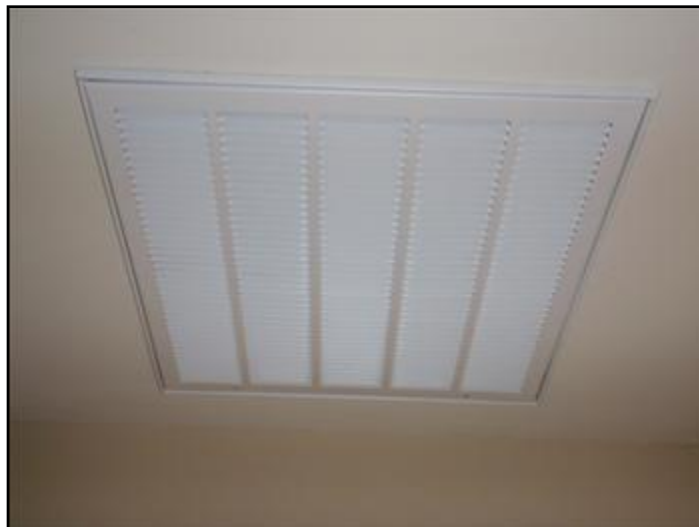
24. Condition: • [Dirty, obstructed or collapsed](#)

Task: Replace

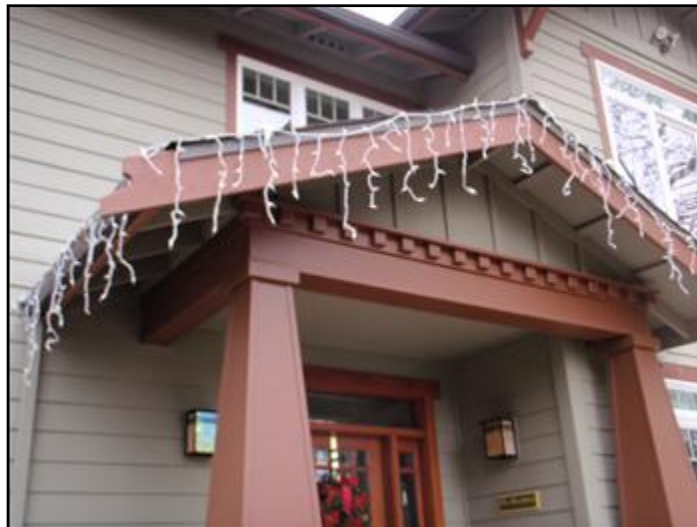
25. Condition: • [Inadequate attic venting](#)

There is no venting on entry porch roof. This may lead to moisture related issues.

Task: Correct

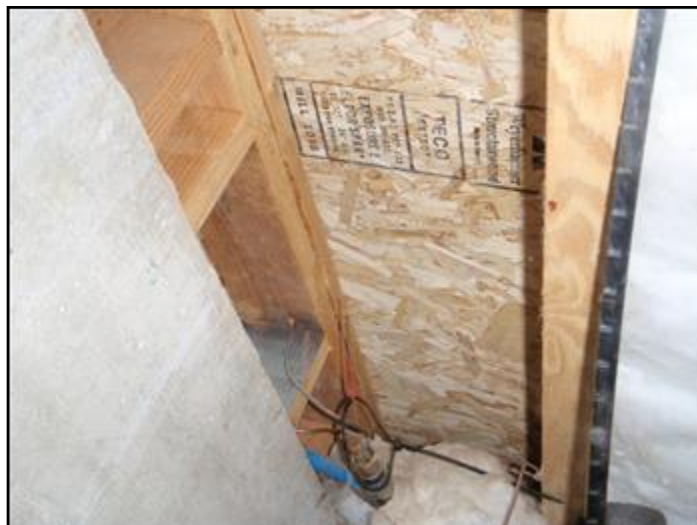
26. Condition: • [None](#)

Task: Improve

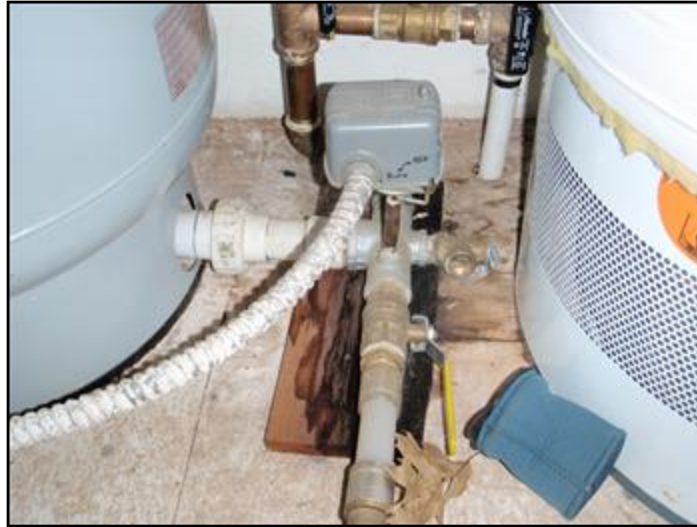
27. Condition: • [Leak](#)

Implication(s): Chance of water damage to contents, finishes and/or structure | Reduced system life expectancy | No domestic water

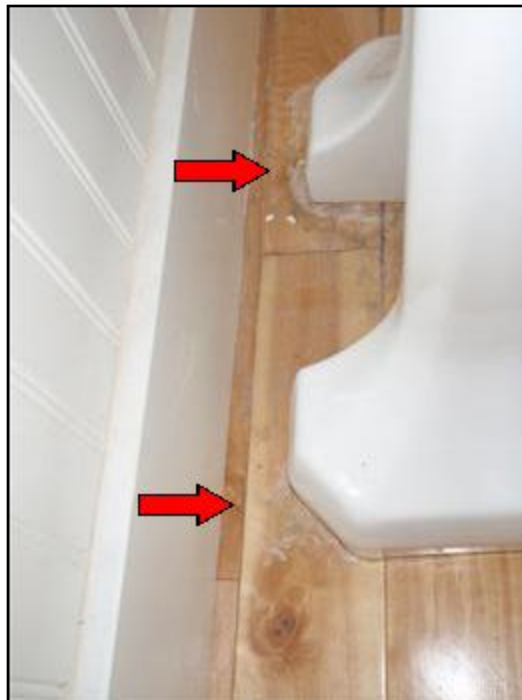
28. Condition: • [Leak](#)

Prior leak evidence.

Implication(s): Chance of water damage to contents, finishes and/or structure | System inoperative

Task: Monitor

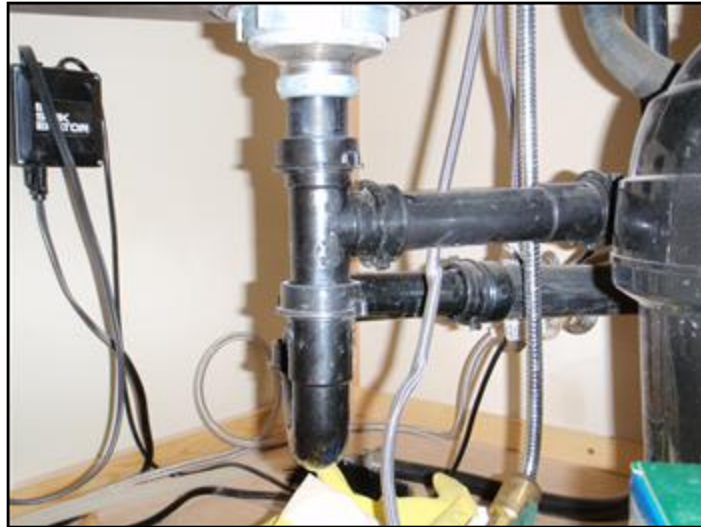
29. Condition: • [Leak](#)

Task: Correct

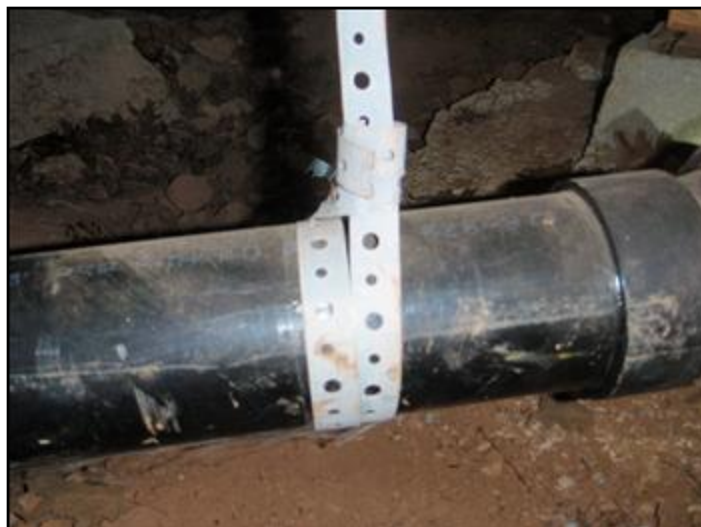
30. Condition: • [Poor support](#)

Waste lines have improper support. Support should restrict upward movement.

Implication(s): Chance of water damage to contents, finishes and/or structure | Sewage entering the house

Task: Improve

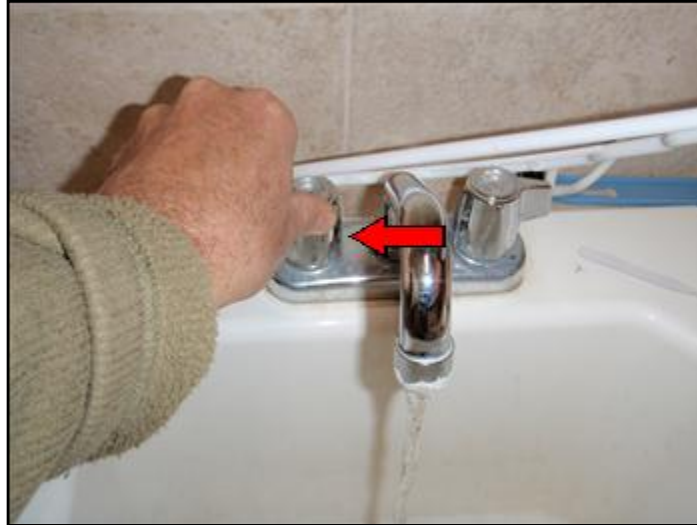
31. Condition: • [Drip, leak](#)

Leaks around the hot faucet

Implication(s): Chance of water damage to contents, finishes and/or structure

Task: Repair

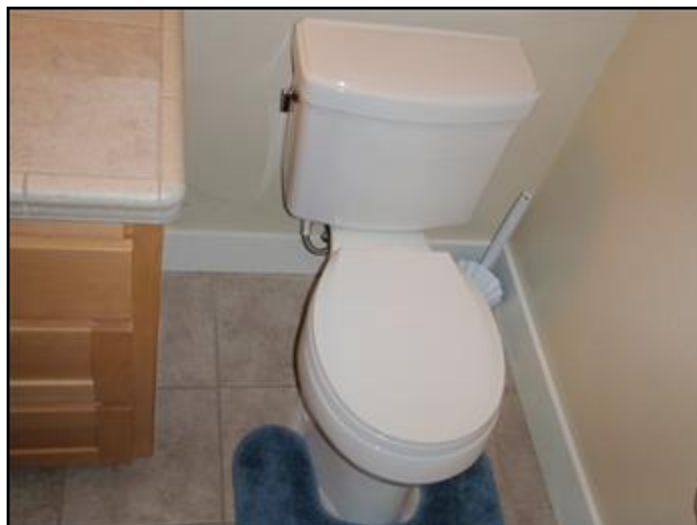
32. Condition: • Toilet loose on floor. Install new wax ring and tighten

Implication(s): Water damage to sub floor

Task: Correct

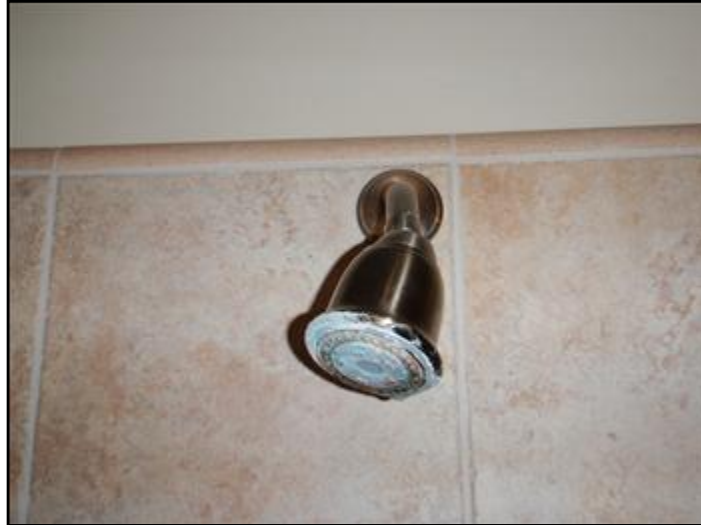
33. Condition: • [Leak](#)

Implication(s): Chance of water damage to contents, finishes and/or structure

Task: Correct

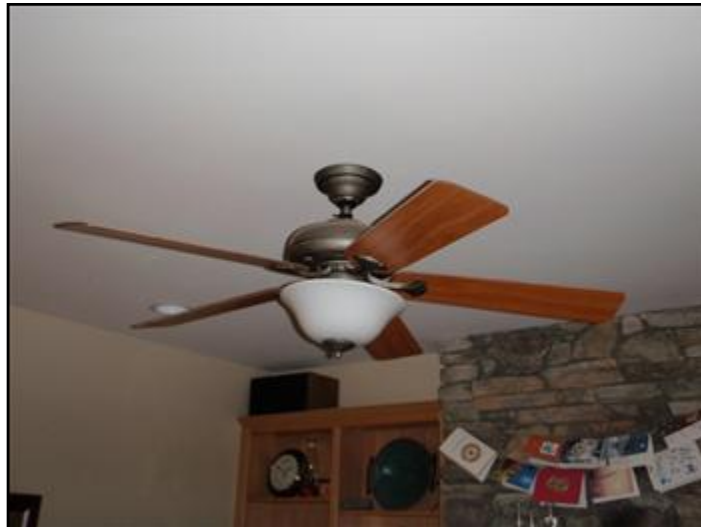
35. • Ceiling fan noisy, wobbles

Implication(s): Nuisance

Task: Monitor

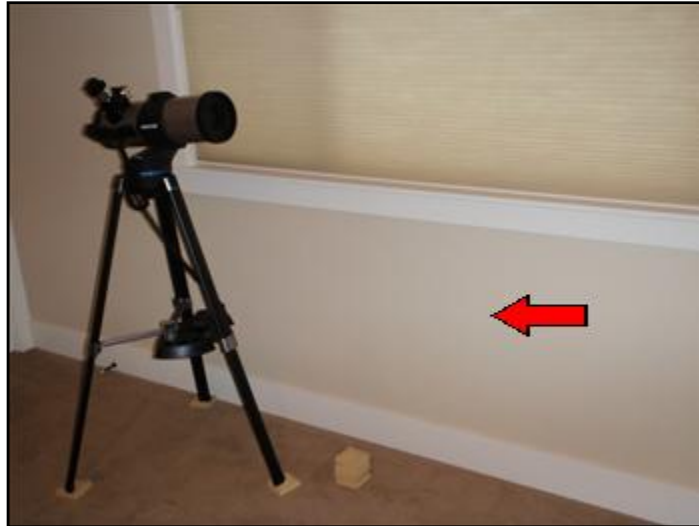
37. Condition: • [Cracked](#)

Typical shrinkage crack

Implication(s): Cosmetic defects

Location: Bonus room

Task: Monitor

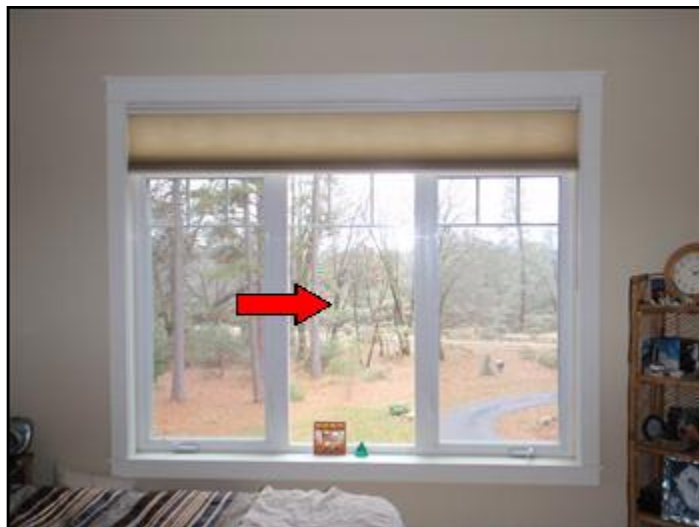
38. Condition: • [Lost seal on double or triple glazing](#)

Implication(s): Cosmetic defects

Task: Improve

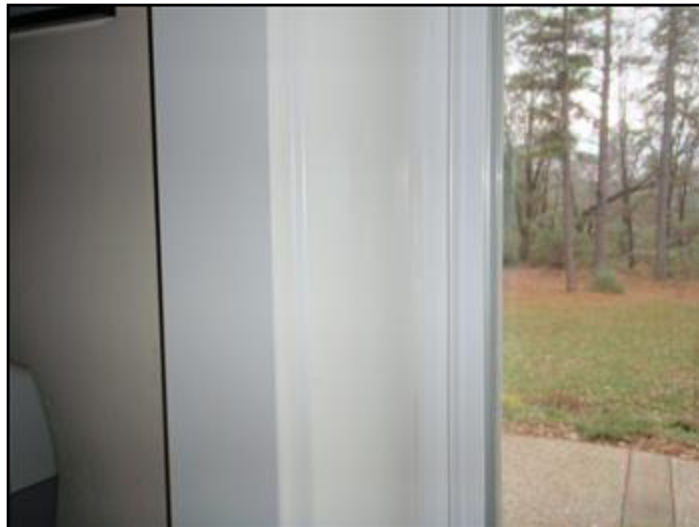
39. Condition: • Moisture intrusion evidence.

Implication(s): Possible hidden damage

Task: Monitor / Repair as necessary

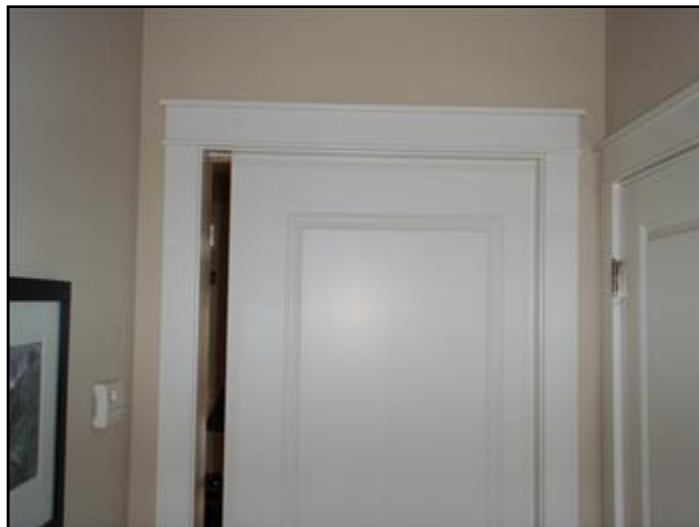
40. Condition: • [Stiff](#)

Task: Improve

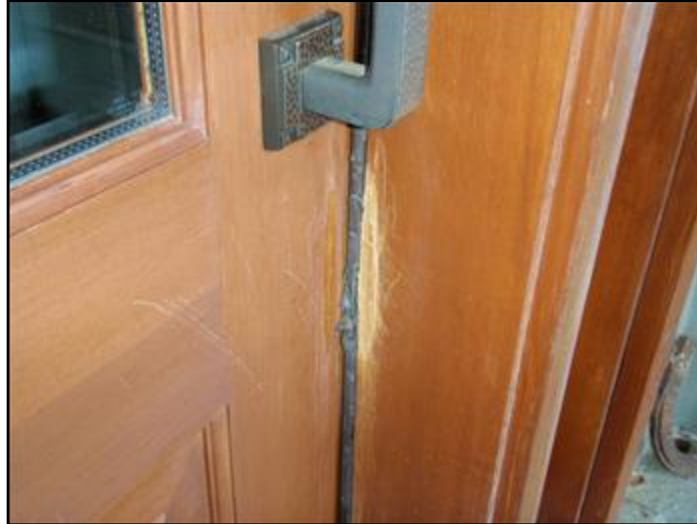
41. Condition: • [Weatherstripping missing or ineffective](#)

Task: Correct

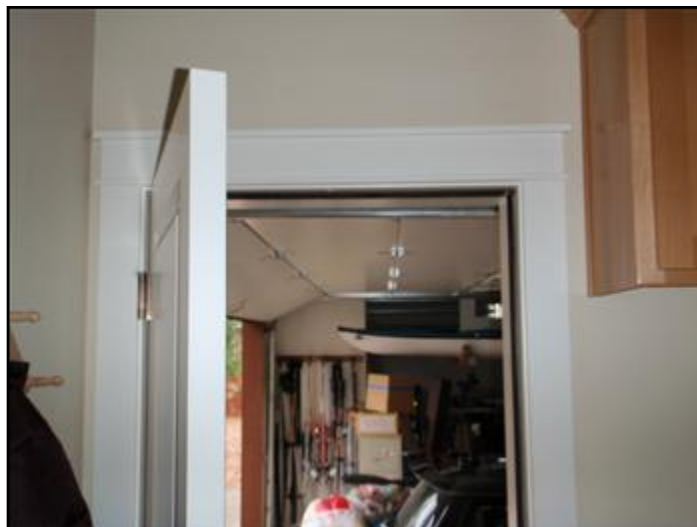
42. Condition: • [No self closer](#)

Implication(s): Hazardous combustion products entering home

Task: Correct

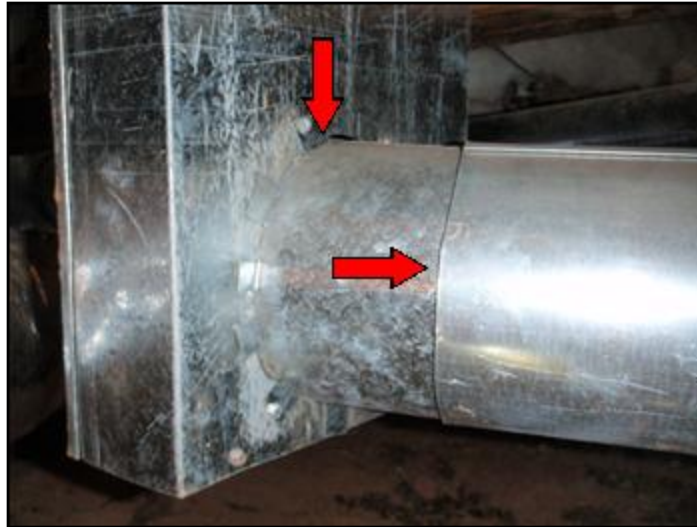
43. Condition: • Down draft vent in need of sealant

Implication(s): Air infiltration issues

Task: Correct
