Your Inspection Report

1625 2nd Street
Surrey, BC V3W 3E5

INSPECTION DATE:
Monday, December 1, 2008

Report No. 1008, v.3

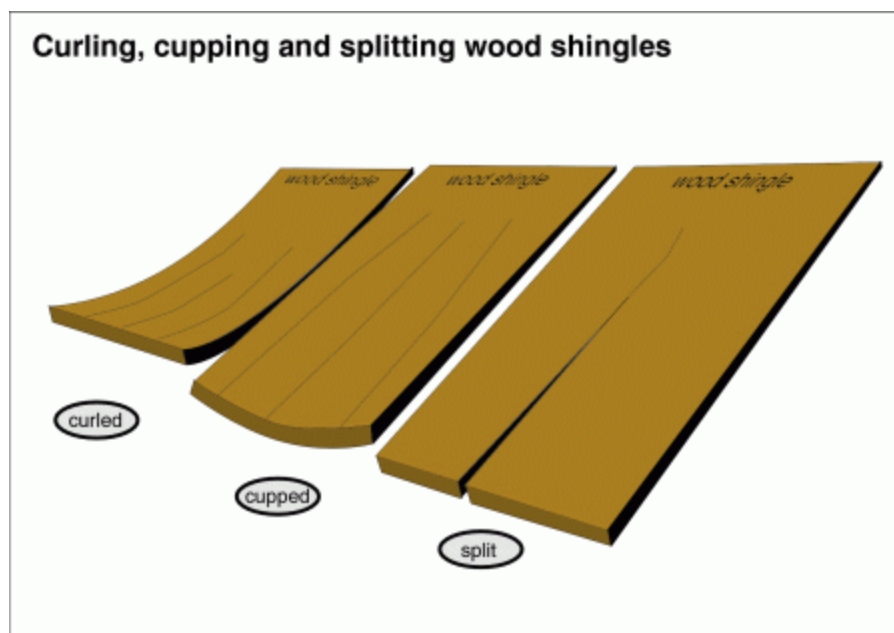
Condition: • [Cupping, curling](#)

Some cupping on wider shingles.

Implication(s): Chance of water damage to contents, finishes and/or structure

Location: Throughout Roof

Task: Monitor

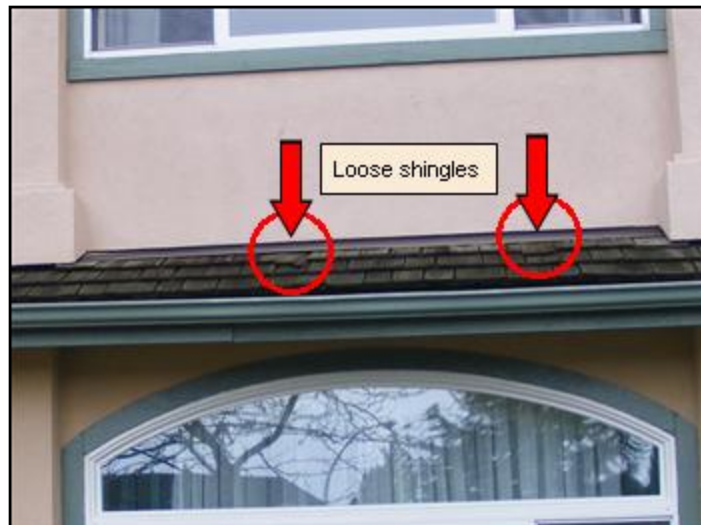
2.

Condition: • [Loose pieces](#)

Implication(s): Chance of water damage to contents, finishes and/or structure

Location: East

Task: Repair

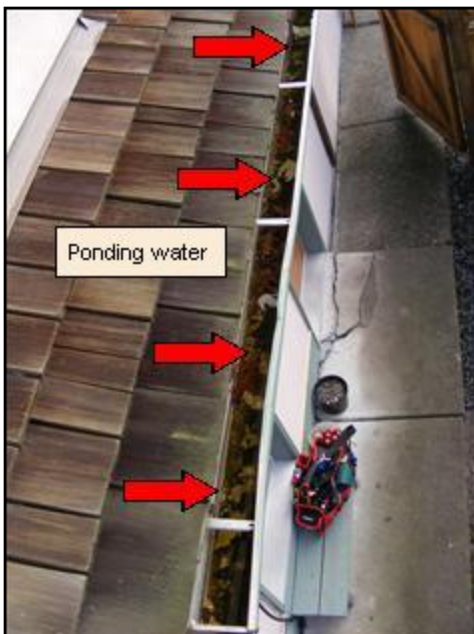
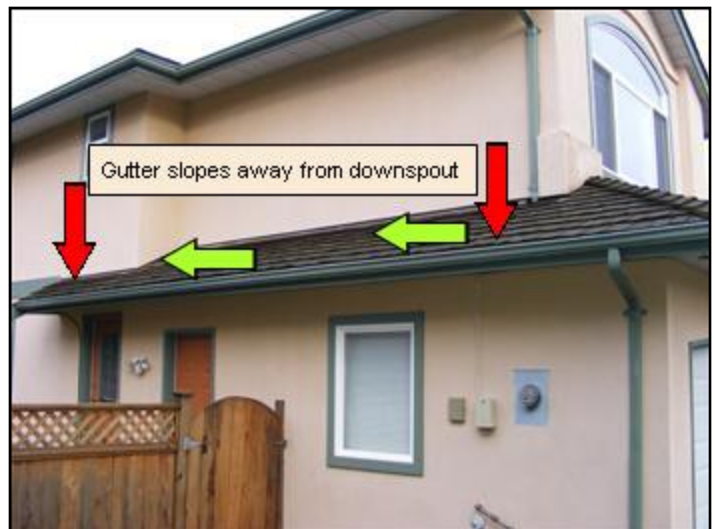
3.

Condition: • [Improper slope, ponding](#)

Implication(s): Chance of water damage to contents, finishes and/or structure

Location: South Exterior

Task: Further evaluation

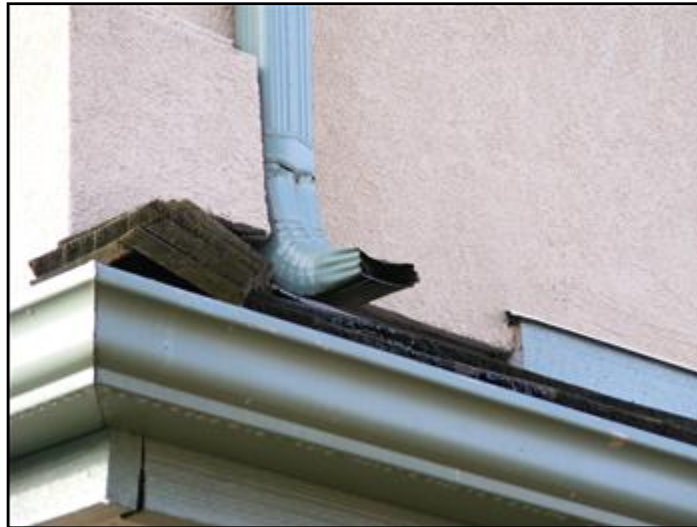
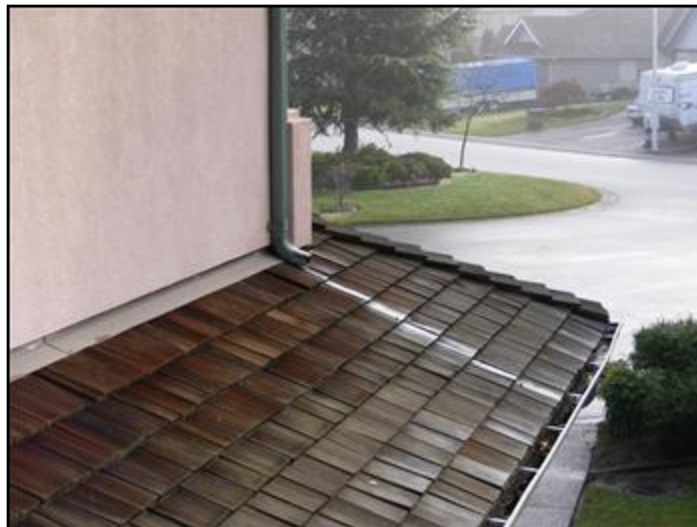
5.

Condition: • [Downspouts discharging onto roofs](#)

Implication(s): Chance of water damage to contents, finishes and/or structure

Location: Northeast Corner

Task: Improve

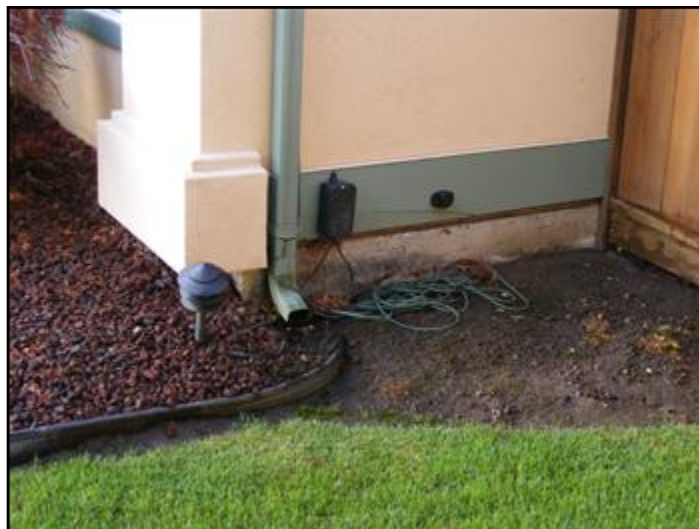
7.

Condition: • Should discharge 6ft. from home

Implication(s): Chance of water damage to contents, finishes and/or structure

Location: Northeast Corner

Task: Improve

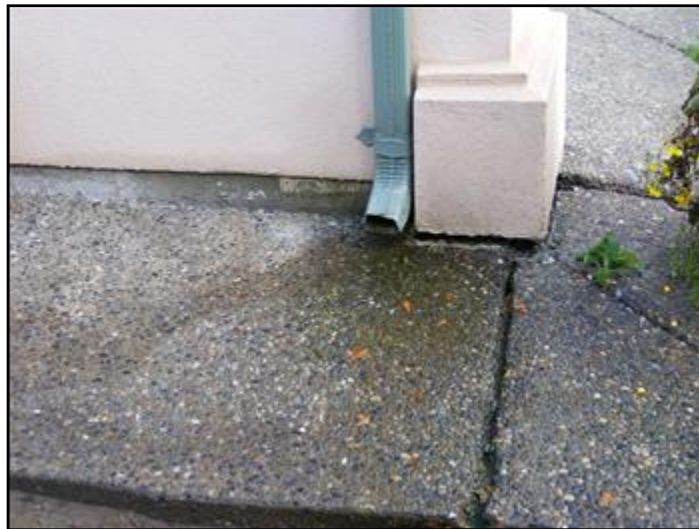
8.

Condition: • Should discharge 6ft. from home

Implication(s): Chance of water damage to contents, finishes and/or structure

Location: Southeast Corner

Task: Improve

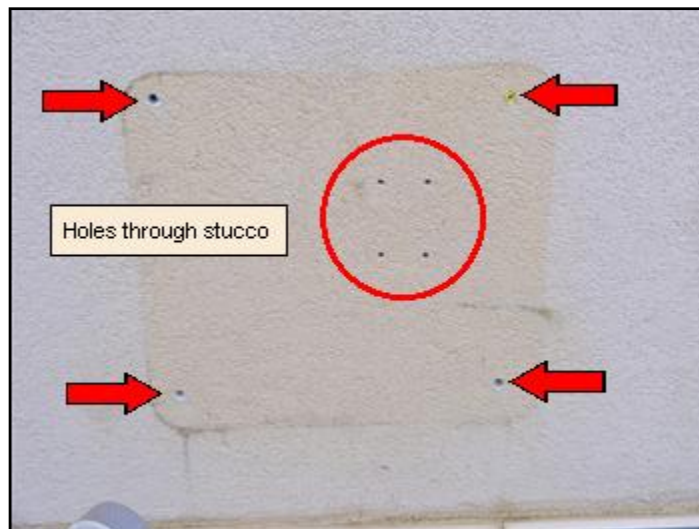
9.

Condition: • [Mechanical damage](#)

Holes should be filled to prevent water penetration behind stucco

Implication(s): Cosmetic defects | Chance of water damage to contents, finishes and/or structure | Material deterioration

Location: North Exterior Wall Kitchen

Task: Improve

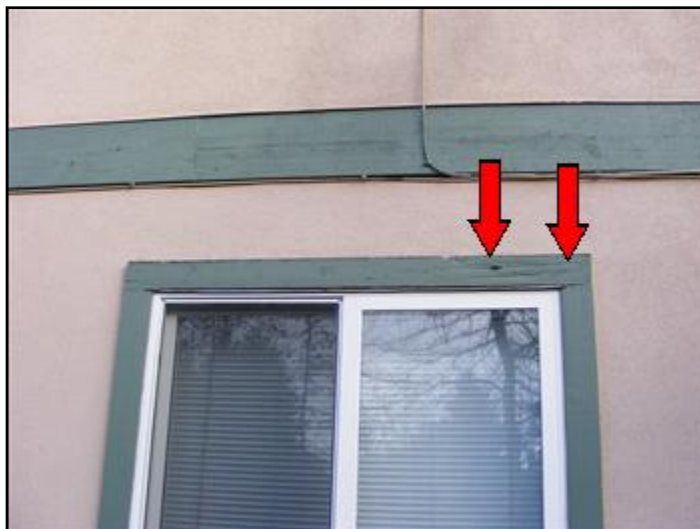
10.

Condition: • [Rot](#)

Implication(s): Cosmetic defects | Chance of water damage to contents, finishes and/or structure | Material deterioration

Location: South Exterior Wall

Task: Repair

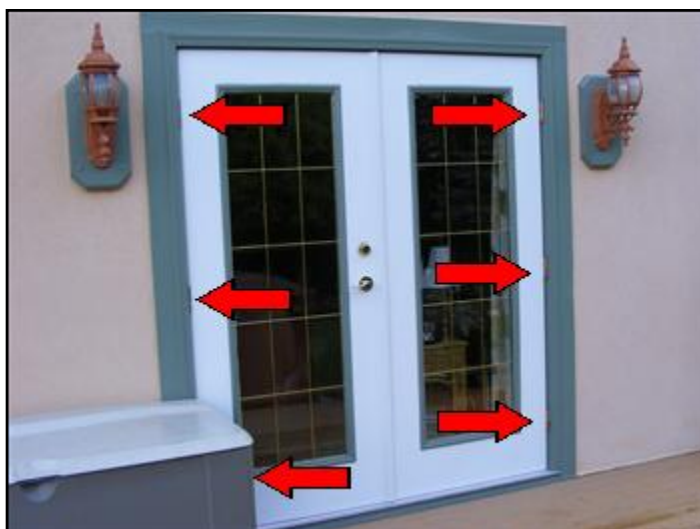
11.

Condition: • Hinge pins on exterior side of door

Implication(s): Security issue

Location: Rear Exterior Family Room

Task: Improve

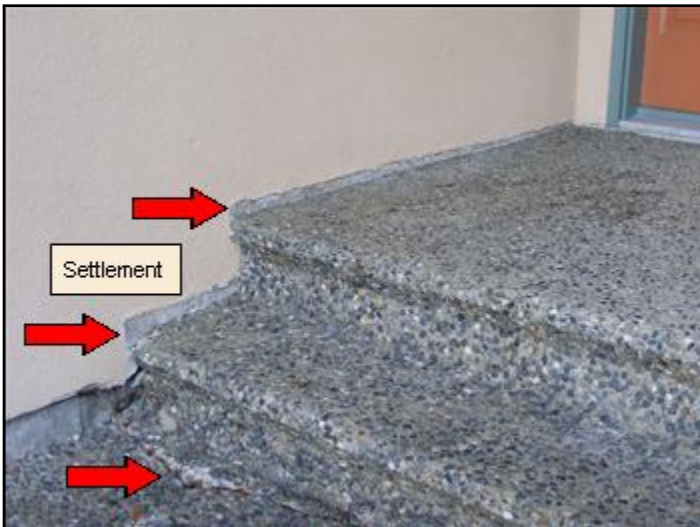
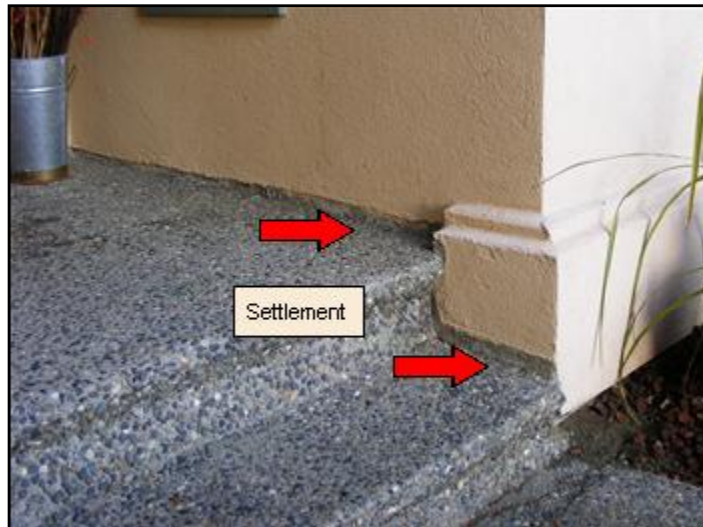
12.

Condition: • [Steps or landings settling or heaving](#)

Implication(s): Weakened structure | Trip or fall hazard

Location: Front Exterior

Task: Further evaluation

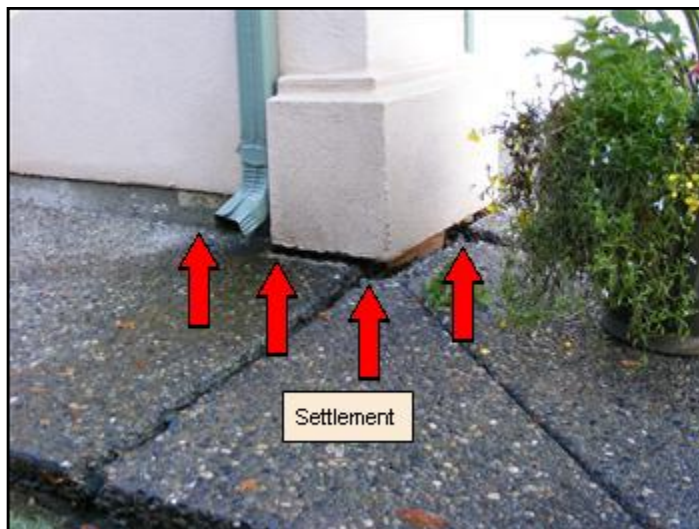
14.

Condition: • Walkway settlement

Implication(s): Water damage / trip hazard

Location: Southeast

Task: Further evaluation

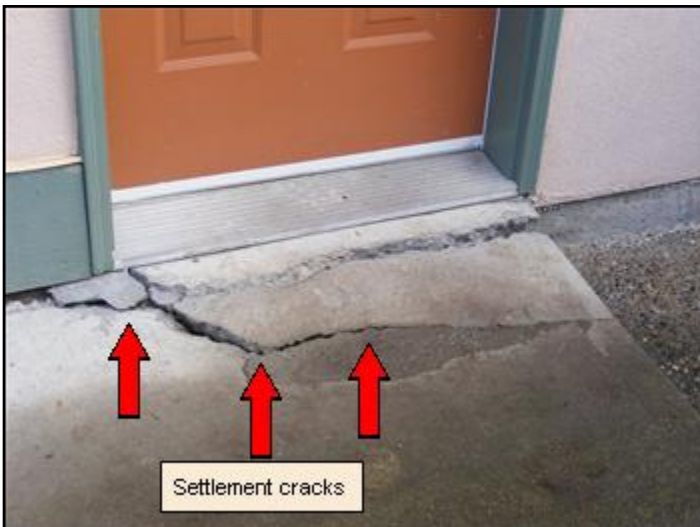
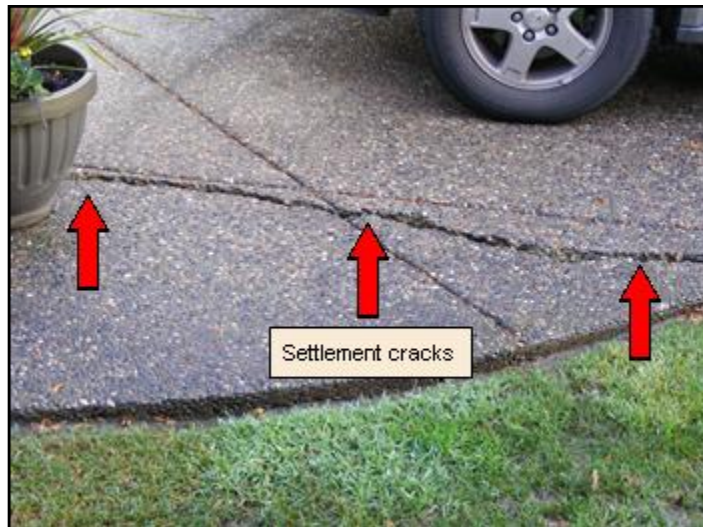
15.

Condition: • [Cracked or damaged surfaces](#)

Implication(s): Trip or fall hazard

Location: Southeast at garage

Task: Further evaluation

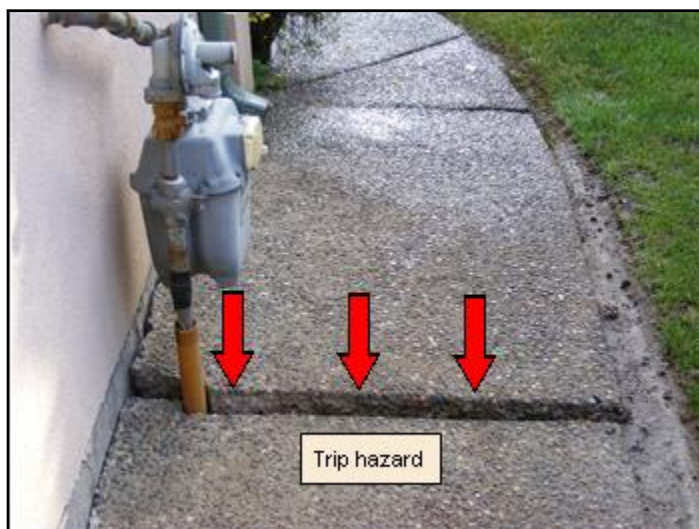
17.

Condition: • [Uneven \(trip hazard\)](#)

Implication(s): Physical injury

Location: Southeast Exterior Garage

Task: Improve

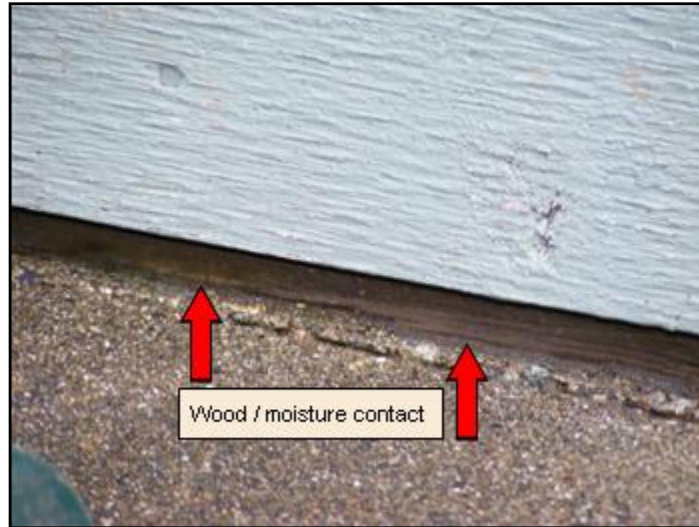
18.

Condition: • [Too close to grade or wood/soil contact](#)

Implication(s): Chance of water entering house | Weakened structure | Rot | Insect damage

Location: South Exterior

Task: Further evaluation

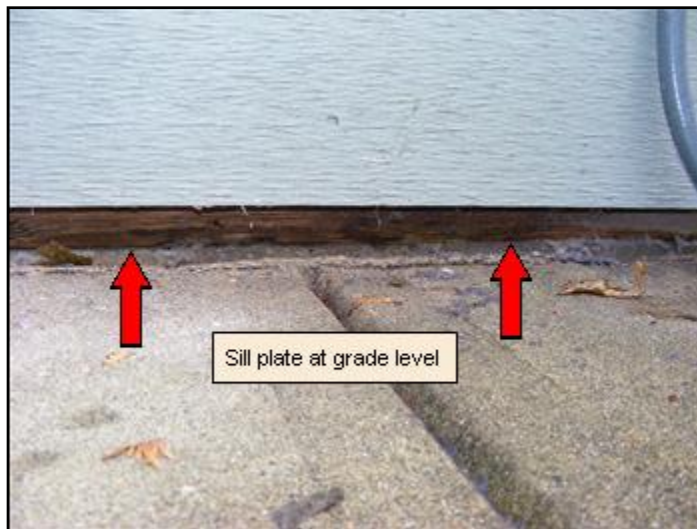
19.

Condition: • [Settled](#)

Implication(s): Chance of structural movement

Location: South Middle

Task: Further evaluation

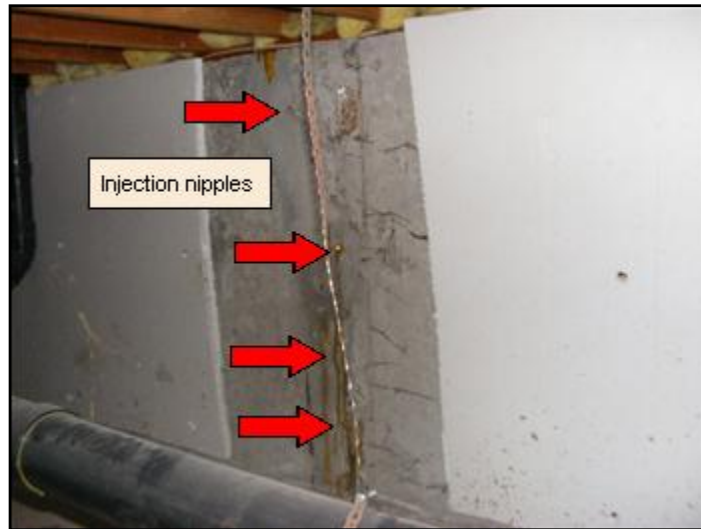
20.

Condition: • [Prior repairs](#)

No visible leakage at time of inspection

Implication(s): Weakened structure

Location: West Crawl Space

Task: Monitor

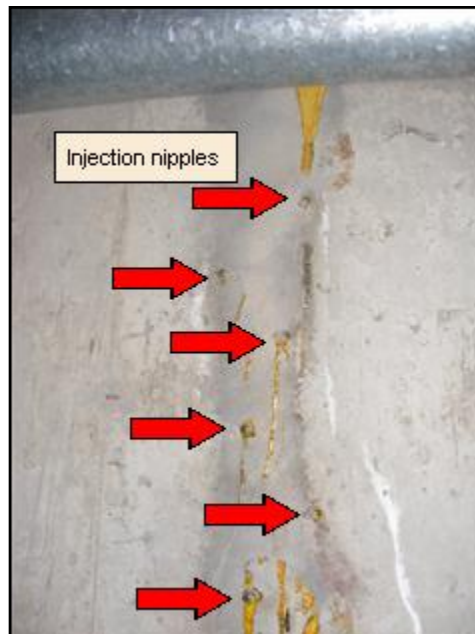
21.

Condition: • [Prior repairs](#)

No visible leakage at time of inspection

Implication(s): Weakened structure

Location: South Crawl Space

Task: Monitor

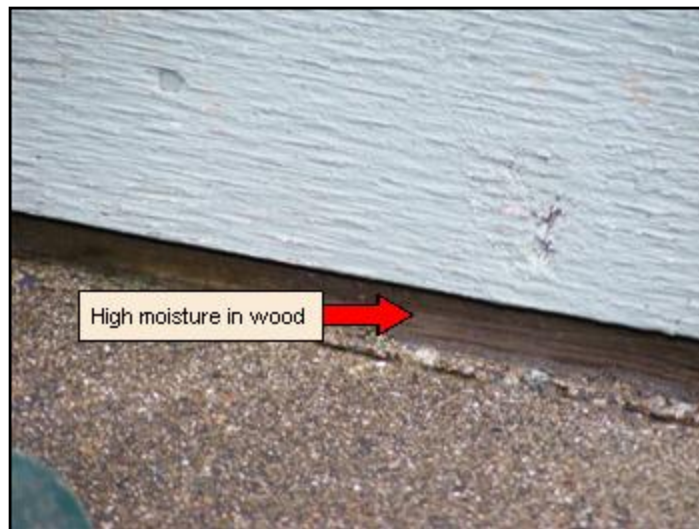
22.

Condition: • [Rot or insect damage](#)

Sill plate is at grade level due to foundation settlement.

Implication(s): Weakened structure

Location: South Middle

Task: Further evaluation

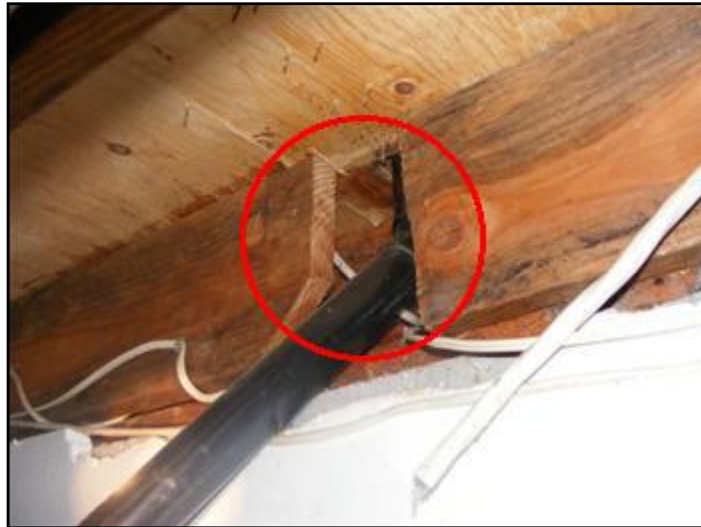
23.

Condition: • [Notches or holes](#)

Implication(s): Weakened structure

Location: Northwest Crawl Space

Task: Further evaluation

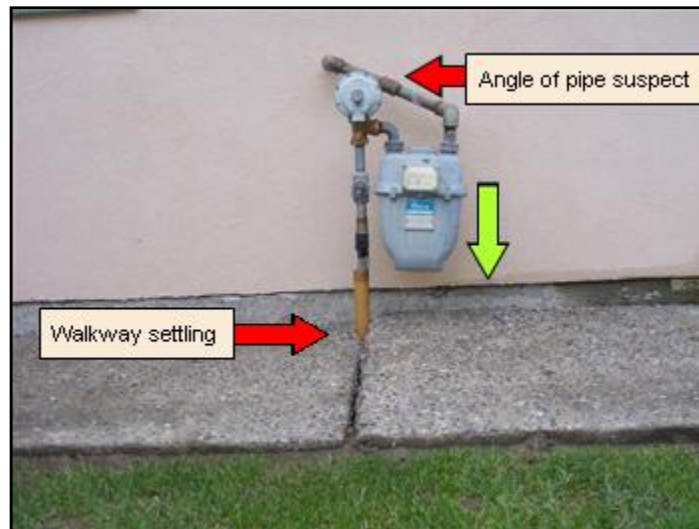
24.

Condition: • Dropping

Implication(s): Equipment not operating properly, Fire or explosion, Increased heating costs

Location: Southeast Exterior Wall

Task: Further evaluation

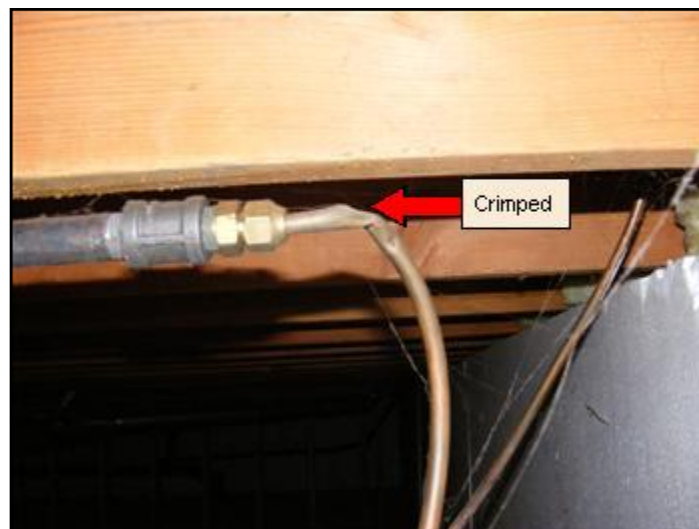
25.

Condition: • [Mechanical damage](#)

Implication(s): Fire or explosion

Location: Northeast Crawl Space

Task: Repair

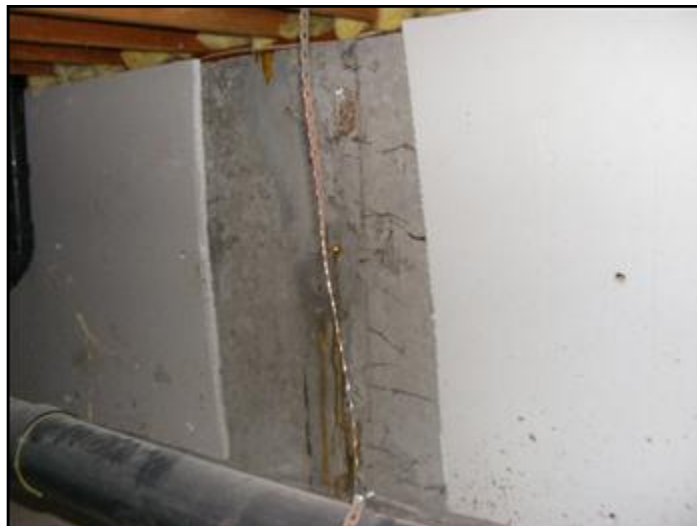
26.

Condition: • [Loose, sagging or voids](#)

Implication(s): Increased heating costs

Location: Crawl Space

Task: Improve

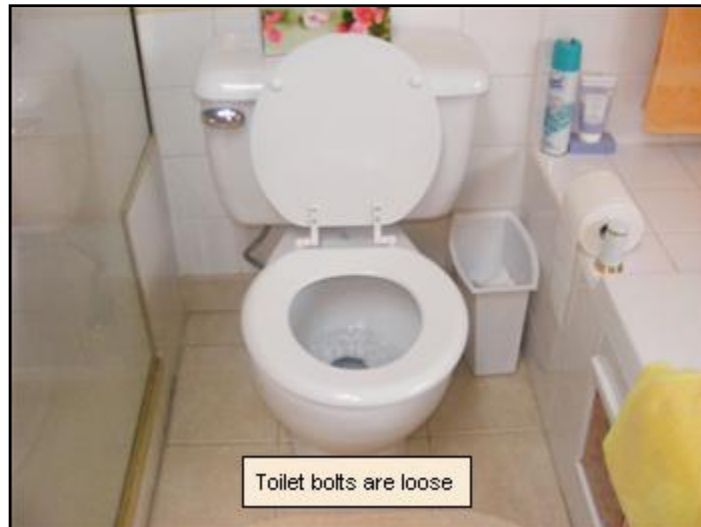
27.

Condition: • [Loose](#)

Implication(s): Chance of water damage to contents, finishes and/or structure | Sewage entering the house

Location: Second Floor Ensuite Bathroom

Task: Repair

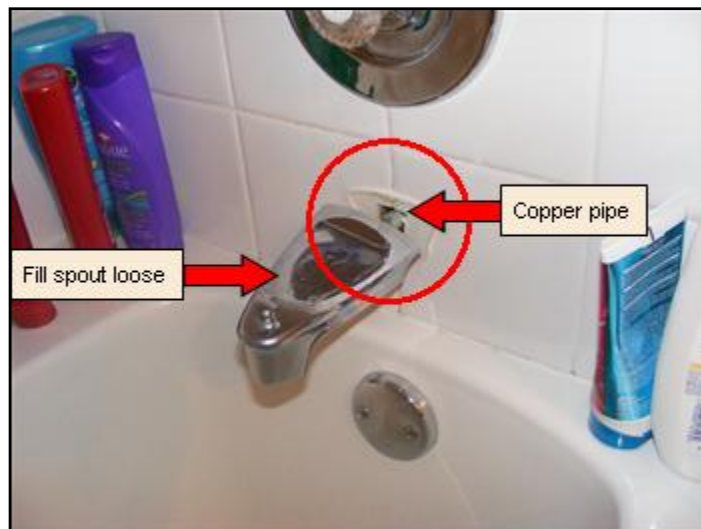
28.

Condition: • [Caulking loose, missing or deteriorated](#)

Possible water penetration around copper pipe

Implication(s): Chance of water damage to contents, finishes and/or structure

Location: Second Floor Bathroom

Task: Improve

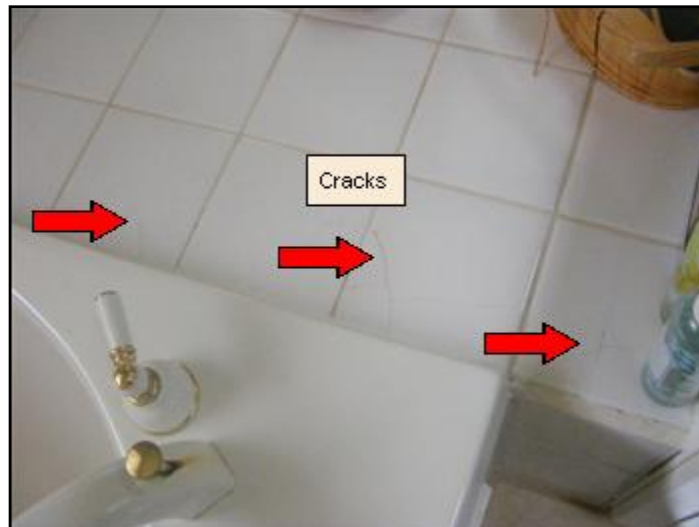
29.

Condition: • [Surface defects](#)

Implication(s): Cosmetic defects

Location: Second Floor Master Bathroom

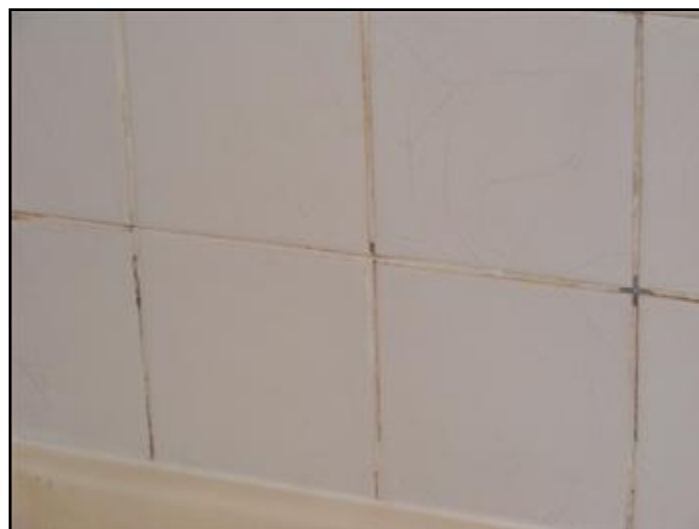
30.

Condition: • [Grout loose, missing or deteriorated](#)

Grout missing on lower portion of shower stall

Implication(s): Chance of water damage to contents, finishes and/or structure

Location: Ensuite Bathroom

Task: Correct

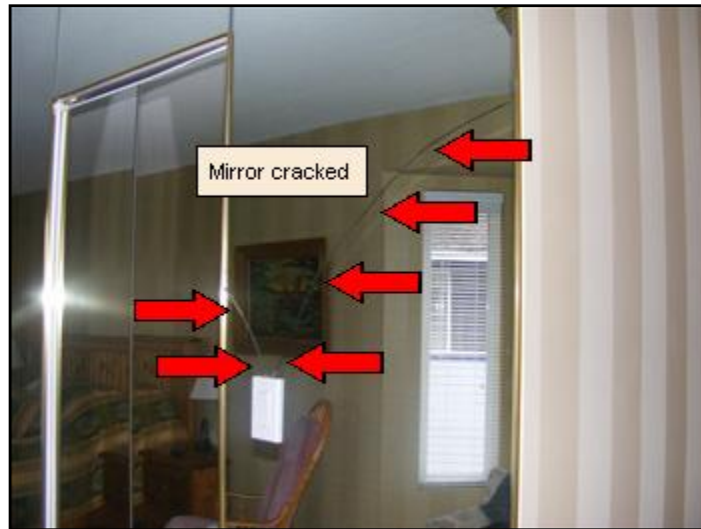
31.

Condition: • Damaged

Further evaluation needed to determine if arrangement is safe

Implication(s): Cosmetic defects

Location: Second Floor Master Bedroom

Task: Further evaluation

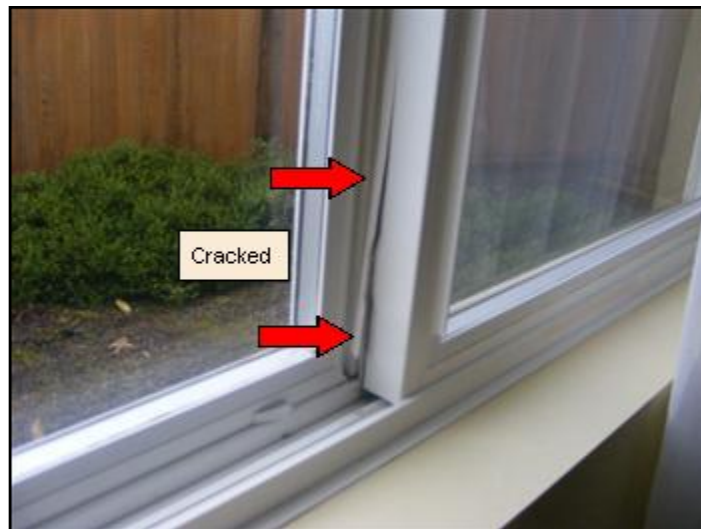
32.

Condition: • [Sash coming apart](#)

Implication(s): Chance of damage to finishes and structure | Glass breaking

Location: First Floor Dining Room

Task: Further evaluation

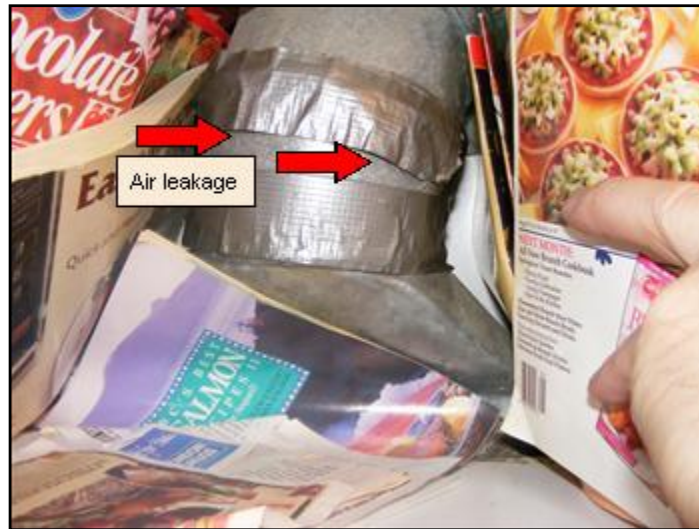
33.

Condition: • Leak in exhaust duct

Implication(s): Chance of condensation damage to finishes and/or structure

Location: Kitchen

Task: Improve
