# YOUR INSPECTION REPORT

1234 InterNACHI Certified  
Madera, CA

Wednesday, January 1, 2014

RE: Report No. 1072  
1234 InterNACHI Certified  
Madera, CA

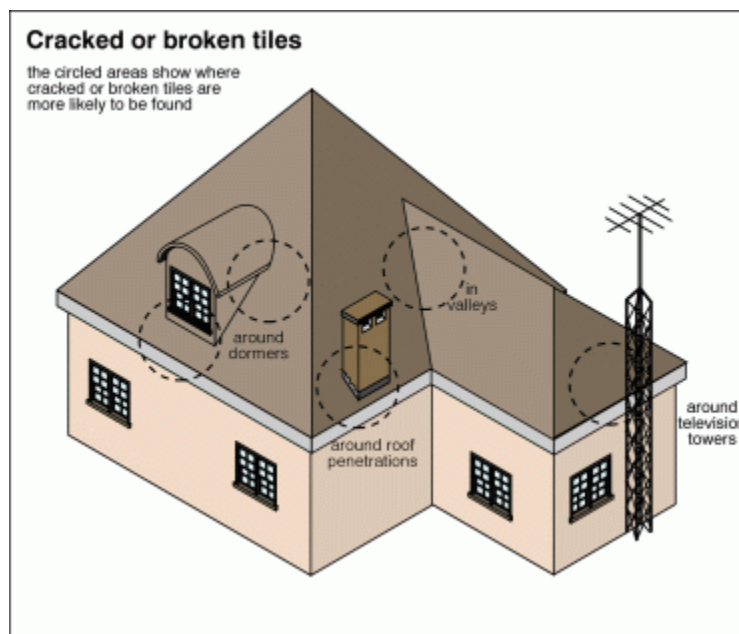
**Condition:** • [Missing, loose or broken pieces](#)

**Implication(s):** Chance of water damage to contents, finishes and/or structure | Damage or physical injury due to falling materials

**Location:** North Exterior Roof

**Task:** Repair or replace

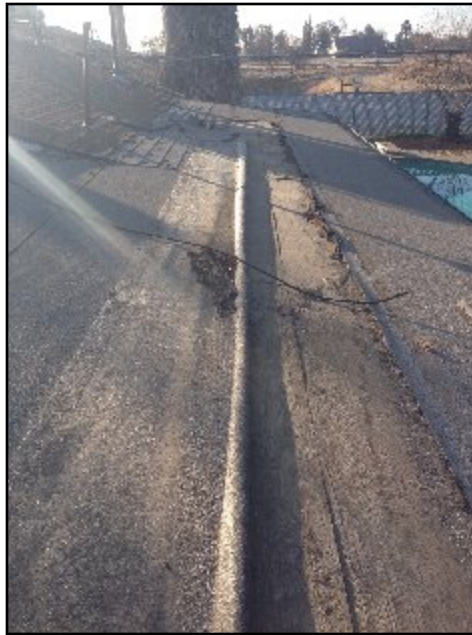
**Condition:** • [Damage, punctures, tears](#)

**Implication(s):** Chance of water damage to contents, finishes and/or structure

**Location:** Northeast Exterior

1. Damage, punctures, tears

**Task:** Repair or replace

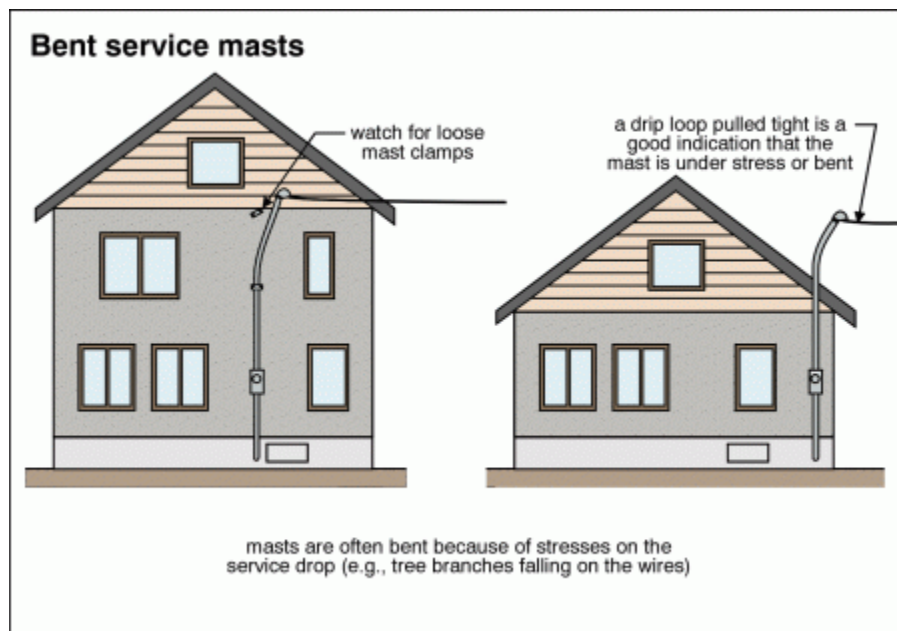
**Condition:** • [Mast bent](#)

**Implication(s):** Electric shock | Interruption of electrical service

**Location:** Southeast Exterior Roof

**Task:** Repair or replace

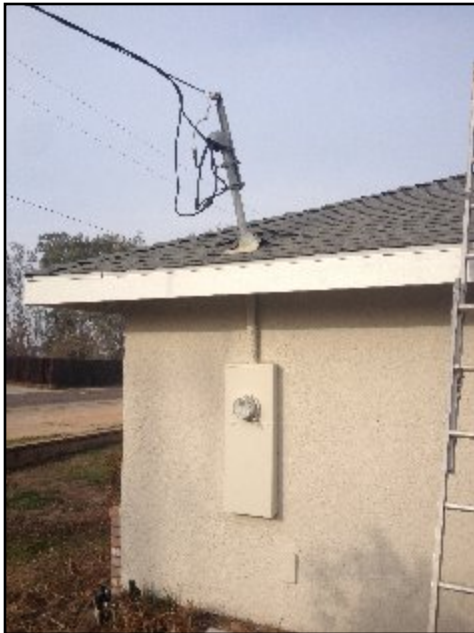
2. Mast bent

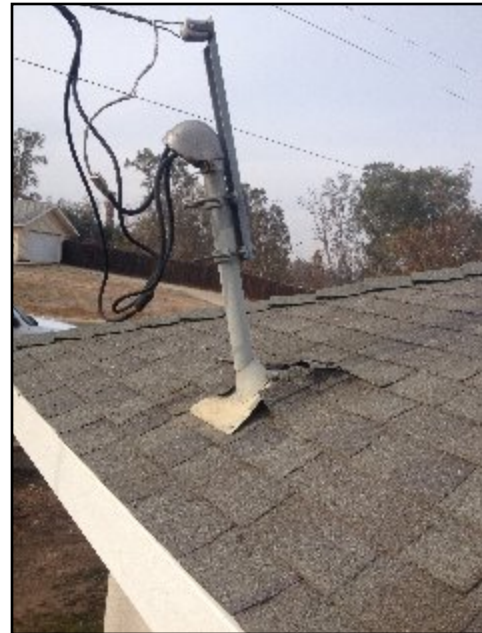
3. Mast bent

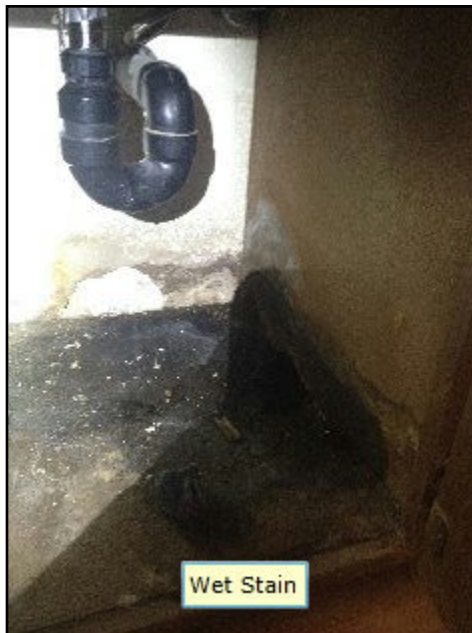
**Condition:** • [Water damage](#)

Dry / Wet stains throughout all water sink false bottom boards, shower floor pans, and around tub enclosures.

**Location:** East First Floor Kitchen Bathroom

4. Water damage

Recommend further evaluation by qualified termite contractor

**Task:** Repair or replace Further evaluation

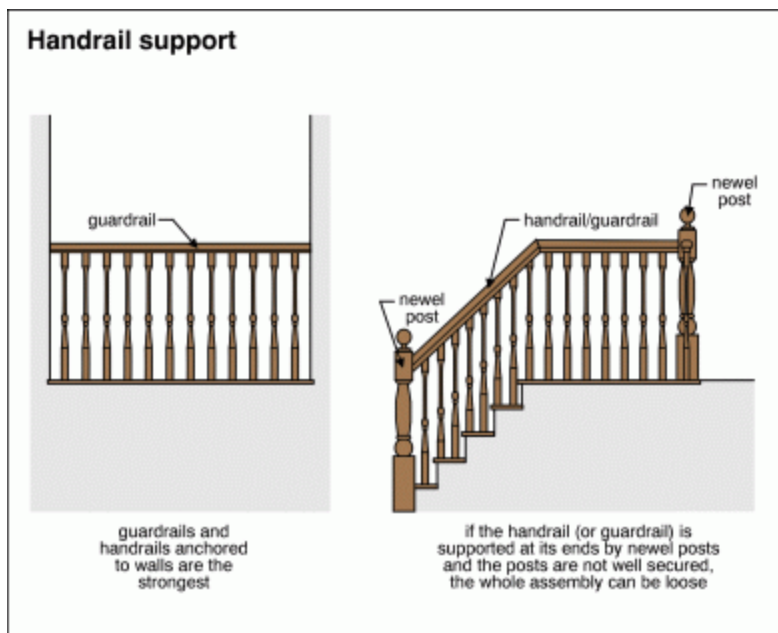
**Condition:** • [Loose](#)

**Implication(s):** Fall hazard

**Location:** Center First Floor Living Room

**Task:** Repair or replace

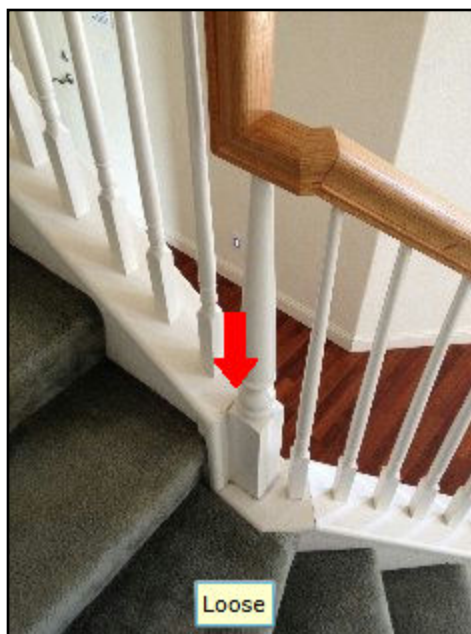
5. Loose

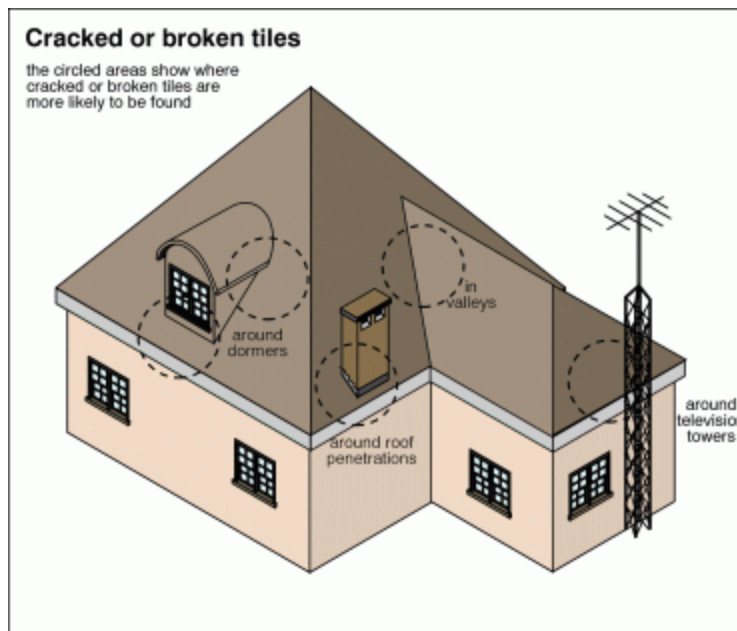
**1. Condition:** • [Missing, loose or broken pieces](#)

**Implication(s):** Chance of water damage to contents, finishes and/or structure | Damage or physical injury due to falling materials

**Location:** North Exterior Roof

**Task:** Repair or replace

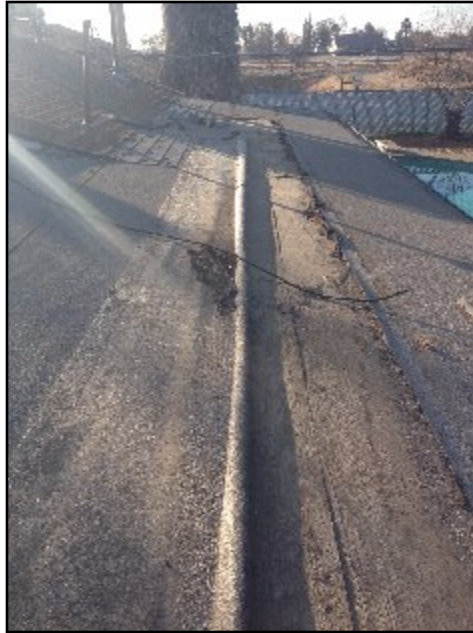
**2. Condition:** • [Damage, punctures, tears](#)

**Implication(s):** Chance of water damage to contents, finishes and/or structure

**Location:** Northeast Exterior

6. *Damage, punctures, tears*

**Task:** Repair or replace

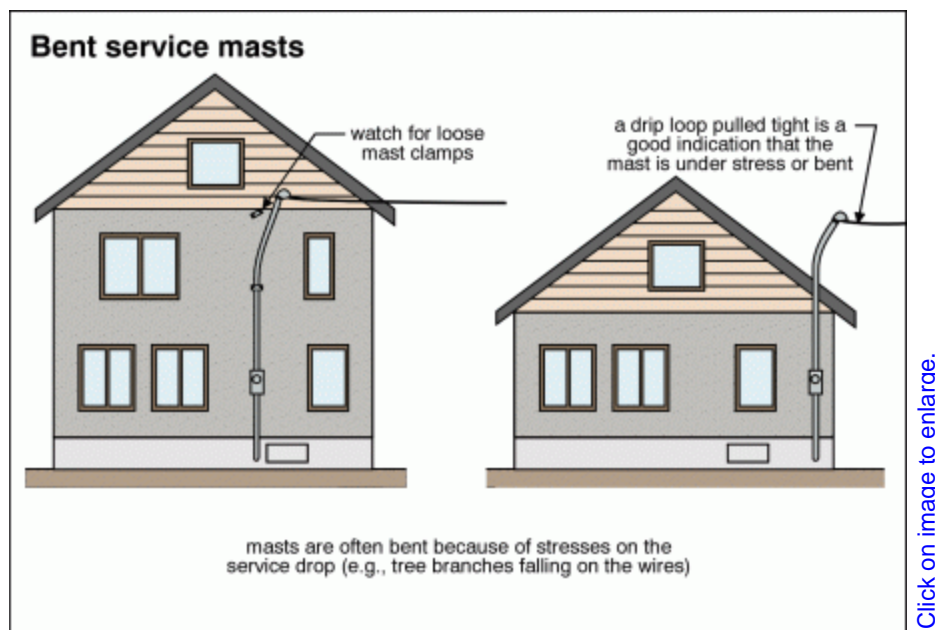
**3. Condition:** • [Mast bent](#)

**Implication(s):** Electric shock | Interruption of electrical service

**Location:** Southeast Exterior Roof

**Task:** Repair or replace

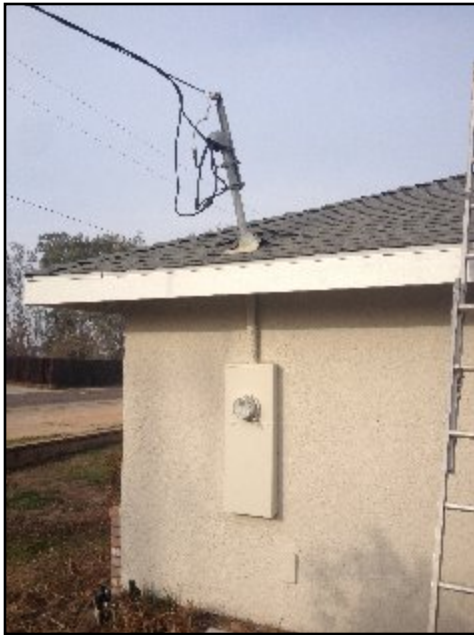
7. Mast bent

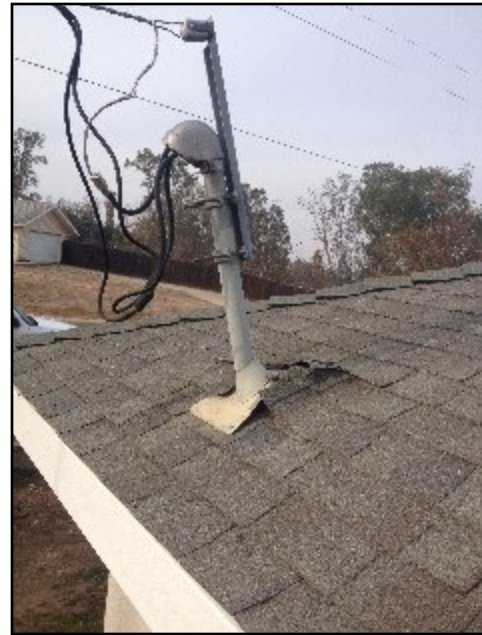
8. Mast bent

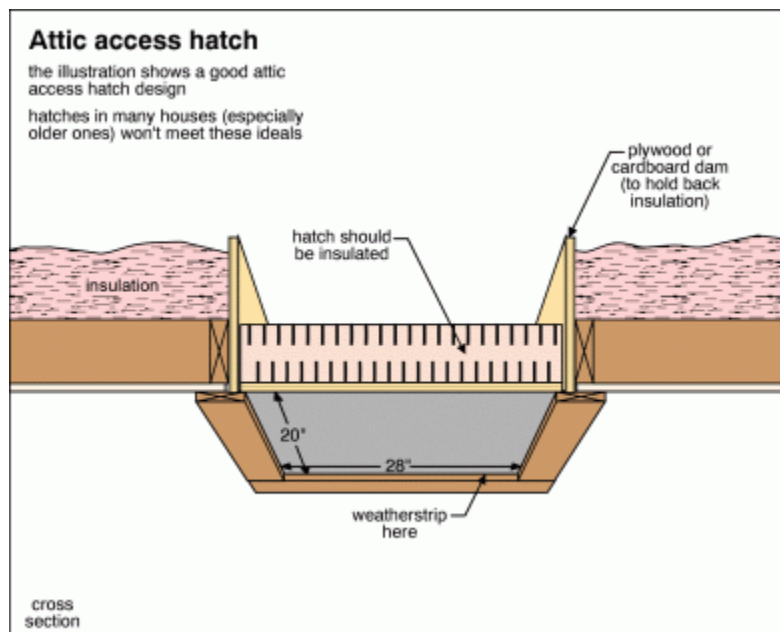
8. Condition: • [Not insulated](#)

Implication(s): Increased heating and cooling costs | Reduced comfort

Location: West First Floor Bedroom

Task: Improve

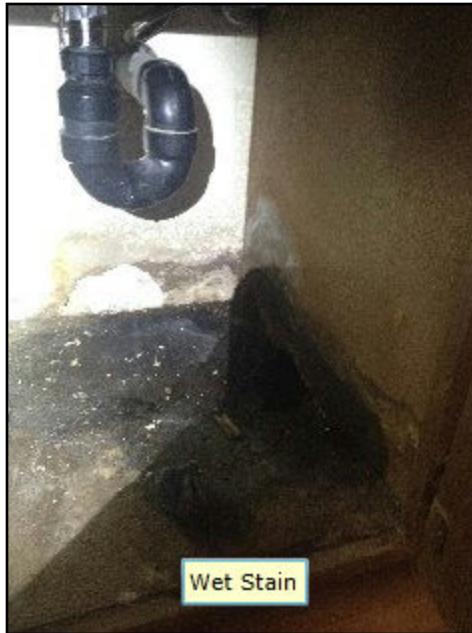
**11. Condition:** • [Water damage](#)

Dry / Wet stains throughout all water sink false bottom boards, shower floor pans, and around tub enclosures.

**Location:** East First Floor Kitchen Bathroom

9. Water damage

Recommend further evaluation by qualified termite contractor

**Task:** Repair or replace Further evaluation

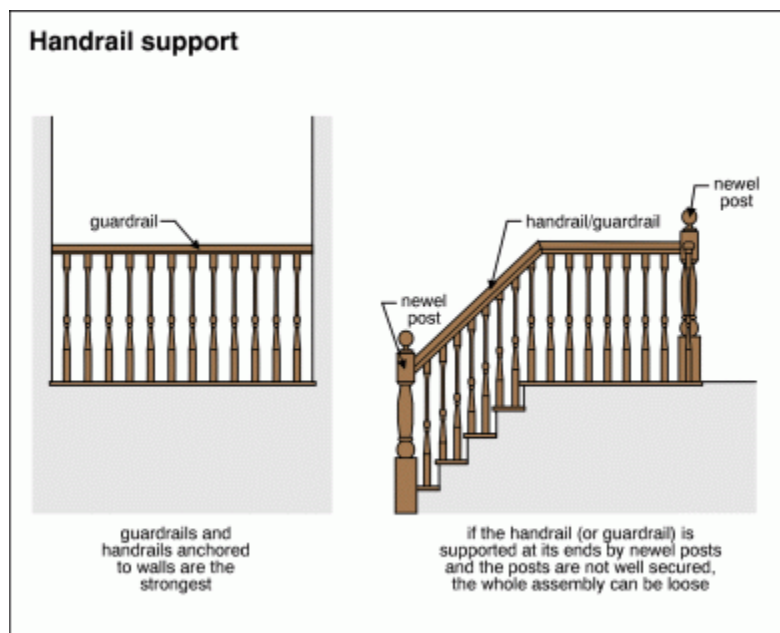
12. Condition: • [Loose](#)

Implication(s): Fall hazard

Location: Center First Floor Living Room

Task: Repair or replace

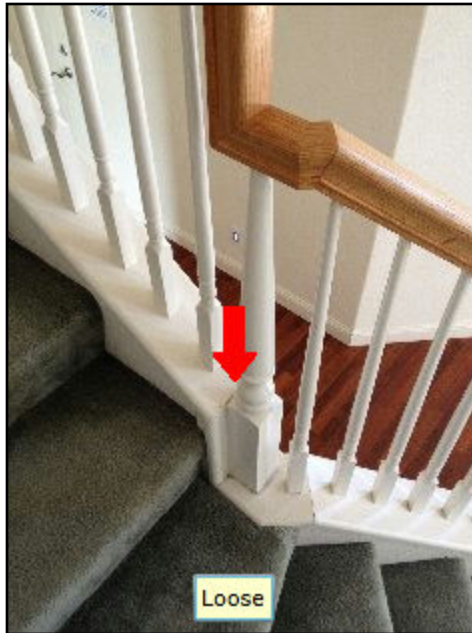
10. Loose

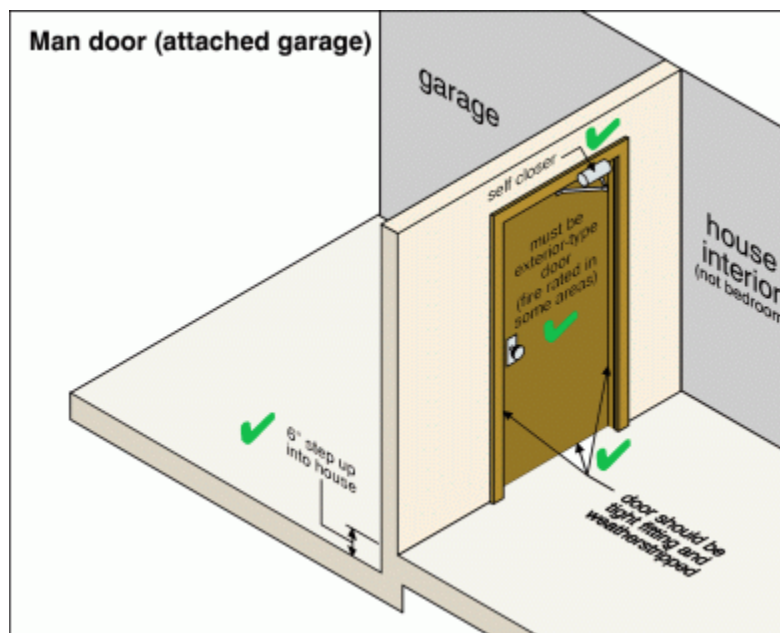
13. Condition: • [No self closer](#)

Implication(s): Hazardous combustion products entering home

Location: North First Floor Kitchen

Task: Provide
