Your Inspection Report

22 Strickland Ave Toronto, ON

INSPECTION DATE: Tuesday, November 10, 2015

RE: Report No. 50998 22 Strickland Ave Toronto, ON

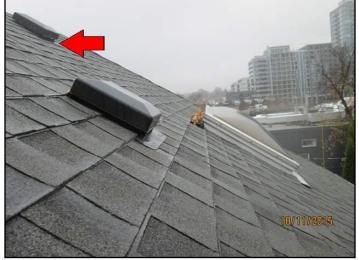
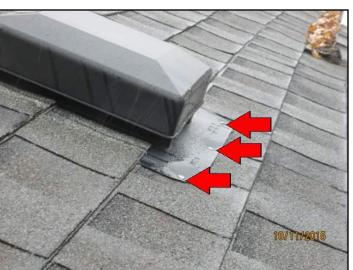
Condition: • <u>Nail Heads - exposed (risk of leak)</u> Location: Roof Task: Improve Time: Less than 1 year Cost: Minor

Nail Heads - exposed (risk of leak)

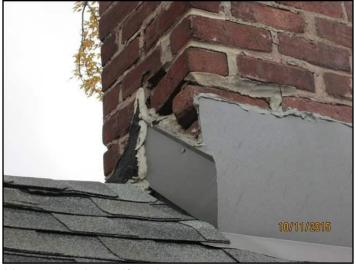
Nail Heads - exposed (risk of leak) CHIMNEY \ Observations Condition: • Mortar - deteriorated/missing Location: Exterior Roof Task: Repair Time: Less than 1 year Cost: Regular maintenance item

Mortar - deteriorated/missing

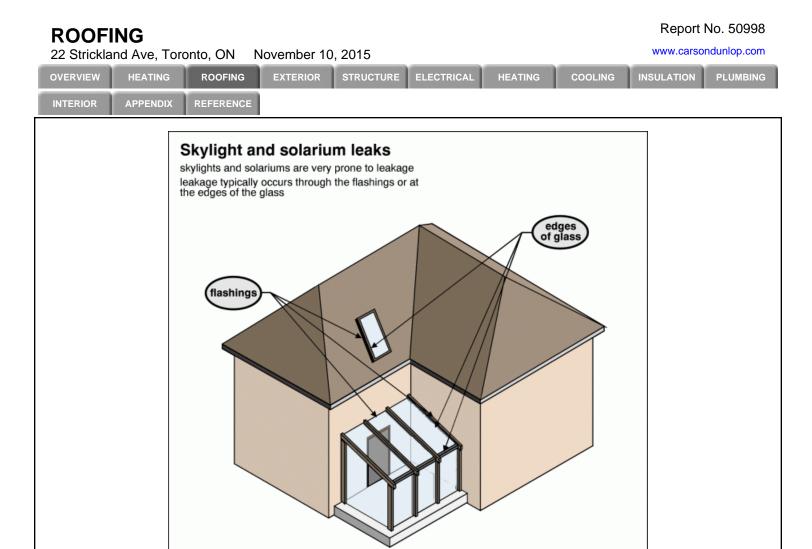
VULNERABLE AREAS \ Observations Condition: • Skylight(s) - vulnerable area for leaks Location: Roof Task: Monitor Time: Ongoing Cost: Regular maintenance item

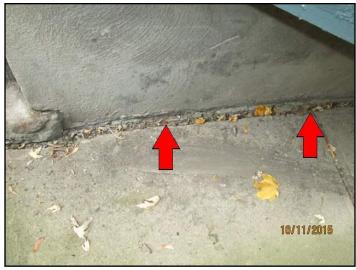
Condition: • <u>Gap at house</u> Location: Left Side Exterior Task: Improve Time: Regular maintenance Cost: Regular maintenance item

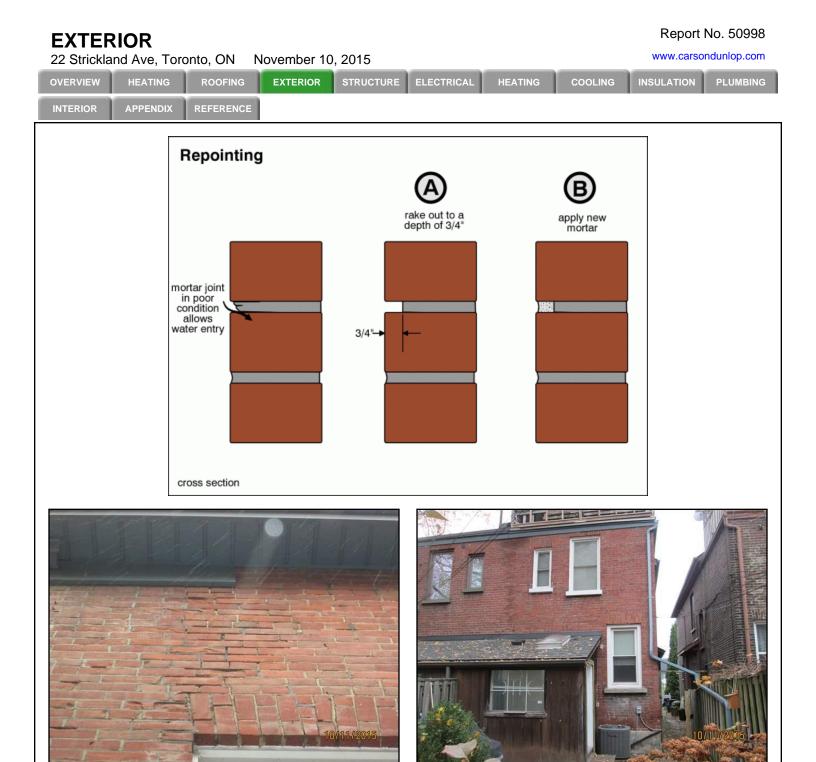
Condition: • Mortar deteriorated/missing

Tuck pointing needed at various areas of the exterior walls. Most homes of this age need regular maintenance of exterior brickwork. Overall, the brickwork appears in good condition for the age of the home. Repointing:

Mortar deteriorated/missing

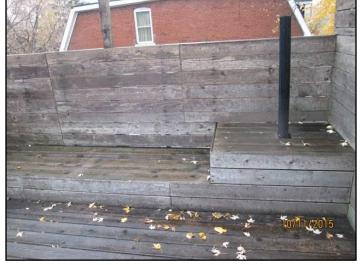
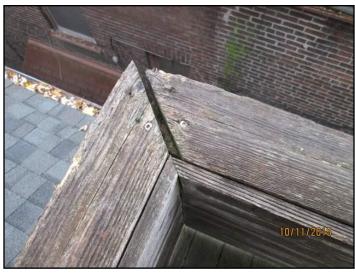
Condition: • Not well secured

Not well secured

Cost: Consult with deck specialist

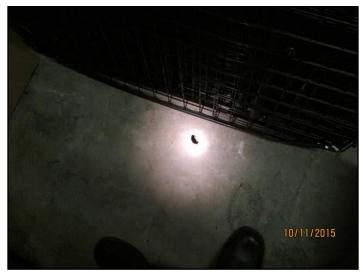
Condition: • Concrete basement, crawlspace and garage floors are not typically part of the structure. Almost all basement, crawlspace and garage concrete floors have minor shrinkage and settlement cracks. Also, we noted hollow areas below areas of the concrete slab.

Task: Monitor/Repair Time: As Needed

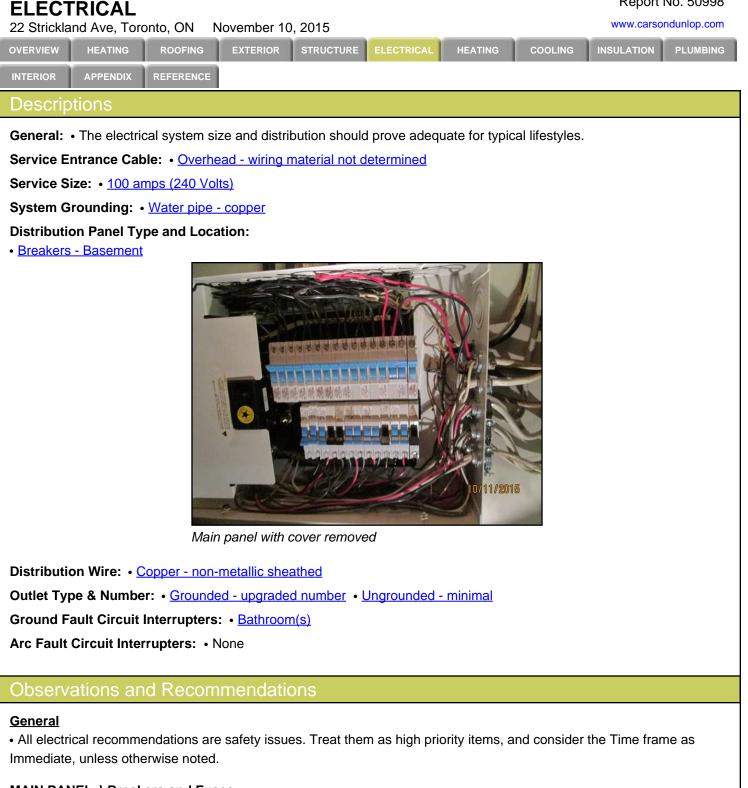
Condition: • Link - missing on multiwire circuit Location: Basement Panel Task: Correct Time: Immediate Cost: Minor

Link - missing on multiwire circuit

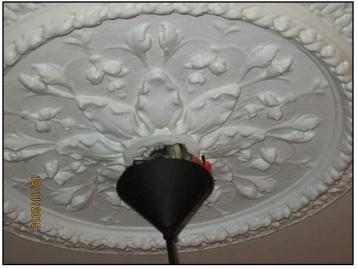
Condition: • Exposed wiring Location: First Floor Task: Correct Time: Immediate Cost: Minor

Exposed wiring

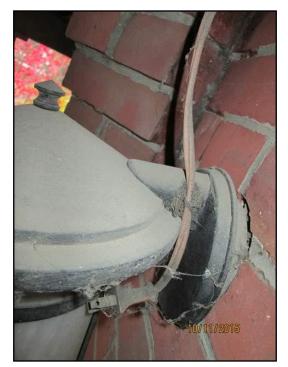
Condition: • Loose Location: Front Exterior Wall

Task: Correct

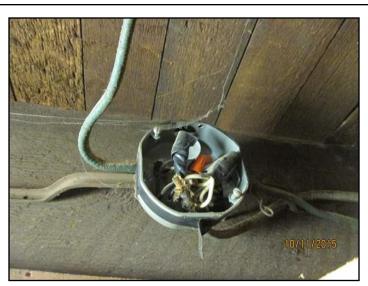
Condition: • <u>Cover Plate(s) - missing</u> Location: Various Basement Task: Correct Time: Immediate Cost: Minor

Cover Plate(s) - missing

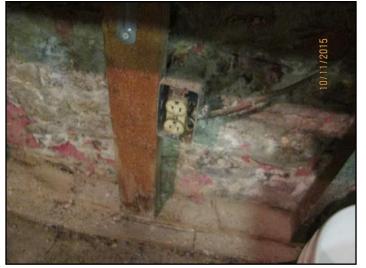
Cover Plate(s) - missing COVER PLATES \ Observations Condition: • Missing Location: Various Basement Task: Provide Time: Immediate Cost: Minor

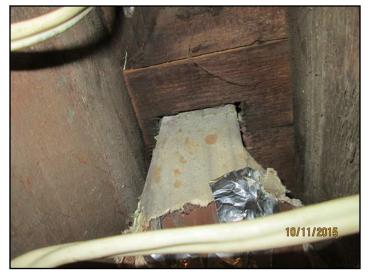
Condition: • Insulation on or above the ducts may contain asbestos. Health Canada recommends the insulation be left in place undisturbed unless there is a risk of asbestos fibers being released into the house air. If this is a concern, a specialist should be consulted. If the insulation is damaged or is to be disturbed, and if it contains asbestos (confirm with Laboratory test), precautions should be taken that asbestos fibers are not released into the house air.

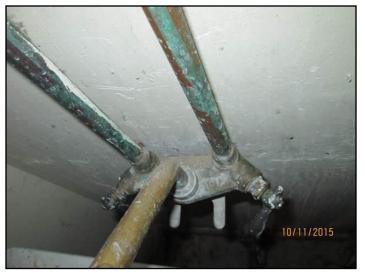
Condition: • Support inadequate Location: Basement Laundry Area Task: Improve Time: Less than 1 year **Cost**: Regular maintenance item

Support inadequate

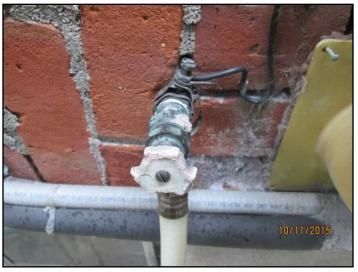
Condition: • <u>Handle - damage / missing</u> Location: Left Side Exterior Task: Replace Time: Regular maintenance Cost: Minor

Handle - damage / missing

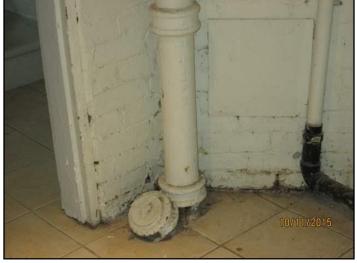
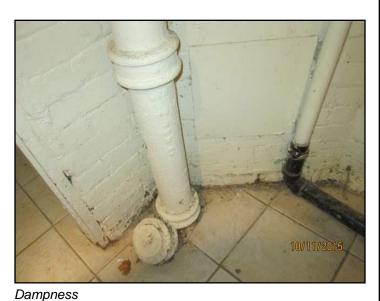
Dampness Location: Basement Laundry Room Task: Monitor / Improve

Dampness

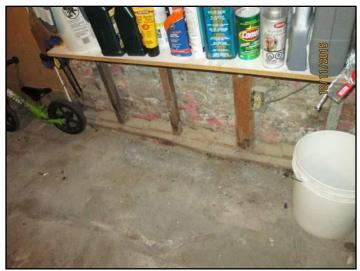
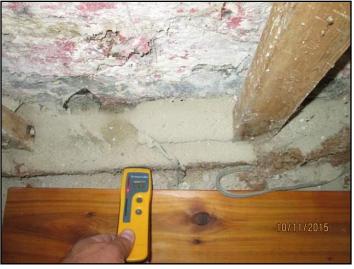
We noted dampness along the left side basement wall. Stone foundations are porous and are typically more damp than other foundation materials. Basement dampness is common with homes of this age. Follow exterior recommendation in the report. Also, you may consider parging the interior basement with a breathable portland cement. Consult with a masonry specialist familiar with stone foundations.

Dampness

Location: Left Side Basement Task: Monitor / Parge Time: Ongoing / if desired
