# INSPECTION REPORT

For the Property at:  
**6266 PARK RIDGE DRIVE**  
PARK CITY , UT

Prepared for: BUTCH CASSIDY  
Inspection Date: Friday, May 4, 2007  
Prepared by: Matthew Stouffer

RE: Report No. 1044, v.9  
6266 Park Ridge Drive  
Park City , UT  
84098

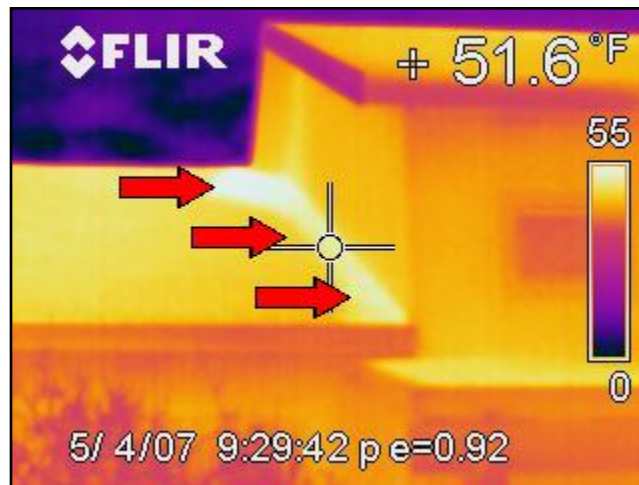
- ITEM 1. Missing insulation was detected along the South roof wall intersection.

1. Poor insulation along roof wall intersection

**Task:** Poor insulation

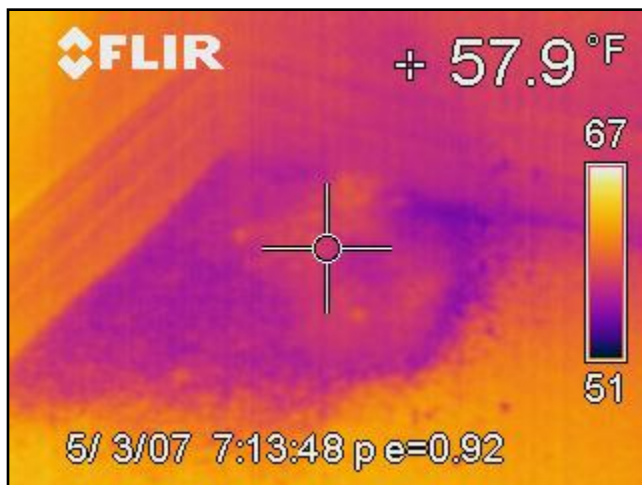
**Note:** ITEM 2. Water damage is present along the master bedroom wall and floor. Water penetration is a result of a missing kick out flashing.

2. Water damage/rot resulting from poor flashing

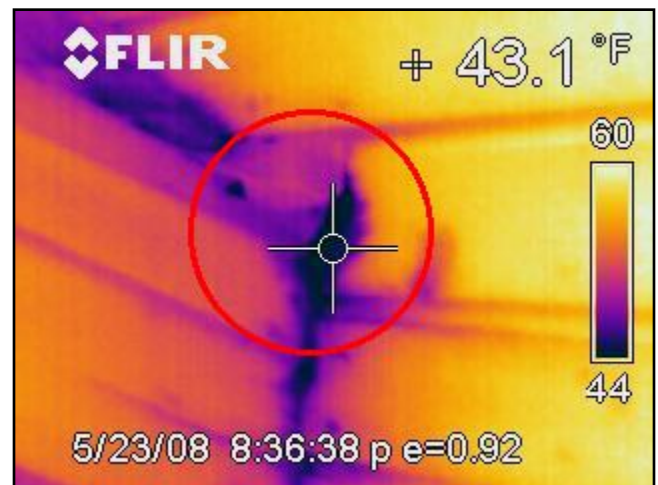
3. Water entering wall behind kick out flashing

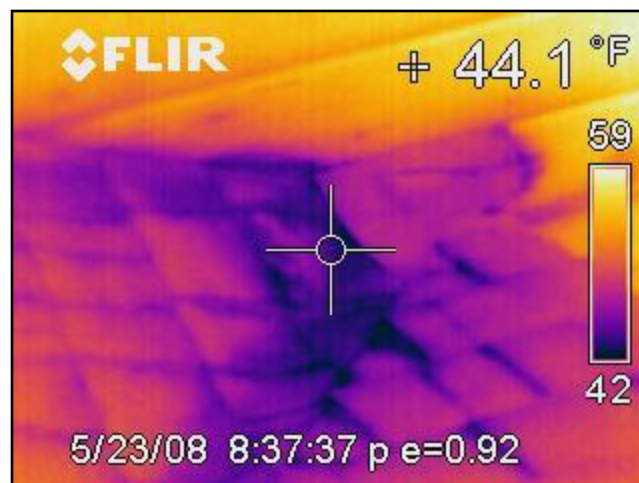
4. Saturated roof shingles at penetration area

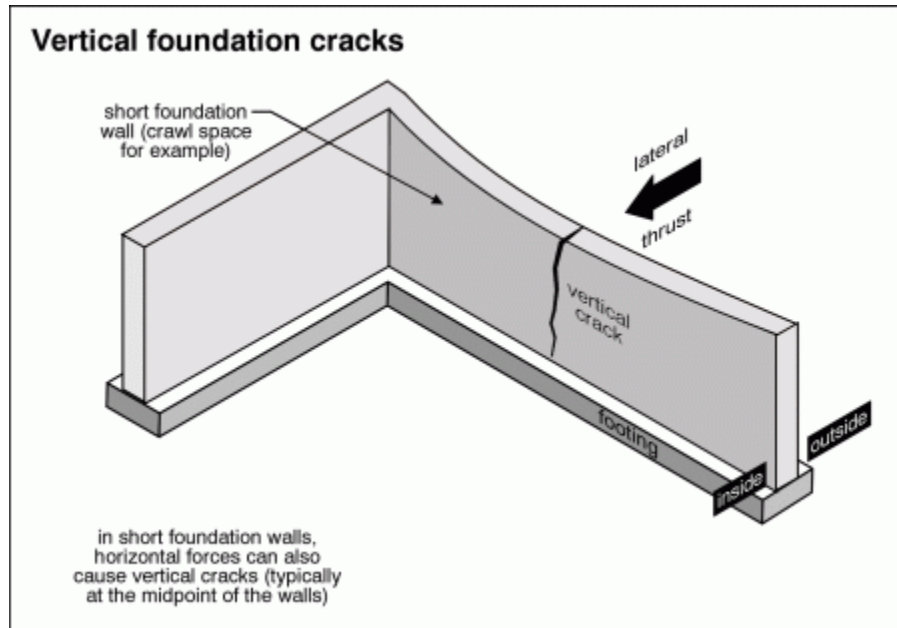
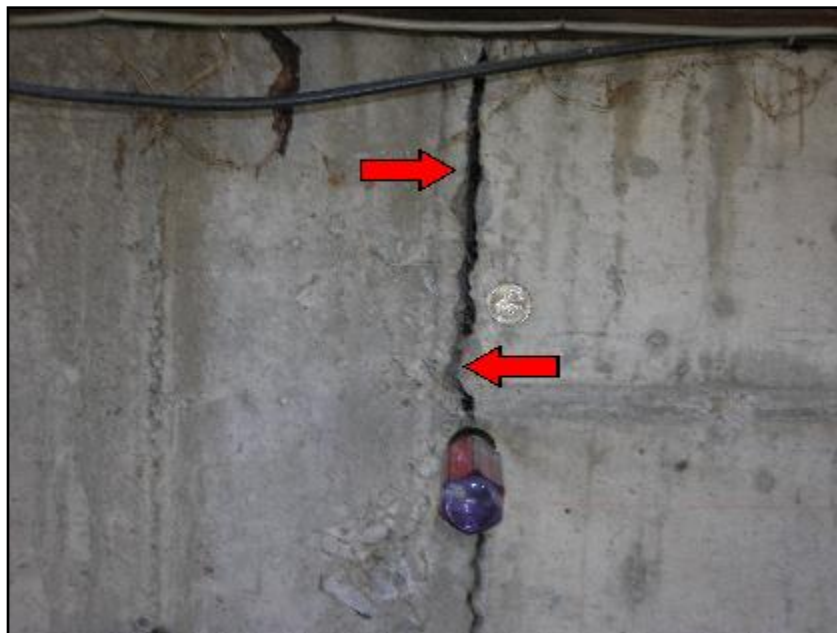
**Implication(s):** Chance of water damage to contents, finishes and/or structure | Weakened structure

**Note:** ITEM 3. A crack is present along the Northern aspect of the foundation. Suggest further evaluation by structural engineer.

5. Crack in foundation

**Task:** Further evaluation

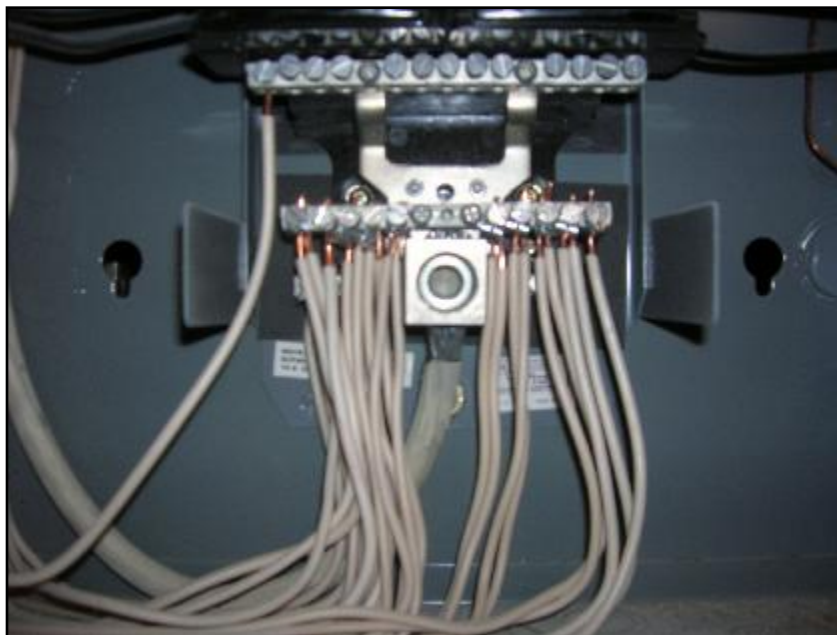
**Condition:** • ITEM 4. Neutral wires in the distribution panel need to be in separate terminals.

6. Neutral wires without separate terminals

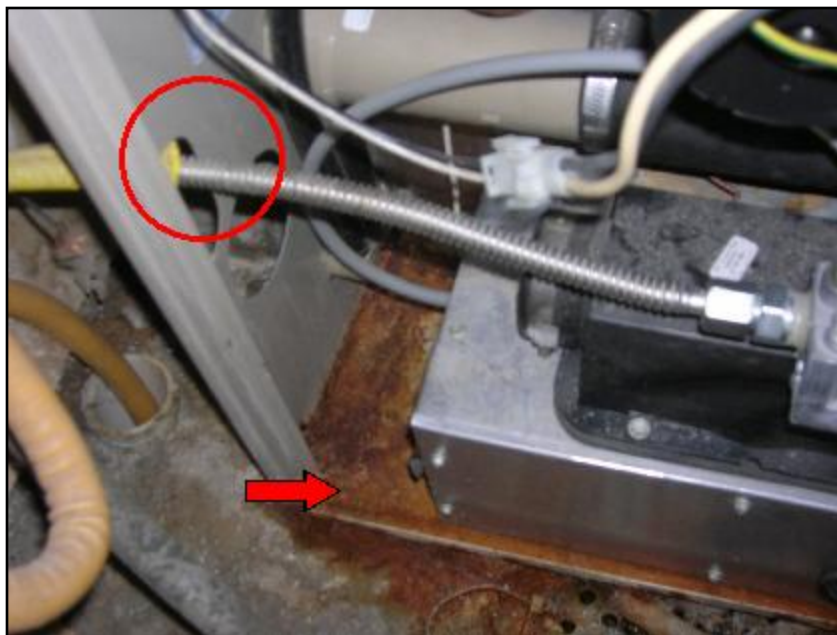
**Note:** ITEM 6. In addition to the rust, flexible gas piping is not allowed to penetrate the housing of the furnace. This should be replaced with solid gas piping.

10. Rust in furnace

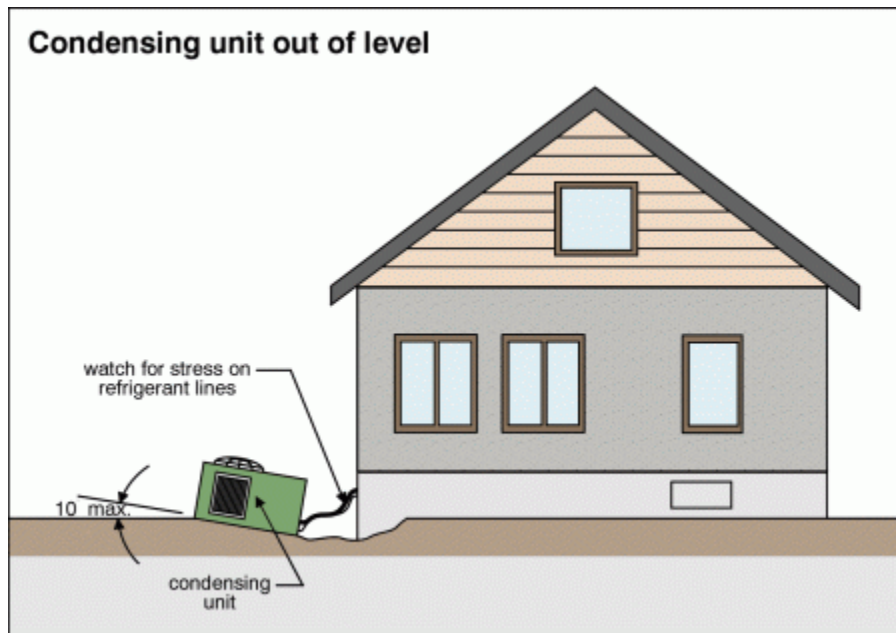
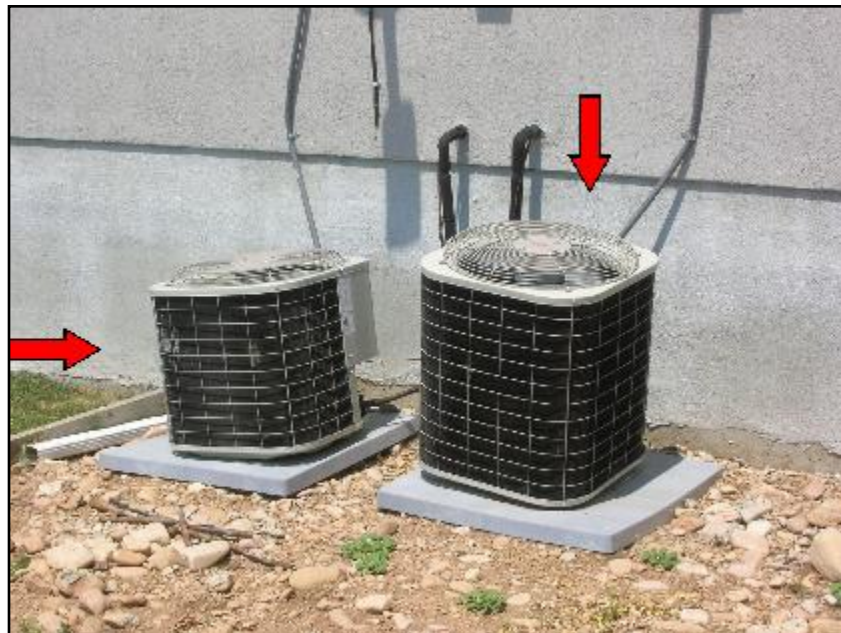
**Note:** ITEM 7. The compressor units are not level.

11. Compressors out of level

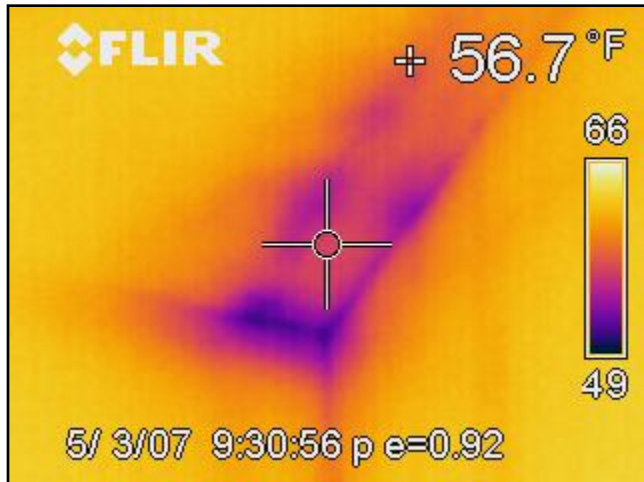
**Condition:** • ITEM 8. A section Insulation is missing in the ceiling of the North second floor bedroom.

12. Missing insulation

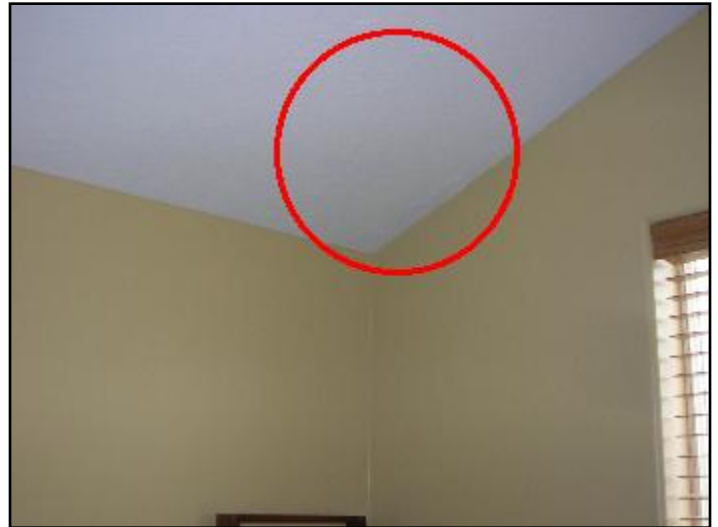
13. Area of missing insulation

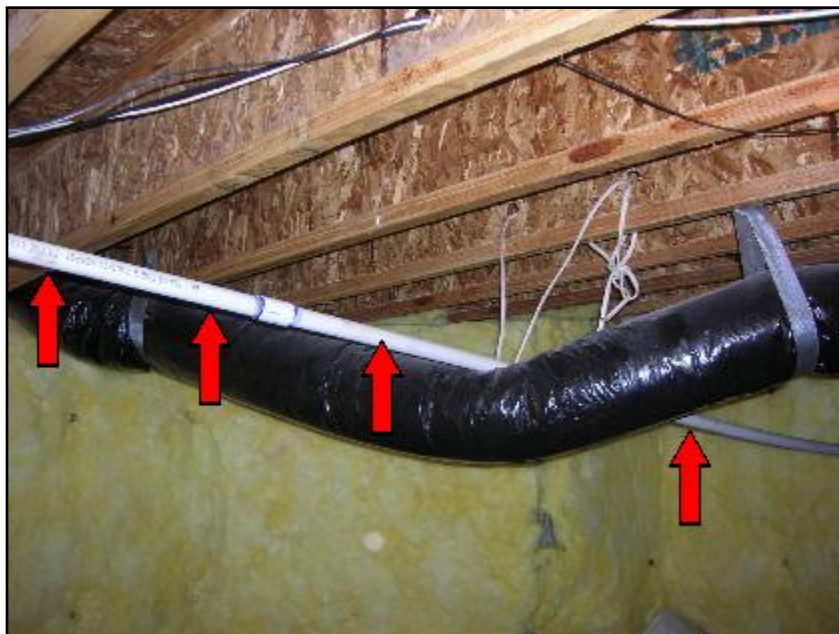
**Note:** ITEM 9. PVC piping is poorly support in the East crawl space area.

14. Poor support for PVC water line

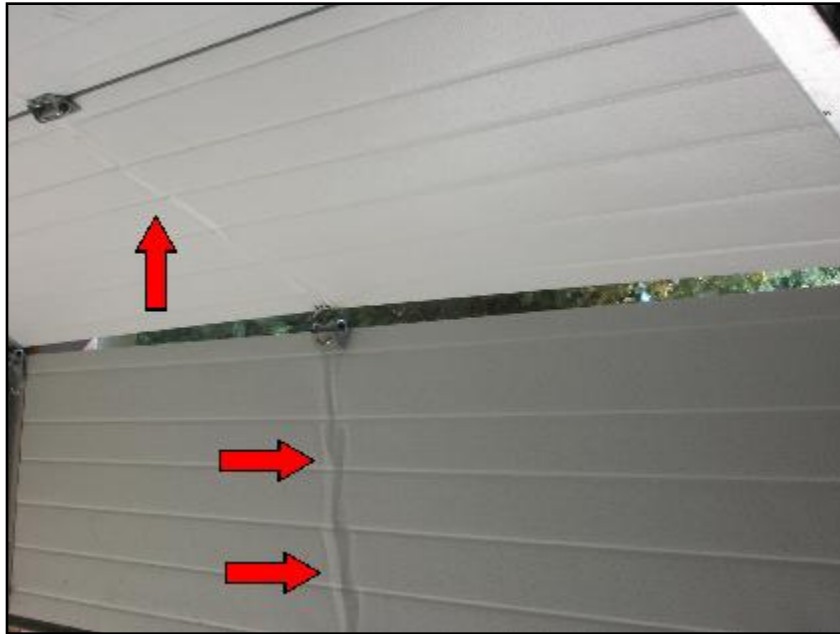
**Note:** ITEM 11. The garage door is damaged.

**15.** *Mechanical damage to garage door*

**Task:** Repair
