YOUR INSPECTION REPORT

XXXXXXXXXX Rd

Duluth, MN 55803

Tuesday, April 9, 2019

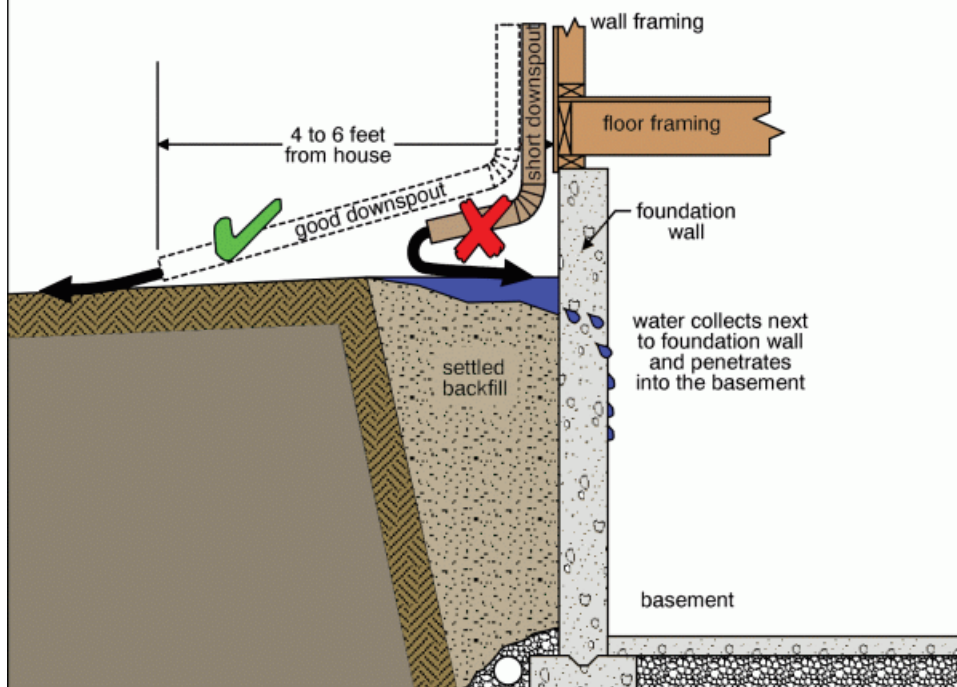
1. Condition: • [Should discharge 6 feet from building](#)

Downspout extension too short

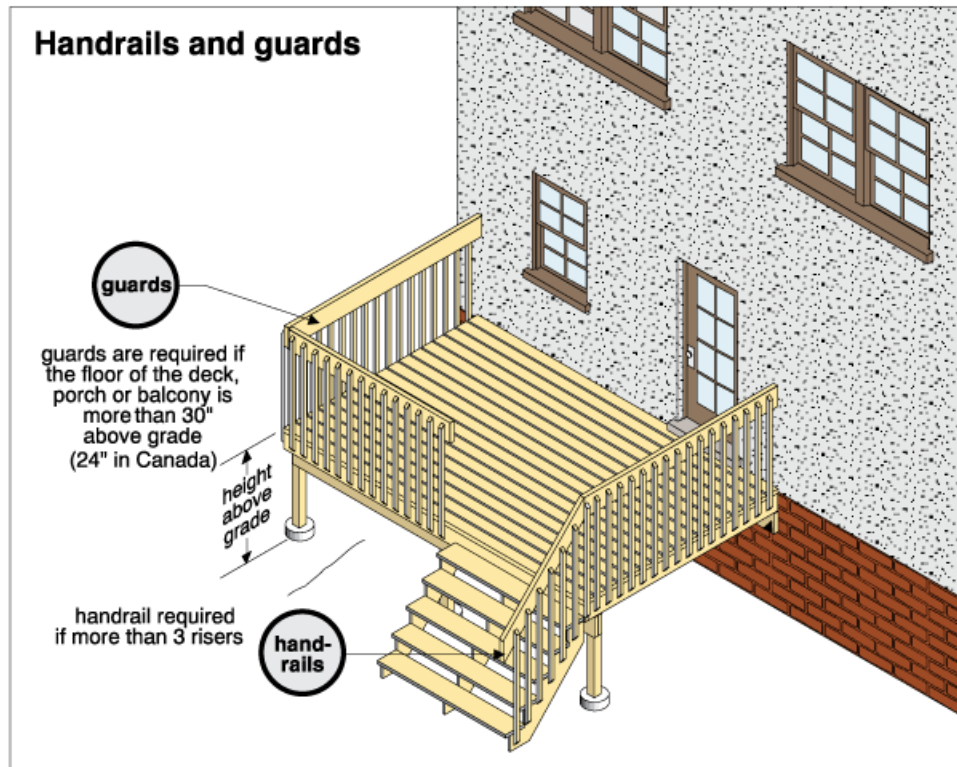
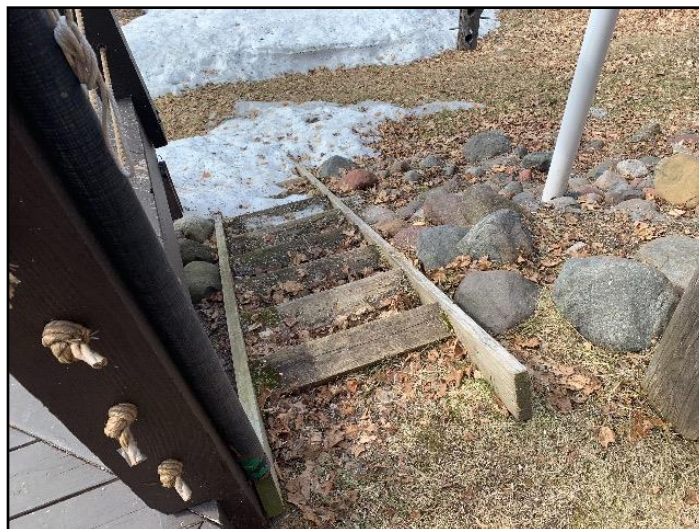
6. Missing

2. Condition: • [Missing](#)

Implication(s): Fall hazard

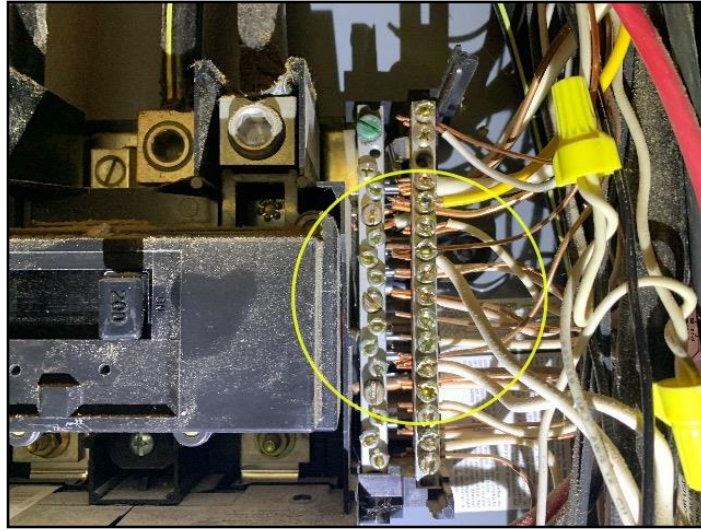
10. *Multi-wire circuit on same bus*

Various neutral and ground wires sharing same ports. Contact licensed electrical contractor for further evaluation.

4. Condition: • [Multi-wire circuit on same bus](#)

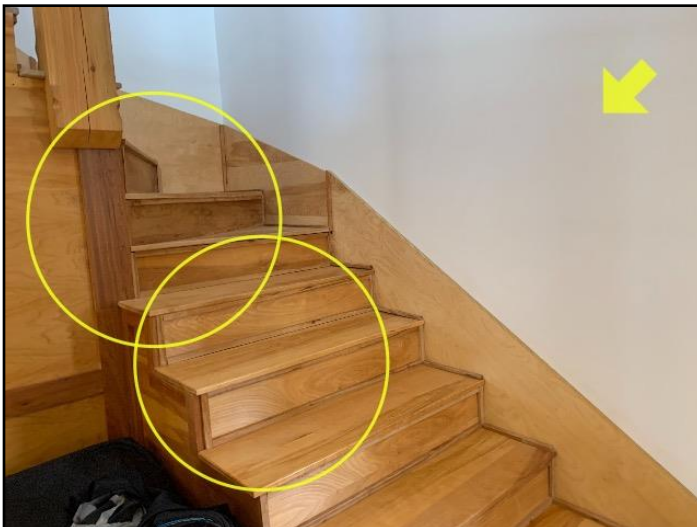
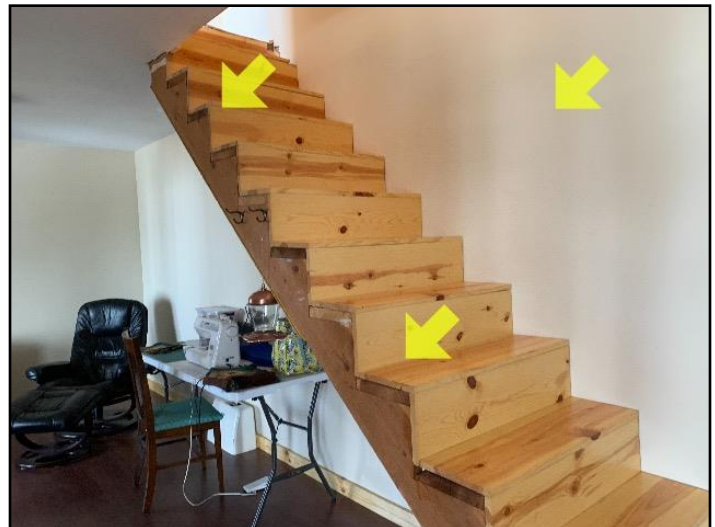
5. Condition: • [Missing](#)

Missing handrails on both stair cases. Recommend installing rails on both staircases. Contact qualified contractor for further evaluation.

18. Missing

19. Missing

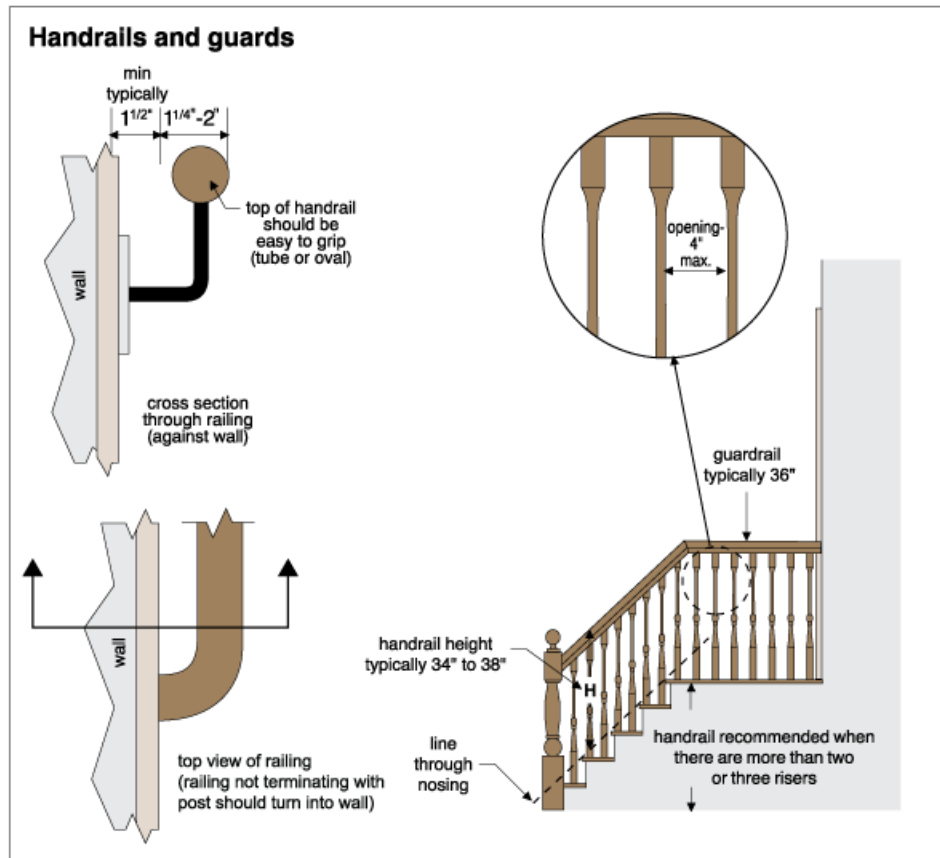
6. Condition: • [Too far apart](#)

Spindles on catwalk railing are too far apart. Recommend installing spindles that are 4" apart. Contact qualified contractor for further evaluation.

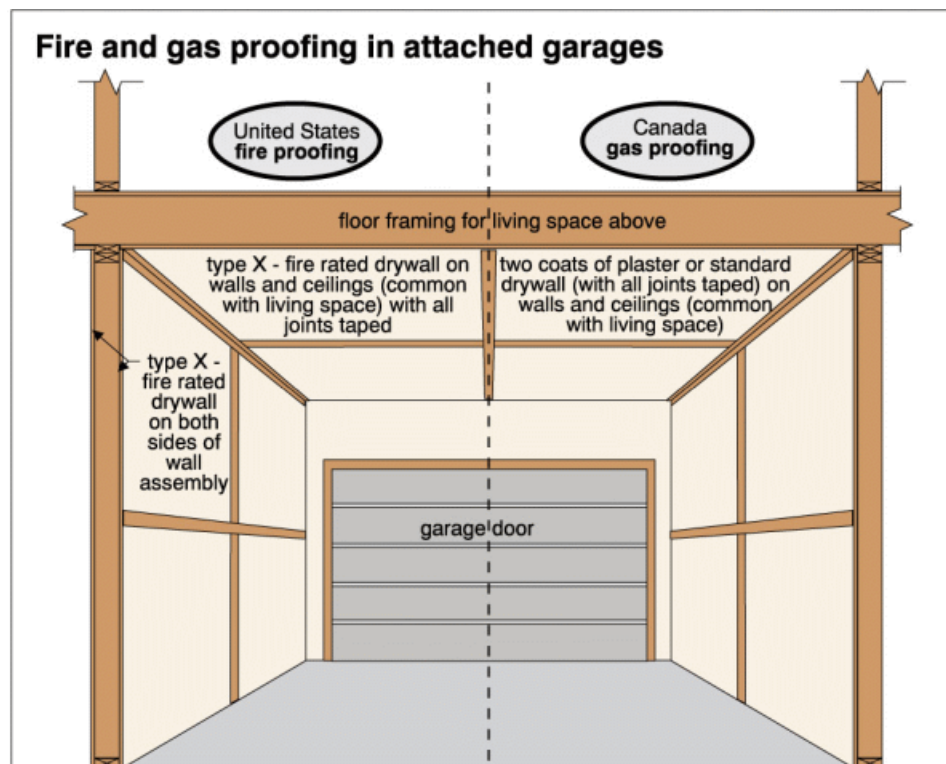
8. Condition: • [Not gastight](#)

Adjoining walls between garage and house are not gaslight. Possible C02 contamination. Recommend sealing with foam or plaster. Contact qualified contractor for further evaluation.

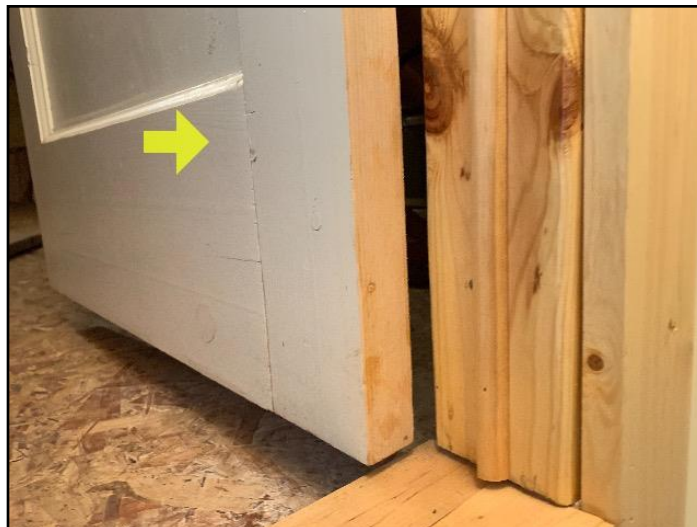
10. Condition: • [No self closer](#)

Man doors to the garage and the garage attic do not have self closers to protect from CO2 contamination. Attic to garage door is not fire proof. Contact qualified contractor for further evaluation.

20. No self closer

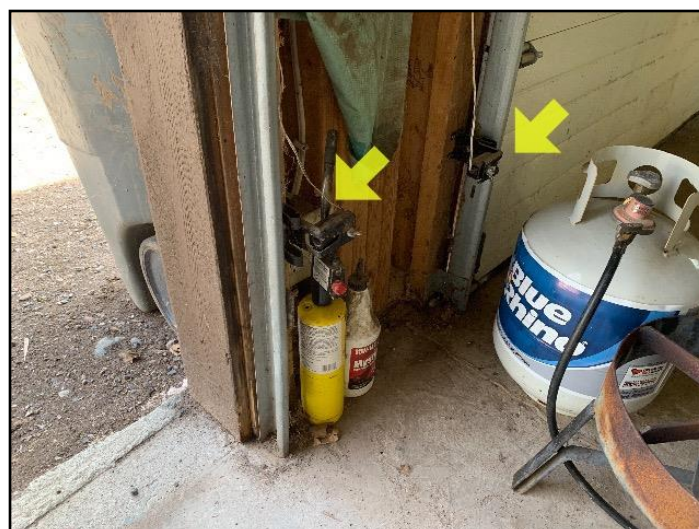
Sensors too high in garage. Correct. Contact qualified contractor for further evaluation.

11. Condition: • Sensors poorly located

21. Sensors poorly located

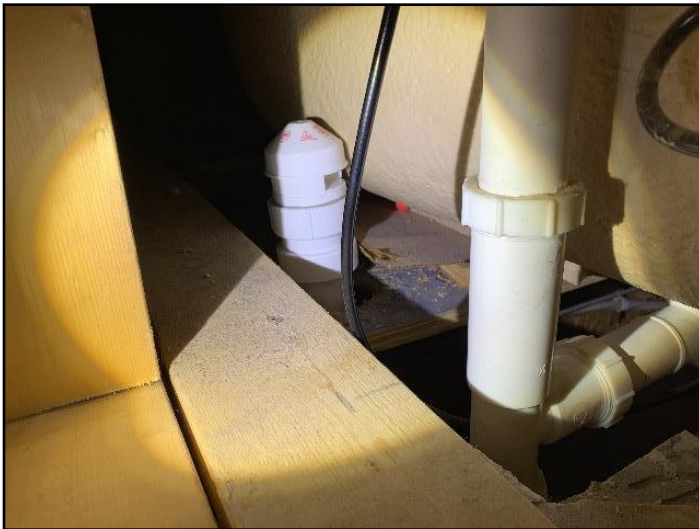
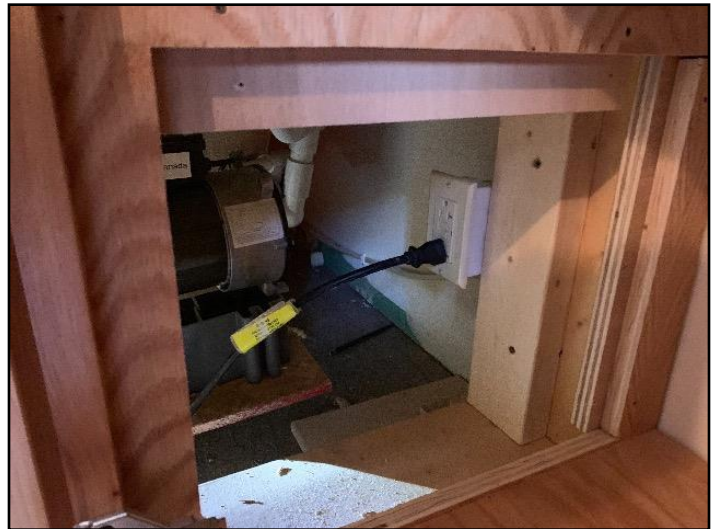
Musty smell in bathroom. Possible mold. Did not test tub because the panels were removed. Contact qualified contractor for further evaluation.

12. Condition: • Mold

22. Mold

23. Mold
